Northern Corridor and Nairobi County Route Hazard Mapping Report

May 2017

Developed by Safe Way Right Way and National Transport and Safety Authority

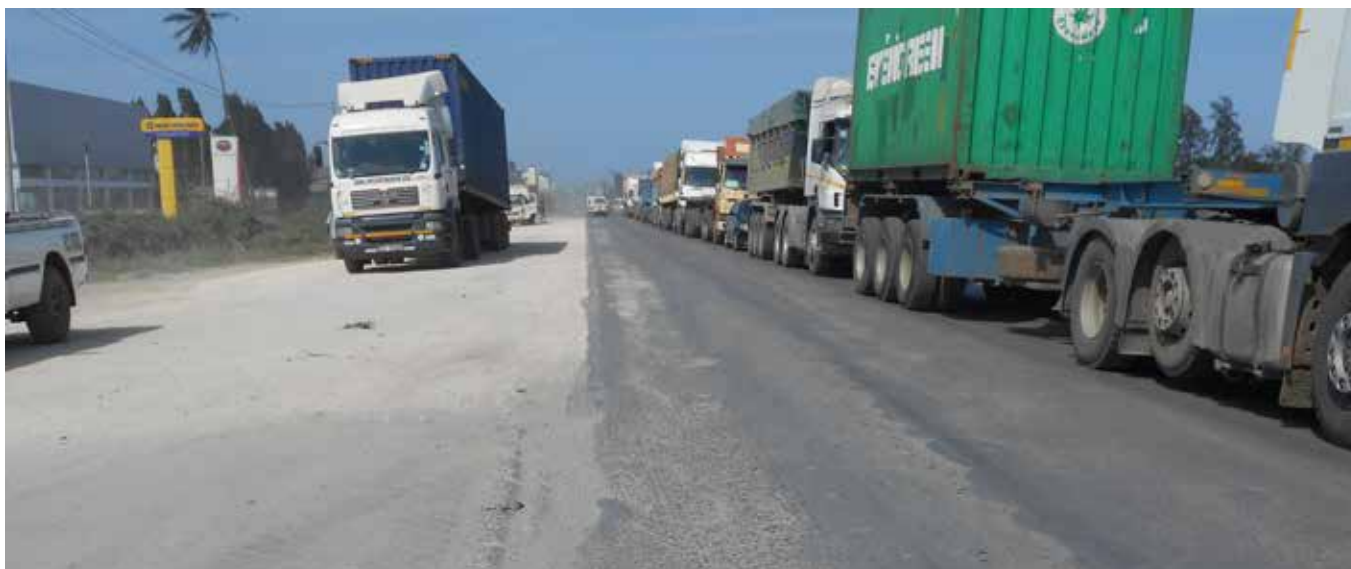
Picture: Part of Tran-spares road section

This 300-meter road section has an intersection on a bend and a gentle slope with neither road markings nor signs and through a busy Mabati market. The road shoulder is damaged. The reason for black spot is careless driving and overtaking as well as careless entry into the road junction; heavy pedestrian traffic. Crashes happen throughout the week and during both night and day time, and in both dry and wet seasons. Vehicles mostly involved in crashes are mini buses - includes PSVs and vans, and heavy commercial vehicles. Crash victims are taken to Bomu Medical and Coast General Hospitals.

Engineering - road design/furniture/features	Enforcement - law	Education - Road user awareness
<ul style="list-style-type: none"> Mark the road. Instal speed limit signage. Repair the road shoulder. 	<ul style="list-style-type: none"> Enforce speed limits and safe entry on to the main road once signage is in place. 	<ul style="list-style-type: none"> Create awareness on safe crossing, careful entry from the junction and overtaking.

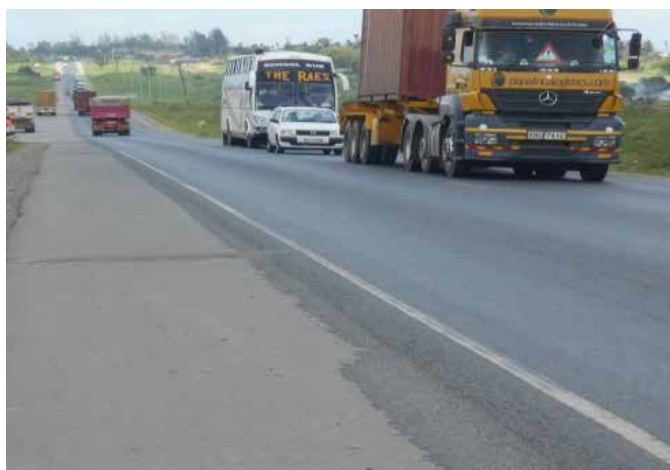
Picture: Part of Kibanda Hasara road section

This is a 1.3-kilometer road section along straight stretch on a gentle slope and sharp bend and has no road signs at Kibanda Hasara. The reason for the black spot is speeding motorists and careless overtaking by motorists. Crashes happen throughout the week and during both night and day time, and in both dry and wet seasons. Vehicles mostly involved in crashes are personal cars (saloons), mini buses - includes PSVs and vans, large buses and heavy commercial vehicles. Crash victims are taken to Mariakani District Hospital.

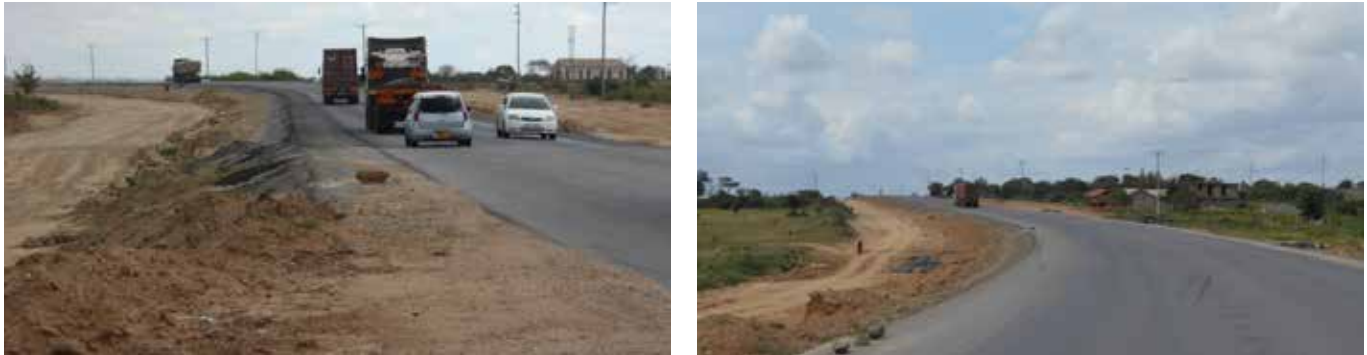
Picture: Part of Samburu area road section

This is a 1 kilometer road section that has a sharp bend and brow of a hill near Samburu Market Center. The section of road has no signage. The reason for black spot is speeding motorists and careless overtaking. Crashes happen throughout the week and equally at both night and day time, and in both dry and wet seasons. Vehicles mostly involved in crashes are personal cars (saloons), large buses, light and medium size trucks, and heavy commercial vehicles. Crash victims are taken to Samburu Health Center.

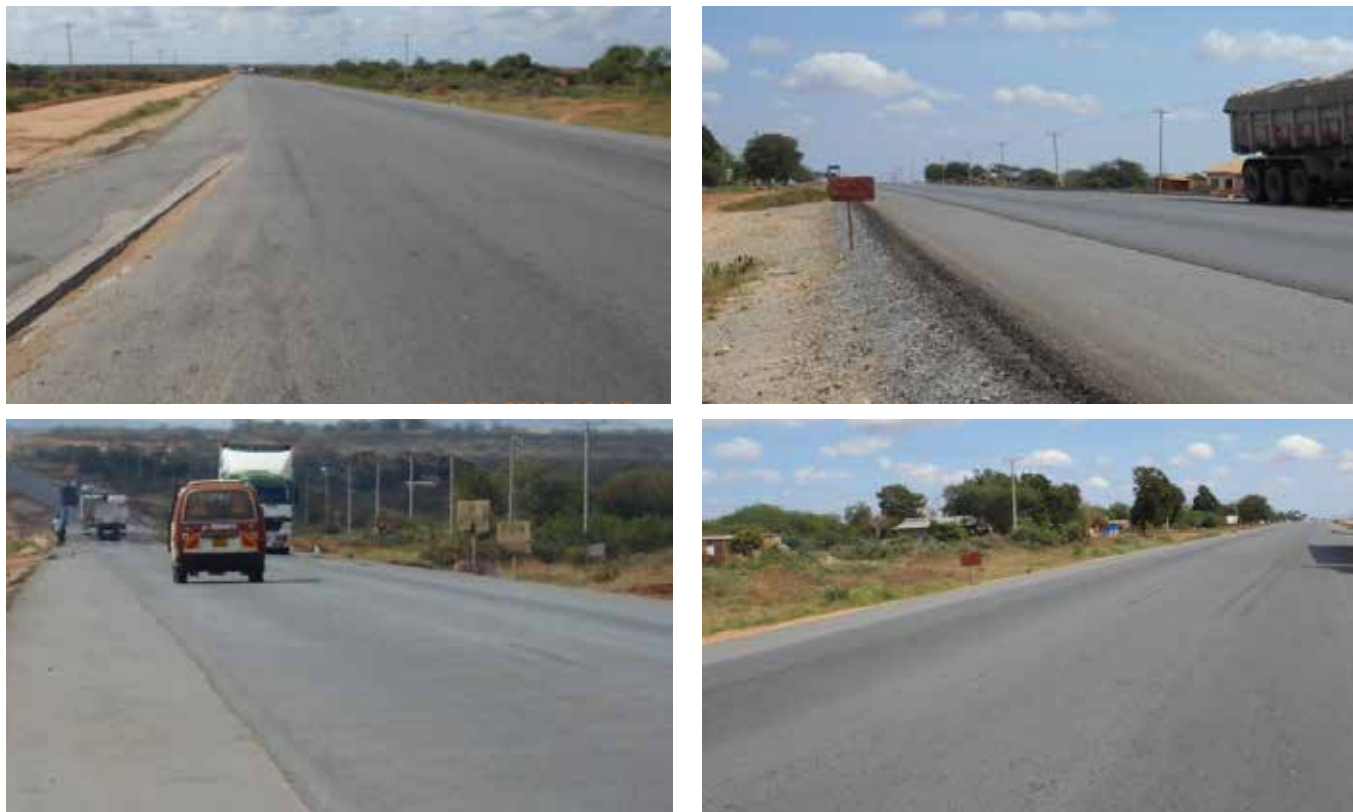
Picture: Part of Miasenji road section

This is a 1.5-kilometer road section on a long curved stretch on a steep slope with a sharp bend. The road surface is uneven but is currently under repair by Kenya National Highway Authority. The existing signage is temporary for road construction purposes. The reason for the black spot is speeding motorists. Crashes happen throughout the week but mostly at night and in wet season. Vehicles mostly involved in crashes are personal cars (saloons), light and medium trucks, and heavy commercial vehicles. Crash victims are taken to Samburu Health Center.

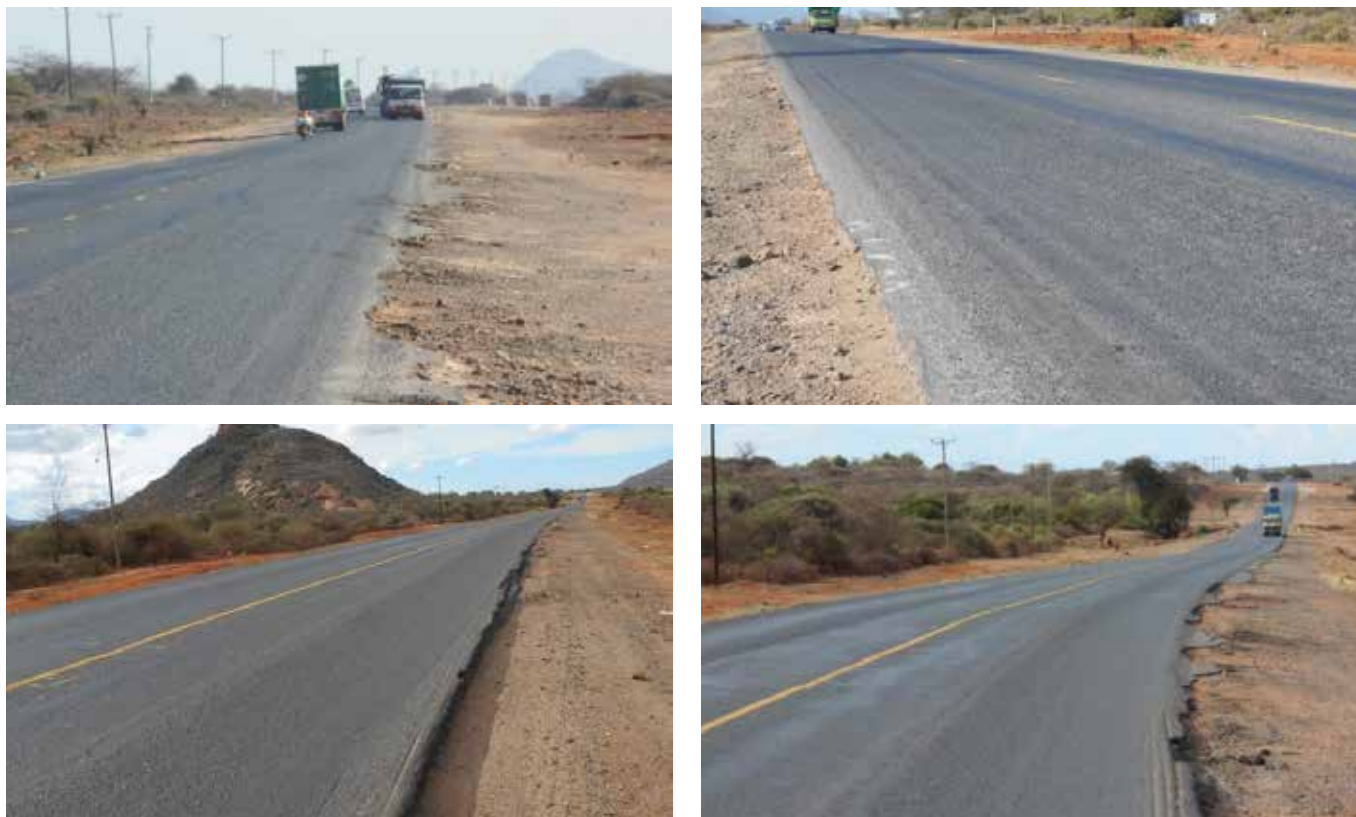
Picture: Part of Canaan road section

This is a 1 kilometer road section along a steep stretch with sharp bends. There is no road signage and the road shoulder is damaged. The reason for the black spot is speeding motorists and the hazard posed by the worn out road shoulder. Crashes happen throughout the week, in both wet and dry seasons but mostly at night. Vehicles mostly involved in crashes are personal cars (saloons), large buses, light and medium trucks, heavy commercial vehicles. Crash victims are taken to Moi Voi District Hospital.

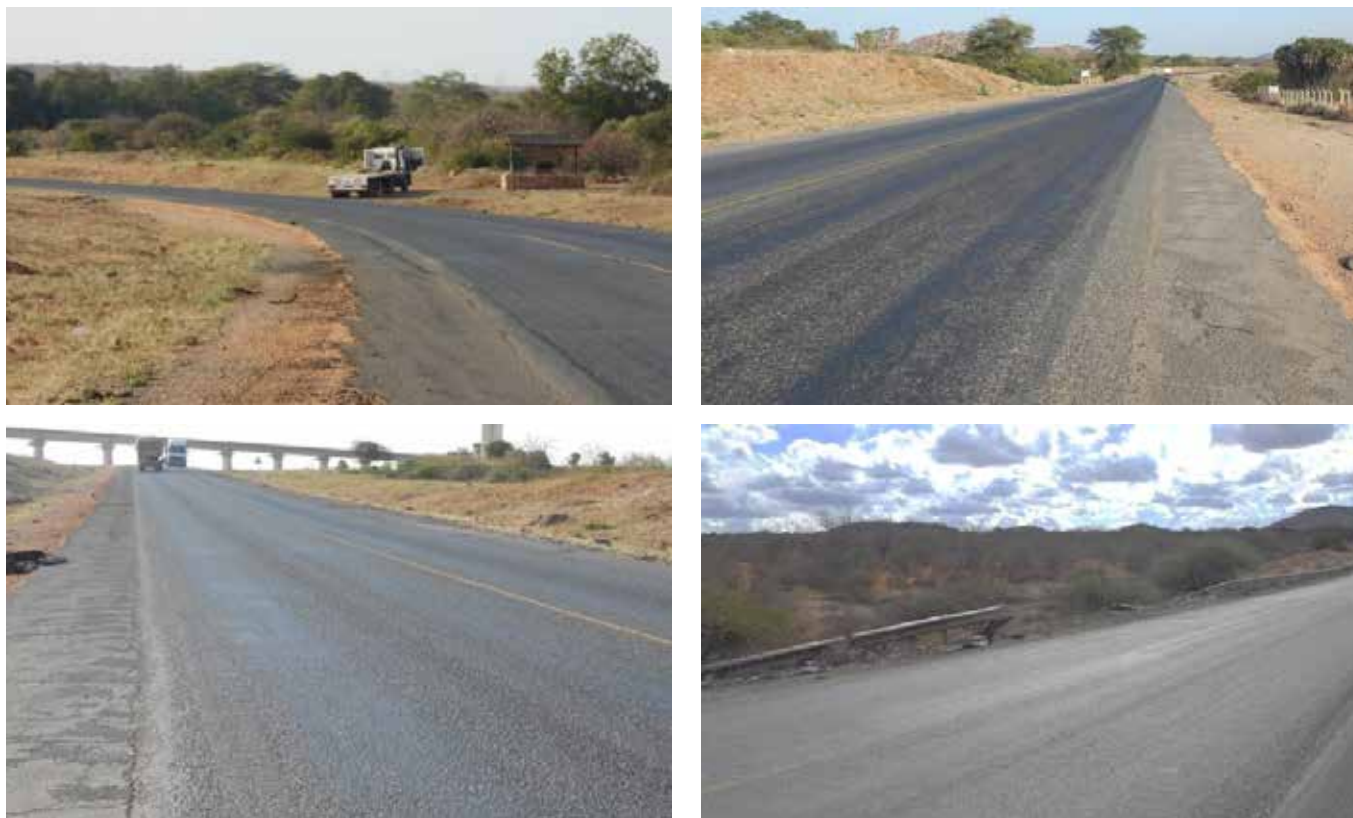
Picture: Part of Tsavo River/Man Eaters road section

This is a 1.5-kilometer road section along a steep slope on the road that crosses at Tsavo River with a sharp bend at Man Eaters. Part of the road is worn out and guardrails are damaged. The Standard Gauge Railway runs close to the road section. The Reason for black spot is speeding motorists, poor visibility and careless overtaking. Crashes happen throughout the week in the dry and wet season but mostly at night. Vehicles mostly involved in crashes are personal cars (saloons), large buses, light and medium trucks and heavy commercial vehicles. Crash victims are taken to Moi Voi District Hospital.

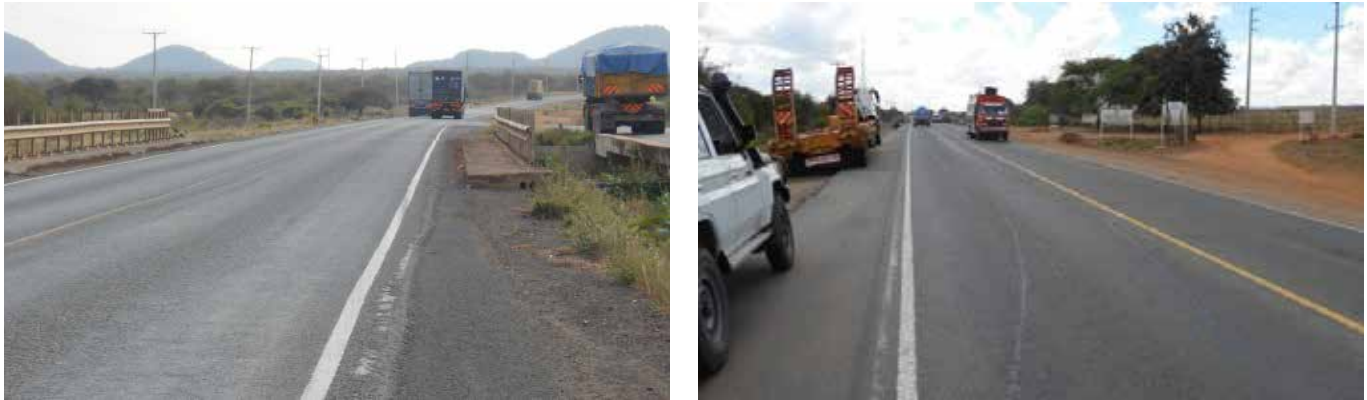
Picture: Part of Kiboko Double Bridge road section

This is a 1.5-kilometer road section along a curved stretch with a sharp bend and intersection. There are no road signs but the road is fairly well marked with good shoulders. The reason for the black spot is speeding motorists and careless overtaking. Crashes happen throughout the week and equally in both wet and dry seasons but mostly at night. Vehicles mostly involved in crashes are personal cars (saloons), large buses, and heavy commercial vehicles. Crash victims are taken to Makindu District Hospital.

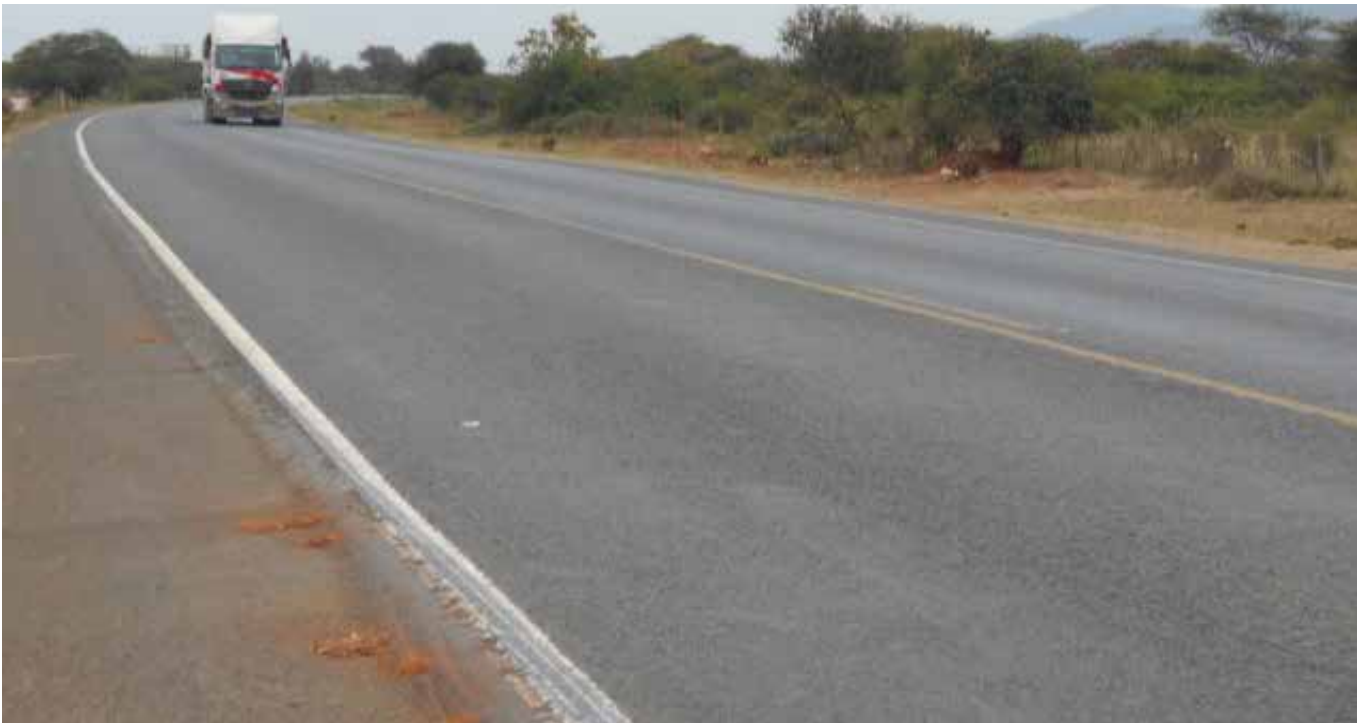
Picture: Part of Kwa Msomba road section

This is a 0.9 kilometer road section near Sultan Hamud with a long bend and no road signs. The reason for the black spot is speeding motorists, careless overtaking and poor visibility. Crashes happen throughout the week and in both wet and dry seasons but mostly at night. Vehicles mostly involved in crashes are personal cars (saloons), large buses, and heavy commercial vehicles. Crash victims are taken to Sultan Hamud Sub County Hospital.

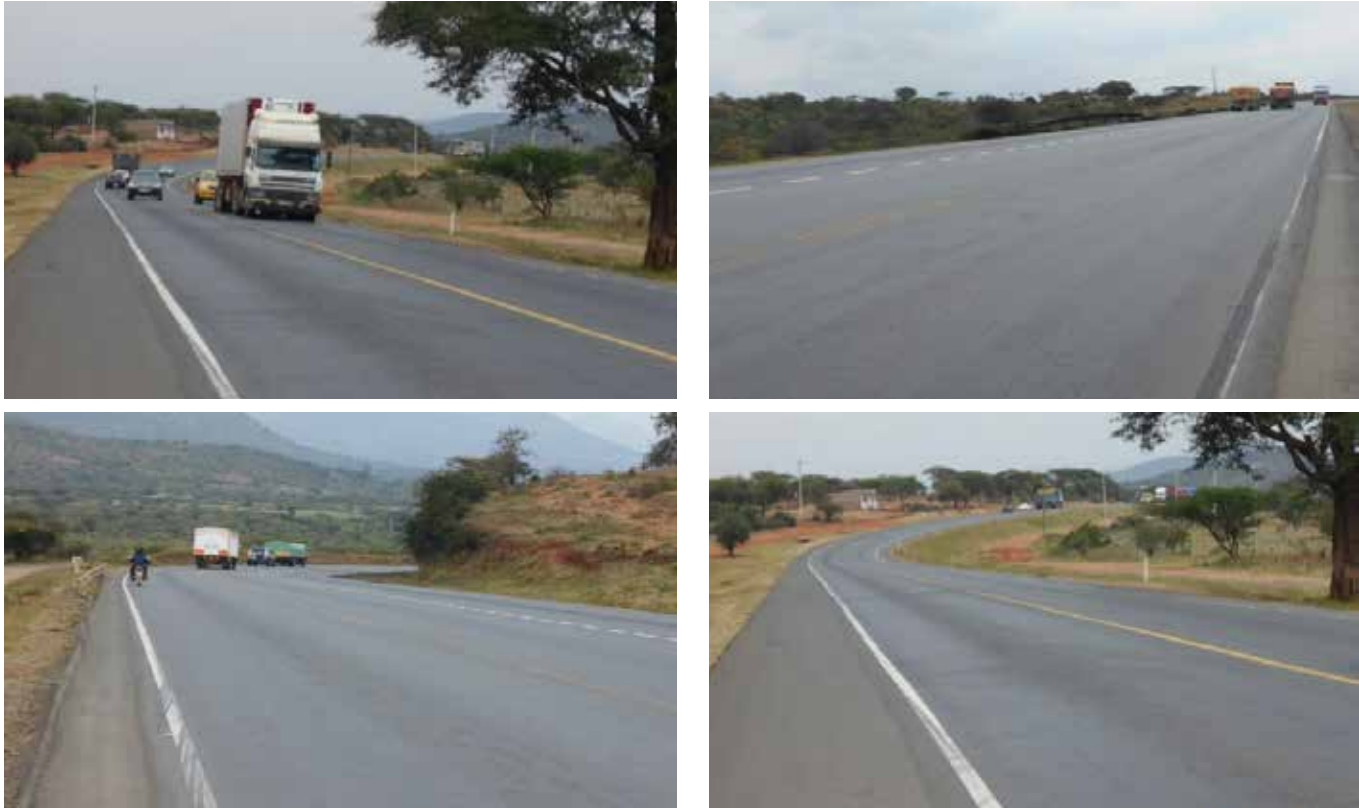
Picture: Part of Mlima Kiu road section

This is a 3.2-kilometer road section that has bends and a straight stretch on a steep slope with no road signs. The reason for the black spot is speeding motorists, careless overtaking and overloading. Crashes happen throughout the week and equally in both wet and dry seasons but mostly at night. Vehicles mostly involved in crashes are personal cars (saloons), large buses, and heavy commercial vehicles. Crash victims are taken to Machakos County Referral Hospital.

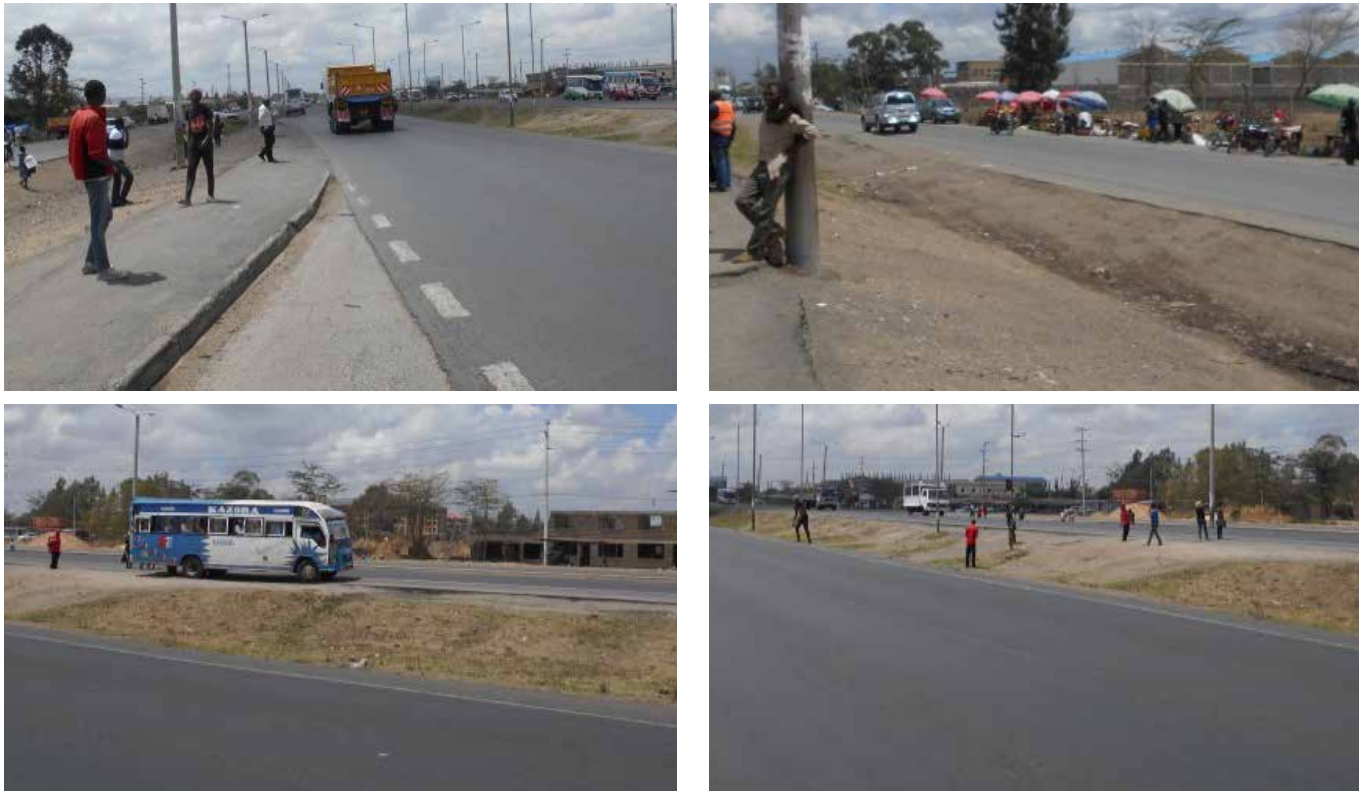
Picture: Part of Syokimau road section

This new blackspot is 0.3 kilometer along a straight stretch with high pedestrian traffic. There are few designated bus stops. The road side market has encroached on the pavement forcing pedestrians to walk on the road. The reason for the black spot is unsafe pedestrian crossing, undesignated bus stops, encroaching market and speeding motorists. Crashes happen throughout the week in wet and dry seasons, and both day and night time. Vehicles mostly involved in crashes are personal cars (saloons), mini buses – (PSVs and vans), large buses, light and medium trucks, heavy commercial vehicles and motorcycles. Crash victims are taken to Shalom Hospital.

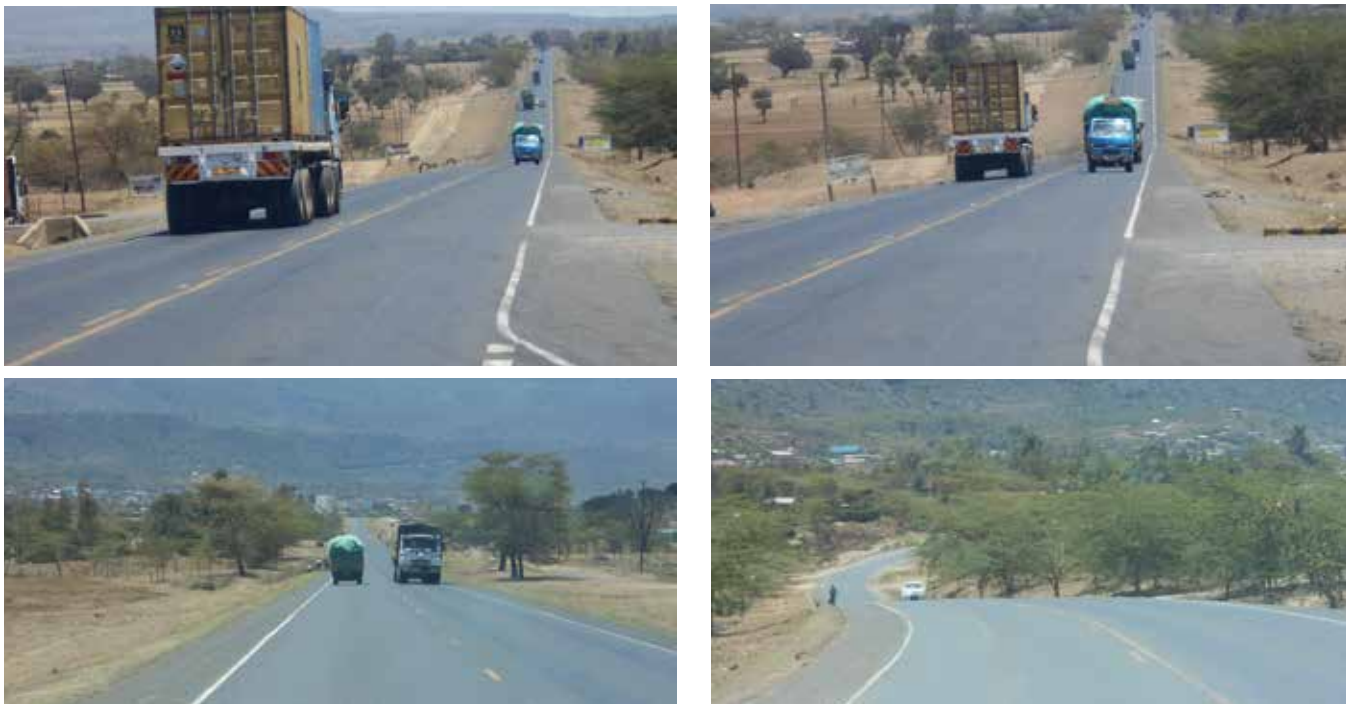
Picture: Part of Mai Mahiu road section

This is a 2.8 kilometer road section along a straight stretch on a steep slope from Mai Mahiu town heading to Naivasha. There are no road signs but speed bumps are present in some sections. The reason for the black spot is speeding motorists and careless overtaking. Crashes happen throughout the week but mostly at night and equally during wet and dry seasons. Vehicles mostly involved in crashes are personal cars (saloons), heavy commercial vehicles and motorcycles. Crash victims are taken to Naivasha District Hospital. There is an undesignated truck stop and North Star wellness center in Mai Mahiu town.

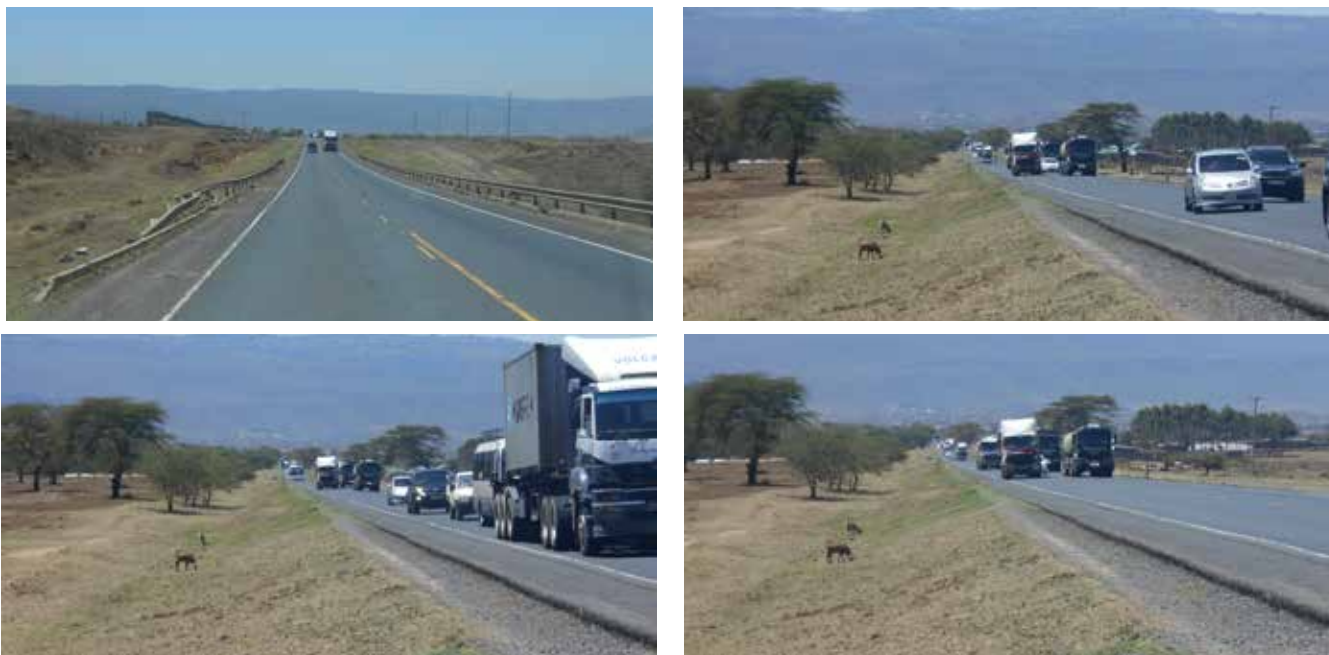
Picture: Part of Muniu road section

This is a 4.9 kilometer road section along a straight stretch on a steep slope within Muniu area. There are no road signs. The reason for the black spot is speeding motorists and loss of vehicle control. Crashes happen throughout the week but mostly at night and during wet and dry seasons. Vehicles mostly involved in crashes are personal cars (saloons), mini buses - includes PSVs and vans, heavy commercial vehicles and motorcycles. Crash victims are taken to Naivasha District Hospital. There is an undesignated truck stop-over at Longonot.

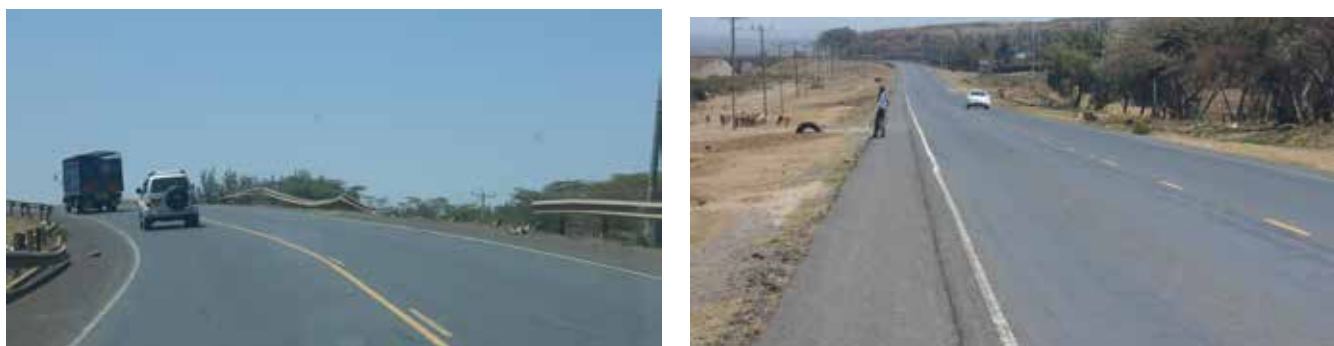
Picture: Part of Oasis Area road section

This is a 2 kilometer road section along a straight stretch on a gentle slope. There are no road signs and the guardrail is damaged. The reason for the black spot is speeding motorists and careless driving. Crashes happen throughout the week but mostly night and equally during wet and dry seasons. Vehicles mostly involved in crashes are personal cars (saloons), mini buses - includes PSVs and vans, and heavy commercial vehicles. Crash victims are taken to Naivasha District Hospital.

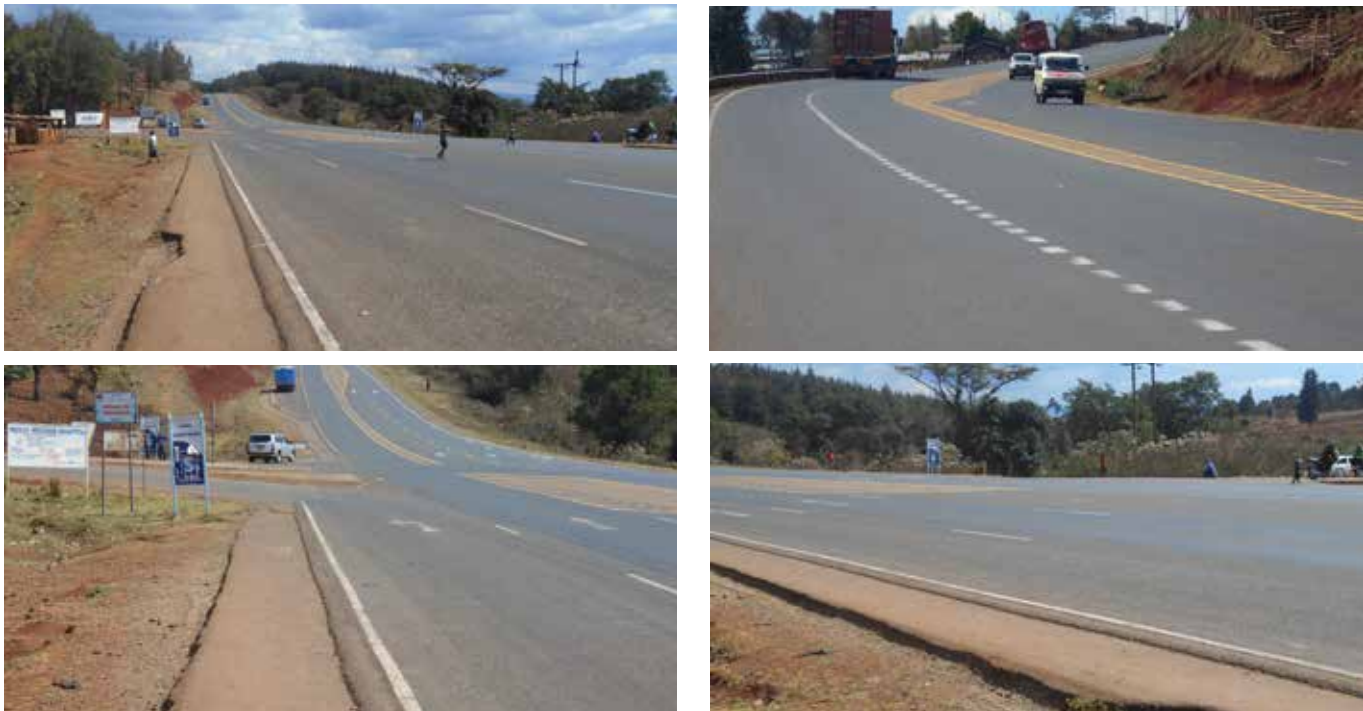
Picture: Part of Makutano Junction– Eldama Ravine road section

This is a 0.5-kilometer road section with an intersection to Eldama Ravine on a brow of a hill. There are no road signs. The reason for the black spot is speeding motorists and careless entry from the intersection. Crashes happen throughout the week but mostly at night and during wet seasons. Vehicles commonly involved in crashes are personal cars (saloons), mini buses (PSVs and vans), and heavy commercial vehicles. Crash victims are taken to Eldama Ravine Hospital.

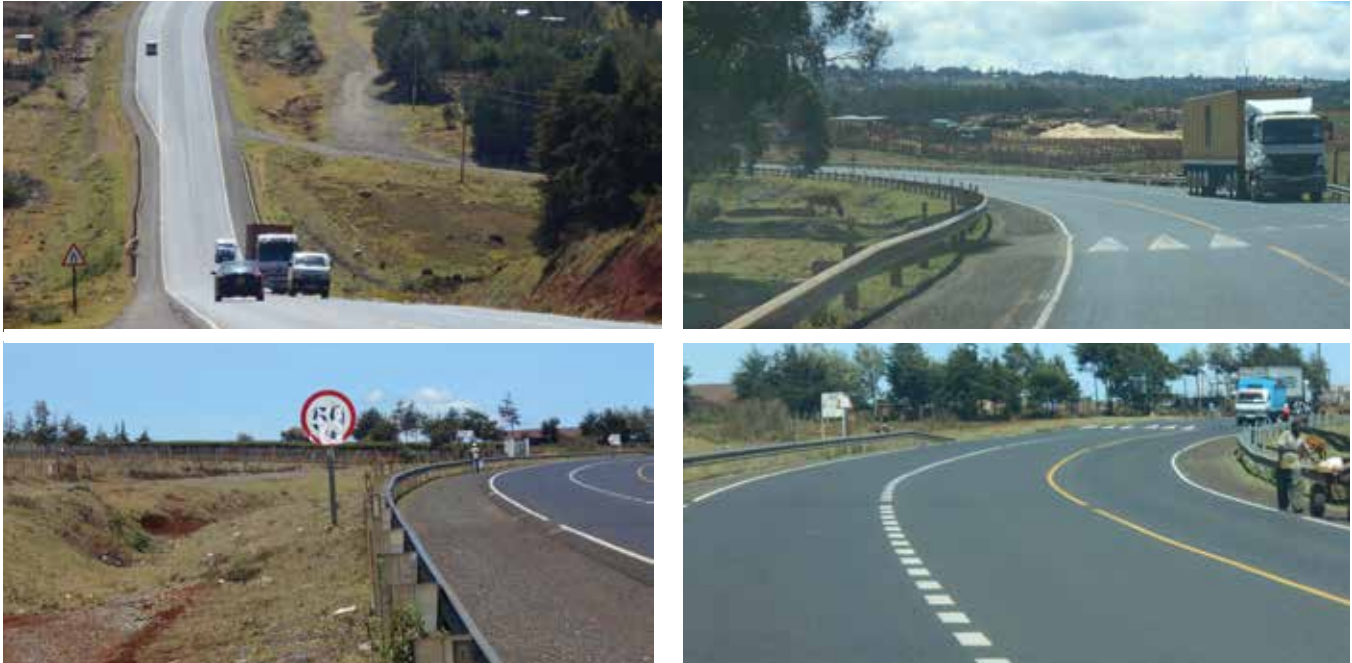
Picture: Part of Matharu - Chirchir road section

This is a 1.5 kilometer road and has a bend, a steep descent and blind spot Ravine. The road signage is blocked by advertisement stickers placed on them. There are speed bumps, which are only marked in one direction. The reason for the black spot is speeding motorists and careless driving. There is an unsafe pedestrian crossing and motorists do not observe lane discipline. Crashes happen throughout the week both day and night, but mostly during wet seasons. Vehicles frequently involved in crashes are personal cars (saloons), mini buses (PSVs and vans), light and medium trucks and heavy commercial vehicles. Crash victims are taken to Burnt Forest Sub County Hospital and Moi Teaching and Referral Hospital.

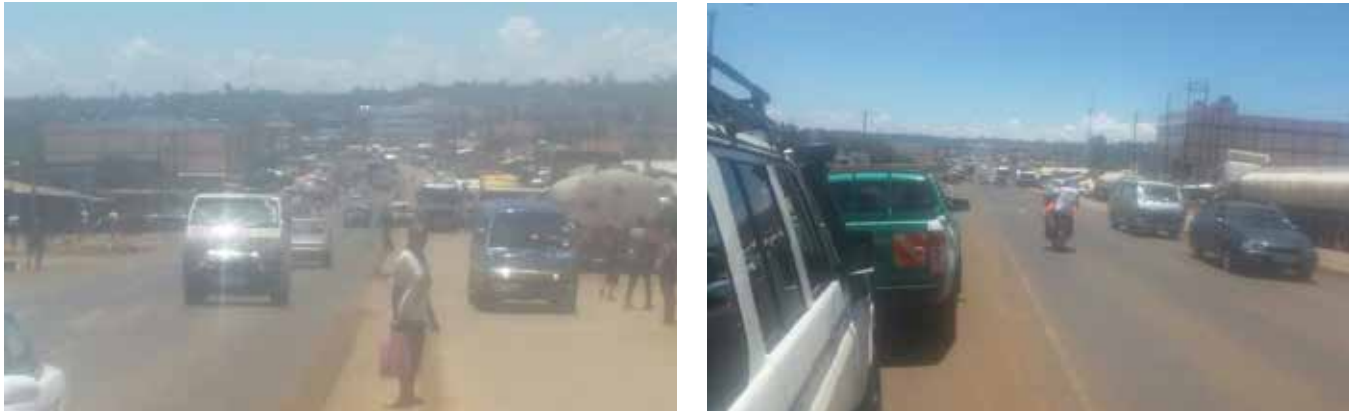
Picture: Part of Burnt Forest road section

This is a 0.3-kilometer road section on a steep slope, through a trading center. There is a designated truck stop-over point. There are speed bumps. The reason for the black spot is speeding motorists, and unsafe pedestrian crossing at undesignated points. Crashes happen throughout the week but mostly at night and during wet seasons. Vehicles mostly involved in crashes are heavy commercial vehicles. Crash victims are taken to Burnt Forest Sub County Hospital and Moi Teaching and Referral

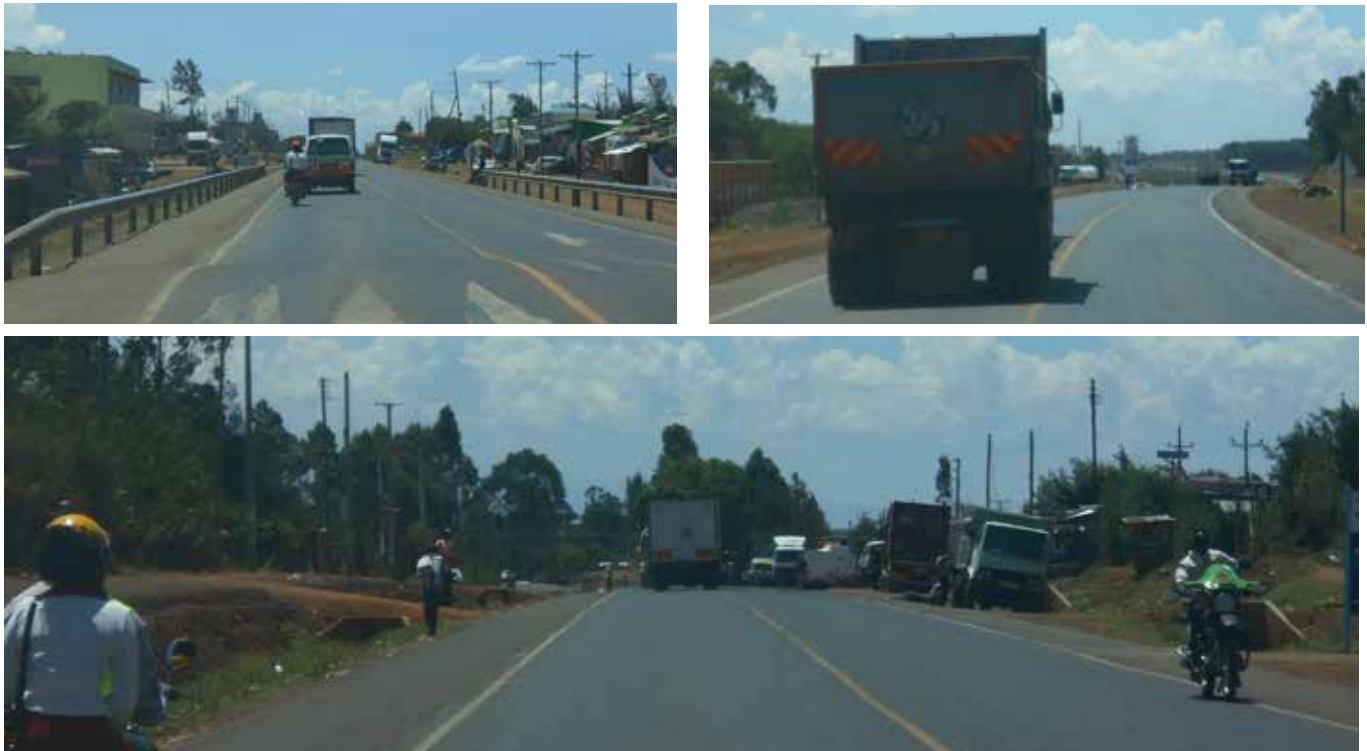
Picture: Part of Raiply – Tairi Mbili - Maili Nne road section

This is a new blackspot on 8.1-kilometers road section along a straight stretch. The section has a gentle slope and road intersections. There are speed bumps installed in certain sections. The reason for the black spot is speeding motorist, careless overtaking, careless motorcycle riders turning on the road, undesignated bus stops and truck parking along the road, as well as vehicles turning into Raiply factory. Crashes happen throughout the week but mostly at night and during both dry and wet seasons. Vehicles mostly involved in crashes are personal cars (saloons), mini buses (PSVs and vans), heavy commercial vehicles and motorcycles. Crash victims are taken to Moi Teaching and Referral Hospital and Mediheal Hospital. There are both designated and undesignated truck stop-over points at Tairi Mbili.

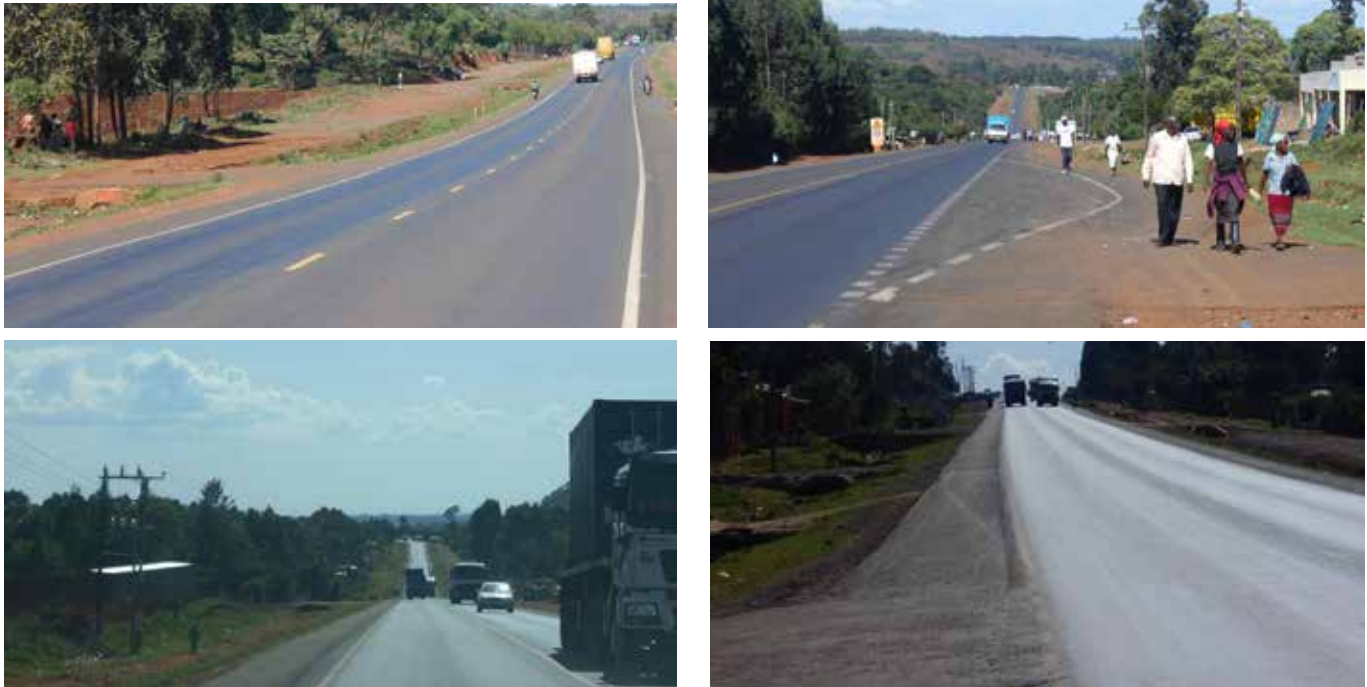
Picture: Part of Mwamba Area road section

This is a 1.9 kilometer road section along a straight stretch on gentle slope and through Mwamba Market. There are no road signs and road marking is faded in some areas. The reason for black spot is speeding motorist and unsafe pedestrian crossing. Crashes happen throughout the week but mostly at night and during wet seasons. Vehicles mostly involved in crashes are personal cars (saloons), and heavy commercial vehicles as well as bicycles. Crash victims are taken to Lumakanda Sub County Hospital.

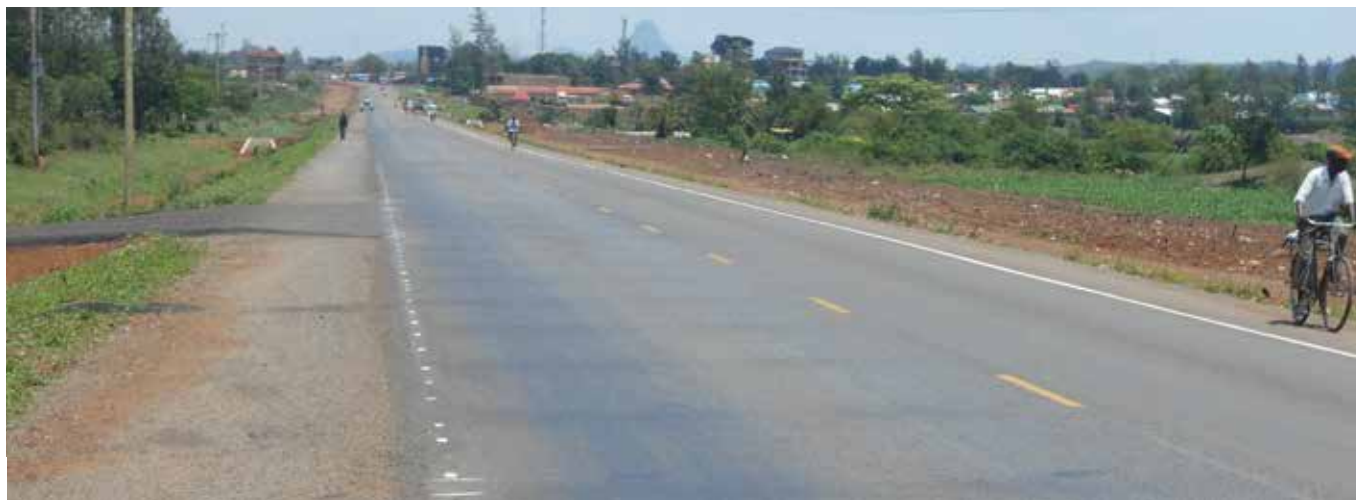
Picture: Part of Ikapalok - Malaba road section

This is a 1.4 kilometer road section along a straight stretch on a gentle slope and no speed bumps. There are no road signs. The reason for the black spot is speeding motorists and unsafe pedestrian crossing. Crashes happen throughout the week, day and night, and during dry and wet seasons. Vehicles mostly involved in crashes are personal cars (saloons), mini buses (PSVs and vans), and heavy commercial vehicles. Crash victims are taken to Busia County Referral Hospital. There is an undesignated truck stop-over point at Malaba.

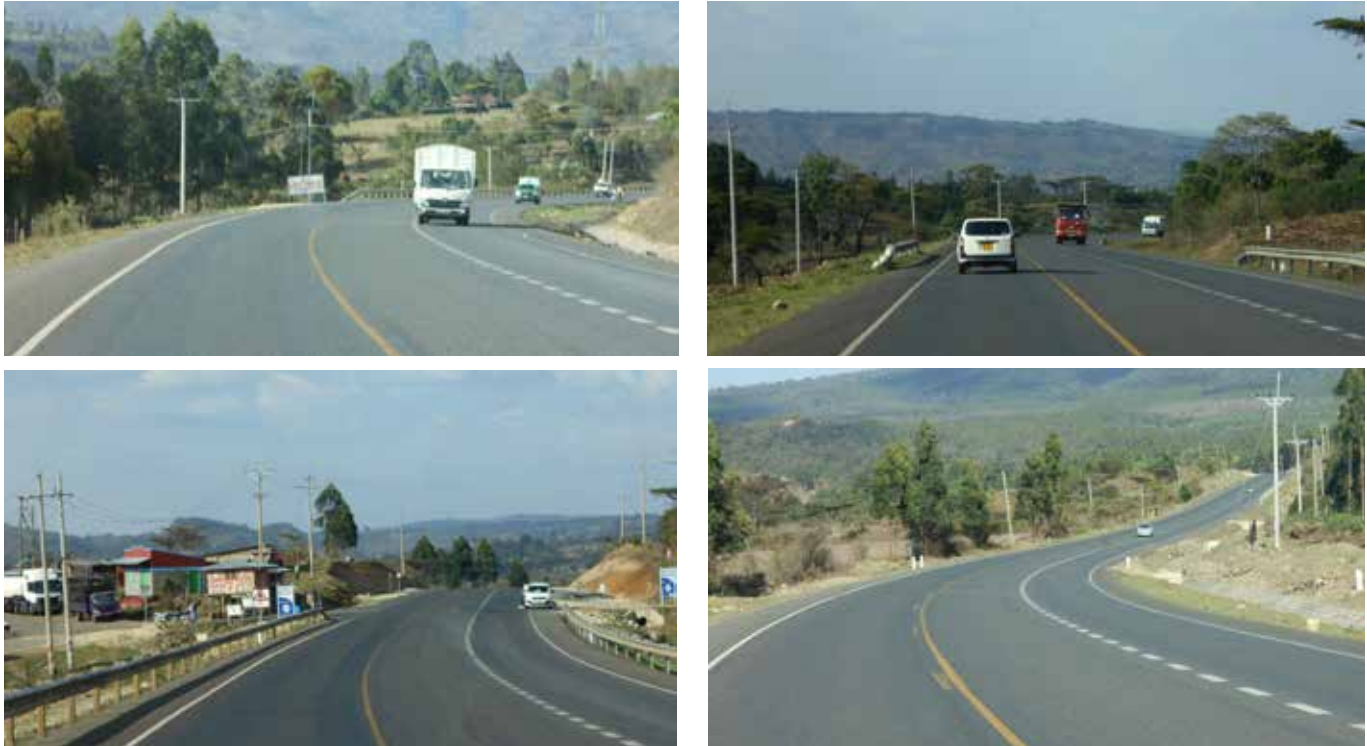
Picture: Part of Kap David - Kedowa road section

This 6.9-kilometer road section has series steep slopes and sharp bends, and brow of hill. There road is well marked and has some signage. The reason for the black spot is speeding motorists, brake failure, and poor visibility due to misty conditions during wet season. Crashes happen throughout the week, day and night, and during dry and wet seasons. Vehicles mostly involved in crashes are personal cars (saloons), mini buses (PSVs and vans), and heavy commercial vehicles. Crash victims are taken to Kericho County Referral Hospital.

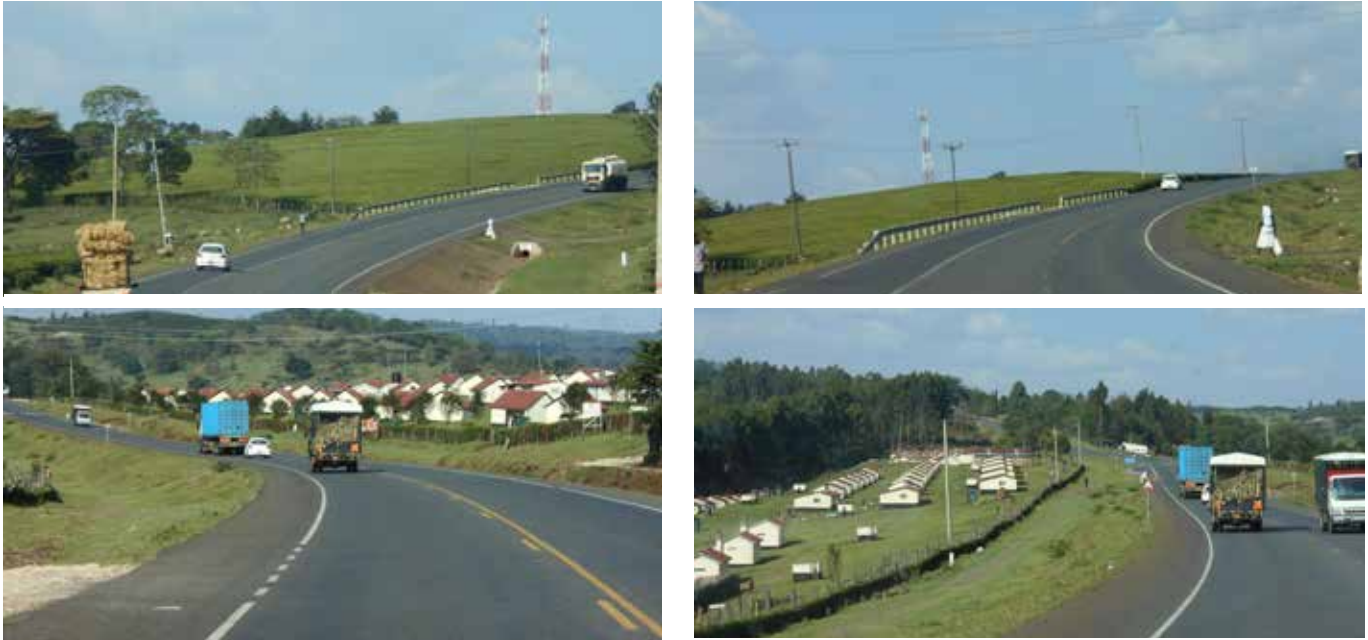
Picture: Part of Kapkatunga road section

This is a 150-meter road section that has a brow hill on gentle slope and across a high density settlement heading into Kericho town. There road signs are not adequate and missing important signs like speed limit and hazards. There are speed bumps and a climbing lane already in this section. The reason for the black spot is speeding motorists and unsafe pedestrian crossing. Crashes happen throughout the week, day and night, and during dry and wet seasons. Vehicles mostly involved in crashes are personal cars (saloons), mini buses (PSVs and vans), and light and medium trucks. Crash victims are taken to Kericho County Referral Hospital and Siloam Hospital.

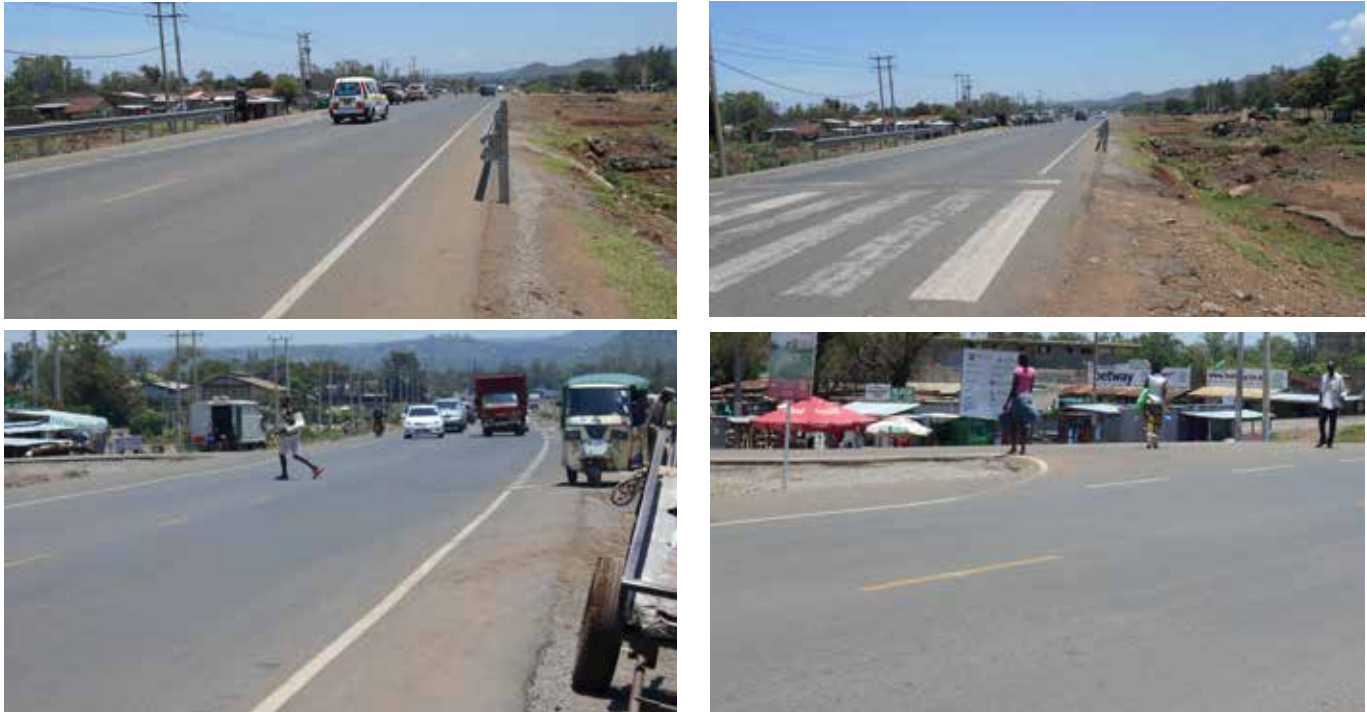
Picture: Part of Otonglo Area road section

This is a new blackspot on a 0.5-kilometer road section near the Otonglo area of the highway along a straight stretch with a slight bend in a densely populated area. There are also speed bumps and intersections. There are no pedestrian crossing points and the road does not have signage. The reason for the black spot is unsafe pedestrian crossing, speeding motorists and motorcycle riders crossing the highway carelessly and dangerous entry from the intersections. Crashes happen equally over weekend and weekday but mostly at daytime, as well as equally during both dry and wet seasons. Vehicles mostly involved in crashes are personal cars (saloons), mini buses (PSVs and vans), motorcycles and bicycles. Crash victims are taken to Jaramogi Oginga Odinga Referral Hospital.
