Northern Corridor and Nairobi County Route Hazard Mapping Report

May 2017

Developed by Safe Way Right Way and National Transport and Safety Authority

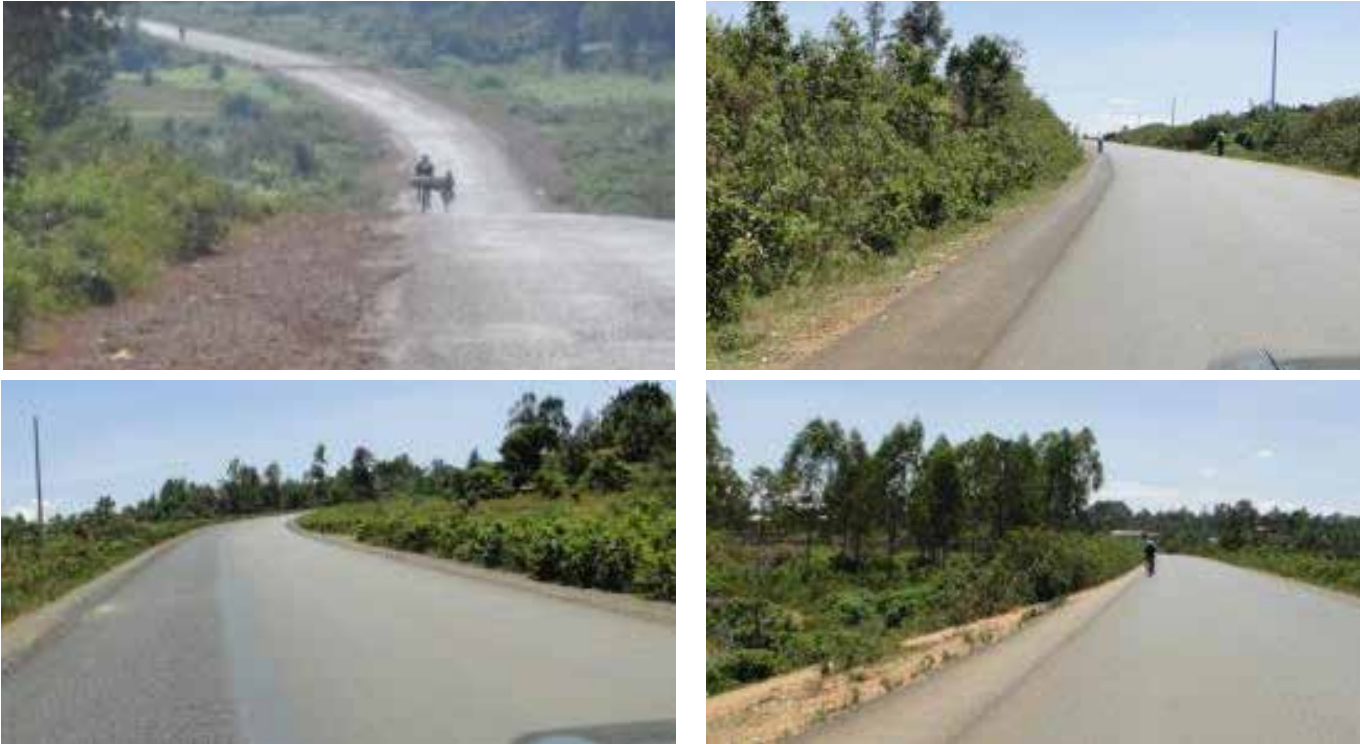
Picture: Part of Dudi road section

This is a 0.2-kilometer road section on a steep slope with sharp bend near Dudi Market center. There are no road signs and the road is not marked. The reason for the black spot is speeding and unsafe pedestrian crossing at the market center. Crashes happen throughout the week, day and night, and during dry and wet seasons. Vehicles mostly involved in crashes are personal cars (saloons), mini buses (PSVs and vans), large buses, light and medium trucks, heavy commercial vehicles and motorcycle. Crash victims are taken to Maseno Mission Hospital.

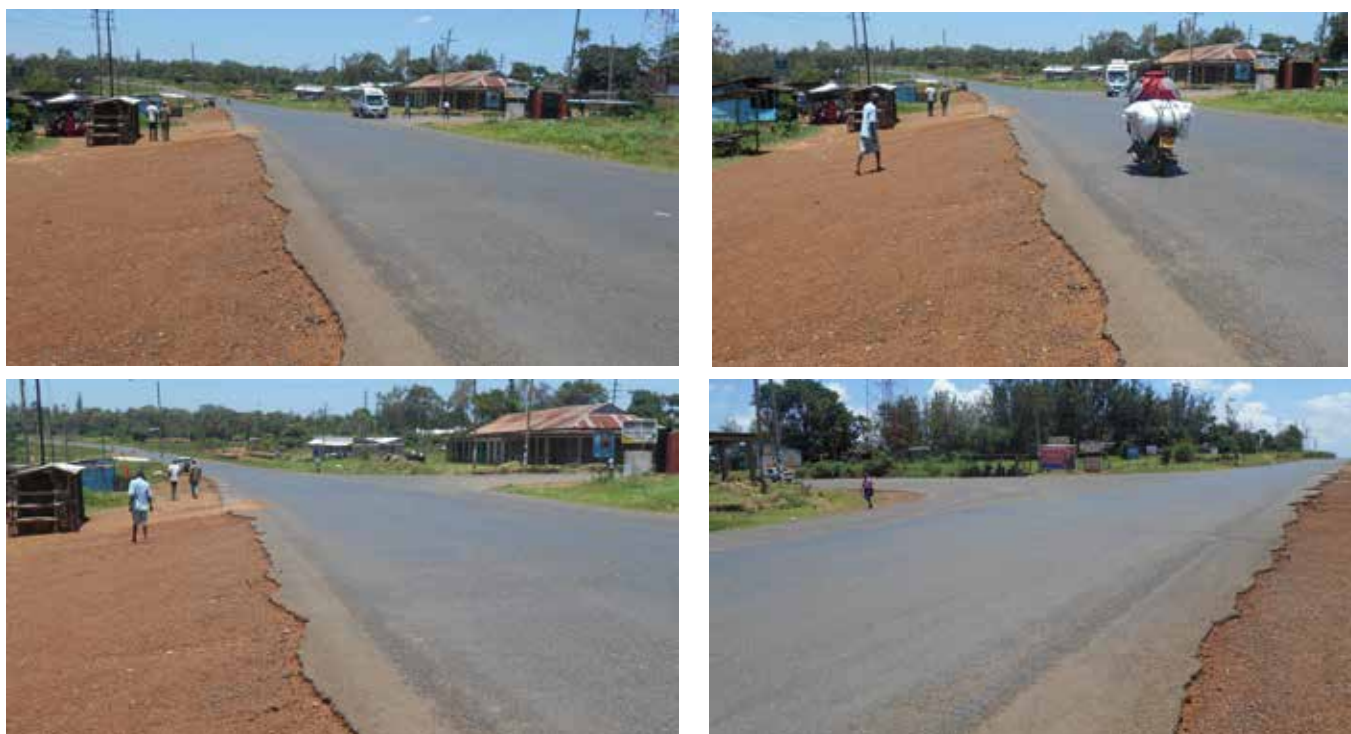
Picture: Part of Rangala junction road section

This is a new blackspot on a 2.1-kilometer road on a straight stretch with intersection at Rangala. It crosses through a Rangala junction roadside market center. There are no road signs or designated pedestrian crossing points. The road is not marked and the shoulder is damaged. The reason for the black spot is speeding motorists, careless overtaking and unsafe pedestrian crossing. Crashes happen throughout the week, at night, and during dry and wet seasons. Vehicles mostly involved in crashes are personal cars (saloons), mini buses (PSVs and vans), large buses, light and medium trucks, heavy commercial vehicles and motorcycle. Crash victims are taken to Rangala Mission Hospital and Ambira District Hospital.

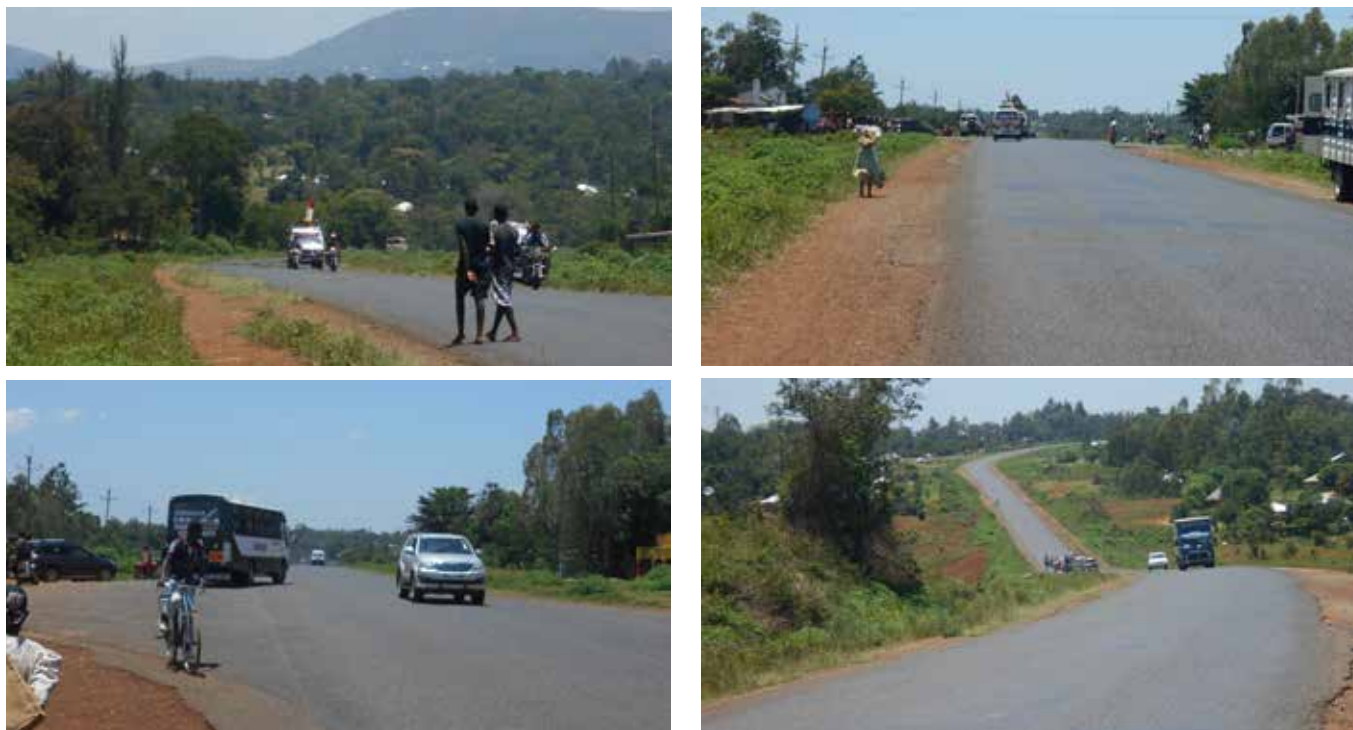
Picture: Part of Got Nanga road section

This is a 0.7-kilometer road section on a steep slope with a bend. Road is unmarked, shoulder is damaged and there are no road signs. The reason for the black spot is speeding motorists and unsafe pedestrian crossing. Crashes happen throughout the week, day and night, and during dry and wet seasons. Vehicles mostly involved in crashes are personal cars (saloons), mini buses (PSVs and vans), large buses, light and medium trucks, heavy commercial vehicles and motorcycles. Crash victims are taken to Yala Sub County Hospital.
