# MARS – Lessons Learned

MARS Report No 376 February 2024

## Bad hose blanking practice

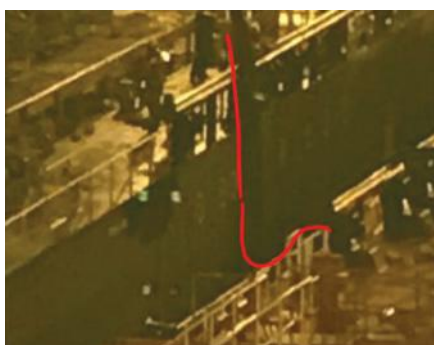
The first attempt to lift the cargo hose was unsuccessful. The hose was lifted only 10m over the upper deck, leaving another 14 metres of hose bent in a U shape between the vessels. Due to the improper lifting and U shape, the cargo line could not drain to the receiving vessel and an excessive bend developed at the hose support of the receiving vessel. This created so much pressure in the hose that the oil remaining in the hose was forced up and back out, escaping the hose at the loosely bolted flange at the supply vessel. An estimated 15L of oil was sprayed on deck, onto the fenders, and into the sea between the two vessels.

Incorrect lift causing U in hose

- STS guidance specifies blanked flanges should be securely bolted to prevent pollution.
- Introducing atmospheric air to the cargo system constitutes an explosion risk.
- A STS Joint Plan of Operations should include all operations such as cargo hose connection, draining, purging and disconnection.

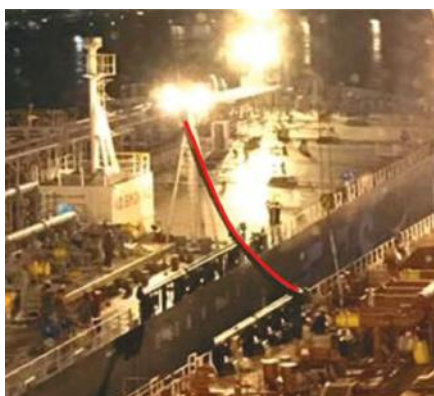
Correct lift for drainage

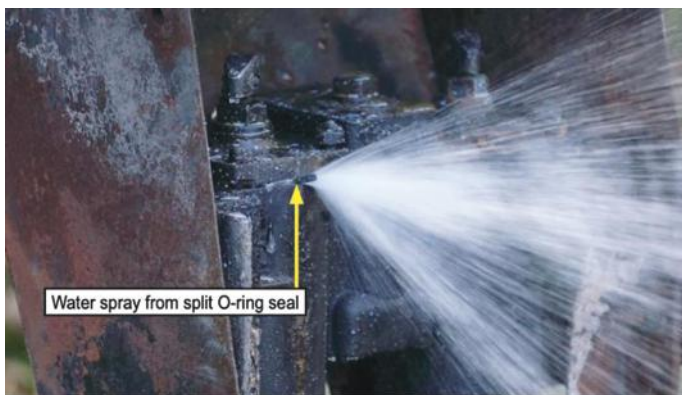
The 3rd engineer decided to clean the AE1 fuel filters as his first task. He undid the two locking screws on the splash shield and removed it from the housing to access the duplex fuel filters. As he was undoing the front right-hand nut of the filter, the fuel pressure (5.5 bar) still present in the system lifted the cover and forced the O-ring seal out of its recess, causing it to split. Marine gas oil sprayed out over a large area, covering the crewmember. The spray also reached the nearby AE2's turbocharger and exhaust pipework about 1m away. These engine parts were very hot. The fuel ignited almost immediately and thick black smoke began to emanate from the AE2 exhaust insulation.

Post-accident test using water to simulate fuel spray

- The victim's action to remove the AE1 fuel filter elements without first isolating the fuel from the filter assembly was the major contributing factor to this accident. How could this mistake have been avoided? A procedure? A checklist? Better supervision? Teamwork? Better training?
- The shore-based search and rescue team located the victim in the smoke-filled space using a thermal imaging camera. This device could be a valuable addition to shipboard emergency equipment.
- A ship fire is an imposing challenge for crew and drills that replicate the difficulties that may be faced, such as searching in near zero visibility, can pay dividends.

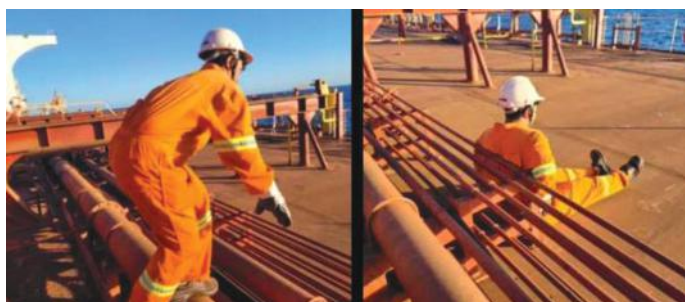
→ On a vessel at anchor, a crewmember was assigned to replace a leaking hydraulic pipe on one of the hatch covers. Once the job was completed the crewmember attempted to regain the clear deck area by walking over adjacent deck pipes that were about 50cm above deck level, rather than walking to one of the raised walkways allowing access over the pipelines at regular intervals. While walking over these raised pipes he slipped and fell, with his back striking the raised pipes. He suffered disc lesions to his lower spine.

There are raised walkways allowing access over the pipelines at regular intervals on the main deck.

- Decisions made for the sake of expediency are rarely compatible with safety.
- Ask yourself, is there a safer way? If the answer is yes, take the safer way.

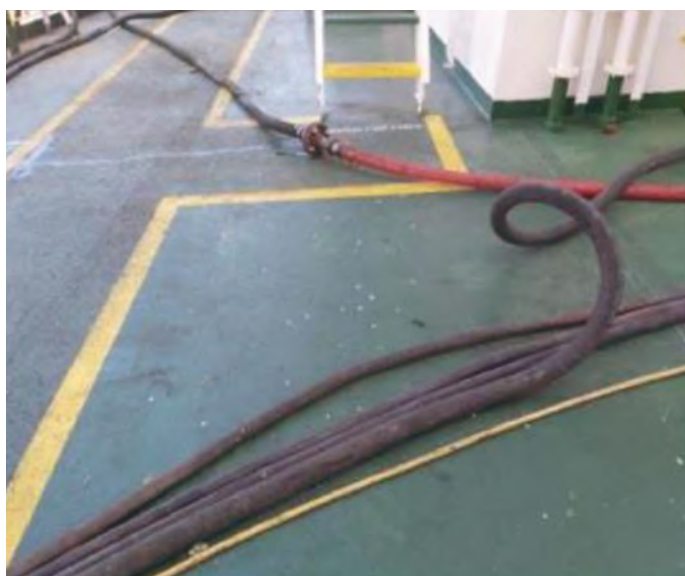
→ A ship was in dry dock and deck crewmember on the night shift was undertaking a safety round. As he reached the bottom of an exterior stairway and began walking, his foot caught a two-inch hose laid on deck. He tripped and fell, but initially thought he was uninjured. Later, his ankle became swollen and a sprained ankle was diagnosed.

- Dry dock work is notorious for snake-like arrays of hoses and other tripping hazards on deck areas. Keep walkways safe by making them as clear as possible and using high visibility cable ramps (covers) in areas where there is foot traffic over hoses.
- Keep walkways and stair landings well lit during the hours of darkness.
