March 1, 2023

## Harbortown SB326 Inspection Report

WJE No. 2022.3823

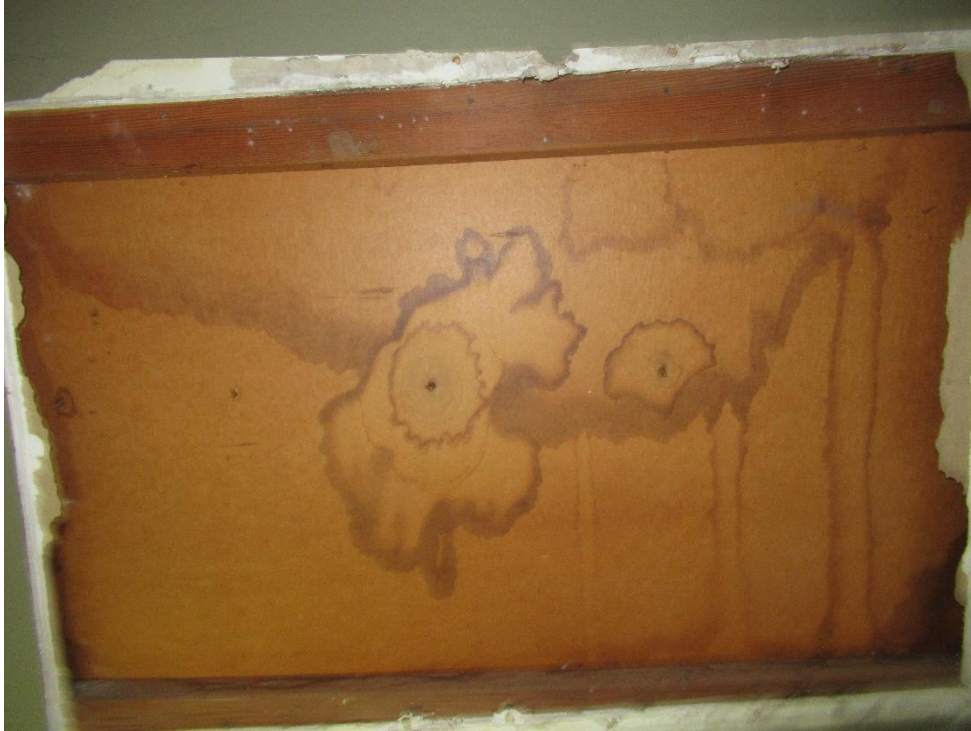
Figure 14. Inspection opening in ceiling of garbage and recycle area, showing moderate water staining.

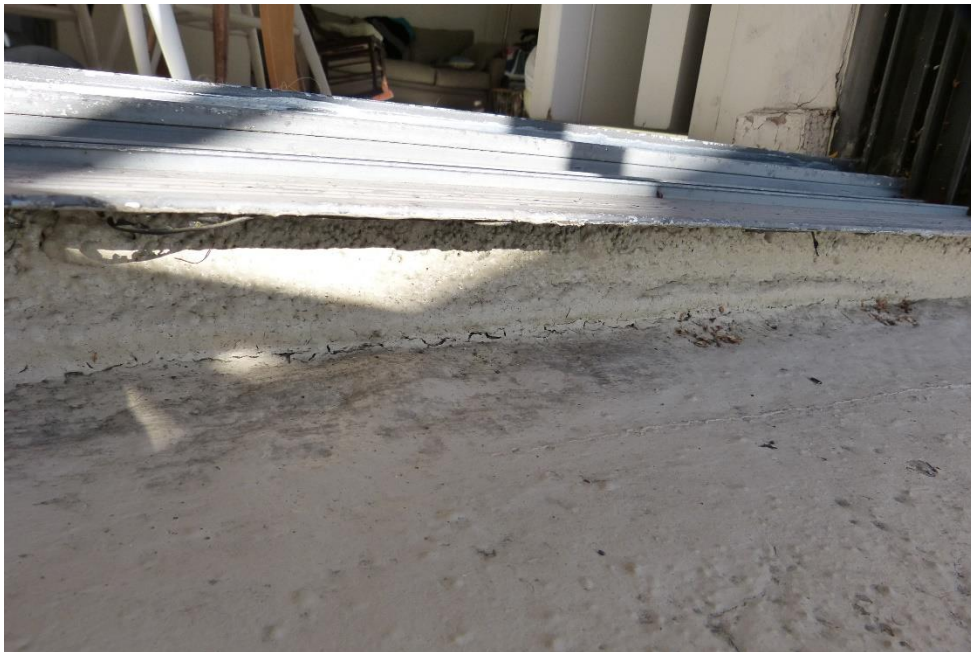
- Widespread occurrences of bubbling, peeling, cracking, and delamination within the field of the exposed waterproofing overcoating system (Figure 19 to 20),
- Occasional locations of cracking at the deck perimeter where edges are turned-up (Figure 21),
- Occasional extensive biological growth on the concrete topping slab, indicating retention of water for extended periods of time and likely caused by inadequate deck drainage (Figure 22),
- Locations with water ponding on the deck, and some deck drains that were clogged and not draining freely (Figure 23),
- Occasional scuppers that are reverse sloped or in other ways not functioning efficiently (Figure 24), and
- Widely varying downspout systems, including some downspouts that deposited water from the roof gutters onto decks rather than routing to drainage systems (Figure 25).

Figure 21. Cracking in upturned edge of exposed waterproofing.

inadequate application of the overcoating has led to the overcoating conditions observed. Repair is recommended as discussed in Section 4.1 of this report.

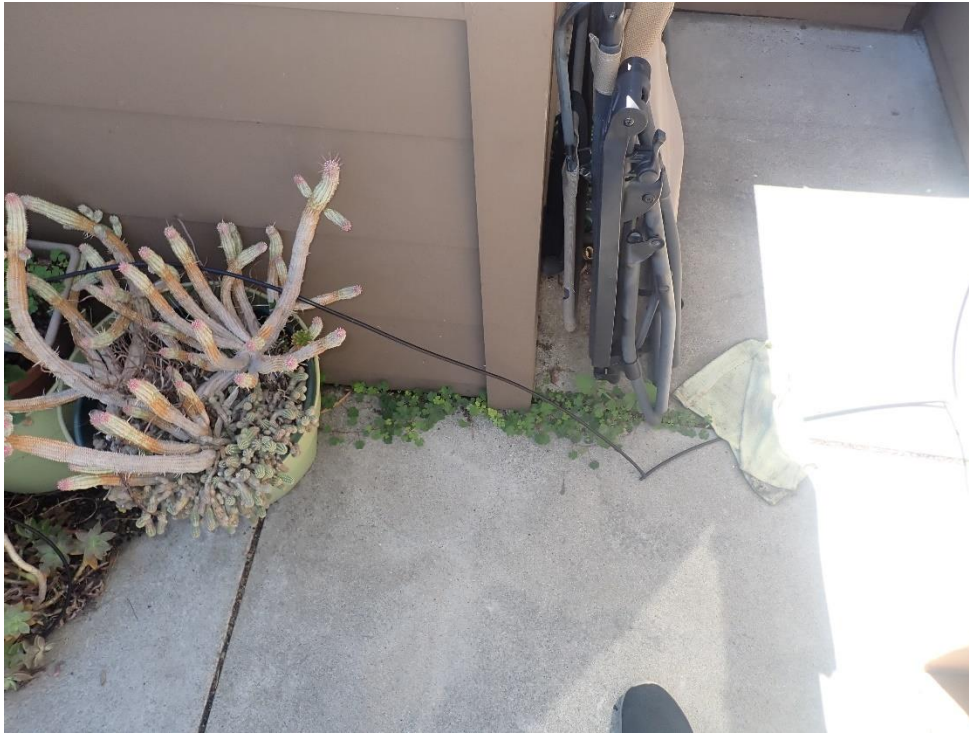
Figure 22. Growth on topping slab.

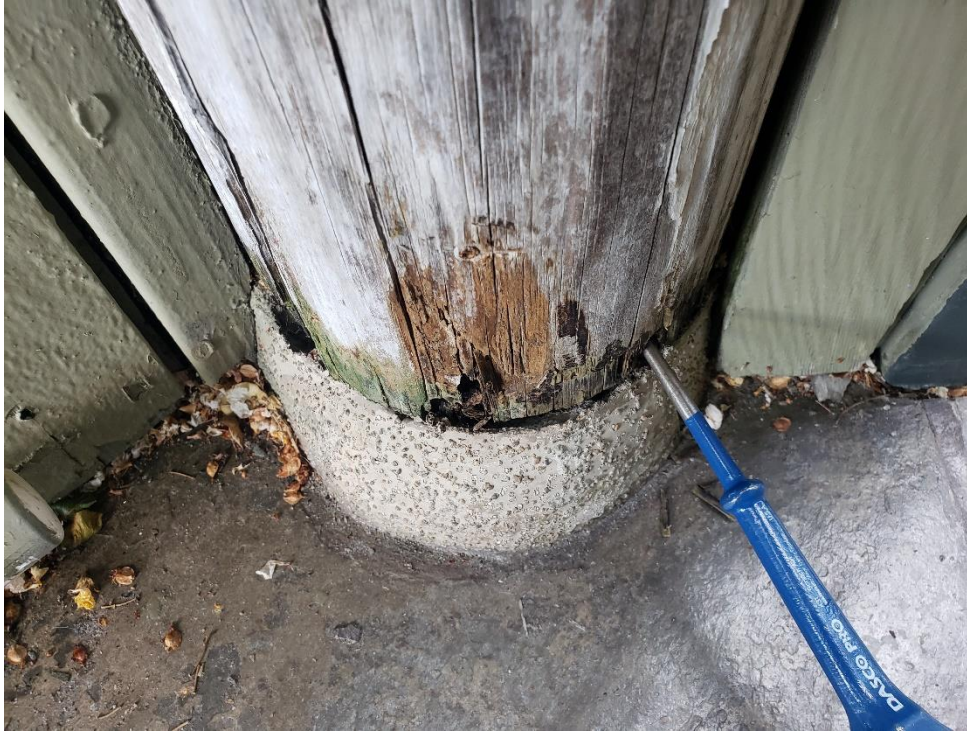
The exposed wood posts supporting the decks are logs rather than standard lumber posts. An estimated 14% of these posts (14 out of 100 inspected) have decay damage at the bottom or top of the post (Figure 26). The extent of the decay damage does not rise to the level of requiring emergency shoring, but repair of the affected posts is needed. Two additional posts are recommended for repair based on other observed conditions.

Figure 26. Decay damage at bottom of log post.

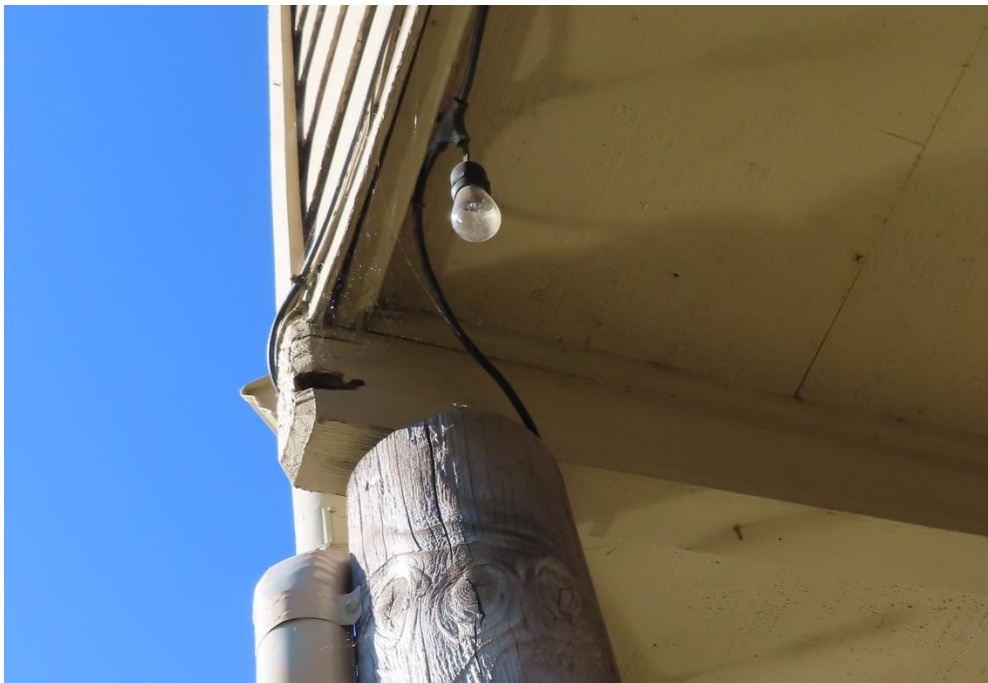
The deck beams appeared to be free of deterioration of structural concern, with the exception of one beam at 1088 Shoreline (Building 13), which has decay damage at the weather-exposed end of the beam (Figure 27). The decay damage is very local to the end and does not require emergency shoring but will require repair.

Figure 27. Decay damage in end of beam at 1088 Shoreline (building 13).

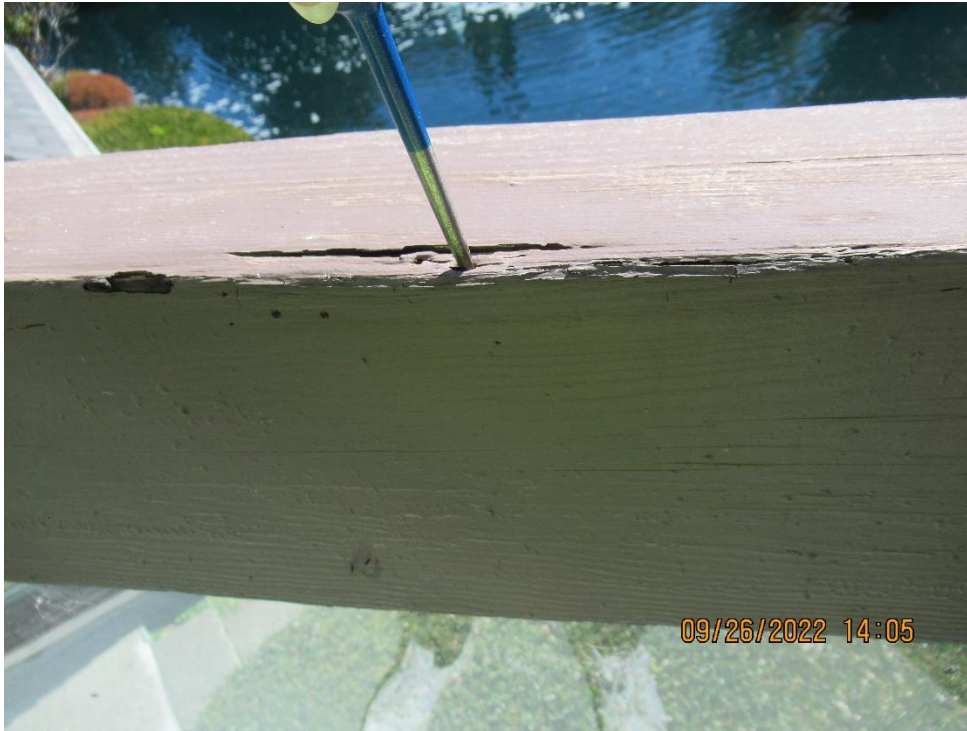
Figure 28. Decay damage in guardrail top rail.

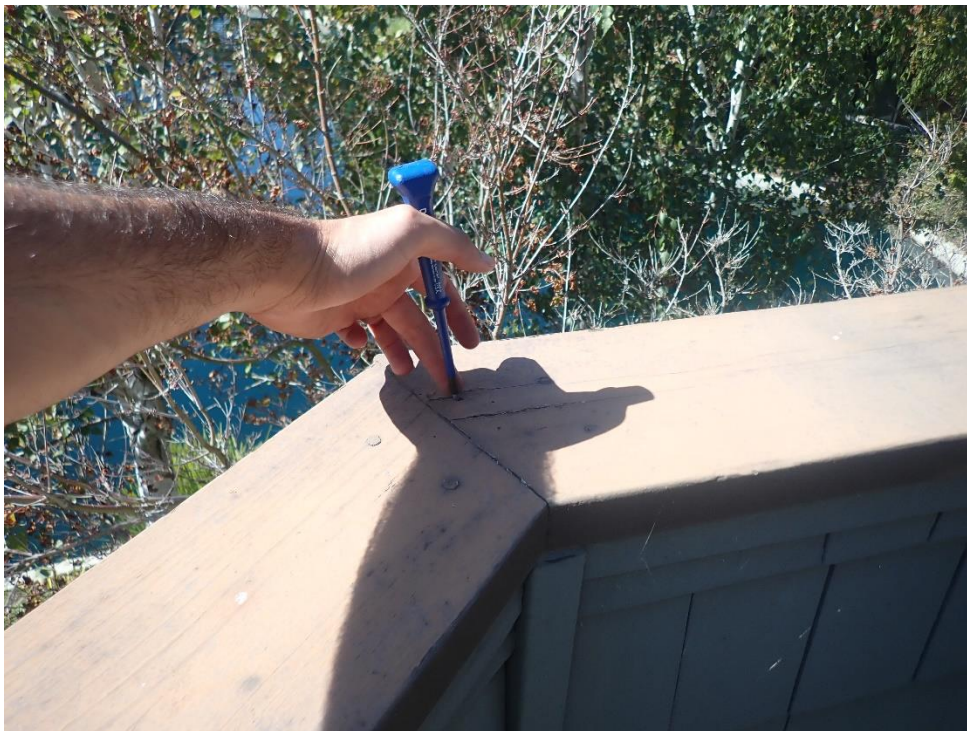
Figure 29. Decay damage in other guardrail framing.

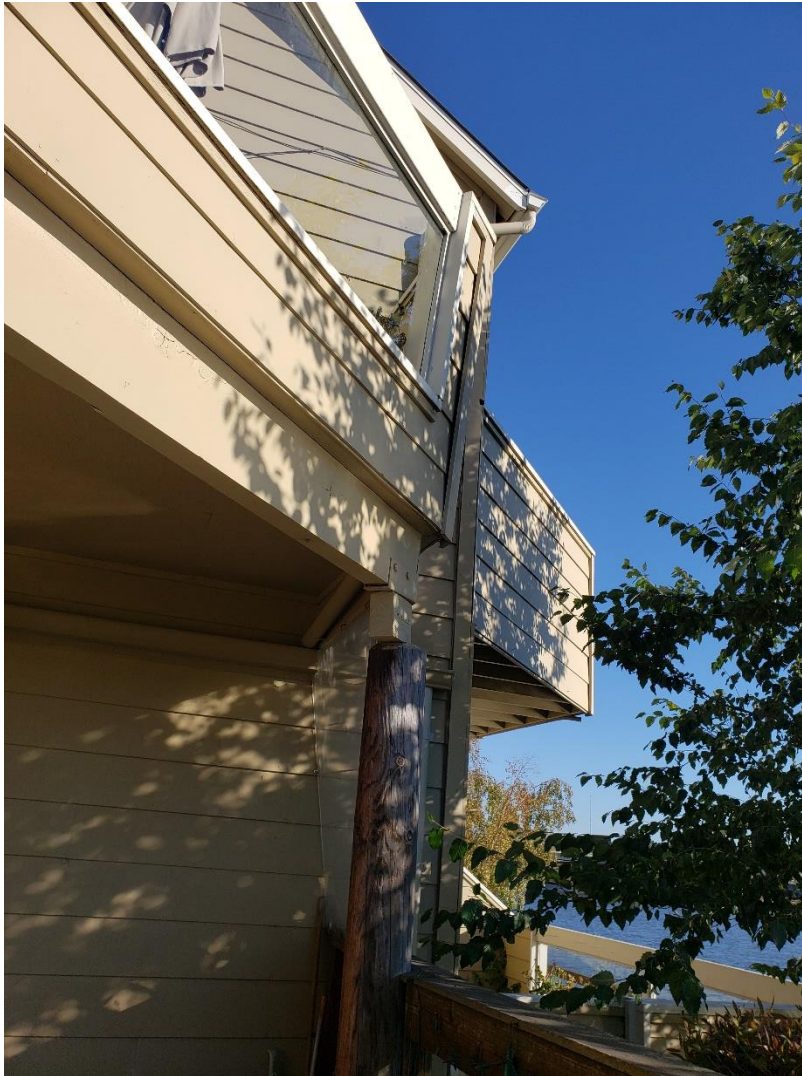
In several locations it was observed that existing guardrails were notably out of plumb (Figure 30). In these locations either damaged framing or improper framing repair is suspected but could not be verified. These locations will need to be opened to determine required repairs.

Figure 30. Leaning deck guardrail at 1130 Shoreline (Building 15).

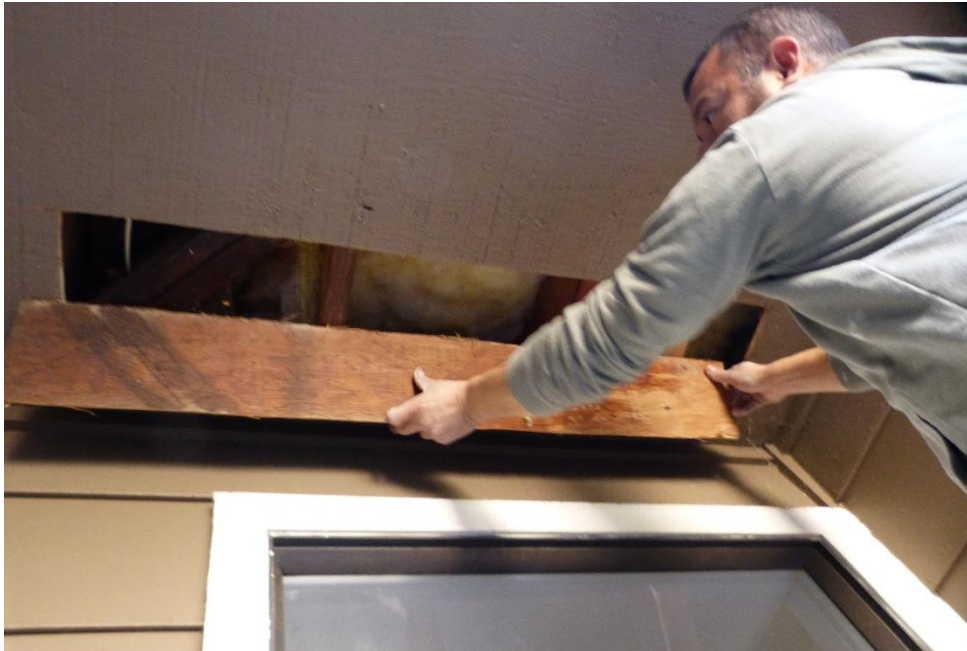
Figure 31. Water intrusion at local decay damage at 941 Shoreline (Building 26).

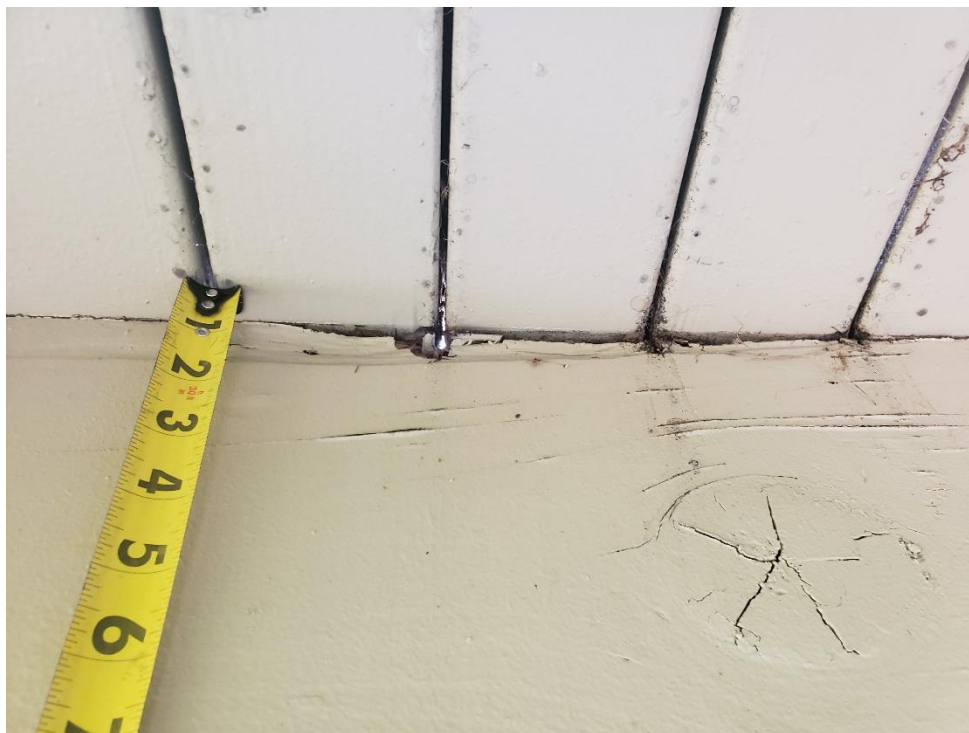
- Localized wood decay at the top of deck joists ranging from ½" to 1" in depth was noted at roughly one third of decks inspected (Figure 36). Decay noted was typically limited to a couple joists per deck or was isolated to locations where the joists had been notched for flashing.

Figure 36. Localized wood decay at top of exposed joist.

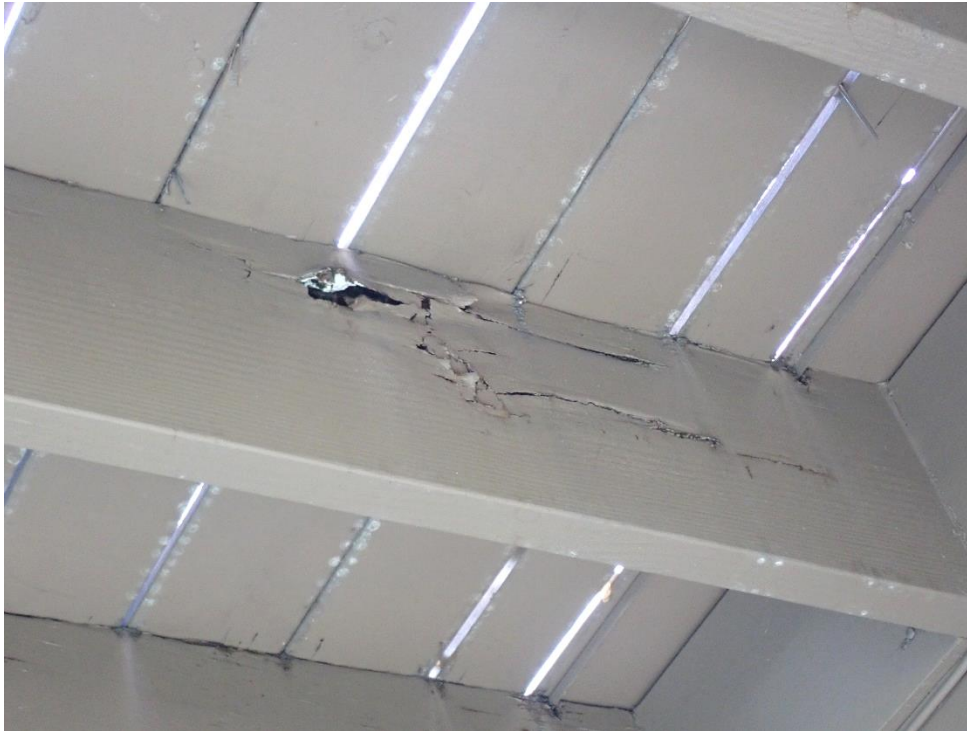
- Occasional locations of significant wood decay at deck joists were observed at roughly 10 percent, (nine of 92 decks inspected) (Figure 37). The decay typically extended most of the depth of the joist and was noted at several of the joists in the affected decks.

Figure 37. Significant wood decay at exposed deck joist.

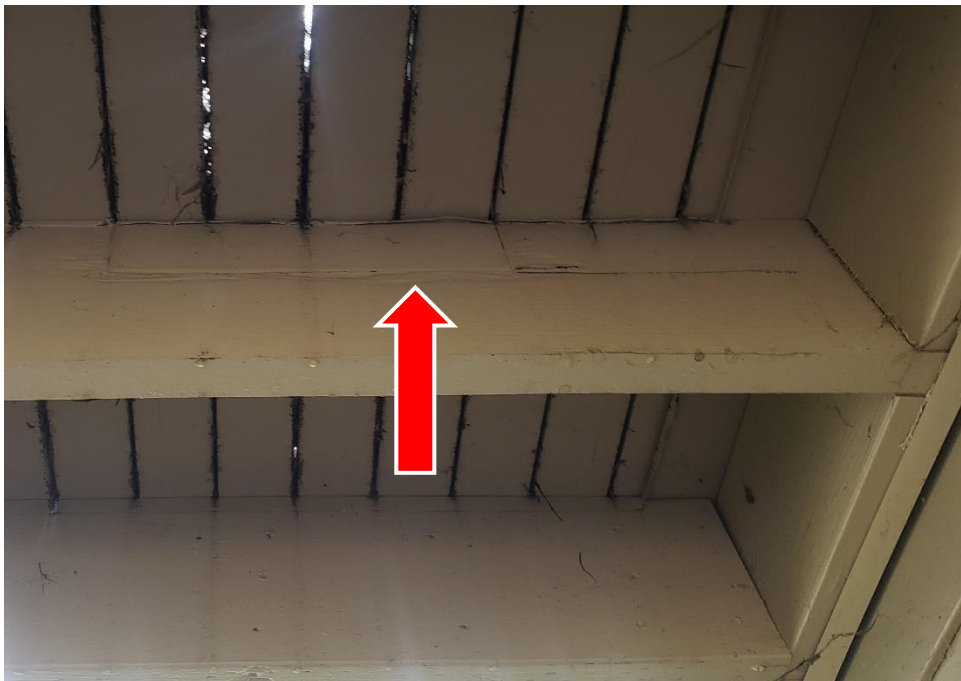
- Indications of previous deck repairs were noted at roughly one third of decks inspected. Signs of previous repairs included deck joists with a second joist alongside (i.e., sistered deck joists), decks with manufactured deck board instead of the original wood decking, and locations of deck joists that had been cut off/notched and infilled/patched (i.e.: Dutchmen installed) (Figure 38 and 39). Many of the repairs do not appear to have had engineered designs. , The observed repairs to the joists that have

involved cutting/notching and infilling/sistering have resulted in weakening of the decks. In no locations was the existing condition believed to create a safety hazard, however a safety hazard could be created if additional non-engineered repairs are installed.

Figure 38. Inappropriate deck joist repair that compromises deck strength. Joist has been cut out and patched back in.

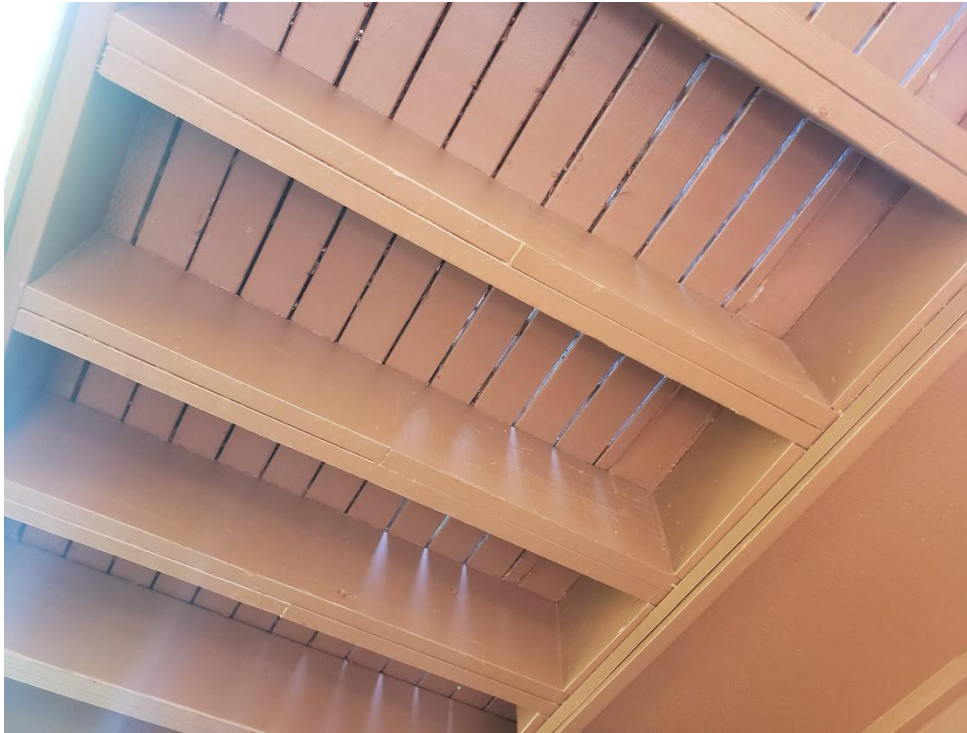
Figure 39. Inappropriate deck repair where joists have been cut back and then sistered.

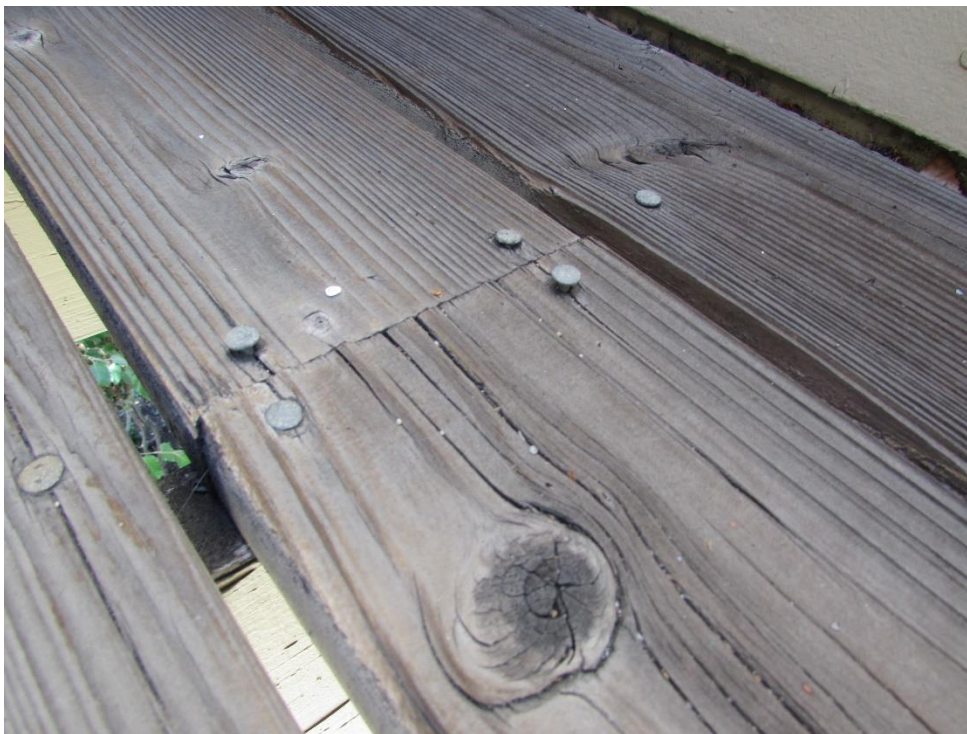
- The wood decking condition was noted to be fair to poor at decks inspected. At roughly one third of decks inspected (approximately 23 of 71 decks where access was provided) we noted distress to the deck boards, consisting of deck nails that were withdrawing (popping), weathered deck boards, localized wood decay, biological growth, etc. (Figures 40 and 41).

Figure 40. Deteriorated deck boards with nail popping.

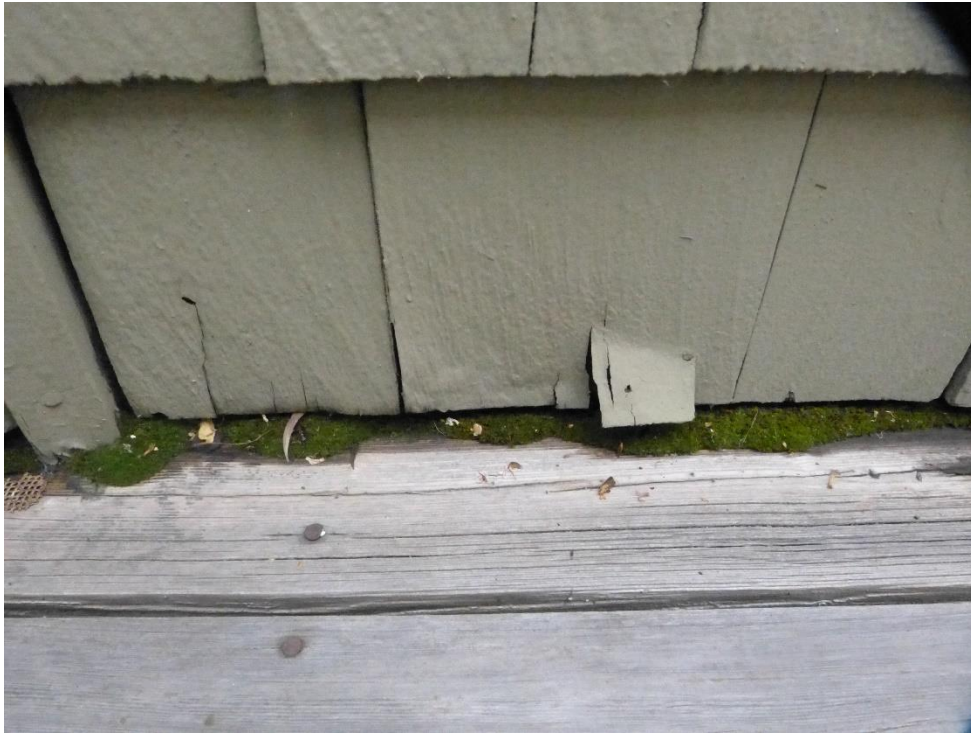
Figure 41. Bio growth on deck boards.

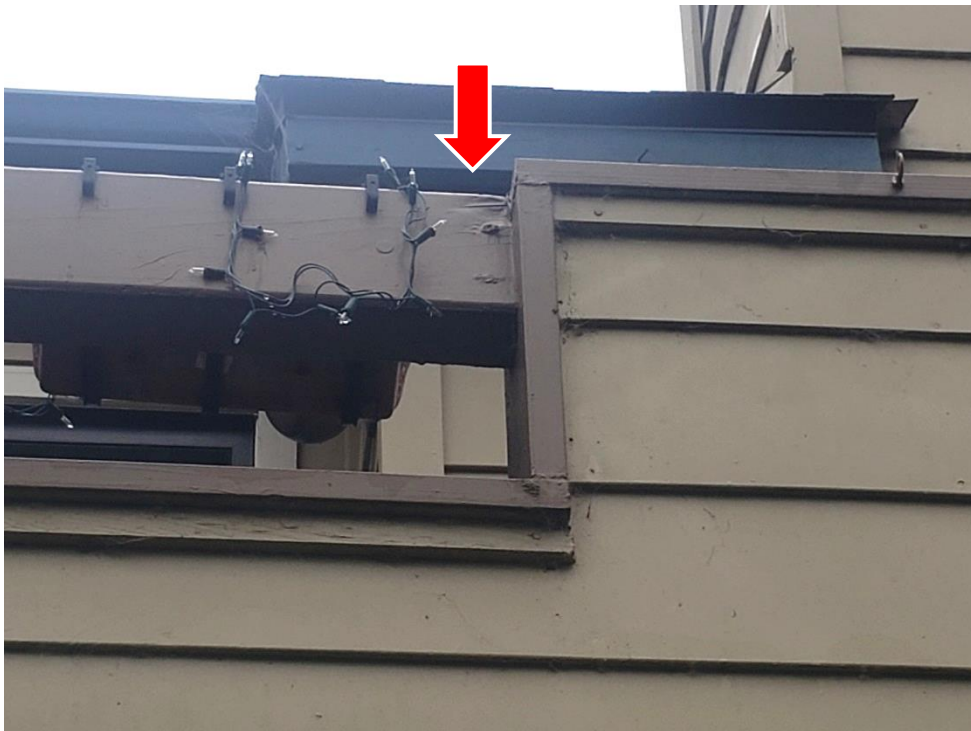
Visual inspection of the decks also included the second-floor deck guardrails. The portions of the guardrail wood framing exposed to view (typically sections of guardrail top rails) were checked for decay and deterioration. No occurrences of widespread decay of concern were noted, but there were a series of conditions in which local deterioration of the exposed top rail and/or adjacent exterior finishes and trim were noted (Figure 42).

Figure 42. Decay damage to guardrail top rail.

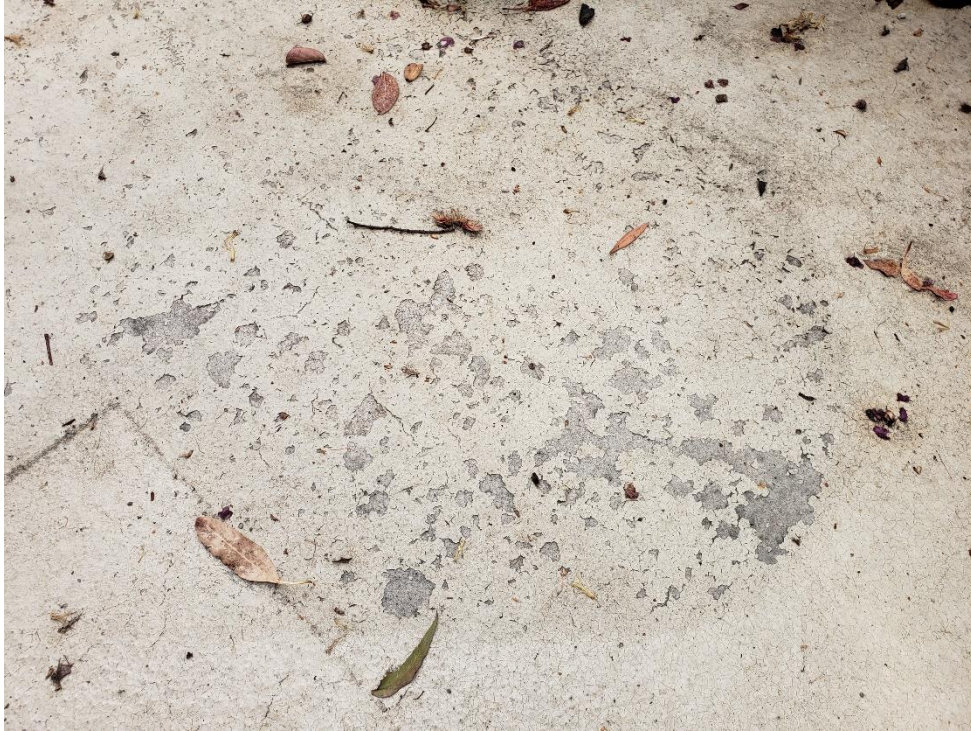
- Widespread occurrences of bubbling, peeling, cracking, and delamination within the field of the exposed waterproofing system (Figure 45),
- Occasional locations of peeling and cracking at the deck perimeter where edges are turned-up (Figure 46),
- Occasional extensive biological growth on the concrete topping slab, indicating retention of water for extended periods of time and likely caused by inadequate deck drainage (Figure 47),
- Locations with water ponding on the deck, and some deck drains that were clogged and not draining freely,
- Occasional scuppers that are reverse sloped or in other ways not functioning efficiently, and
- Widely varying downspout systems, including some downspouts that deposited water from the roof gutters onto decks rather than routing to storm drain systems.

Figure 45. Bubbling and peeling of exposed waterproofing.

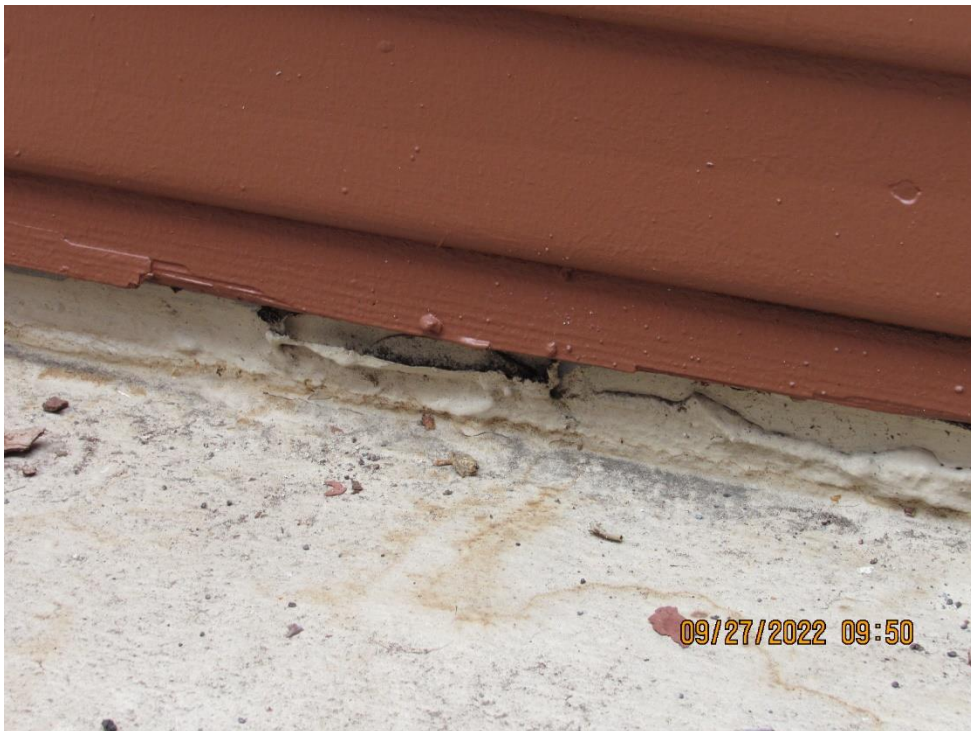
Figure 46. Peeling and cracking of exposed waterproofing at upturned edge.

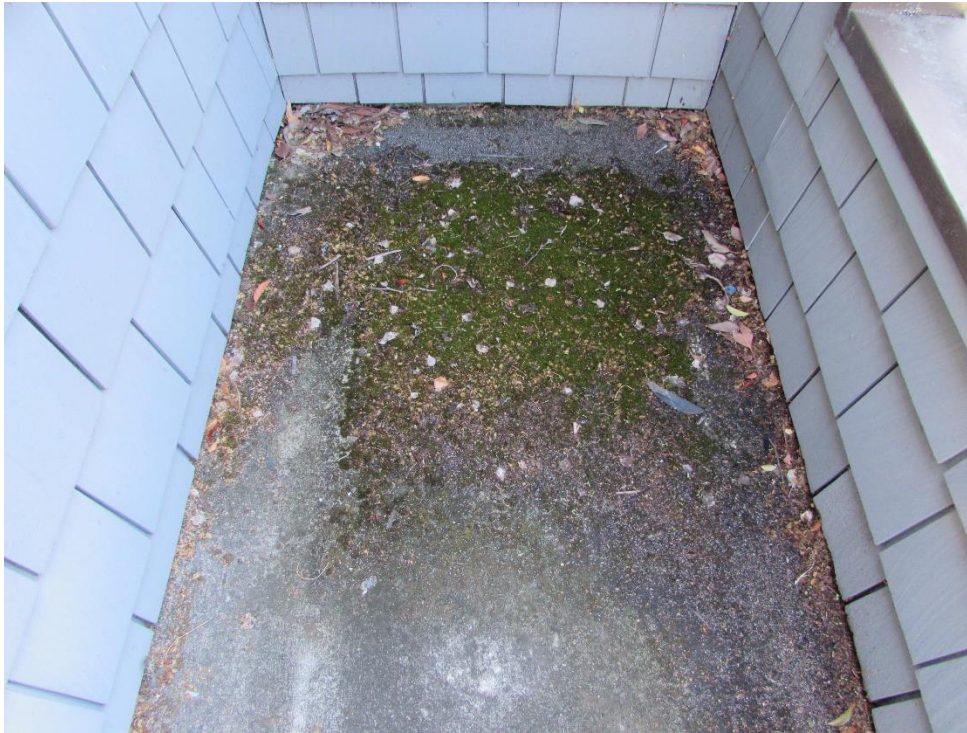
Figure 47. Bio growth on exposed topping slab.

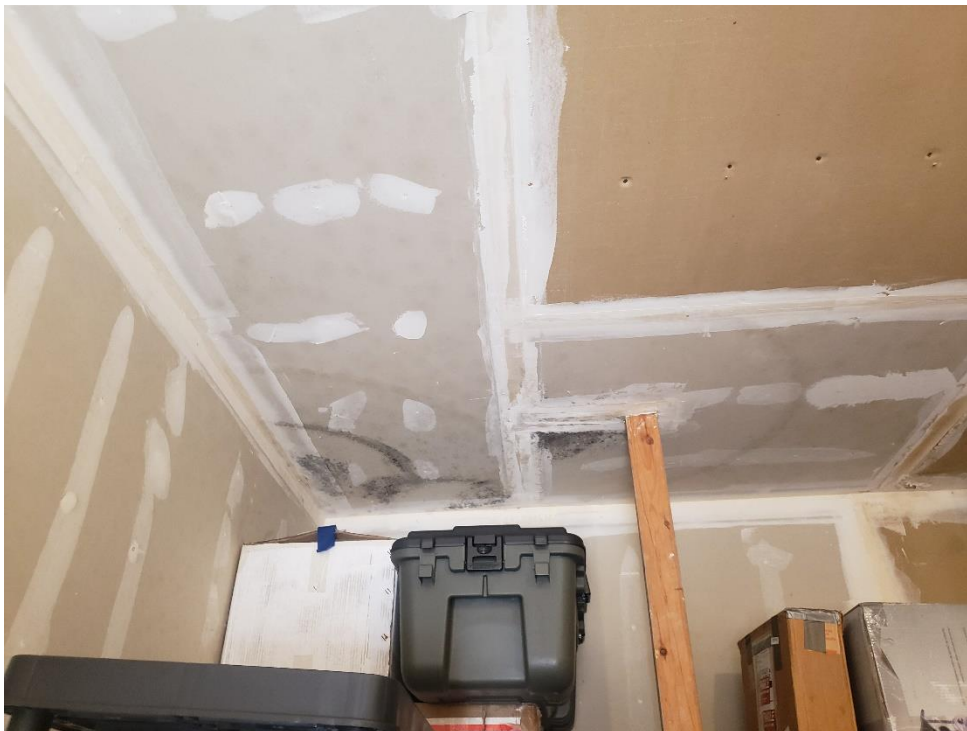
Figure 48. Bio growth on garage ceiling at active leak.

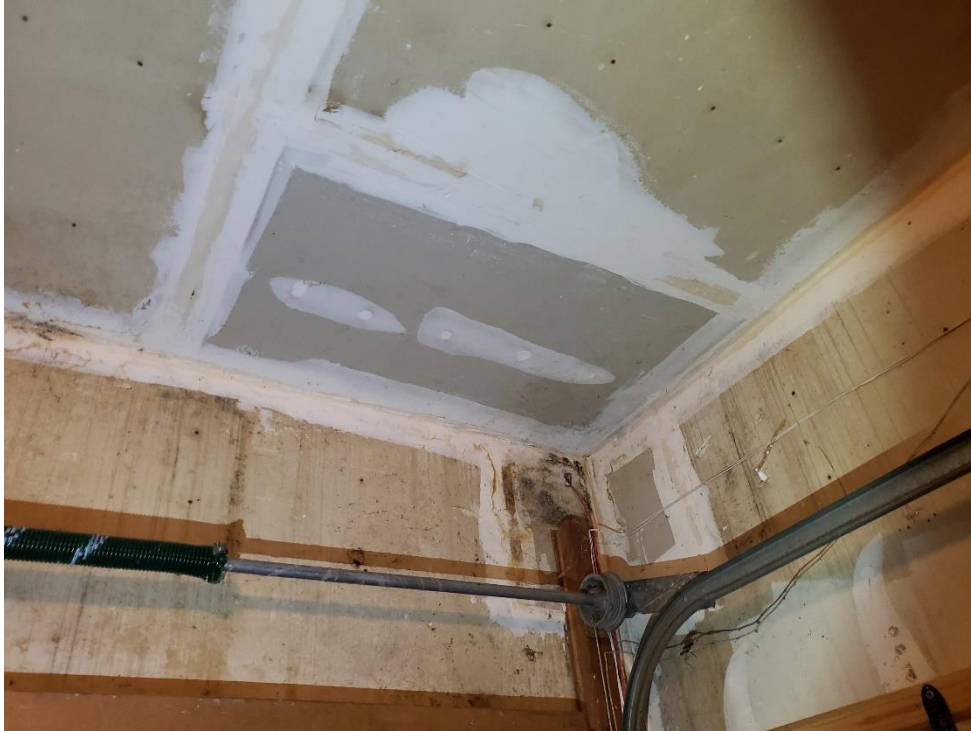
Figure 49. Garage walls and ceiling with water staining on both older and newer gypboard.

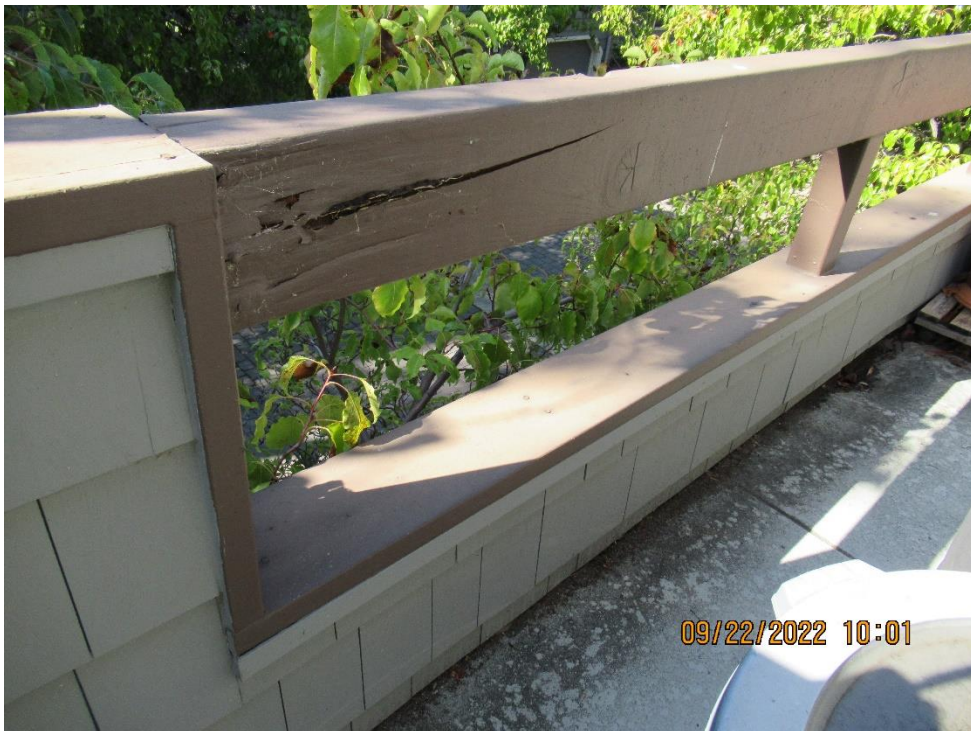
Visual inspection of the decks also included the second-floor deck guardrails. The portions of the guardrail wood framing exposed to view (typically sections of guardrail top rails) were checked for decay and deterioration. No occurrences of widespread decay of concern were noted, but there were a series of conditions in which local deterioration of the exposed top rail were observed (Figure 50).

Figure 50. Decay damage to guardrail top rail.

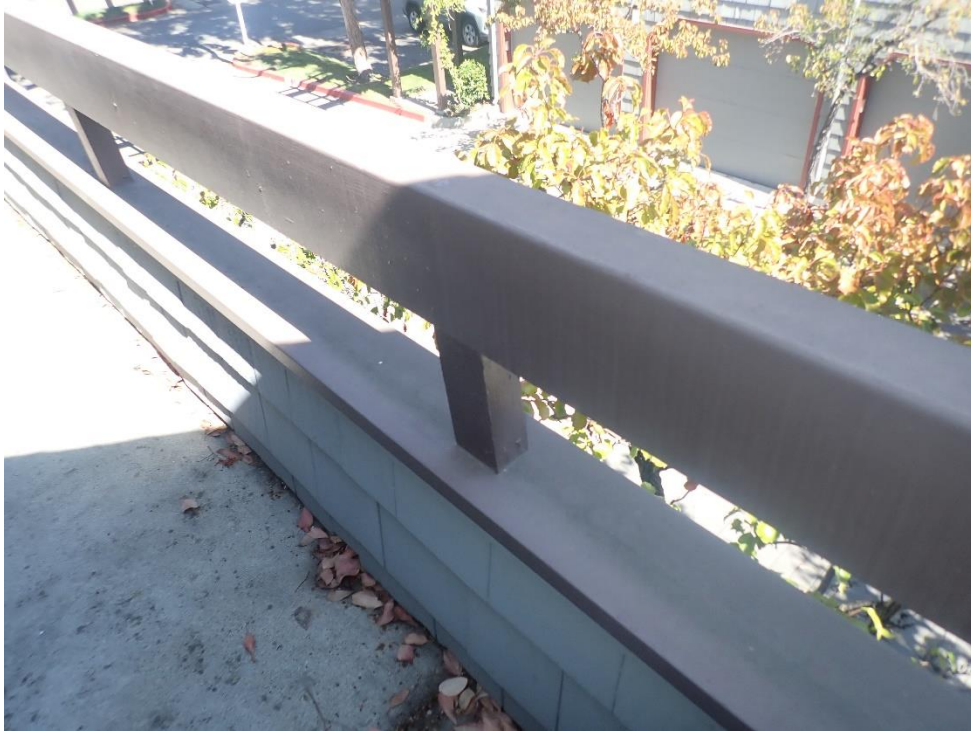
In several locations it was observed that existing guardrails were notably more flexible than typical (Figure 51). In these locations either damaged framing or improper framing repair is suspected, and repair is needed. These locations will need to be opened to determine required repairs.

Figure 51. Guardrail that is more flexible than typical.

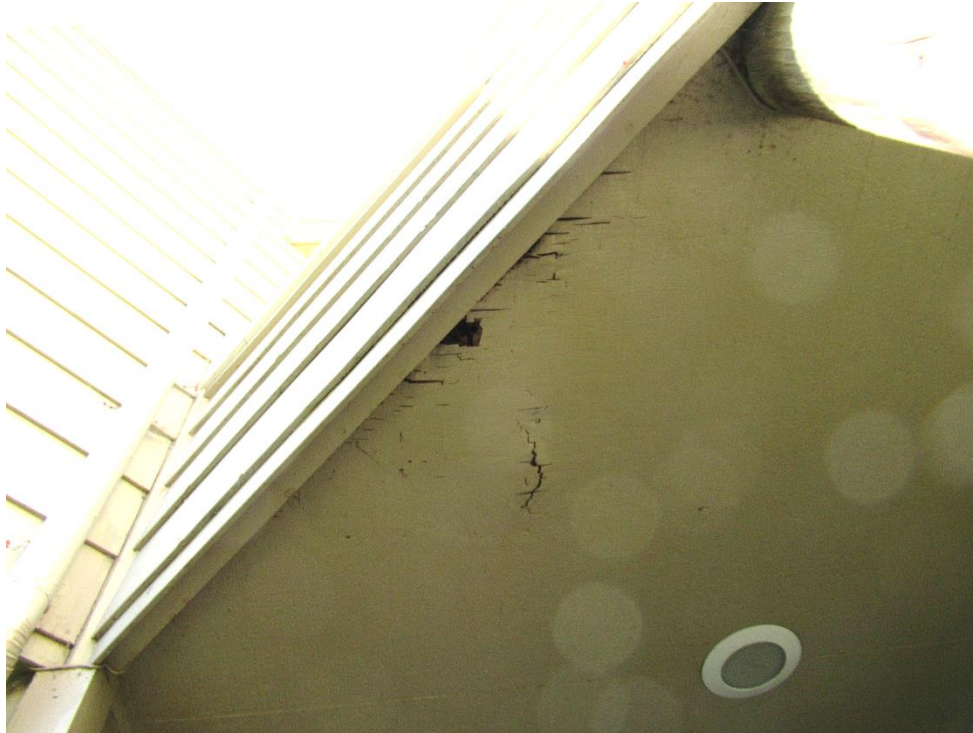
Figure 57. Entry deck soffit with decay damage.

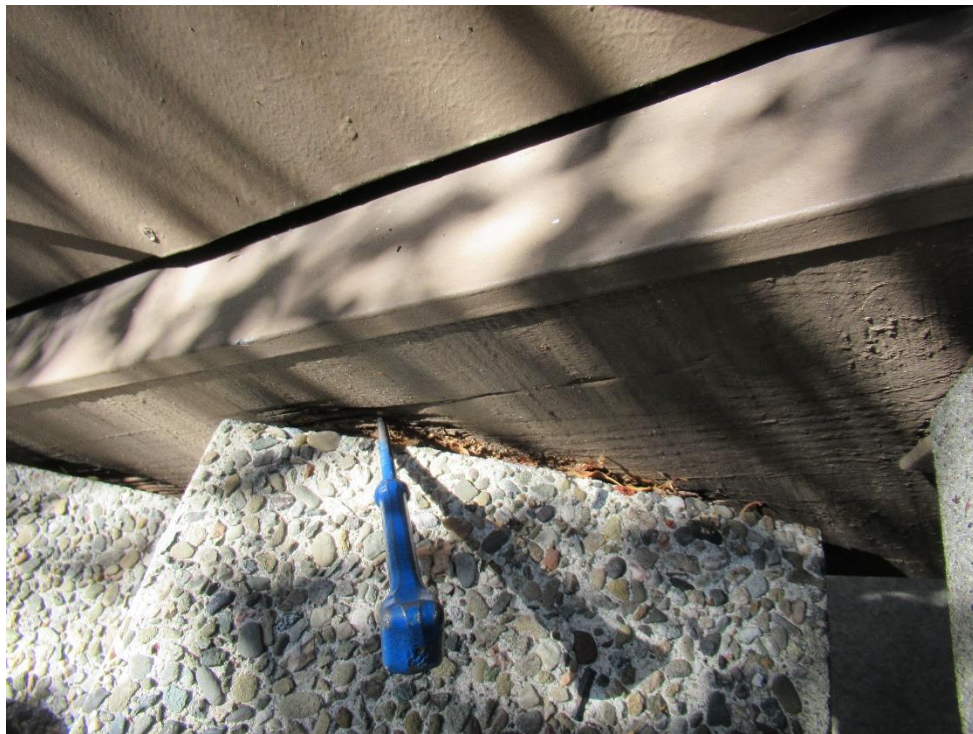
The stair stringers were observed to have widespread decay damage, ranging from minor damage to damage posing a safety hazard. Decay damage to stringers was seen at approximately half of the stairs (19 of 44 entry stairs). Stringers at four stairs have subsequently been repaired. We also observed a number of locations where we believe that stringers have been replaced since original construction. In a lot of locations, the decay damage occurs in a pocket where the stair tread abuts the stair (Figure 58) but other damage types have also been seen (Figure 59).

Figure 58. Decay damage pocket at exposed stair stringer.

The decay damaged stairs will require repair. In addition, we anticipate that ongoing regular inspection of the stairs will be needed to maintain them in a safe condition.

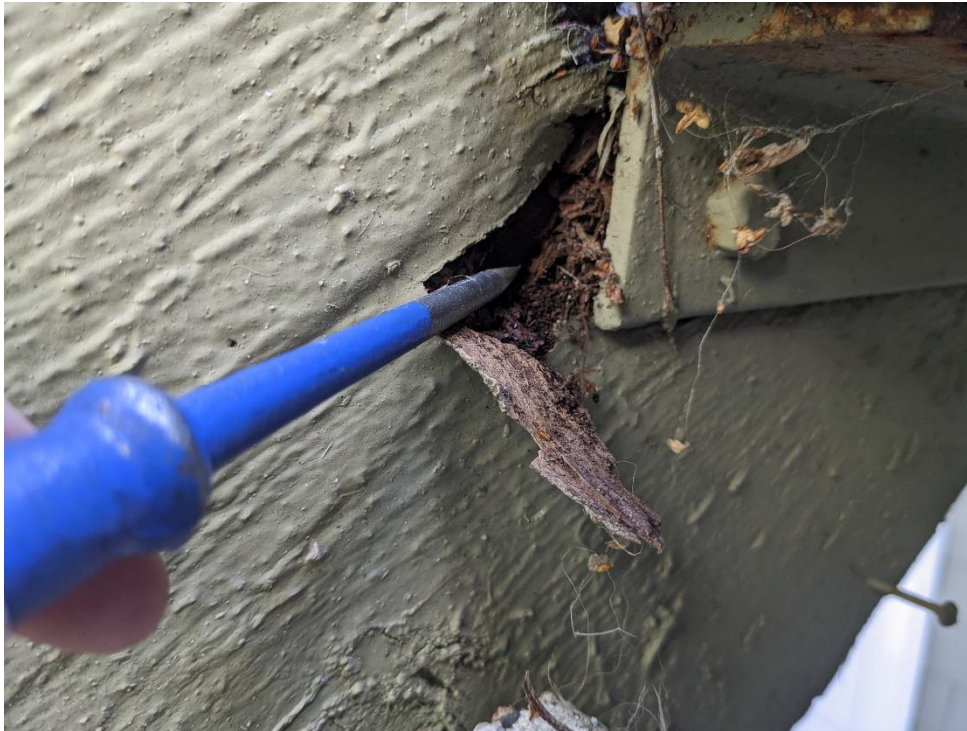
Figure 59. Decay damage at stringer support connection.

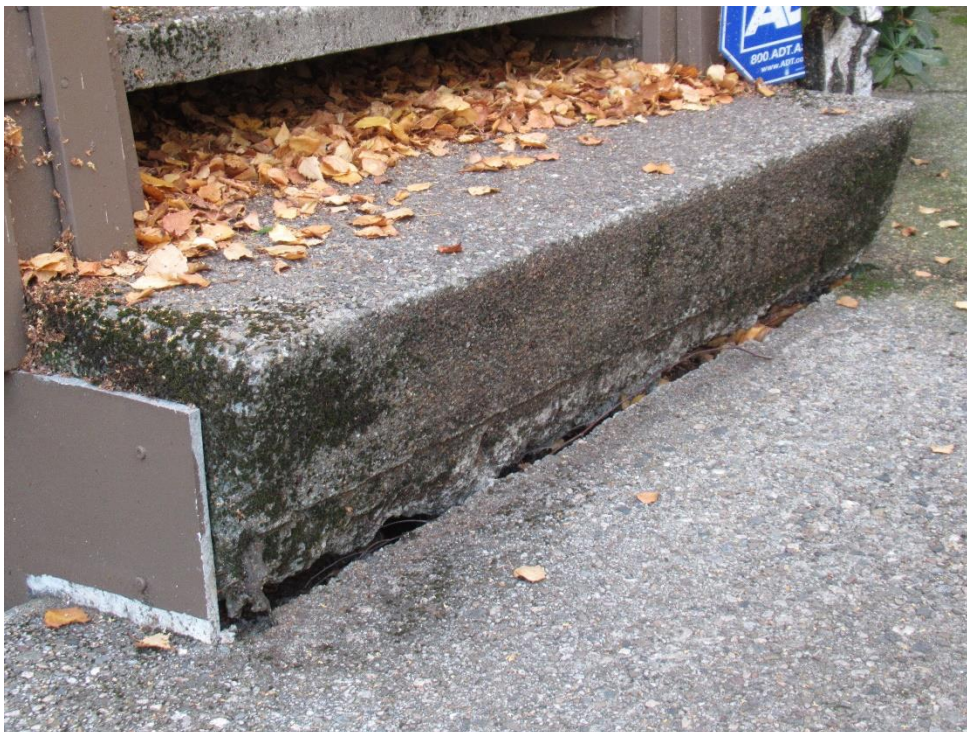
Figure 60. Base of entry stair with tall stair riser and gap between lowest riser and surrounding flatwork.
