March 1, 2023

## Harbortown SB326 Inspection Report

WJE No. 2022.3823

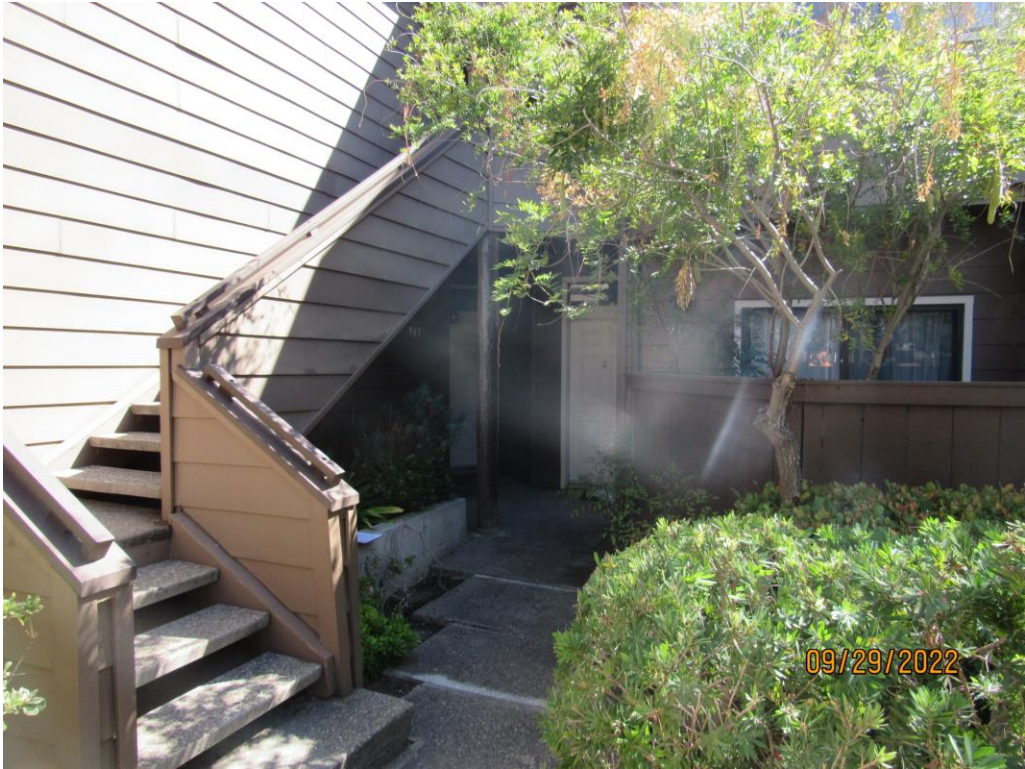
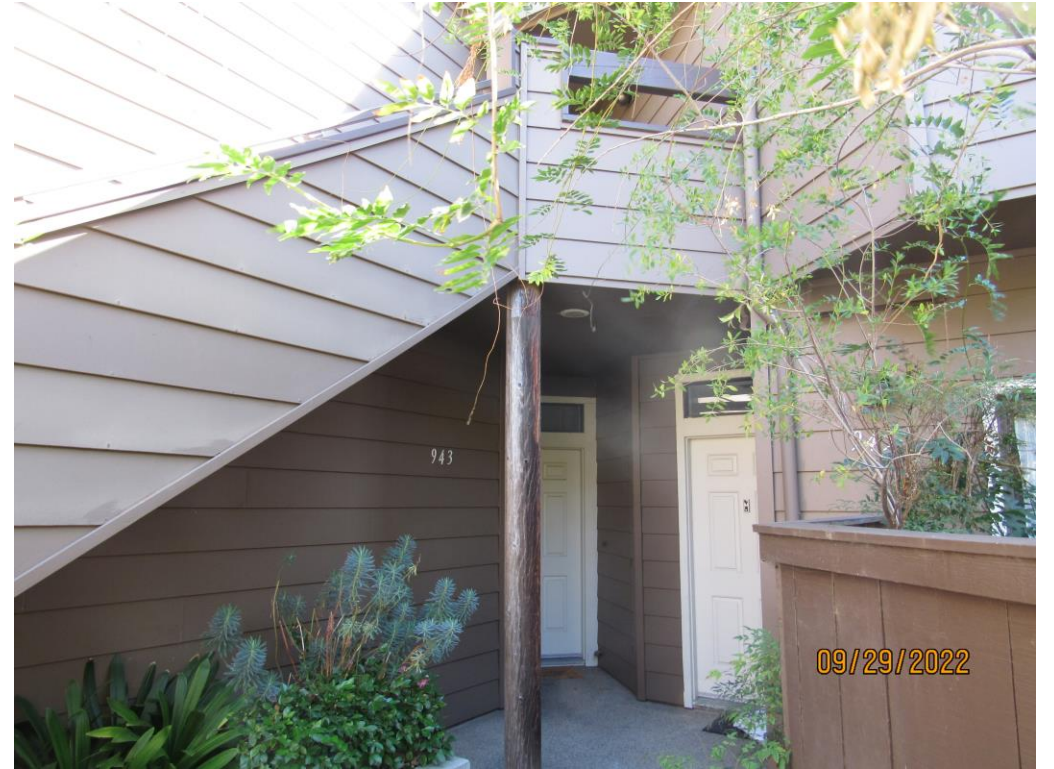
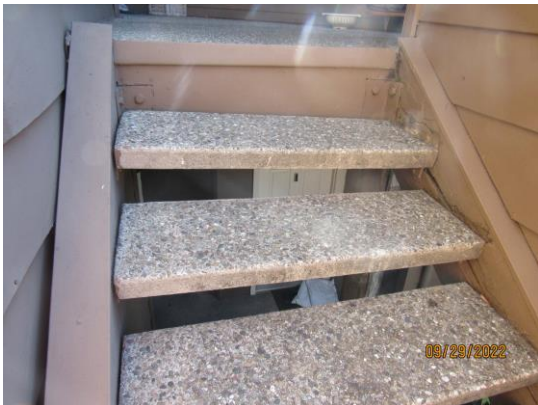
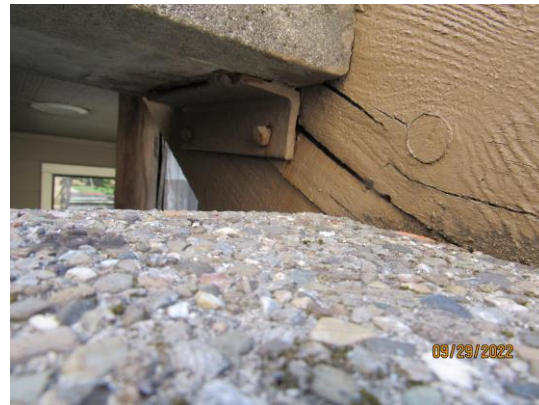
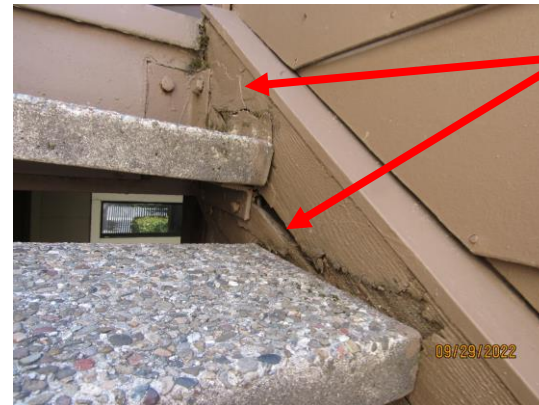
# Harbortown - 941 Shoreline Stair Repair (Building 26)

Significant decay damage and splitting of stringer at support. This stringer was observed to be shored on 10-24-2022.

As was communicated in our September 29 email, we recommend emergency temporary shoring of these stair stringers as soon as possible. Attached to this email are some annotated photos to clarify the type and location of damage that is prompting us to recommend shoring. We would be happy to discuss the damage and reasons for shoring if that would be of help.

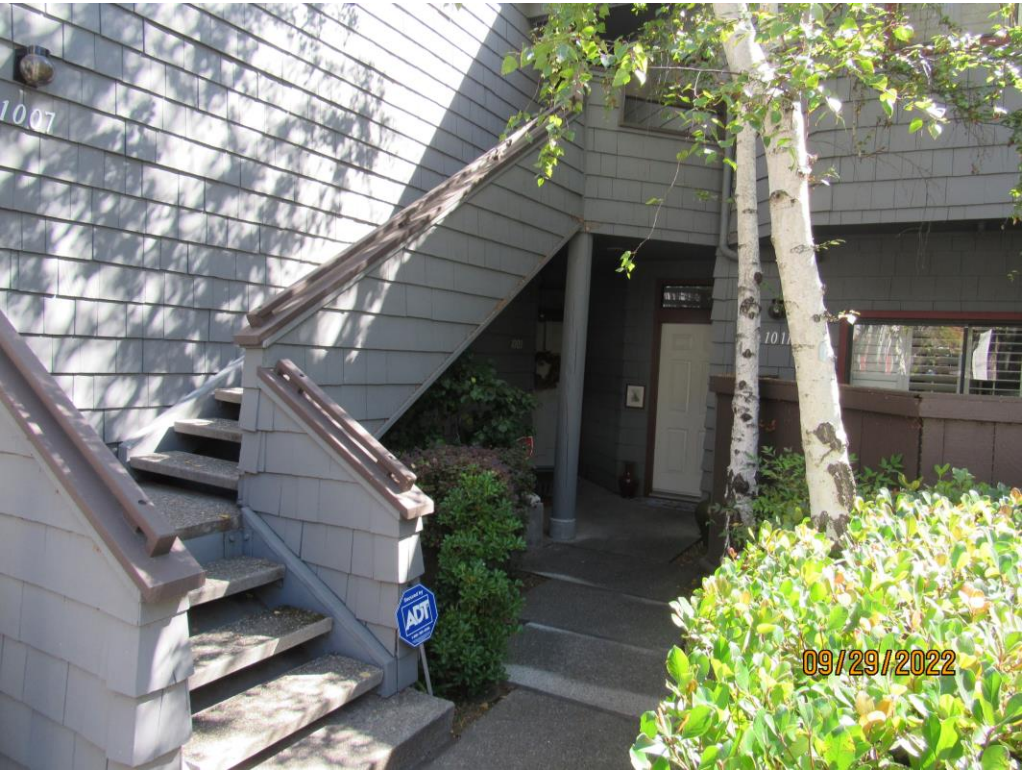
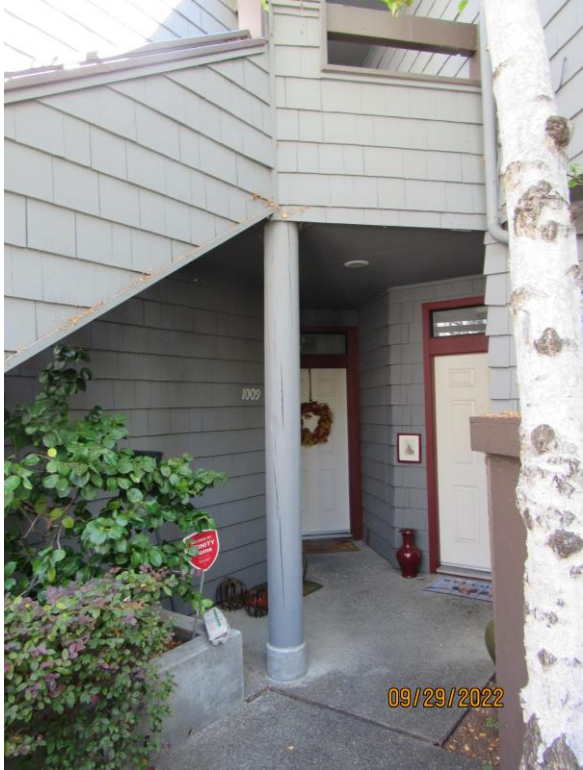
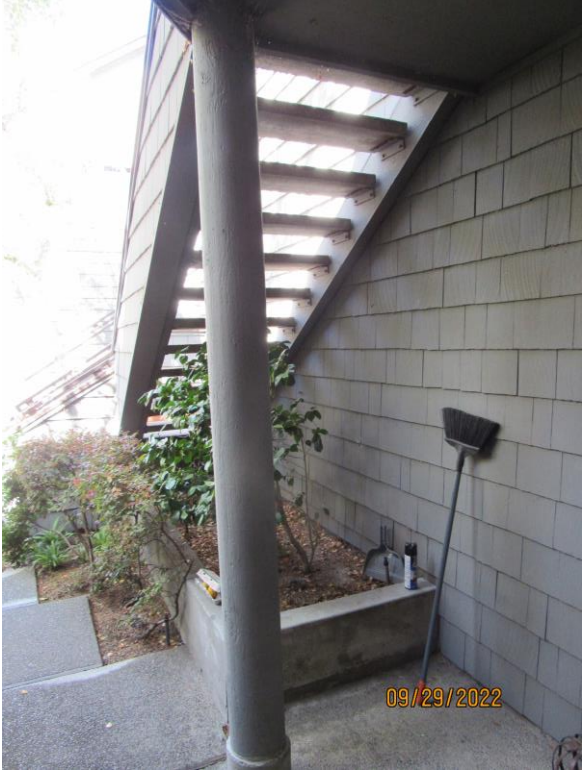
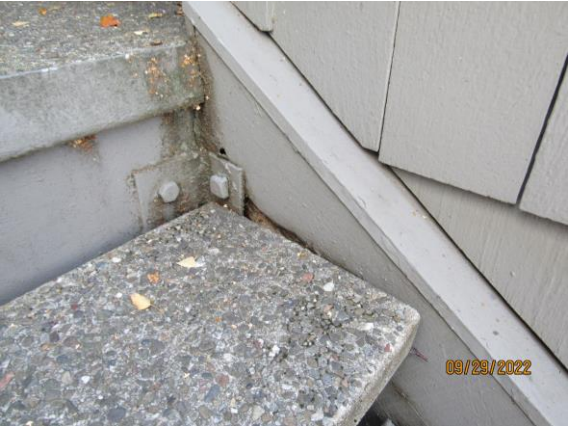
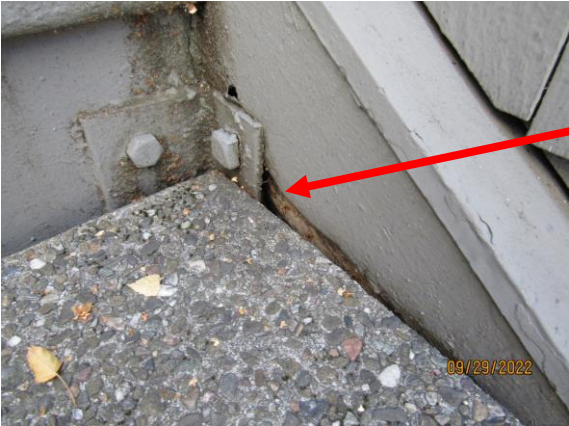
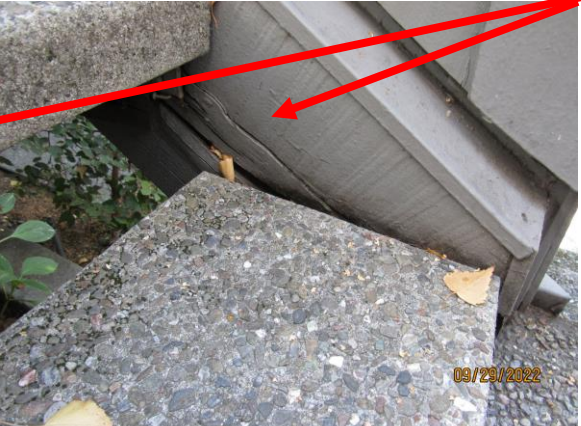
# Harbortown - 1007 Shoreline Stair Repair (Building 28)

Significant decay damage and splitting of stringer at top and bottom supports. This stringer has not been shored 10-24-2022.

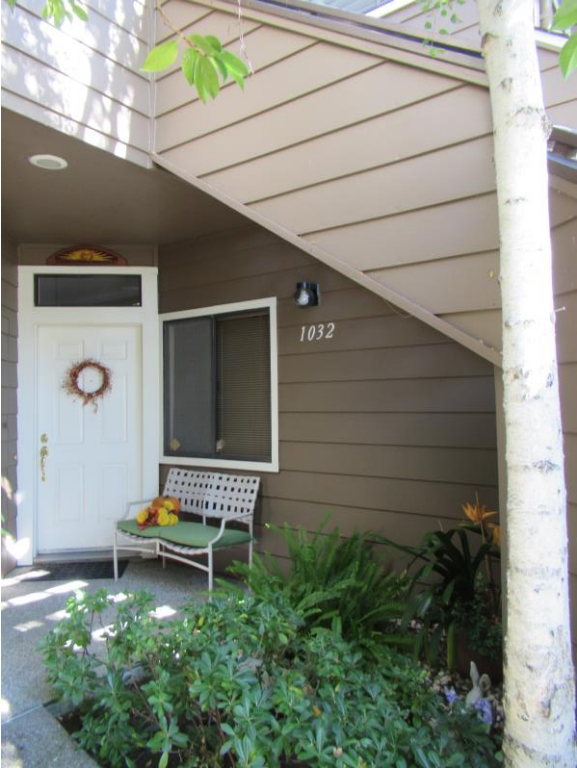
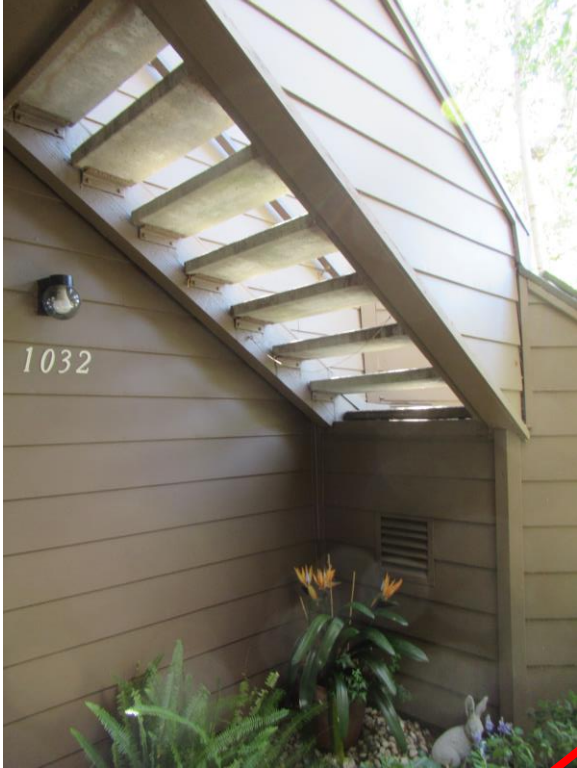
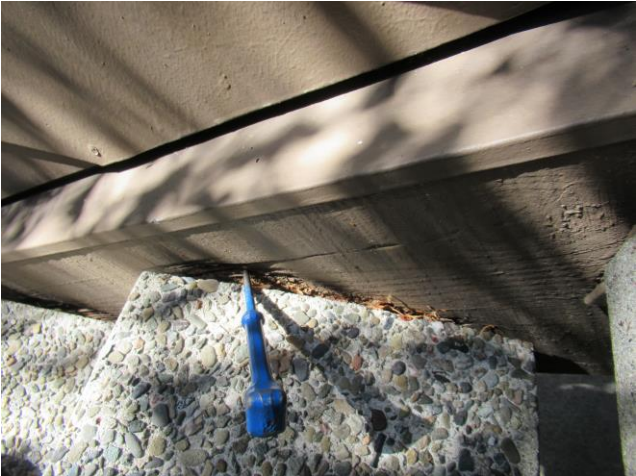
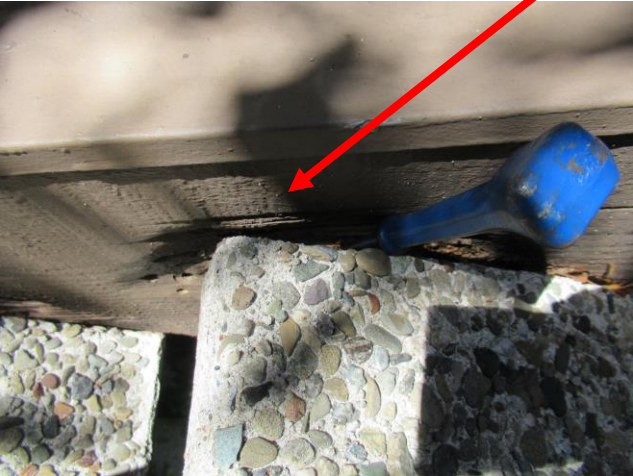
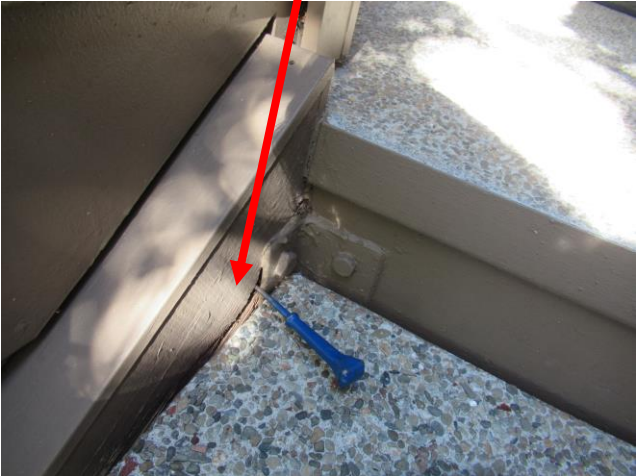
# Harbortown - 1030 Shoreline Stair Repair (Building 11)

Significant decay damage to stringer at top and bottom supports. This stringer has incomplete shoring 10-24-2022.

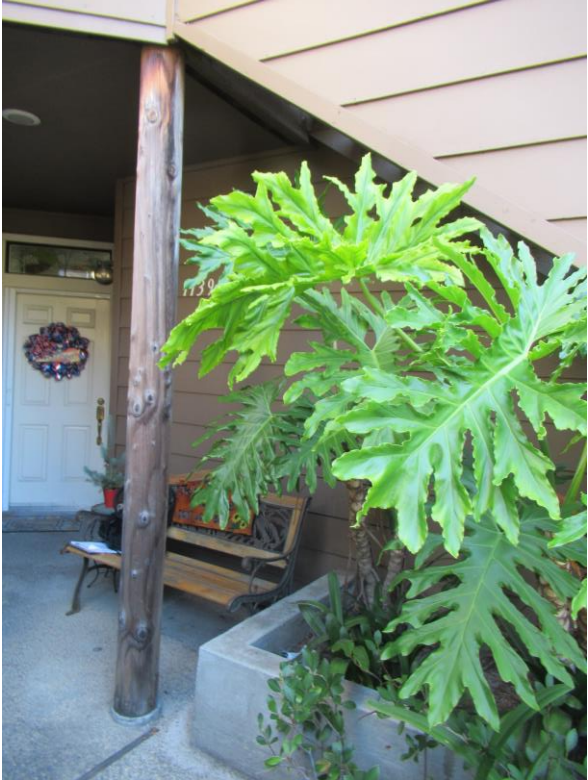
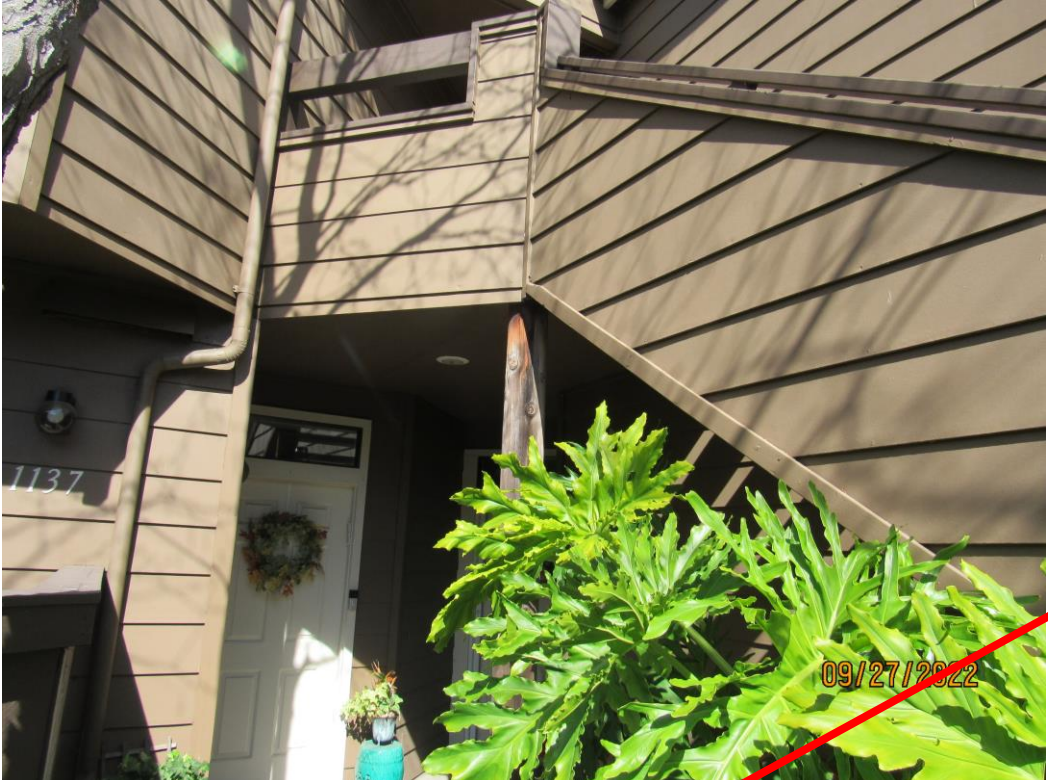
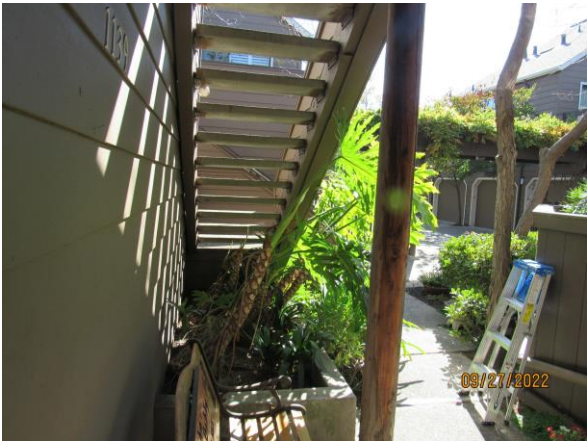
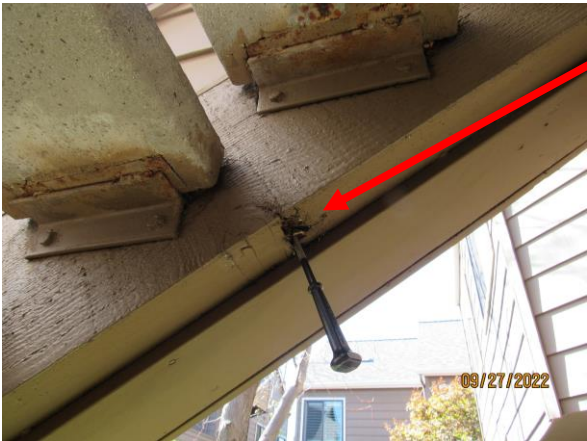
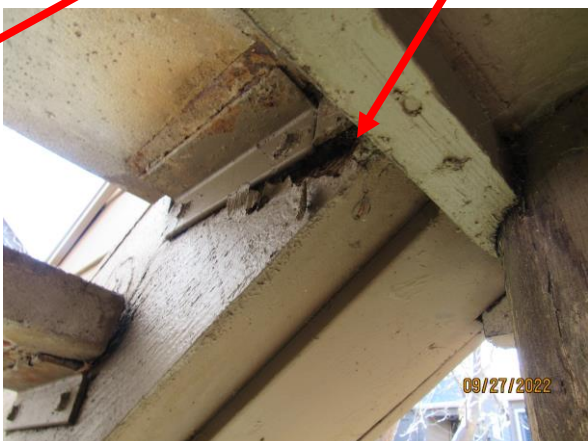
# Harbortown - 1141 Shoreline Stair Repair (Building 31)

Significant decay damage to stringer at top support. This stringer has not been shored 10-24-2022.
