Harbortown

San Mateo, CA

INVASIVE BUILDING REVIEW

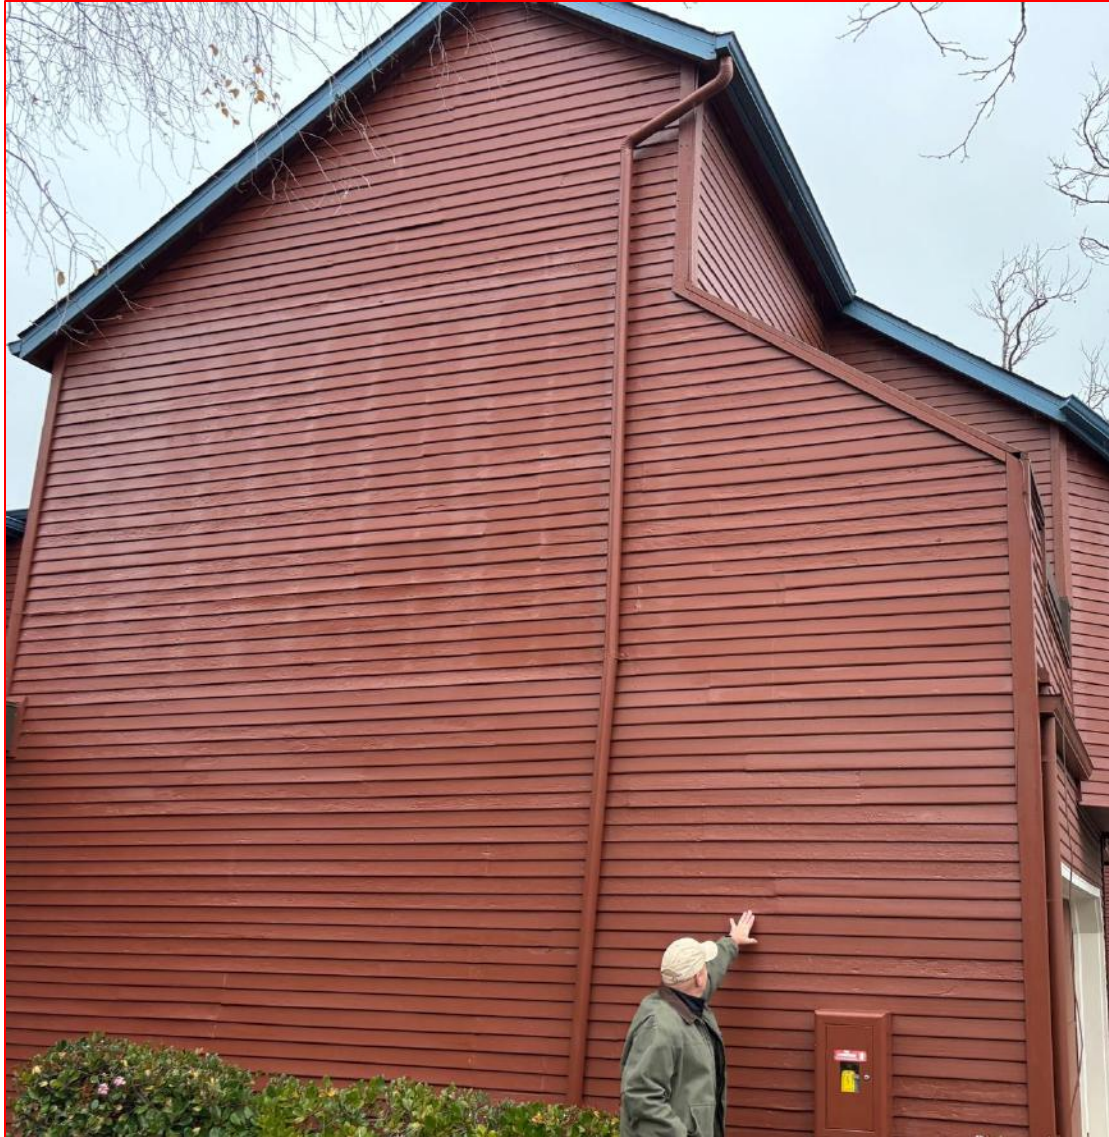
Spot Repaired Aged and Worn Painted Wood Siding. Noted signs of moisture transfer, blistering paint, peeling paint, UV degraded, decayed with visible signs of top grain eroded surfaces

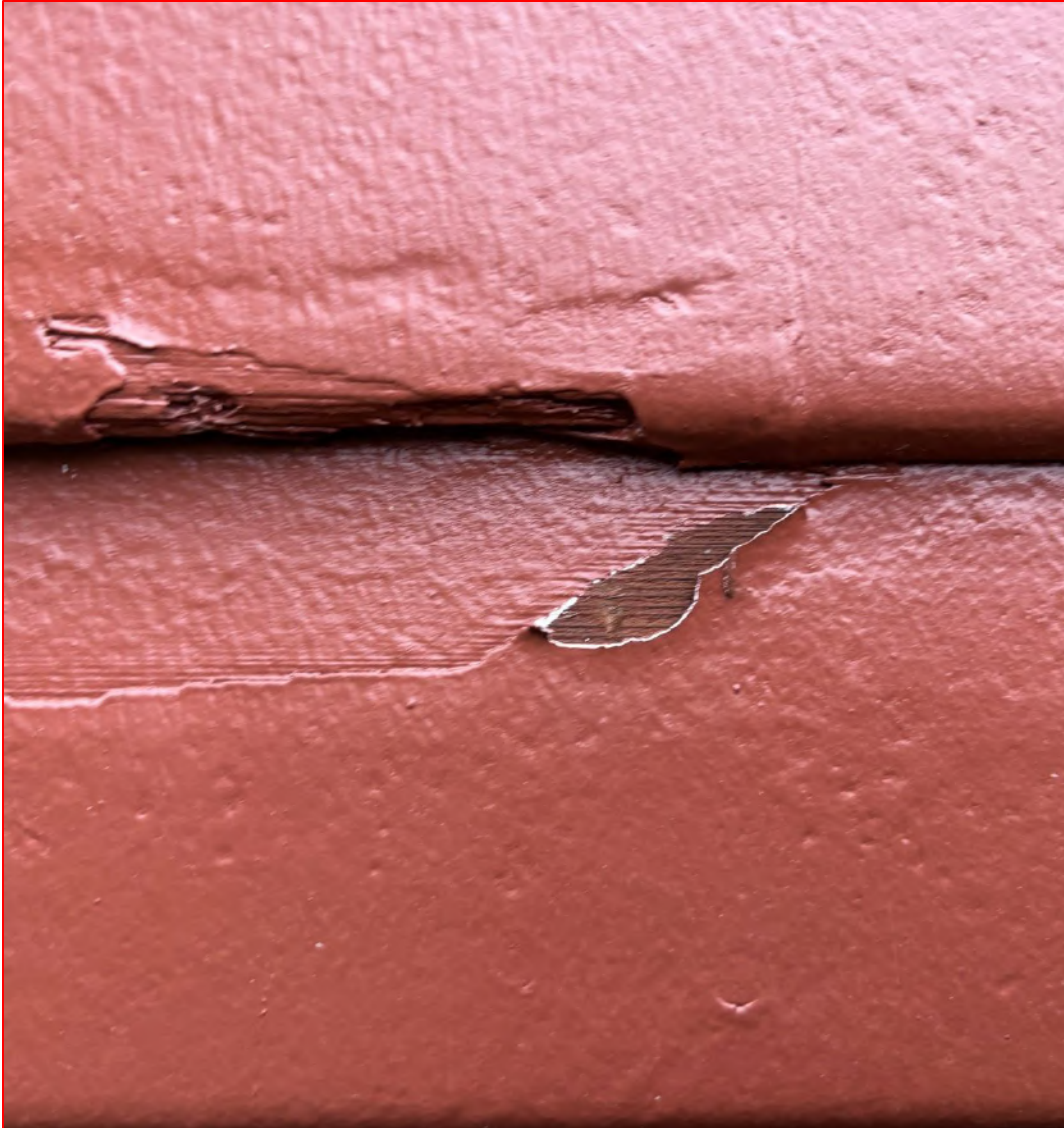
Visible Adhesion and Coating Failures on recently painted wood siding surfaces - Pervasive

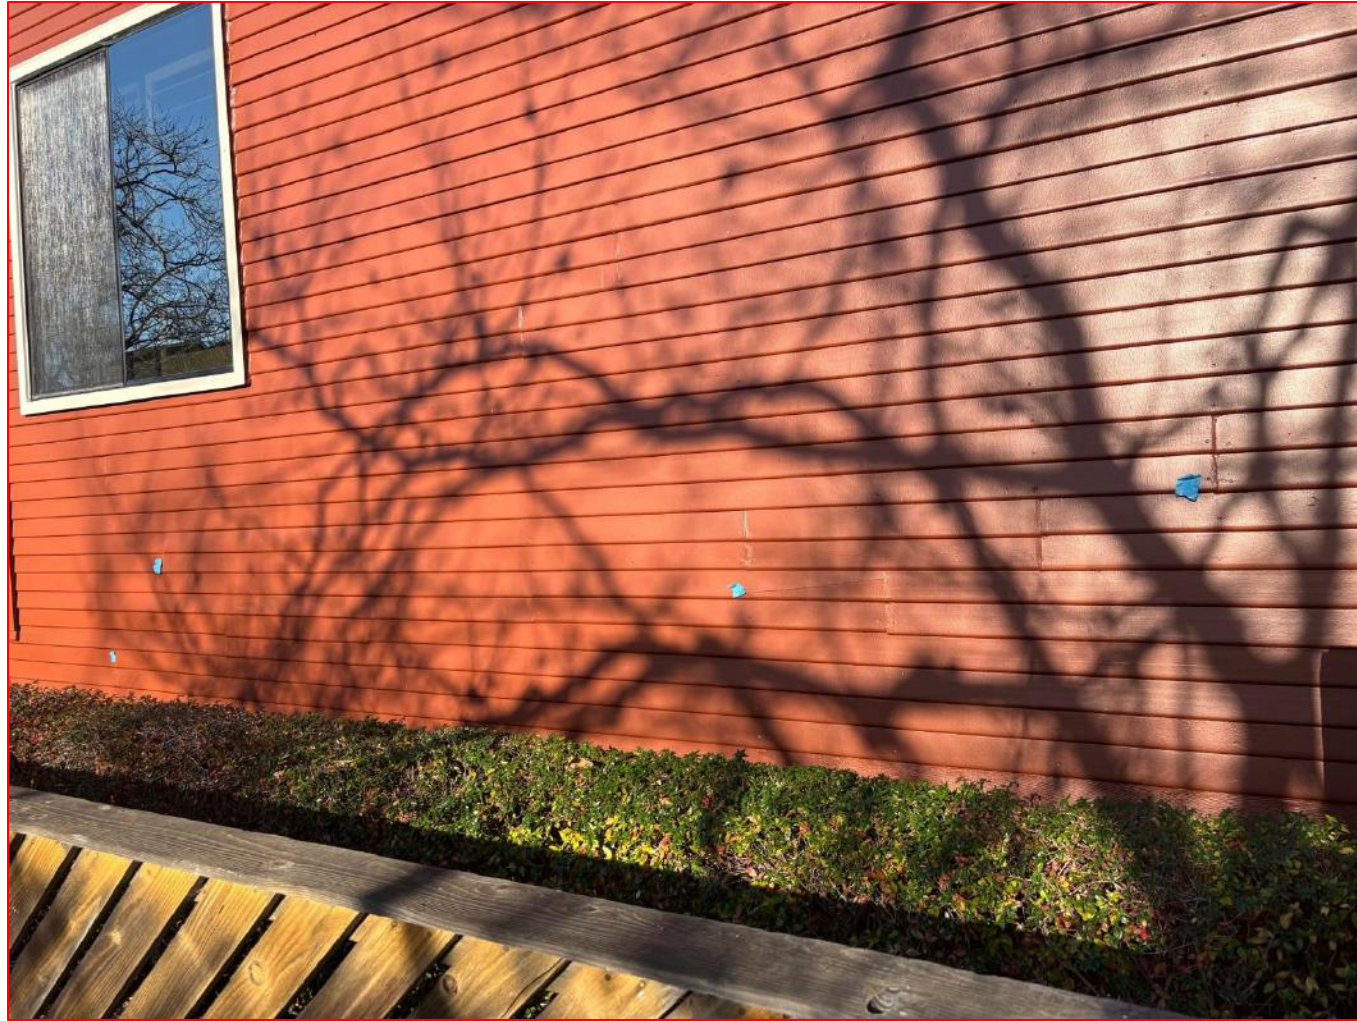
Noted recently painted wood siding surfaces with visible blisters, peeling, bubbles, and marked repairs

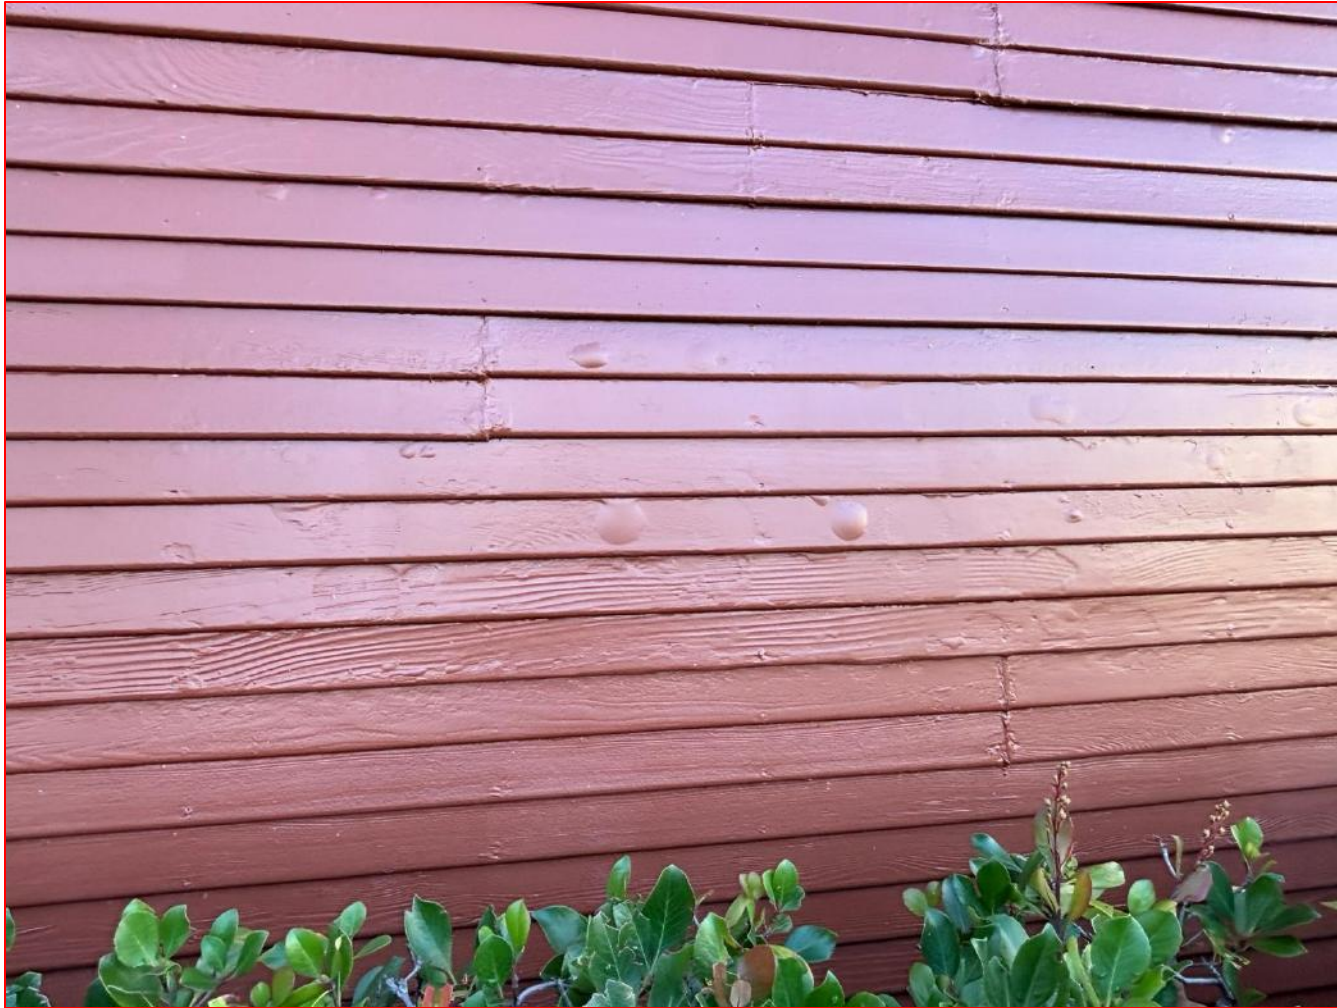
Noted dated and spot-replaced lap siding with stacked joints, overlaps, and signs of excessive moisture transfer - blisters

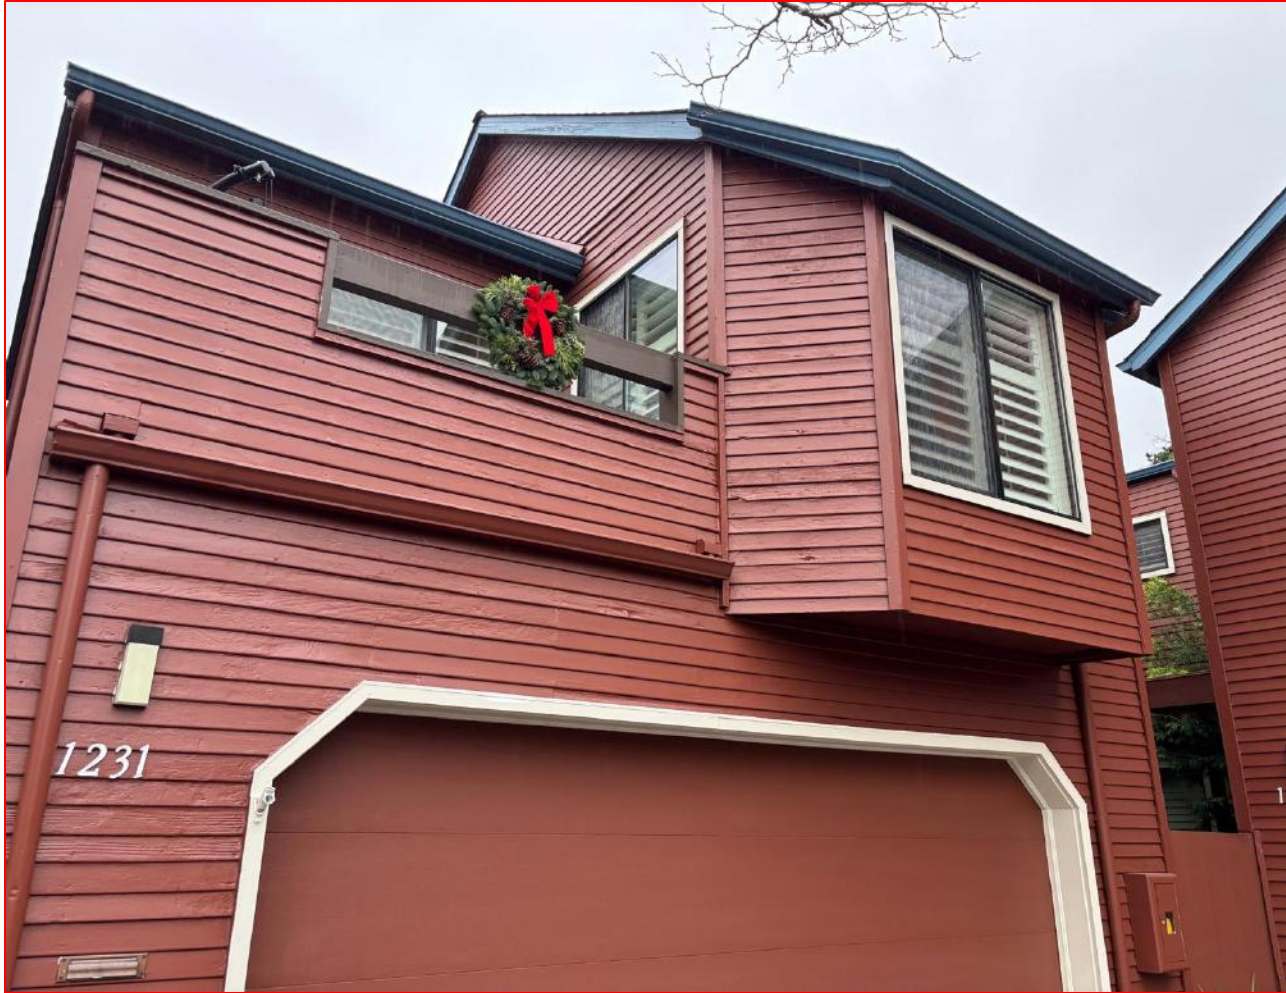
Aged, Worn, and Decayed Wood Siding Surfaces - Pervasive

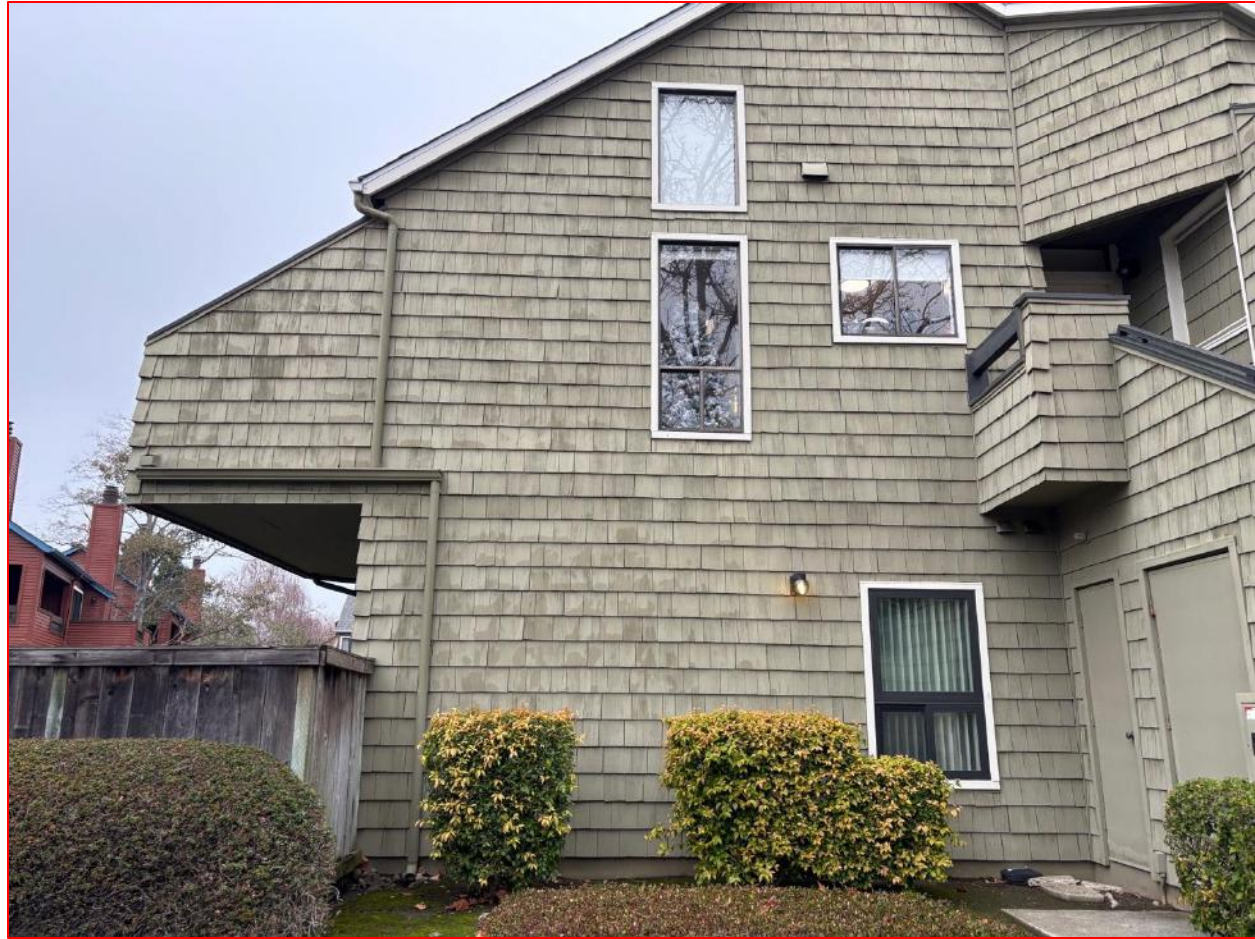
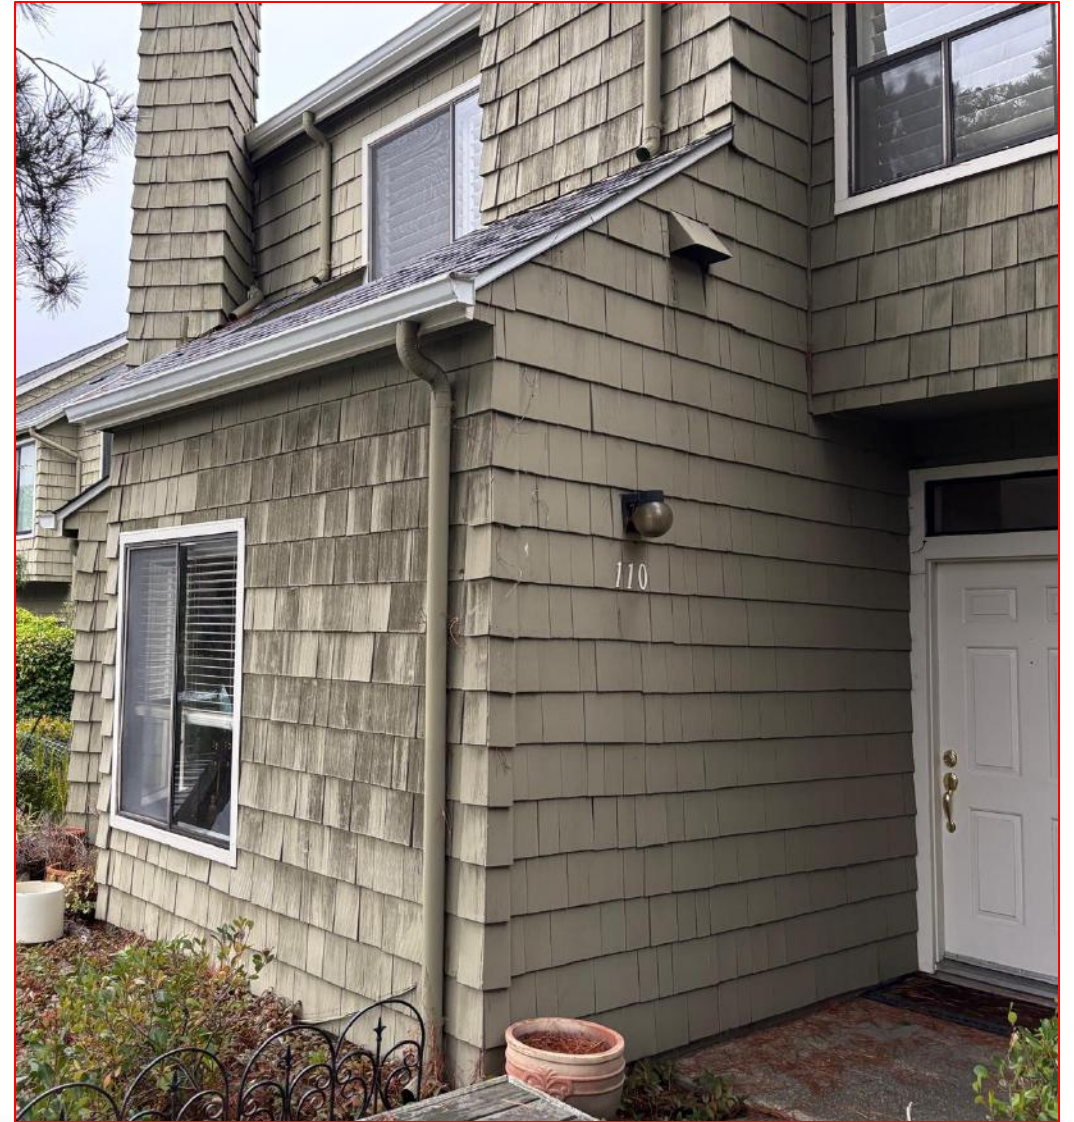
Aged and Worn Wood Shingles, Wood and PVC trim, Visible Signs of UV Degraded Shingle Surfaces, and Excessive Moisture Transfer

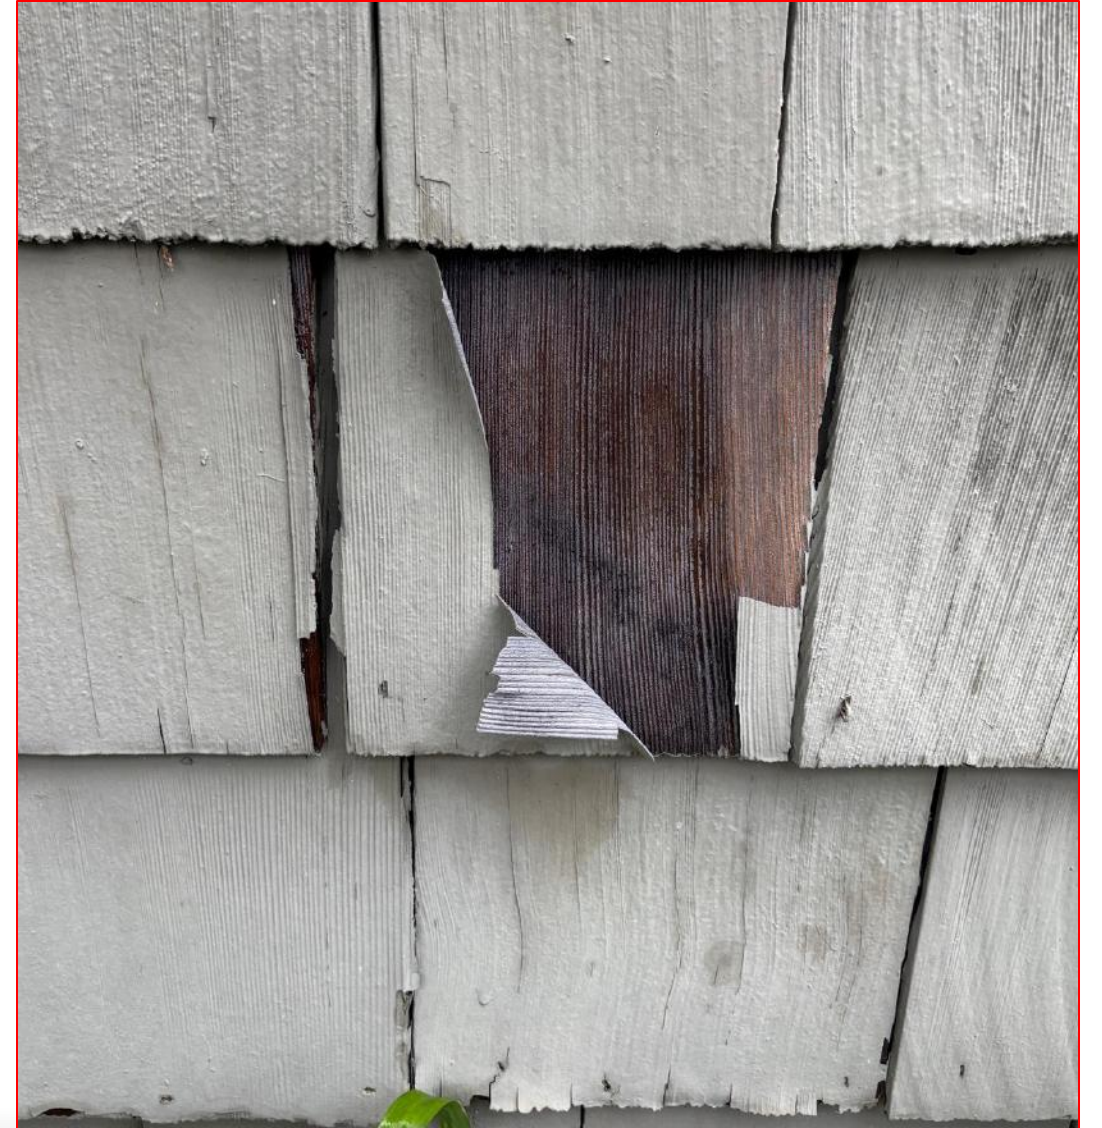
Adhesion and Coating Failures - Pervasive

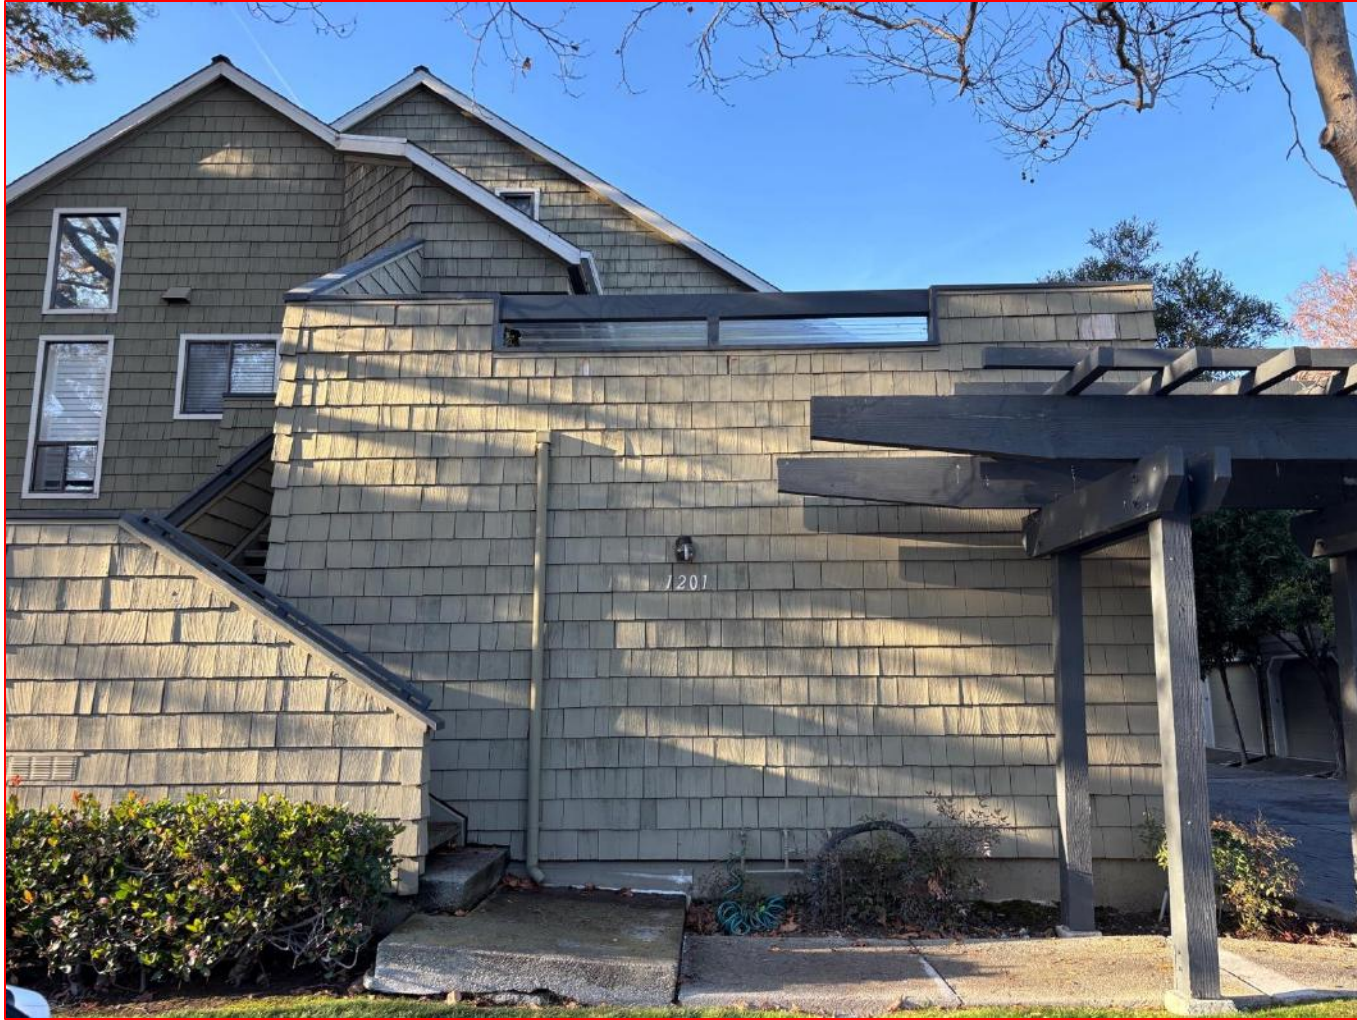
Cupped, Curled, and Decayed Wood Shingles - Pervasive

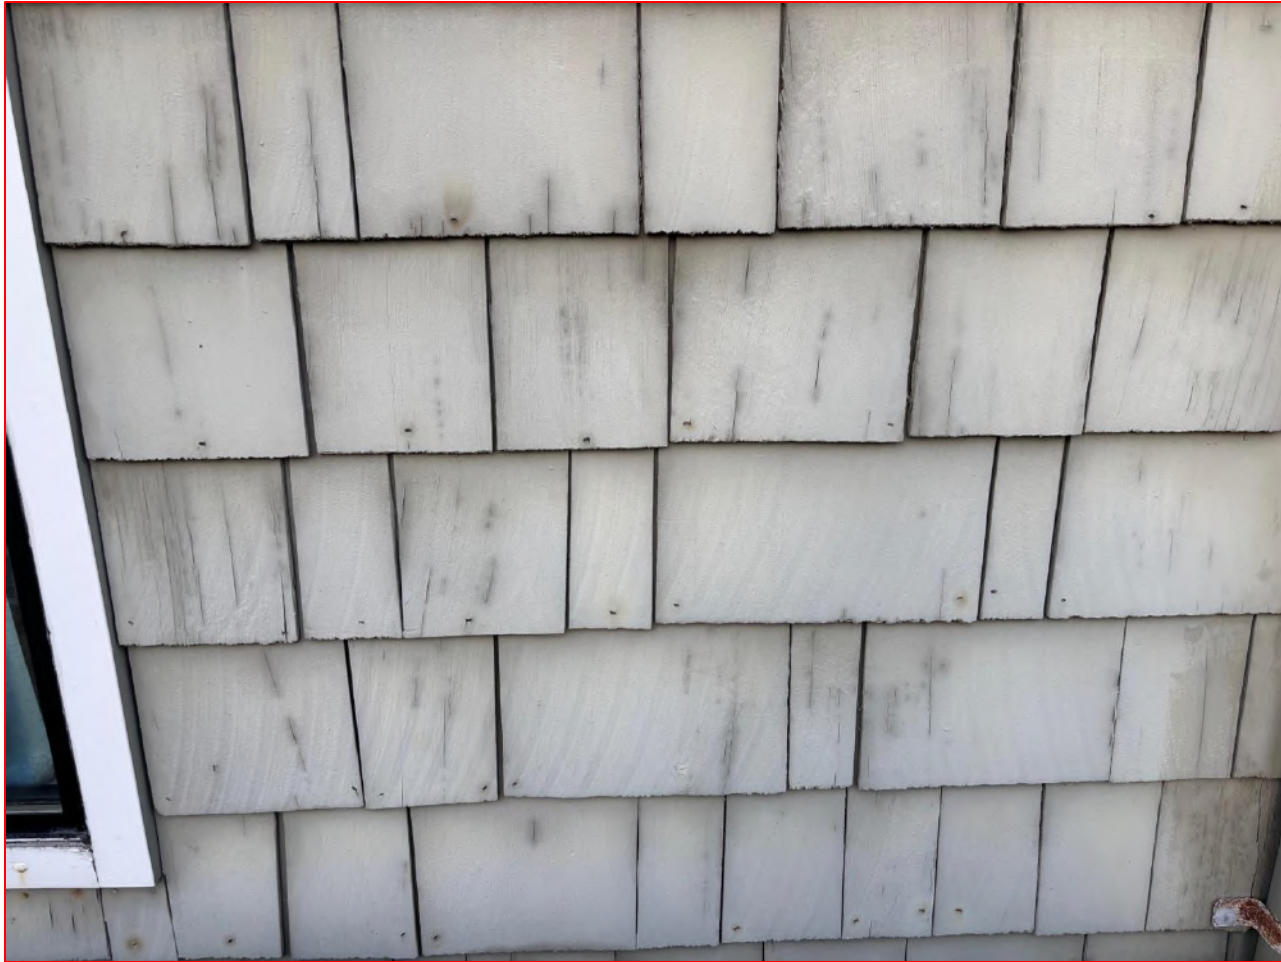
Adhesion and Coating Failures - Pervasive

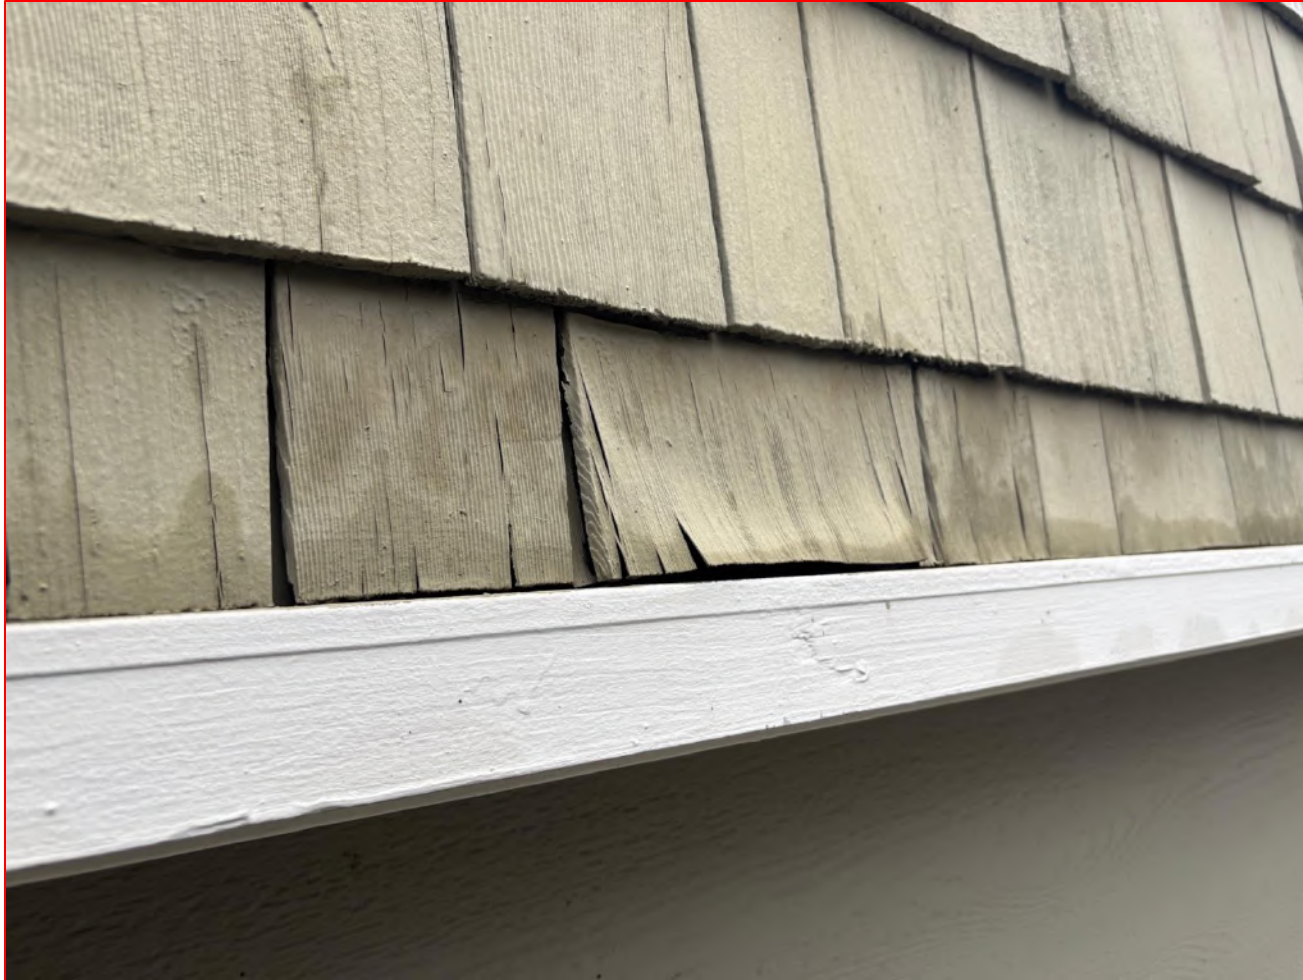
Adhesion and coating failures on shingles and visible gaps exposing sheathing

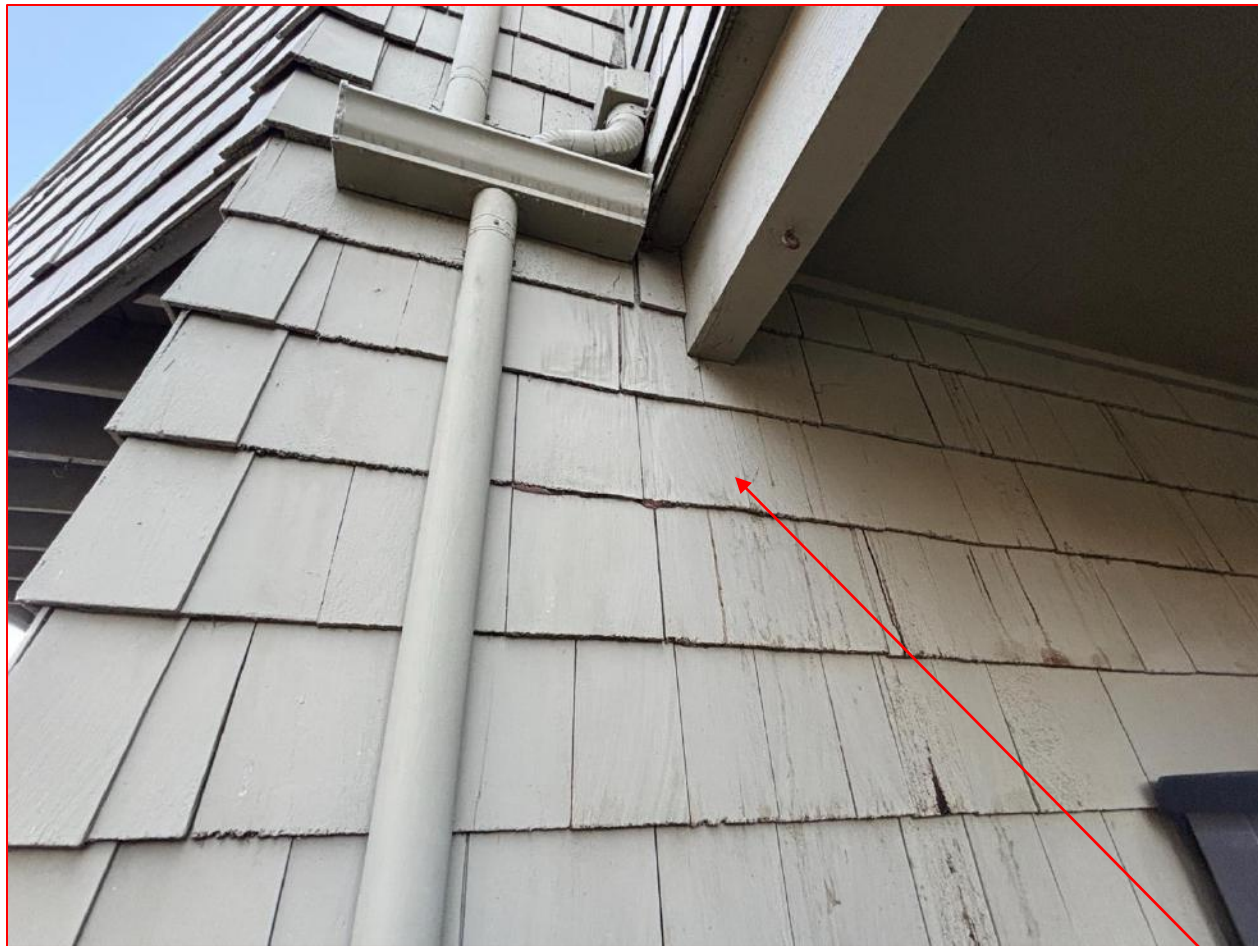
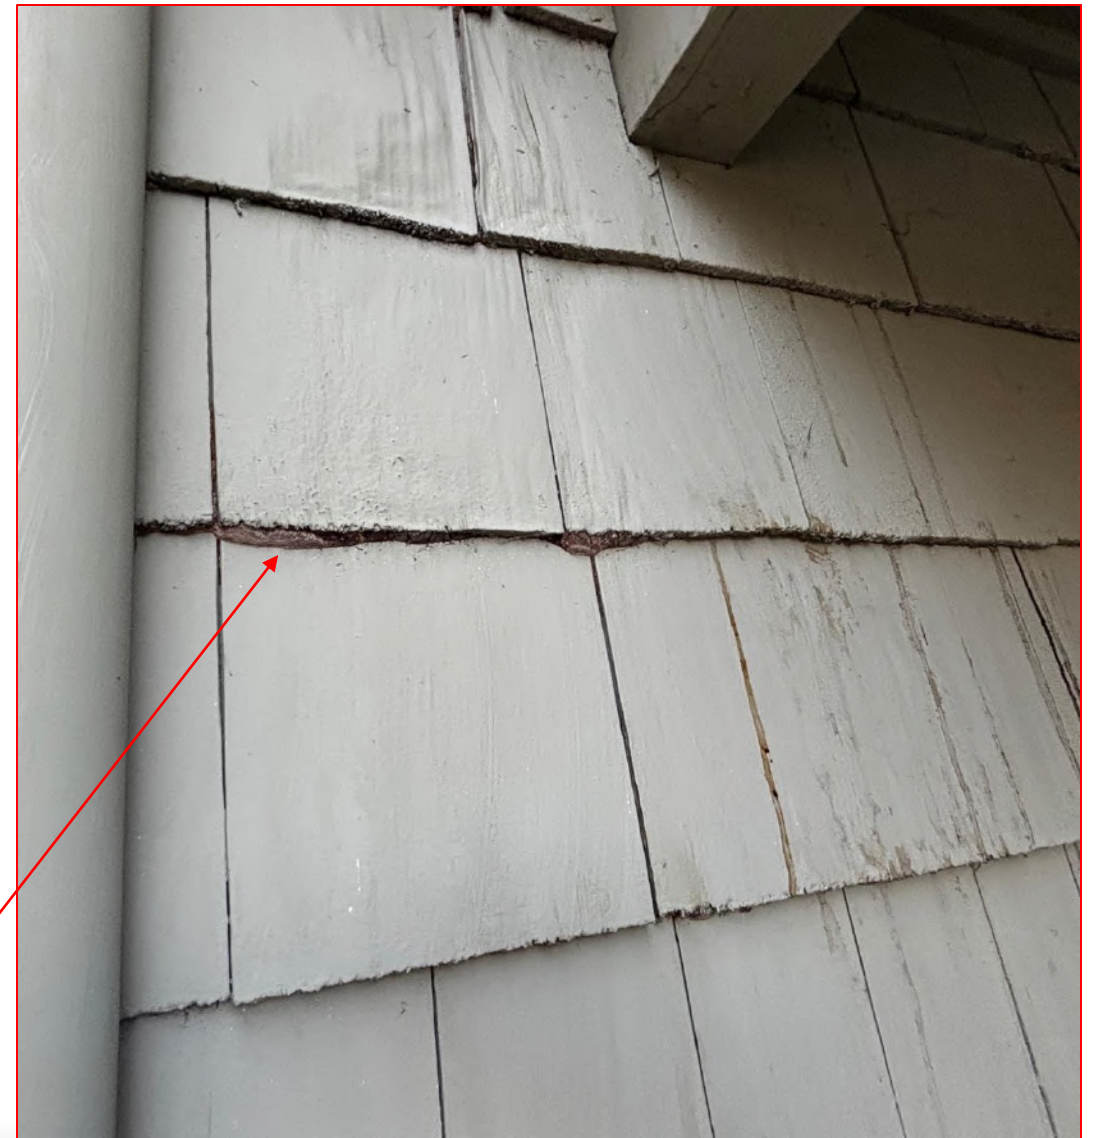
Visible signs of excessive moisture intrusion from deck above.
Note organic growth and rotting wood shingles

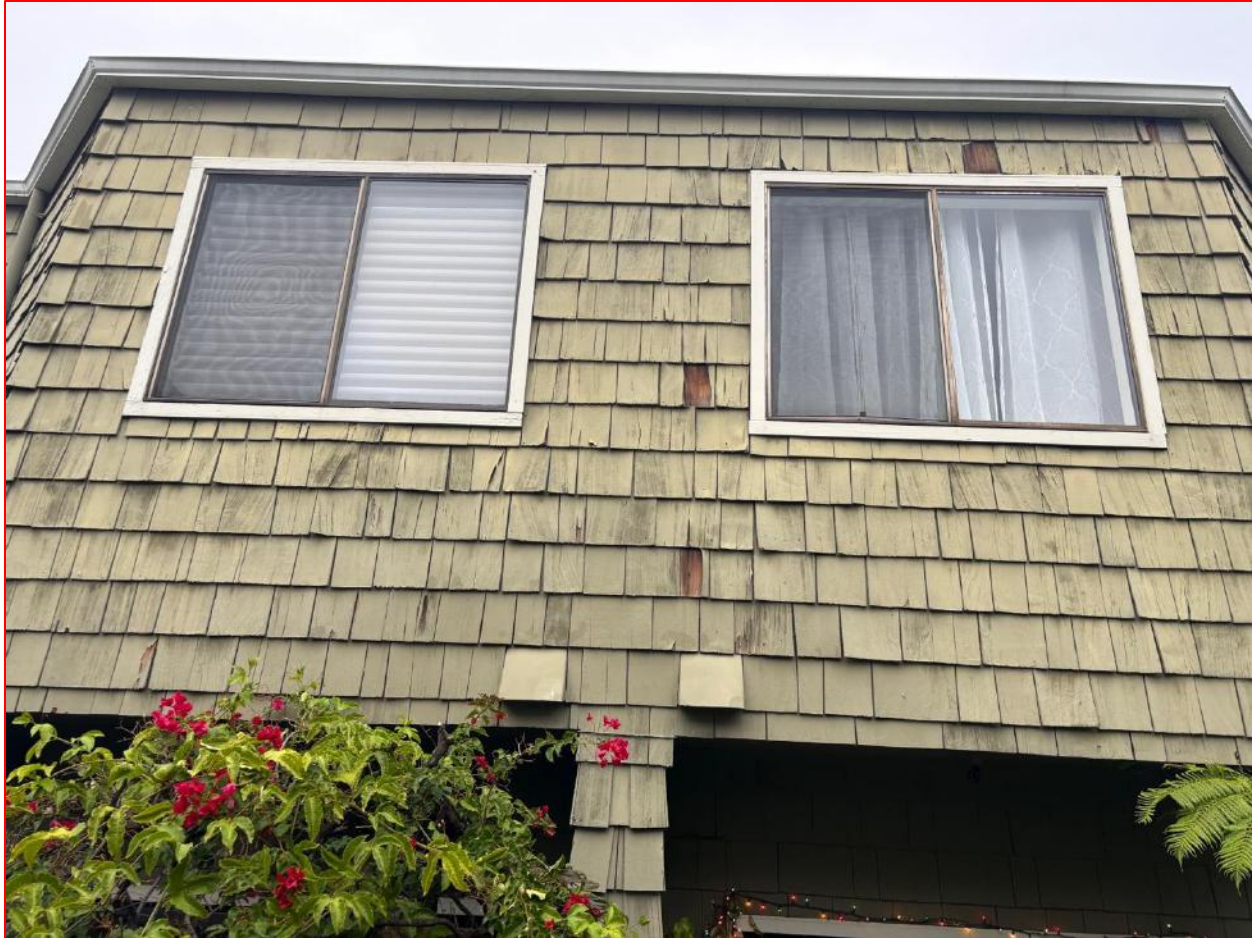
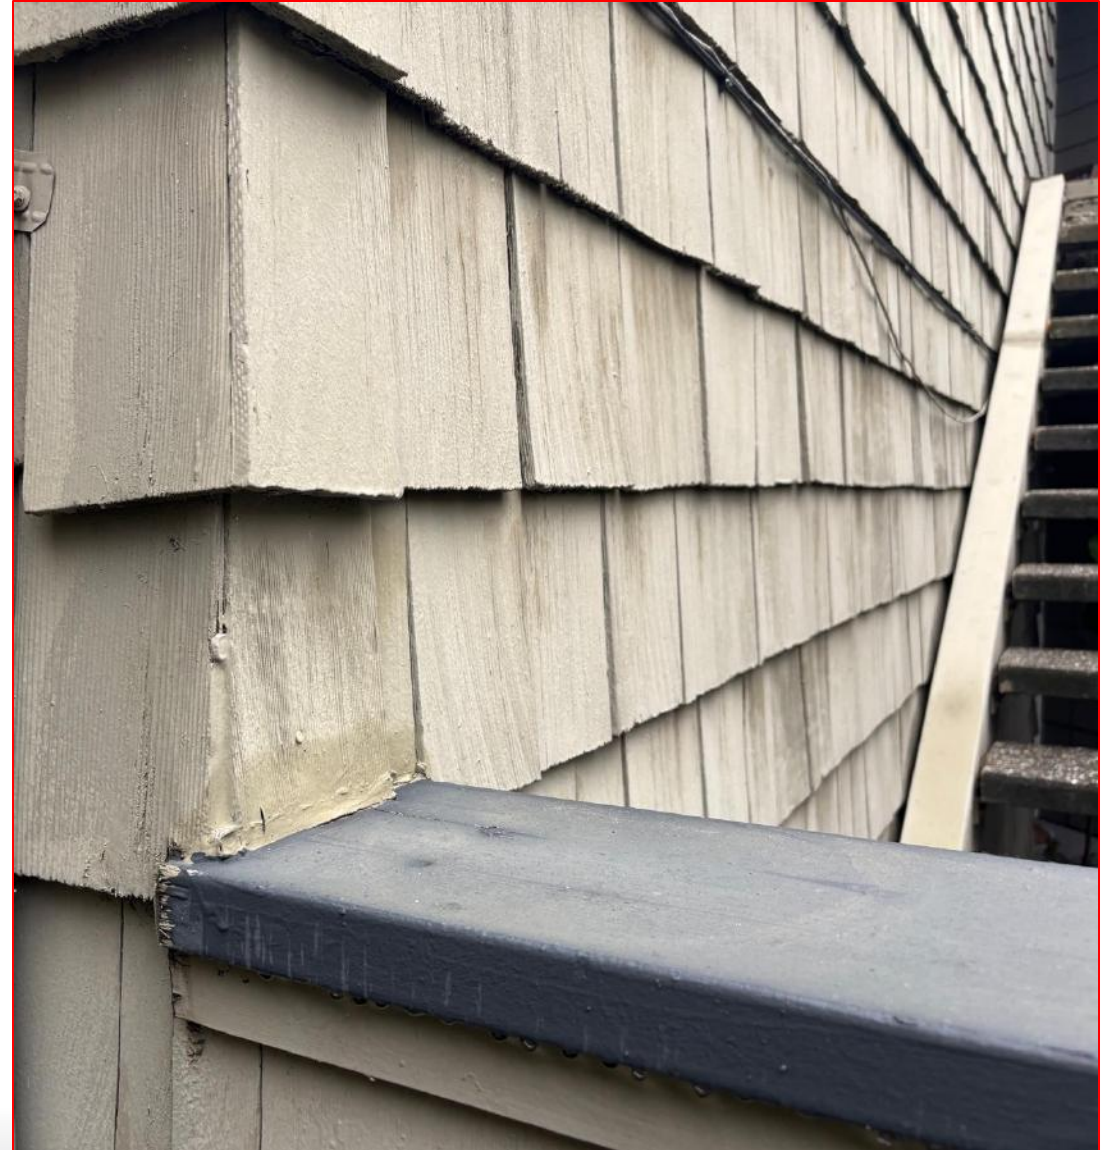
Cupped, curled, UV faded, and missing wood shingles. Noted signs of excessive moisture intrusion behind the siding

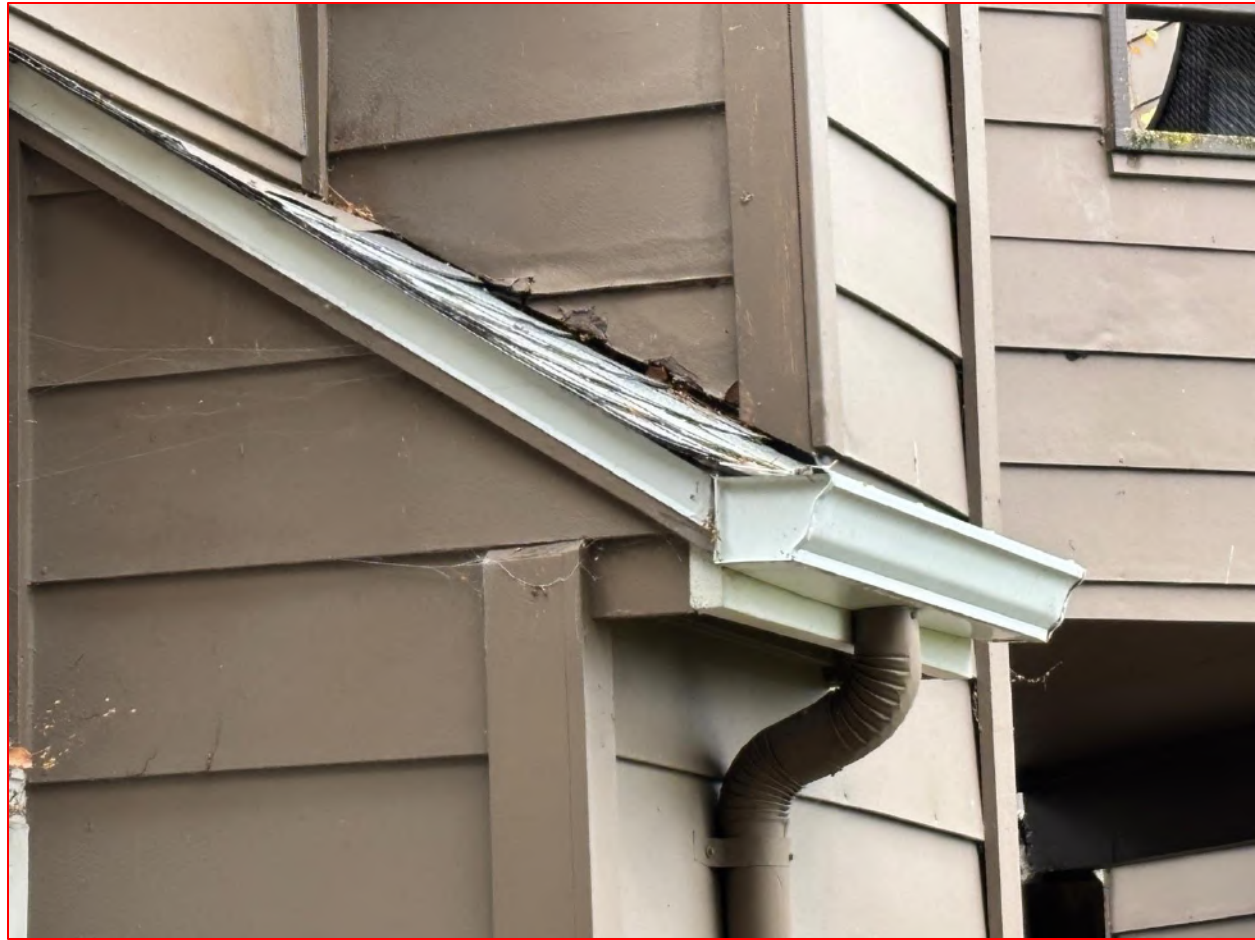
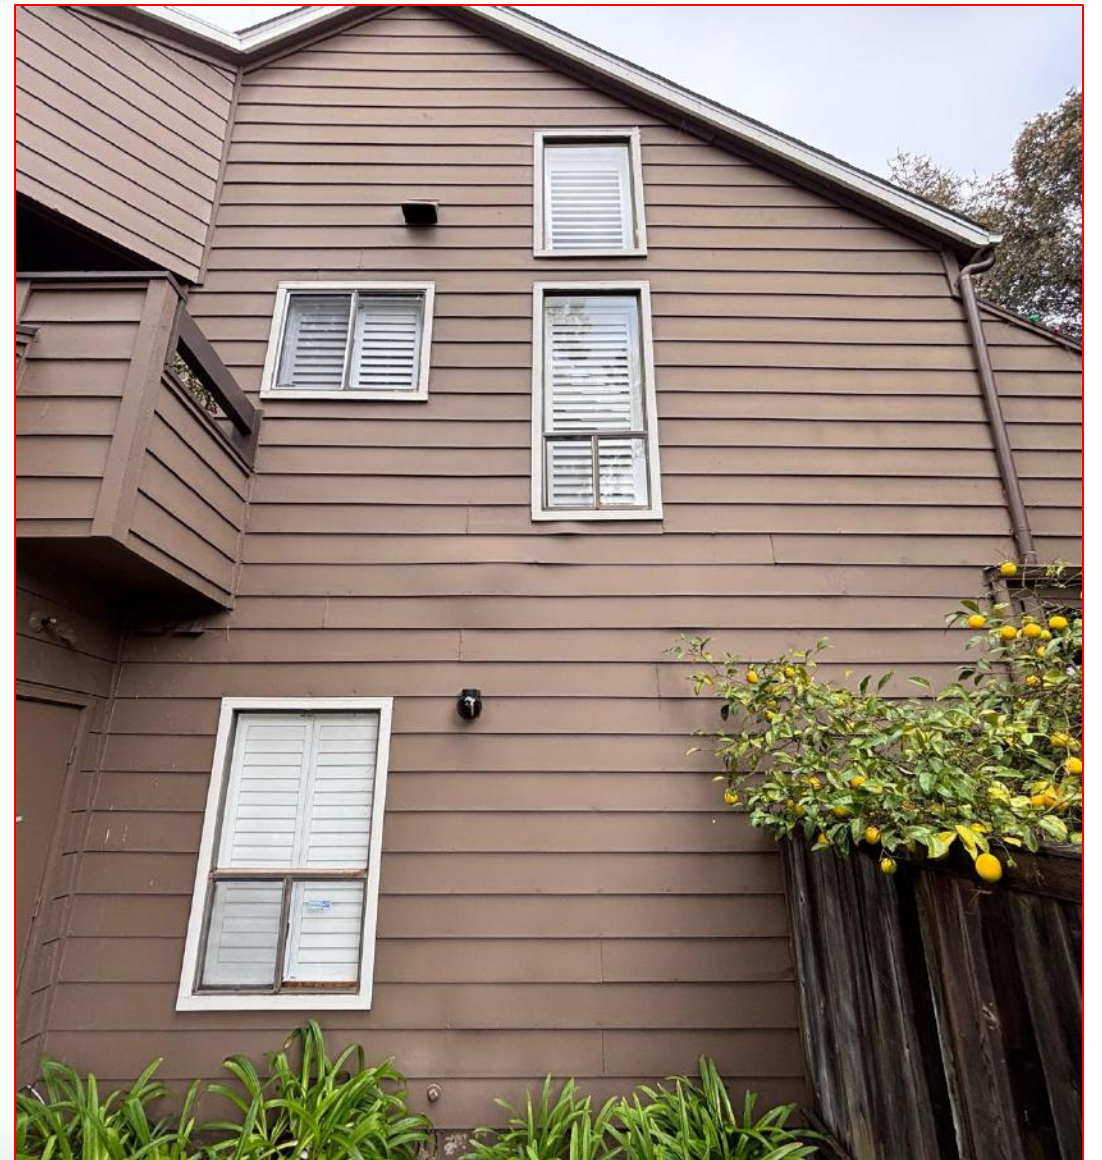
Visibly deteriorated lap siding at roof line transitions. Signs of moisture intrusion and wall damage below windows and penetrations.

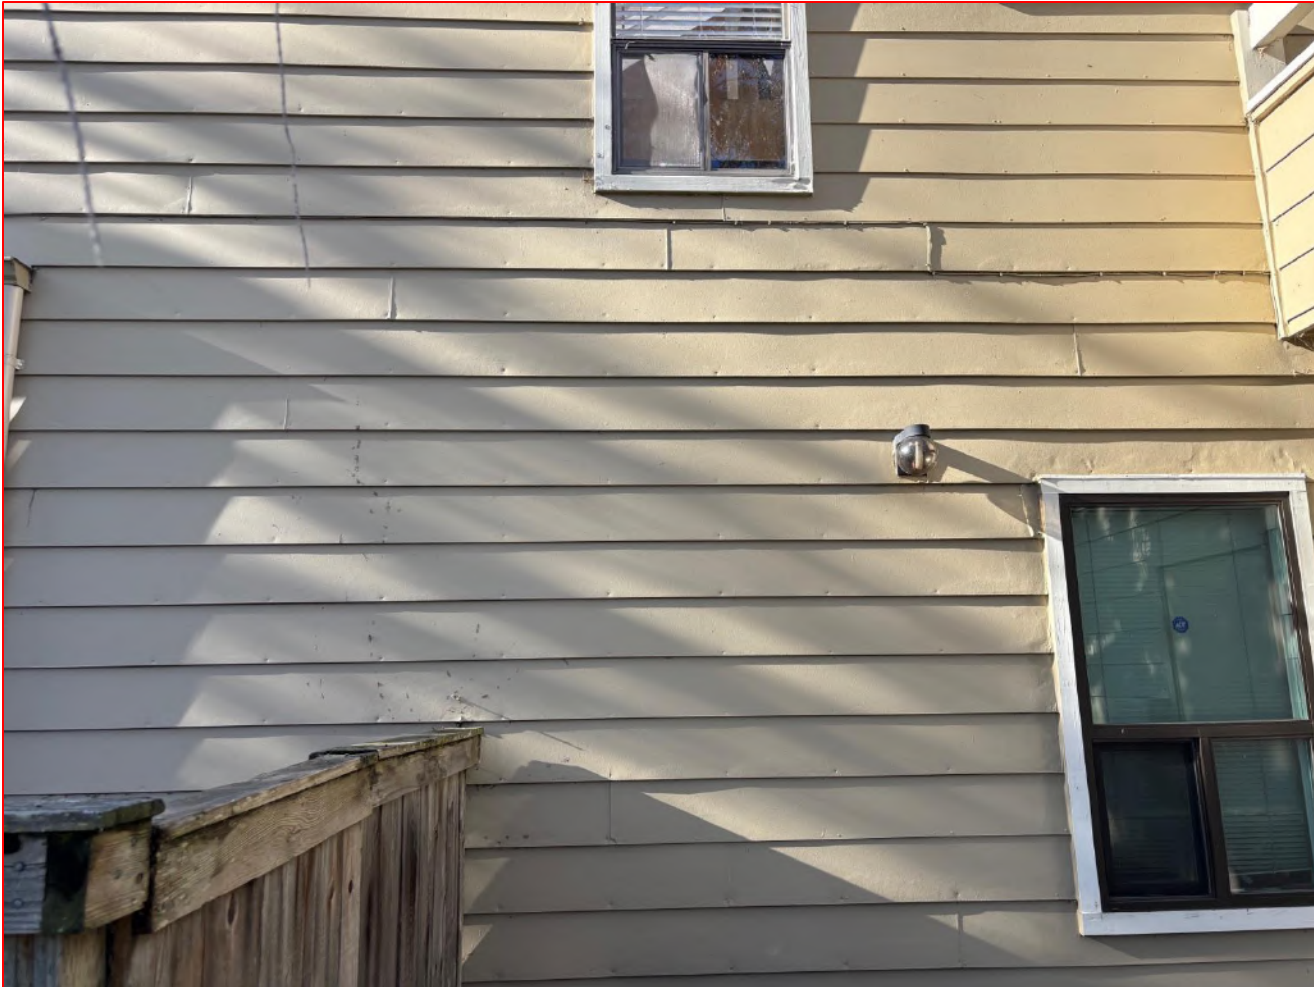
Noted moisture-damaged and deteriorated lap siding below numerous windows and balcony transitions.
