Harbortown

San Mateo, CA

INVASIVE BUILDING REVIEW

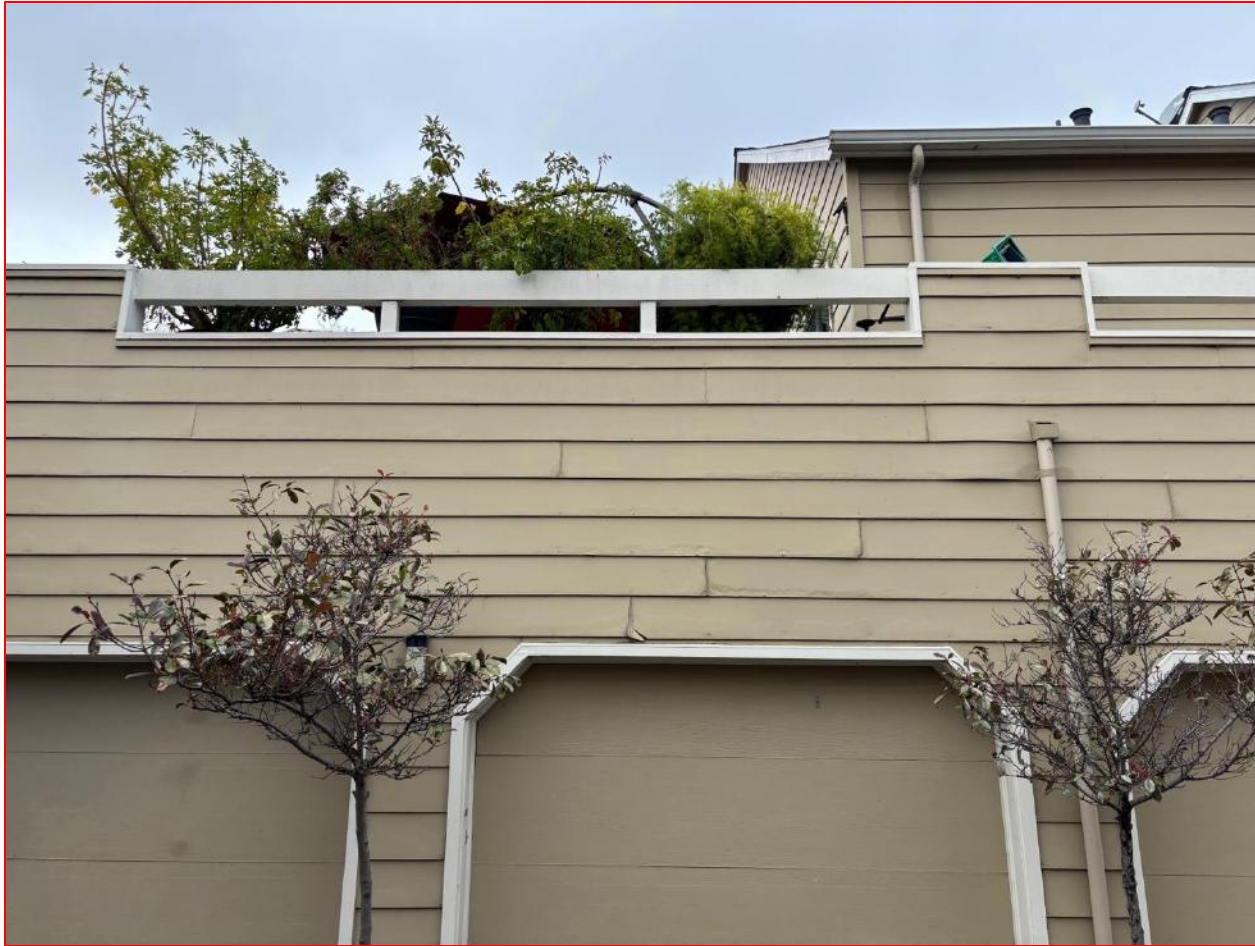
Noted moisture-damaged and deteriorated lap siding below numerous windows and balcony transitions.

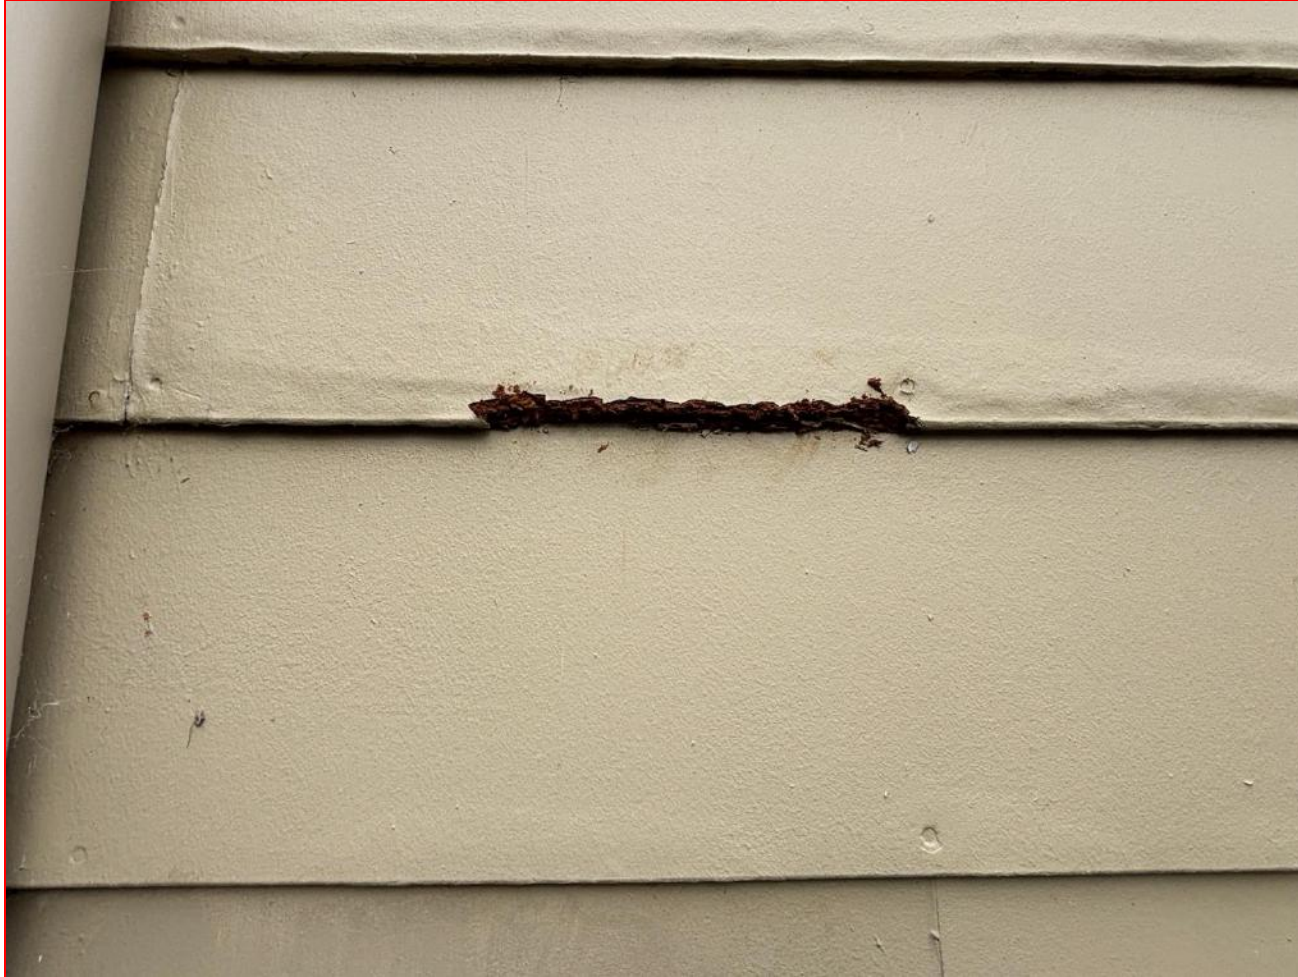
Noted moisture-damaged and deteriorated lap siding - Pervasive

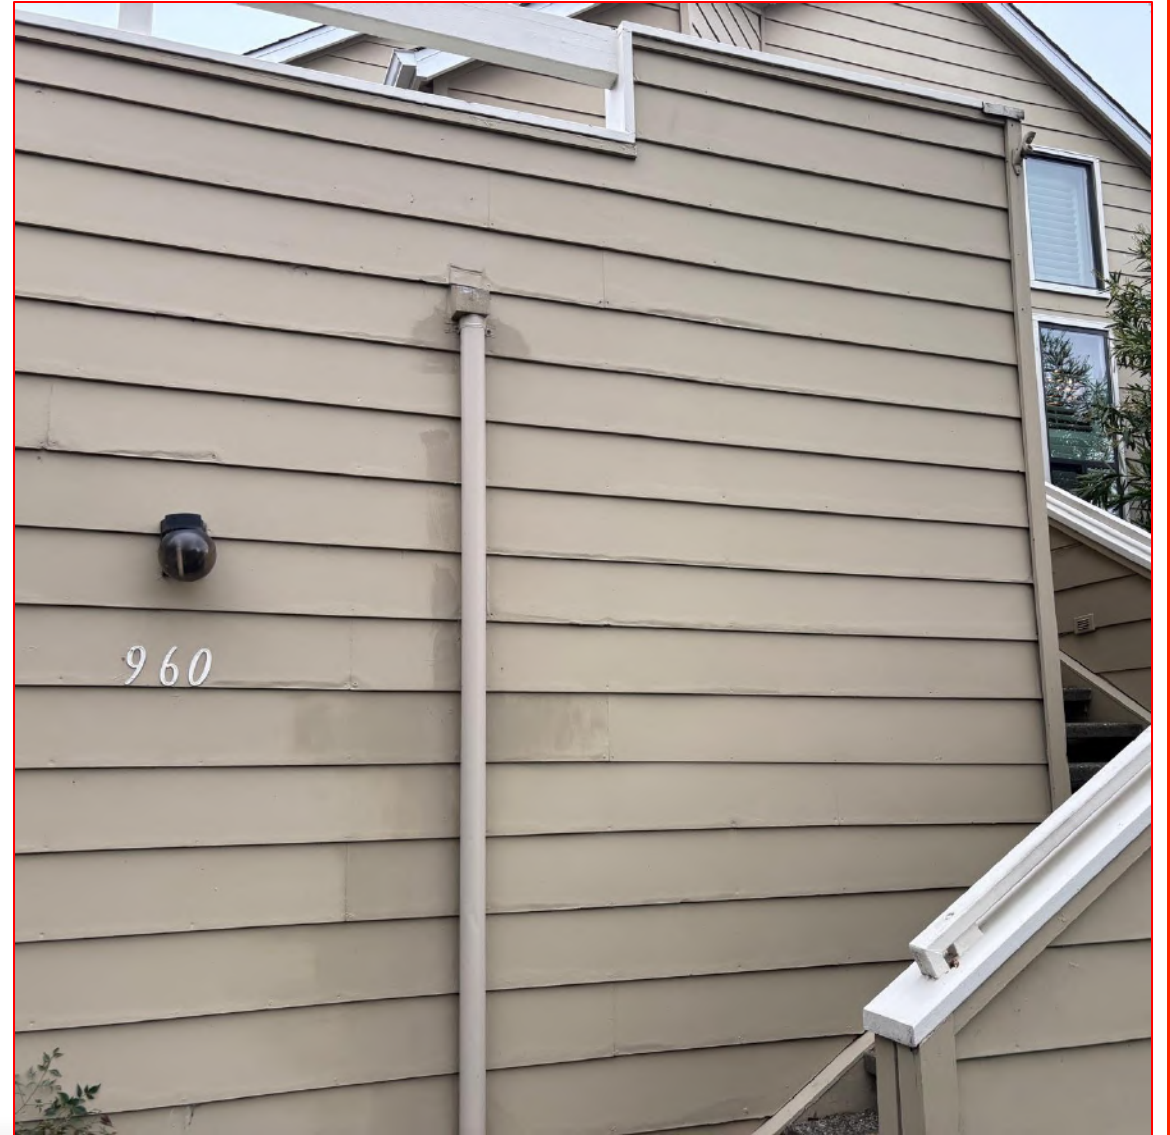
Spot repair locations of aged and worn compressed fiber siding. Note swelled siding and rusting fasteners

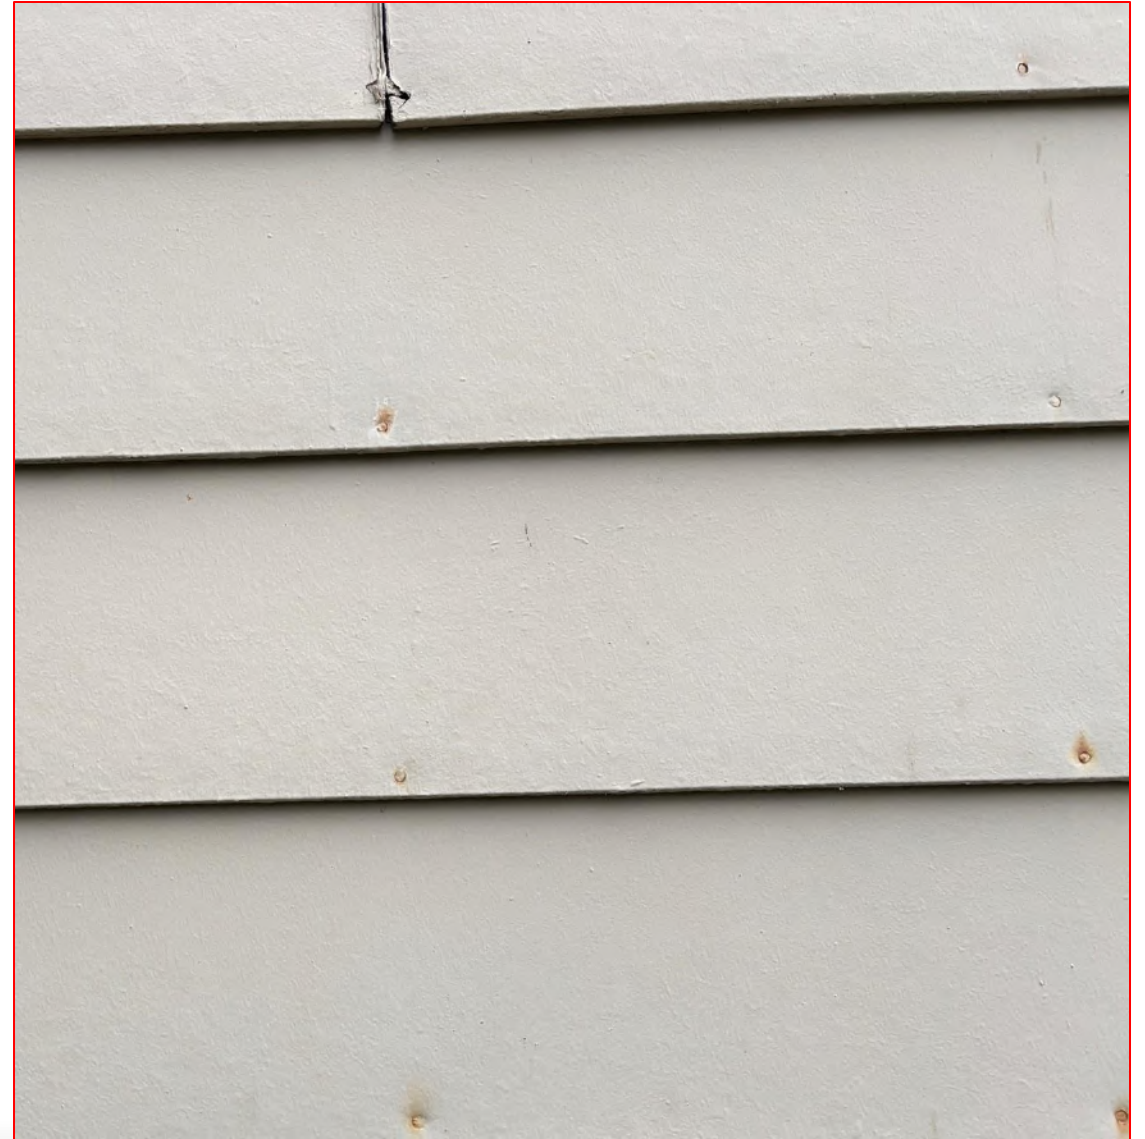
Visible moisture and signs of water intrusion above and below transitions. Pervasive

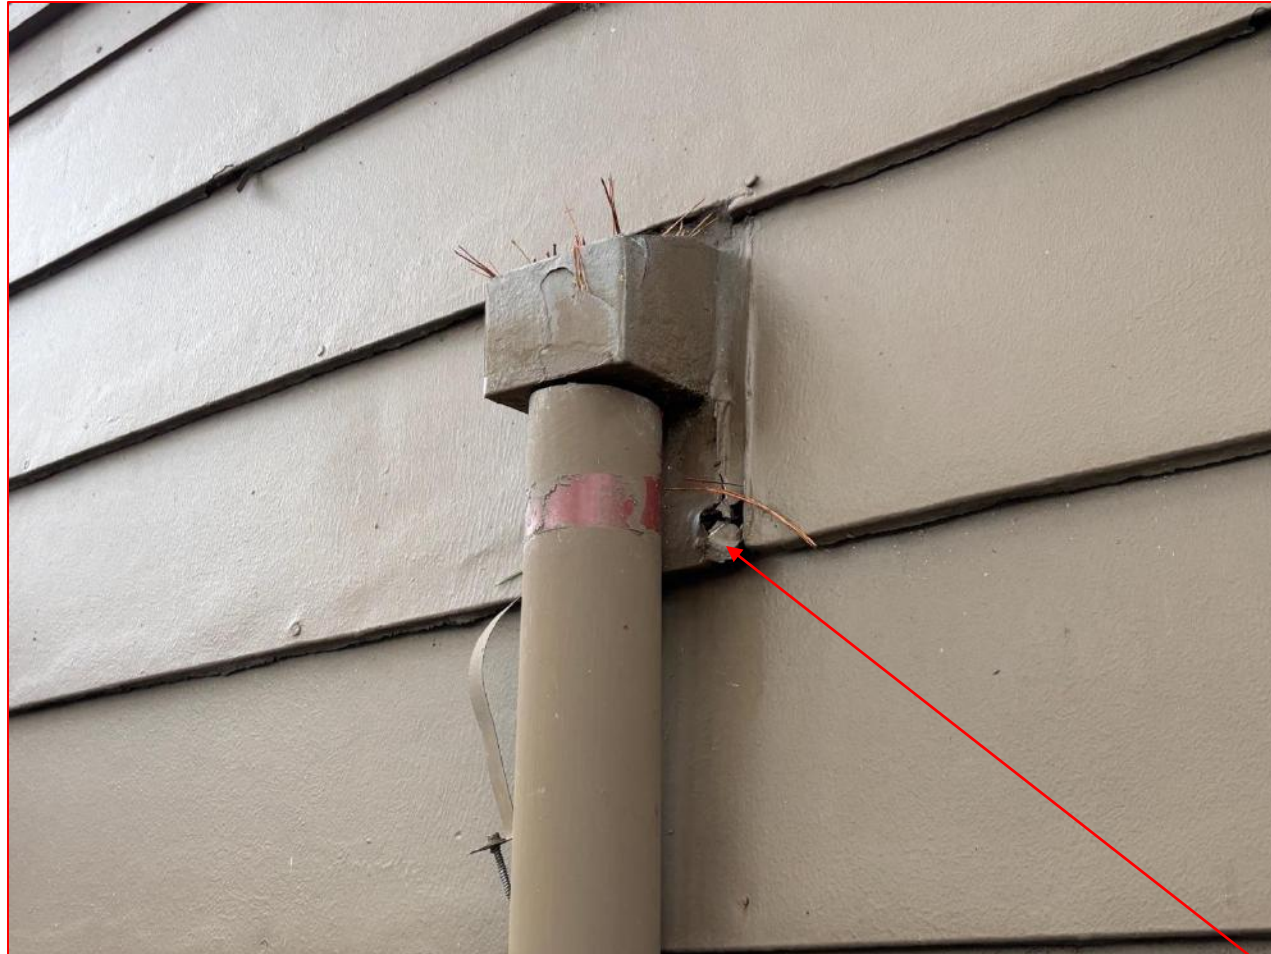
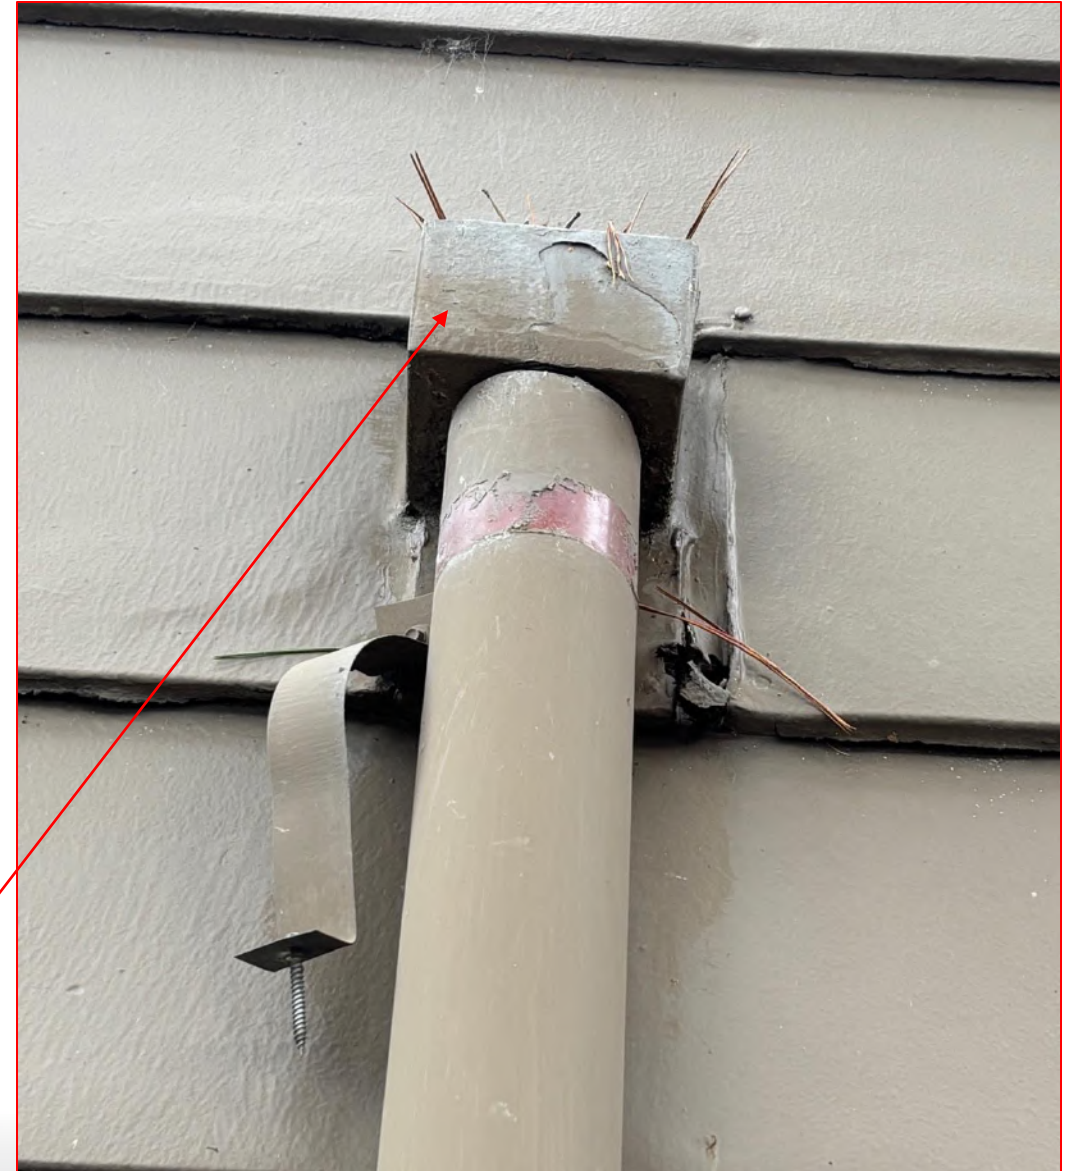
Recently painted lap siding with clogged scuppers, deteriorated siding, and excessively caulked transitions.

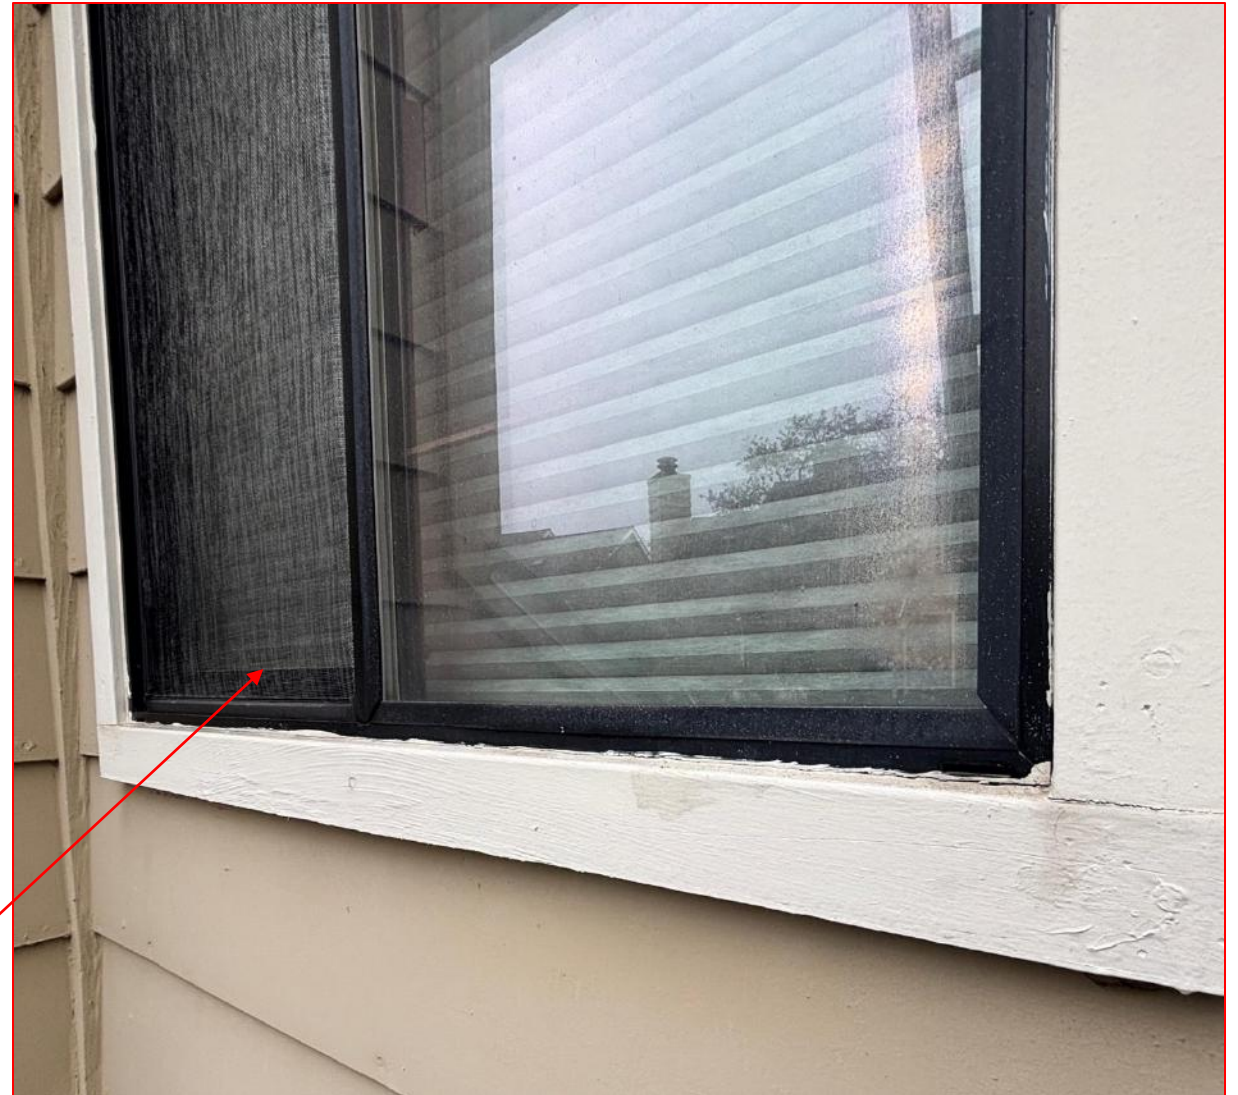
Aged and Worn Windows. Noted numerous failing seals, gaskets, screens, and frames. Pervasive

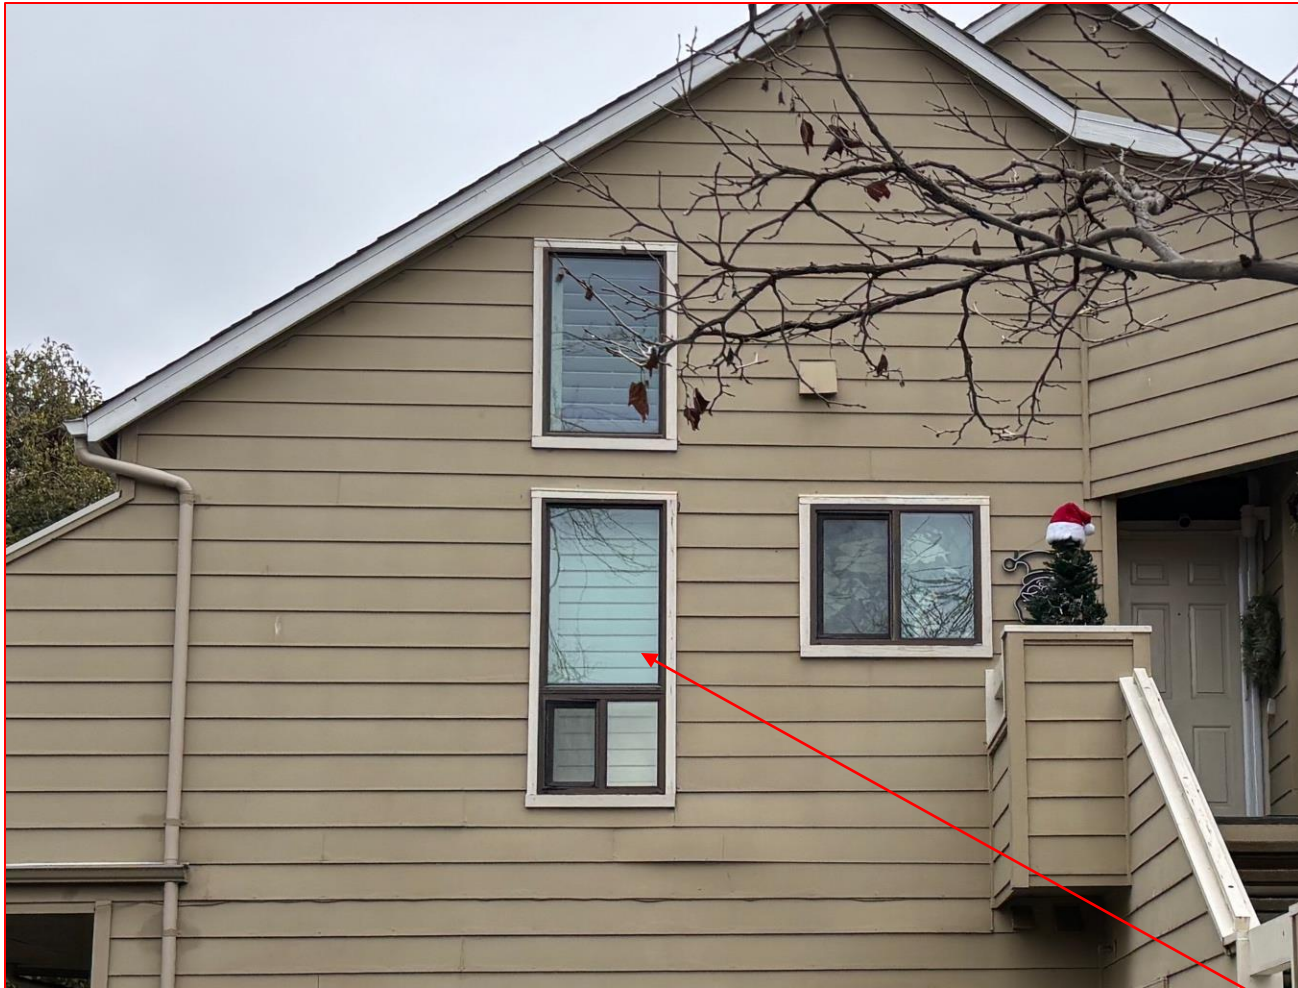
Aged and Updated Flanged Windows and Doors. Noted numerous locations of moisture penetration behind siding

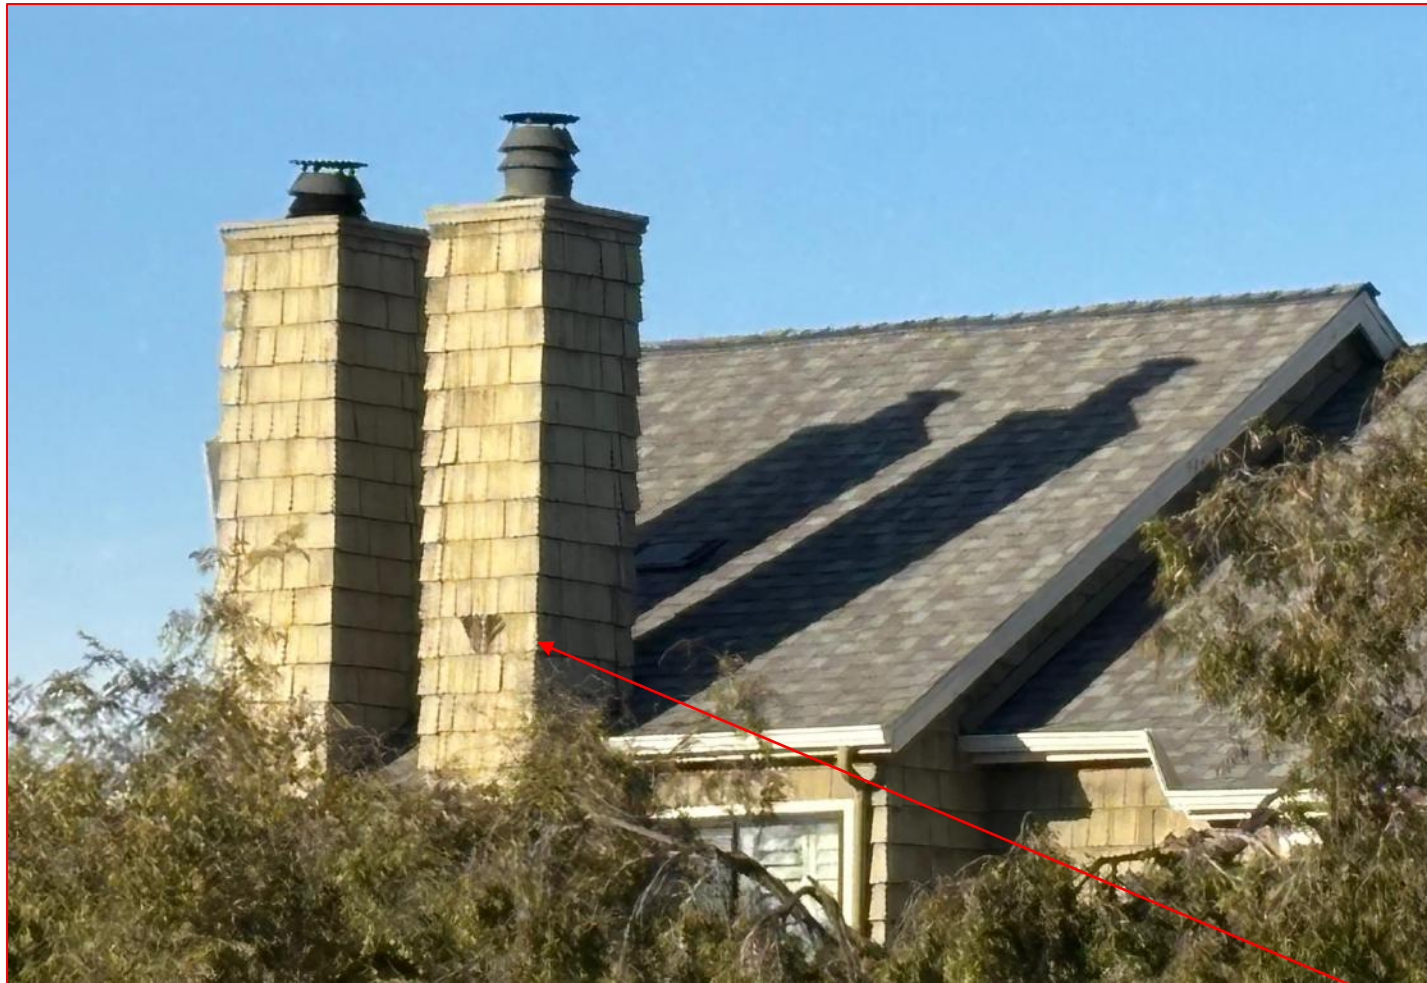
Aged, Worn, Weathered, and UV Degraded Shingle Siding. Noted Loose, cupped, missing, and curled shingles on above roof locations and chimneys

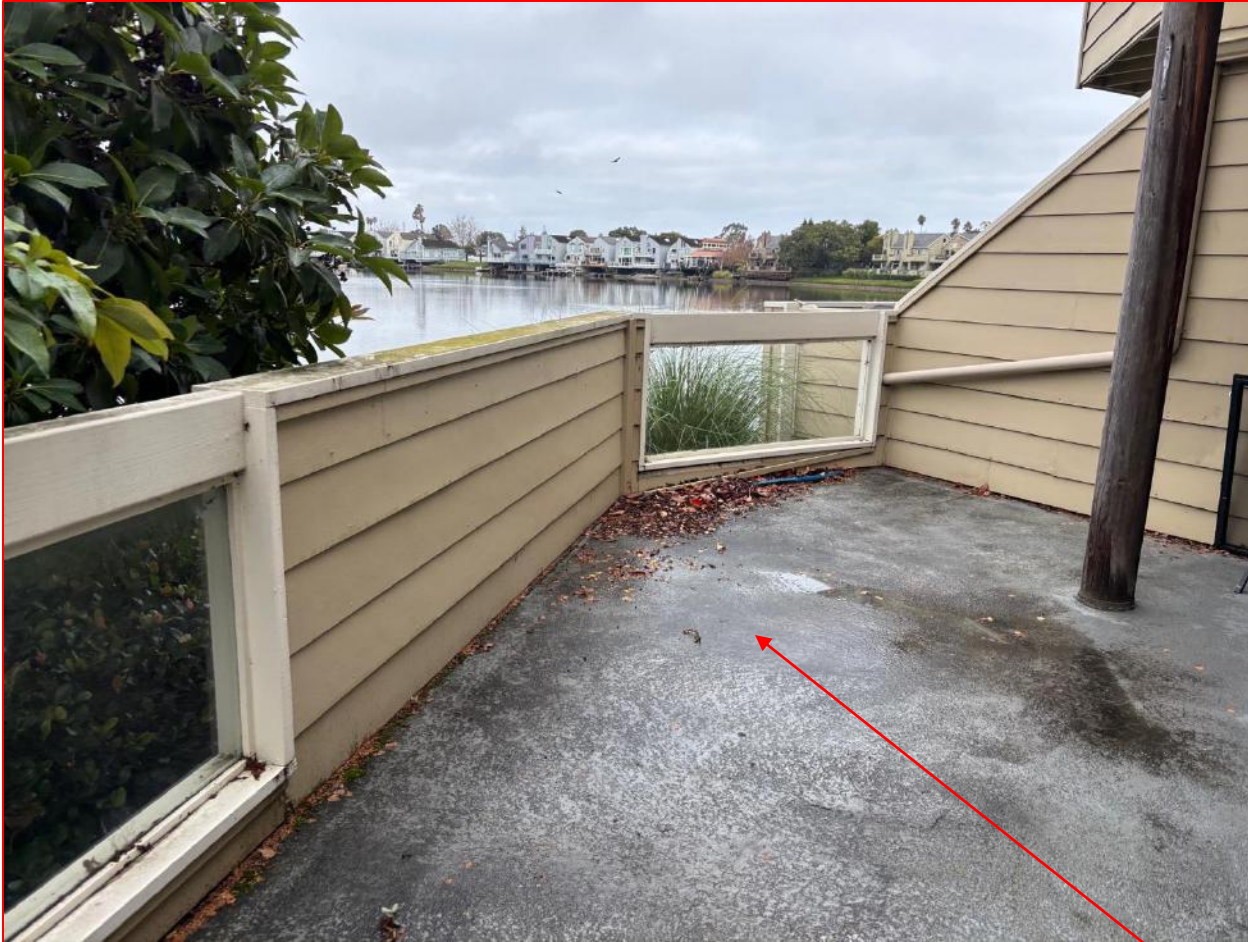
Aged, Worn, Weathered, and UV Degraded deck coating, and common area mailboxes, utility doors, and extinguisher boxes

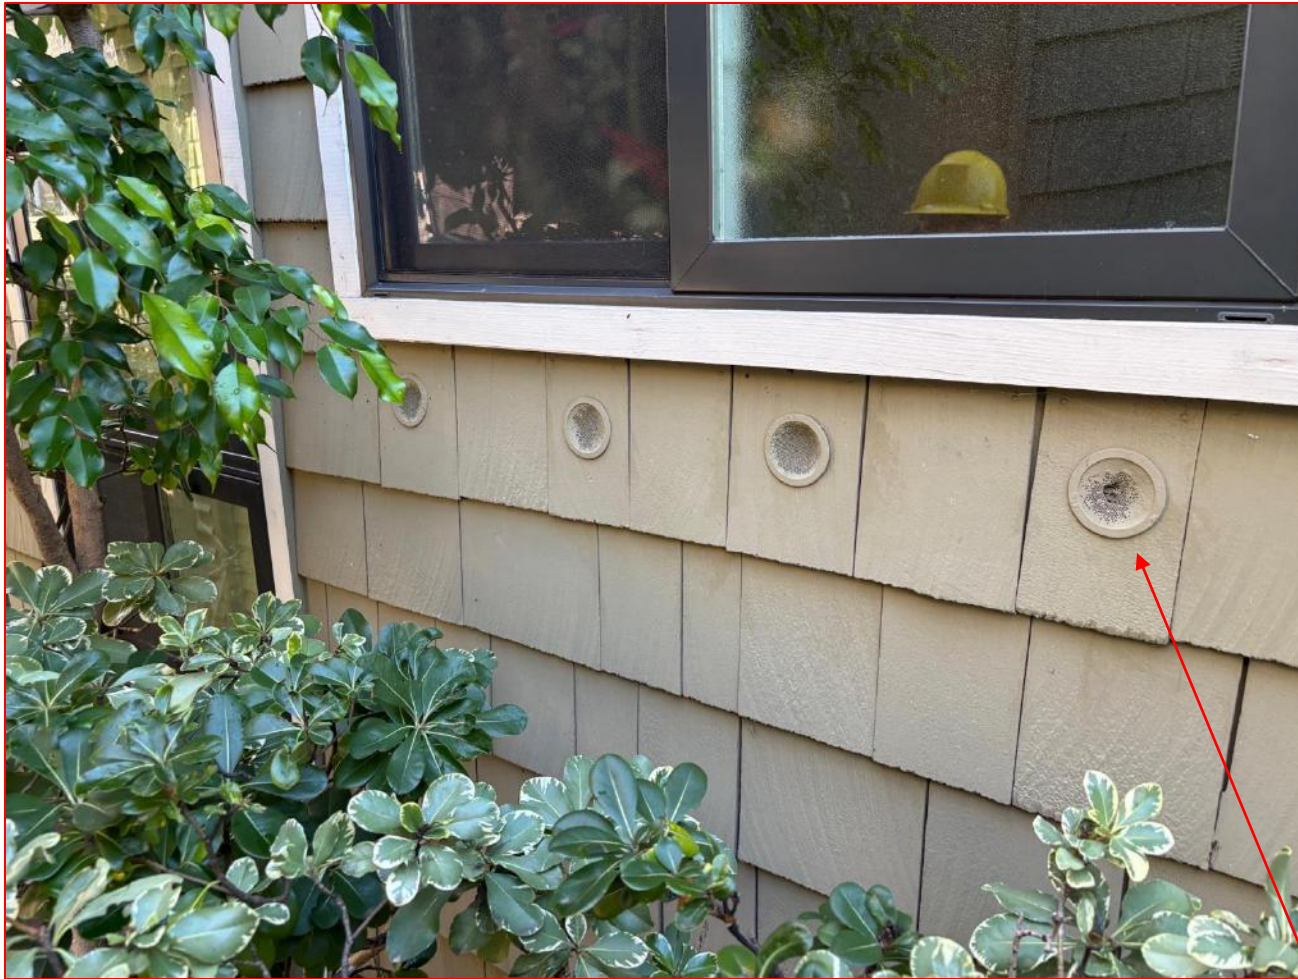
Aged, Worn, and Varying types of vents at high moisture locations and wall cavities. Noted many were clogged and painted closed

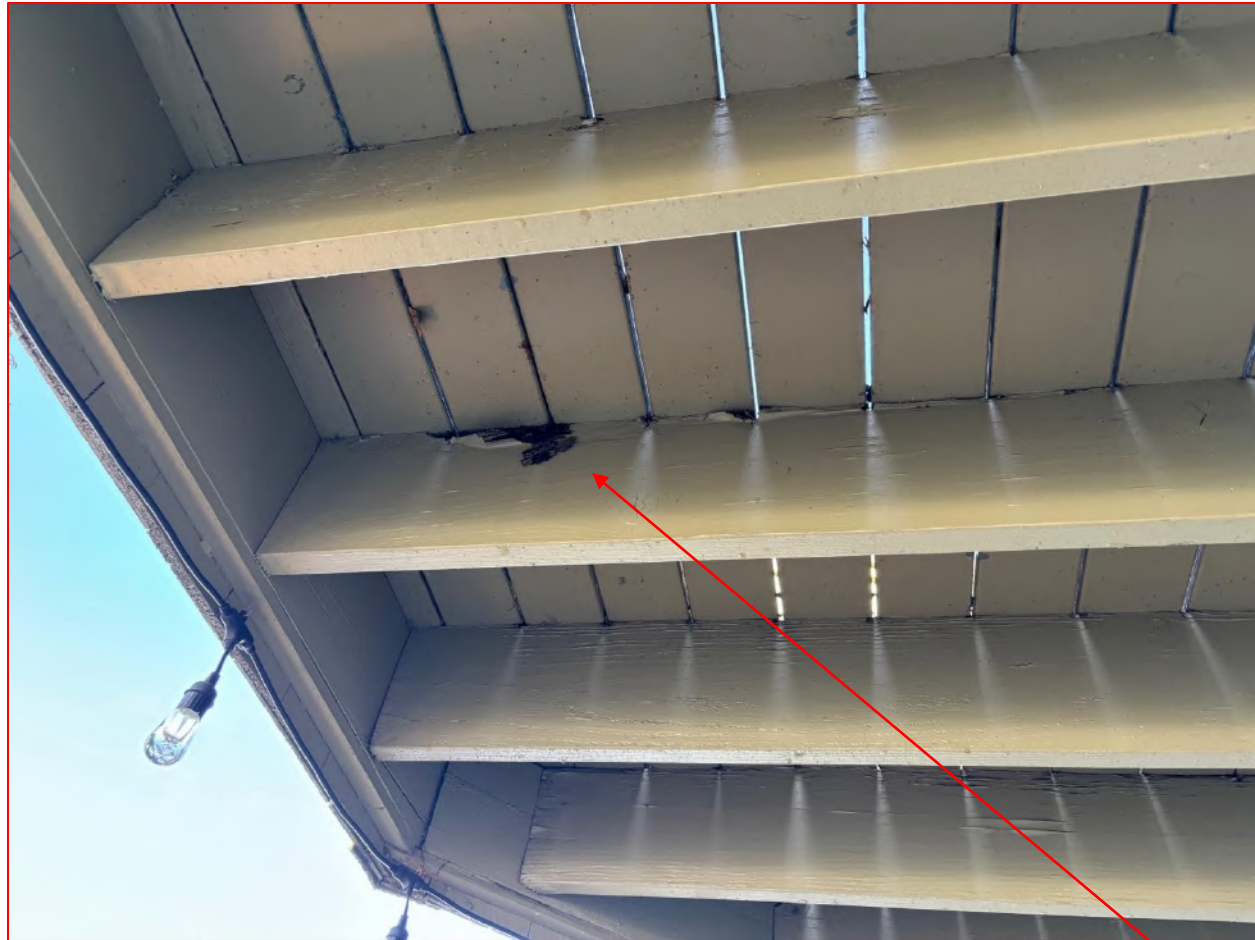
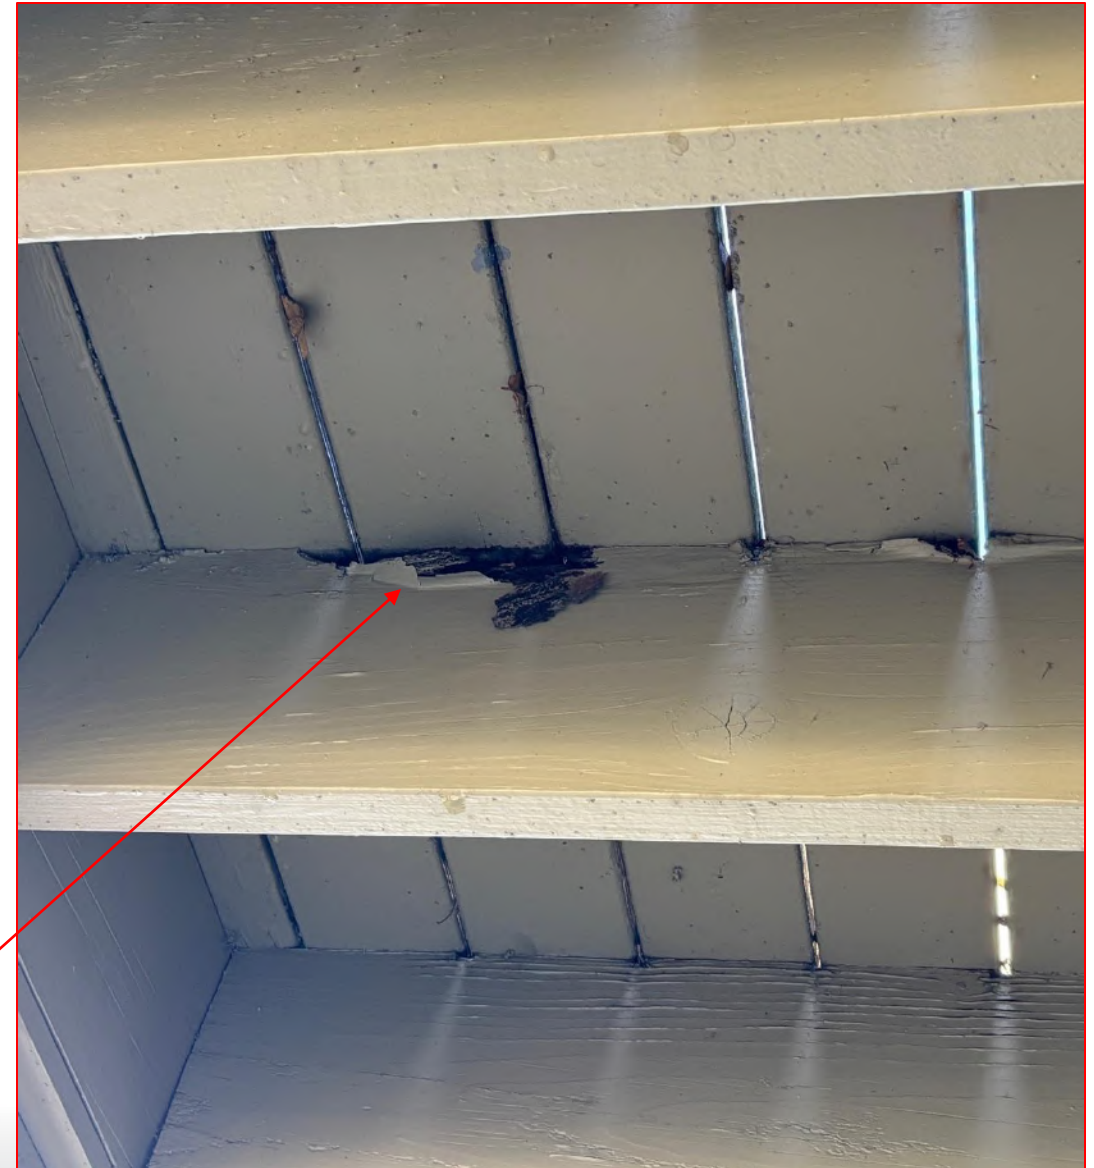
Visible framing decay, damage, and rot on wood cantilevered balconies.

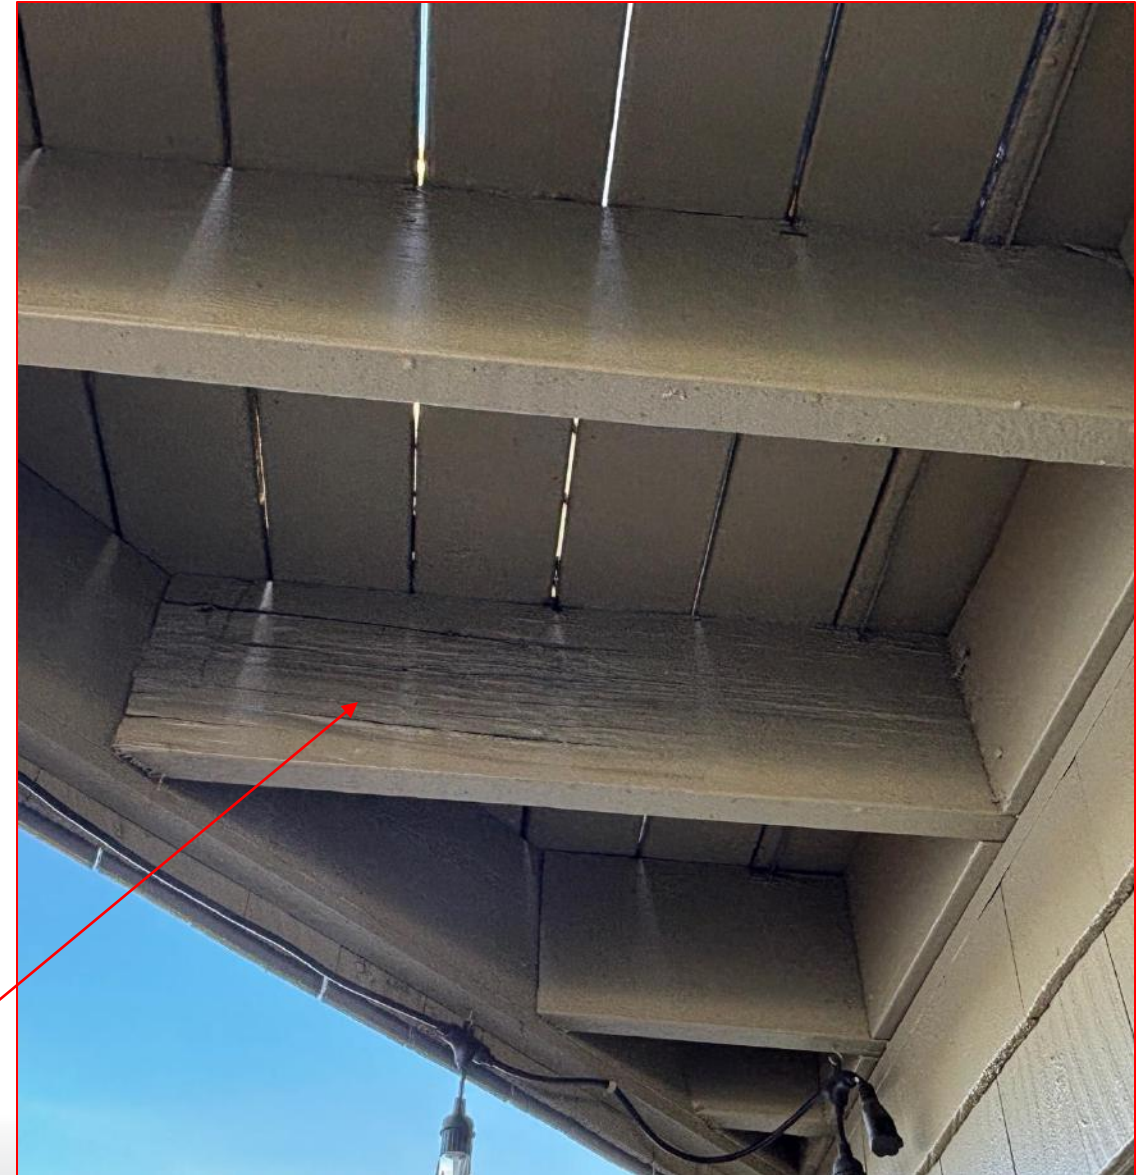
Visible framing decay, damage, and rot on wood cantilevered balconies.

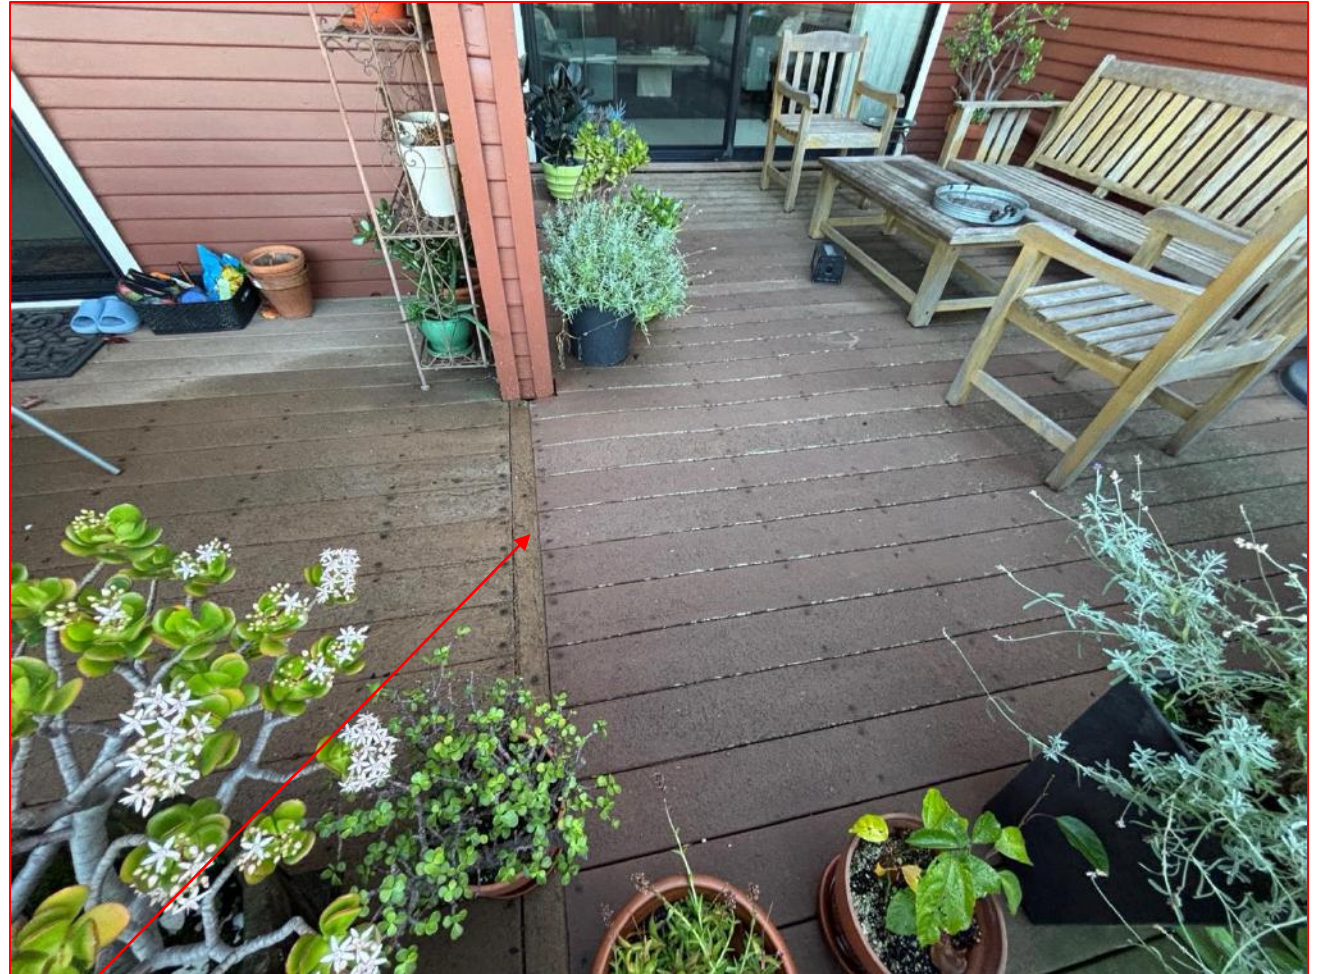
Aged, Worn, Weathered, and Degraded Wood Fences, Wood and Composite Decks.

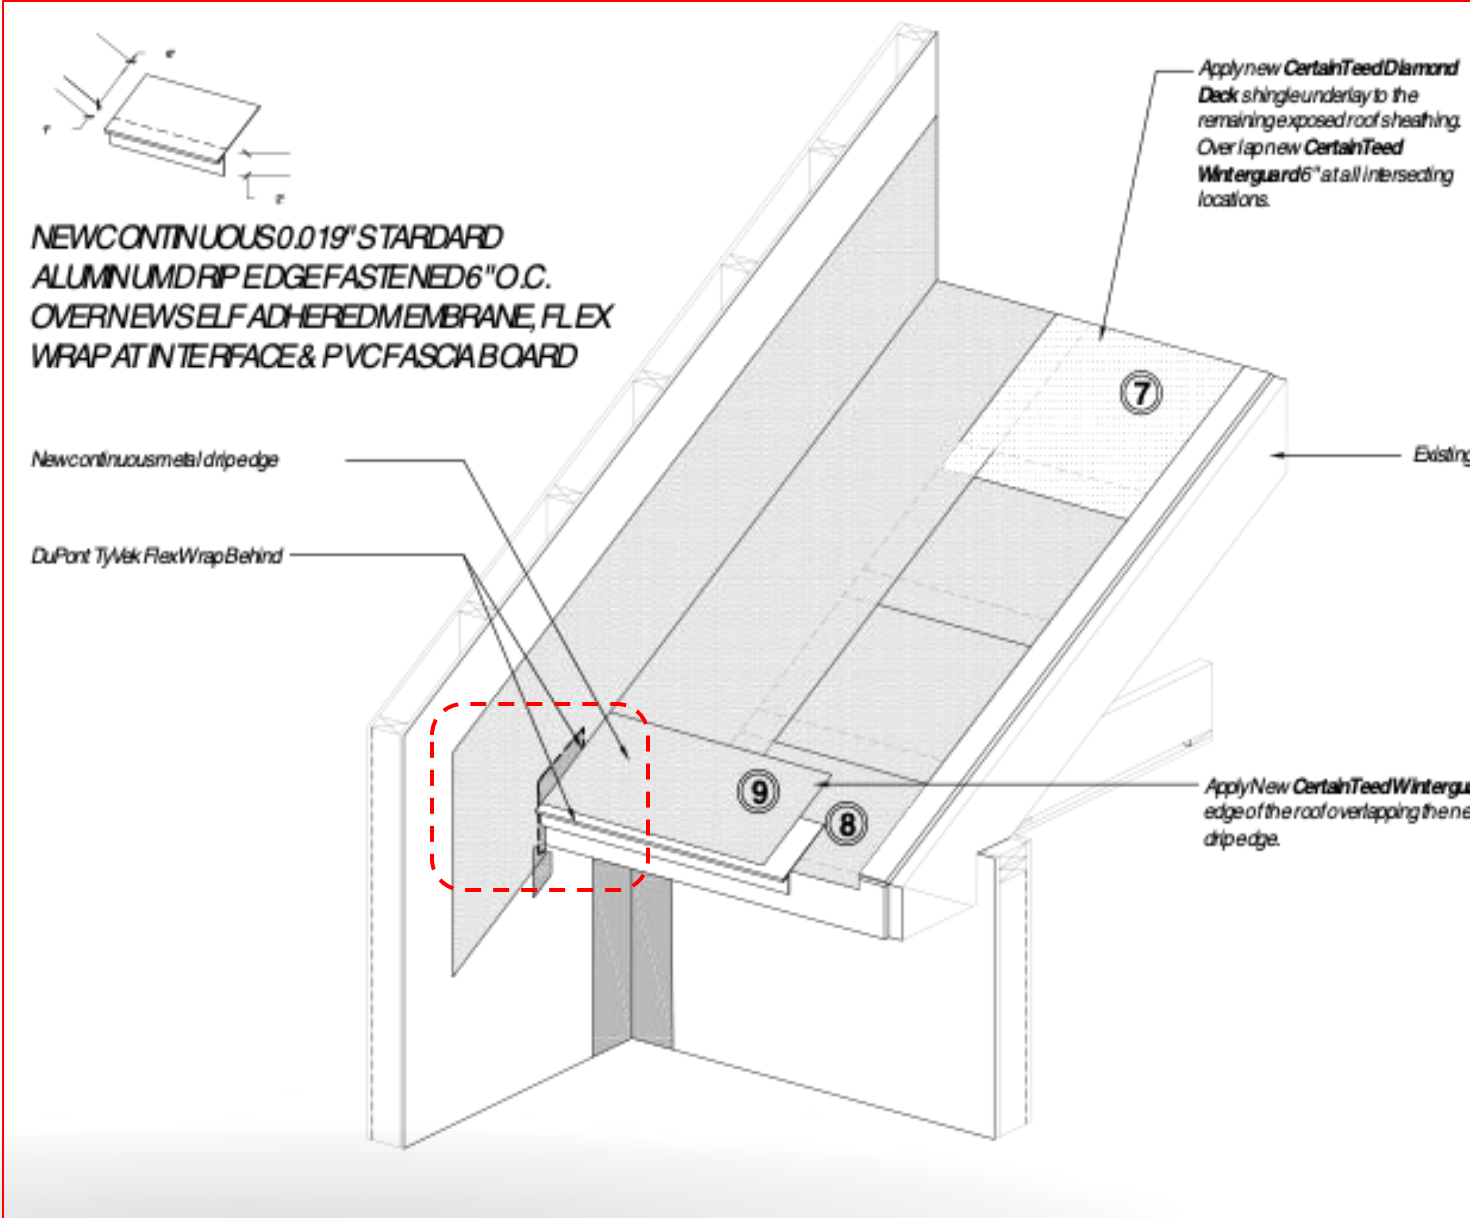
Noted roofing was not installed with “kick outs” or wall diverter flashings. Please note “Kick Outs” will help keep water away and/or from getting behind siding and into the structure of the building.

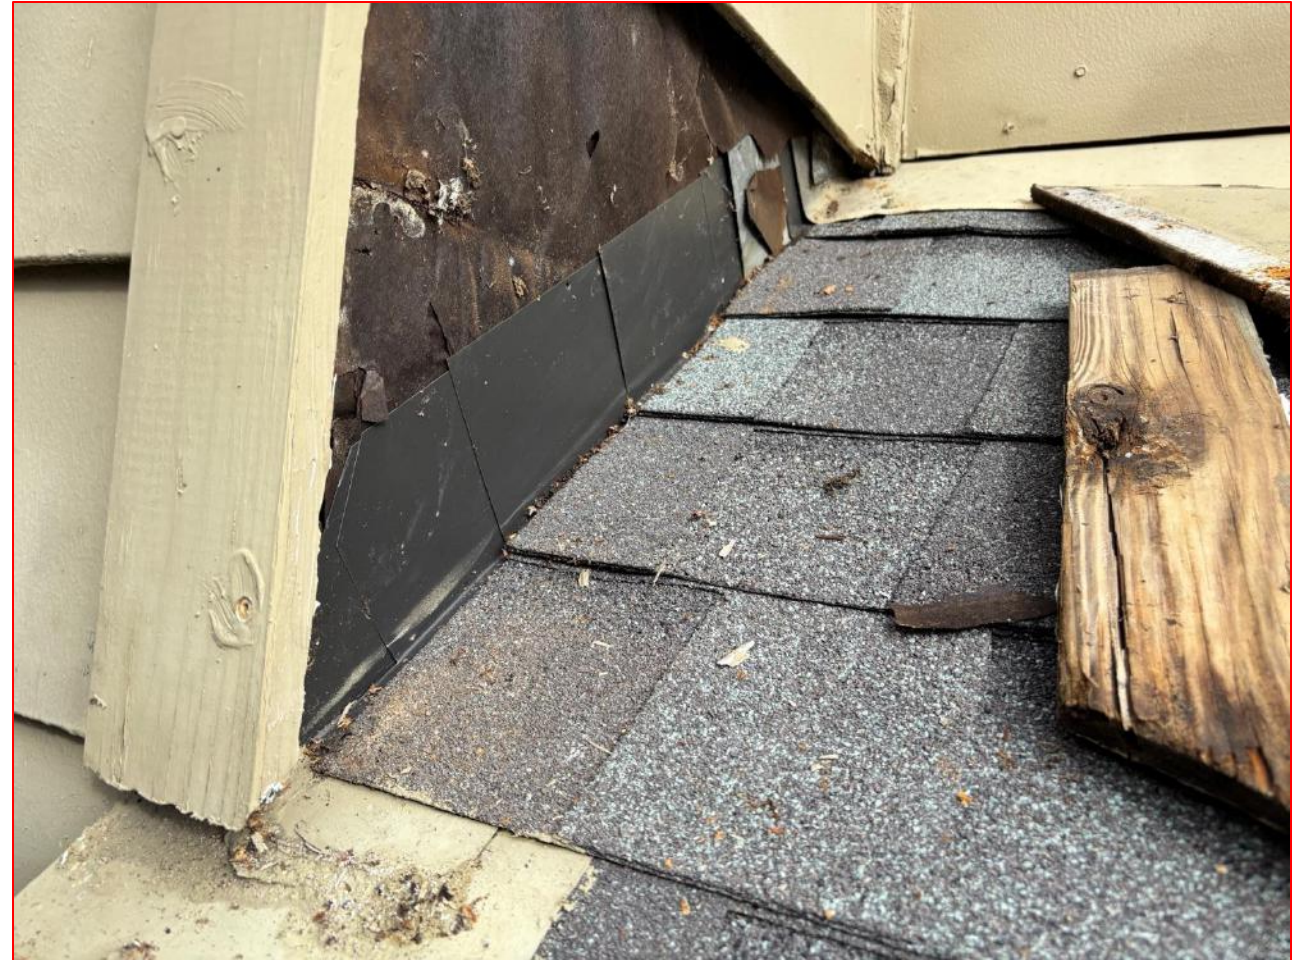
Front roof-to-wall transition. Noted Tyvek WRB System and Grace Installed incorrectly over cedar shingles with – Poor Sequencing
