Harbortown

San Mateo, CA

INVASIVE BUILDING REVIEW

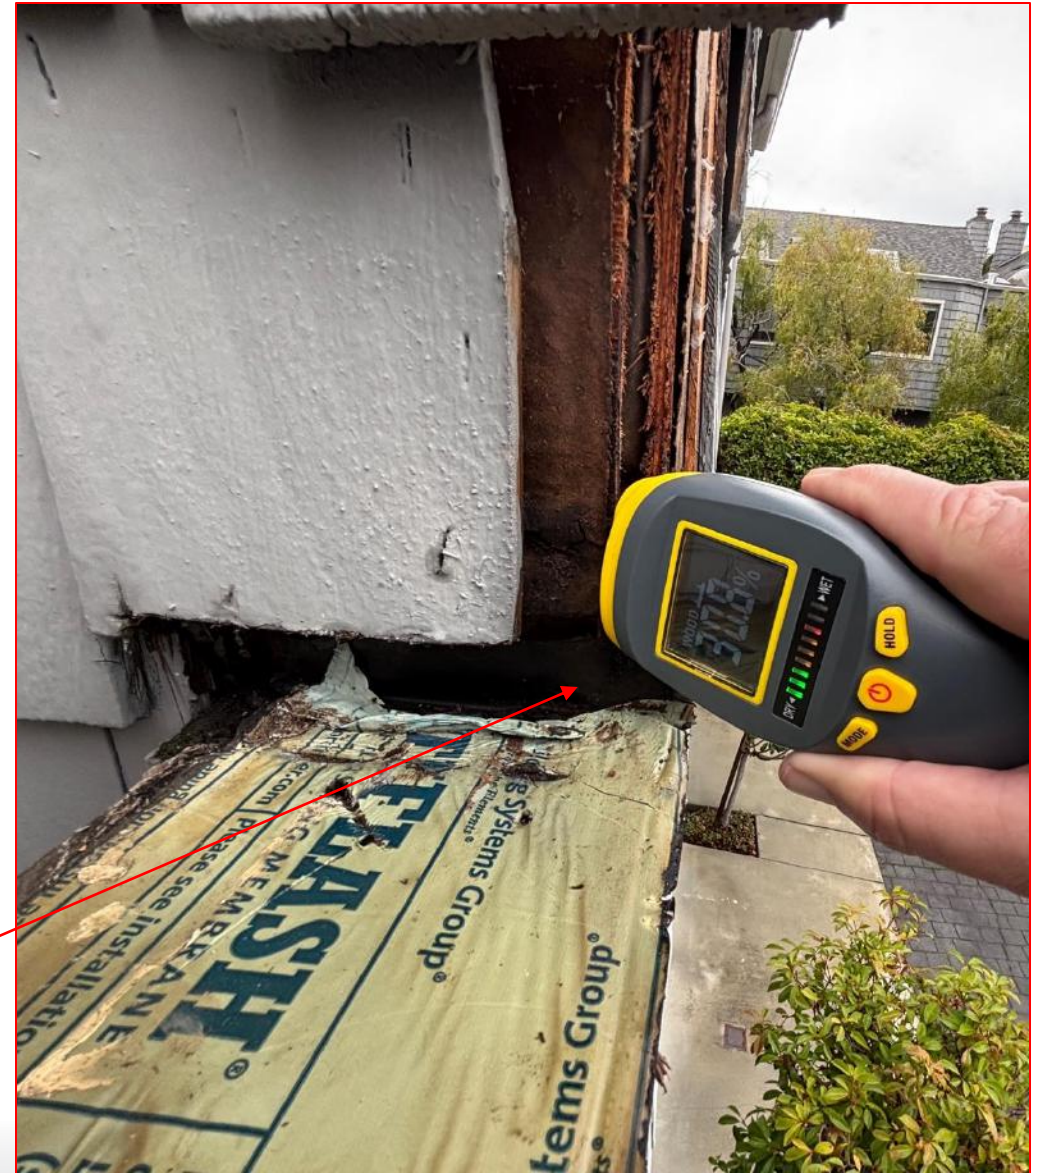
Typical deck-to-wall transition. Noted spot repaired flashing and aged and worn felt paper WRB. Detected elevated moisture readings. Please Note: Moisture readings of 12% and Less can be considered to be "Dry"

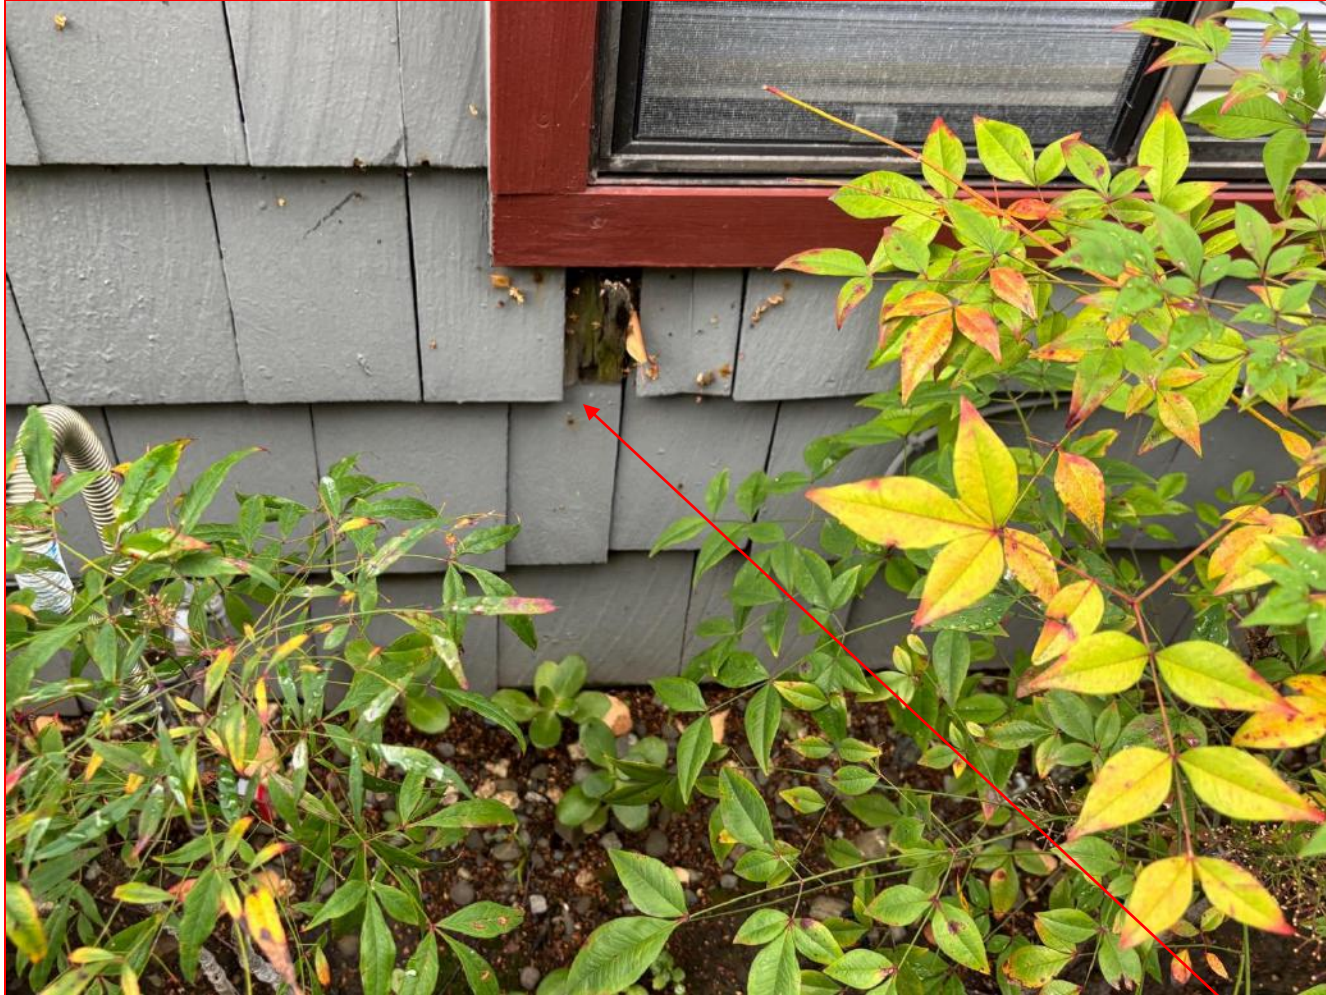
Visibly Missing wood shingles and sheathing Rot below windows

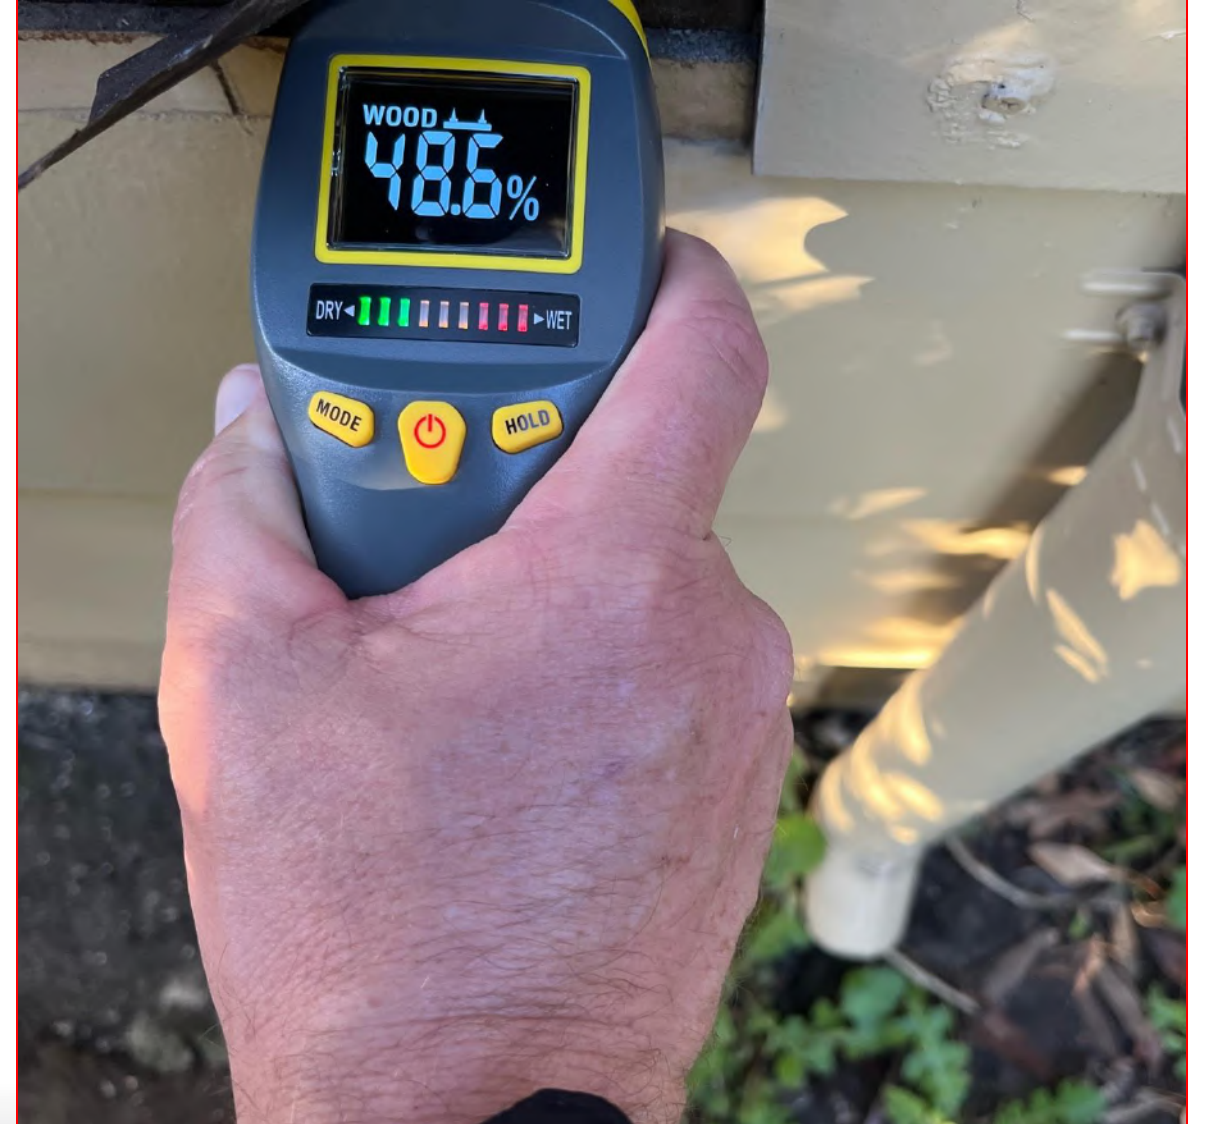
Noted Elevated Moisture Readings Below Window Corners – 26.4% Left and 48.6% Right – Please Note moisture readings of 12% and Less can be considered to be “Dry”

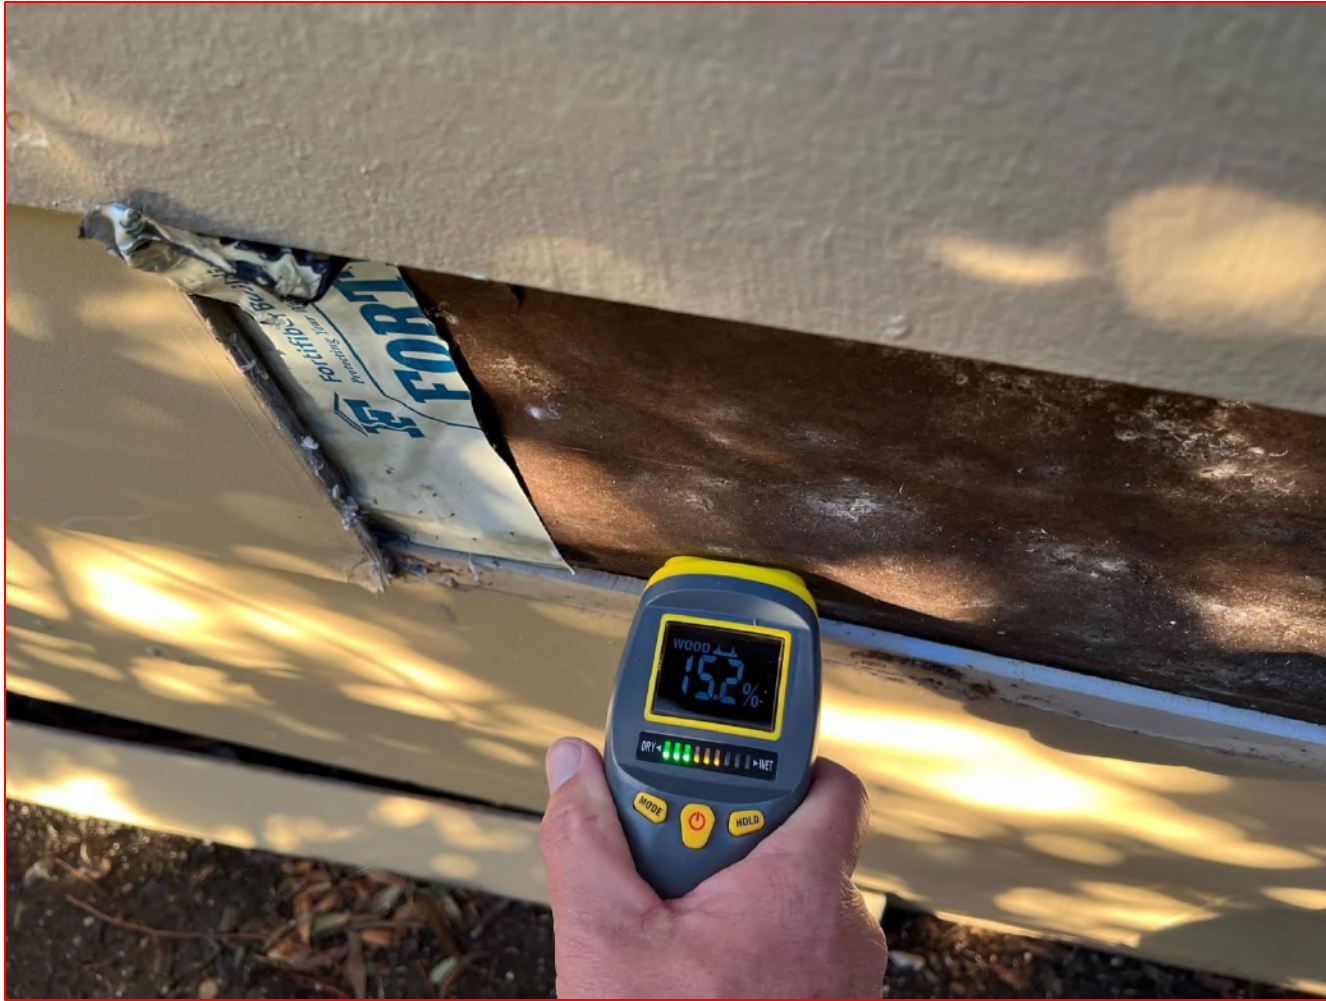
Noted Moisture Readings Below Left Siding Transition and Right Window Corners – Ranging from 15.2% up to 45.6% – Please Note moisture readings of 12% and Less can be considered to be “Dry”

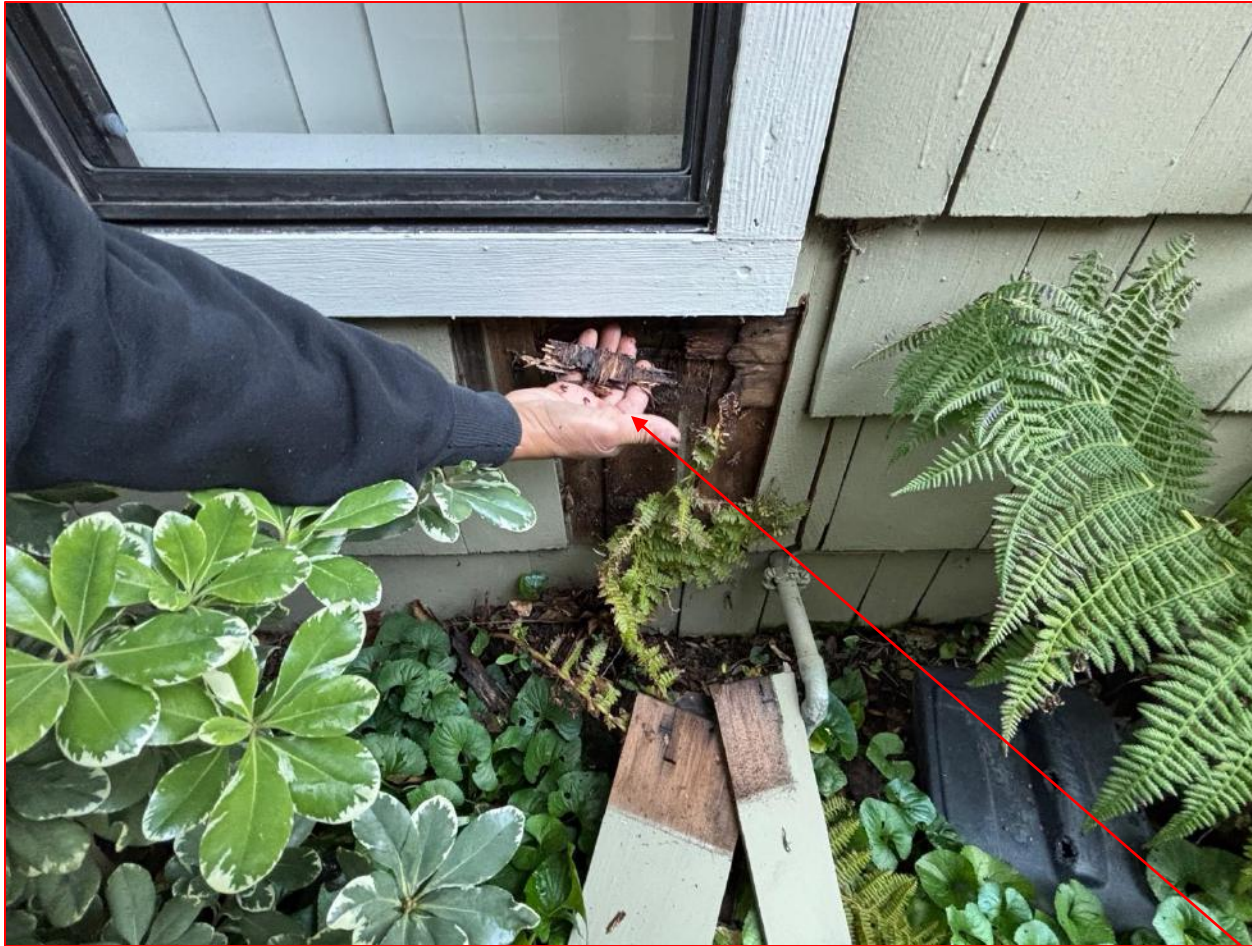
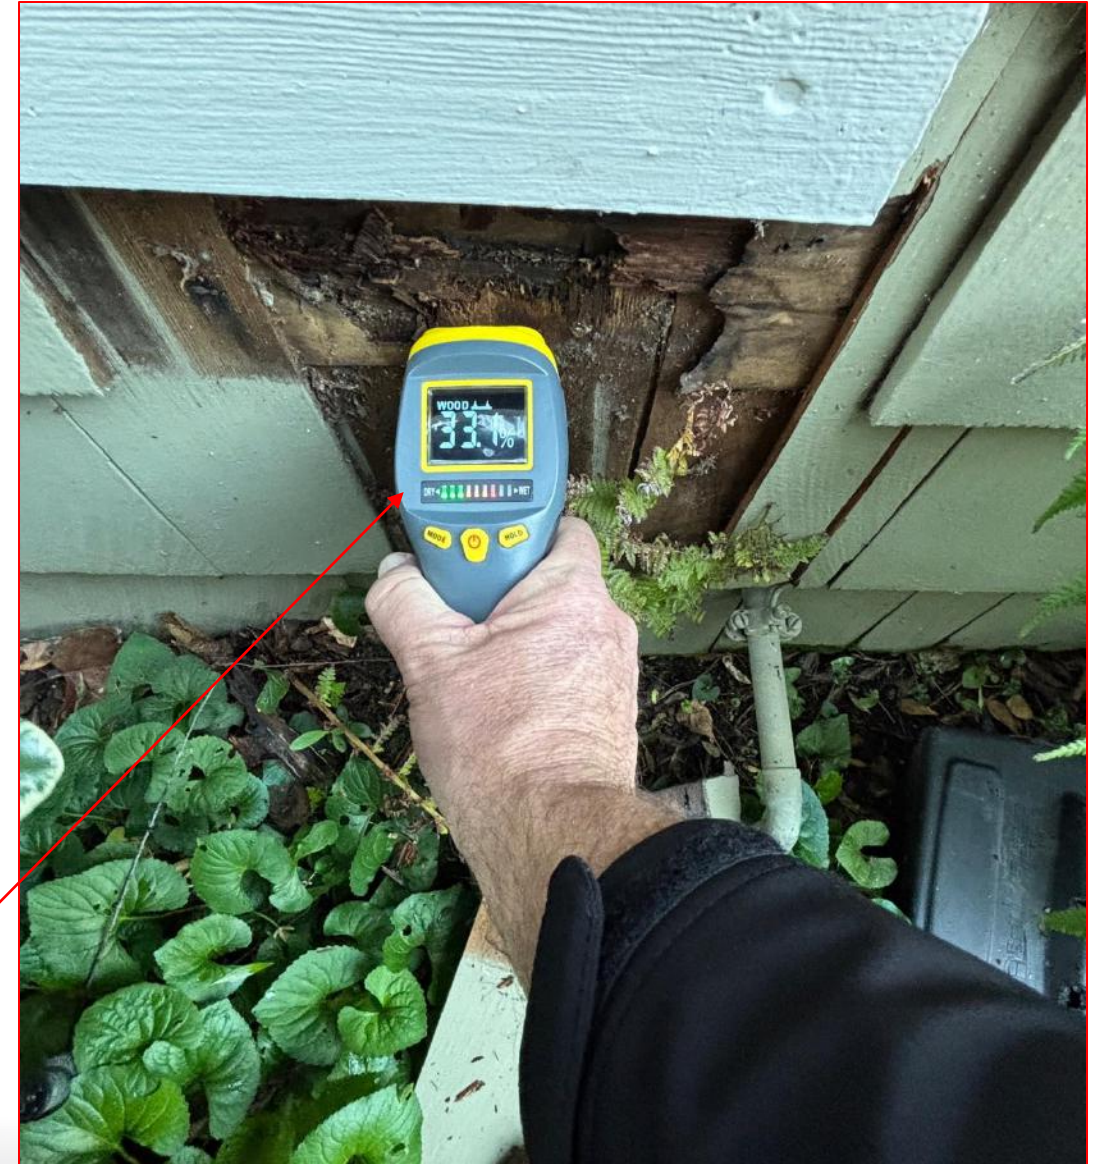
Noted elevated moisture readings and sheathing Rot below the right window of 33.1% Please Note moisture readings of 12%, and Less can be considered to be "Dry"

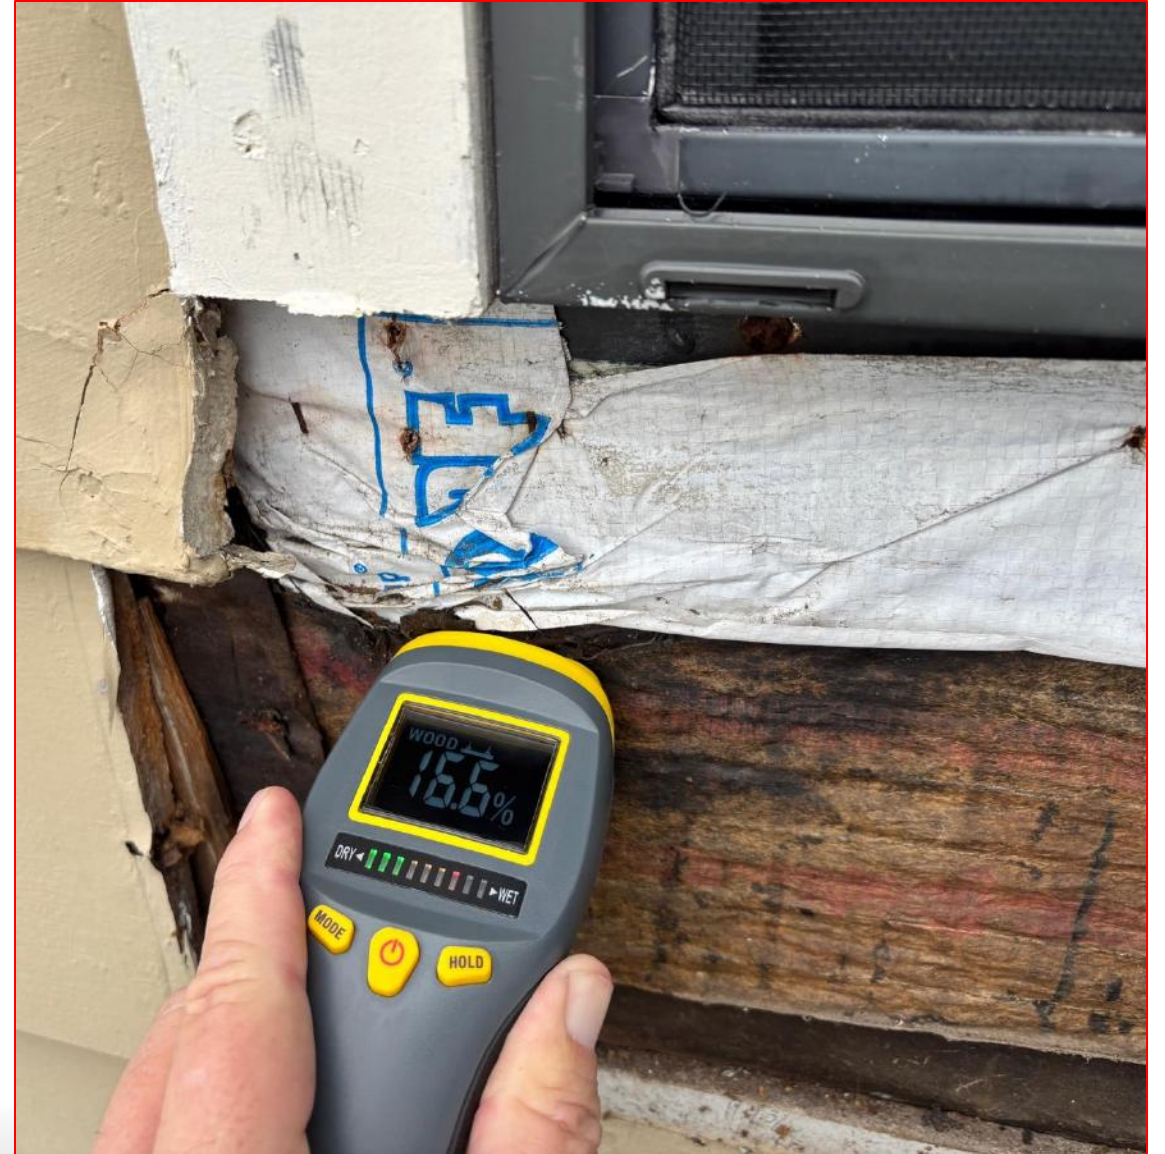
Typical Updated Flanged Window Installation and Flashing Sequences. Detected low moisture readings below the left corner of the windows

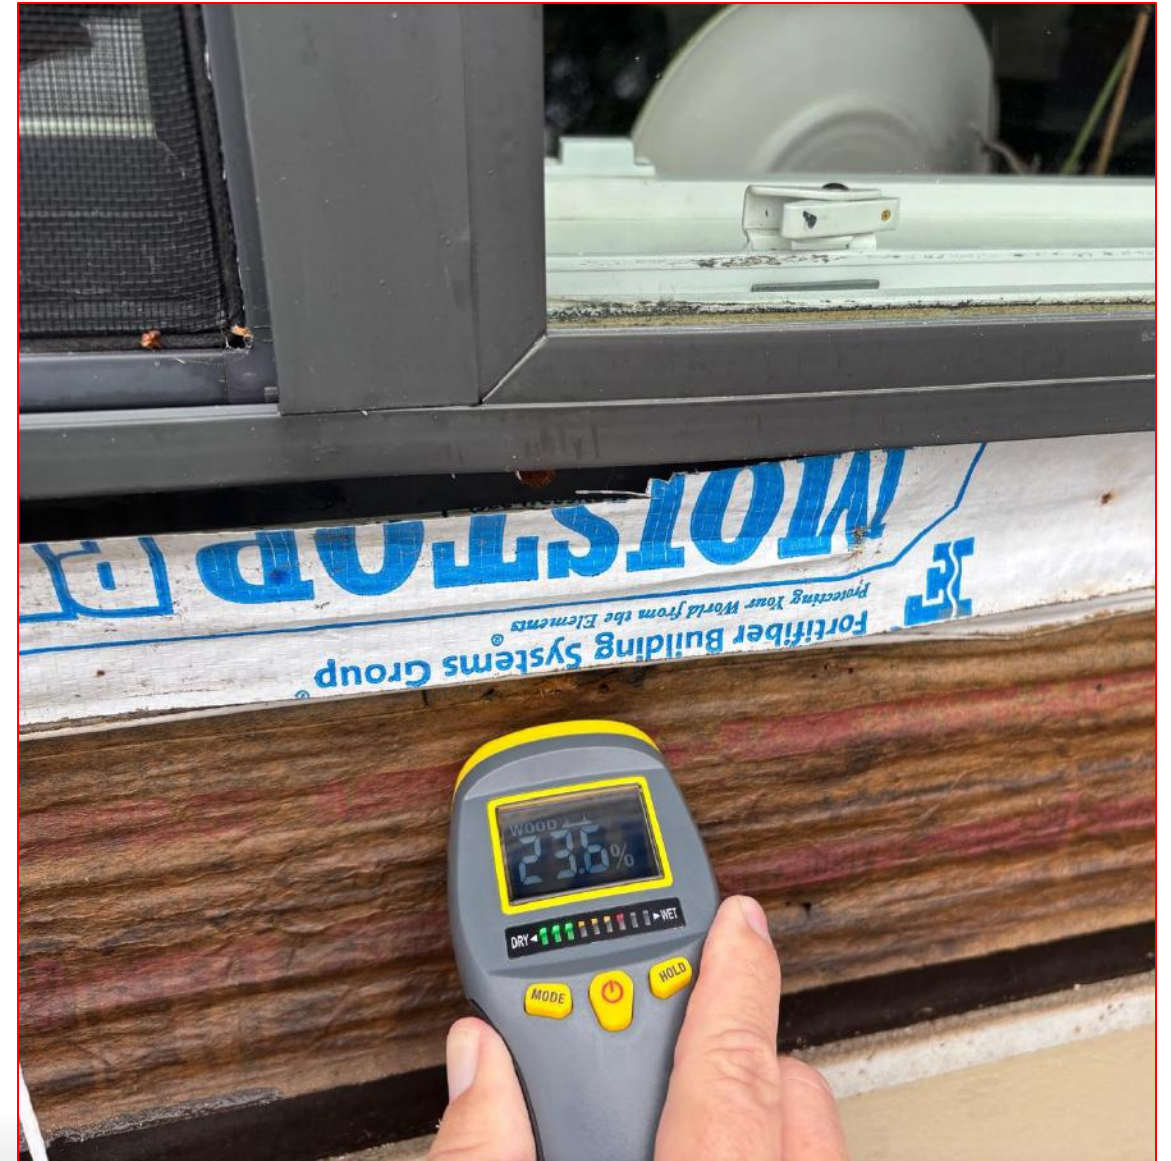
Noted Moisture Readings Below the Window of 23.6% - at center – Please Note moisture readings of 12%, and Less can be considered to be “Dry”

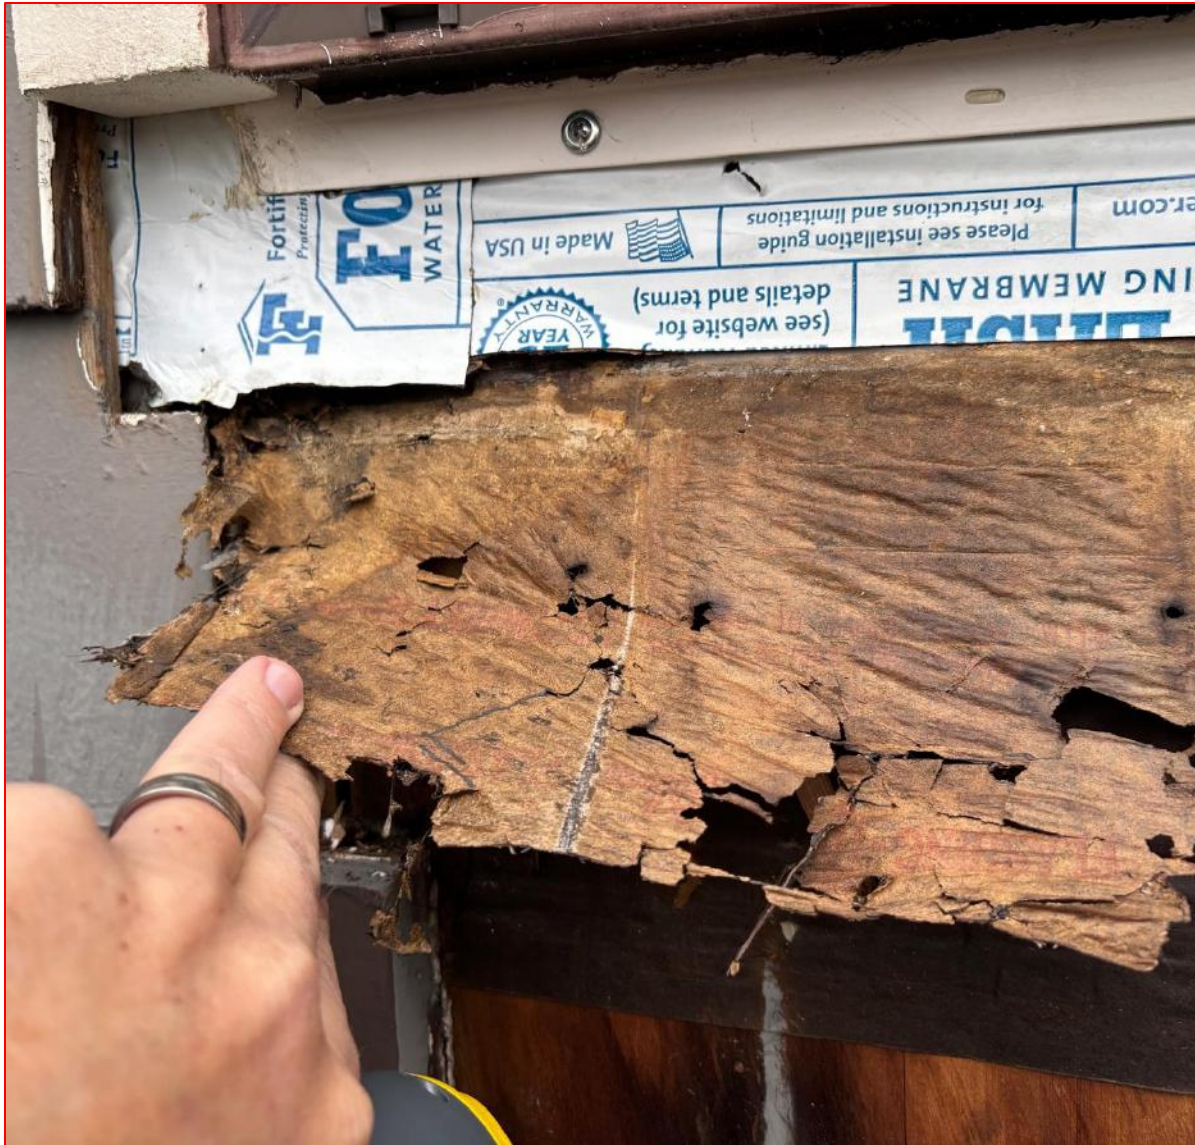
Noted updated window sill flashing installed on the aged, worn, and deteriorated WRB. Noted staining and surface damage on CDX sheathing below the window

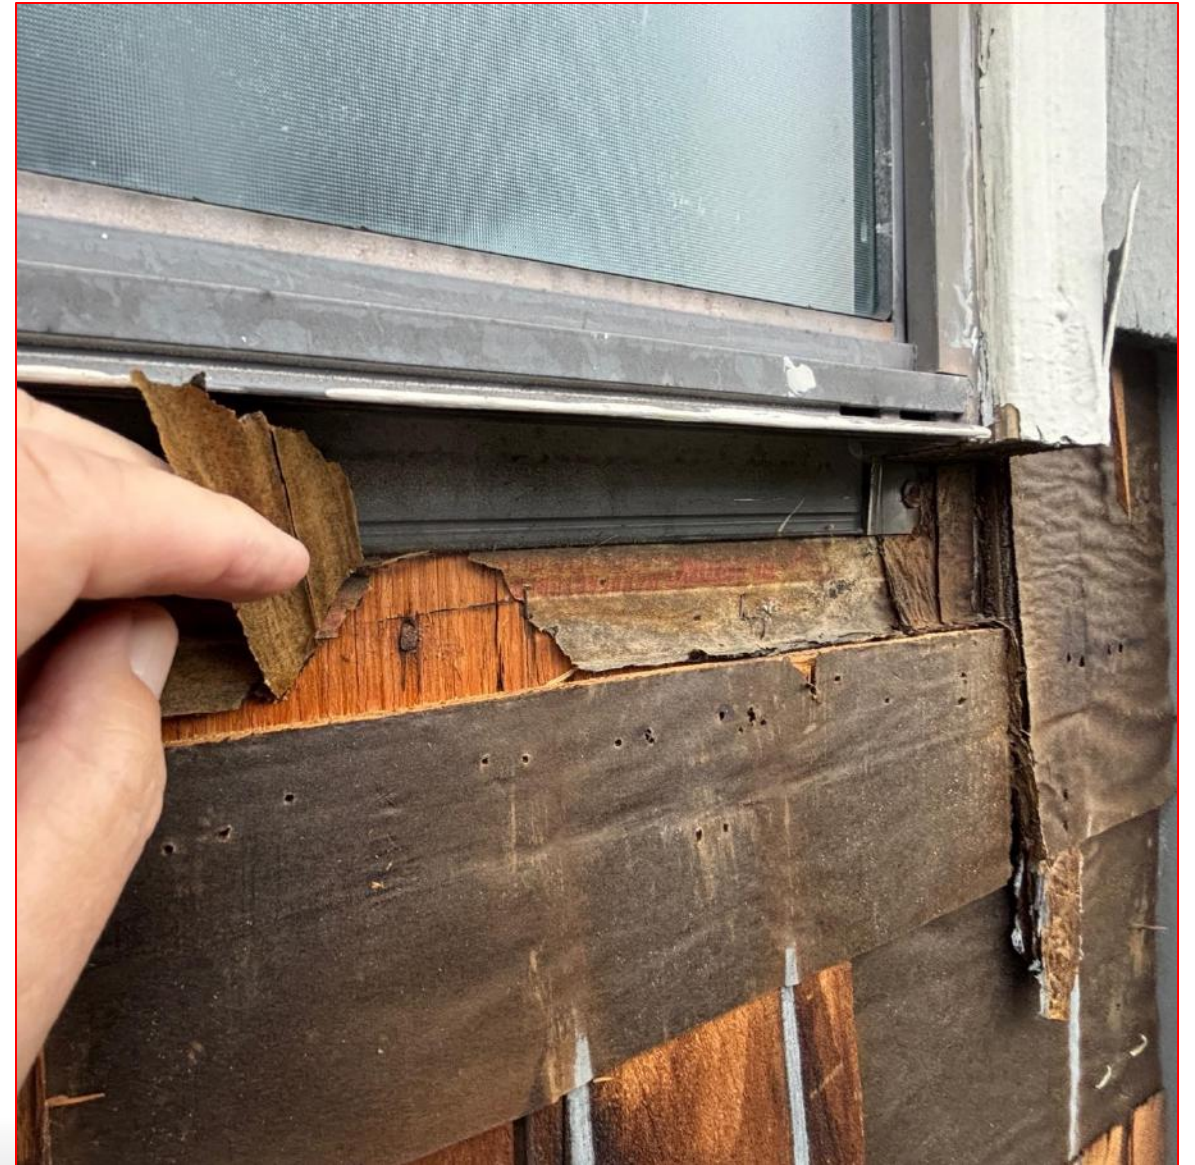
Typical Original Flanged Window Installation, Aged WRB, and Existing Flashing Sequence. Noted deteriorated window sill flashing, Felt Paper WRB, and Jamb Paper Flashing

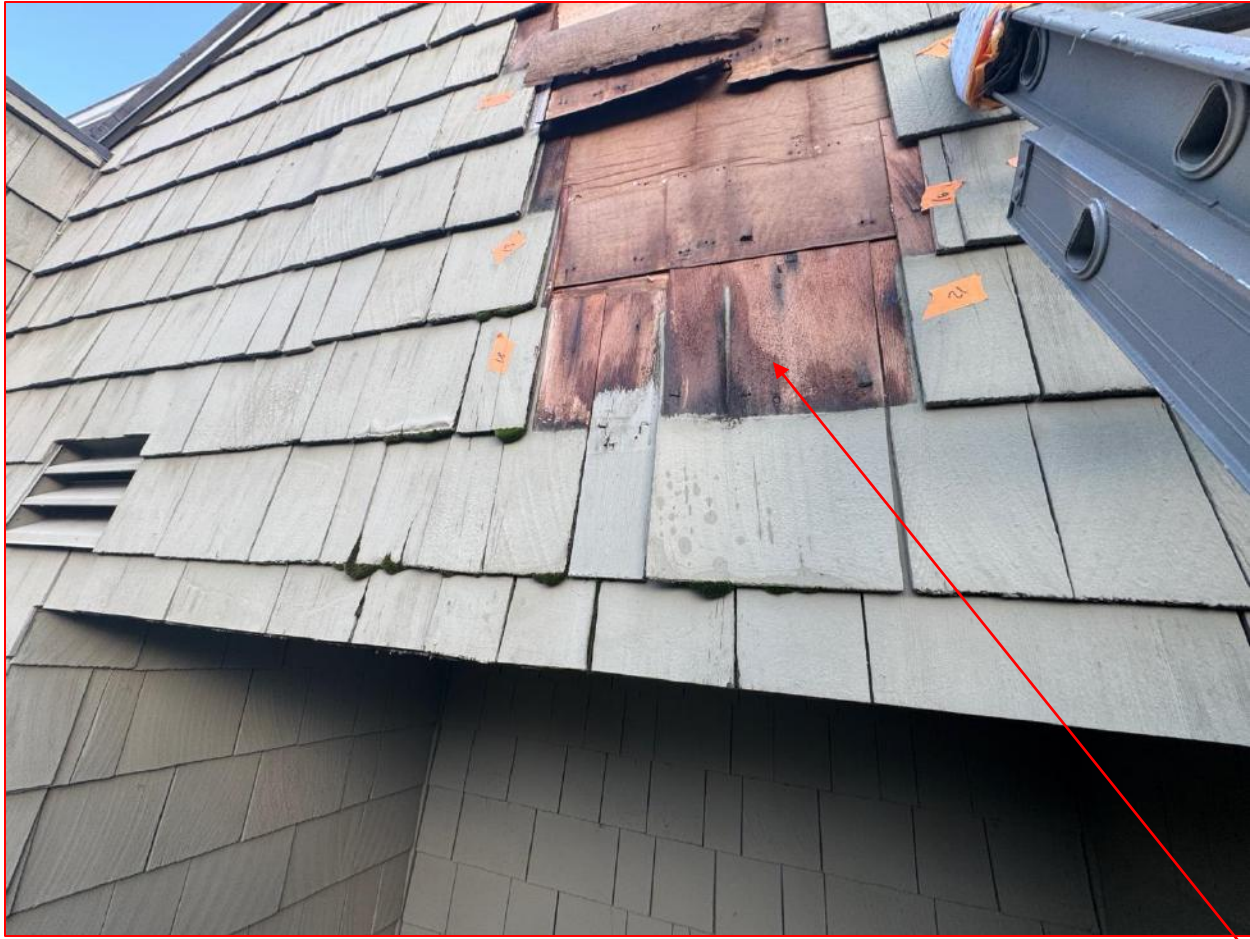
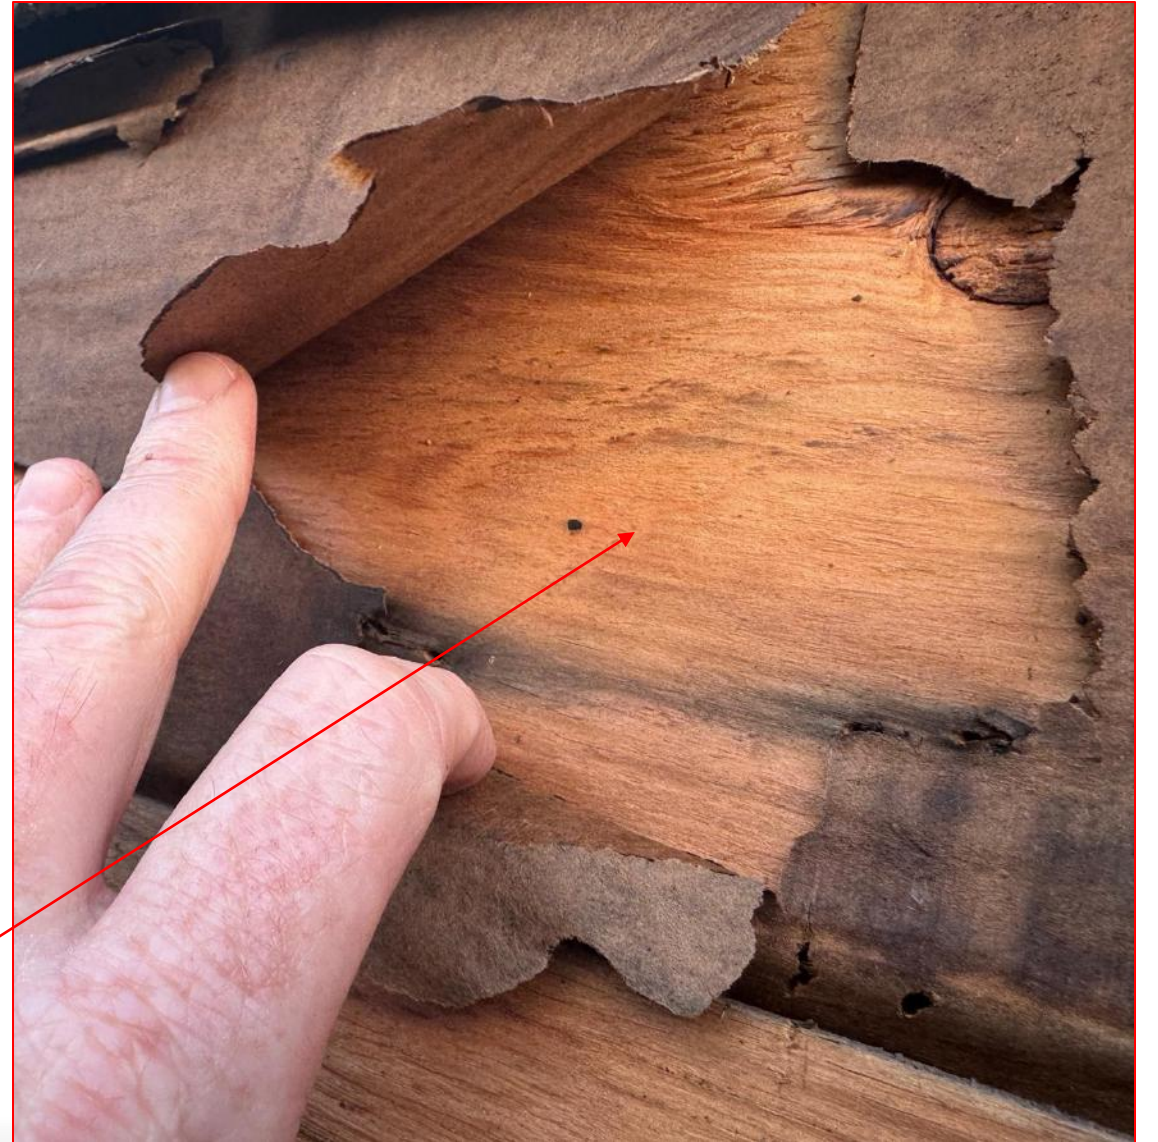
Typical Aged and Worn WRB and CDX sheathing behind painted wood shingles

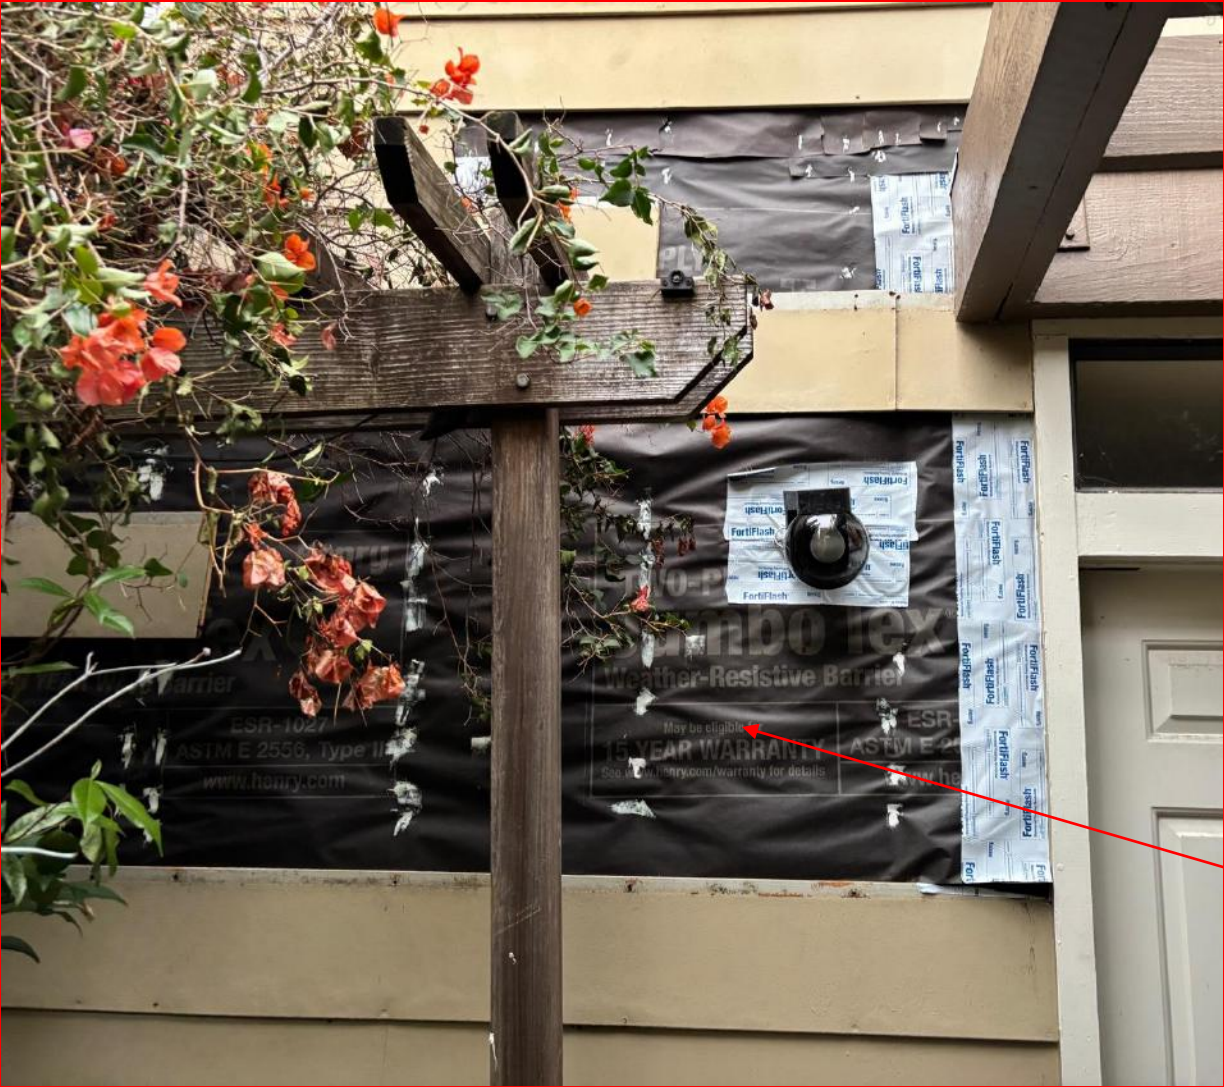
Noted updated “Spot” repaired lap siding, trim, membrane flashing, and WRB – Noted additional sealant added to WRB fastener heads.

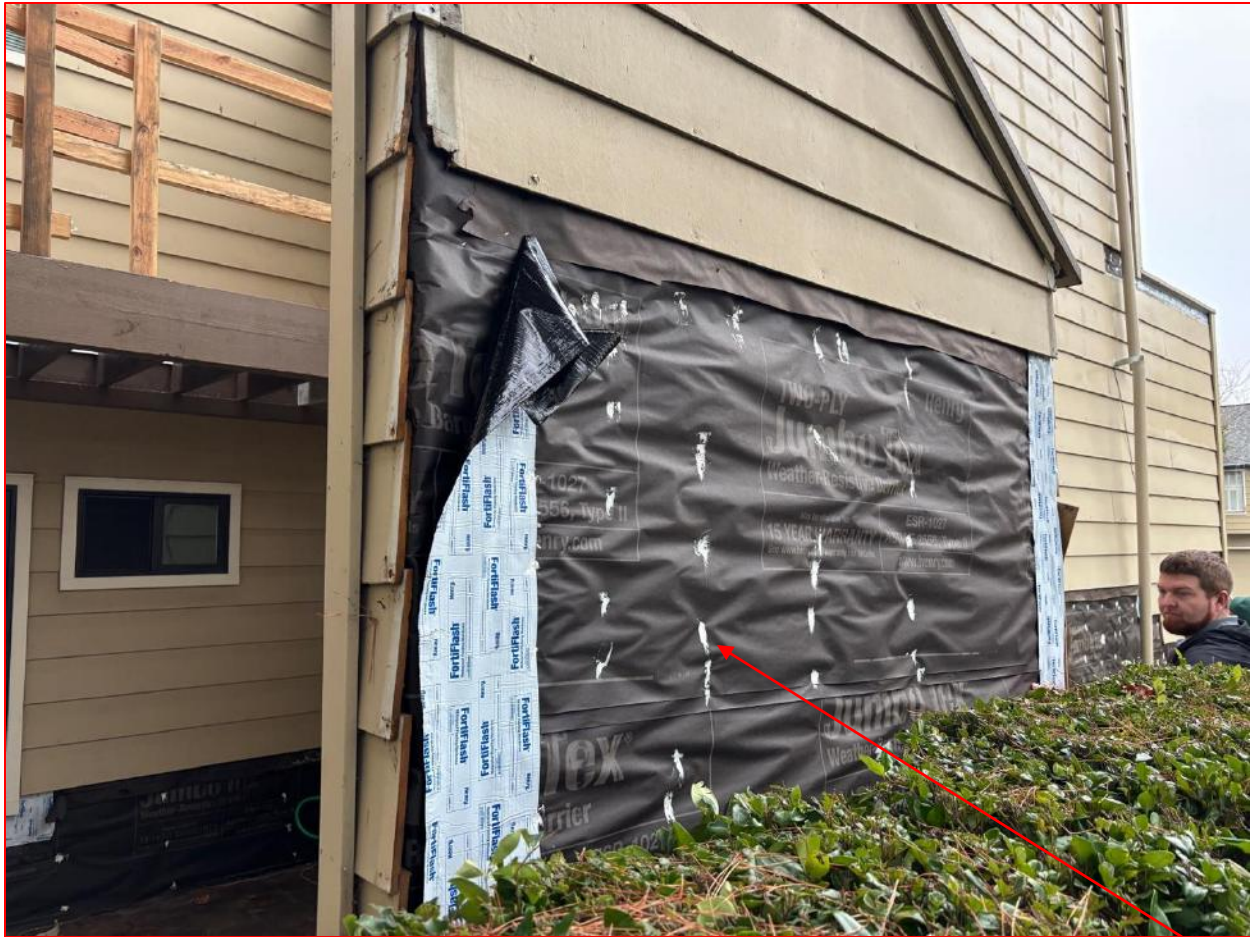
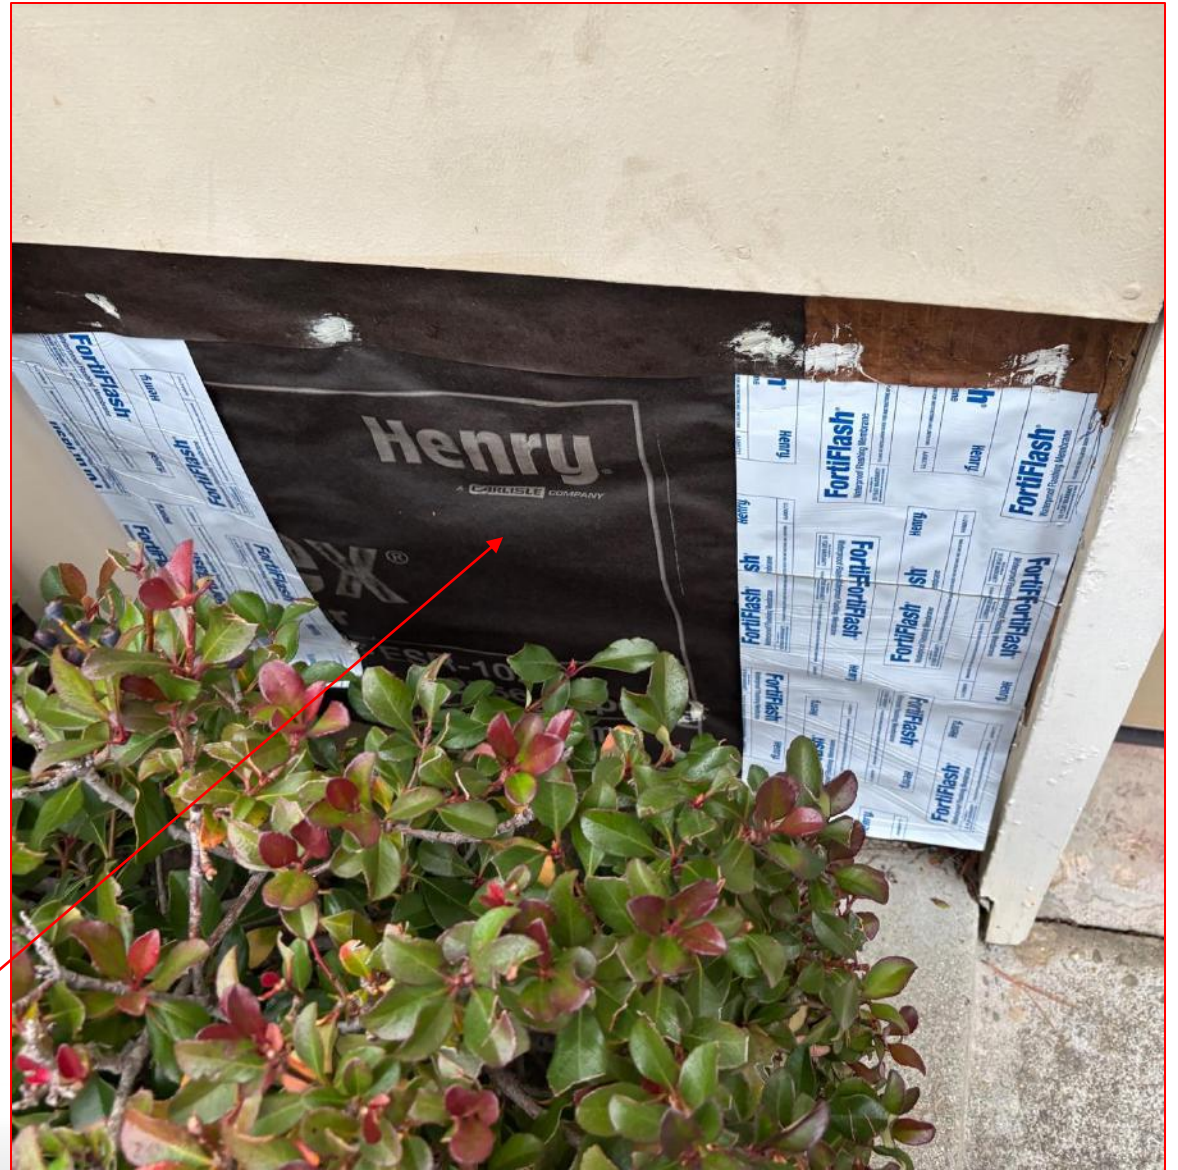
Noted updated “Spot” repaired lap siding, trim, membrane flashing, and WRB – Noted additional sealant added to WRB fastener heads.

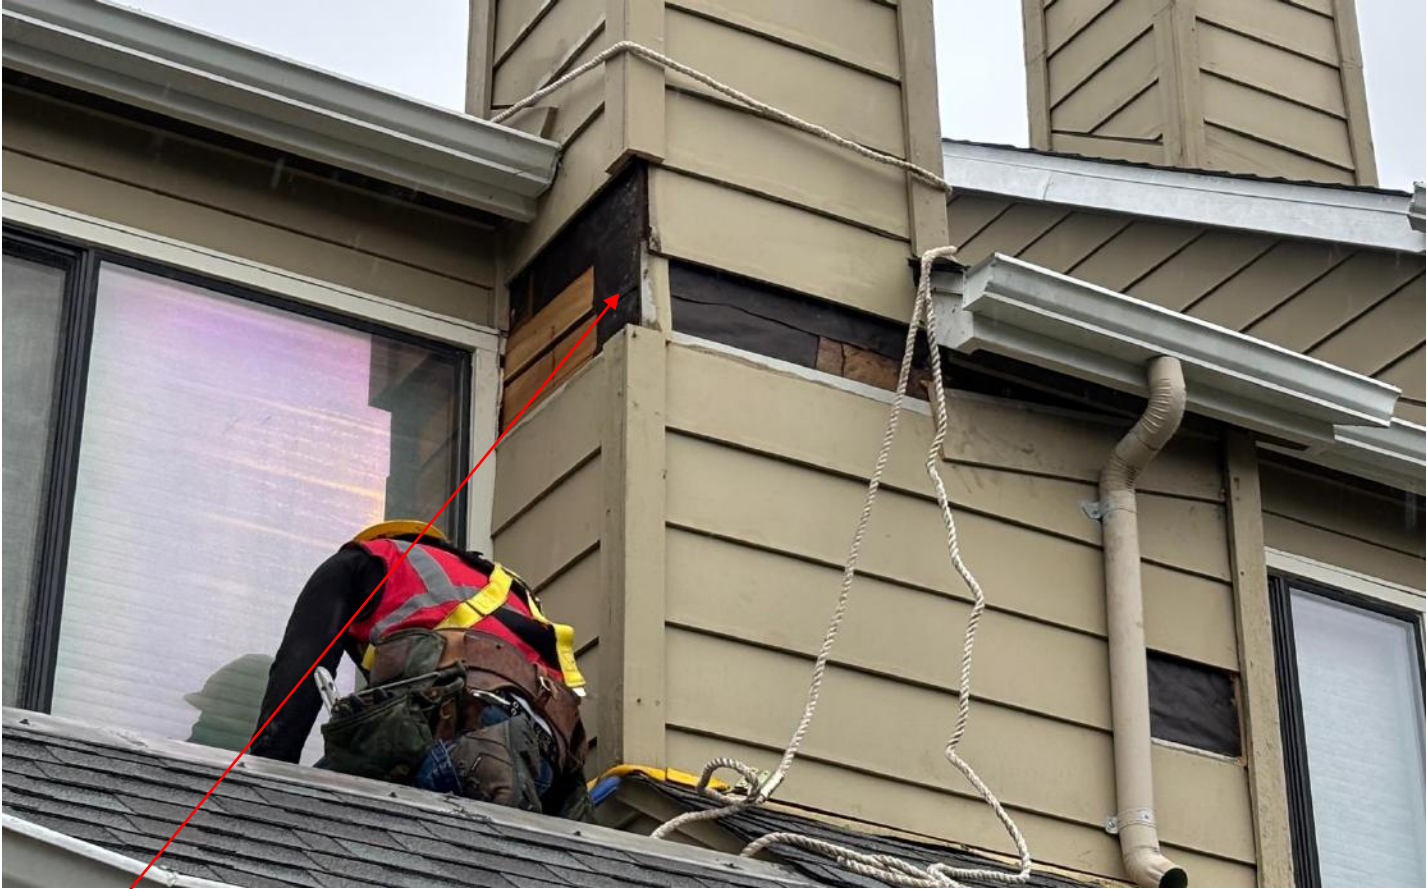
Typical Existing Aged and Worn Felt Paper WRB

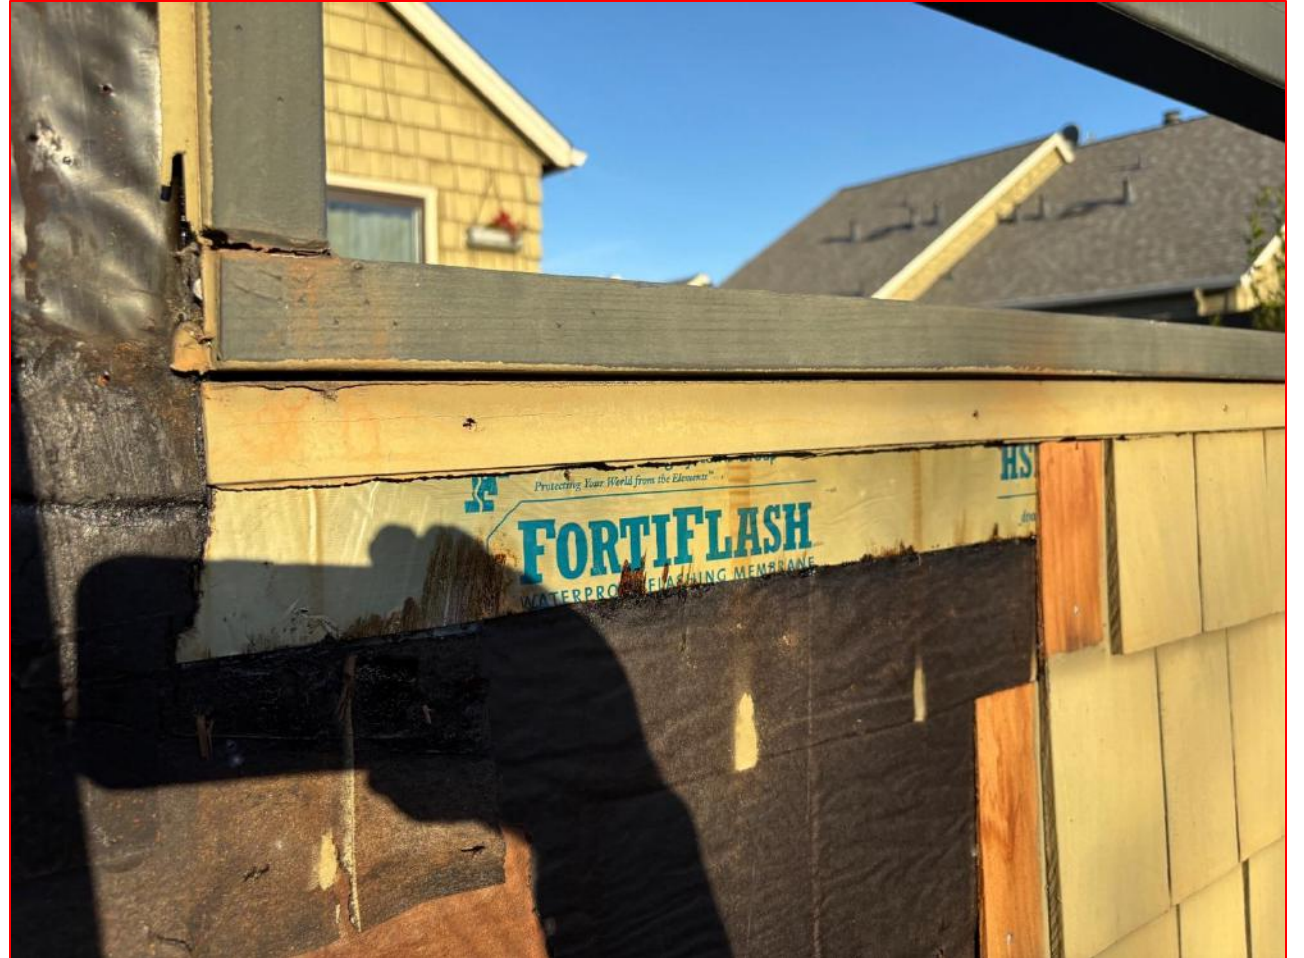
Typical Deck Wall and Cap Flashing and WRB Repairs. Noted Membrane flashing installed onto aged and worn Felt paper WRB. Detected low moisture readings.
