Harbortown

San Mateo, CA

INVASIVE BUILDING REVIEW

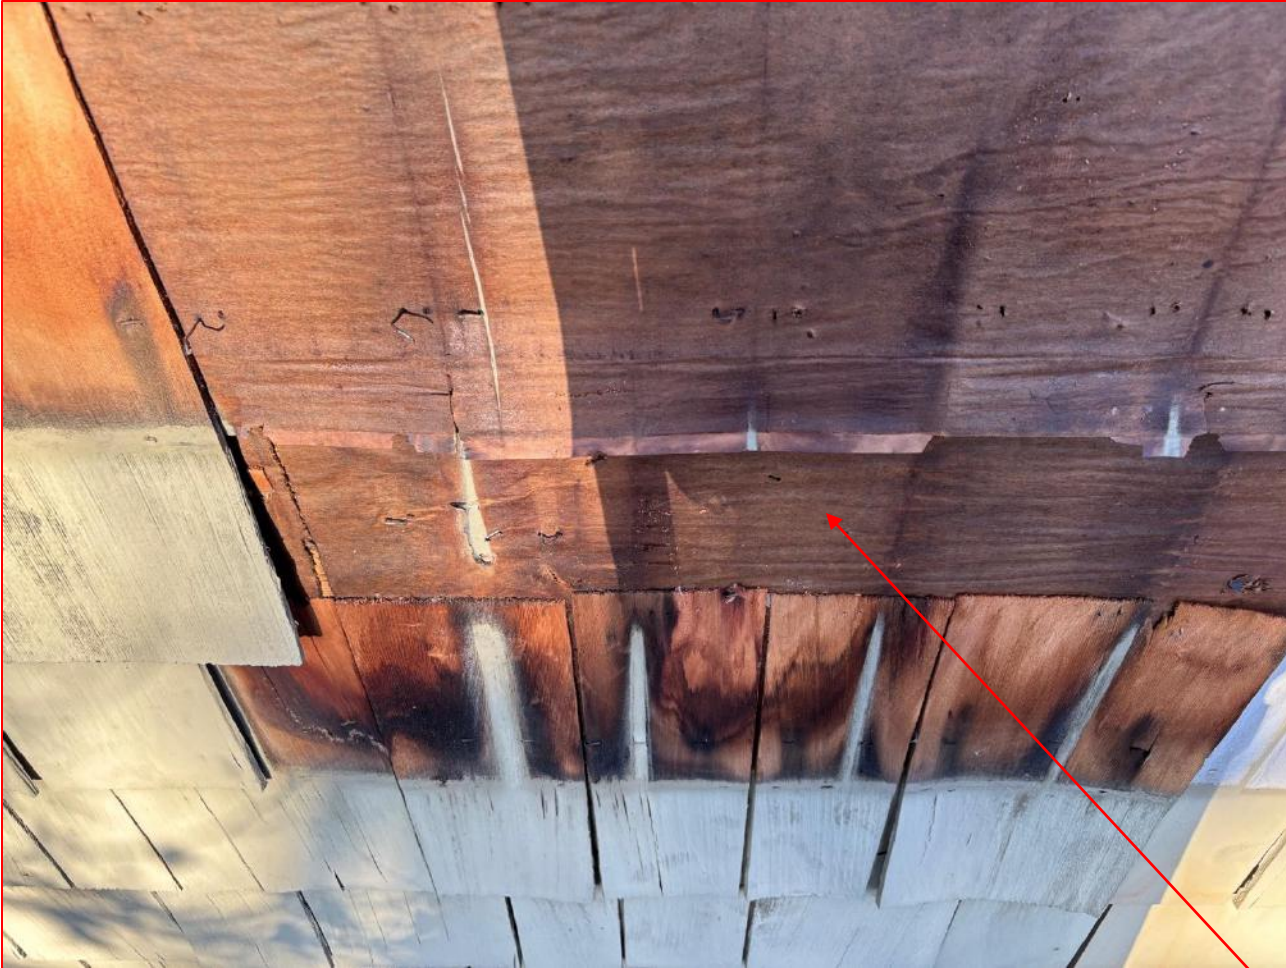
Noted original aged and worn felt paper WRB. Noted surface of CDX sheathing was dry.

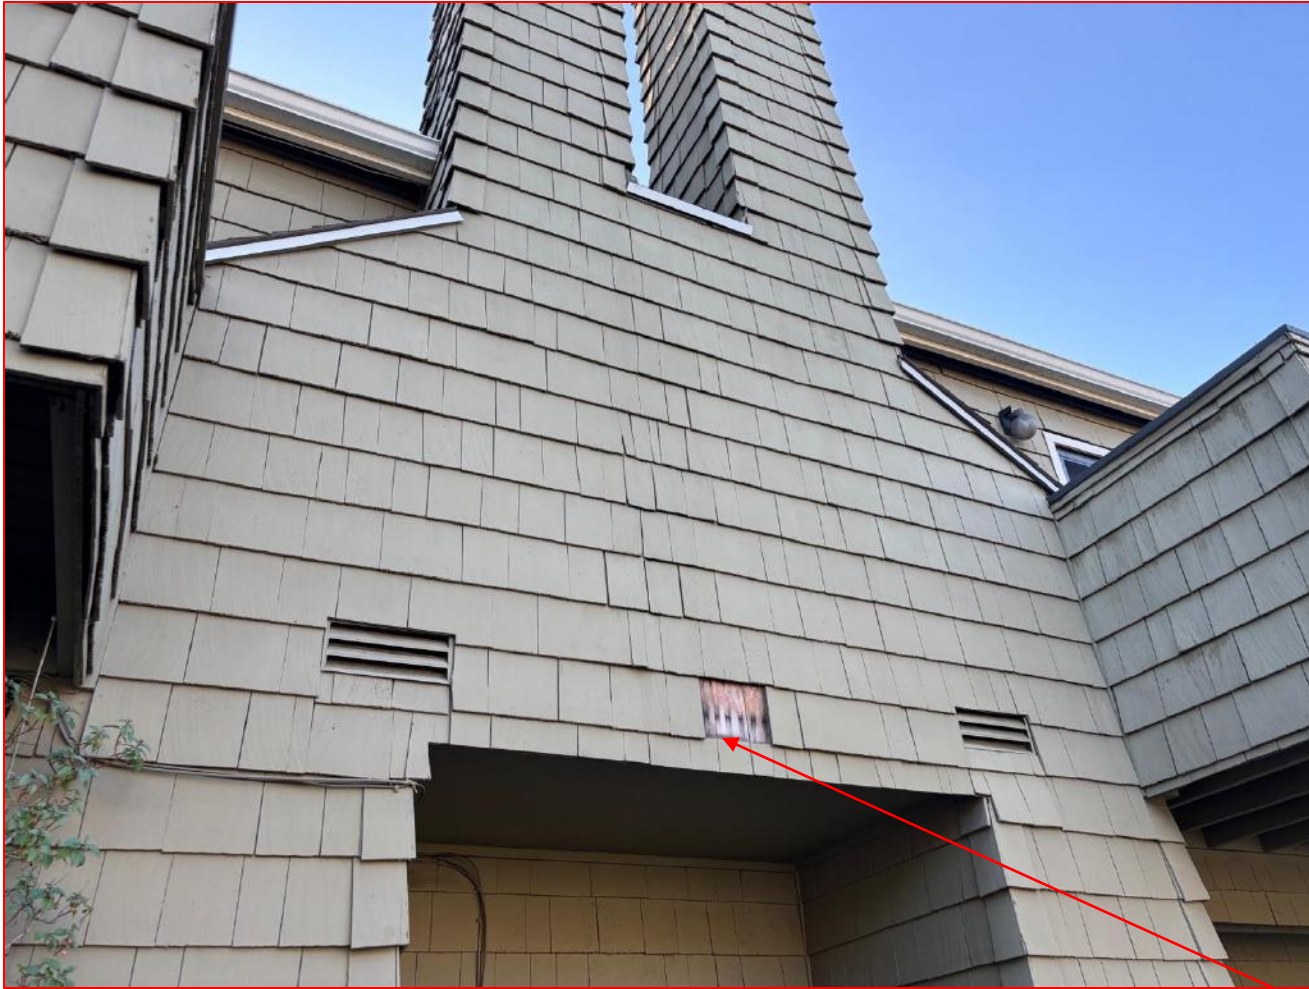
Noted Typical aged and worn WRB behind the cedar shingles.
Detected low moisture readings and noted surface of CDX sheathing was good shape and dry

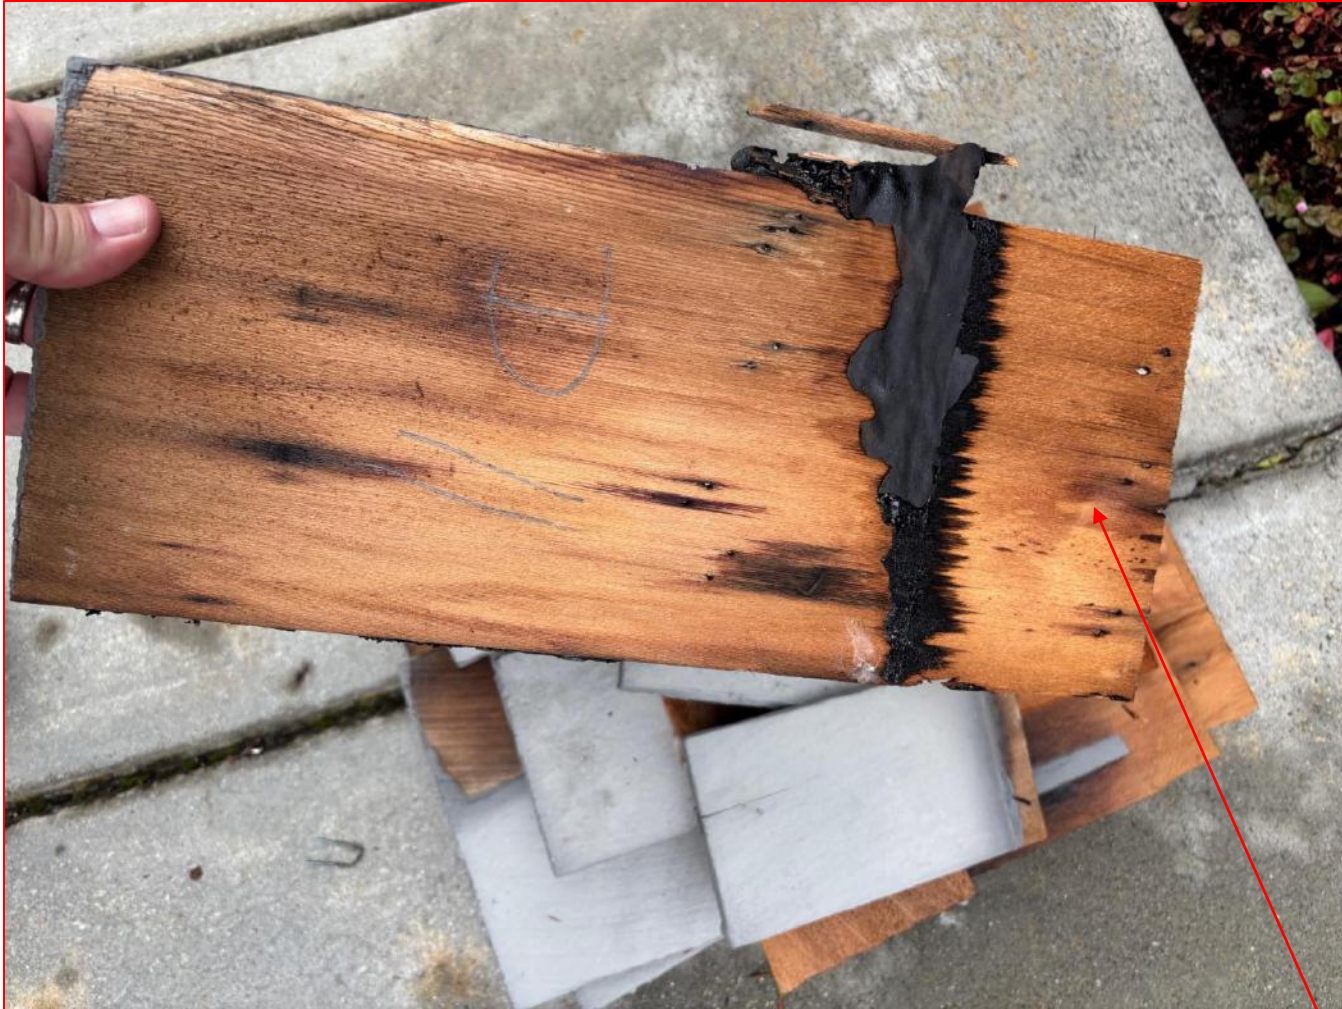
Noted typical original Felt paper WRB and wood shingle siding.
Noted aged and worn shingles, felt paper WRB, and CDX sheathing.
