Pepys Power & Hypergreening

Supplementary Material 2

Home Consultation Reports

BENCE HOUSE

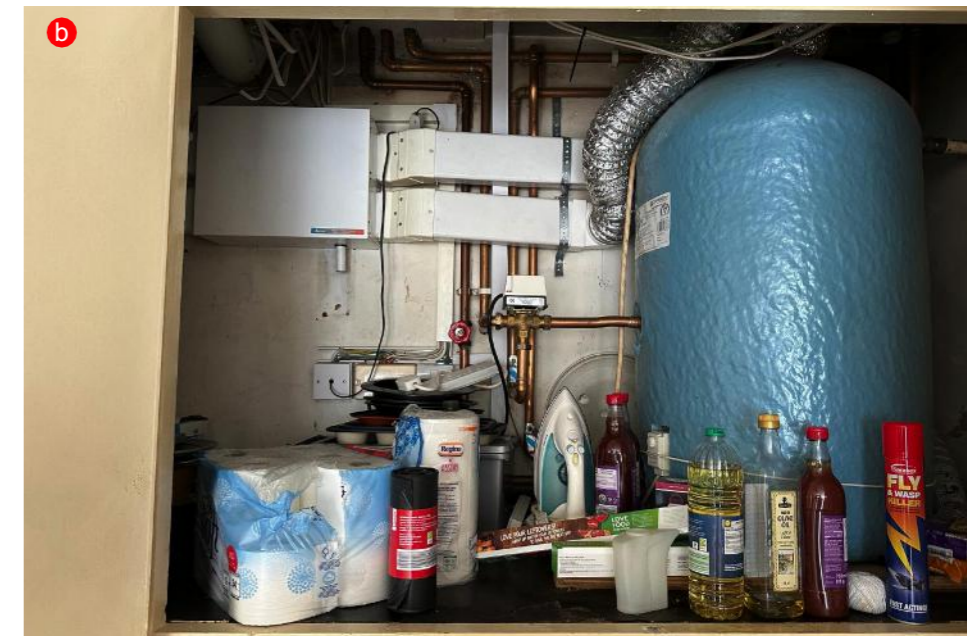
Kitchen utility cupboard with MVHR ventilation unit and ductwork, and hot water cylinder

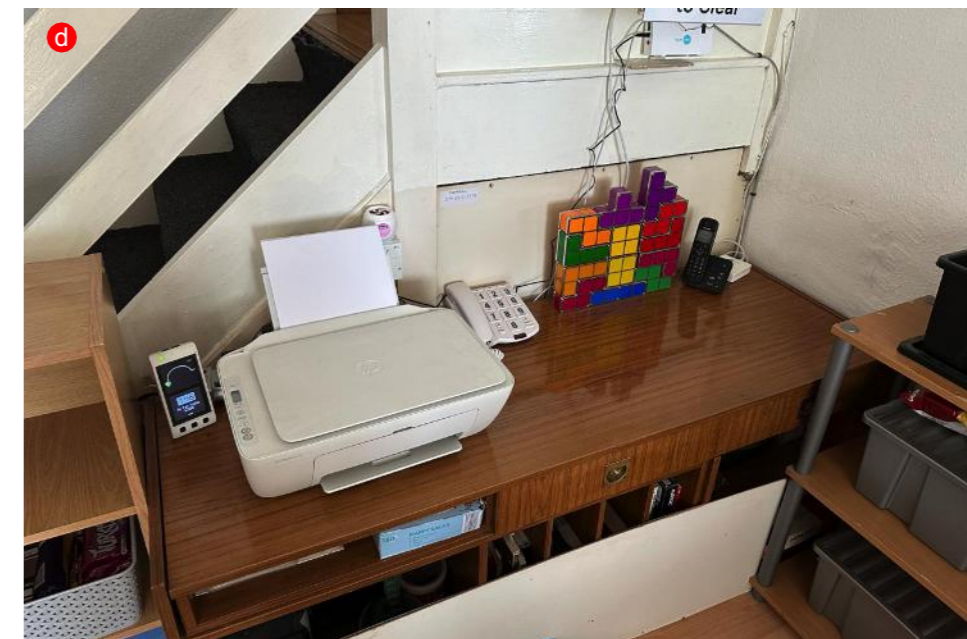
Access to original entrance and stair blocked off and built over

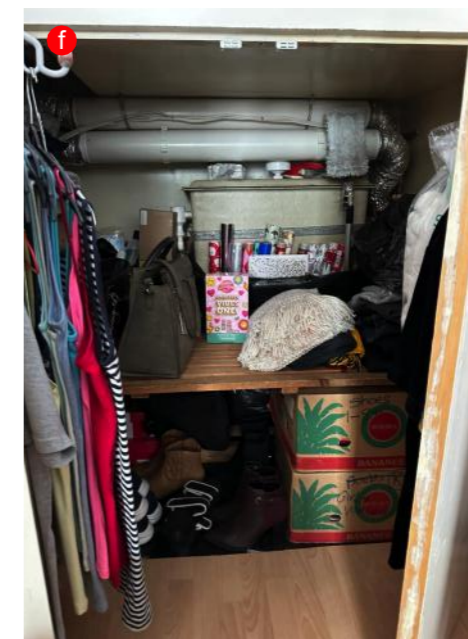
Bedroom utility cupboard with header tank and MVHR ductwork

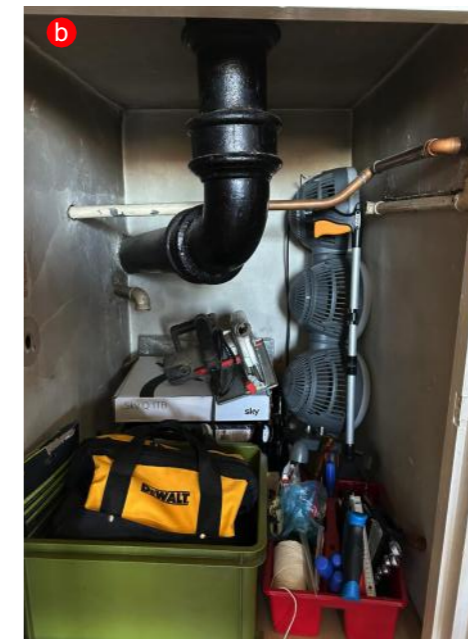
Living room cupboard adjoining WC with soil pipe bend and other services

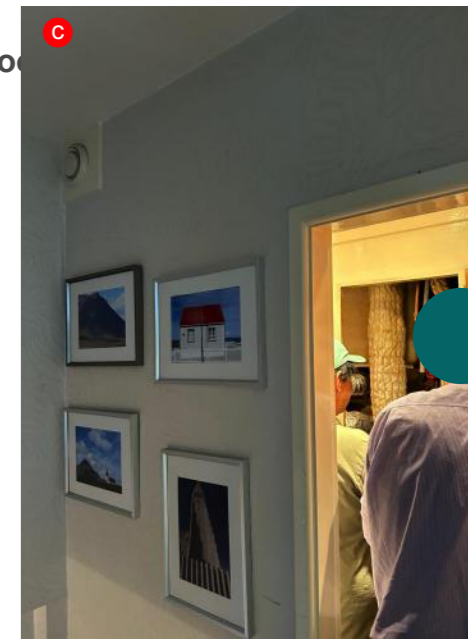
Ventilation register in hallway, unclear function and connection

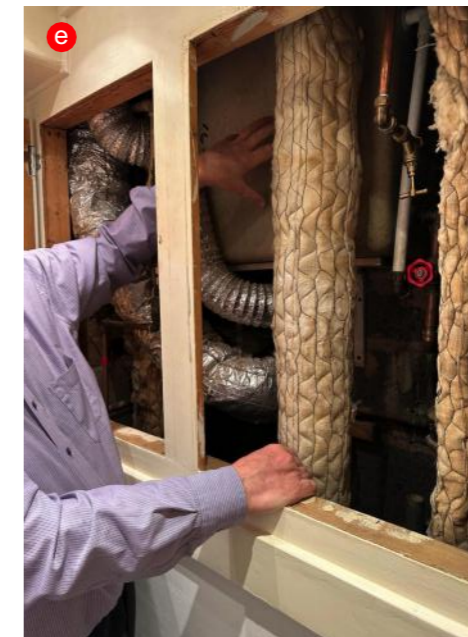
Service duct (WC) ventilation ductwork with unclear function and connection

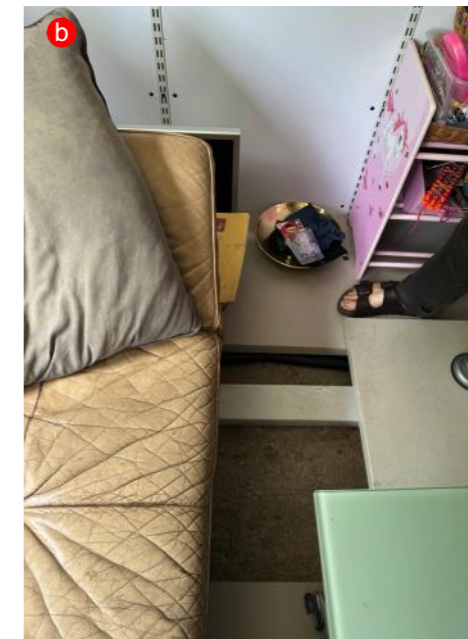
(b) Floor had a layer of screed, removed by occupant and replaced with tiles on pedestal to original FFL with service run under tile.

Screed removed for MVHR ventilation ducts to outside to run under floor tiles

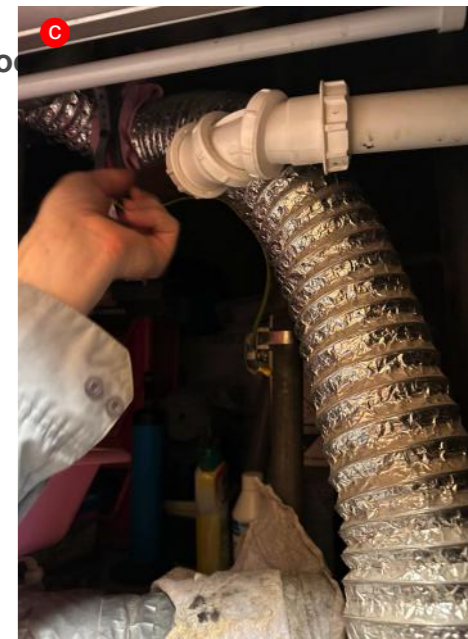
(h) Leaks above entrance are likely from copper pipes that have failed at bends, connecting into cast iron soil pipe, such connections visible in bathroom panel (c) including repairs with plastic pipework.

Failed copper pipework repaired with plastic in WC service duct

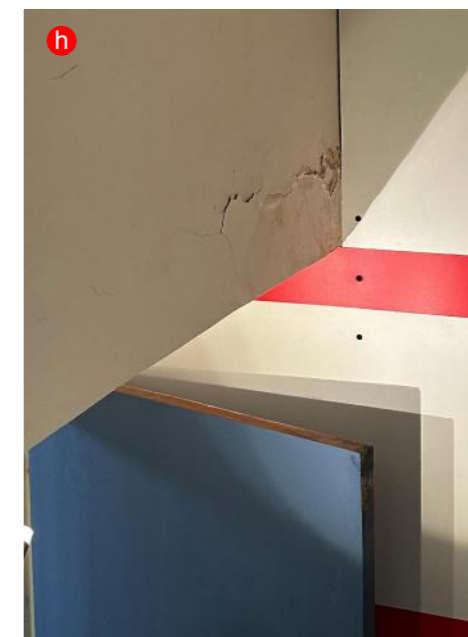
Historic water damage in hallway over entry from burst pipe, similar to (c)

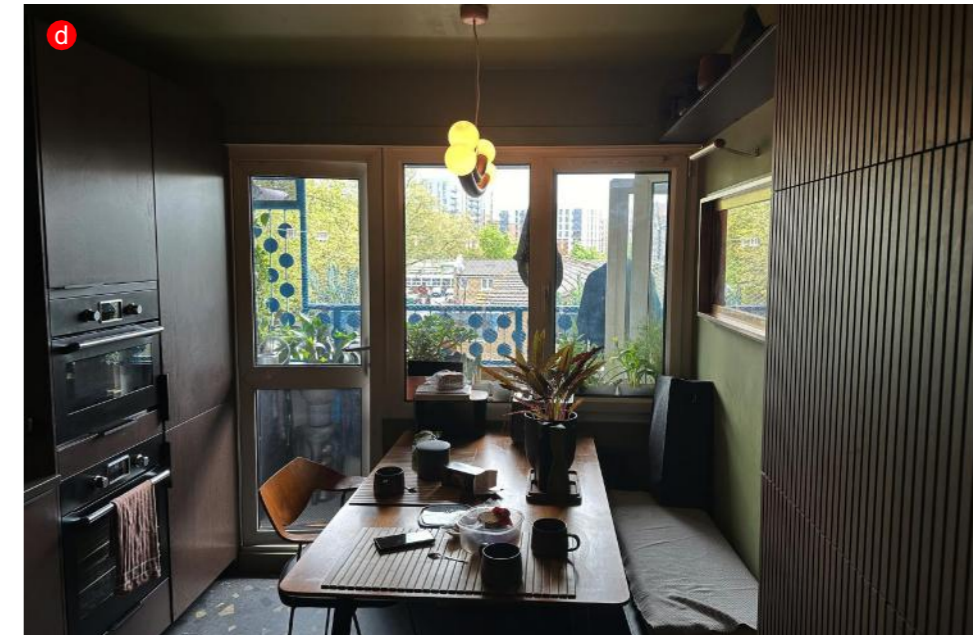
Kitchen with external terrace

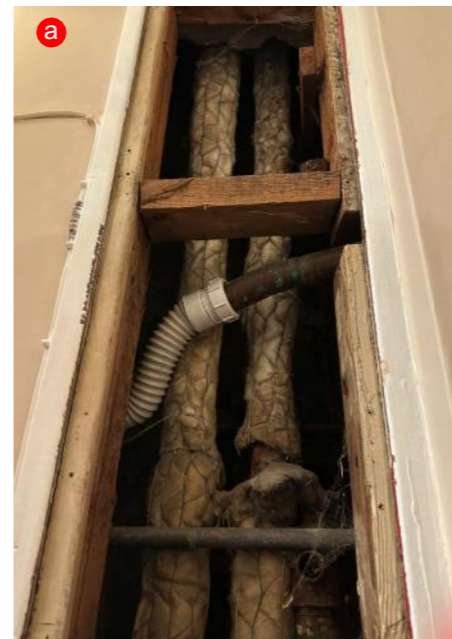
Service riser in entrance lobby with repair copper waste pipe

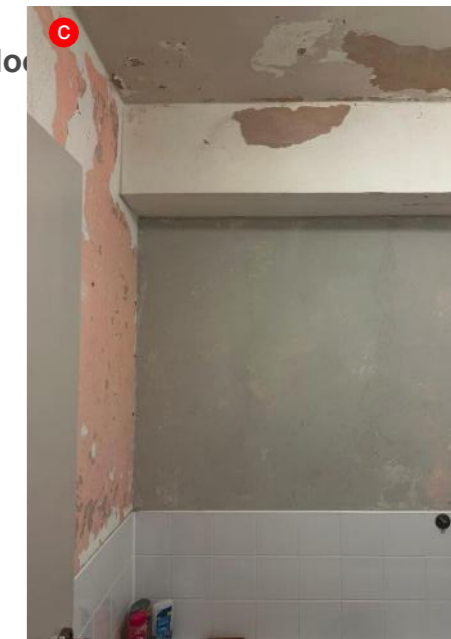
Extensive condensation damage to finishes in bathroom

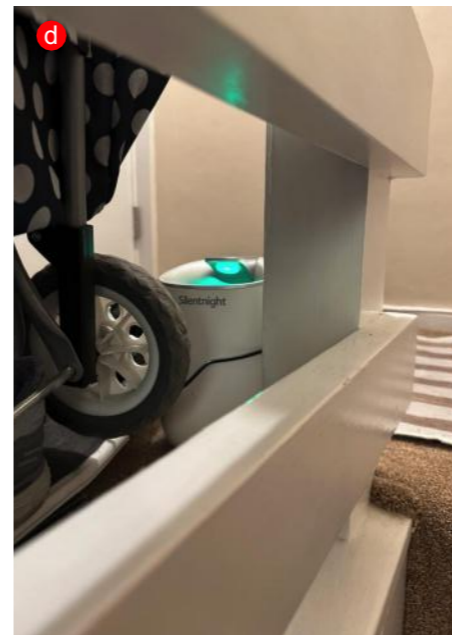
Portable dehumidifier used by resident to manage humidity in home

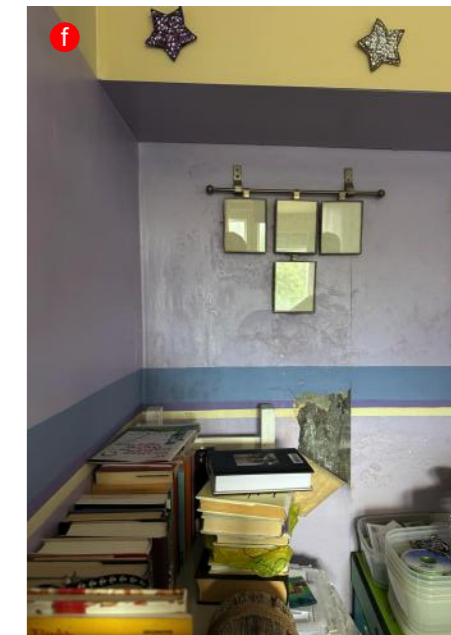
Damp/condensation damage in master bedroom at separating wall

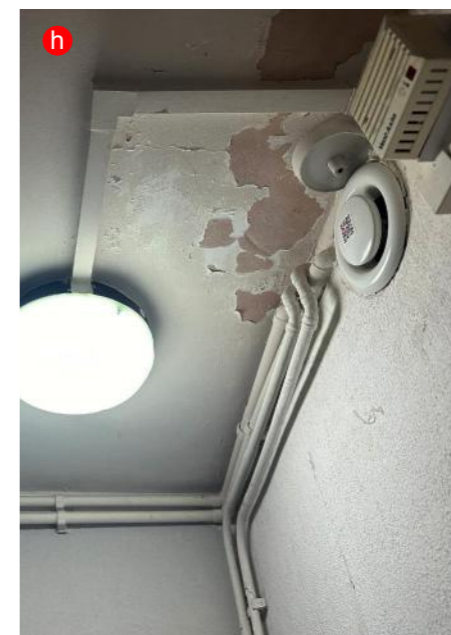
Non-operable extract register and condensation damage in WC

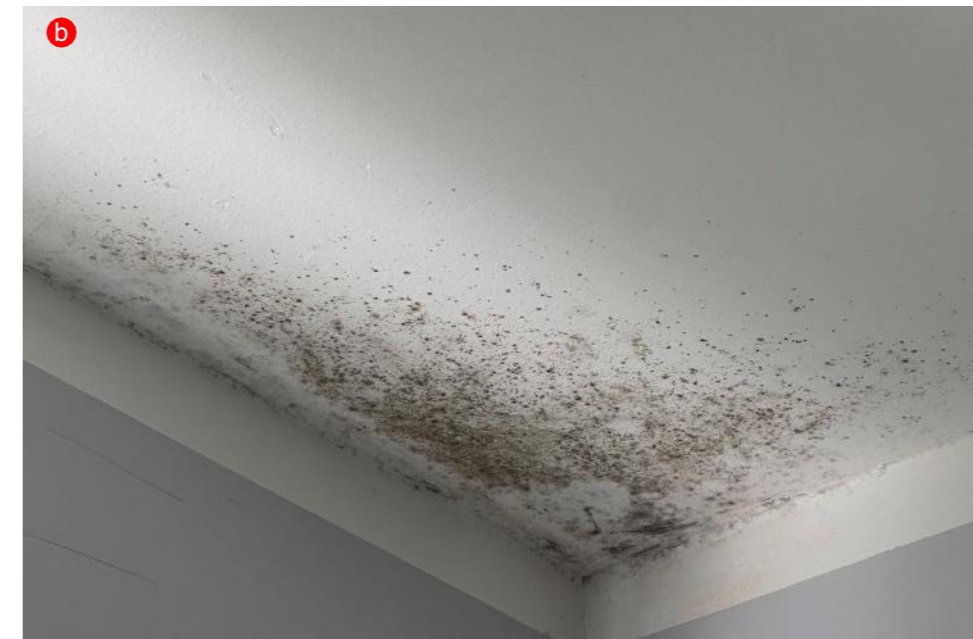
Black mould on living room ceiling under area of communal roof of 6th floor escape balcony

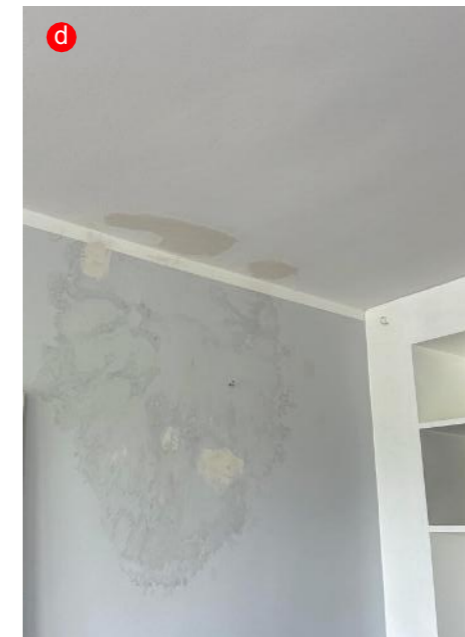
Water damage in living room under upper floor service duct

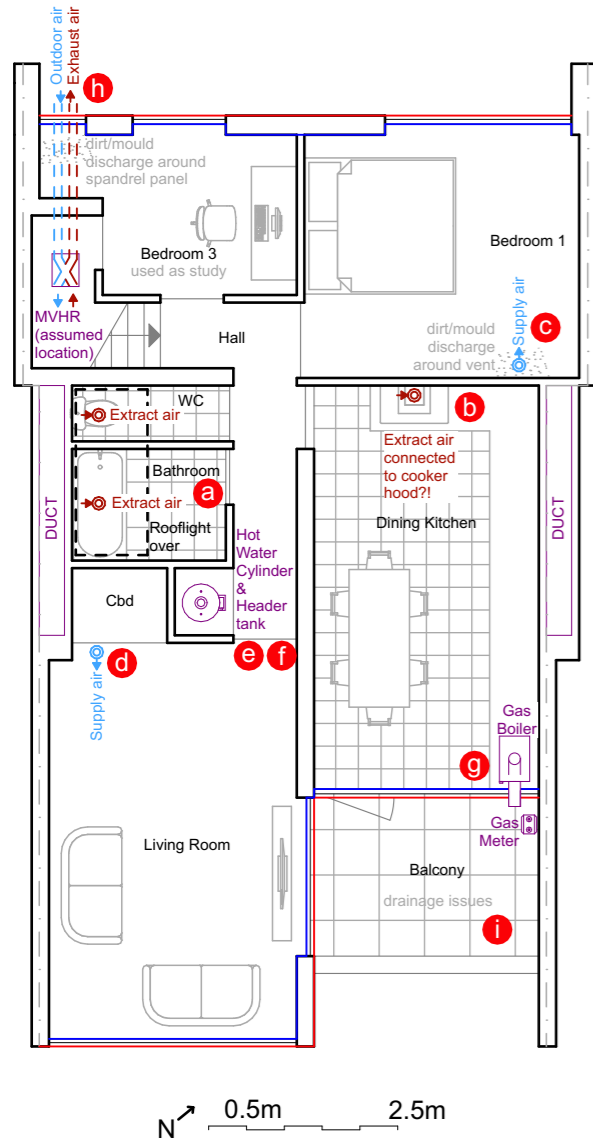
Rooflight over bathroom and extract fan (light switch activated)
