# MARS – Lessons Learned

MARS Report No 384 October 2024

MARS 202450

## High pressure hose whip causes eye injury

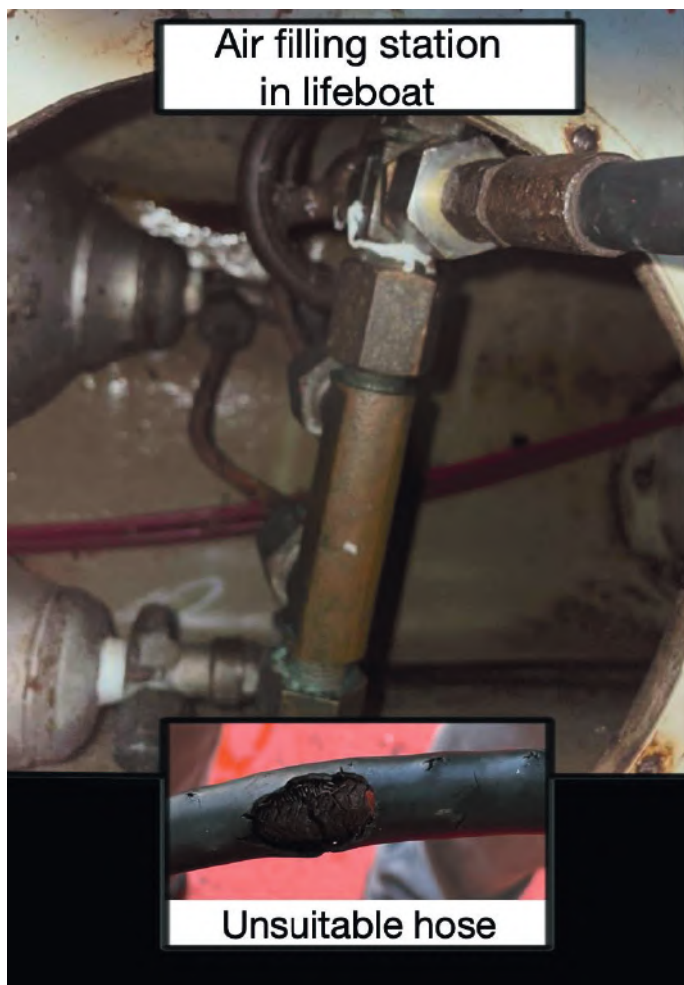
The crew member in the lifeboat also confirmed that the pressure gauge inside the lifeboat was zero. He then started to disconnect the air hose. When the air hose was almost completely disconnected, he heard air escaping from the filling valve; a small pressure had apparently built up in the supply line. He bent forward to check whether the cylinder valves were properly closed. At that moment the hose came off the connection and whipped his face. The crew member at the compressor heard shouting for help over the radio. He went immediately to the lifeboat and saw the victim was bleeding near his right eye. First aid was given and the victim was sent to a shore hospital.

The investigation found, among other things, that some air had re-pressurised the hose. This pressure was enough to initiate a whipping movement when the hose connection released of its own accord, having been nearly unscrewed by the victim.

Due to the lay-out of the air supply system, the person manipulating the air cylinder valves is in a vulnerable position in close proximity to the pressurised air hose. Although the filling hose was found to be in unsatisfactory condition, this was not a contributing factor to the accident. It should have been checked, discarded and replaced with an adequate hose by the crew members prior to commencing the job.

- Gases under high pressure are a potential hazard and risk assessments should adequately capture the risks and present reasonable mitigating practices for workers.
- High pressure components, such as air hoses, should be regularly inspected and unsparingly relegated if found in any way worn.
- Eye protection at all times and for all tasks; ideally it should become as ubiquitous as hardhat use.

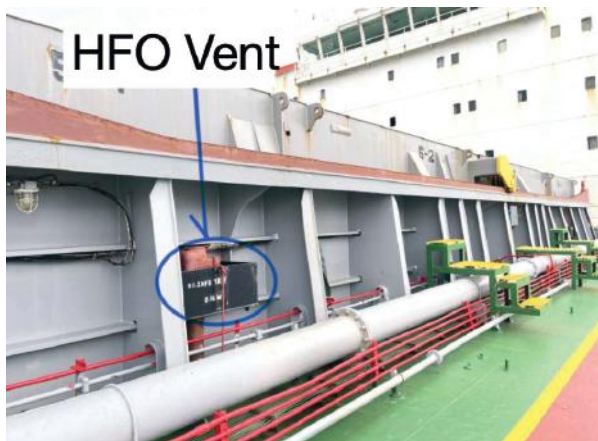
→ On a cargo vessel at sea, two crew members, a fitter and a cadet, were tasked with a welding job in a hold. As they gathered on deck near where the work was to be done, they both noticed a strong smell of heavy fuel oil (HFO) fumes from a nearby vent. While the fitter entered the hold to weld, the cadet stayed on deck to pass hoses and equipment. He was about 3.5m from the HFO vent during the time of work, which took about 15 to 20 minutes.

It was agreed to divert to a port to allow medical attention for the cadet. Before the vessel could reach port, and some 13 days after having been exposed to HFO vapours, the cadet was found deceased in his bed. An autopsy determined the cause of death to be asphyxia due to aspiration of stomach content.

- Never be complacent about the medical care of a suffering crew member. If symptoms are prolonged or beyond the competencies of crew on board, seek radio medical advice directly from the Centro Internazionale Radio Medico (C.I.R.M.) or equivalent facilities.
- Be aware of skewed judgement calls. In this case the Master's sense of urgency may have been dulled by thoughts that the new cadet was suffering more from sea sickness and/or ship adaptation rather than gas poisoning.

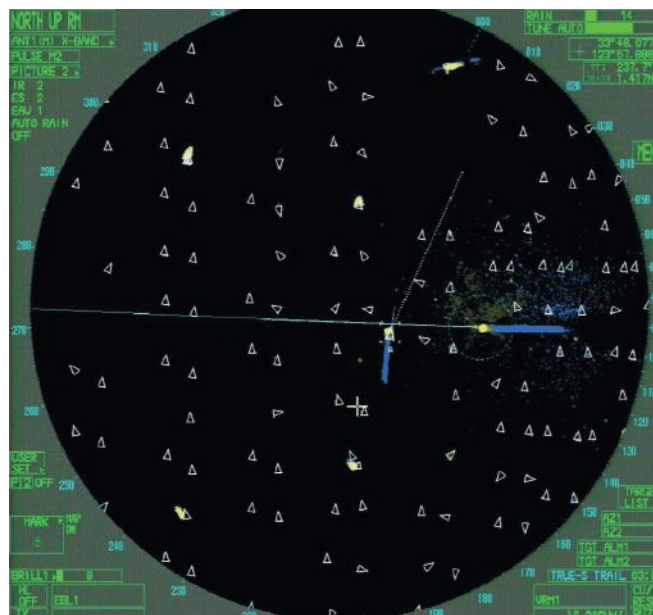
Tanker's radar at 21.33

At 23:19 the lookout reported what he believed to be a fishing vessel ahead and the OOW acquired it as an ARPA target on the X-band radar soon after.

The investigation found, among other things, that there were no navigational constraints that prevented the tanker from reducing speed or altering course to starboard in ample time. Also, whilst the tanker attempted to attract the attention of the FTV with an Aldis lamp, no use was made of suitable sound signals until five seconds before the collision, when the tanker sounded two short blasts.

- Passage plans should, to the extent possible, be adjusted to avoid well known highly congested fishing grounds.
- It is good practice to reduce speed when in highly congested waters.
- Trying to attract the attention of another vessel? Rule 34(d) is clear. When vessels in sight of one another fail to understand the intentions or actions of the other, or if one vessel is in doubt whether sufficient action is being taken by the other to avoid collision, the vessel in doubt shall immediately show such doubt by giving at least five short rapid blasts on the ships whistle.

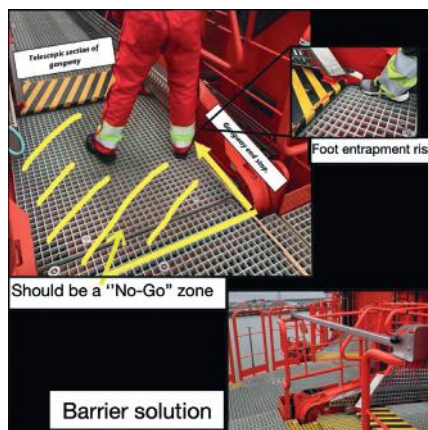
The weather conditions were determined to be within the capabilities of the gangway system and SOV, so a second attempt was made to connect. The gangway operator was again unable to make the connection and retracted the gangway. During this retraction, the telescoping section of the gangway frame travelled over the gangway operators' right foot, trapping it, and causing a compound fracture of the foot.

The investigation found, among other things, that the final section of the travel path (soft stop) for the gangway frame was not guarded. Additionally, the gangway operator's training had reinforced the practice of standing on the Telescope Access Bridge platform or in the operator shelter during gangway connection attempts, thus normalising the operators to this practice.

- Guarding was installed along the exposed soft stop of the gangway to ensure a person cannot place their feet in the path of the retracting gangway frame.
- A physical barrier was installed at the base of the telescopic gangway section which prevents the operator from encountering the gangway when it is fully retracted.
- Gangway operator training program was updated with specific focus on entrapment and shearing potential areas on the gangway.
- Develop a set of sea state/vessel movement limits for gangway connections that the gangway operators can use as guidance to make an informed decision on when to stop the job independent of the vessel's station keeping abilities.
