The following pages contain comments provided by Golf Course Architect, Drew Rogers.

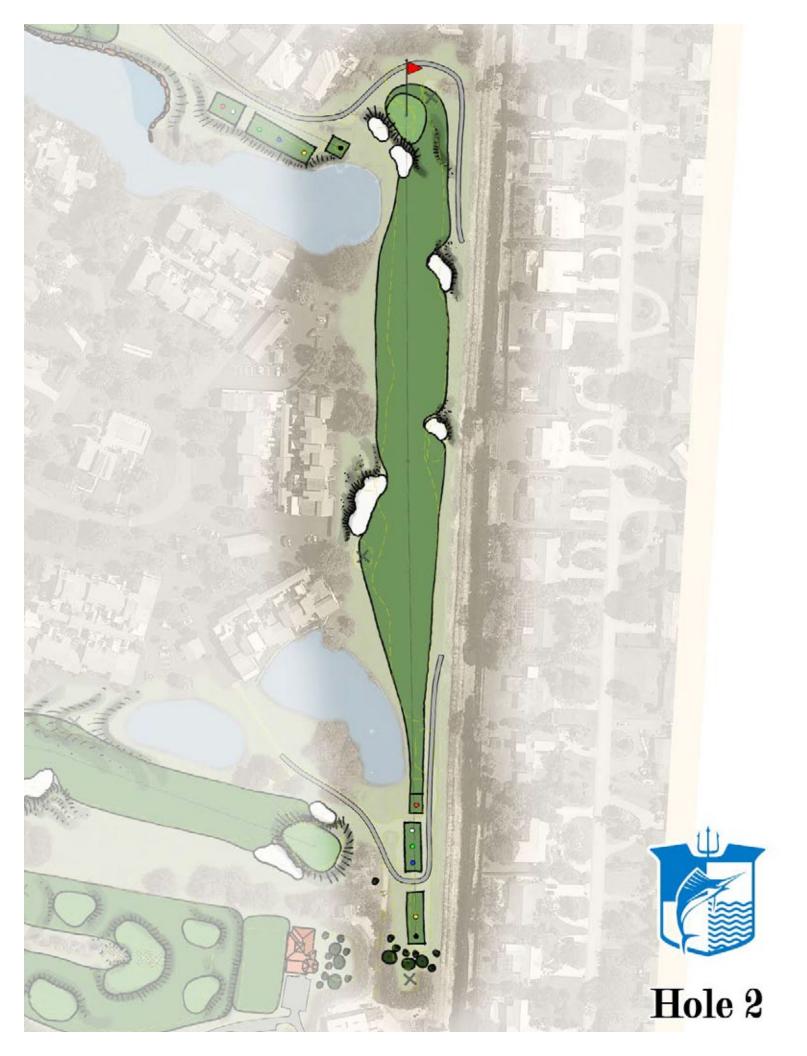
- The tees are pushed back into a corner of sorts, surrounded by planted vegetation. There is a sizable gap between the main and forward tees.
- The fairway bunkers are fairly small and don't tend to define any angles or strategy. The bunkers on the left hardly seem part of the hole, though I'm sure they do deter some shots from heading into the condos.
- It seems a bit strange to me that the pond on the left side of the approach really doesn't have any relationship with the hole or, in particular, the green.

- The fairway bunkering is to be modified, by removing the first bunker on the left and then enlarging and reorienting the second bunker. On the right side, the bunker is to be introduced on the right side of the long approach and it will offset the water on the left. A third bunker is to be introduced on the right side of the long approach and it will offset the water on the left.
- Bring the green back away from the property line to invoice a more fitting route for the cart path as well as a more playable bailout fairway option on the right shoulder.

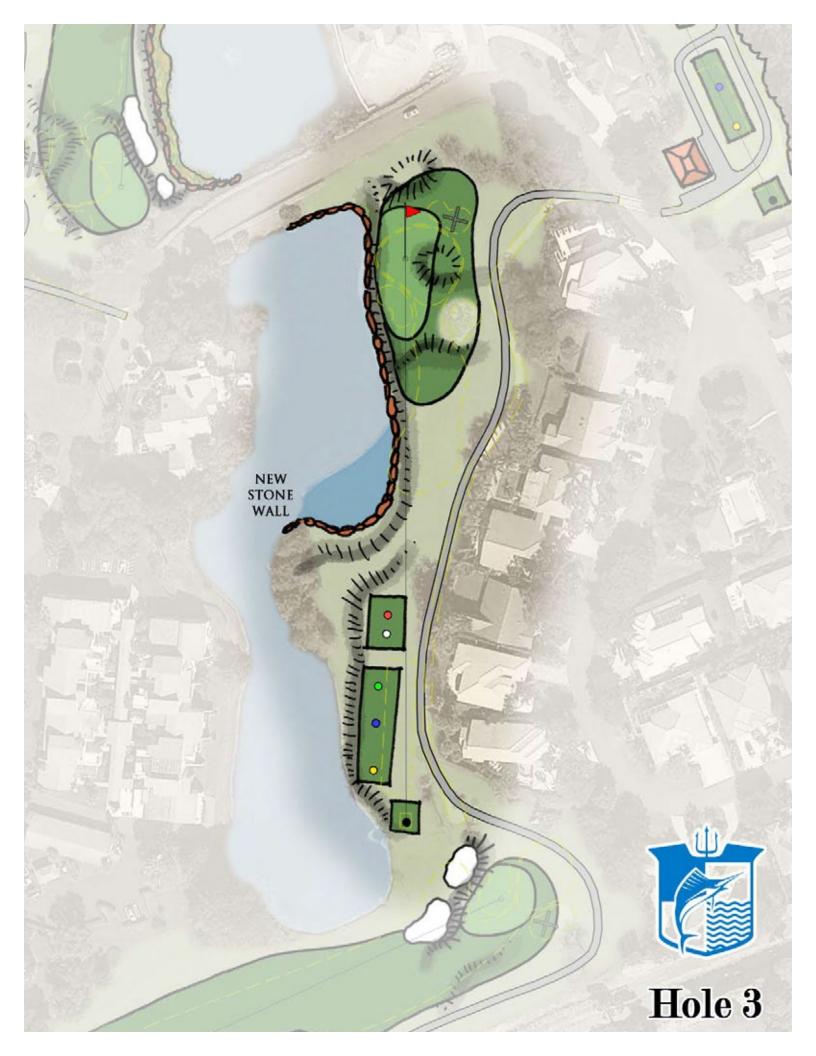
- The main tee is expansive, but feels odd being up so high, and with so much room to the left being unused. It is a long tee and accommodates five of the six tee positions.
- The green complex, overall, seems like it could be much better...if the large pine tree were not so impacting and if the green could be closer to the water (without the redundant bunker in between).
- The timber retaining wall does not have an extended life...it will need to be replaced in the near future. Certainly, it would be timely to replace it when the green is being reconstructed. Consideration should be given to going in the direction of stacked capstone instead of timber.

- Lower and shift the main tee further to the left for much better viewing perspective of the green and a slightly more testing angle.
- Build a new forward tee ahead of the main tee to accommodate the V and VI tee positions. This will shorten the hole up for those players a bit as well

- Replace the timber retaining wall with a capstone wall of similar length but perhaps a lower height, then build a new green at a slightly lowered elevation that relates more directly to that length of wall (and elevation) and the water itself. The green can and should be much longer in relation to the water, and that will produce a few extra yards of distance overall.

- The large pine tree is to be retained, but all of the sand can be removed from the hole- no bunkers. The test of the hole will be the long, skinny green and its tight relationship with the water. Hence, there is little need for bunkering...just an expansive fairway approach and bailout area on the right side of the green.

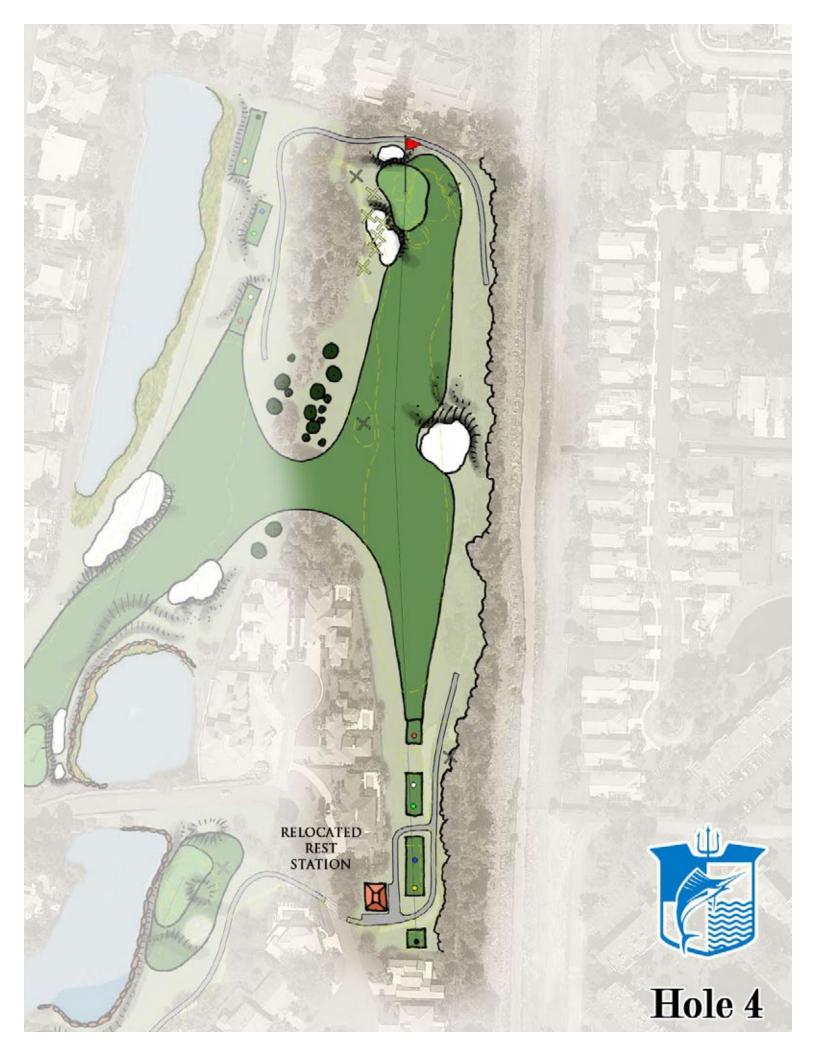
- The back tee is fronted by a low timber retaining wall.. I'm not certain what that wall is intended to hold up. The main tee is maybe a little high.
- The right side of the hole is rather over-grown, mostly with invasive Brazilian pepper and some Australian pine...and also a power line that is hiding behind all of that.
- The path accesses the green from the left side where it tends to be more in full view.

- Remove the timber wall on the front of the back tee it is not necessary. Lower and reposition the main tee further to the right. Build an intermediate tee for the IV and V positions and a new forward tee. Realign the tees further to the left.
- Remove all of the invasive vegetation on the right margin of the hole, realizing that this may create some holes or gaps in the buffer that must be revegetated.
- Relocate the cart path to the right side of the green to provide access on that side and also around the back of the green.

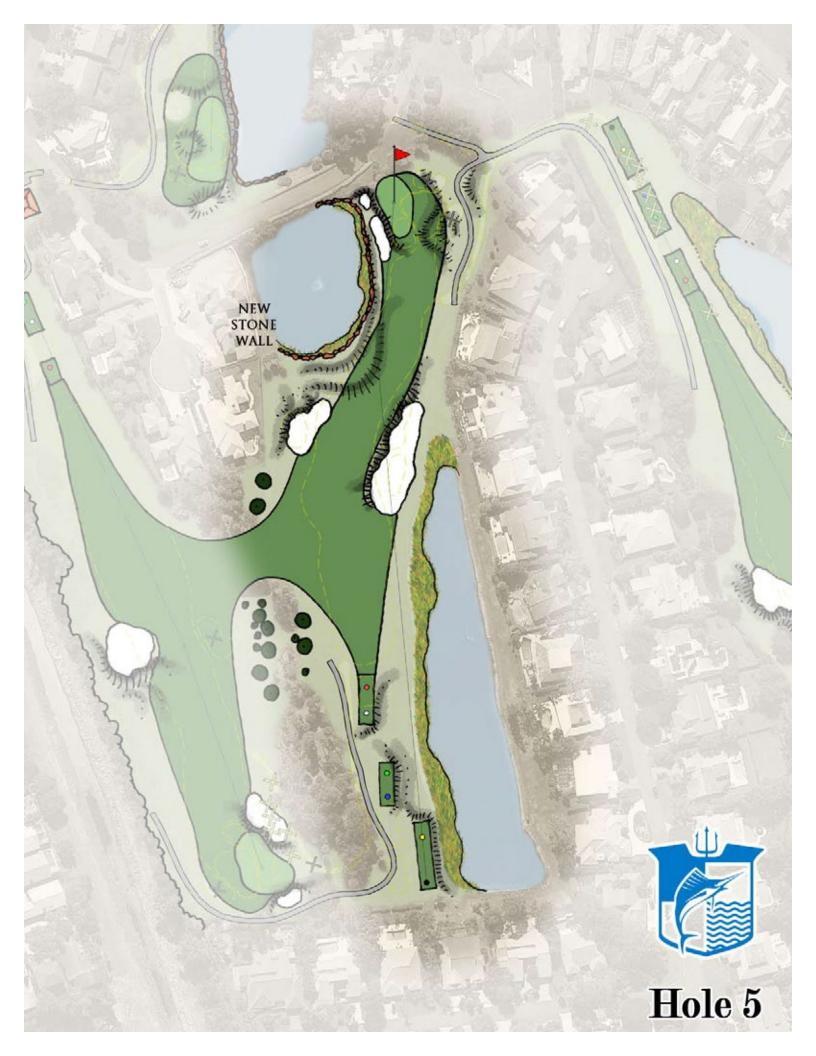
- I see this hole as a tremendous opportunity from tee to green. There is some great width and openness here there are playing angles here that are begging to be defined.
- The fairway bunkering on the right side, though perfectly positioned, seems much too high and uninviting...especially when that alignment is really the preferred line of play, strategically speaking.
- The biggest surprise here is the green complex. The current design presentation completely ignores the water feature to the left. In fact, the green is perched high above that elevation as well as being nearly 70 feet away from it.

- Re-work the bunker complex on the right side, lowering the horizon line to invite bolder play and this alignment. The floor should be cut in much deeper into the landform as well. Probably more effective as a single bunker rather than two, with proper scale. This is an important feature to get right!
- Relocate the main tee further to the right, lowering it to create more
 of an uphill feel to the tee shot while also engaging the water on the
 right side.
- Build a new green complex that is positioned directly against the water on the left and back as far as possible to stretch out the yardage. Lower the green 3-4 feet so that it fits INTO the landform rather than UPON it.

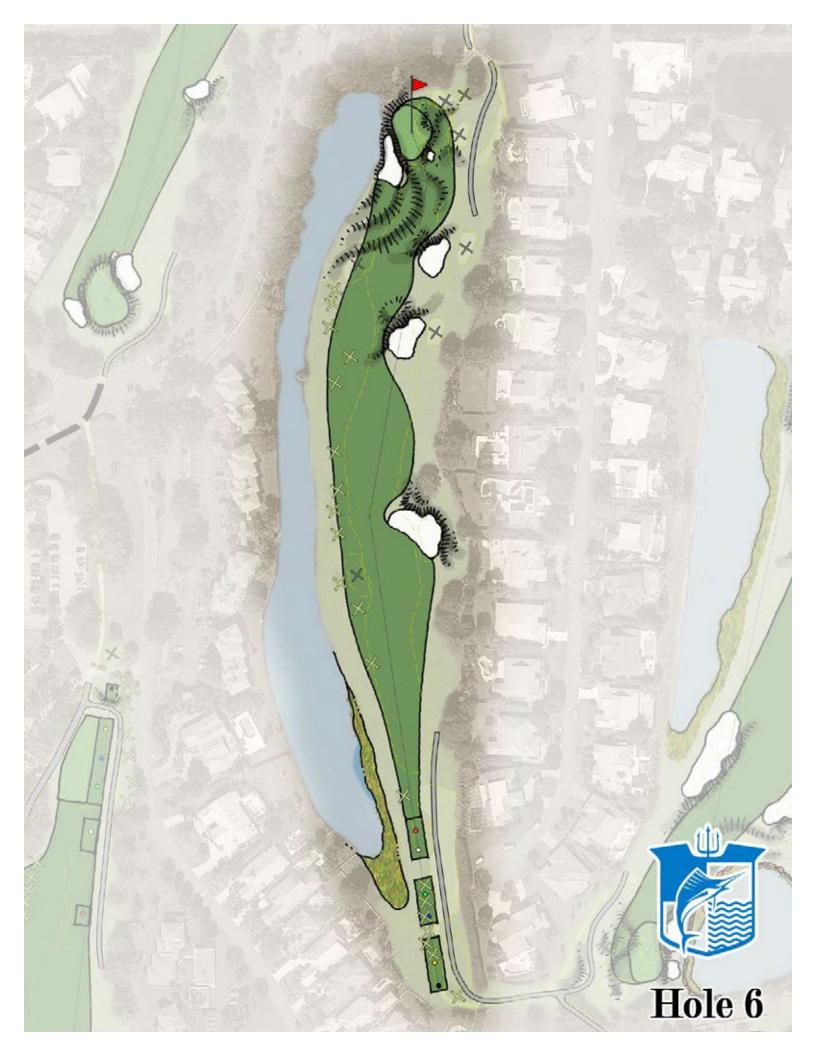
- I really can't seem to identify any inherent playing strategies here other than to keep the ball down the center of the corridor. The hole is absent of strategic angles, per se.
- Though the hole is bounded by water down the entire left side, there has been no effort whatsoever to engage it or expose it. One can barely notice its presence at all except to acknowledge the poor bank conditions. Perhaps that is why trees have been planted along the left side of the fairway-to keep players more inwardly focused?
- The green complex is also rather bland... again with no engagement of the inherent feature of the corridor, which is the pond on the left.

- Remove ALL of the trees and vegetation down the left side of the hole so that the views are open to the water and the fairway can be shifted further left to engage this width and get away from the homes along the right margin. This includes the bunkers as well (one in the first landing area and another further down the hole).
- The green complex should be redeveloped and shifted further to the left (lowered slightly), to better relate to the aforementioned features and to open up ore bailout width on the right side. Remove the waterfall feature, as this is where the green should be. This movement really takes advantage of existing features and available width. The result will be more drama, more defined angles, and a wider range of playing options. It all begins at the tee!

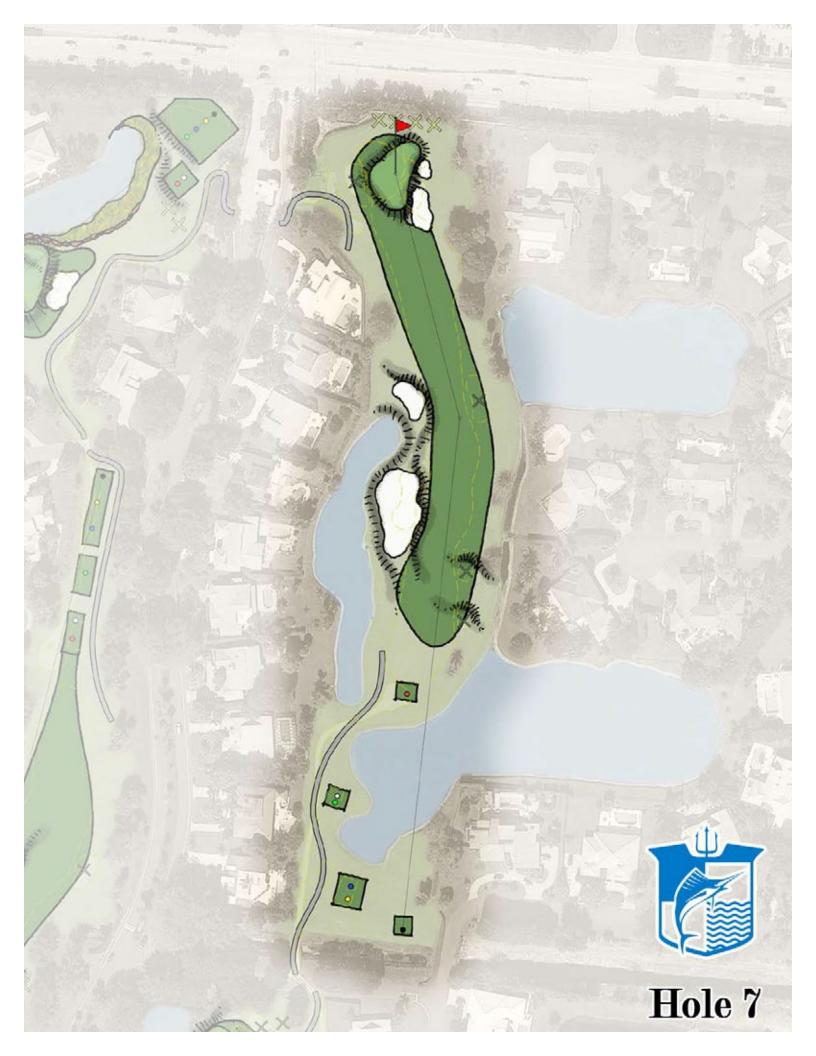
- The back tee here really seems forced (on the other side of the road, adjacent to the previous green). As a result, length was certainly created (roughly 79 yards), but at the cost of awkwardness and safety, in my opinion. It's also a challenging location to grow grass due to shade.
- From the main tees, the corridor is really open, but also somewhat void. The bunkering and shaping don't seem to be in sync with the scale of the space or with any specific playing strategies. It's a rather confusing hole to me, visually and otherwise.
- The first two fairway bunkers (on the right) are rather small for the scale of the space, but more importantly, they are positioned where they only really impact the shorter hitter unless, of course, you're playing the existing back tee... and that's likely why these bunkers were added in the first place.

- Consider omitting the existing back tee. It's really a forced issue, like
 a good many of the other back "after-market" tees that were added
 to the course. Build a new back tee to the right of the existing main
 tee. The angle is interesting, and it will play at approximately 413
 yards.
- Remove all three fairway bunkers on the right and widen the fairway on that side. Completely rework the fairway bunker on the left side. Cut it into the ground where we can see beyond it and enlarge it so that its scale fits the space. That alone will make it more fitting and strategic.
- Look to reconfigure the green complex, raising it very slightly for definition. Create a more defined left-to-right angle in the alignment and position of the green that will reward those tee shots that stay closest to the bunkers.

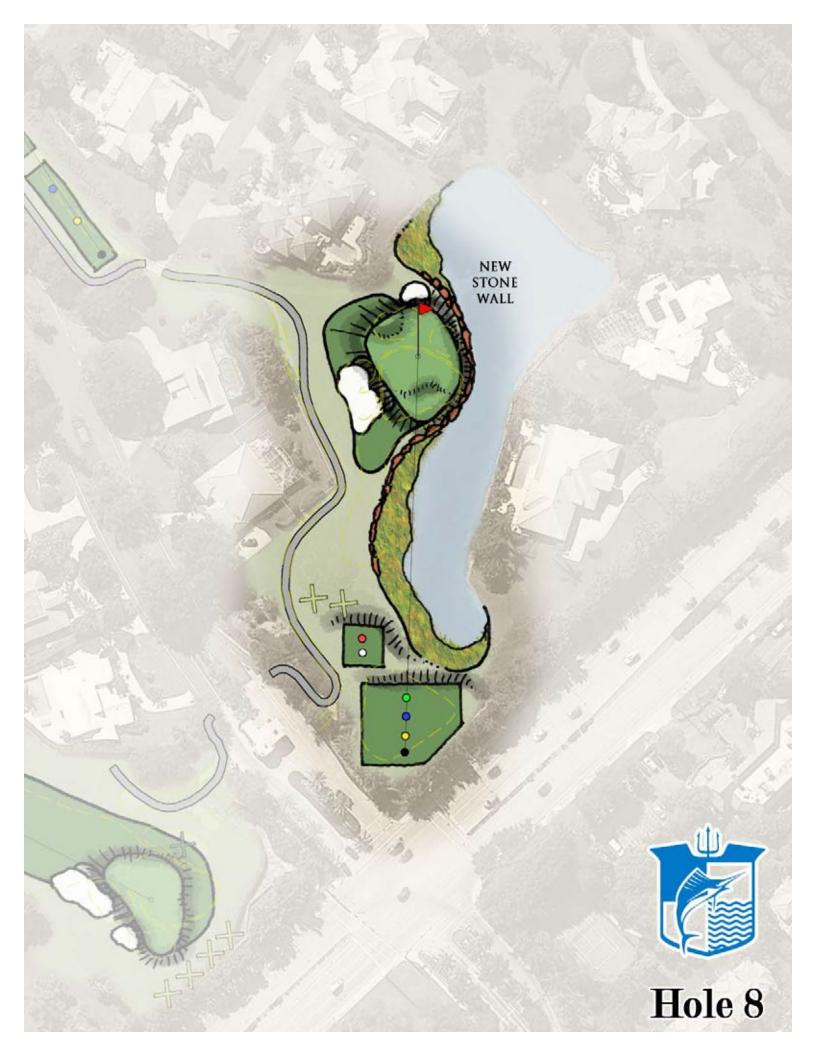
- This par 3 is certainly one of the older, short hole expressions at Seagate. This is the 17th at present but will become the 8th.
- All of the tee positions are placed on a single pad. There is only 50 yards of difference between the back and forward-most tees.
- The forward tee players face much of the same angle and difficulty that the back and main tee players do... a rather testing shot over water – or a bailout to the left that will likely find a bunker. The only real spot to miss here is to be short (on the shortest hole on the course).
- The timber retaining wall treatment is completely falling apart and needs to be replaced.

- Lower the overall tee by several feet so it can be expanded and its shape refined. The lower elevation will make access easier from the path so that steps are no longer necessary. Omit the back "pocket tee" at the cost of ten yards of length. It's not a useful or practice tee to retain, in my opinion.
- Remove two trees on the left side so that a new forward tree
 position can be constructed. This will help to break up the tees and
 provide an alternative alignment/angle into the green one that
 doesn't not force players to carry their shots over water.
- Replace the existing timber retaining wall with a new stacked capstone treatment. The green elevation should be more or less flush with the top of the new all and a proper collar treatment can be established around the perimeter of the green.

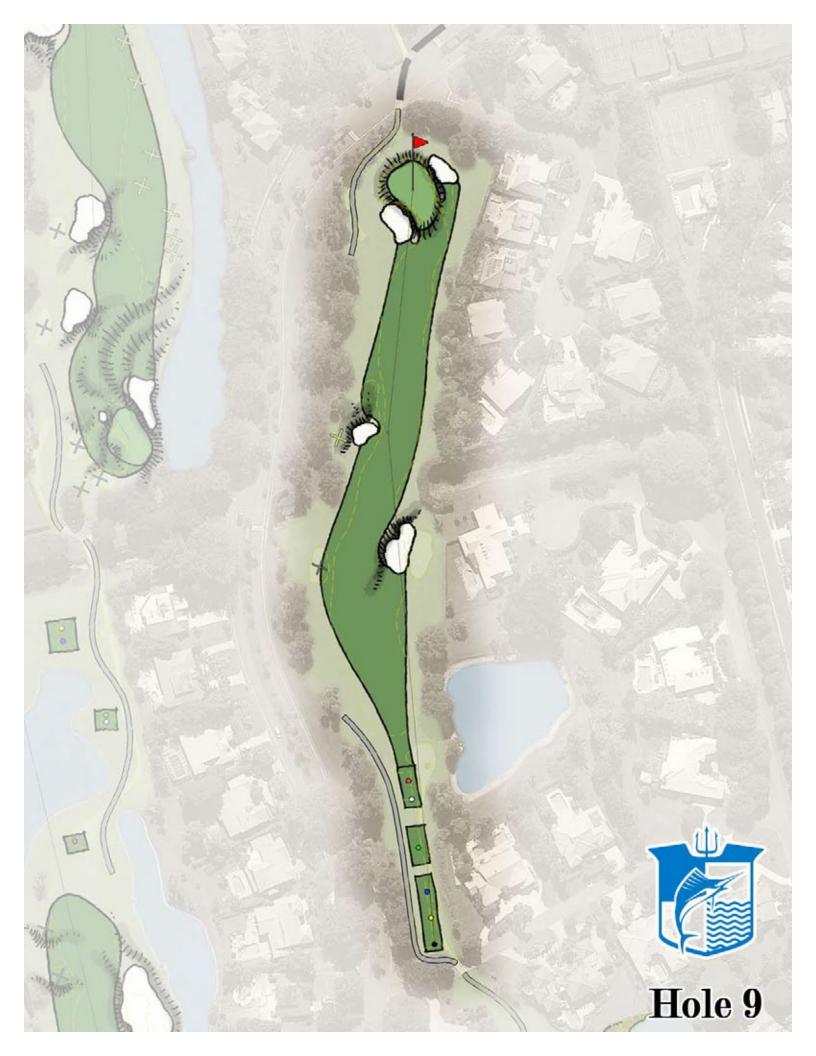
- The tees here seem unnecessarily raised. Is there anything gained from their current elevation? Nothing seems to change when we step down the slopes by 2-3 feet. The forward tee is also raised/ pronounced... and it tends to block a bit of the fairway foreground view.
- The first fairway bunker on the left seems unnecessary... a bit short and tends to catch players who are trying to take a less aggressive line. That bunker is also built on a rather large chunk of fill. That landform is completely contrary to the low-profile, right-to-left pitch of the natural grade.
- The green complex has some nice qualities; the bunkering however is rather unnaturally perched above the ground and the adjacent earthen shoulders are really bulky and that makes the entire green complex look very manufactured and unnecessarily complex.

- Lower the tees by 2 feet or so and shift them further left by 14-20 feet. This will provide an amazingly improved angle that opens the hole up from the tree. Also look to build a new intermediate tee to bridge the gap between he main and forward tees, while lowering and enlarging the forward tee.
- Remove the left fairway bunker and the entirety of the landform it is built upon so that the ground can flow more naturally from right-toleft alignment of the fairway.
- Rebuilt the right fairway bunker. Reposition that bunker so that it comes out more into play and sets an angle that reinforces the fairway alignment... a feature that players will aim to conquer! If successful, they will effectively open up their approach shot.
- Remove some of the extended fill/slopes that support the bunkers

they are unnecessary, and they detract from the definition of the
 green. The greenside bunkers should press hard against the raised
 green surface with defined depth and steepness.

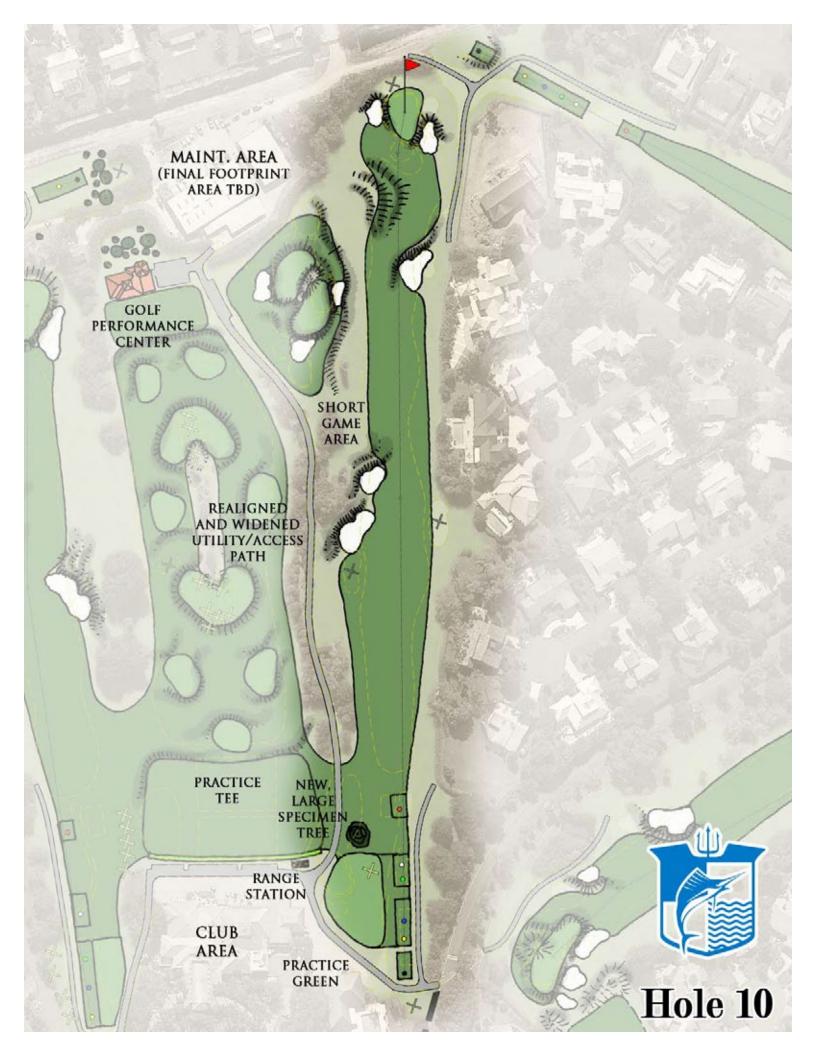
- This hole has long served Seagate as the starting hole, #1 and will now become the 10th. It has good control from the golf shop and plenty of space around the tees.
- The existing back tee is entirely forced... really a challenge to access by golfers and maintenance personnel alike. Its height is unnatural and opens up views down the adjacent boulevard.
- The entire tee complex here requires some study, including the path, circulation and the overall visual identity of the space and its connective elements. The practice areas, staging areas and the overall flow of the area around the clubhouse is part of the solution.
- The green is slightly elevated and nicely angled from right-toleft, guarded by a complementary bunker. The back, right bunker, however, isnt' as well developed and its floor is more or less propped up above the green surface and takes up a lot of space in doing so.

- The after-market back tee should be omitted... and I believe
 there are other plans for that space that are connective with the
 clubhouse area improvements. As the back tee relocates to the back
 of the main tee, there is still ample length here to retain the hole as a
 short part-5 from all six tee positions.
- As we look at the tee complex as a whole, we show a concept that involves shifting the tees to the left (where the existing math is) while relocating the path to the right side of the tees, which can now open up to a turn connection over to what can become the new practice putting green.
- Although the existing green complex has some nice qualities, we can better maximize the use of space by removing the back bunker and building a small, elevated green that provides an appropriate and well-defined target for a shorter par-5.

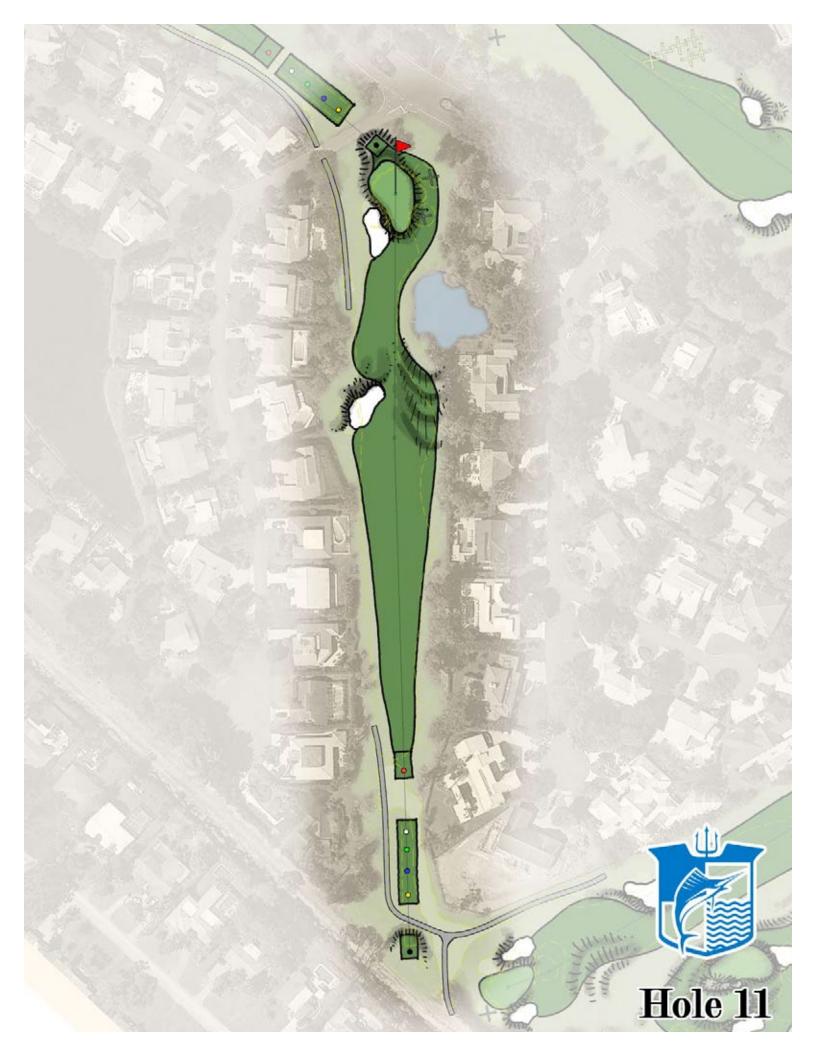
- The tee complex is very long and linear... and it seems very unnecessarily elevated as well, which makes golfer and maintenance access a challenge. Although there is a planted hedge to the left of the tees, one can still see over the vegetation inot the canal easement and homes.
- The greenside bunkers could use some work they just don't complement the green very well and there is an abundance of soil built up around them... for that reason, I don ot know... but the resulting slopes tend to carom missed shots well away from the green and possibly into greater trouble.

- Build a separated back tee, lowered slightly, and pushed back as far as feasible to maximize the length of the hole. Lower the main tee by 3 feet or more as needed to achieve both proper accessibilities, a well fitted tee with clear forward visibility of the hole and also easy access from the path.
- Build a new forward tee that will measure approximately 310 yards.
- The front left greenside bunker is an important one, and it should be expanded in length to define the angled edge of the green on that side... a bold-faced feature for certain. The two bunkers on the right, back side of the green don't seem necessary, in my opinion.

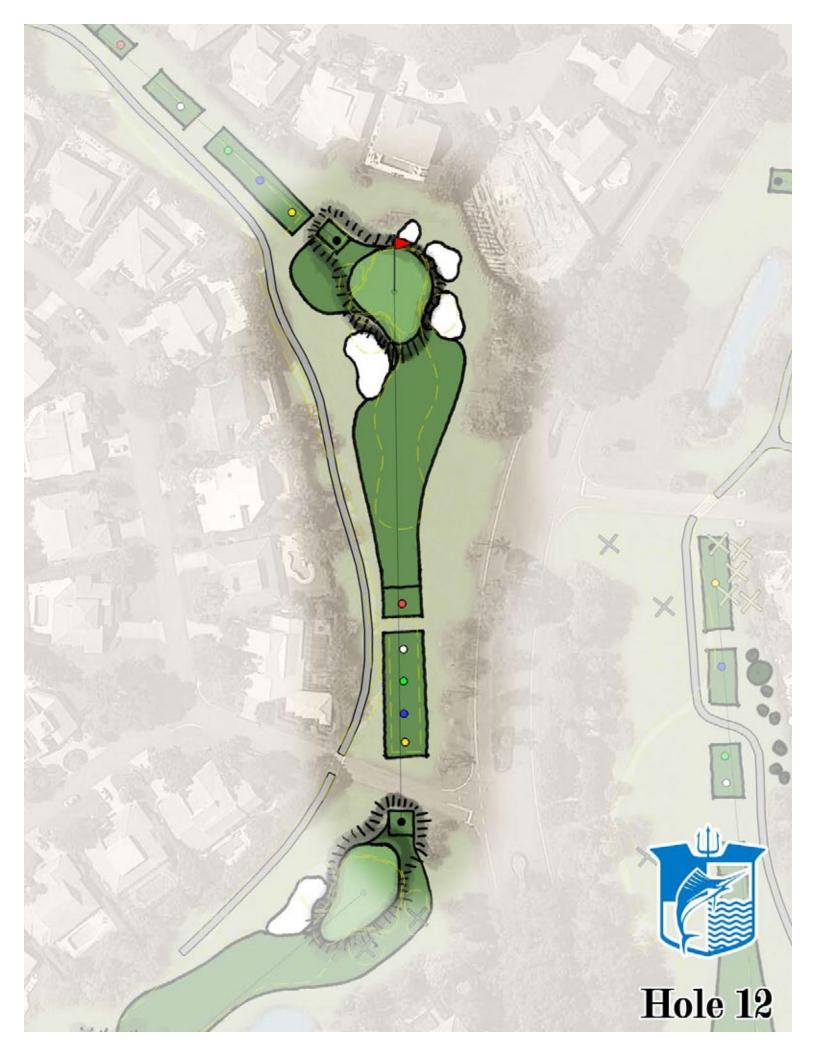
- Other than the existing back tee, all the other tee positions (five of them) are set on a single deck. That deck is sizeable... about 3,600 SF (almost as big as the green) but may need to be bigger/longer or another tee added if the back tee play comes to this side of the road.
- Some thought should also be given to the recontouring off the back, left of the green, including yet another add-on tee, but also the access to/from the cart path and the sort of desired recovery shots we want to employ here.

- The main tee should be lowered by 1-2 feet, and expanded to better accommodate four tee positions, and a new forward tee position is to be built as well.
- The existing bunker off the back, left side should be removed so that the slope on that side of the green can be re-graded/lengthened to accommodate more recovery shots and easier access to/from the path.

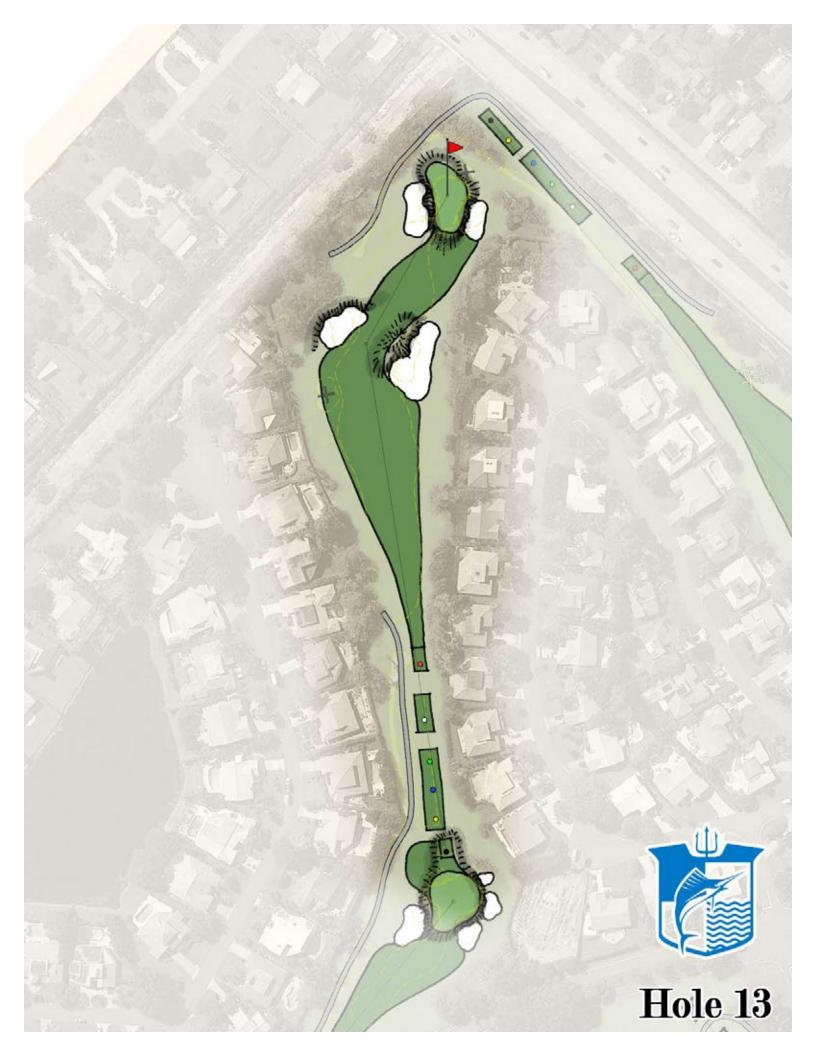
- The main tee here seems unnecessarily elevated, which complicates access and management. There are also five tee positions on the long, single deck here as well... not a lot of variability between those positions, although it IS about 215 feet in length!
- The first fairway bunker on the left seems a little out of the way...
 not much of a factor. By the same token, the bunker on the
 right side appears to me to be in a decent position but is way
 underdeveloped... a real opportunity for enhanced architectural
 impact.
- In looking at the green, it is quite small... only about 2600 SF, compared to 5,000 SF main tee
- Some of the bunker positions are fine, but the front bunker blocks off any attempt at bold play, and the back bunker just isn't necessary.

- The main tee should be lowered by 3-4', and then widened slightly. Also build a separate forward tee to measure around 2655 yards.
- Remove the fairway bunker on the far left and instead make the next bunker bolder... stronger... larger in scale. Rebuilt the fairway bunker on the right side so that is a proper architectural element
- The redesign of the green must take the tee shot strategies into full account. That means we must remove the front bunker so to invite bold play directly at the green... or from the angle that engages the bold bunker on the inside turn of the dogleg. The green elevation seems pretty good, but we need to make a larger surface. It should be angled from left-to-right and doesn't need a lot of depth... but it needs to be large enough to vary the cupping positions along its rotated length.

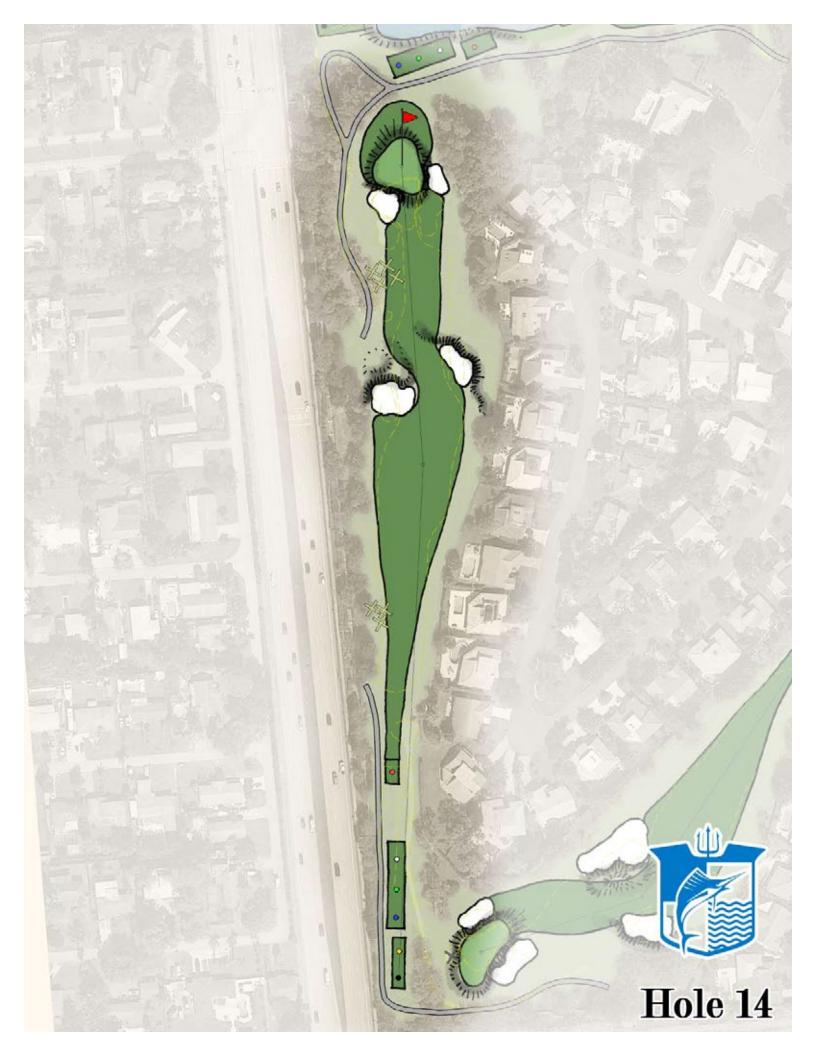
- In my opinion this may be the prettiest hole at Seagate. It is very well framed by mature vegetation. And although it a rather narrow corridor, it seems to have ample width where it is most useful, and the original design does a good job of achieving a proper fit with a gentle turn and a gorgeous green setting among the pines.
- Again here, like with many holes, the tee complex is unnecessarily raised... and that makes access and management a challenge.
- The green complex here is also quite good... it's a bit small, however... only 3,600 SF.

- Lower the existing back and main tees by 2 feet and get them to relate better to the path. Consider building an intermediate and a forward tee here to break up the positions and create more variety in lengths.
- Look to rebuilt the green here with some very similar characteristics to the existing one... just a bit larger... a slightly simpler shape, etc. Our plan indicates relocating the green further back (60-70').

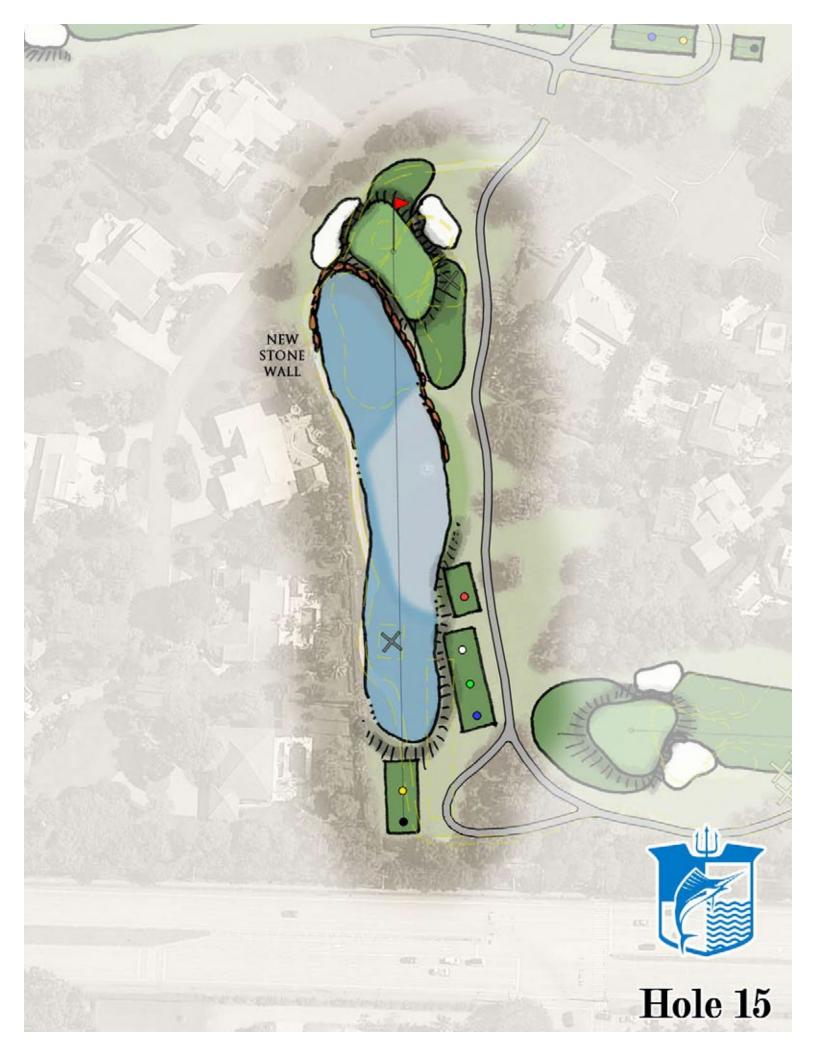
- This par-3 is literally full of pieces and parts, none of which are homogenous or inter-related. Everything just seems out of balance here... but the good news is that we seem to have many options.
- The tees are OK, but we have another "pocket tee", that helps to force the length of the hole... and the forward tee presents a really difficult angle, with no real open entry into the green.
- The pond feature seems to have been developed with no real thought in mind... it doesn't relate to the green at all it just seems to be utilitarian, for the most part... a place for water to go. The timber wall is failing and otherwise unappealing.
- A study of the green complex conjures plenty of thoughts... a real need to redesign to fit the space and surrounds, features, etc. also rather small, only 3,600 SF.

- Omit the back "pocket tee". Build a new tee left of the current main tee (at a slightly lower elevation). Build a larger, main tee to the right of the current tee, with a difference angle. Build a new forward tee ahead on the right side where there is a chance to avoid a carry over water and a running shot into the green a possibility.

- Reconfigure/expand the pond, fitting its shape to be more linear in the space and take up more area so the scale is better balanced – make the pond a proper feature rather than an in-between sort of retention basin. The pond should extend both towards the tees as well as the green.

- Build a stacked capstone wall as a defining feature in front of and along the extended shoreline margins of a new green complex.
- Reconfigure/relocate the green to take more advantage of the available space. Build a larger green that relates to the expanded water feature and still affords plenty of bailout area on the right side.

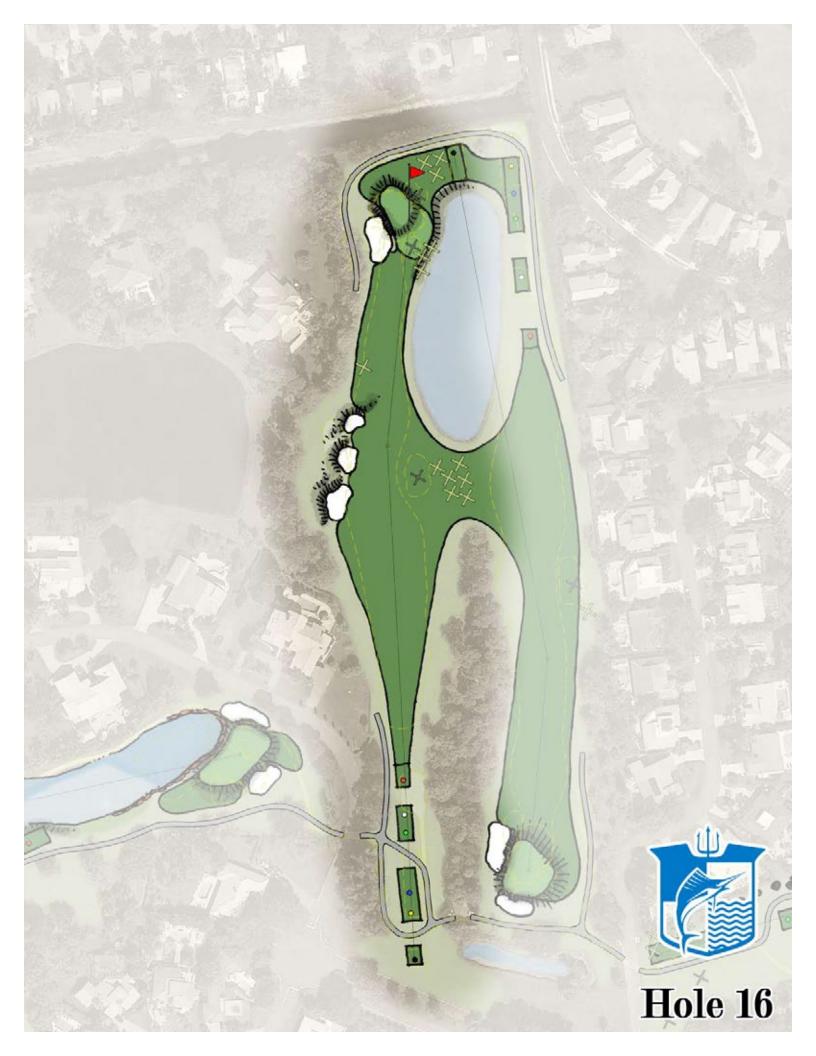
- The tees come out of a narrow chute and then the fairway landing area widens a bit. The back and main tees here are probably a bit too elevated, but their positions are fine. Like with some other holes, the tee surface arrangement tends to bunch the positions rather tightly, i.e. six positions separated by only about 60 yards.
- The bunker on the left is a bit detached, and the bunker on the right side seems to block any view or relationship with the pond on that side (which is in-play).
- There are some odd trees in play throughout the hole... before the pond/next to the bunker on the right, along the pond in front of the green, and between the left fairway bunker and the green.

- Rebuild the back and main tees, lowering them approximately 2 feet. Build an additional intermediate tee and a forward tee as well so the tees spread out more to offer lengths pf 402, 373, 360, 330, 321, and 301 yards, respectively among the six positions.

- Remove the fairway bunker on the right side along with the raised fill and about 8-10 trees. This will promote the widening of the fairway here and enhanced visibility of the water.

- On the left side, build an angled bunker complex with three bunkers that turn inward as the hole lengthens. These features will provide a very strong and defining visual from the tee that will offset the placid views of the pond on the other side of the fairway

- We show a redesign green complex that features a much larger green with two personalities. First, a lower level that reaches out to the water edge. This portion will have more of an open, at-grade entry. The angled, back, left portion of the green will be slightly elevated and heavily protected by a front bunker. The entire back side of the green will be a gentle roll-off collar area that connects with the back tee on #17.

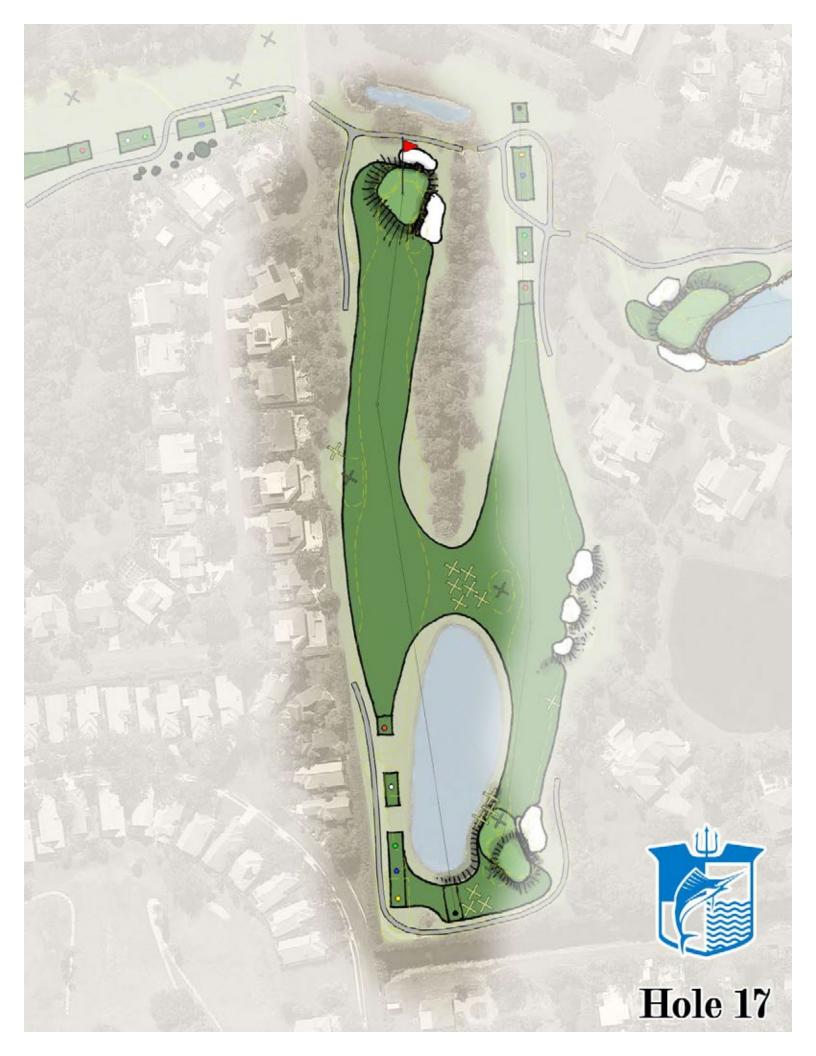
- The tee shot from the back tee is one of the more appealing views on the course... mostly because of the angle!
- There is a need, on both sides of the hole, to thin out the vegetation a bit... especially the palms on the right side, which are literally suffocating the pines.
- The green complex here is really quite good. The surface is raised and has a bold runoff slope on the front right. The surface here, like with so many others, is rather small at only 4,000 SF, but it does feature a subtle left-to-right angle.

- Reposition and elongate the main tee so that it is placed ahead
 of the back tee, not even with it. Also build an intermediate and a
 forward tee ahead on the same line to offer more varied lengths to
 meet with varied skill levels.
- Trees are to be removed in the right rough (along with those on #16) so that the right side of the fairway can be joined with #16 fairway.
 Also, thin out the palms among the pins in the right margin between the holes.
- Build a new green here that bares similarity to the existing one...
 similar elevation, slightly larger, an almost identical front-facing
 slope, etc. The greenside bunker on the right really needs to be
 chiseled into the slope to define the gentle angle green edge.

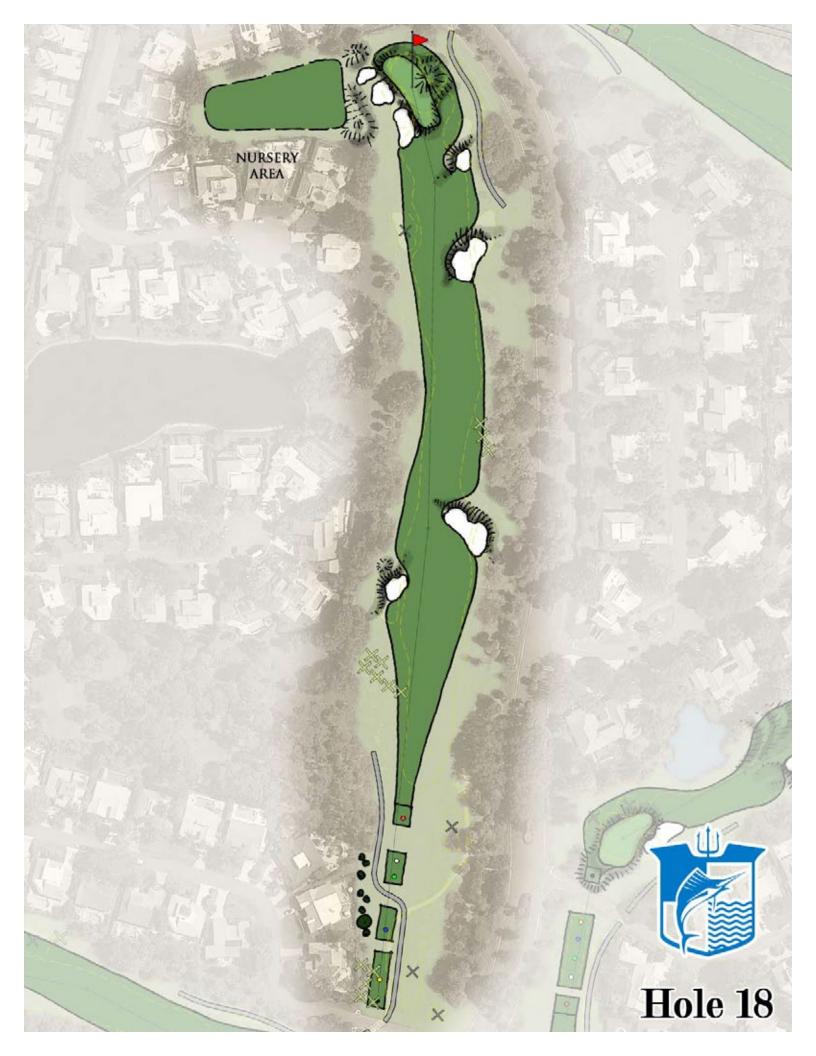
- The new finishing hole for Seagate has traditionally been the 9th... a long par-5 that comes to rest across the road from what will be the 10th tee. The existing "after-market" back tee that is positioned across the road stretches out the hole to 613 yards. That tee is raised up like an ant hill, with really steep side slopes.
- There is a ton of space around the tees... and abundance of turf, optional angles... much to consider.
- My impression of the first landing area is that its rather wide and void... missing some focal definition and strategic qualities. There are two fairway bunkers (one on each side), but they don't necessarily engage the tee shot very effectively. Both of those bunkers are perched up on fill... unnaturally raised up from the fairway floor.

- Remove the existing back tee. Consider relocating the alignment of the main tee to the left... more where the path is now (and some trees must be removed). This will create an instant oblique angle (which opens up the corridor) for the tee shot instead of the straightline presentation we see today.
- Build several intermediate tees to help bridge some of the yardage gaps. Relocate the forward tee to the left side, in line with others.
- Rebuild the fairway bunker on the right, reorienting it and extending it into the fairway, out of the tree line. Rebuild the two fairway bunkers in the right approach... get them to angle in a way that sets up a more strategic fairway alignment for second shots.
