# Commercial HVAC Applications - Cooling Towers

# WINT Cooling Tower Solution

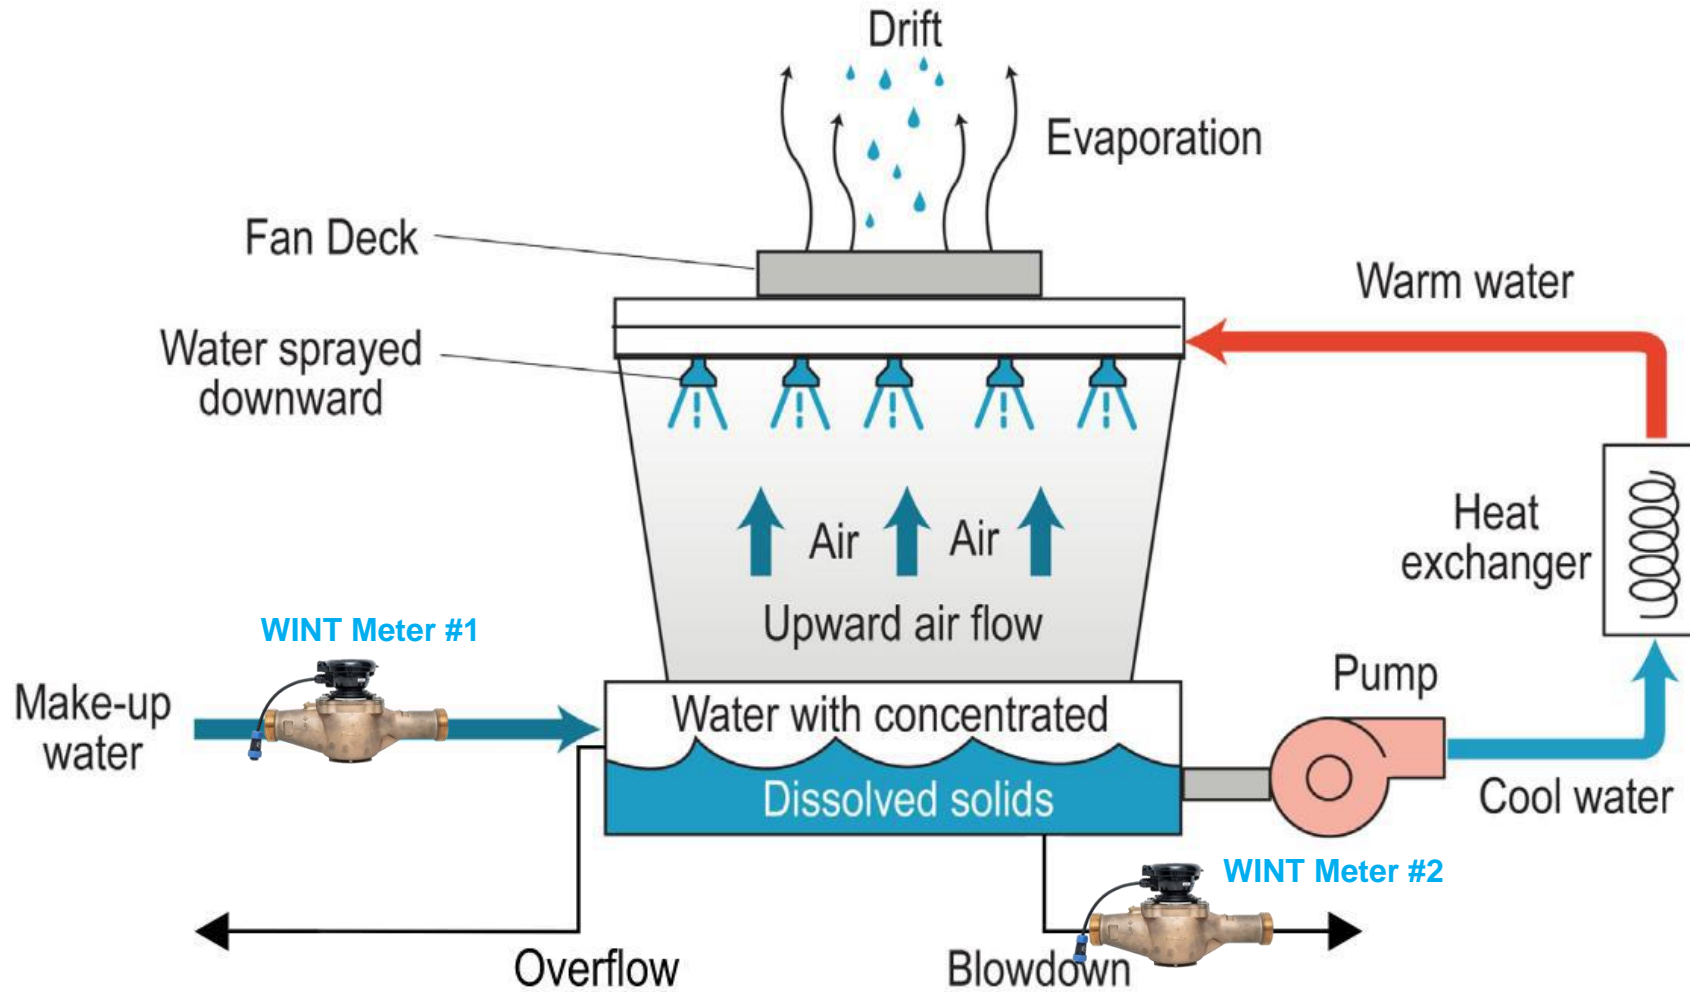
- Locate Meter #1 on the Make-up Water.
- Locate Meter #2 on the Blowdown.
- Overflow meter is optional.
- By monitoring both, the data analytics can provide a Cycles of Concentration (CoC), and a datapoint that can affect cooling tower maintenance.
- Higher CoC means the tower is running efficiently. Lower CoC means the tower is running inefficiently.
  - Reduce water consumption and chemical usage, saving in operational costs when tower is operating at high CoC.

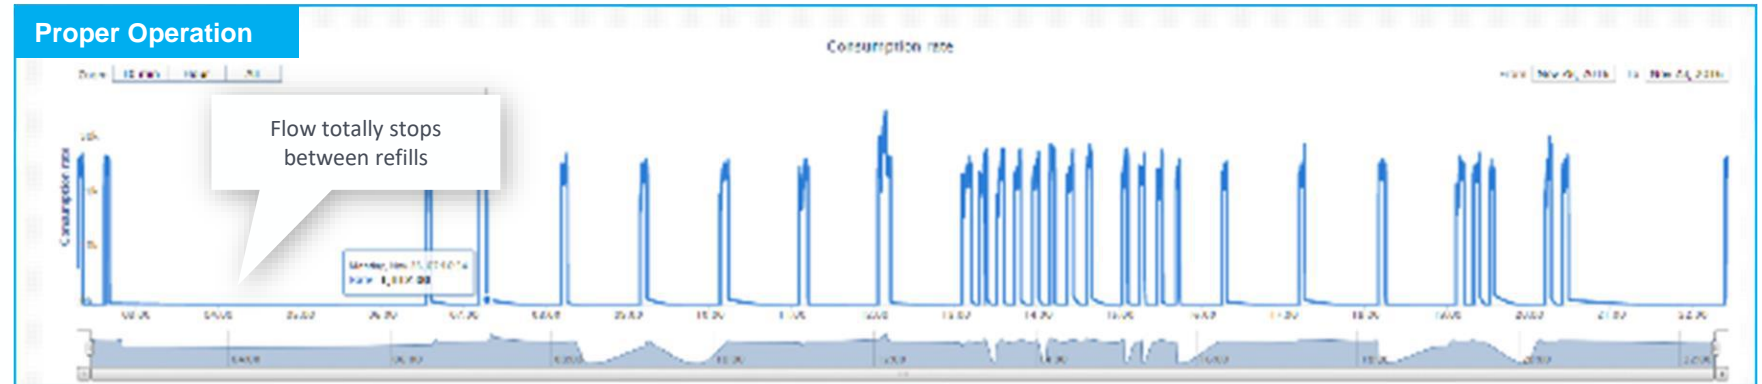
## Proper Refill Process

- Refills only as needed
- No excessive overflow

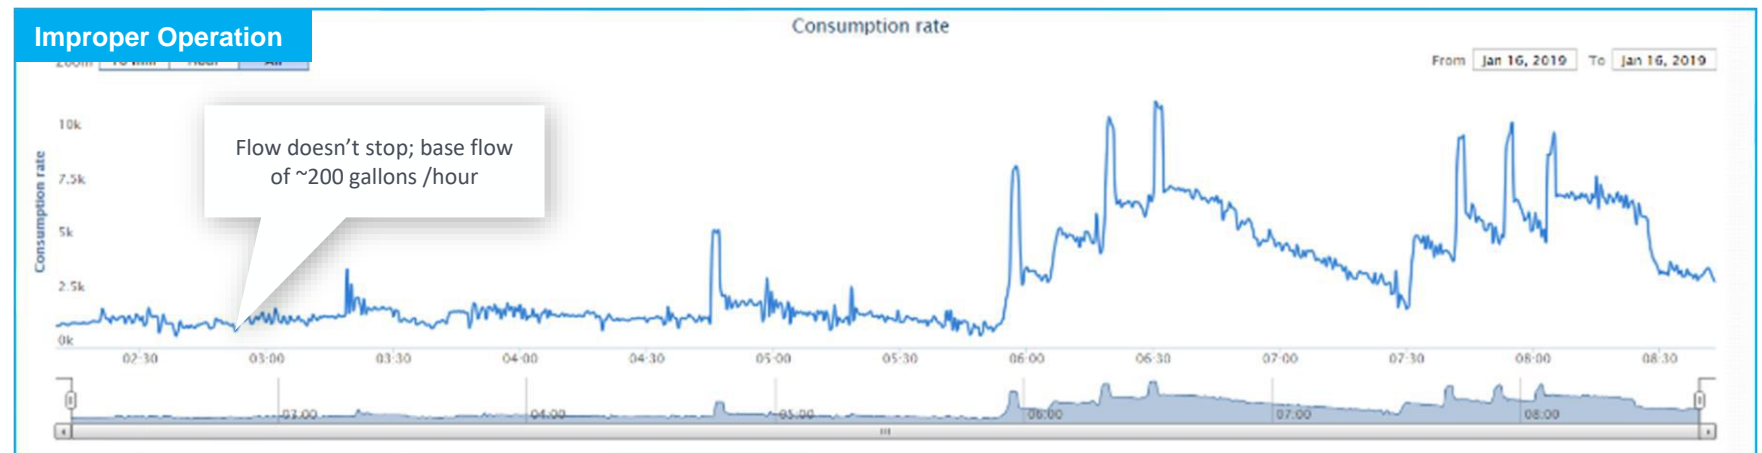
## Malfunctioning Process

- ~200 Gallons per hour
- ~\$65K per year

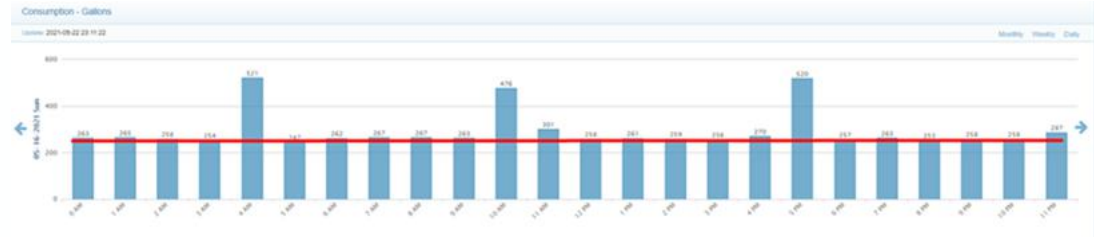
May 16<sup>th</sup>, **Before** the leak was eliminated – shows a steady 24/7 backflow leak of 260 gallons/hr

May 17th, the support team investigated the consumption patterns and detected a steady 24/7 backflow leak of 260 Gallons per hour every 45 minutes.

- They shared the information with the site lead technician, which found and repaired a flow switch that caused steady water flow when the pump and chiller were off.

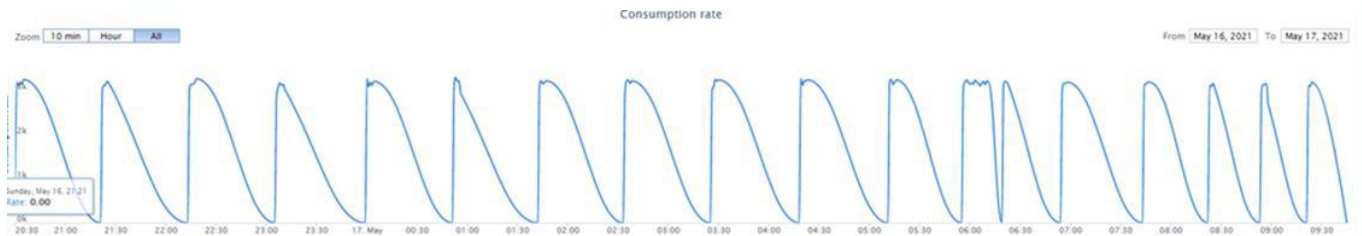
May 17<sup>th</sup>, shows the repeated pattern of water peaks of 260 Gallons every 45 minutes.

May 19th, the support team detected that even though the leak stopped, it was active again every night starting from 8pm.

- At 21:00, the site lead technician approached Cooling tower makeup and found a **drain gate valve** leaking on the Main condenser header, which was leaking into a sealed drainpipe.

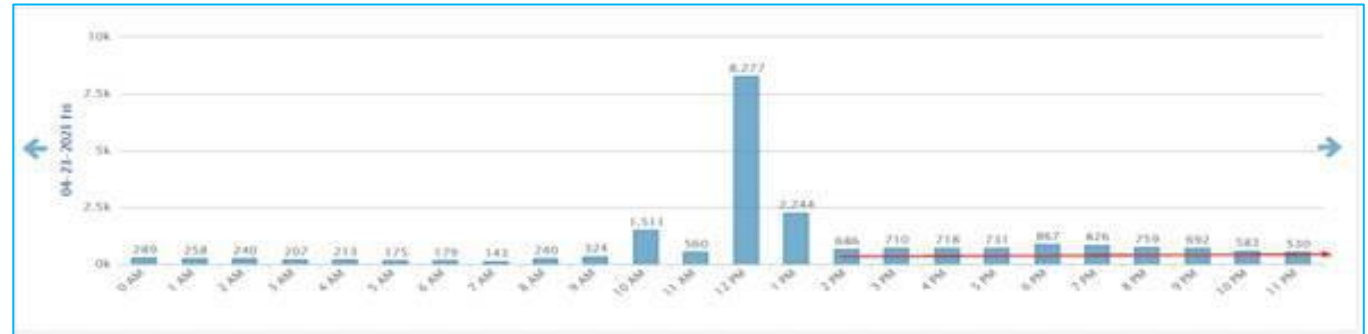
April 23<sup>rd</sup> shows a steady background flow starting of 550 gallons per hour.

- April 2021 the WINT system alerted due to a background flow of 550 gal/hr. Through out the month the system alerted periodically.
- This was brought to the attention of the engineering team, and they found an emergency fill float valve that needed the link adjusted.
- At this point the event had been ongoing for a month. Overall, the water wasted was 620 CCF (463,760 gallons/1,755,522 Liters).

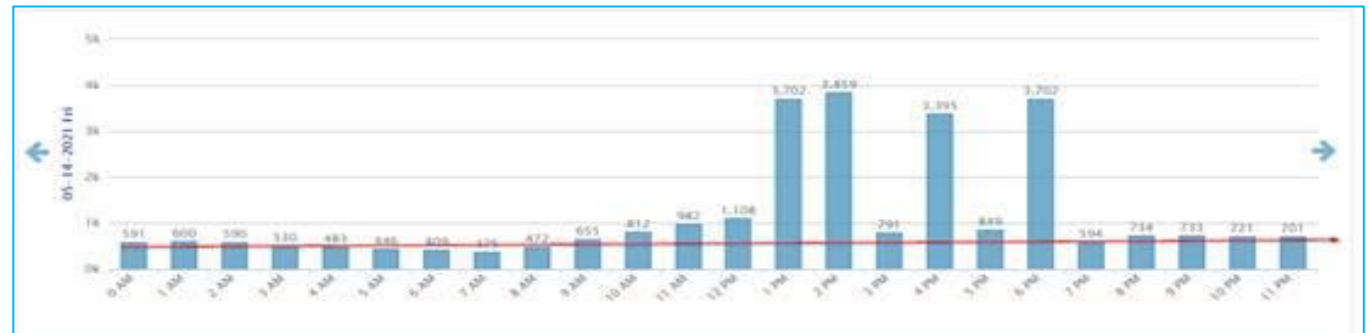
May 14<sup>th</sup> shows the background flow pushing hourly consumption to almost 4,000 gallons - well over the normal thresholds.

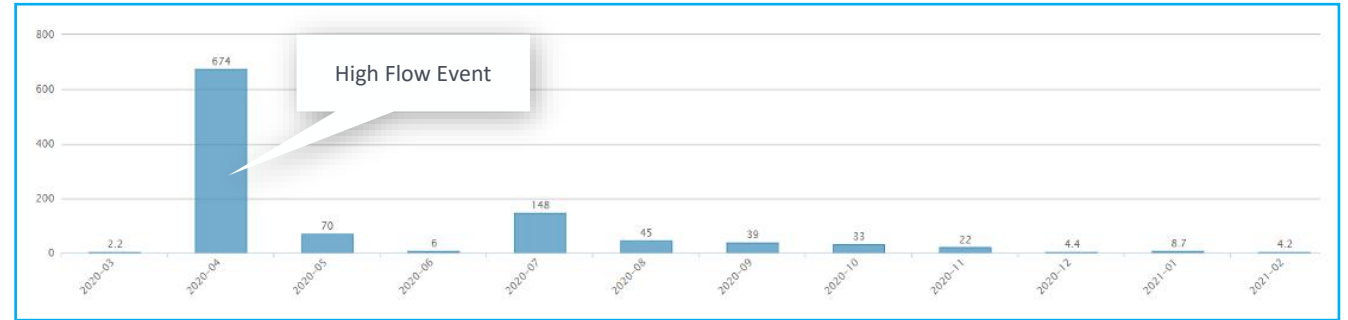
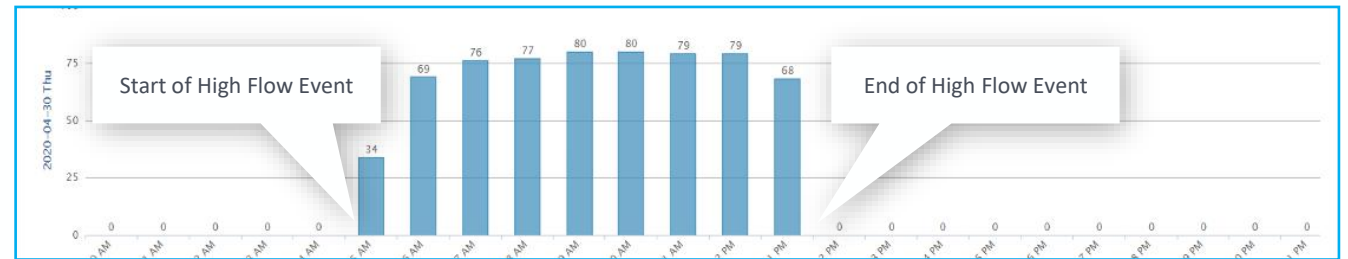
- Normal usage of this chiller system is approx. 40L per month. WINT system detected an abnormal water event which increased the water usage to 674L per month.
- WINT CS team contacted the site manager to inform him on the event. The origin of the leak was a faulty backflow preventer which leaked water on the roof.

With WINT detecting this abnormal water event while the academy was vacant due to Covid-19, **extensive damage was prevented** due to a flow of approx. 115m<sup>3</sup> of water in a course of two months.
