SmartPlaz
Think Smart

Traditional Boxend Protection

One Step Closer

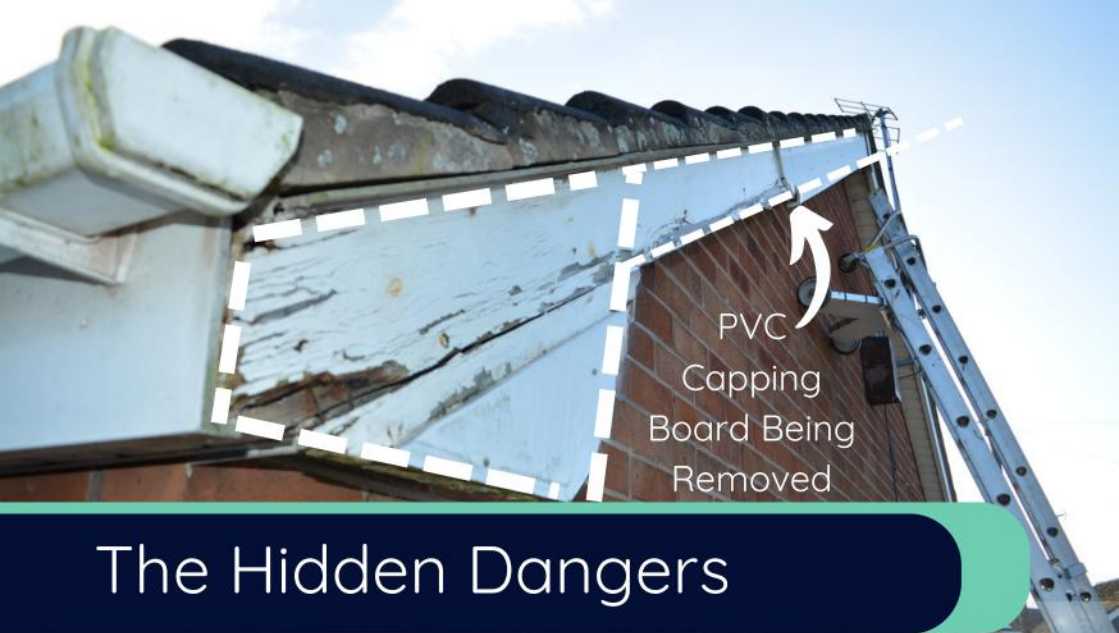
One Piece Box end Problem

We've found water infiltrating behind these one-piece boxends, evident in the rotting fascia and, more critically, the structural roof rafter.

Water infiltration is a serious issue that can cause extensive damage to a building's structure over time. In this case, the one-piece boxends have allowed water to seep in, leading to rotting fascia and a compromised structural roof rafter. It's important to address this issue as soon as possible to prevent further damage and potential safety hazards. A professional inspection should be conducted to determine the extent of the damage and the best course of action for repairs. Regular maintenance and inspections can also help prevent water infiltration issues from occurring in the first place.

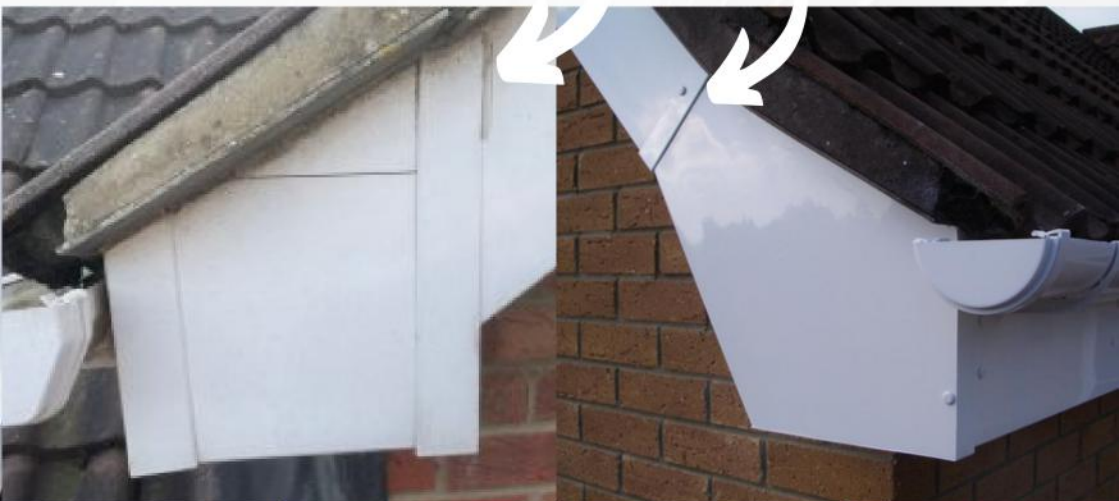
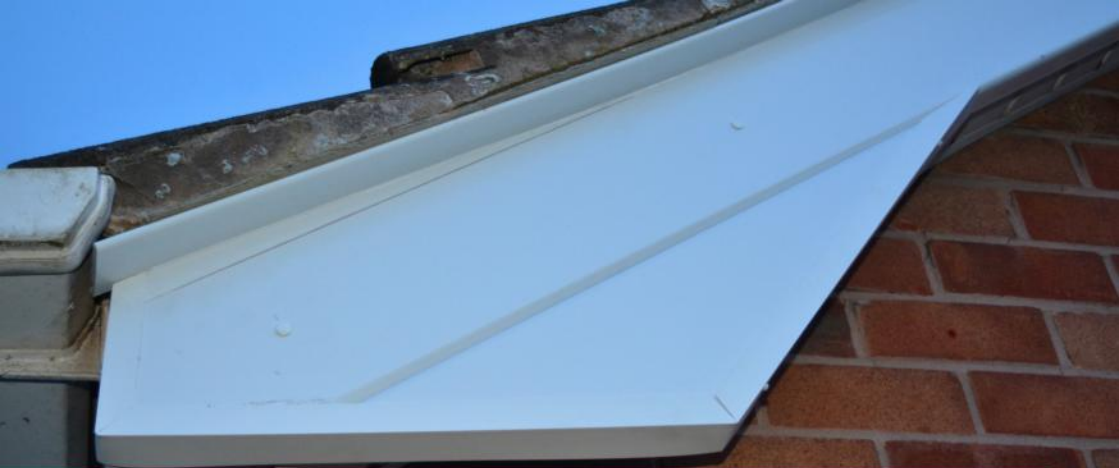
Why This Is Happening

These one-piece boxends feature a joining strip covering the expansion joint. Plastic expands, enlarging the gap, increasing the likelihood of moisture finding its way behind the fascia. This can lead to the onset of rot in the wooden rafters.

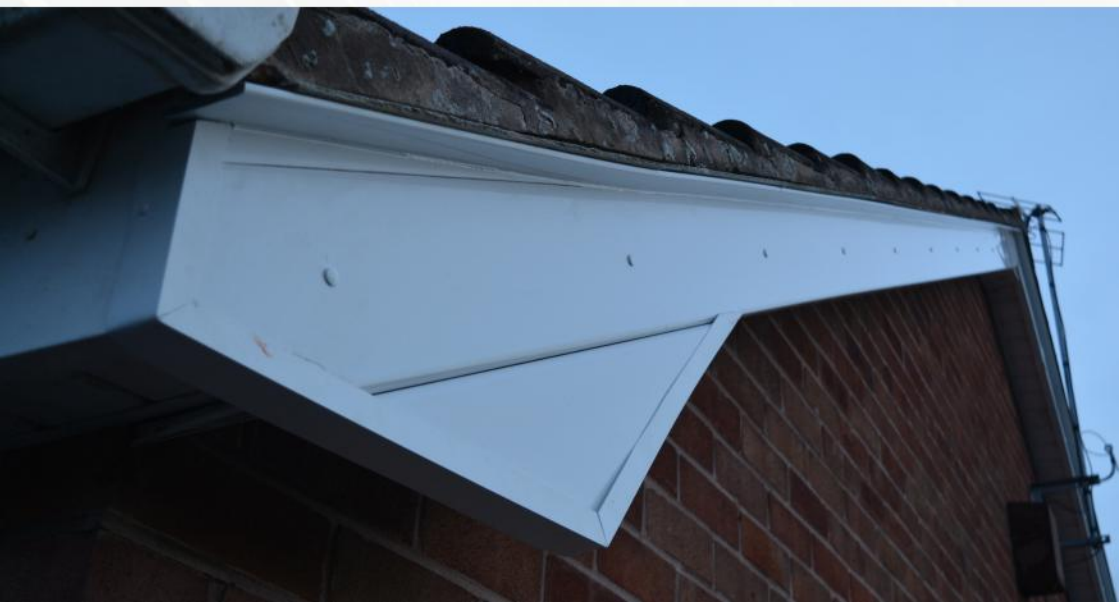
Traditional Box End Solution

A traditional seamless upvc Bargeboard without joints on the box end provides complete protection for your roof rafter.

Smartplaz have been installing this style of boxend for over 25 years, because UPVC expands and contracts it creates gaps allowing water to penetrate. Any vertical expansion on a boxed end can lead to water seeping behind the fascia, initiating the rotting process of the rafter, as we are now discovering!

Make sure that your PVC box ends are installed using the traditional looking method.
