## 1.0 Appointment of new Director General (DG)

## 4.0 Influence of the Restricted Zone of Fine Aggregate on Marshall Design Parameters and Performance of the Wearing Course

## 5.0 Possible Causes of Bridge Failures in Nepal

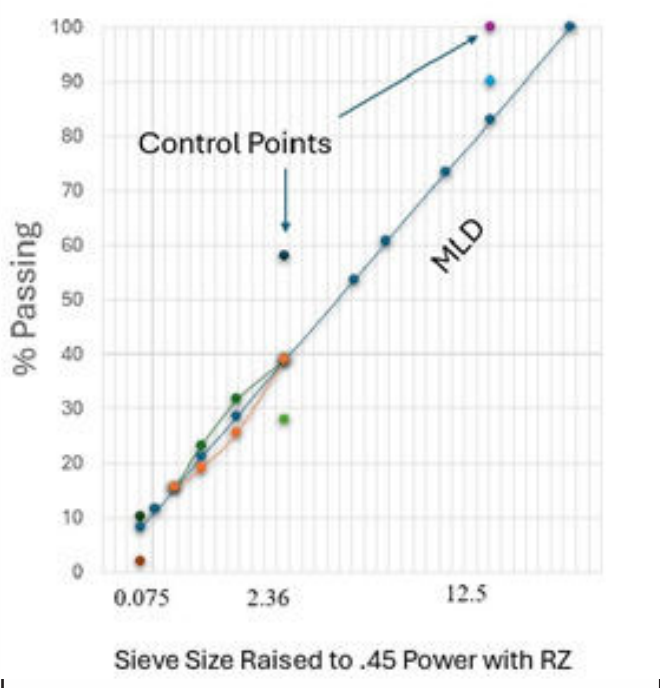
**Fig.1** Restricted zone with Control Points of 13 mm NMAS

Sieve Size mm	Maximum Density Line	Control Points		Restricted Zone	
		LL	UL	LL	UL
19	100				
12.5	82.8	90	100		
9.5	73.2				
6.25	60.6				
4.75	53.6				
2.36	39.1	28	58	39.1	39.1
1.18	28.6			25.6	31.6
0.6	21.1			19.1	23.1
0.3	15.5			15.5	15.5
0.15	11.3				
0.075	8.3	2	10

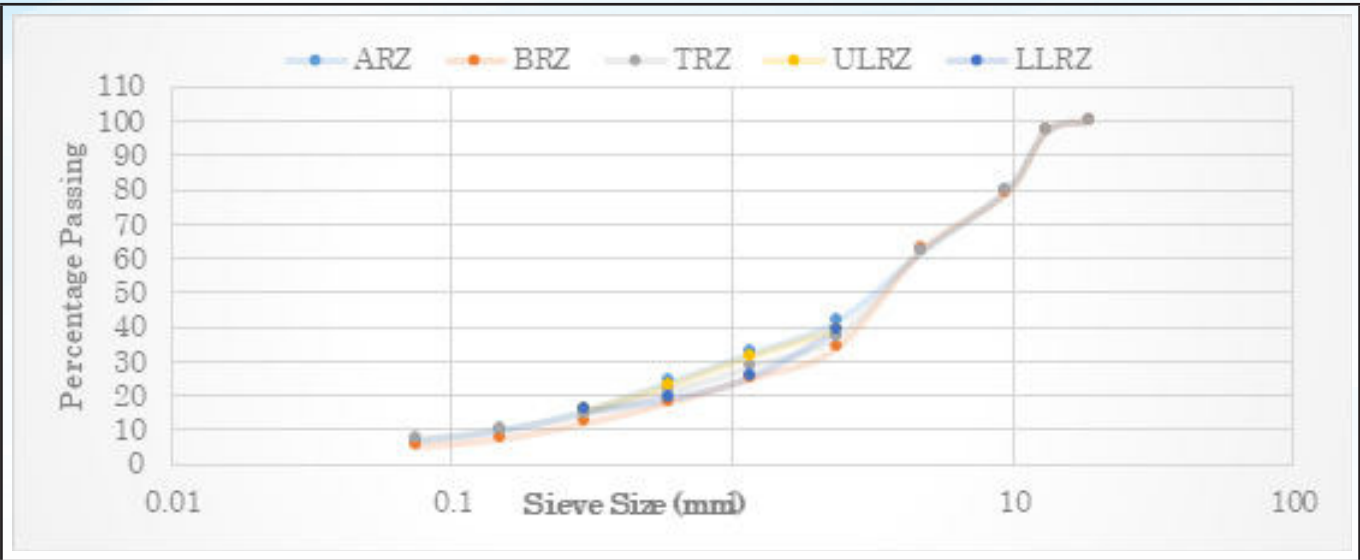
Fig.2 Gradation Chart for different mixes

Sieve Size (mm)	Permissible Limits		Gradation of Mix		
	LL	UL	ARZ	TRZ	BRZ
19	100	100	100	100	100
13.2	95	100	97.3	97.3	97.1
9.5	95	100	79.7	79.8	79
4.75	55	70	62	62.4	62.5
2.36	35	50	41.7	37.2	33.9
1.18	-	-	32.4	28.5	25.2
0.6	18	30	24	21.1	18
0.3	10	21	15.5	14.7	12
0.15	6	16	9.8	9.9	7.4
0.075	4	8	6.9	7.2	5.1

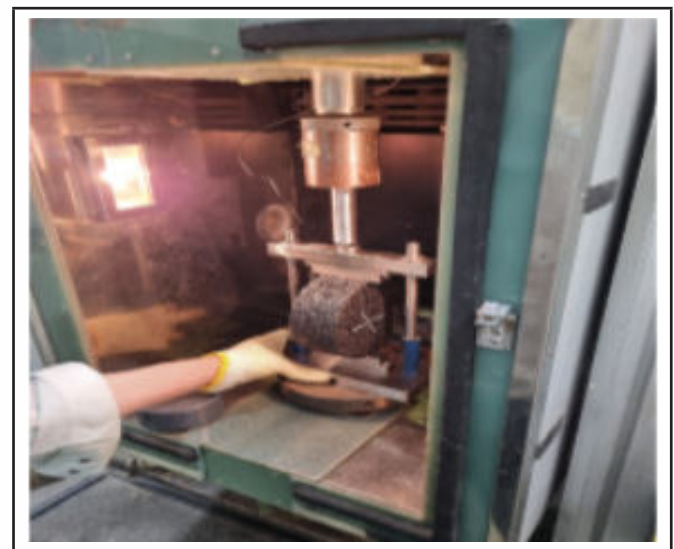
**Fig.4** Ideal CT index Test Machine

Three gradations of Samples ARZ, TRZ, and BRZ were prepared at the designed OBC to conduct the Ideal CT index Test. Three samples from each zone, altogether nine samples, were tested on the CT index test machine. The standard method proposed by Zhou<sup>21)</sup> was used. The test condition is

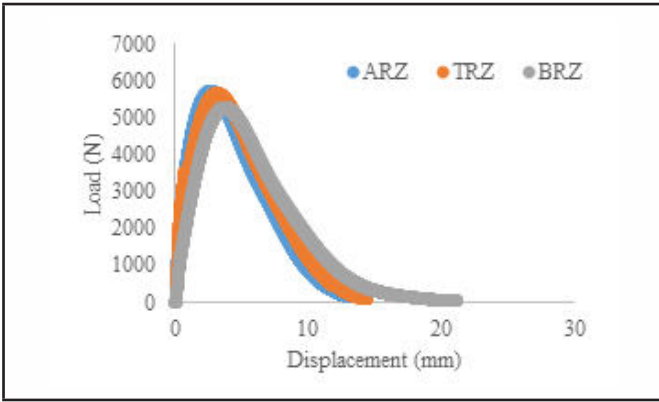
Fig.6 Load versus Displacement Graphs

Ideal CT index Test Result data with Index Values are shown in Table 13. The data shows BRZ has a higher index value and has higher cracking resistance than other mixtures. Figure 4 shows that BRZ has a higher load versus displacement area than other mixtures.

- For the Wheel Tracking Rutting Test, gradation through the restricted zone shows more rutting resistance than other types of mixtures.
- The Ideal CT index Value shows that the gradation below the restricted zone has greater cracking resistance than other types of mixtures.

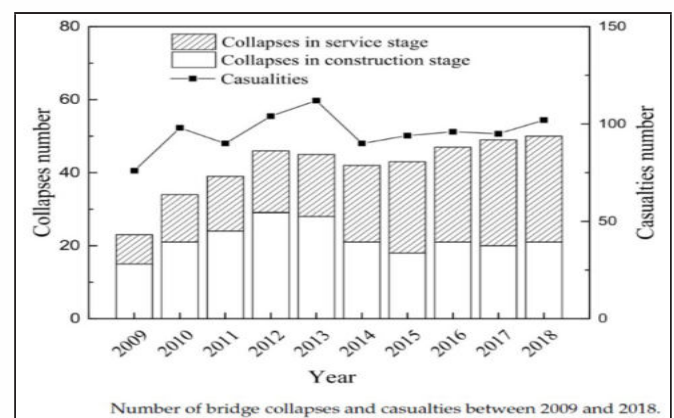
Fig.2- Number of bridge collapses and casualties between 2009 and 2018 in China [1]

The statistics of failures in bridges under construction and those that have been completed and are in service are shown in the diagram. The diagram also indicates that failures during the construction phase are significant.

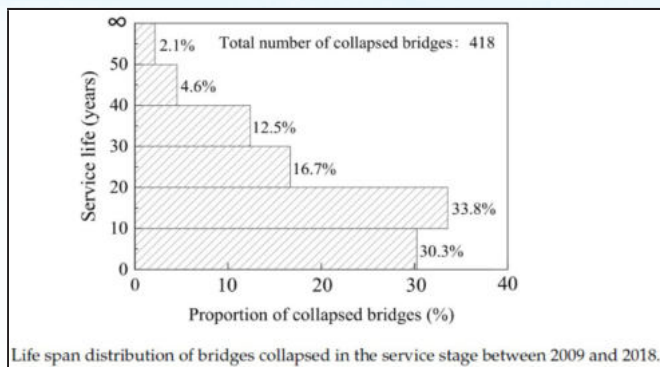
Fig.3- Life span distribution of bridges collapsed in the service stage between 2009 and 2018 in China [1]

The details of bridge collapses during their service life are shown in Fig. 3 According to the data, out of a total of 418 collapsed bridges, 30.3% collapsed within 0-10 years, and 33.8% collapsed within 10-20 years. In contrast, only 2.1% of bridges had a service life of more than 50 years.

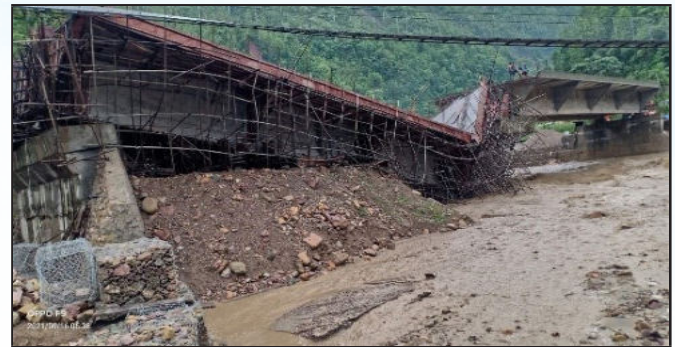
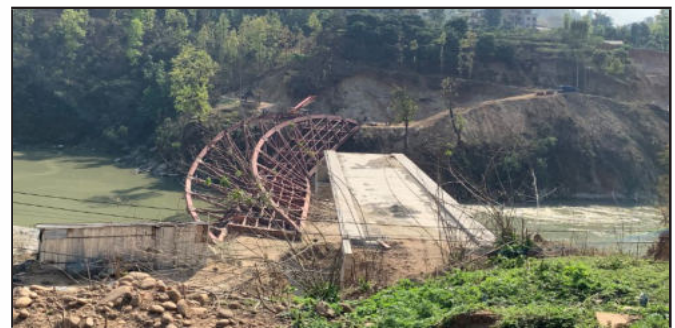
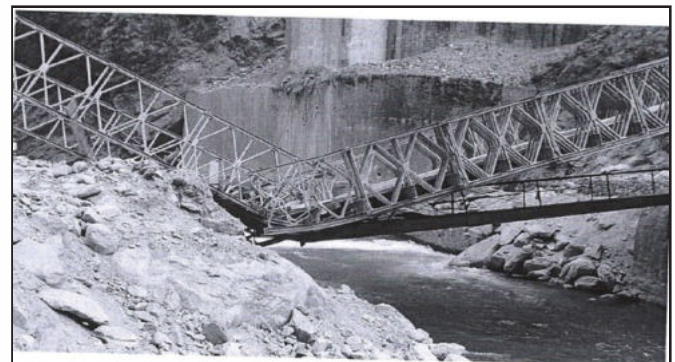
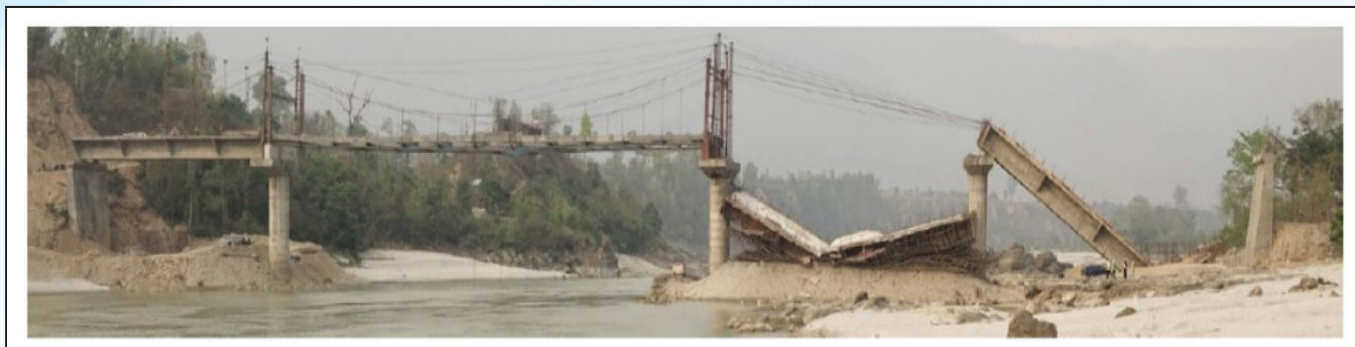
Prestressed Concrete Girders, staging/formwork cannot be removed until the first stage of prestressing is completed, which is generally done after 12 days.

Fig.4-(a) Jhimruk Khola Bridge along Dabra Majhidmar Road

Fig.4(b) Trishuli Bridge, Masstar that has been collapsed in 2021-04-17

Fig 4(c). Bheri Bailey Bridge along Jajarkot-Dolpa collapse due to unbalanced crane in April 21,2003.

Fig.4(d). Larcha Bailey bridge failure during erection (in 2018-02-20)

Fig.4(e). Failure of Thimura Bridge during construction ( in 2021-04-06)

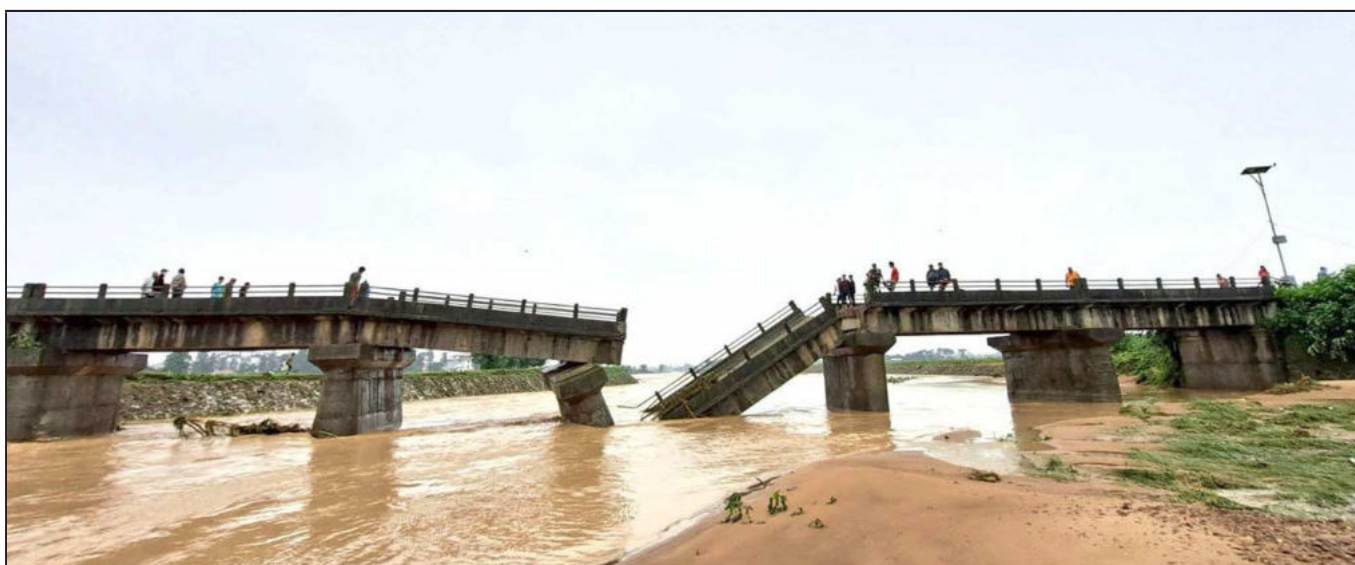
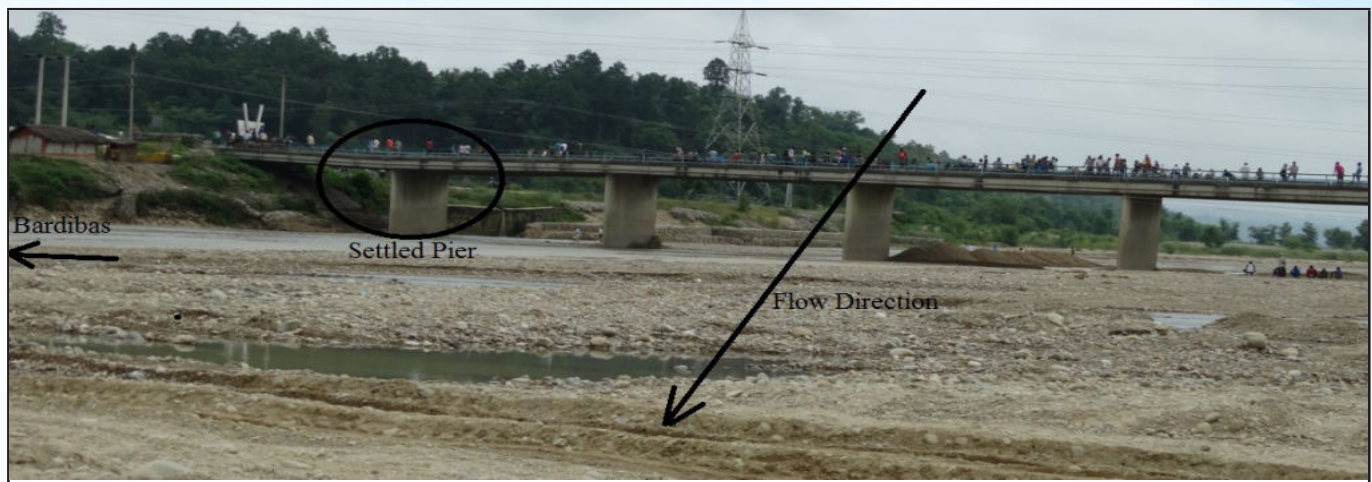
degradation, sand boiling phenomenon etc.

Fig.5 (a): Lodari Khola along Parsa Chainpur road

Fig. 5 (b) Pier of Ratu Khola Bridge settled on 13 Aug, 2014

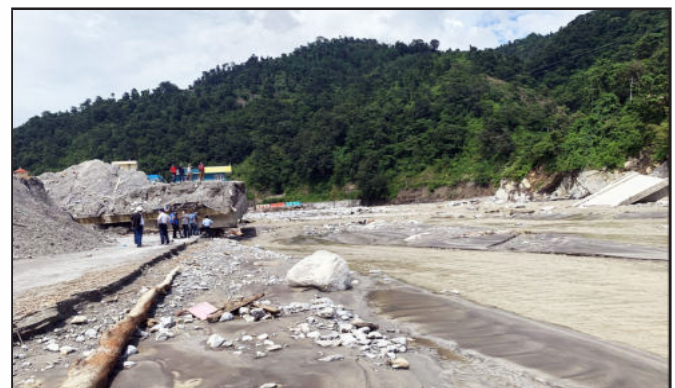
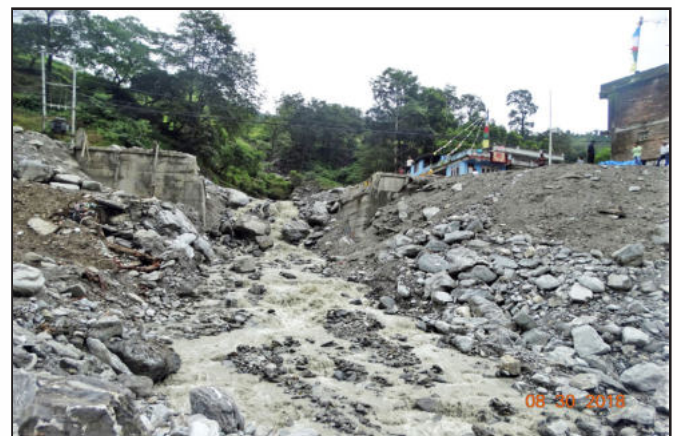
When designing bridges in Nepal, this scenario is generally not considered, as it is complex and could result in an uneconomical or unrealistic design. A sudden flood can increase the scour depth and apply additional hydraulic load to the bridge structure, weakening the foundation and causing the bridge to collapse. The impact of climate change has resulted in extreme precipitation events and flooding. In recent years, this factor has been considered in bridge design guidelines, but it was not included in earlier designs.

Fig. 6 (a) Washed bridges due to Melamchi disaster (Aug 1, 2021), Melamchi Bridge, Sindupalchok

Fig.6 (b): Sadi Khola Bridge (washed on 2018/8/18)

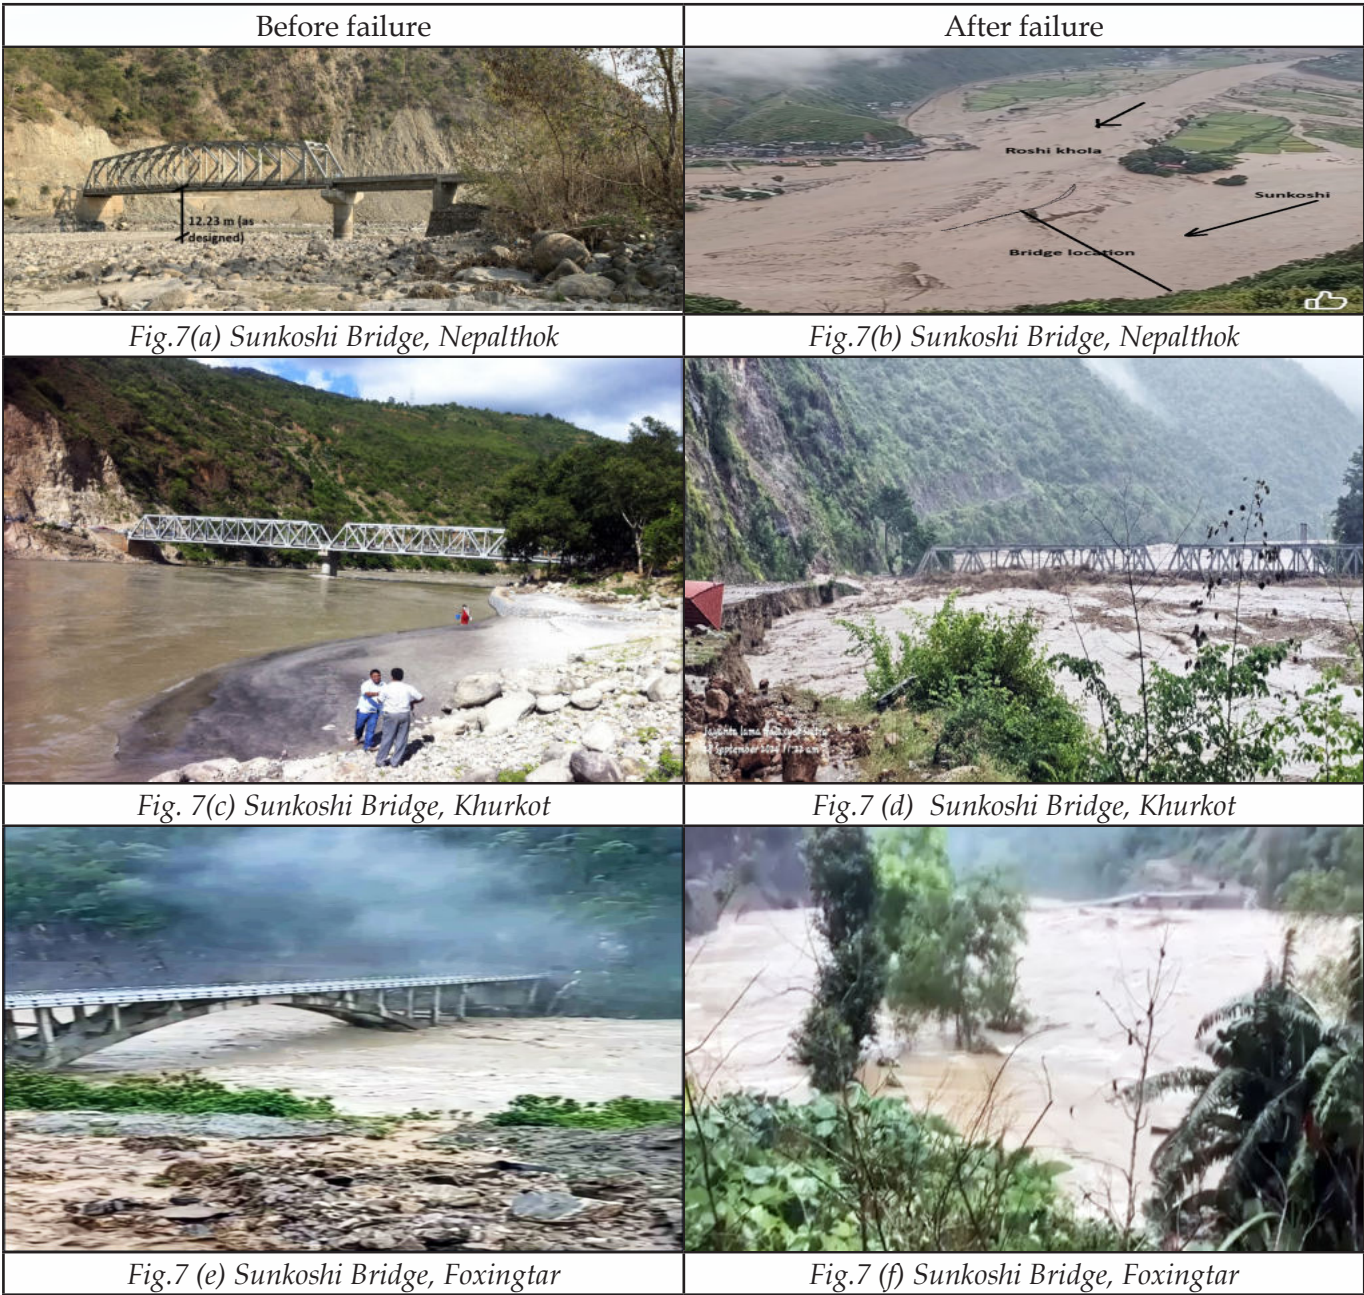
Sunkoshi Basin. The water level exceeded the deck level of these bridges, which was not considered in the design. The water current hitting the deck level was not accounted for in the design code. The Photographs of various bridges before and after failure is shown in Fig. (7). Local road construction, land plotting, and crusher plants in river catchment areas have led to excessive sedimentation in the river, increasing the high flood level and causing damage: Design guidelines should be prepared to consider this phenomena during the design phase, as it also contributes to bridge damage:

Fig.7 Photographs of various bridges in Koshi Basin before and after failure that are collapsed due to record breaking extreme flooding of 2024/9/27-2024/9/28.

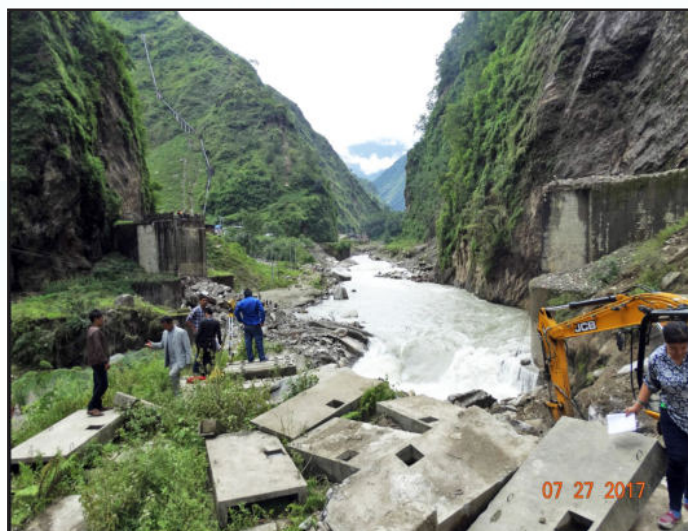
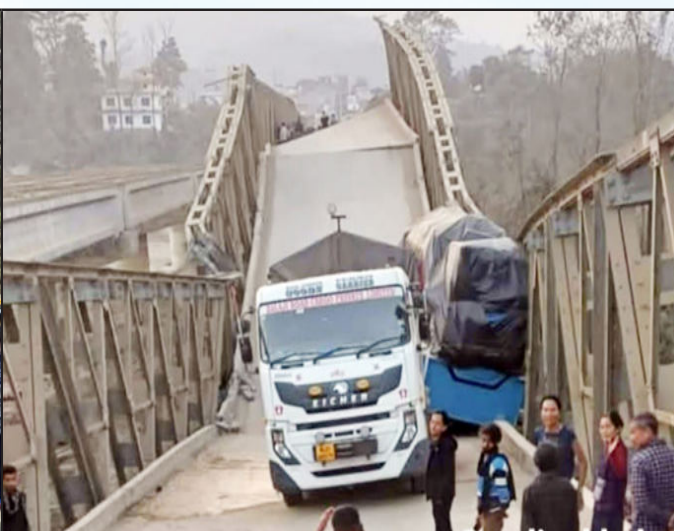
Other important factors are overloading and unregulated traffic, inadequate maintenance and inspection poor construction practices, and design deficiencies. Larcha Arch bridge collapse due to sudden fall of rock from hill side is shown in Fig. 8(a). The failure of Binayi Khola due to possible overload of heavy loaded lorry is shown in Fig.8.

*Fig.8-(a) Larcha Arch bridge collapse due to sudden fall of rock from hill side (2017-7)*

*Fig.8(b) Failed Binayi Khola Bridge along E-W highway near Dumkibas (Jan 10, 2025)*

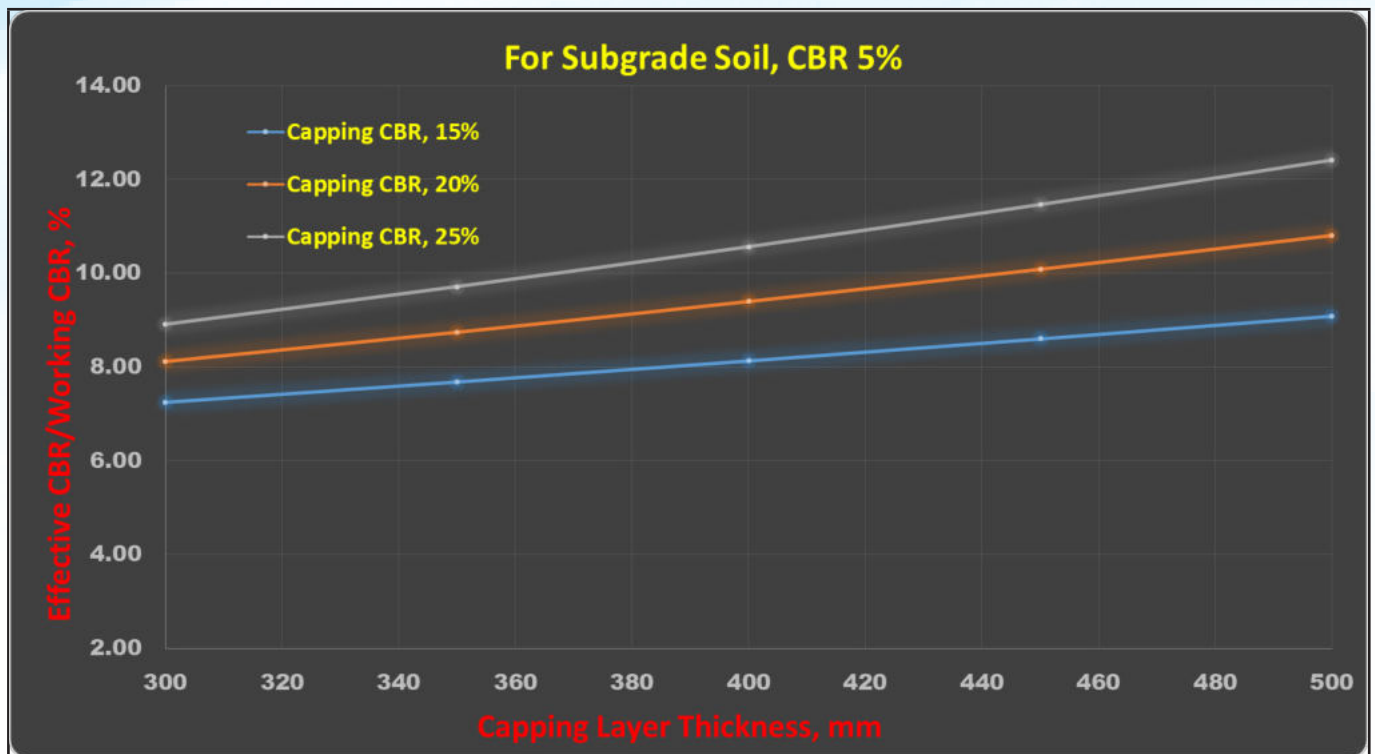
Figure 3: Effective CBR/Working CBR Chart for Subgrade Soil having CBR = 1%

Figure 4: Effective CBR/Working CBR Chart for Subgrade Soil having CBR = 2%

Figure 5: Effective CBR/Working CBR Chart for Subgrade Soil having CBR = 3%

Figure 6: Effective CBR/Working CBR Chart for Subgrade Soil having CBR = 4%

Figure 7: Effective CBR/Working CBR Chart for Subgrade Soil having CBR = 5%

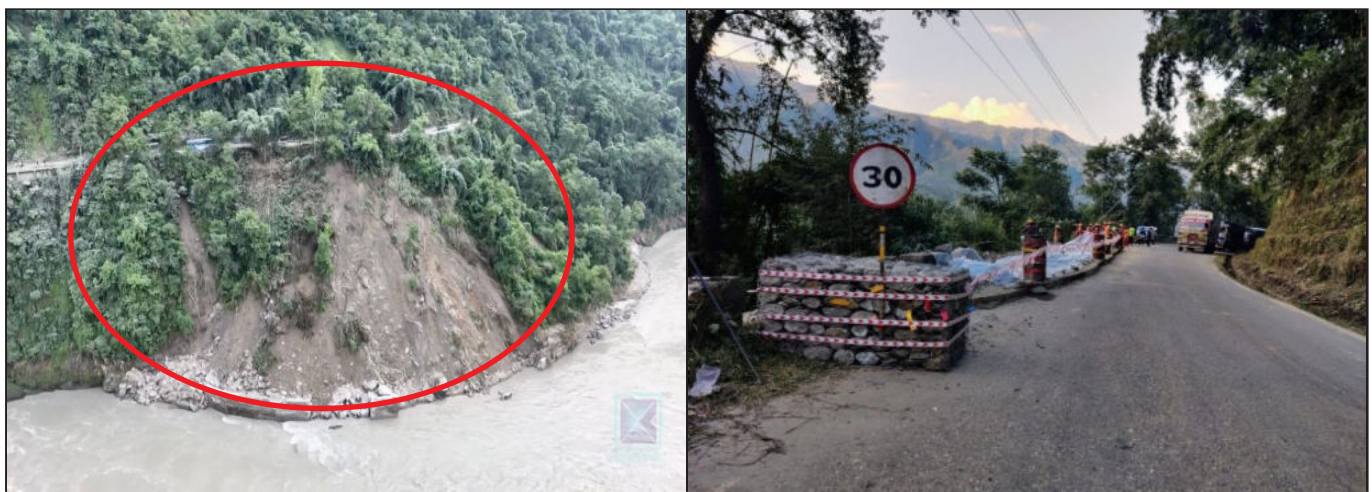
[Source: Field Visit Survey]

A landslide and road pavement subsidence at Krishnabhir were observed due to toe failure at the slope base and a rise in the water table caused by soil infiltration and saturation within a fractured soil mass. The landslide was triggered by unexpectedly high-intensity and prolonged rainfall.

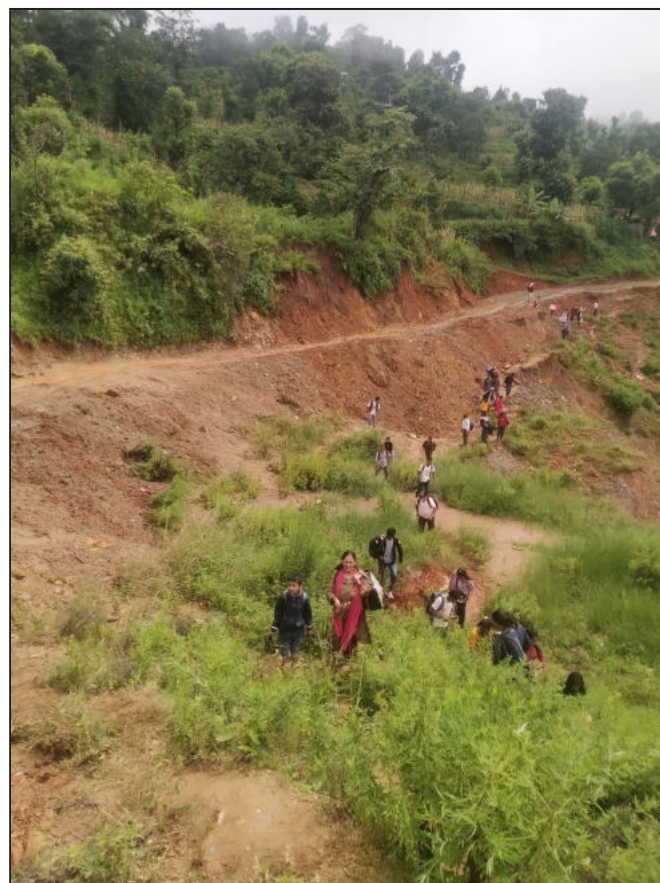
**Figure 1:** Existing condition of the slope at Km 11+000, near Aahale along Gorkha-Ghyampesal road, June 9, 2022.

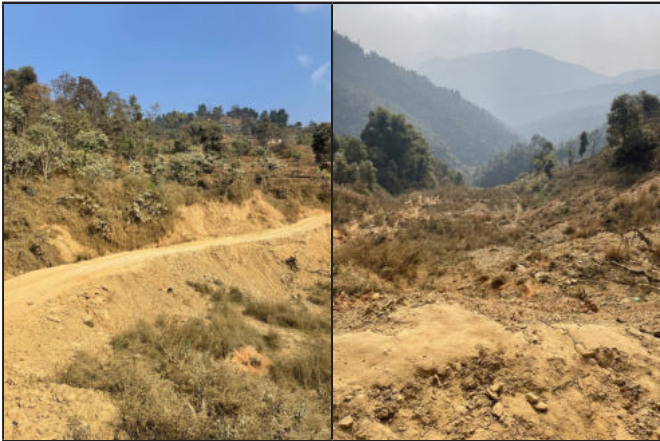
**Figure 2:** Existing condition of the slope at Km 11+000, near Aahale along Gorkha-Ghyampesal road, during site visit on January 17, 2023.

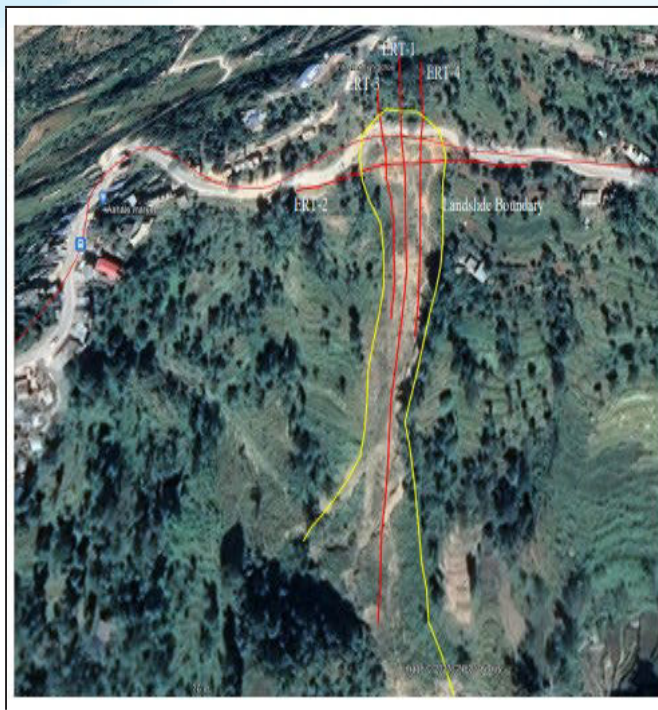
ERT Lines	Northing	Easting	Surveyed Length (m)	Location
ERT 1	3101113.486	566105.916	450	Along the mid slope
	3100711.820	566137.034		
ERT2	3100949.440	566032.840	240	Across the landslide
	3100995.807	566247.315		
ERT 3	3101082.654	566073.772	230	Along the left margin side
	3100893.015	566126.281		
ERT 4	3101107.489	566142.925	240	Along the right margin side
	3100896.410	566147.912

**Figure 3:** Location of project area and ERT survey lines

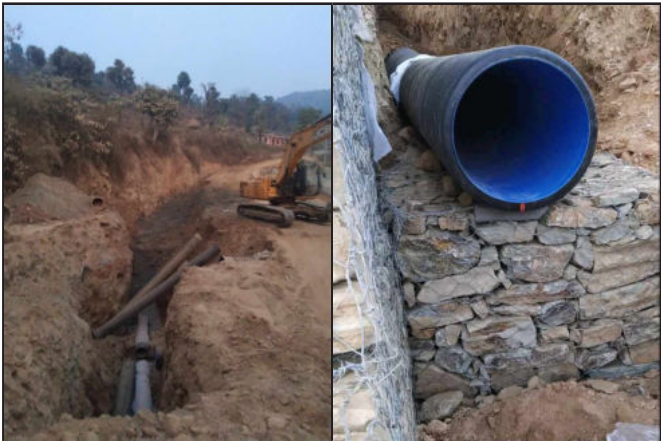
The construction of sub-surface drainage has been carried out in two ways namely vertical gravel trench and use of perforated pipes on the sub-surface by horizontal drilling. Firstly, a vertical trench of 3 m wide and 2 m deep along the drain line has been dug out and then the middle portion of this trench is further excavated to a depth of about 2 m and then 40 cm diameter half side perforated corrugated polyethylene pipe wrapped with geotextile was laid and the trench is filled with gravel (free draining materials up to the base of gabion as shown in **Figure 7**. After construction of gravel trench (**Figure 8**), a layer of gabion is installed on the top of gravel trench and semi-circular section of corrugated pipe is laid on the top of gabion layer for surface drain as shown in **Figure 9**.

*Figure 7: Construction of gravel trench and perforated pipe below side drain and its outlet pipe across road*

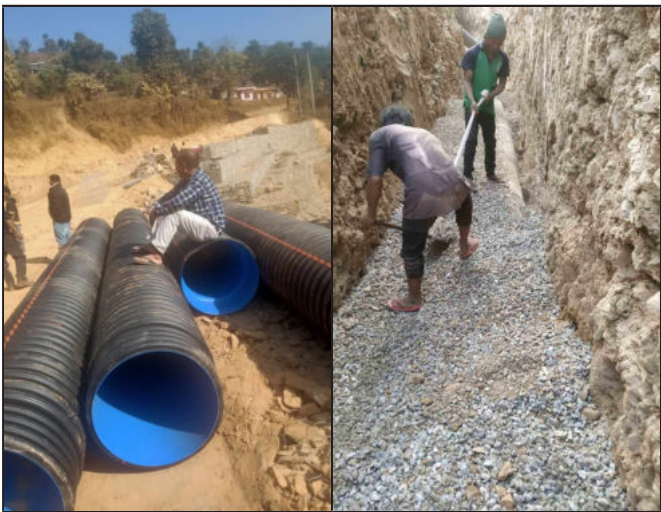
*Figure 8: Corrugated half side perforated HDPE pipe*

on the bottom of gravel trench and gravel filling on the trench below the side drainage.

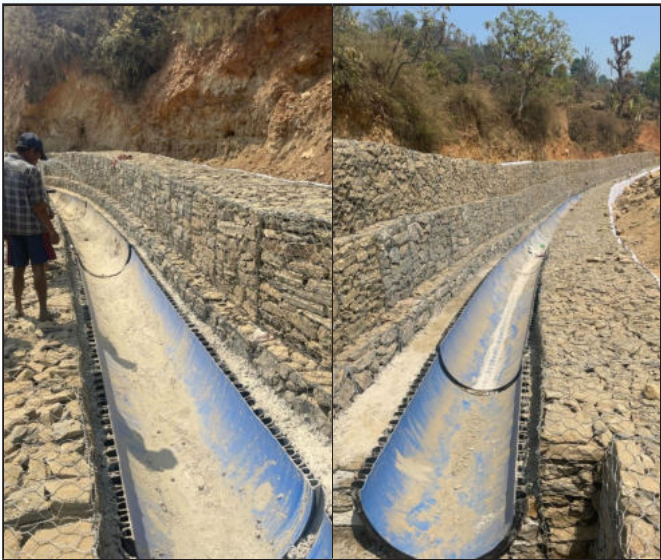
*Figure 9: Semi-circular corrugated HDPE pipe on the top of gravel trench for surface drainage.*

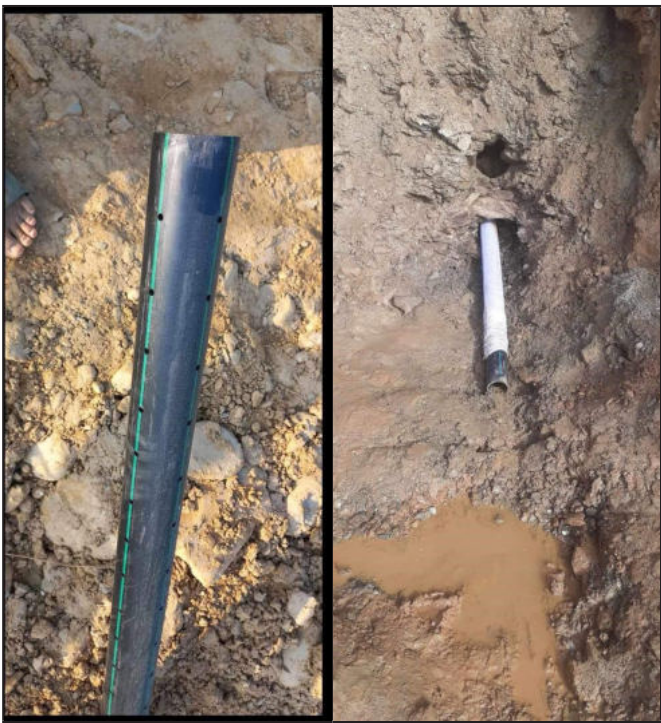
*Figure 10: Perforated HDPE pipe and horizontal drainage in drilled hole for sub-surface drainage.*

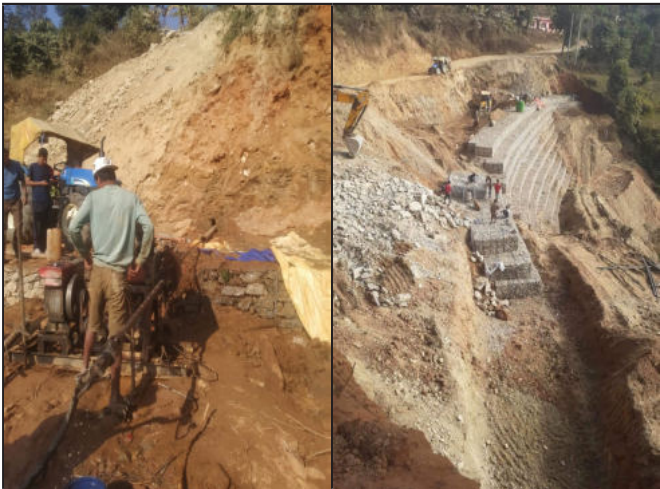
**Figure 11:** Drilling works for horizontal drainage on left and gabion sleep wall construction on the right.

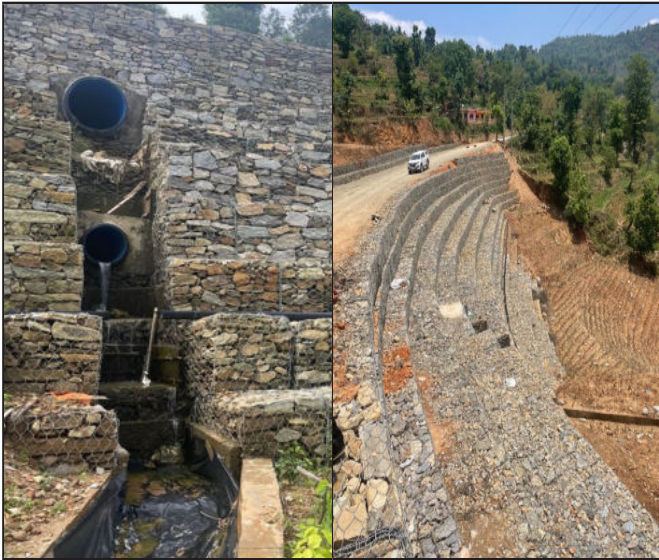
**Figure 12:** Functioning of sub-surface drainage outlets (left) and completed gabion structure, bioengineering works and drainage chute construction on the right.

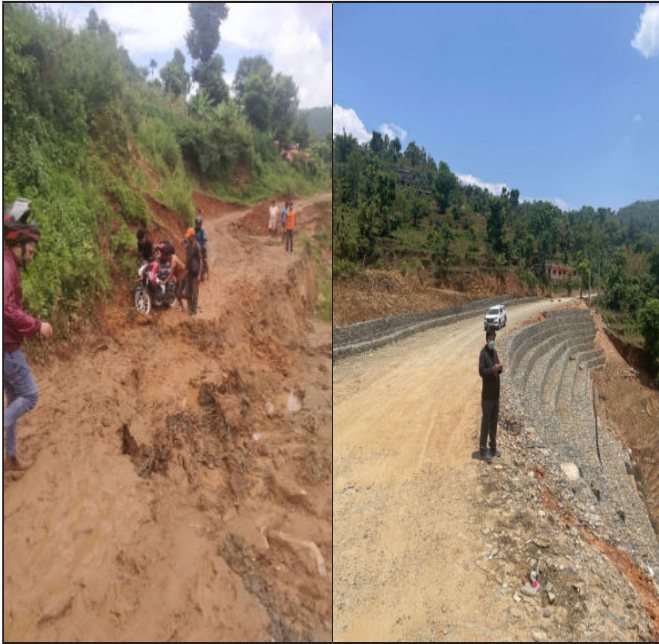
**Figure 13:** Road condition at Kokhe Aahale in June 2022 (left) and road condition after application of mitigation measure in May 2024 (right).

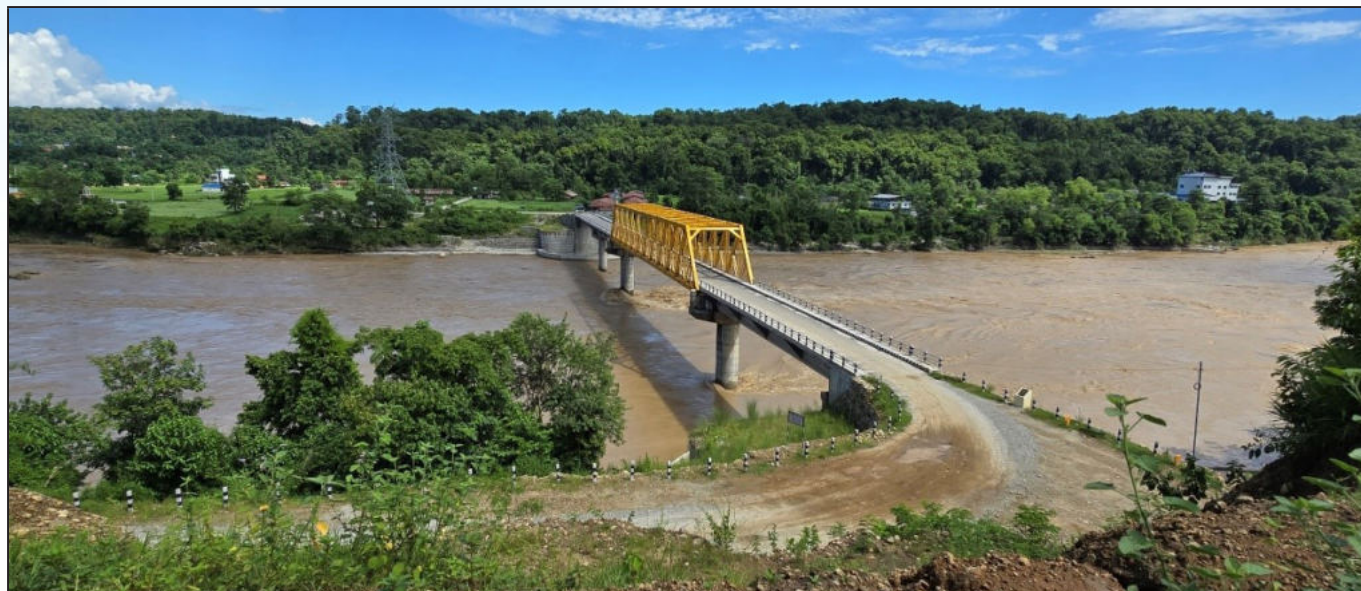
Figure 1: Trishuli River Bridge from the Right Bank Devghat Side

The bridge site is located over Trishuli River connecting Chitwan District of Bagmati Province at Thimura to Tanahu District of Gandaki Province at Devghat. The bridge lies about 3.0 kms upstream from confluence of Kaligandaki and Trishuli River. The Google Coordinates of Bridge site is 27°45'3.79"N, 84°26'37.35"E. The Bridge site is located about 2.6 km west by road distance of Narayanghat Mugling Highway (NH44) at Ramnagar. The contract for construction of this bridge was awarded to the Contractor Elite-Adventure-Indreni JV, Bharatpur. The bridge construction was completed on 2080/09/26 B.S. and Inauguration (figure:14 & 15) was done by Honorable President Mr. Ram Chandra Poudel on 2080/12/17 B.S.

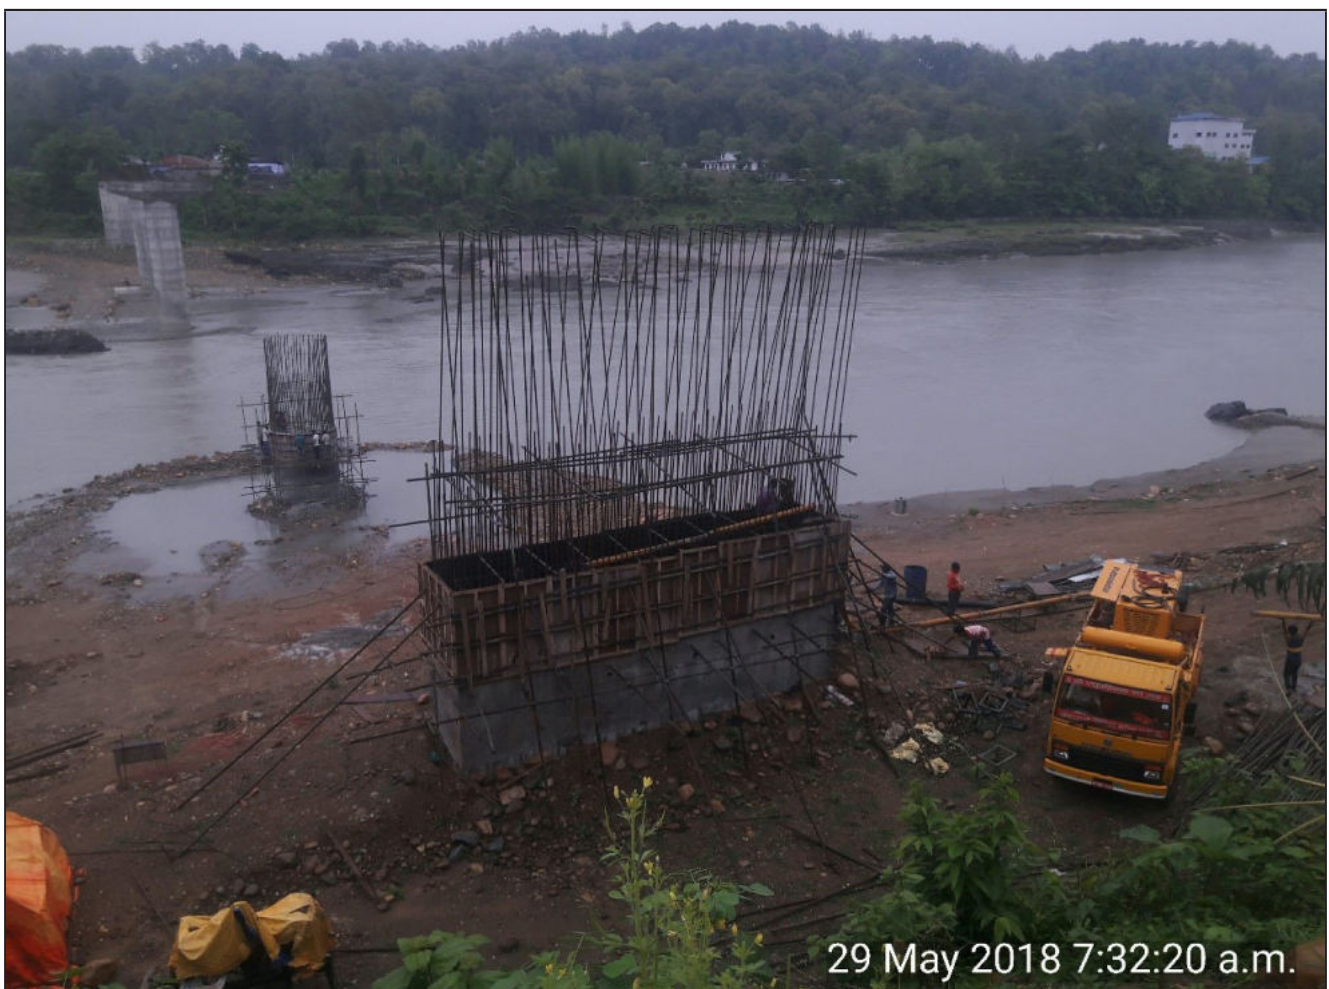
*Figure 3: Foundation and Substructure Works*

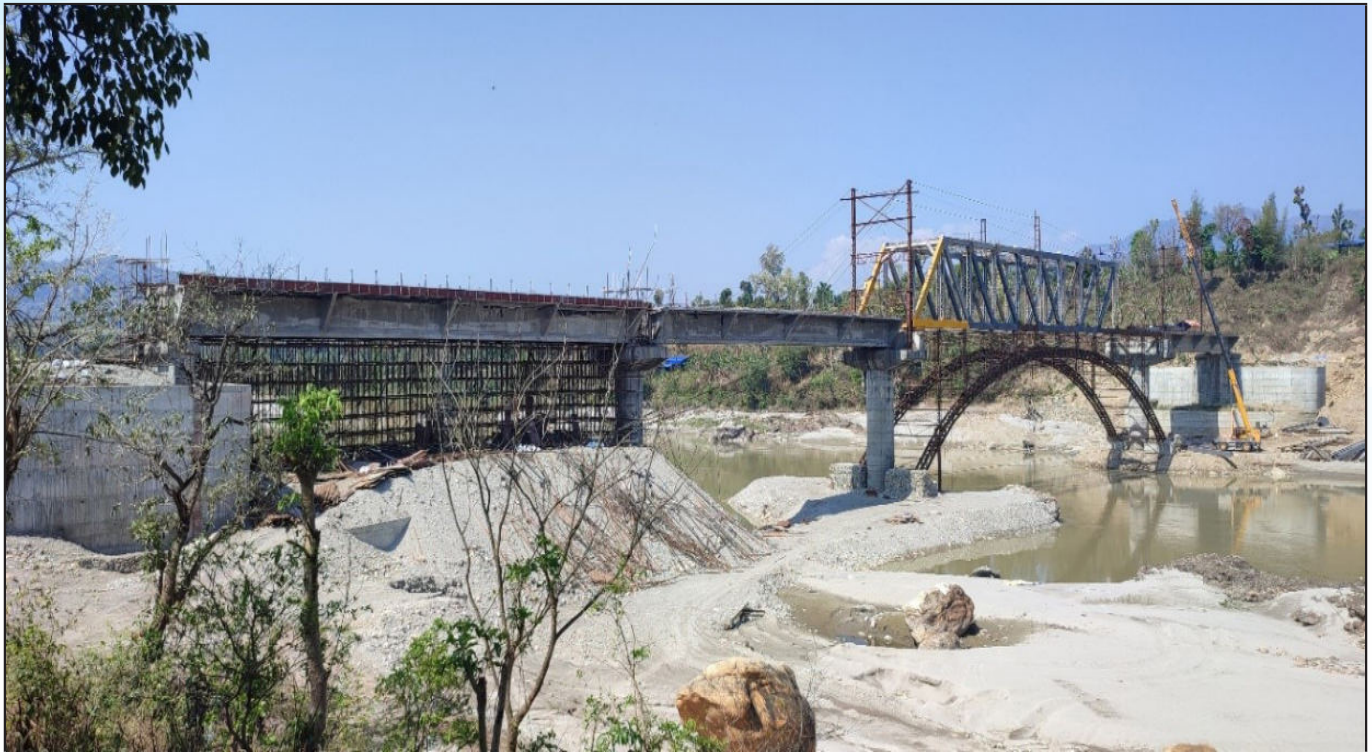
*Figure 4: Construction work of PSC and Truss Span*

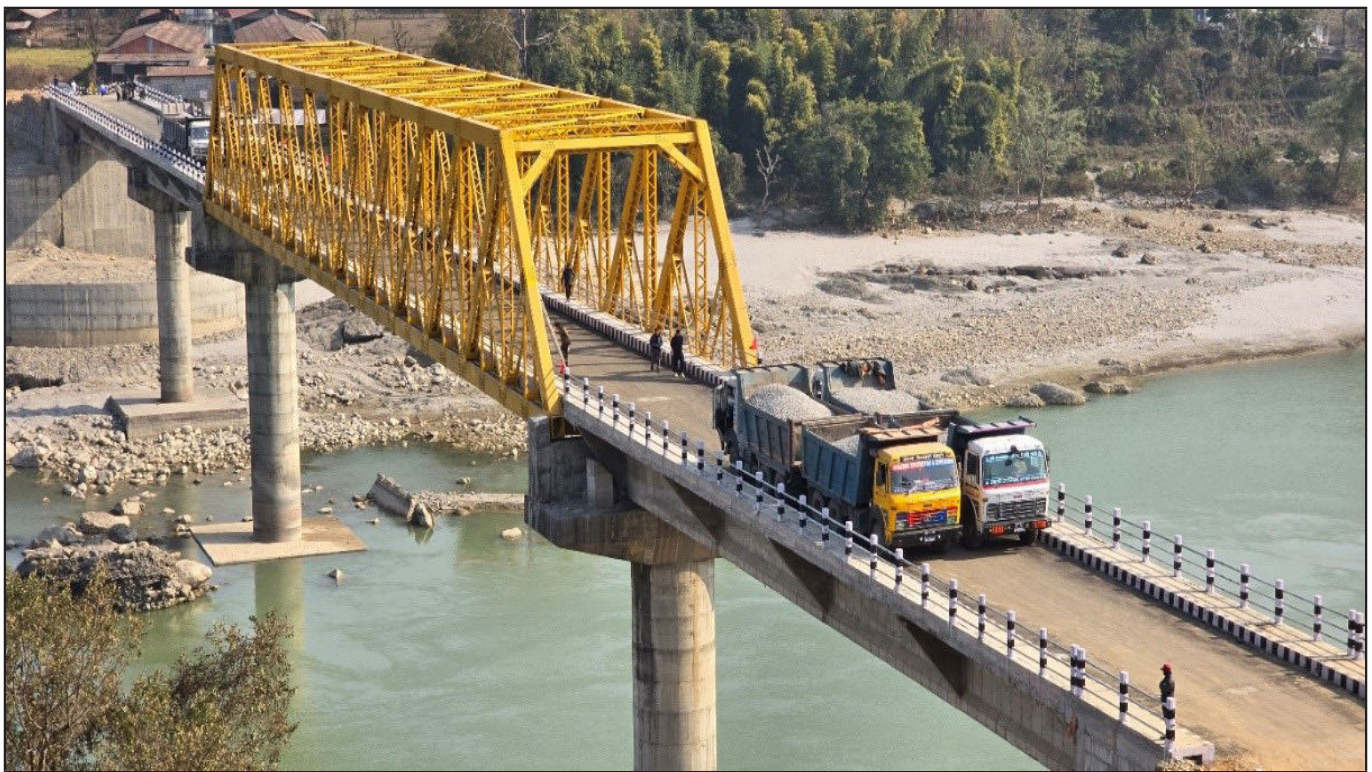
*Figure 5: Bridge Load Test on PSC Span and Truss Span*
