6500 Series Test Report

- PMU LAB REPORT
- THERMAL ANALYSIS OF BLACKLINE 6500 SERIES
- BULLETIN 19R. FIELD TEST

This report covers the laboratory performance mock-up (PMU) testing performed on March 16th, 2022 of the 6500 Series Window Wall system. Project located in Toronto, Ontario, Canada. Testing was conducted on a window wall assembly. The overall nominal dimensions are approximately 3.4 m (11 ft) wide (unfolded) and 6.6 m (21-1/2 ft) high.

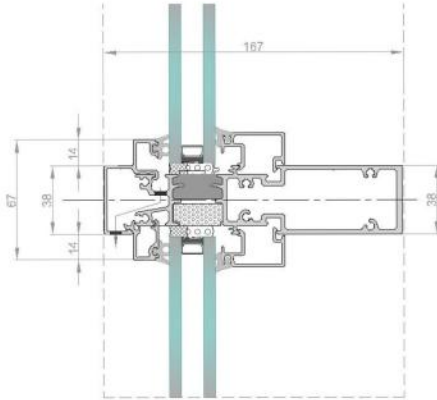
Transom Detail @Vision Glass

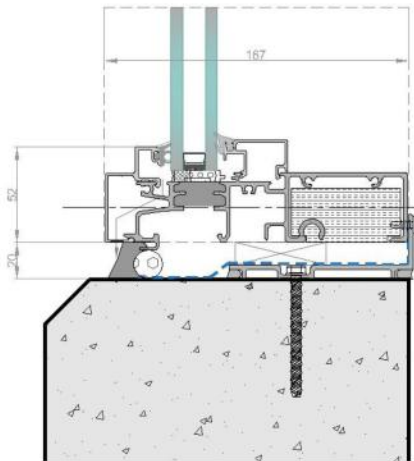
Sill Detail with Starter (No Sill Flashing)

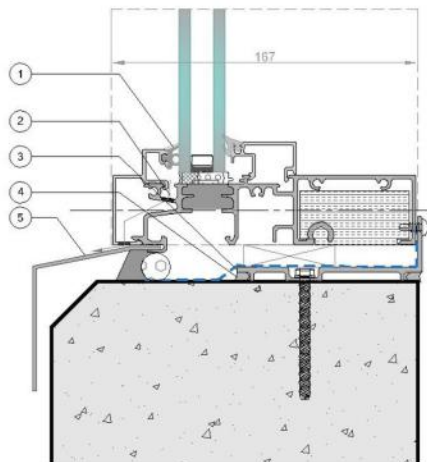
Sill Detail with Starter Track & Sill Flashing

- 1- Extruded EPDM and Silicone gaskets
- 2- Rain Screen Principle.
- 3- Extruded Starter sill track to guarantee continuity seal in all panels.
- 4- Continuous Silicone sealants applied to the face and under the track.
- 5- Extruded sill flashing if required.

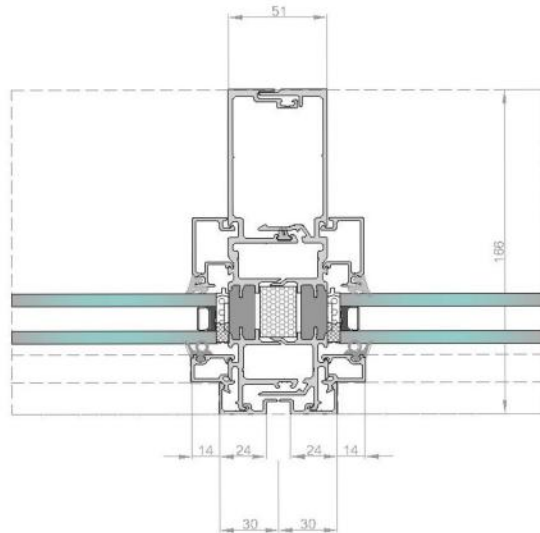
Split Mullion Detail Reveal Cap

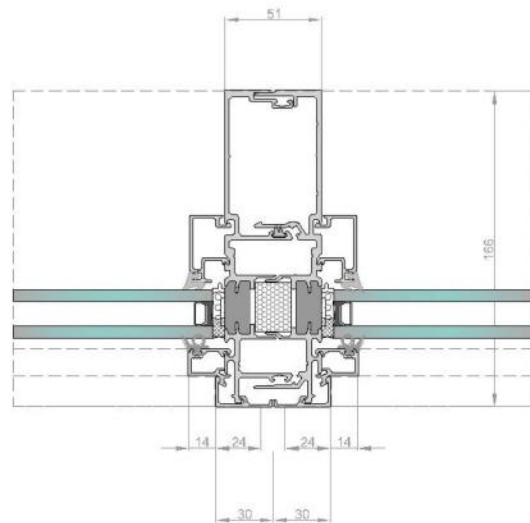
Split Mullion Detail Flush Caps

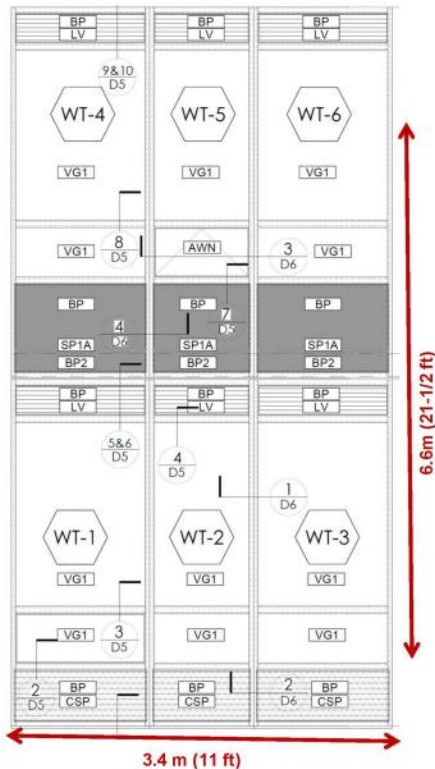
Figure 1 : Dimensions of the prototype (Elevation view)

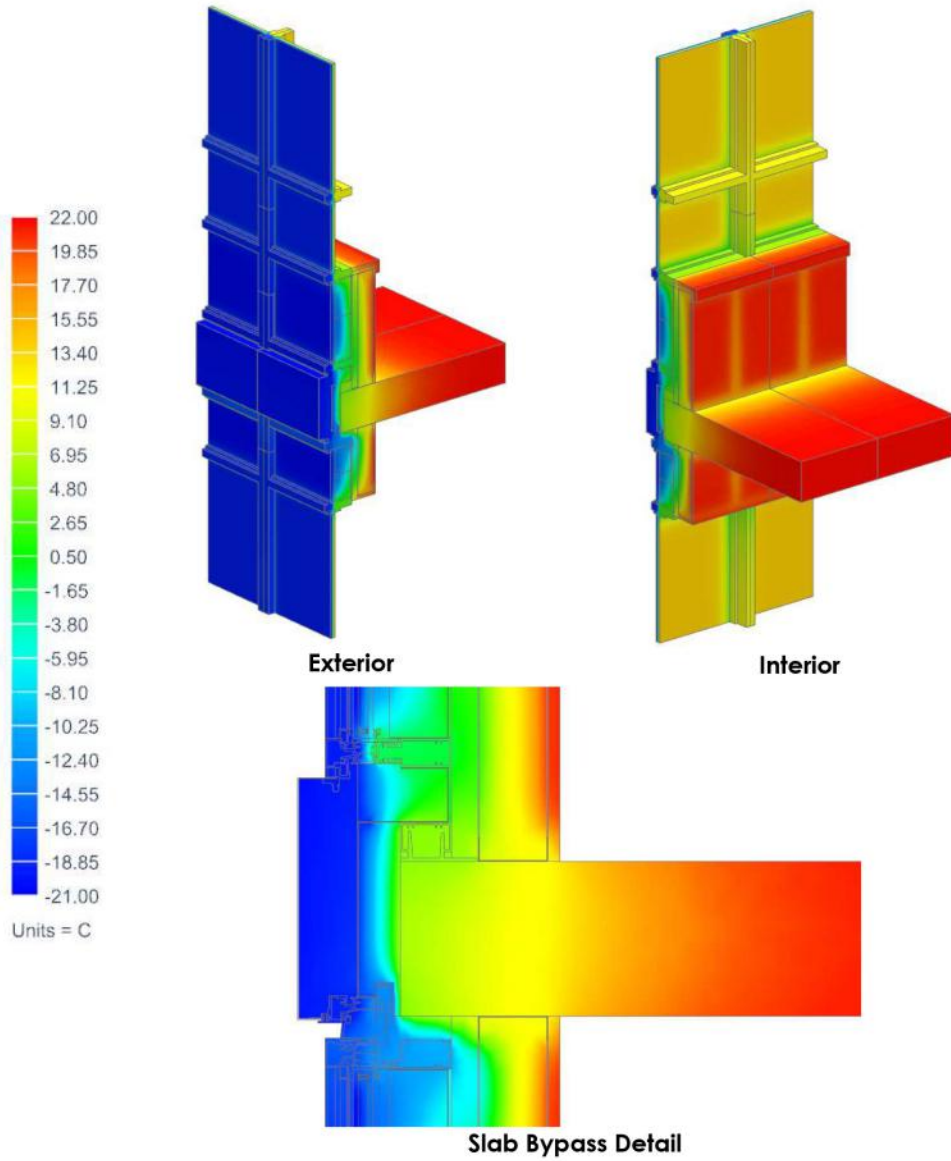
The following figure illustrates the temperature distribution in one of the six scenarios for the Blackline 6500 Series Window Wall System. The full test result is provided upon request.

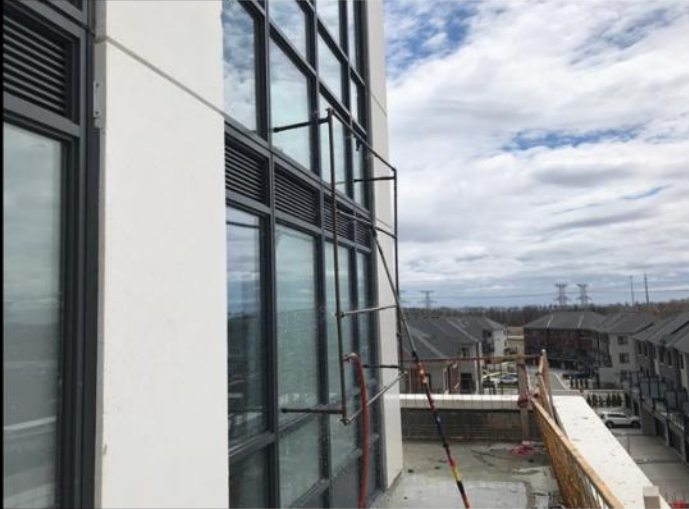
FT.01.02.A - Outside Suite 409: View of spray rack on the slab bypass area between level 3 and level 4.

1. Unit 409 - master bedroom slab bypass windows (See FT.01.02)

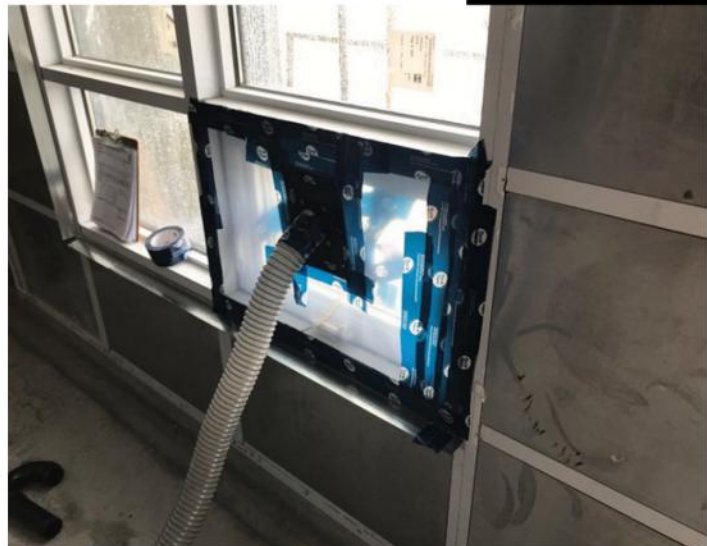
FT.01.03.B - View of interior test chamber.

2. Unit 511 - bedroom awning window (See FT.01.03)

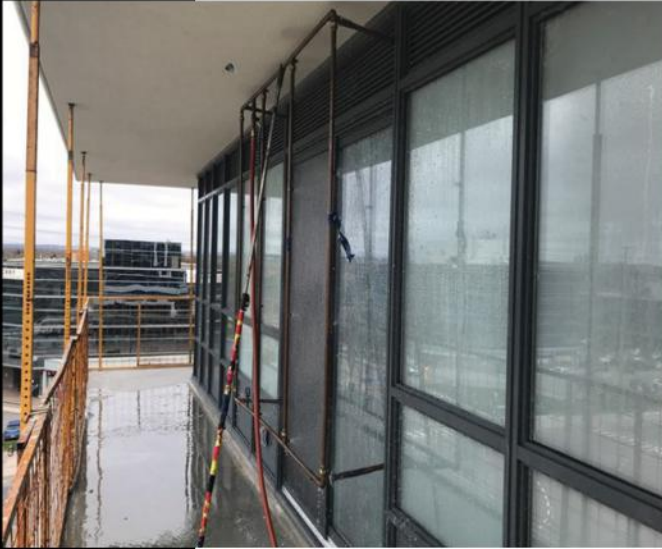
FT.01.04.A - View of spray rack on sliding doors during water penetration test.

3. Unit 512 - master bedroom sliding door (See FT.01.04)

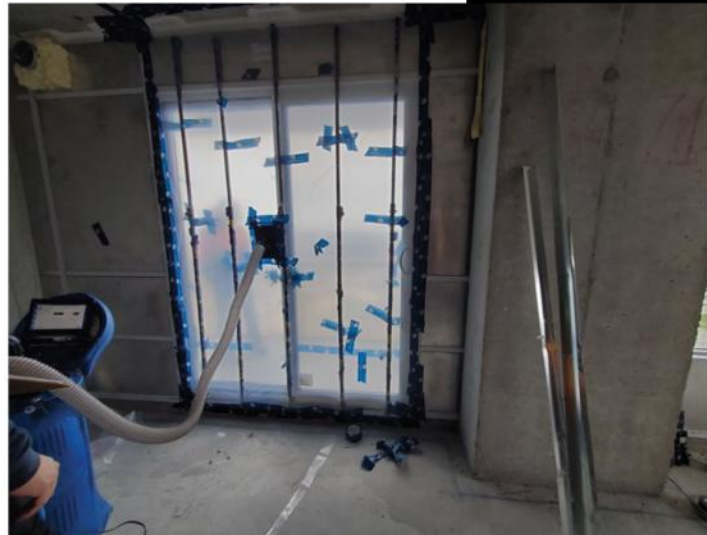
FT.01.04.C - View of interior test chamber.
