Northern Corridor and Nairobi County Route Hazard Mapping Report

May 2017

Developed by Safe Way Right Way and National Transport and Safety Authority

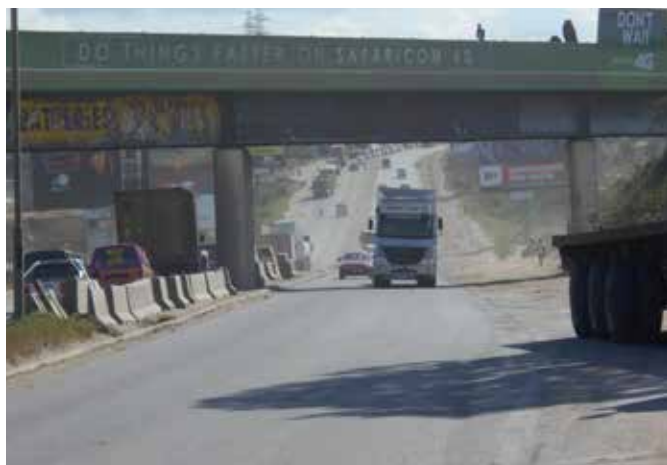
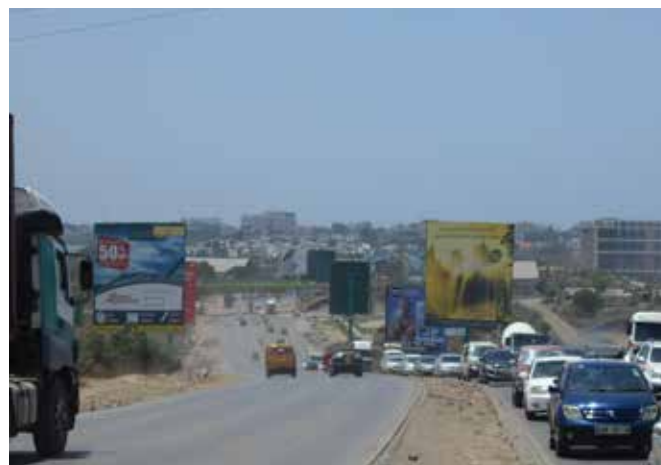
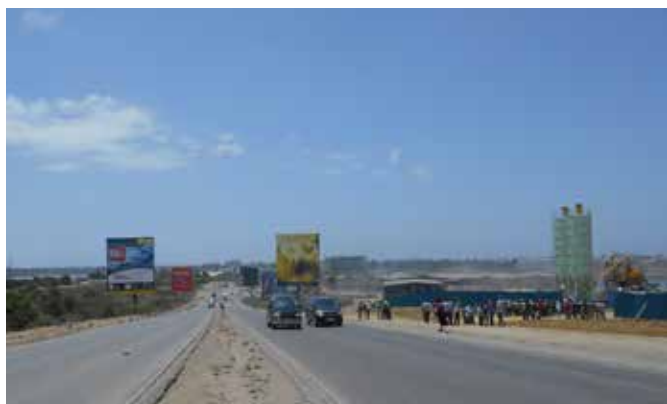
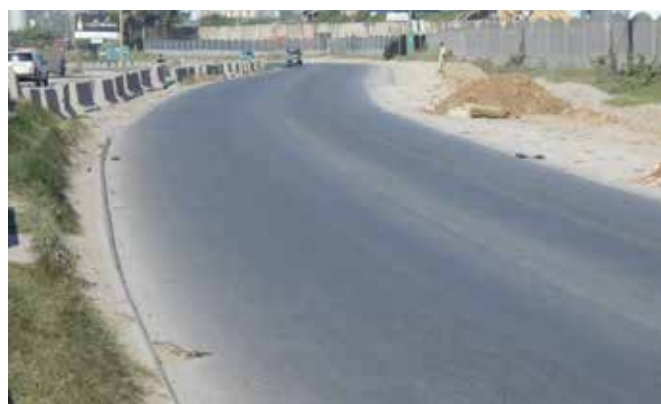
Picture: Part of Kibarani - Makupa road section

This is a new blackspot stretching 1.7 kilometers on a steep slope and brow of a hill at Kibarani – Makupa area. There is heavy pedestrian and PSV traffic, and many undesignated bus stops. There are no road signs and most of the road is unmarked. The reason for the black spot is speeding motorists coupled with a slippery section during the rainy season. Motorists often make illegal turns to the opposite lane at the depression and there are a number of slow moving trucks due to the hill as well as heavy pedestrian crossing. Crashes happen throughout the week and during both night and day time, and in both dry and wet seasons. Vehicles mostly involved in crashes are personal cars (saloons), mini buses and vans, light and medium trucks, and heavy commercial vehicles. Crash victims are taken to Coast General Hospital.

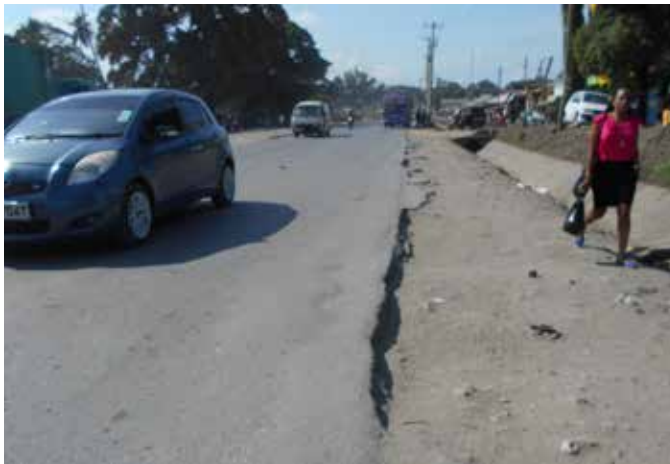
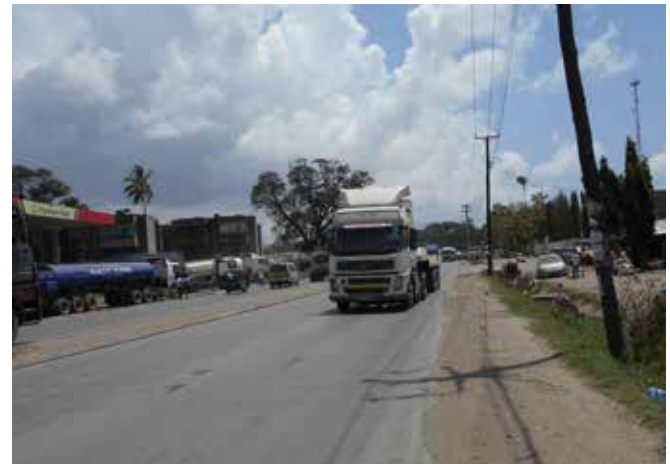
Picture: Part of Bahati - Kibarani road section

This is 1 kilometer section of the road on a steep slope at Kibarani and traverses busy Bahati Center. There are no designated bus stages for the public service vehicles (PSVs) that ply along this road section. Many pedestrians use this road. There are no road signs and the road is unmarked. The road shoulder is worn out. The reason for the black spot is speeding motorists, and motorists making illegal U-turns into the highway as well as unsafe pedestrian crossing. Crashes happen throughout the week and during both night and day time, and in both dry and wet seasons. Vehicles mostly involved in crashes are mini buses, light and medium trucks, and heavy commercial vehicles. Crash victims are taken to Coast General Hospital.

Engineering - road design/furniture/features	Enforcement - law	Education - Road user awareness
<ul style="list-style-type: none"> Designate and mark pedestrian crossing points. Instal a speed limit sign and repair road shoulder. Designate bus stops. Properly mark and put the right signage on the road section. 	<ul style="list-style-type: none"> Enforcement of speed limit by police. Ensure public service vehicles use designated bus stops. Arrest vehicle making illegal U-turns. 	<ul style="list-style-type: none"> Create awareness on speeding and safe crossing.

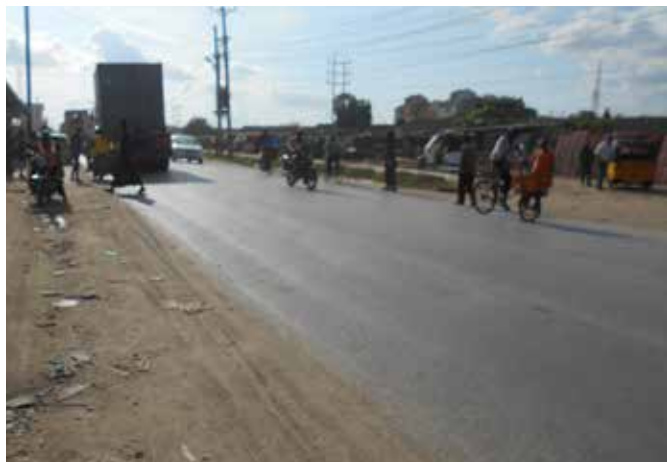
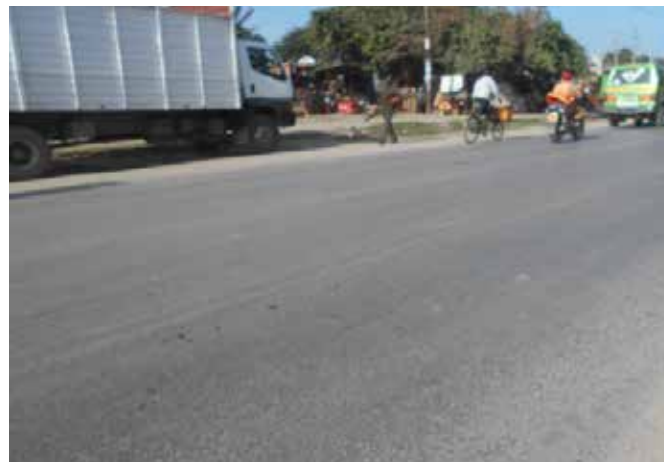
Picture: Part of Magongo road section

This is a 1.6 kilometer road section on a long straight stretch, with intersections through the busy Magongo Road. The road section has no road markings and no road signs. The reason for the black spot is speeding motorists, unsafe pedestrian traffic and undesignated 'PSVs' stops. Crashes happen throughout the week and during both night and day time, and in both dry and wet seasons. Vehicles mostly involved in crashes are mini buses - includes PSVs and vans, and heavy commercial vehicles. Crash victims are evacuated to Coast General Hospital or Bomu Medical Hospital.

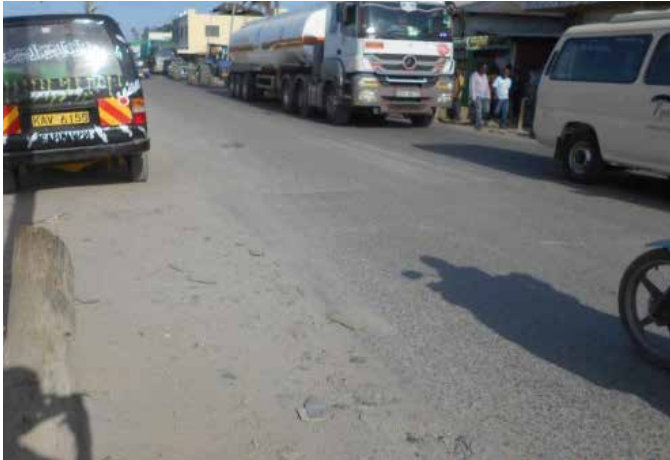
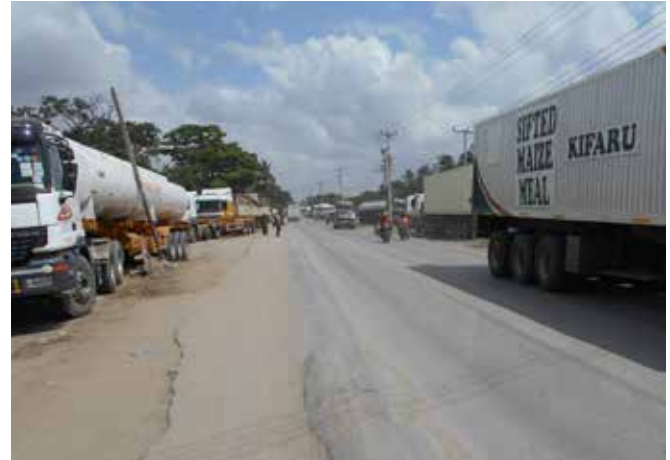
Picture: Part of Wuayani road section

This new blackspot is a 0.2-kilometer road section in Wuayani on Magongo Road. The road section has a number of potholes; there are many motorcyclists in this area. The road section has no road signs. The reason for the black spot is presence of potholes, speeding motorists and careless motorcyclists. The road surface is uneven. Heavy commercial vehicles park along the road making it narrow and obstructing other road users. Motorists are involved in head on collisions as they speed and avoid potholes. Crashes happen throughout the week and during both night and day time, and in both dry and wet season. Vehicles mostly involved in crashes are personal cars (saloons), and motorcycles. When crashes happen, victims are taken to Coast General Hospital or Bomu Medical Hospital.

Engineering – road design/furniture/features	Enforcement – law	Education – Road user awareness
<ul style="list-style-type: none"> Repair road surface and shoulder. Instal appropriate road signage and marking. 	<ul style="list-style-type: none"> Control parking by heavy commercial vehicles. 	<ul style="list-style-type: none"> Create awareness on the need for motorists to drive carefully along this black-spot section.

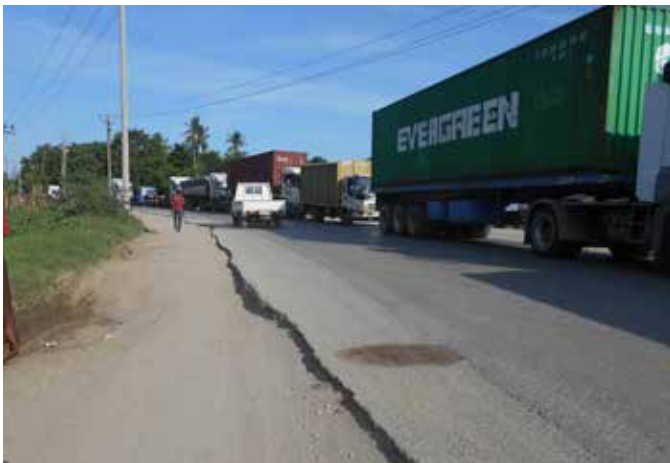
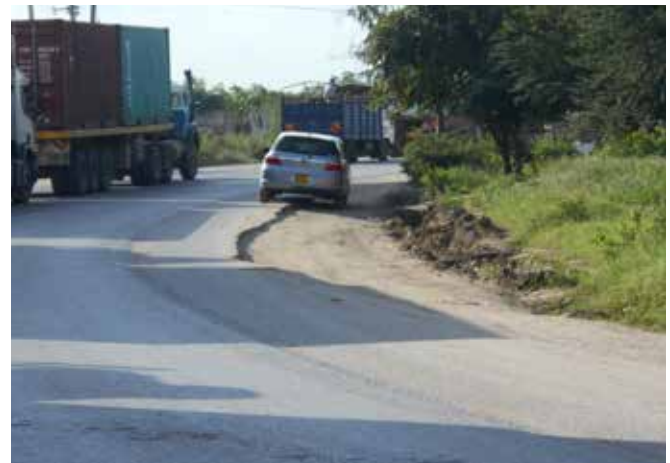
Picture: Part of Doshi Corner road section

This is a 0.5-kilometer road section, on Magongo Road, at a sharp bend with inadequate road signs and missing road markings. The reason for the black spot is speeding motorists, poor visibility at the bend, and heavy commercial vehicles parked on the road. Crashes happen throughout the week and during both night and day time, and in both dry and wet seasons. Vehicles mostly involved in crashes are personal cars (saloons), mini buses - includes PSVs and vans, and heavy commercial vehicles. When a crash happens, victims are taken to Coast General and Bomu Hospitals.

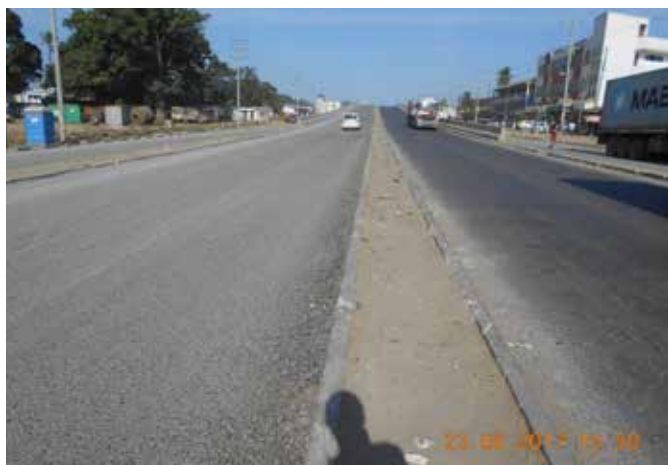
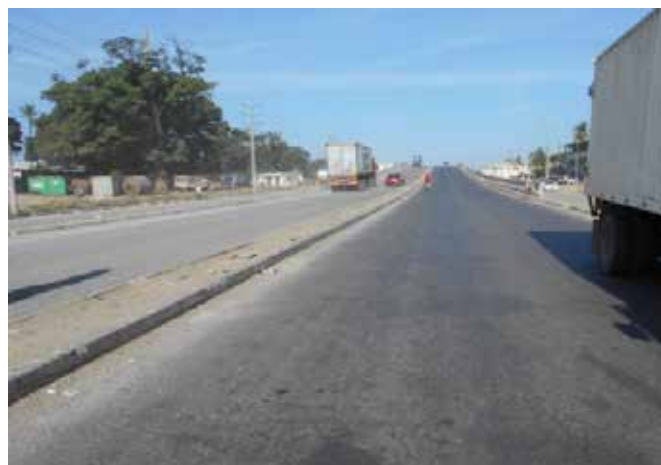
Picture: Part of Nuru Mosque - Bangladesh road section

This is a 1.3-kilometer dual carriage road section located on the highway traversing a busy market area. The road section is under construction. The reason for black spot is the many heavy commercial vehicles on road, undesignated bus stops, and unsafe pedestrian crossing. Crashes happen throughout the week and at both night and day time, in both dry and wet seasons. Vehicles mostly involved in crashes are personal cars (saloons), mini buses (PSVs and vans), and heavy commercial vehicles. Crash victims are taken to Bomu Hospital.

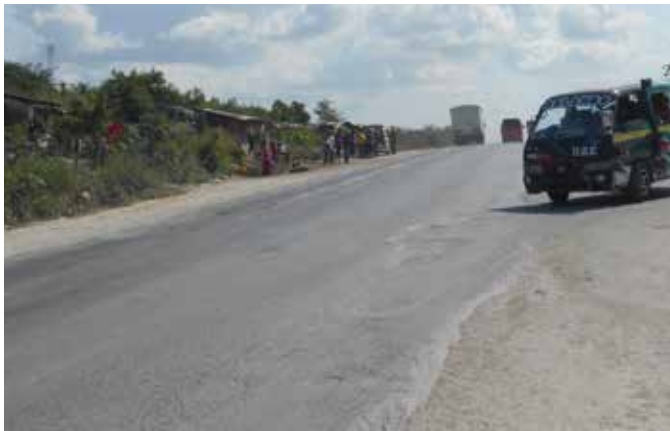
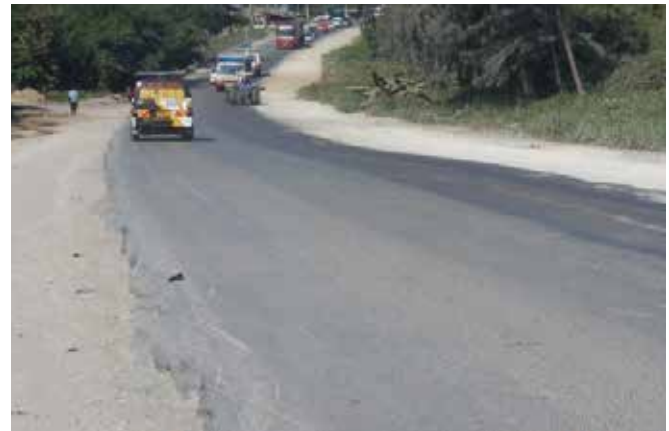
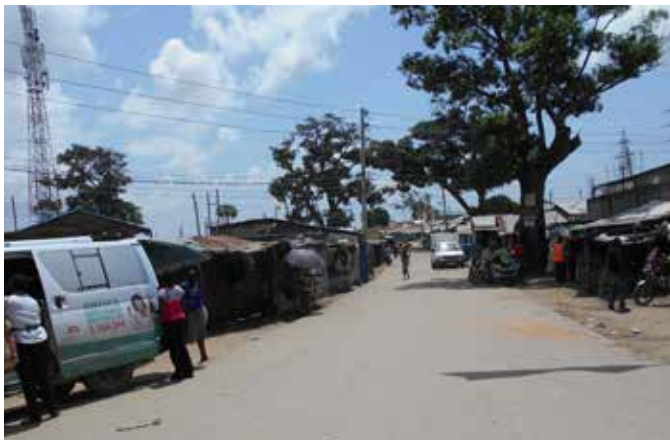
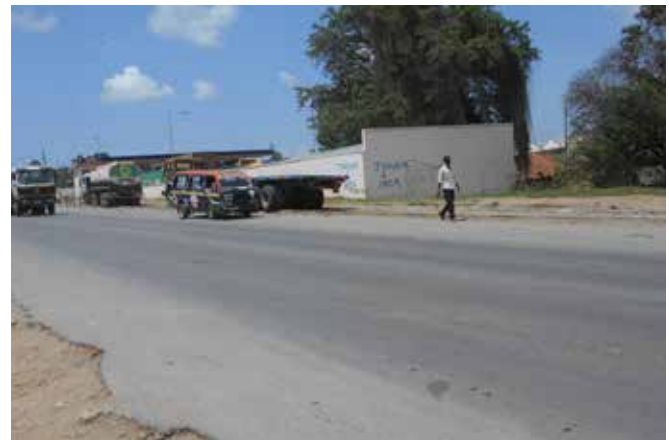
Picture: Part of Bangladesh - Mikindani road section

This is a new blackspot on a 1 kilometer narrow road section located on the highway at Mikindani in Bangladesh area with a sharp bend and a junction immediately after the bend. The road section has neither road signs nor road markings. The road shoulder is damaged. The reason for the black spot is slow moving vehicles, overlapping motorists, as well as a junction that is immediately at the end of the bend. Crashes happen throughout the week and during both night and day time, and in both dry and wet season. Vehicles mostly involved in crashes are personal cars (saloons), mini buses - includes PSVs and vans, and heavy commercial vehicles. Crash victims are taken to Bomu Medical and Coast General Hospitals.

Engineering - road design/furniture/features	Enforcement - law	Education - Road user awareness
<ul style="list-style-type: none"> Repair and expand the road to include an extra lane. Instal road signage at the bend to indicate junction ahead. Create a designated area for trucks to park. Mark the road. 	<ul style="list-style-type: none"> Ensure trucks park in the designated area and not along the road. 	<ul style="list-style-type: none"> Educate motorists on the need to stop before crossing the intersection.

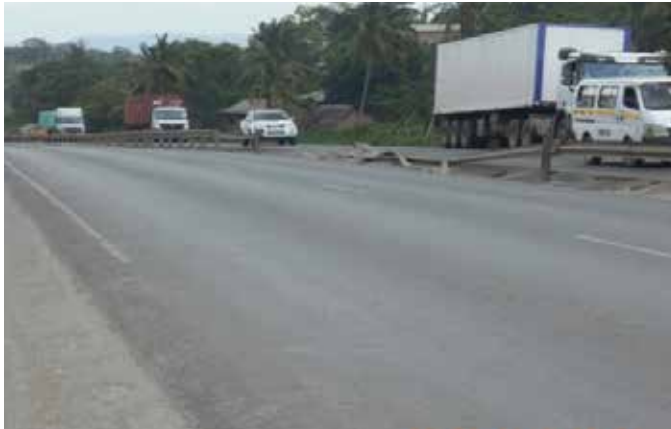
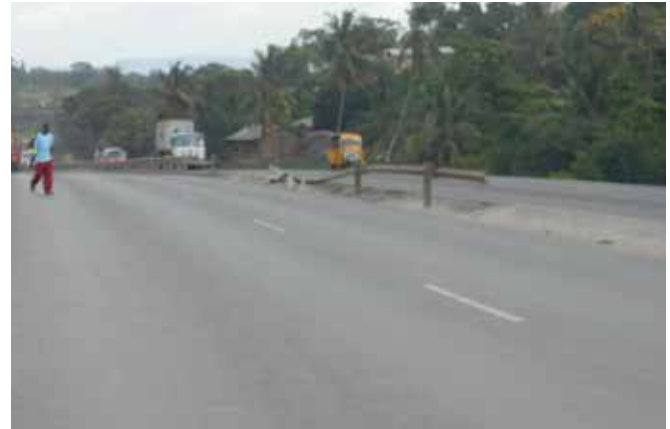
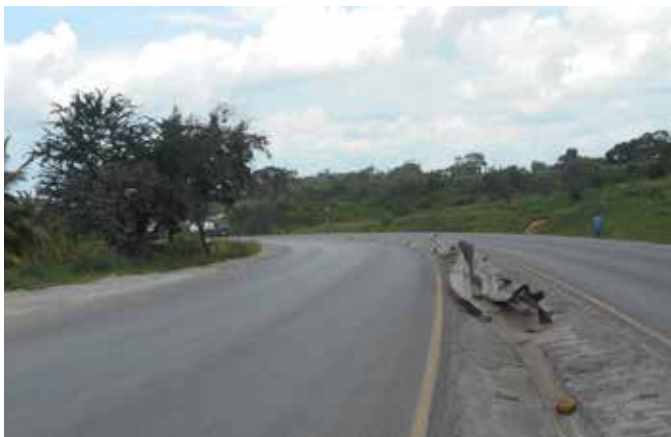
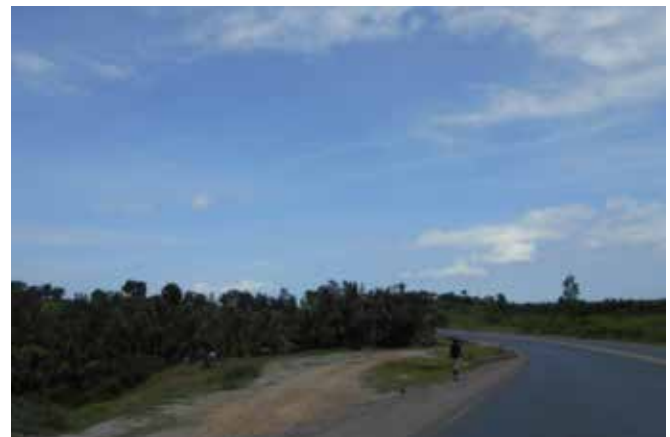
Picture: Part of Bonje road section

This is a 4.5 kilometer road section with sharp bends near Bonje center. The guardrails are damaged and, there are no road signs. The road markings are faded. The reason for the black spot is speeding motorists, and unsafe pedestrian crossing from the busy Bonje market. Crashes happen throughout the week and during both night and day time, and in both dry and wet seasons. Vehicles mostly involved in crashes are personal cars (saloons), mini buses - includes PSVs and vans, and heavy commercial vehicles. Crash victims are taken to Mariakani District Hospital.

Engineering - road design/furniture/features	Enforcement - law	Education - Road user awareness
<ul style="list-style-type: none"> Repair the damaged guard rails. Instal road signage at the sharp bends. Designate pedestrian crossing points and instal traffic calming measures at Bonje Centre. 	<ul style="list-style-type: none"> Enforce speed limits at Bonje centre. 	<ul style="list-style-type: none"> Create awareness on speeding and safe crossing.

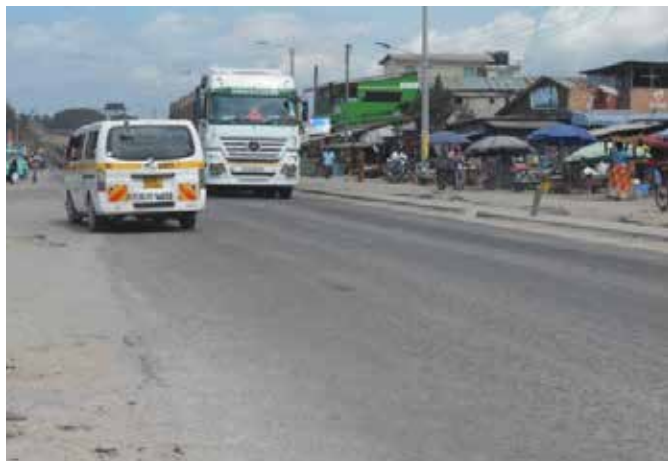
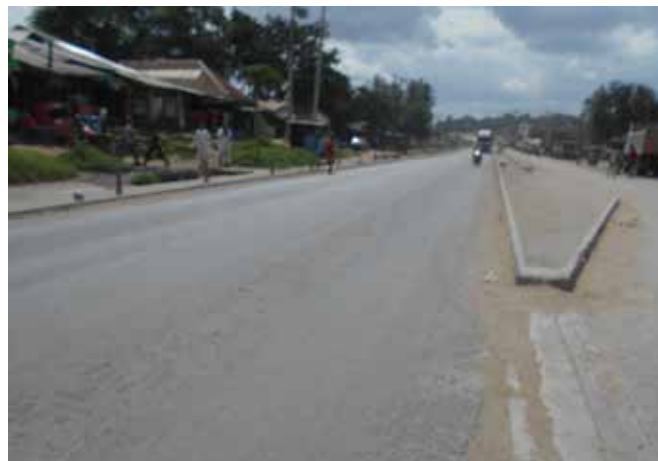
Picture: Part of Mazeras road section

This is a 0.4-kilometer road section that has slight bend and passes through the busy Mazeras market center with no road signage, and missing guardrails at the bend. The reason for the black spot is speeding motorists and unsafe pedestrian crossing in large numbers at undesignated points. Crashes happen throughout the week and equally at both night and day time, and in both dry and wet seasons. Vehicles most involved in crashes are personal cars (saloons), mini buses (PSVs and vans), and heavy commercial vehicles. Crash victims are taken to Mariakani District Hospital.

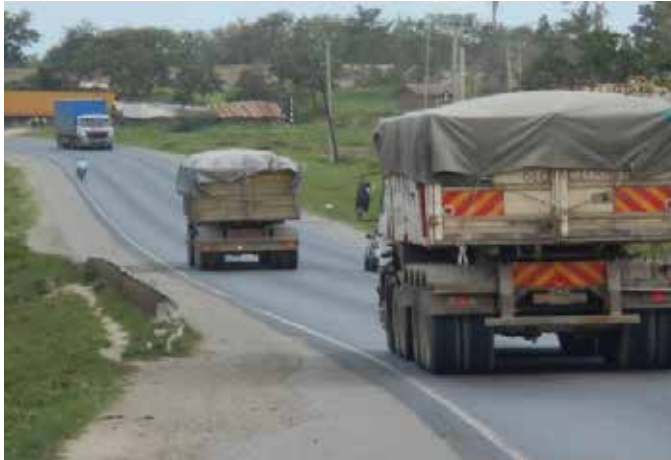
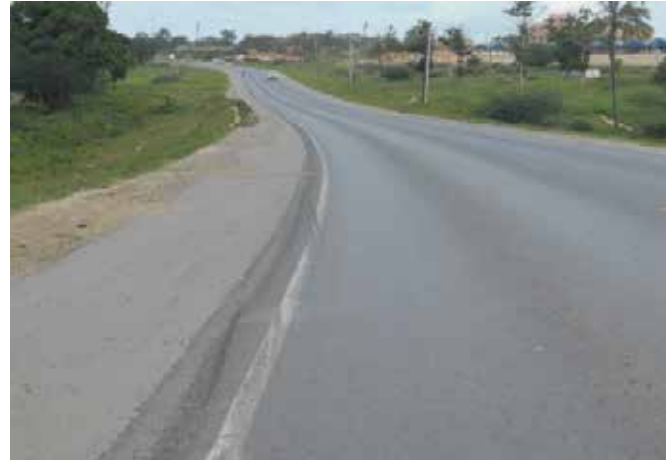
Picture: Part of Uwanja wa Ndege road section

This is a 1.5 kilometer section of the highway at Uwanja wa Ndege with very sharp bends on a steep slope. There are no road signs and the guardrails are damaged. The reason for the black spot is speeding motorist and careless overtaking due to poor visibility at the bends. Crashes happen throughout the week and during both night and day time, and in both dry and wet season. Vehicles mostly involved in crashes are personal cars (saloons), mini buses - includes PSVs and vans, and heavy commercial vehicles. Crash victims are taken to Mariakani District Hospital.

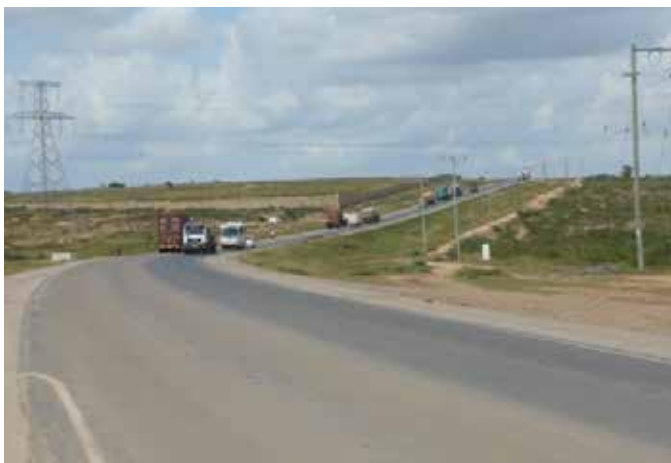
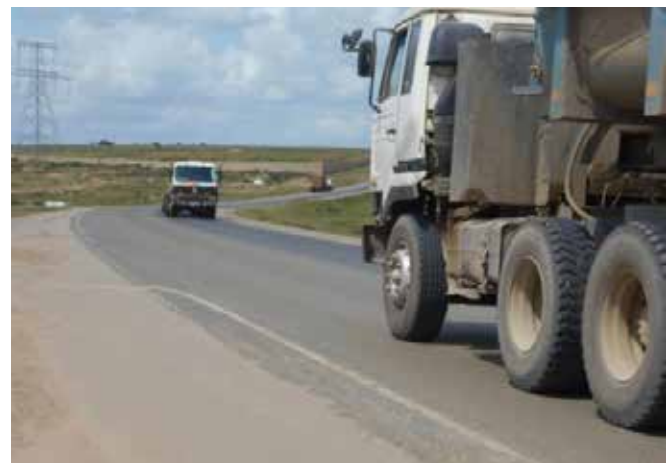
Picture: Part of Kokotoni road section

This is a 1.5 kilometer road section at Kokotoni with sharp bends. There are no road signs and the road markings are fading away. The reason for the black spot is careless overtaking and poor visibility due to the many bends. Crashes happen throughout the week and during both night and day time, and in both dry and wet seasons. Vehicles mostly involved in crashes are personal cars (saloons) and heavy commercial vehicles. Crash victims are taken to Mariakani District Hospital.

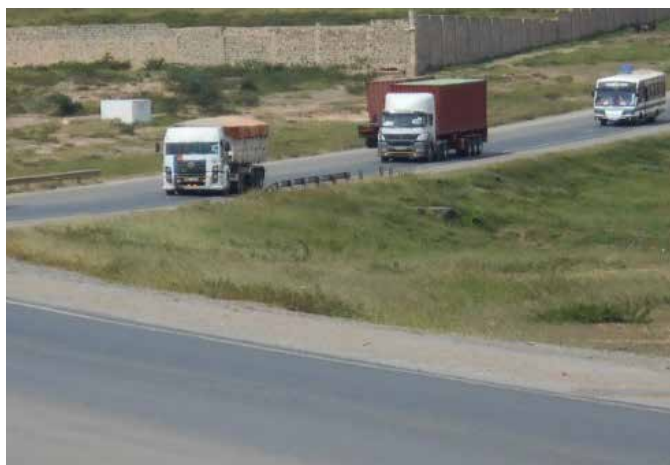
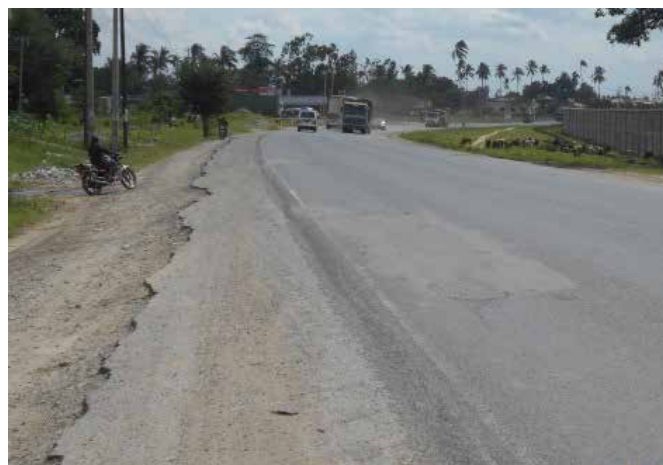
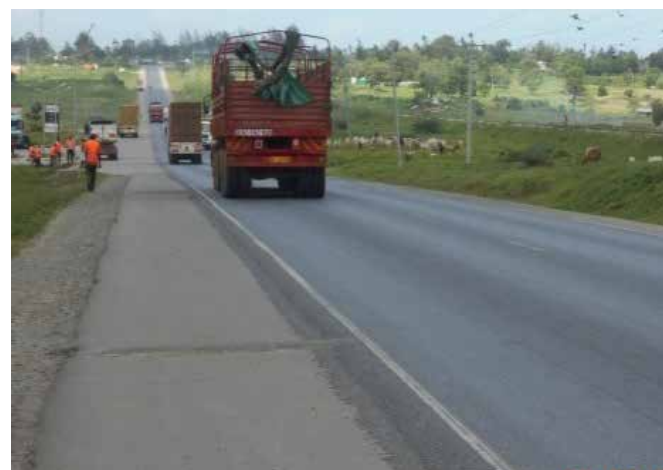
Picture: Part of Kibanda Hasara road section

This is a 1.3-kilometer road section along straight stretch on a gentle slope and sharp bend and has no road signs at Kibanda Hasara. The reason for the black spot is speeding motorists and careless overtaking by motorists. Crashes happen throughout the week and during both night and day time, and in both dry and wet seasons. Vehicles mostly involved in crashes are personal cars (saloons), mini buses - includes PSVs and vans, large buses and heavy commercial vehicles. Crash victims are taken to Mariakani District Hospital.

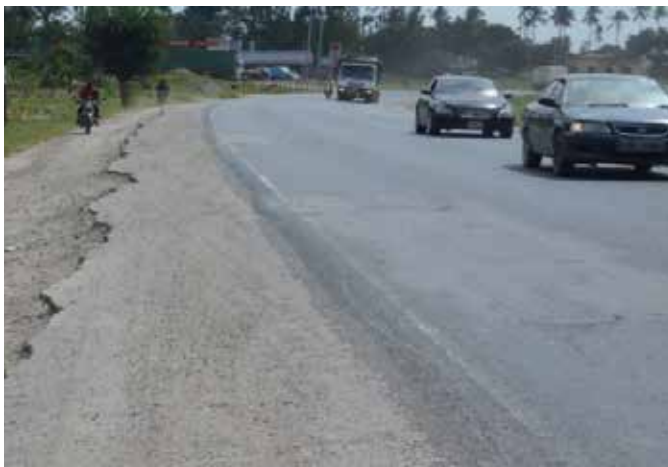
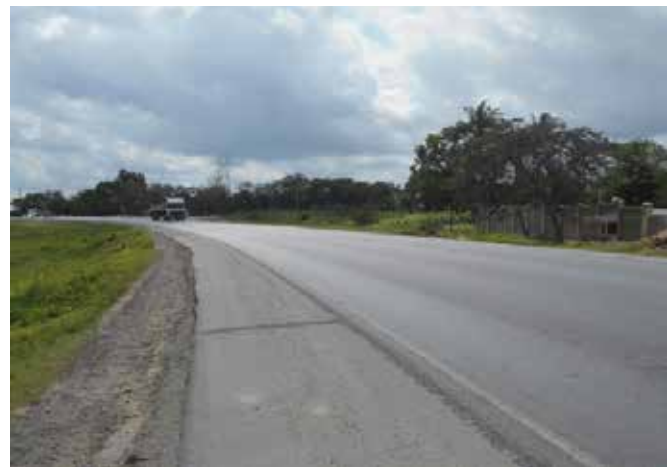
Picture: Part of Katolani road section

This is a 300 meter road section on a sharp bend. The reason for the black spot is speeding motorists and careless overtaking. The section has no road signage, road marking is faded and road shoulder is worn out. Crashes happen throughout the week and equally both night and day time, and in both dry and wet seasons. Vehicles mostly involved in crashes are personal cars (saloons), mini buses (PSVs and vans), large buses, light and medium size trucks, and heavy commercial vehicles. Crash victims are taken to Mariakani District Hospital.

Engineering - road design/furniture/features	Enforcement - law	Education - Road user awareness
<ul style="list-style-type: none"> • Instal speed limit signage. • Repaint the road marking. • Repair damaged road shoulder. 	<ul style="list-style-type: none"> • Enforce speed limit compliance. 	<ul style="list-style-type: none"> • Create awareness on safe speed and careful overtaking.

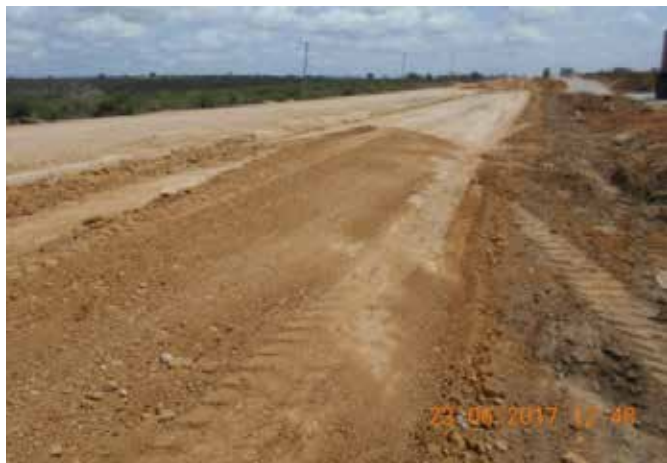
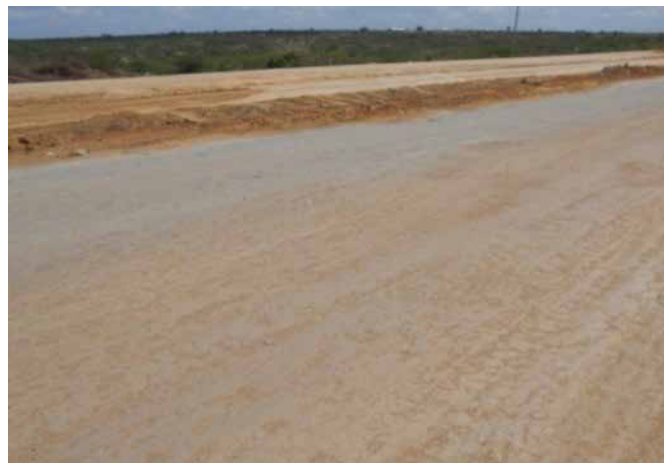
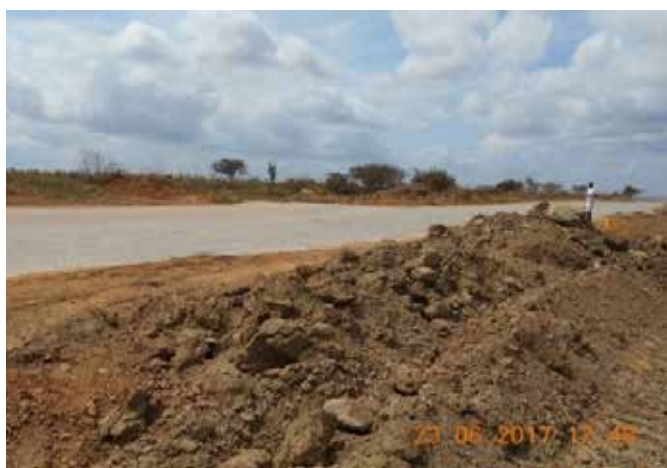
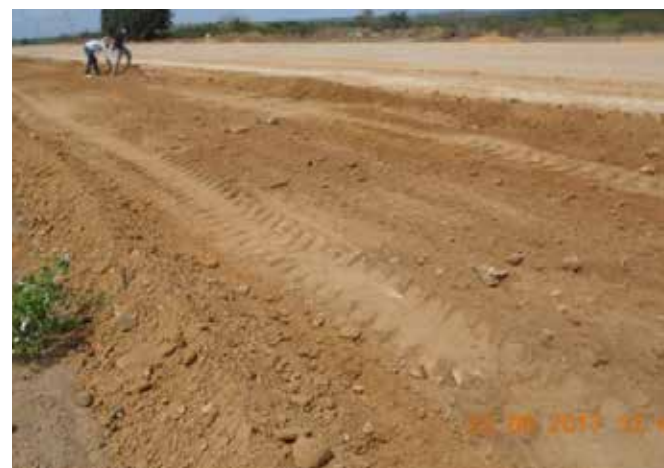
Picture: Part of Maji ya Chumvi road section

This is a 3.2-kilometer road section with sharp bends on a steep slope and has a brow of hill at Maji ya Chumvi. The road section is currently under construction. There is a road diversion. The reason for the black spot is speeding motorists and careless overtaking. Crashes happen throughout the week and equally at both night and day time, but mostly in wet season due to construction. Vehicles mostly involved in crashes are personal cars (saloons), large buses, light and medium size trucks, and heavy commercial vehicles. Crash victims are taken to Mariakani District Hospital.

Engineering - road design/furniture/features	Enforcement - law	Education - Road user awareness
<ul style="list-style-type: none"> Erect appropriate signage and marking to show ongoing construction is complete. Specify speed limit during construction phase. Ensure work site safety is observed in areas under construction. 	<ul style="list-style-type: none"> Enforce speed limit compliance. 	<ul style="list-style-type: none"> Create awareness on safe speed and careful overtaking.

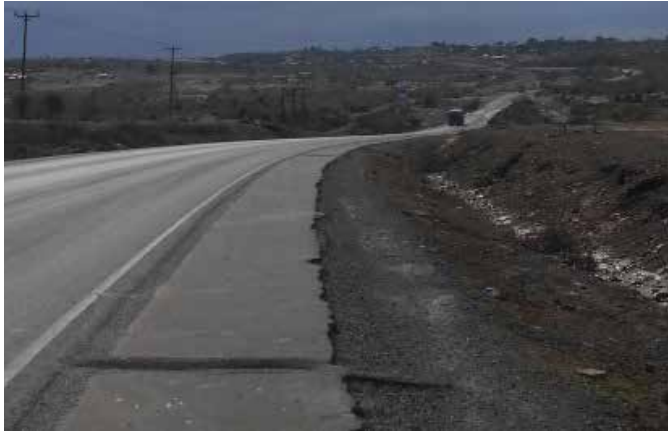
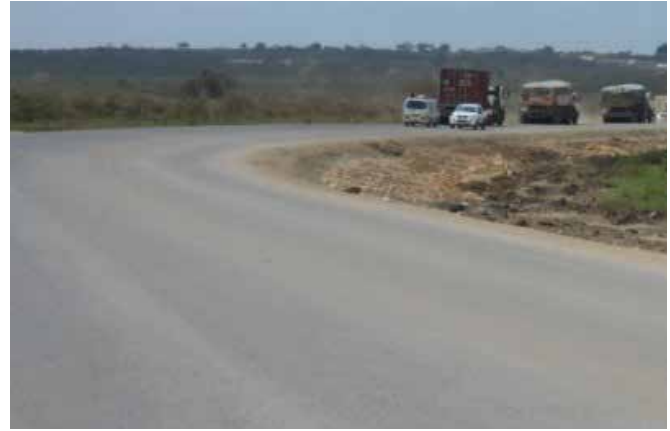
Picture: Part of Kwa Mzungu road section

This is a 2.3-kilometer road section on a long steep stretch with a sharp bend. Some sections are unmarked and with no road signs. The reason for the black spot is speeding motorists and careless overtaking. Crashes happen throughout the week and at night and day time, and in both dry and wet seasons. Vehicles mostly involved in crashes are personal cars (saloons), large buses, light and medium size trucks, and heavy commercial vehicles. Crash victims are taken to Mariakani District Hospital.

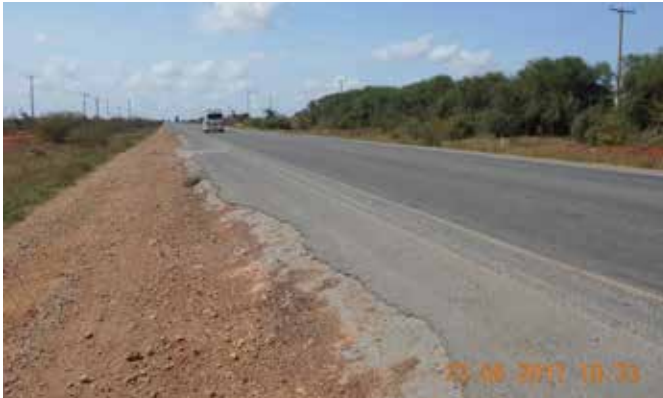
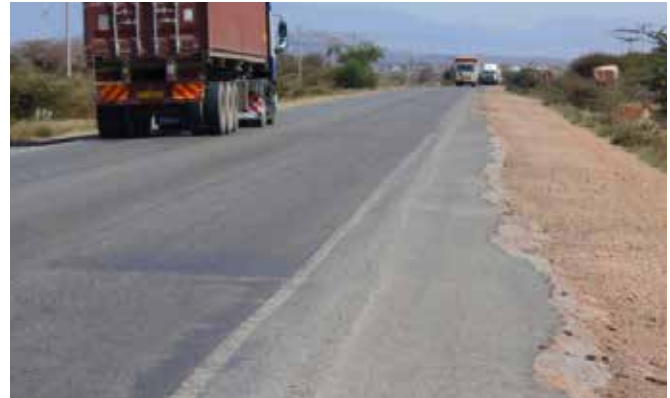
Picture: Part of Taita Village road section

This is a 5.4-kilometer road section along a straight stretch with a slight bend. There is no road signage and the road marking is fading. The road shoulder is damaged.

The main reason for the black spot is speeding motorists. Crashes happen throughout the week but mostly at night and in wet season. Vehicles most involved in crashes are personal cars (saloons), light and medium trucks, and heavy commercial vehicles. Crash victims are taken to Voi District Hospital.

Engineering - road design/furniture/features	Enforcement - law	Education - Road user awareness
<ul style="list-style-type: none"> • Instal speed limit signage as well as signage to show the bend. • Repair damaged road shoulder. • Repaint the road marking. 	<ul style="list-style-type: none"> • Enforce speed limit compliance. 	<ul style="list-style-type: none"> • Create awareness on dangers of speeding especially at night and in rainy season.

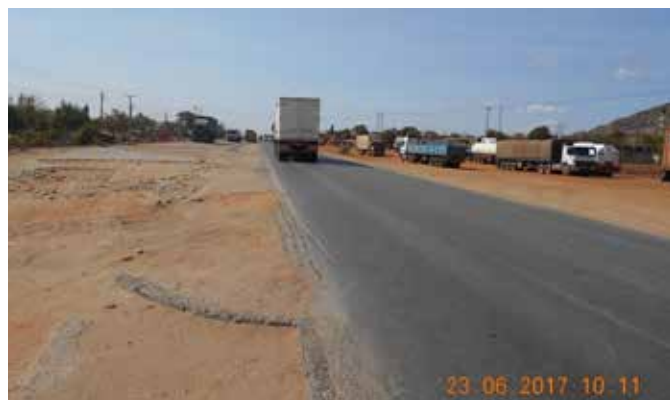
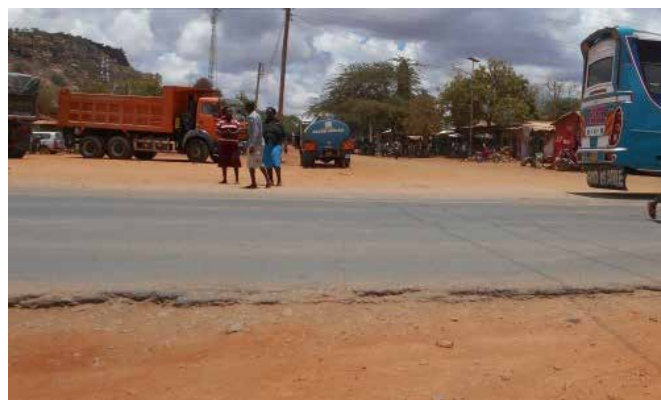
Picture: Part of Maungu Market Area road section

This is a new blackspot on a 1.4-kilometer road section, on a straight stretch and a gentle slope through a wildlife-protected area. The section passes through a roadside market at Maungu. The original blackspot in 2013 was situated at Maungu Pipeline area. There is a truck parking built by the Taita Taveta County Government. There is no road signage especially to warn motorists of cattle or wildlife crossing, the road marking is fading off, and road shoulder is damaged. The reason black spot is speeding motorists, undesignated pedestrian and animal crossing. Crashes happen throughout the week but mostly at daytime and in wet season. Vehicles mostly involved in crashes are personal cars (saloons), large buses, light and medium trucks and heavy commercial vehicles. Crash victims are taken to Voi District Hospital.

Engineering - road design/furniture/features	Enforcement - law	Education - Road user awareness
<ul style="list-style-type: none"> Mark the road appropriately. Designate pedestrian crossing points. Install road signage to warn of animal crossing. Repair damaged road shoulder. 	<ul style="list-style-type: none"> Enforce speed limit compliance. 	<ul style="list-style-type: none"> Create awareness on dangers of speeding and crossing by wild life.

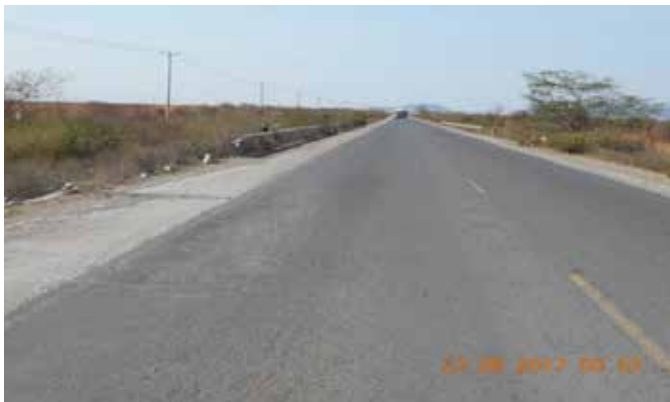
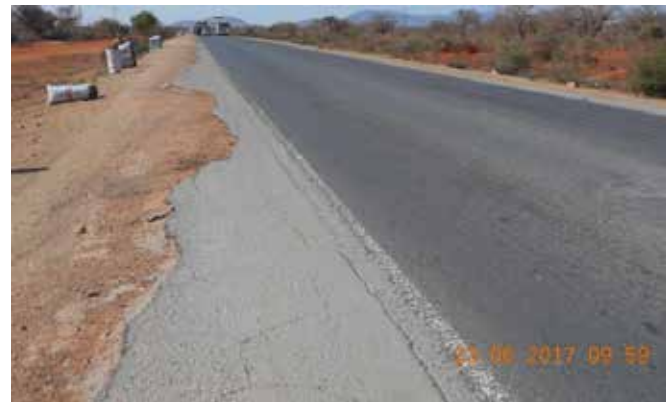
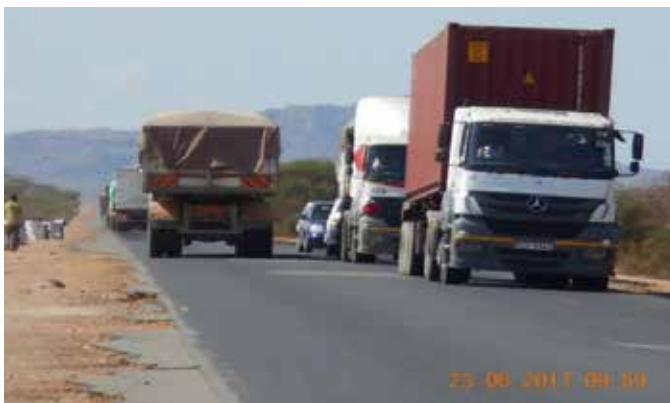
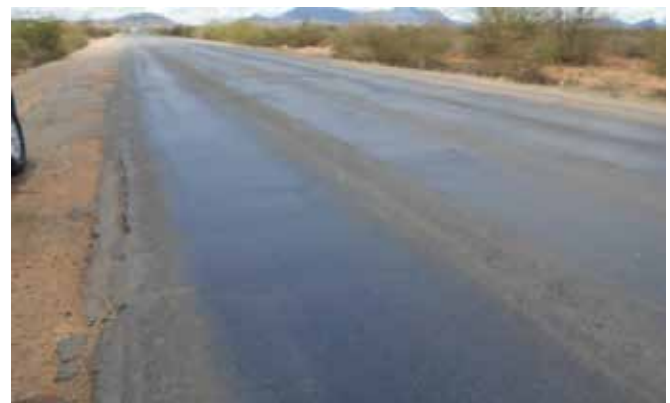
Picture: Part of Ndara area road section

This is a 5.1 kilometer road section along a straight stretch on a gentle slope and a narrow bridge with no road signs and damaged guard rails. The section is missing road markings and road shoulder is worn out. The reason for black spot is speeding motorists, wildlife crossing and many trucks parked on the road side reducing visibility. The section at Mbuyuni is slippery with the risk increasing during rainy season. Crashes happen throughout the week but mostly at night and in wet season. Vehicles most involved in crashes are personal cars (saloons), large buses, light and medium trucks and heavy commercial vehicles. Crash victims are taken to Voi District Hospital.

Engineering - road design/furniture/features	Enforcement - law	Education - Road user awareness
<ul style="list-style-type: none"> Repair the road shoulder and guard rails. Instal appropriate for signage for speed limit and animal crossing. Remark the road. 	<ul style="list-style-type: none"> Enforce speed limit compliance. 	<ul style="list-style-type: none"> Encourage trucks to park in Maungu not Ndara. Create awareness on safe speeds and wild animals crossing.

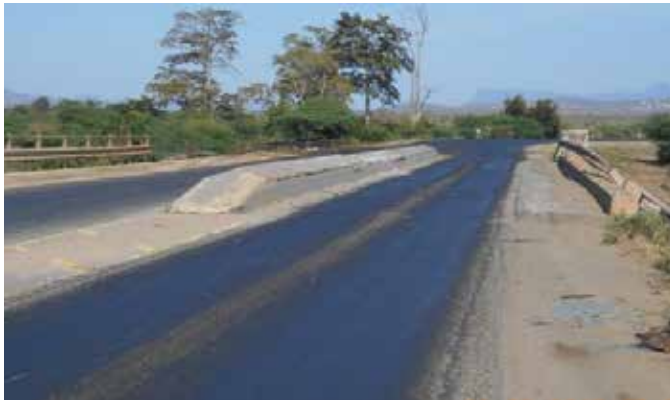
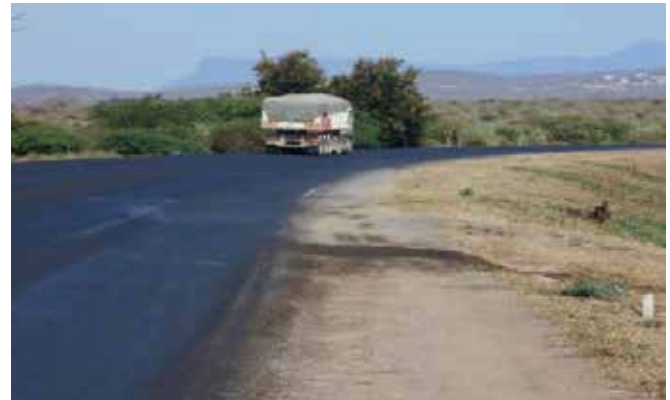
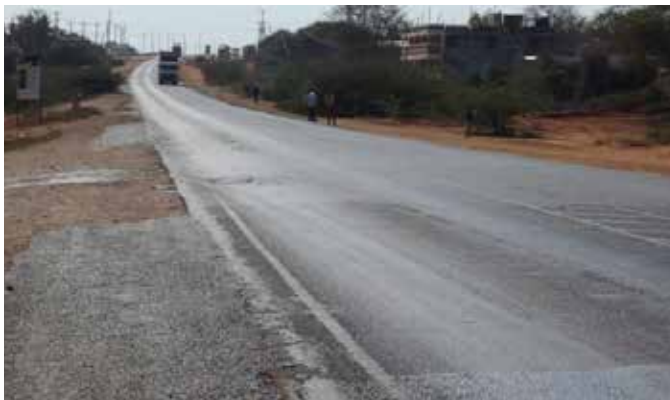
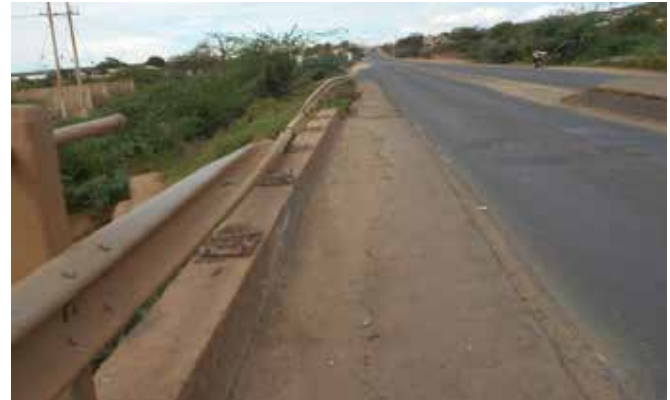
Picture: Part of Kasarani - Voi road section

This is a 4.0 kilometer road section with a sharp bend, along a straight stretch, and has an unmarked concrete road divider. There is no road signage. There are also a high number of motorcycle riders who drive carelessly on the road. The reason for the black spot is speeding motorists and careless driving. Motorcycle riders often make dangerous U-turns while picking passengers. Crashes happen throughout the week and equally in both wet and dry seasons but mostly at night. Vehicles mostly involved in crashes are personal cars (saloons), large buses, light and medium trucks, heavy commercial vehicles and motorcycles. Crash victims are taken to Moi Voi District Hospital.

Engineering - road design/furniture/features	Enforcement - law	Education - Road user awareness
<ul style="list-style-type: none"> Remove concrete road divider at the bridge. Repair guard rail. Repaint the road marking. Instal appropriate signage. 	<ul style="list-style-type: none"> Enforce speed limit compliance. 	<ul style="list-style-type: none"> Road safety awareness to motorcycle riders.

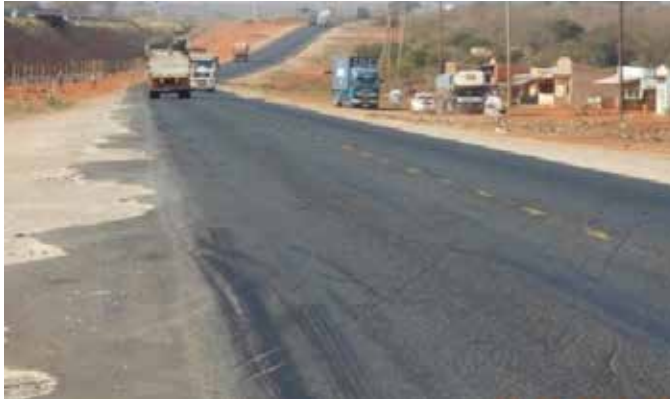
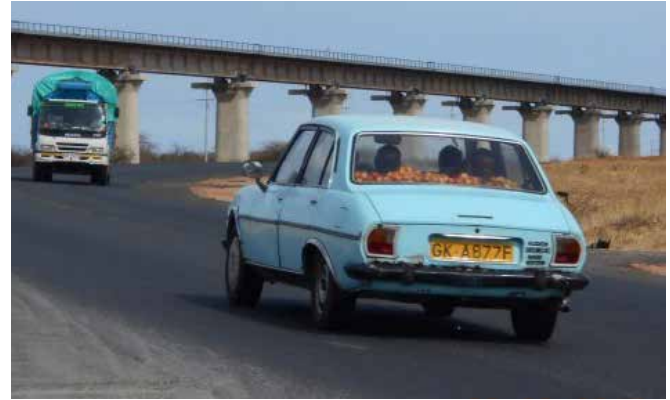
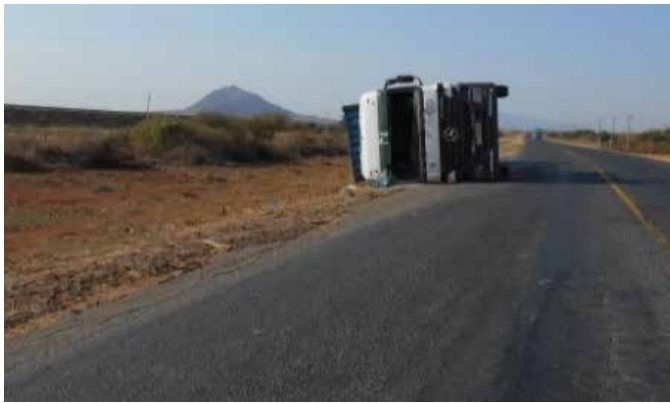
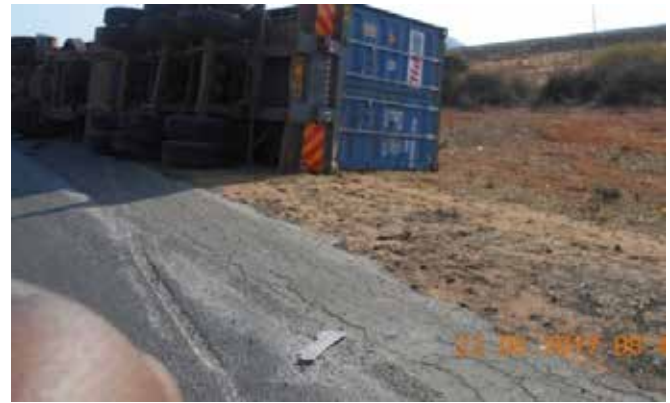
Picture: Part of Ndii area road section

This is a 4.6-kilometer road section on a long steep slope in one direction and hill on the other direction along the highway at Ndii area. There is neither a road marking nor signage and the road shoulder is worn out. Reason for black spot is speeding motorists, careless overtaking, and the hazard posed by slow moving vehicles up hill. Part of the road runs parallel to the Standard Gauge Railway (SGR). Crashes happen throughout the week in both dry and wet seasons, but mostly at night. Vehicles mostly involved in crashes are personal cars (saloons), large buses, light and medium trucks, heavy commercial vehicles. Crash victims are taken to Voi District Hospital. During fieldwork the team photo graphed a rollover crash involving a heavy commercial vehicle.

Engineering - road design/furniture/features	Enforcement - law	Education - Road user awareness
<ul style="list-style-type: none"> Repair the road shoulder. Instal appropriate signage for speed limit and bend. Build a climbing lane. Mark the SGR pillars near the road with chevrons for visibility at night, and erecting guard rails around them for better safety. 	<ul style="list-style-type: none"> Enforce speed limit compliance. 	<ul style="list-style-type: none"> Create awareness on speeding and safe overtaking.

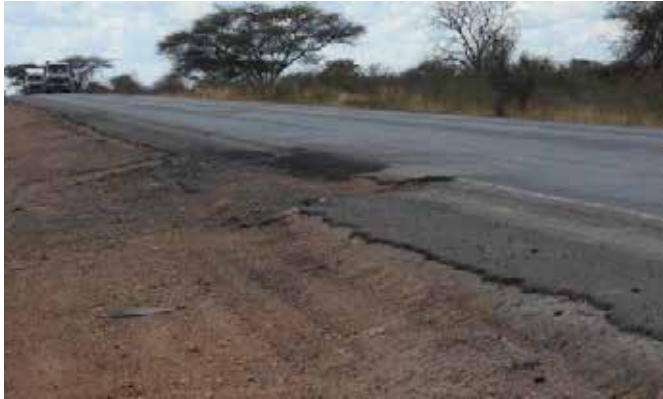
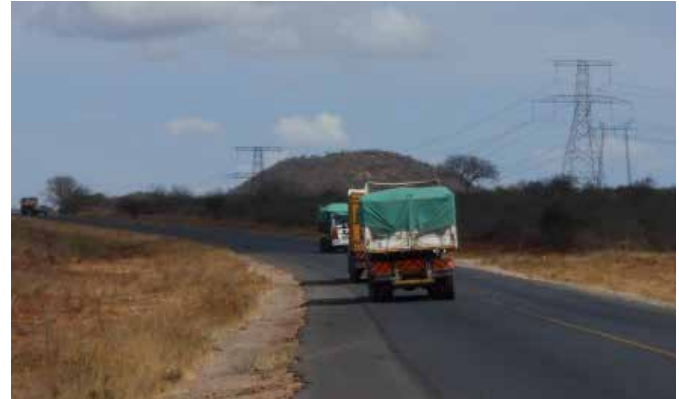
Picture: Part of Manyani area road section

This is a 5-kilometer road section along a straight and steep stretch with a bend at a brow of a hill. The road markings are fading and there is inadequate road signage. The road shoulder is damaged. The reason for the black spot is unpredictable cattle crossing, speeding motorists and careless overtaking. Crashes happen throughout the week in the dry and wet season but mostly at night. Vehicles mostly involved in crashes are personal cars (saloons), large buses, light and medium trucks, heavy commercial vehicles. Crash victims are taken to Moi Voi District Hospital.

Engineering - road design/furniture/features	Enforcement - law	Education - Road user awareness
<ul style="list-style-type: none"> Repair the road shoulder. Instal appropriate signage for animal crossing, and bends. Create a climbing lane. Remark the road. 	<ul style="list-style-type: none"> Enforce speed limit compliance. 	<ul style="list-style-type: none"> Create awareness on dangers of speeding and safe overtaking.
