Northern Corridor and Nairobi County Route Hazard Mapping Report

May 2017

Developed by Safe Way Right Way and National Transport and Safety Authority

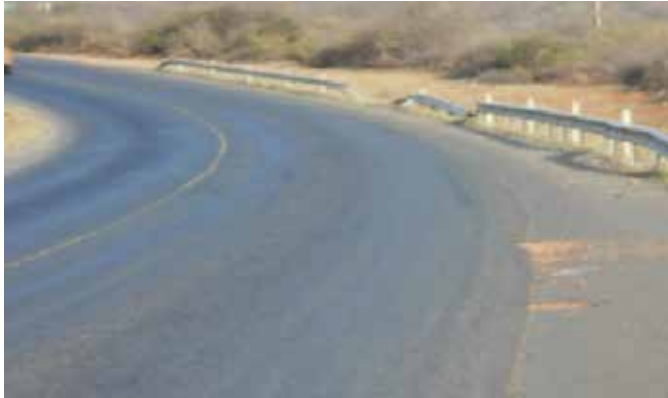
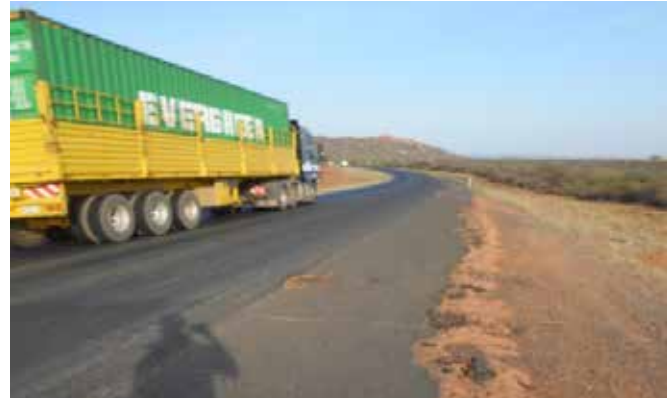
Picture: Part of Chyulu road section

This is a 2 kilometer road section with a very long bend at Chyulu hills. There is no road signage, road marking is faded, and the road shoulder and guardrails are damaged. The reason for the black spot is careless overtaking. Crashes happen throughout the week in the dry and wet season but mostly at night. Vehicles mostly involved in crashes are personal cars (saloons), large buses, light and medium trucks and heavy commercial vehicles. Crash victims are taken to Moi Voi District Hospital.

Engineering - road design/furniture/features	Enforcement - law	Education - Road user awareness
<ul style="list-style-type: none"> • Instal appropriate signage at the river crossing. • Remark the road. • Repair damaged guard rails. 	<ul style="list-style-type: none"> • Enforce speed limit compliance. 	<ul style="list-style-type: none"> • Create awareness on safe overtaking.

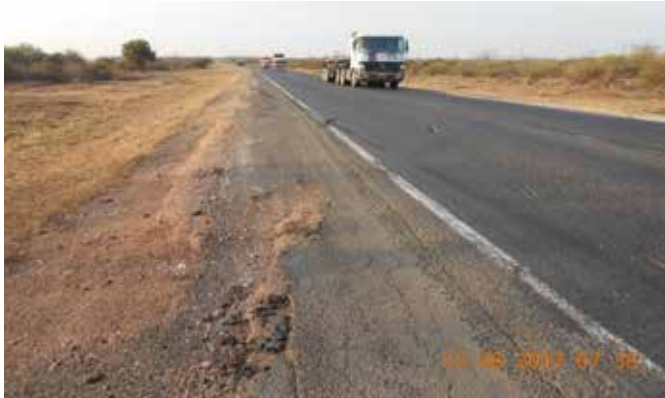
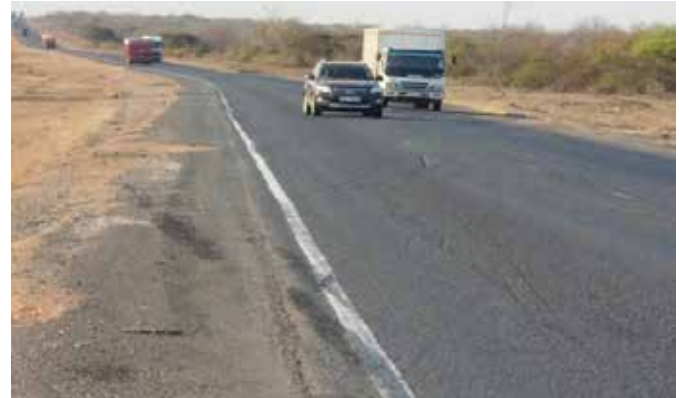
Picture: Part of Kenani Area road section

This is a 1.1 kilometer road section with a brow of hill on a steep slope with a bend. There are no road signs and the road marking is faded. The road is slightly uneven and the road shoulder is worn out. The reason for the black spot is speeding motorists. Crashes happen throughout the week in the dry and wet season but mostly at night. Vehicles mostly involved in crashes are personal cars (saloons), large buses, light and medium trucks and heavy commercial vehicles. Crash victims are taken to Moi Voi District or Mtito Andei Sub County Hospitals.

Engineering - road design/furniture/features	Enforcement - law	Education - Road user awareness
<ul style="list-style-type: none"> • Instal appropriate signage at the river crossing. • Remark the road. • Repair the road shoulder. 	<ul style="list-style-type: none"> • Enforce speed limit compliance. 	<ul style="list-style-type: none"> • Create awareness on safe overtaking and driving at night.

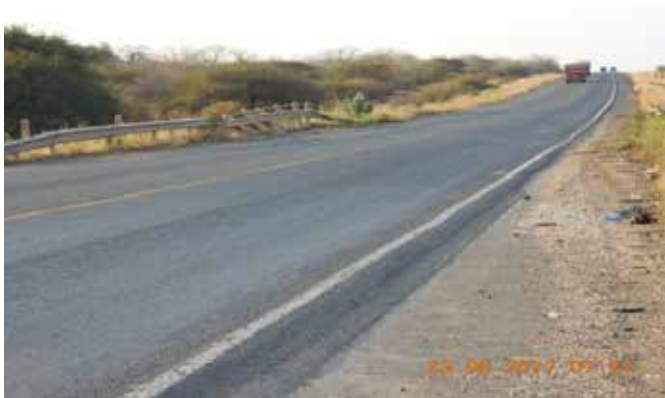
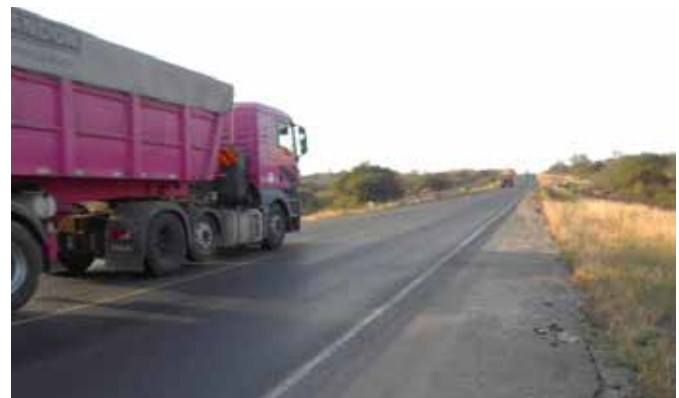
Picture: Part of Kanga Area road section

This 1.1-kilometer road section has a brow of a hill on a steep slope, a bridge with damaged guardrails and no road signage with faded road marking. The road shoulder is also worn out. The reason for the black spot is speeding motorists. Crashes happen throughout the week in the dry and wet season but mostly at night. Vehicles mostly involved in crashes are personal cars (saloons), large buses, light and medium trucks and heavy commercial vehicles. Crash victims are taken to Voi District or Mtito Andei Sub County Hospitals.

Engineering - road design/furniture/features	Enforcement - law	Education - Road user awareness
<ul style="list-style-type: none"> Repair the damaged guard rail at the bridge. Put appropriate signage. 	<ul style="list-style-type: none"> Enforce speed limit compliance. Enforce no overtaking on a continuous median line. 	<ul style="list-style-type: none"> Create awareness on safe speeds and careful overtaking.

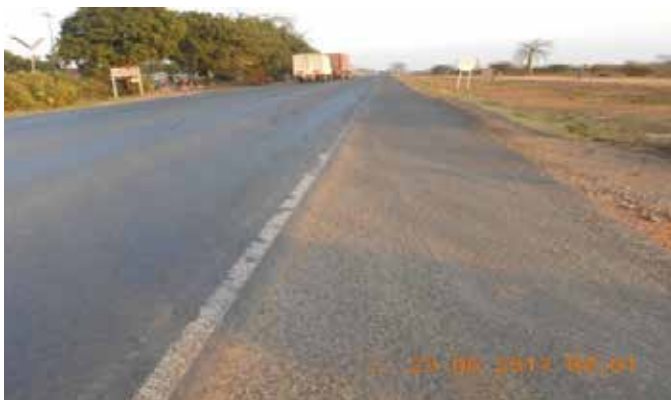
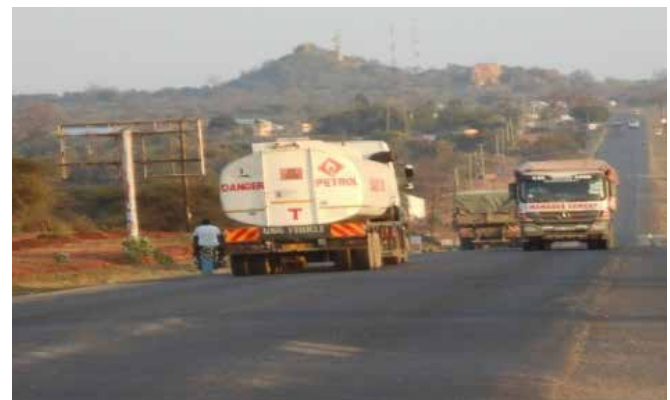
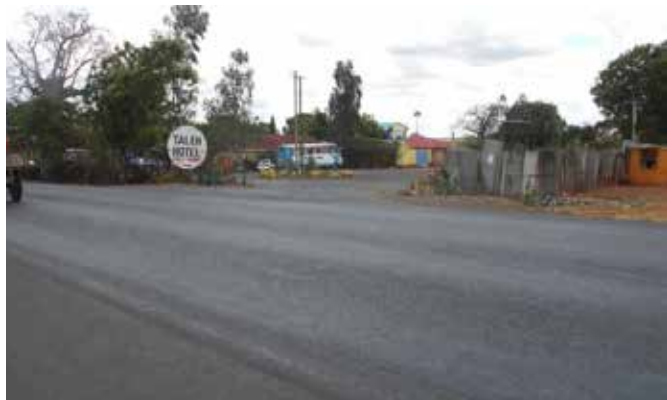
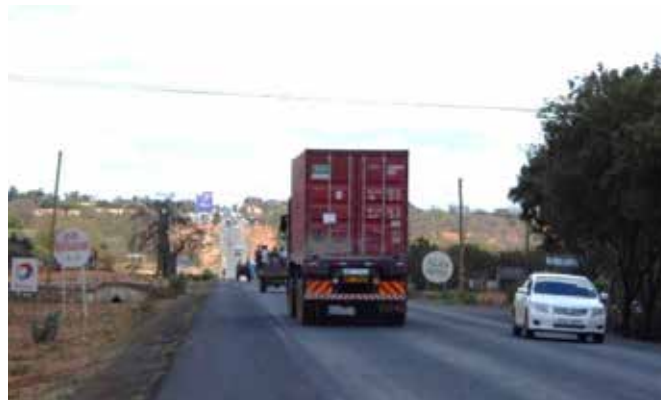
Picture: Part of Taleh Hotel - Mtito Andei road section

This is a 1.7 kilometer road section through Mtitio Andei - Taleh Hotel along a straight steep stretch, through a bridge. The road section is on a steep ascent and descent as well as an intersection to the hotel. There is heavy human and motorcycles traffic. There are no road signs and the road marking is fading off. The reason for black spot is speeding motorists, unsafe pedestrian crossing and careless turns by motorists and careless motorcycle riders. Crashes happen throughout the week and equally in both wet and dry seasons but mostly at night.

Vehicles mostly involved in crashes are personal cars (saloons), large buses, light and medium trucks, motorcycles and heavy commercial vehicles. Crash victims are taken to Mtitio Andei Sub County Hospital.

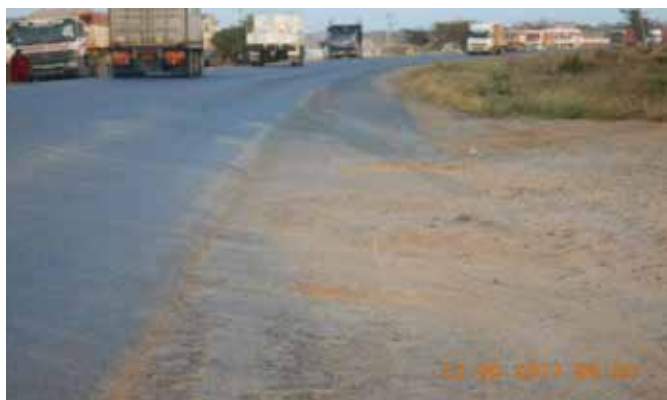
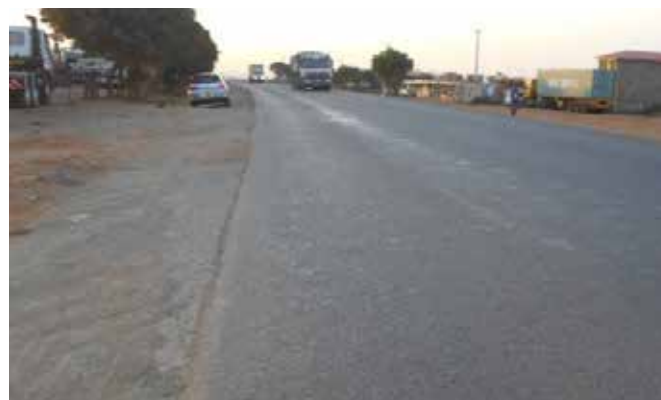
Picture: Part of Migingo Area road section

This is a 0.7-kilometer road section that has a bend, crosses through Migingo market center and has no speed bumps. There is no road signage and the road markings are faded. The reason for the black spot is speeding motorists and unsafe crossing by pedestrians. Crashes happen throughout the week in the dry and wet seasons but mostly at night. Vehicles mostly involved in crashes are personal cars (saloons), large buses, light and medium trucks, and heavy commercial vehicles. Crash victims are taken to Mtito Andei Sub County Hospital.

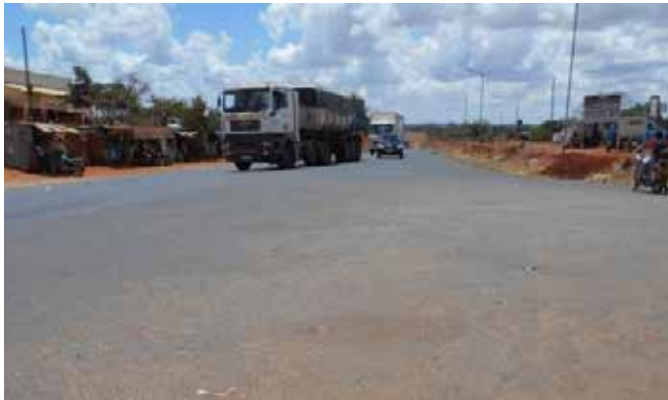
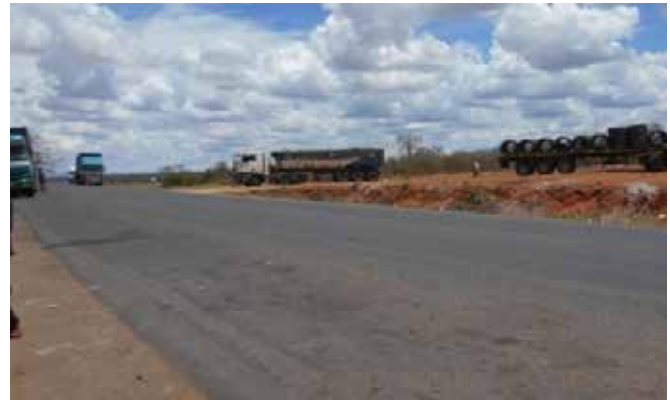
Picture: Part of World Vision Junction - Kambu road section

This is new blackspot on a 0.2-kilometer road section. It has an intersection at the turn to World Vision in Kambu. There are no road signs and the road marking is faded. The reason for the black spot is speeding motorists and missing signage to show that there is a junction. Motorcycle riders also ride and cross carelessly at the junction. Crashes happen throughout the week in the dry and wet season but mostly at night. Vehicles mostly involved in crashes are large buses, motorcycles and heavy commercial vehicles. Crash victims are taken to Mtito Andei Sub County Hospital and Makindu Hospital.

Engineering - road design/furniture/features	Enforcement - law	Education - Road user awareness
<ul style="list-style-type: none"> Instal proper signage for the junction. Re-mark the road. 	<ul style="list-style-type: none"> Enforce speed limit compliance. Enforce careful entry on to the main road from the junction. 	<ul style="list-style-type: none"> Educate motorcycle riders on road safety. Create awareness on dangers of speeding, safe crossing and entry into the main road from the junction.

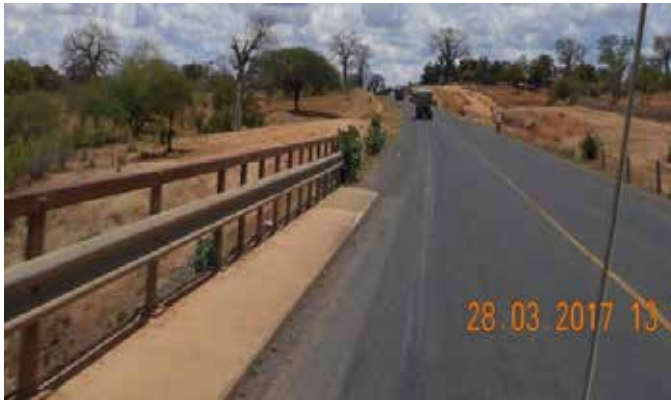
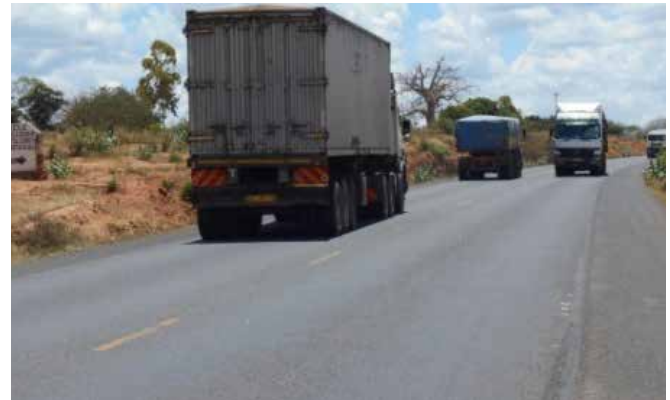
Picture: Part of Machinery road section

This 2-kilometer road section has a long bend on the steep slope, crosses a bridge and has intersections. The road is well marked and the guardrails at the river still intact and good road shoulders. The reason for the black spot is speeding motorists and careless overtaking. Crashes mostly happen throughout the week and equally in both wet and dry seasons but mostly at night. Vehicles mostly involved in crashes are personal cars (saloons), large buses, motorcycles and heavy commercial vehicles. Crash victims are taken to Makindu District Hospital.

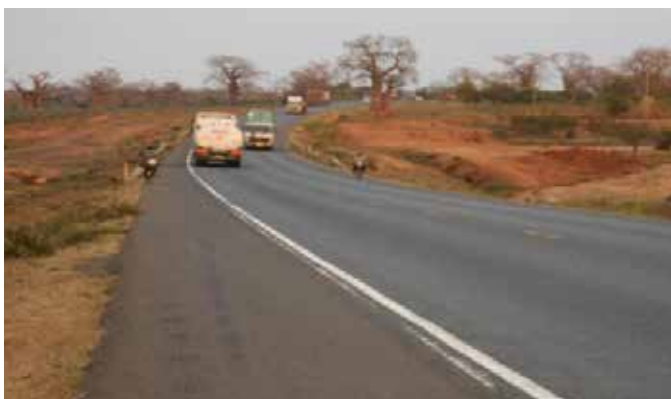
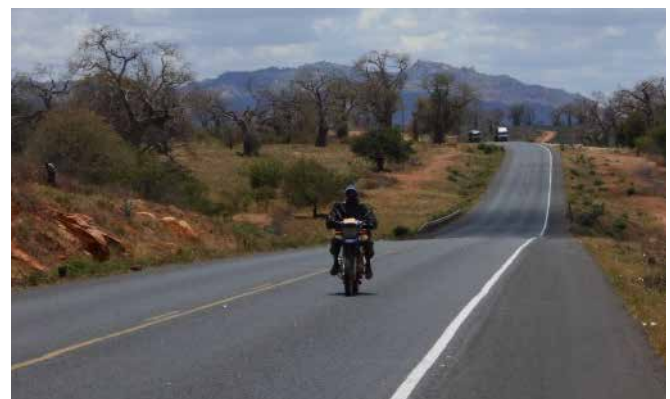
Picture: Part of Manyanga - Kinyambu road section

This 0.4-kilometer road section has a sharp bend and narrow bridge on a steep slope. There are no road signs but the road is fairly well marked. The reason for the black spot is speeding motorists and careless overtaking. Crashes mostly happen throughout the week and equally in both wet and dry seasons but mostly at night. Vehicles mostly involved in crashes are large buses, and heavy commercial vehicles. Crash victims are taken to Makindu District Hospital.

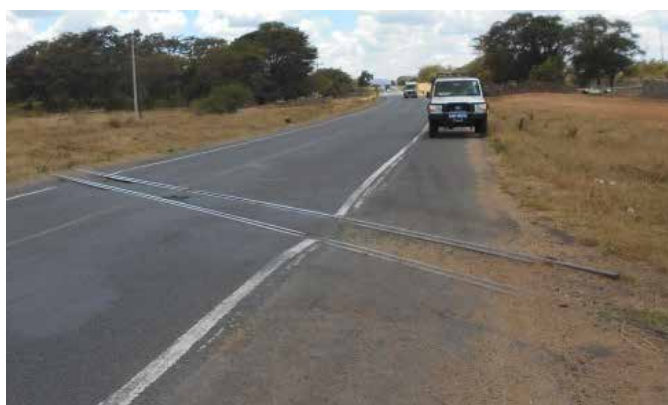
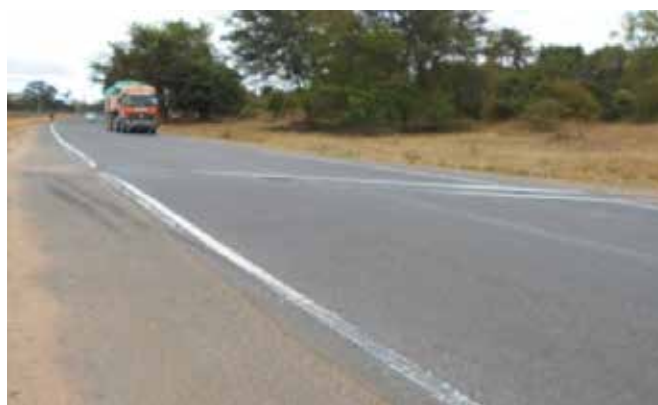
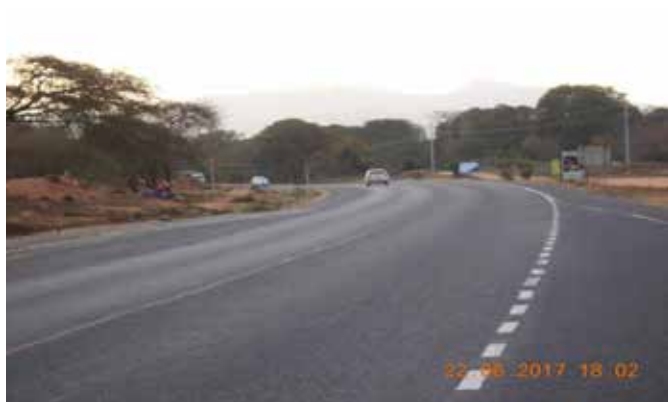
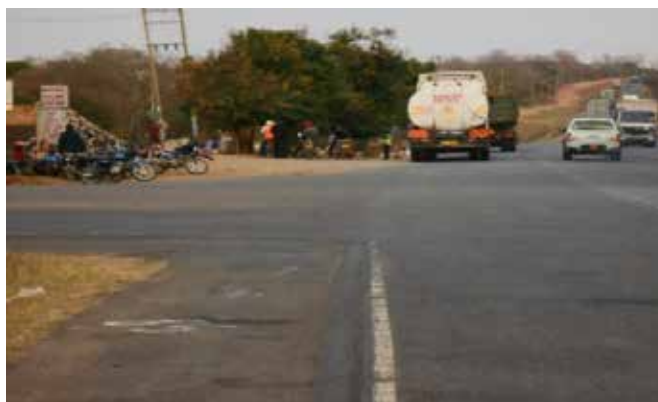
Picture: Part of Kibwezi Junction and Railway road section

This is a 4-kilometer road section with a long sharp bend, brow of a hill, railway crossing and intersections. The blackspot has increased in length from 2.8 kilometers mapped in 2013. The reason for the black spot is speeding motorist, careless overtaking and poor visibility of the railway crossing from the bend. Speeding vehicles often hit the railway line and rollover. Crashes mostly happen throughout the week and equally in both wet and dry seasons but mostly at night. Vehicles mostly involved in crashes are personal cars (saloons), large buses, light and medium trucks and heavy commercial vehicles. Crash victims are taken to Makindu District Hospital.

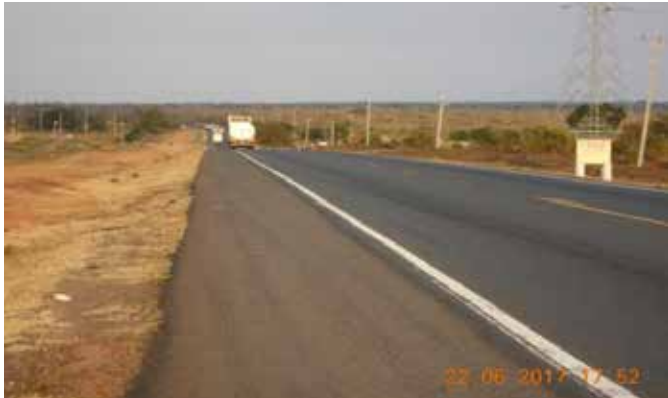
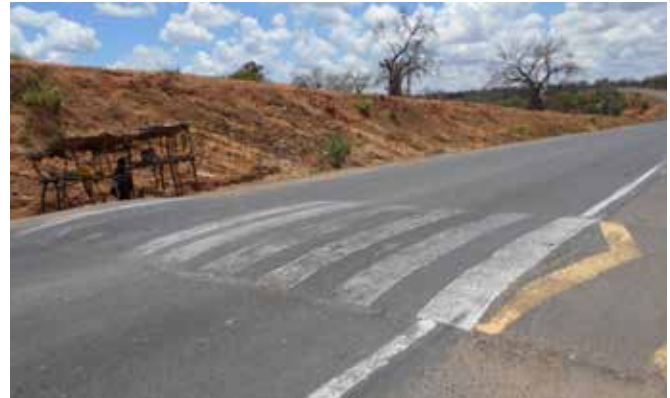
Picture: Part of Wiyani road section

This is a 2.6-kilometer road section with a straight stretch, and has a sharp bend, gentle slope and brow of hill at Wiyani between Mbui Nzau and Kibwezi. Speed bumps have been erected in this section but no signage. The reason for black spot is speeding motorists and careless overtaking. Crashes mostly happen throughout the week and equally in both wet and dry seasons but mostly at night. Vehicles mostly involved in crashes are personal cars (saloons), large buses, light and medium trucks and heavy commercial vehicles. Crash victims are taken to Makindu District Hospital.

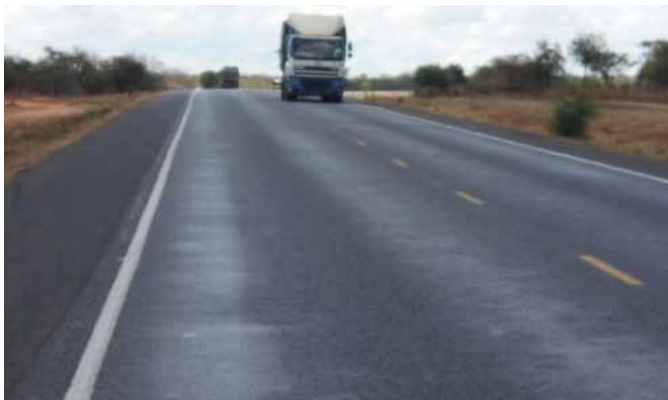
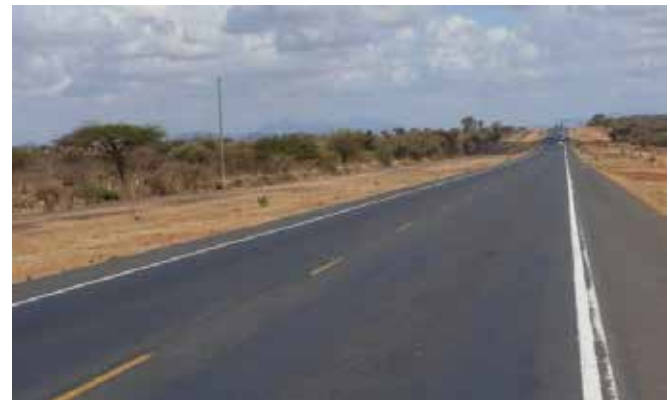
Picture: Part of Kiundwani Kibarani road section

This is a 0.9-kilometer section through Kiundwani-Kibarani area that has a sharp bend and a brow of hill. The section is missing road signage but the road is fairly well marked. The reason for the black spot is speeding motorists and careless overtaking. Crashes happen throughout the week and equally in both wet and dry seasons but mostly at night. Vehicles mostly involved in crashes are personal cars (saloons), large buses, light and medium trucks and heavy commercial vehicles. Crash victims are taken to Makindu District Hospital.

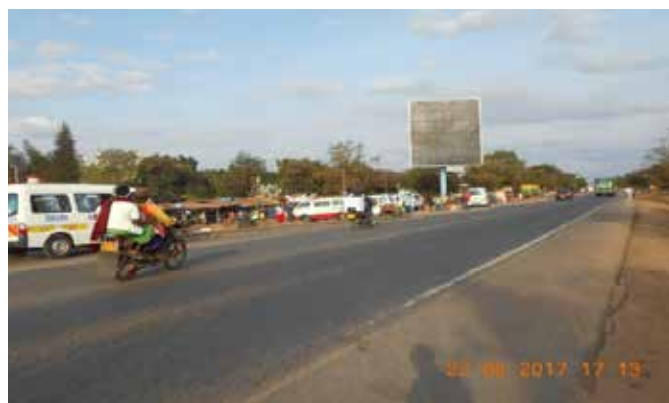
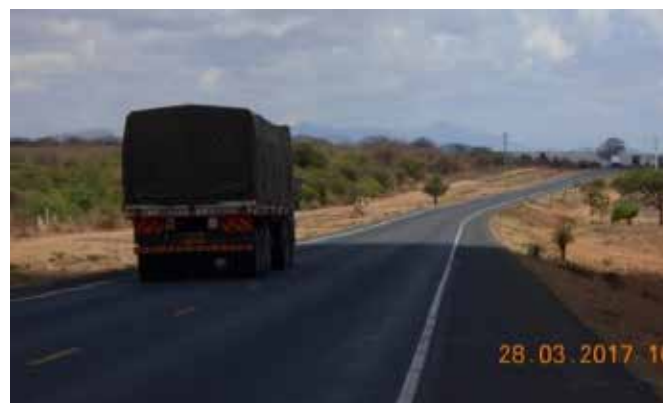
Picture: Part of Ikoyo Makindu stage road section

This is a 1.6-kilometer road section between Makindu and Ikoyo and lies on a straight stretch with a bend. There is a roadside market resulting in unsafe pedestrian crossing. There is also no road signage but the road is fairly well marked. The reason for the black spot is speeding motorists and careless overtaking coupled with unsafe pedestrian crossing. Crashes happen throughout the week and equally in both wet and dry seasons but mostly at night. Vehicles mostly involved in crashes are personal cars (saloons), large buses, and heavy commercial vehicles. Crash victims are taken to Makindu District Hospital.

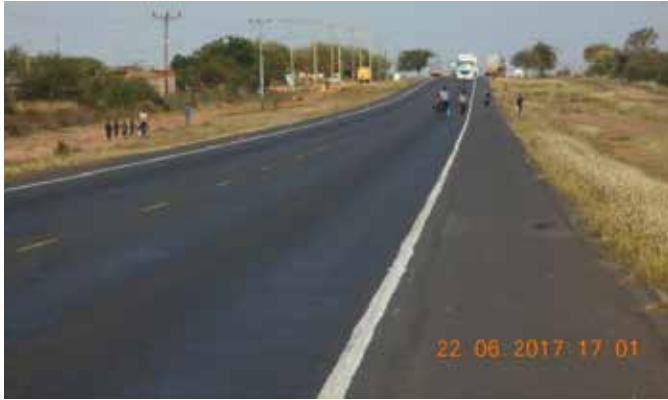
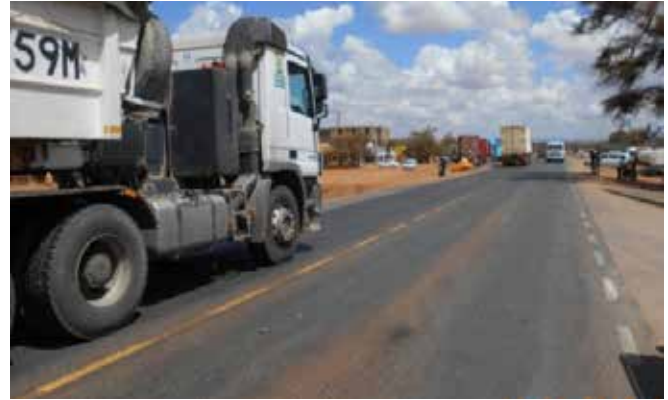
Picture: Part of Ikoyo Township road section

This is a 0.8-kilometer road section on a straight stretch between Makindu- and Ikoyo and has a brow of a hill. The reason for the black spot is speeding motorists and poor visibility occasioned by trucks parking on the roadside. Crashes happen throughout the week and equally in both wet and dry seasons but mostly at night. Vehicles mostly involved in crashes are personal cars (saloons), large buses, and heavy commercial vehicles. Crash victims are taken to Makindu District Hospital.

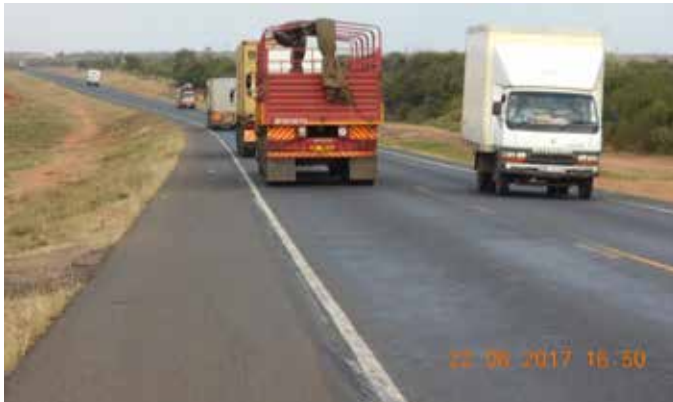
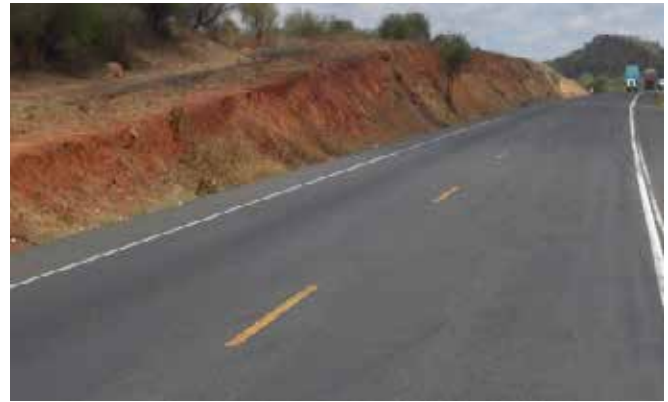
Picture: Part of Tank Kiboko road section

This is 0.4-kilometer road section at Tank Kiboko on a sharp bend on a steep slope and has a brow of a hill. There are no road signs but the road section is fairly well marked with good shoulders. The main reason for black spot is careless overtaking and speeding motorists. Crashes happen throughout the week and equally in both wet and dry seasons but mostly at night. Vehicles mostly involved in crashes are personal cars (saloons), large buses, and heavy commercial vehicles. Crash victims are taken to Makindu District Hospital.

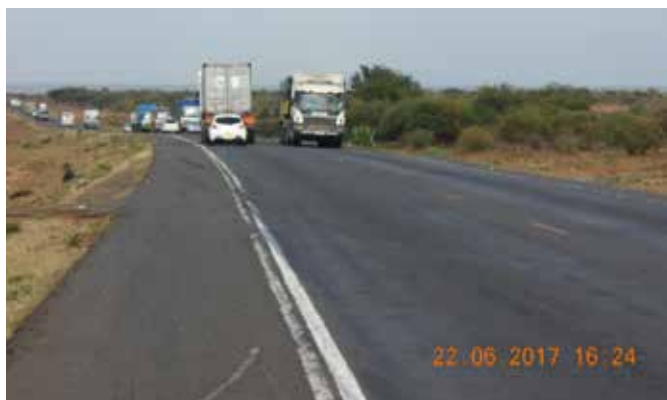
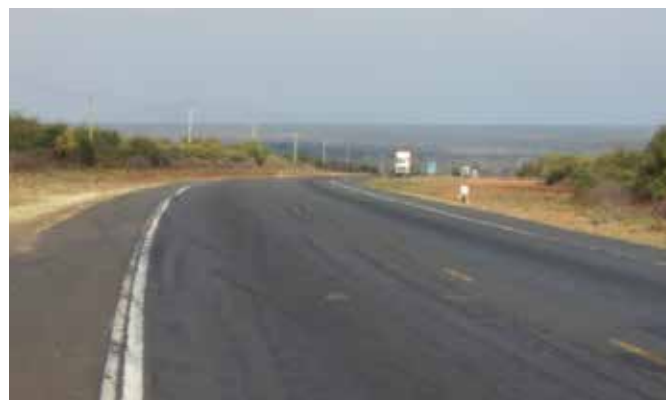
Picture: Part of Ndogotei road section

This is a 1-kilometer road section on a long curved stretch with a slight bend with no road signage and faded road marking. The reason for black spot is speeding motorist, careless overtaking and careless motorcycle riders crossing unsafely. Crashes happen throughout the week and equally in both wet and dry seasons but mostly at night. Vehicles mostly involved in crashes are personal cars (saloons), large buses, heavy commercial vehicles and motorcycles. Crash victims are taken to Makindu District Hospital.

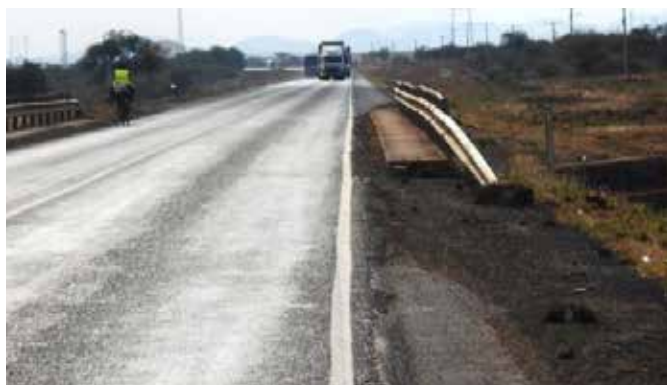
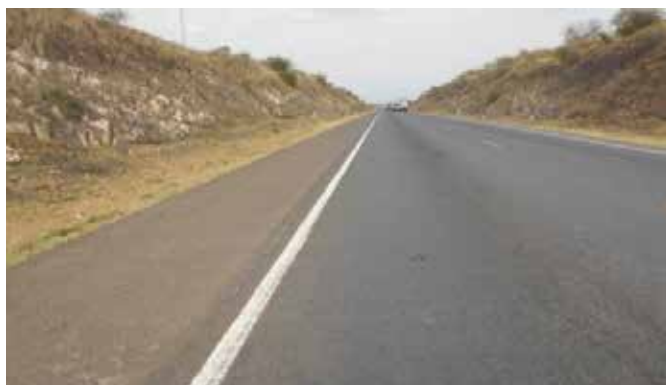
Picture: Part of Ndogotei quarry/Ndumoto Bridge road section

This is a 0.6-kilometer road section along a straight stretch with a sharp bend at the Ndumoto Bridge and has a junction at Ndogotei quarry. There are no road signs. The reason for black spot is speeding motorists, careless overtaking, and missing guard rails at the bridge.

Crashes happen throughout the week and equally in both wet and dry seasons but mostly at night. Vehicles mostly involved in crashes are personal cars (saloons), large buses, and heavy commercial vehicles. Crash victims are taken to Makindu District Hospital.

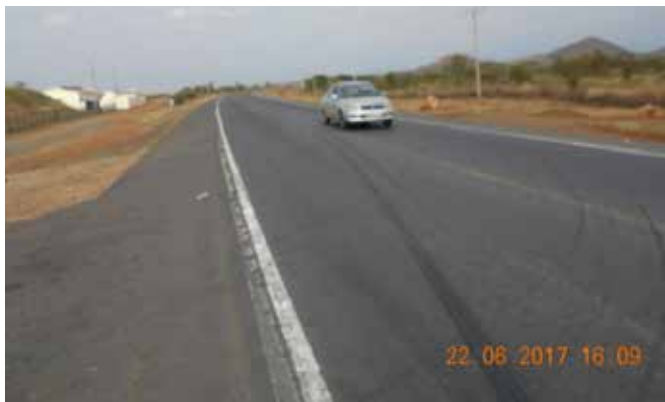
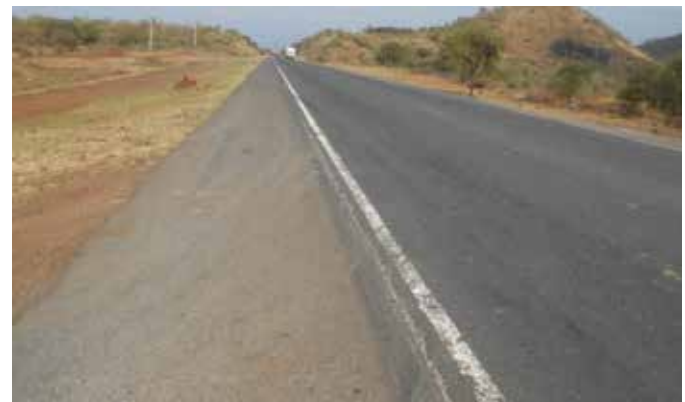
Picture: Part of Mbukani road section

This is a 1.1-kilometer road section that has a bend and intersection at Mbukani area. There are no road signs. The reason for the black spot is speeding motorists and careless overtaking. Crashes happen throughout the week and equally in both wet and dry seasons but mostly at night. Vehicles mostly involved in crashes are personal cars (saloons), large buses, and heavy commercial vehicles. Crash victims are taken to Makindu District Hospital.

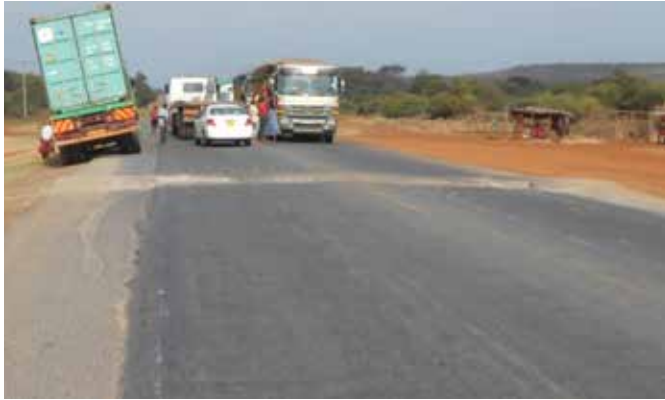
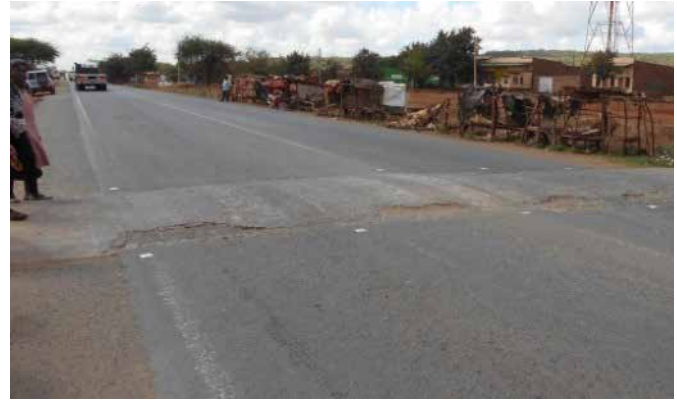
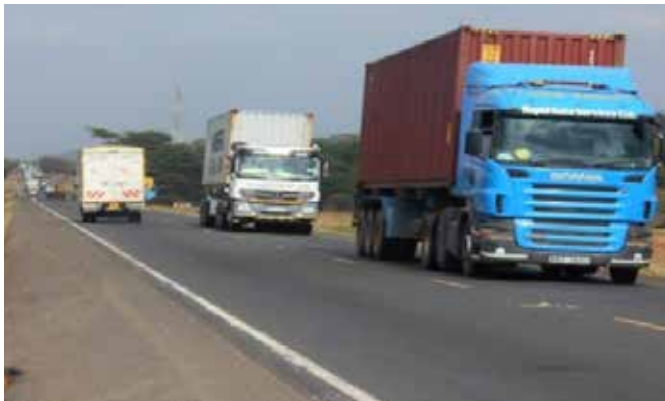
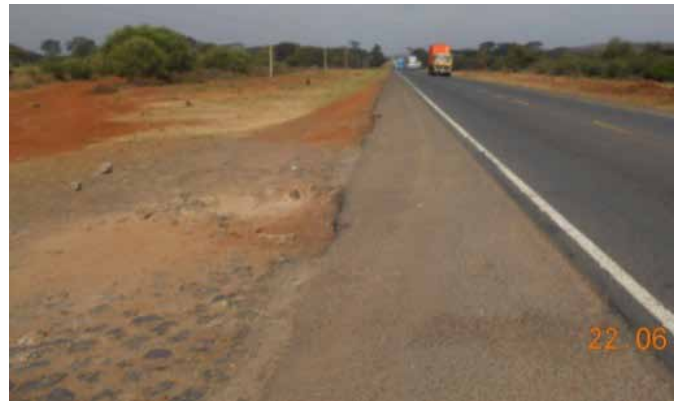
Picture: Part of Masimba bumps road section

This is a 0.8 kilometer road sections along a straight stretch on a steep descent with no signage near Masimba market center. The section has bumps with no road markings and no road signs as well as a growing roadside market. The reason for the black spot is unsafe pedestrian crossing, speeding motorists and careless driving. Crashes happen throughout the week and equally in both wet and dry seasons but mostly at night. Vehicles mostly involved in crashes are personal cars (saloons), large buses, light and medium trucks and heavy commercial vehicles. Crash victims are taken to Makindu District Hospital.

Engineering - road design/furniture/features	Enforcement - law	Education - Road user awareness
<ul style="list-style-type: none"> • Instal speed limit and hazard signage. • Repair the bump and mark the road. • Designate pedestrian crossings. • Relocate the traders from the road. 	<ul style="list-style-type: none"> • Enforce speed limit compliance. 	<ul style="list-style-type: none"> • Sensitize pedestrian on road safety. • Create awareness on speeding, careful overtaking and night driving.

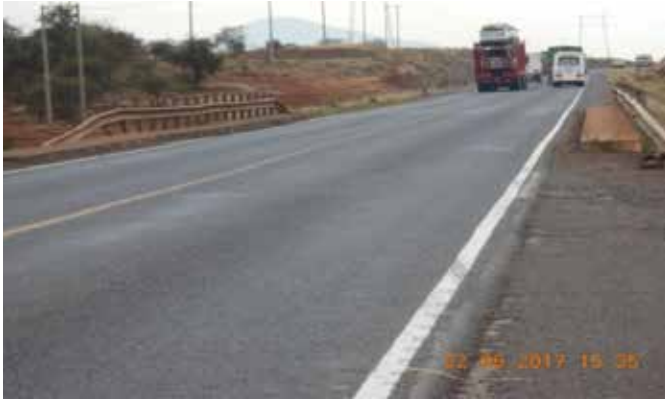
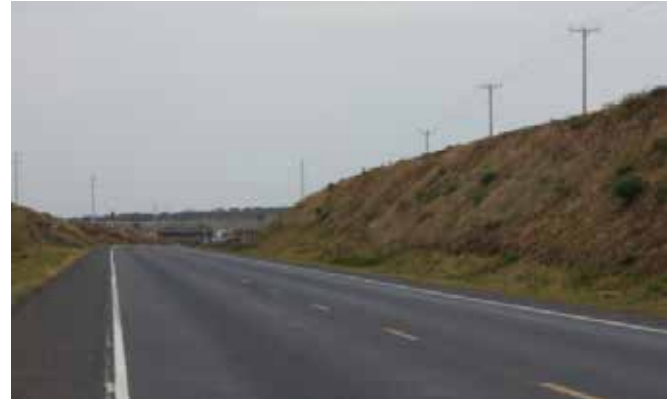
46. Ndumoto Bridge Area

This is a 3.3-kilometer road section along a straight stretch and has a slight bend at the bridge and no road signs. The main reason for black spot is speeding motorists and a blind spot at the bridge. Crashes happen throughout the week and equally in both wet and dry seasons but as well as equally during day and night. Vehicles mostly involved in crashes are personal cars (saloons), large buses, and heavy commercial vehicles. Crash victims are taken to Emali Nursing Home.

Picture: Part of Ndumoto Bridge road section

Engineering - road design/furniture/features	Enforcement - law	Education - Road user awareness
<ul style="list-style-type: none"> Instal speed limit and hazard signage. 	<ul style="list-style-type: none"> Enforce speed limit compliance. 	<ul style="list-style-type: none"> Create awareness on safe speed at night and danger of overtaking at the bridge.

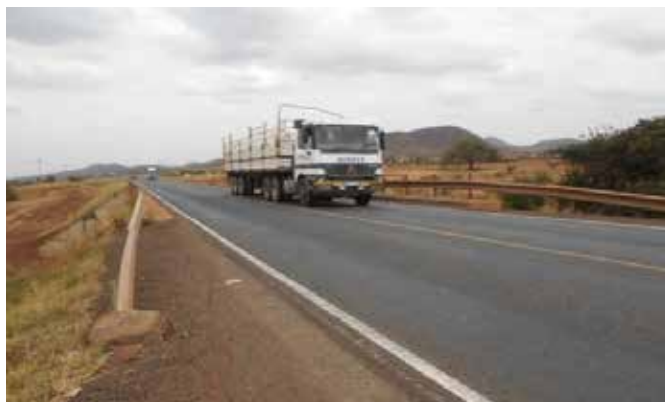
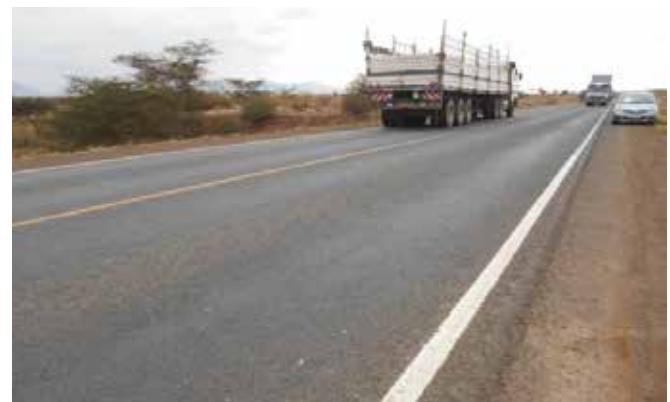
This is a 4.9 kilometer road section along a straight stretch with a bridge. There are no road signs. The main reason for black spot is speeding motorists and careless overtaking. Crashes happen throughout the week and equally in both wet and dry seasons but mostly at night.

Picture: Part of Tarda road section

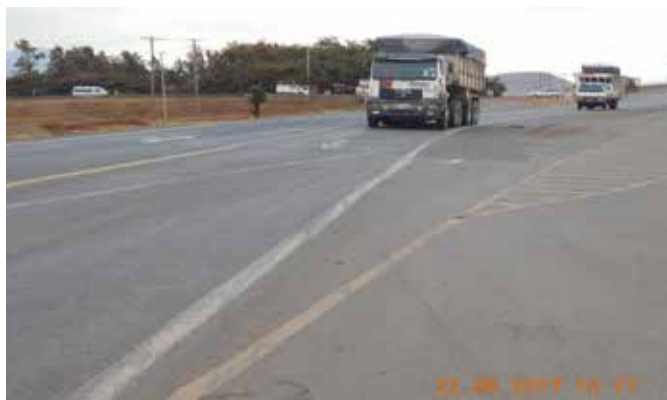
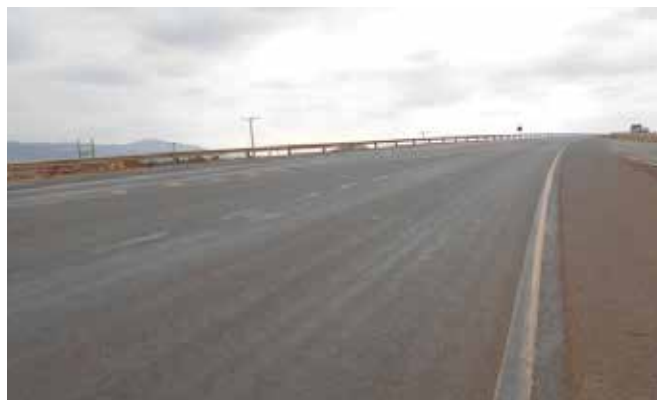
48. Emali- Loitokitok Junction

This is a 1.1-kilometer road section along a long straight stretch at Emali with a bend, intersection and no road signage as well as fading road markings particularly on the speed bumps. The junction has grown into a roadside market with high pedestrian traffic. The reason for the black spot is unsafe pedestrian crossing, speeding motorists and careless overtaking. Crashes happen throughout the week and equally in both wet and dry seasons but mostly at night. Vehicles mostly involved in crashes are personal cars (saloons), large buses, and heavy commercial vehicles. Crash victims are taken to Emali Nursing Home.

Picture: Part of Emali Loitokitok Junction road section

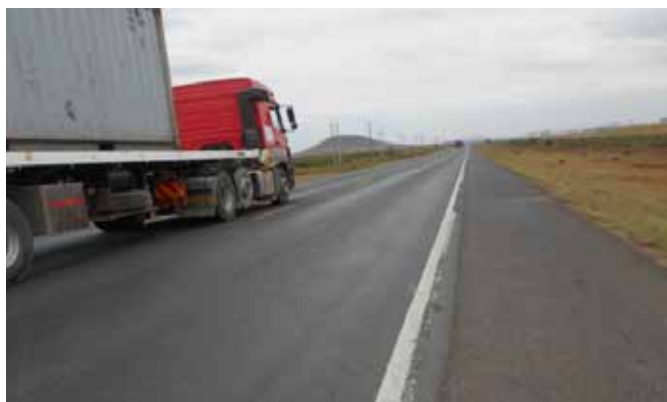
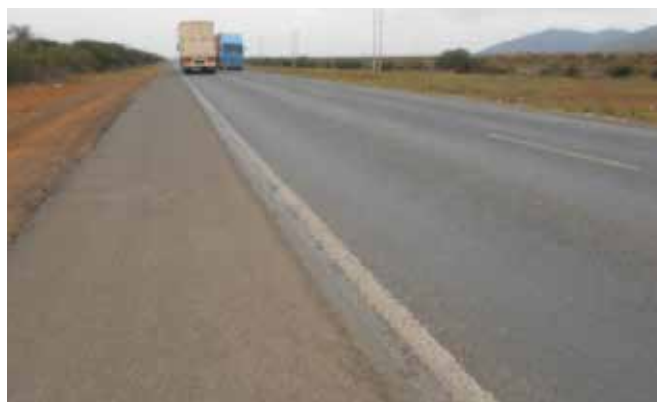
49. Pipeline Area

This is a 7.1-kilometer road section along a straight stretch at Pipeline area with no road signs. The reason for the black spot is speeding motorists and careless overtaking. Crashes happen throughout the week and equally in both wet and dry seasons but mostly at night. Vehicles mostly involved in crashes are personal cars (saloons), large buses, and heavy commercial vehicles. Crash victims are taken to Sultan Hamud District Hospital.

Picture: Part of Pipeline Area road section

Engineering - road design/furniture/features	Enforcement - law	Education - Road user awareness
<ul style="list-style-type: none"> • Instal speed limit signage. • Repair the damaged guard rails. 	<ul style="list-style-type: none"> • Enforce speed limit compliance. 	<ul style="list-style-type: none"> • Create awareness on safe speed and careful overtaking. • Create awareness on speeding, careful overtaking and night driving.

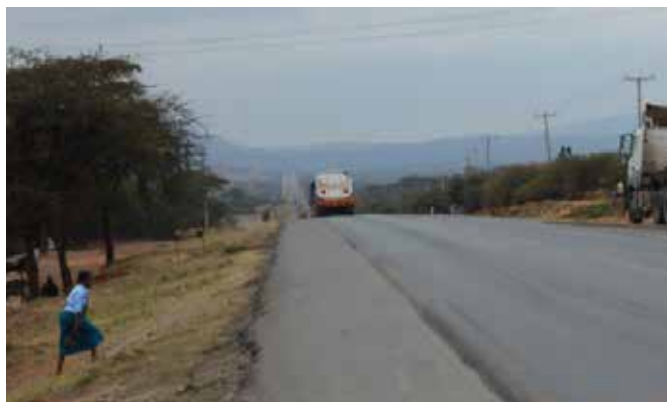
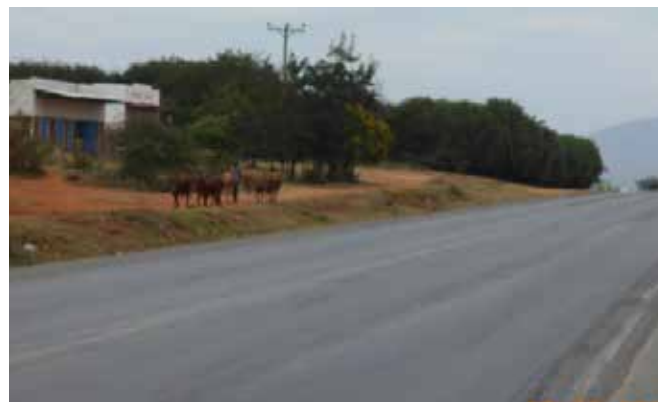
51. Ngokomu

This is 1.8 kilometer road section through Ngokomu centre that has a sharp bend on a gentle slope, the road marking has faded away in some places; no road signs, and the speed bumps are damaged and unmarked. The reason for black spot is speeding motorists and unsafe pedestrian crossing at undesignated areas. Crashes happen throughout the week and equally in both wet and dry seasons but mostly at night. Vehicles mostly involved in crashes are personal cars (saloons), large buses, and heavy commercial vehicles. Crash victims are taken to Sultan Hamud Sub County Hospital.

Picture: Part of Ngokomu road section

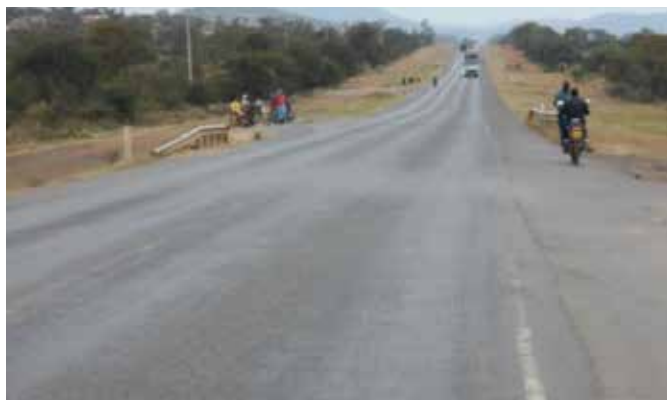
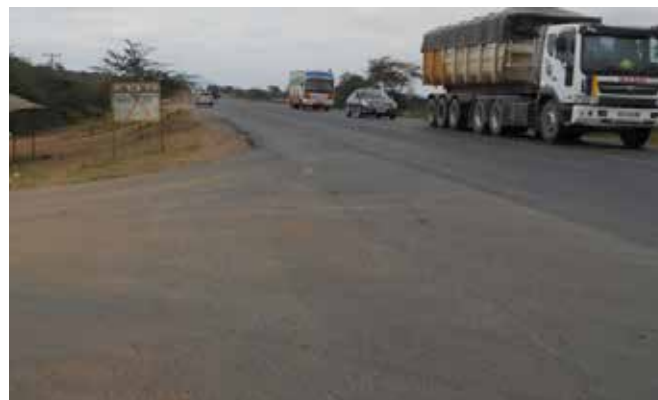
52. Kima Area (Kiungwani)

This is a 0.7-kilometer road section crossing a bridge, which is on a blind spot with no road signs, and the road marking is faded. The reason for the black spot is speeding motorists and careless overtaking at a blind spot. Crashes happen throughout the week and equally in both wet and dry seasons but mostly at night. Vehicles mostly involved in crashes are personal cars (saloons), large buses, and heavy commercial vehicles. Crash victims are taken to Sultan Hamud Sub County Hospital.

Picture: Part of Kima Area road section

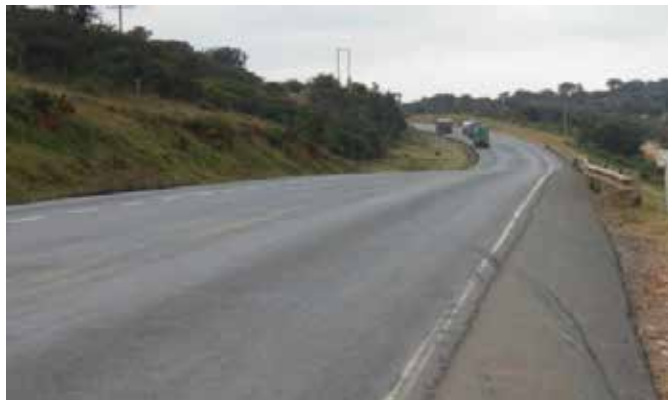
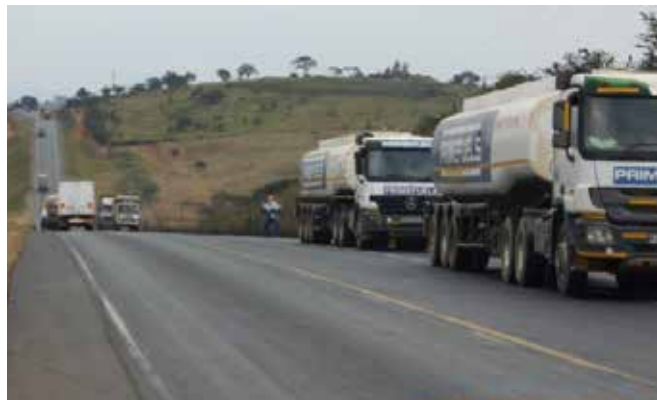
54. Muiya Kali

This is a 2.4 kilometer road section that has long sharp bend on a steep slope. The reason for the black spot is speeding motorists, and careless overtaking. Crashes happen throughout the week and equally in both wet and dry seasons but mostly at night. Vehicles mostly involved in crashes are personal cars (saloons), large buses, and heavy commercial vehicles. Crash victims are taken to Machakos County Referral Hospital.

Picture: Part of Muiya Kali road section

Engineering - road design/furniture/features	Enforcement - law	Education - Road user awareness
<ul style="list-style-type: none"> Instal speed limit and hazard signage. 	<ul style="list-style-type: none"> Enforce speed limit compliance. 	<ul style="list-style-type: none"> Create awareness on safe speeds and careful overtaking.

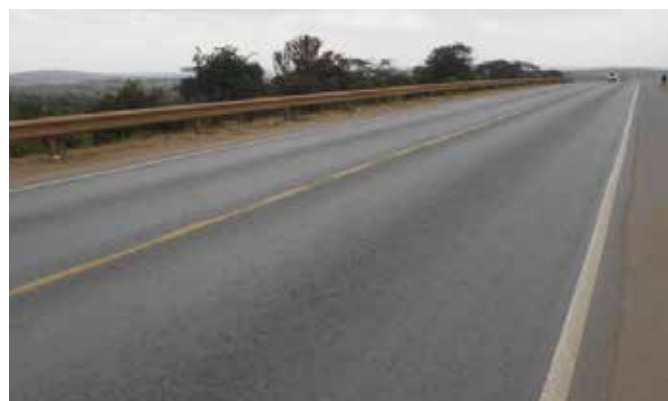
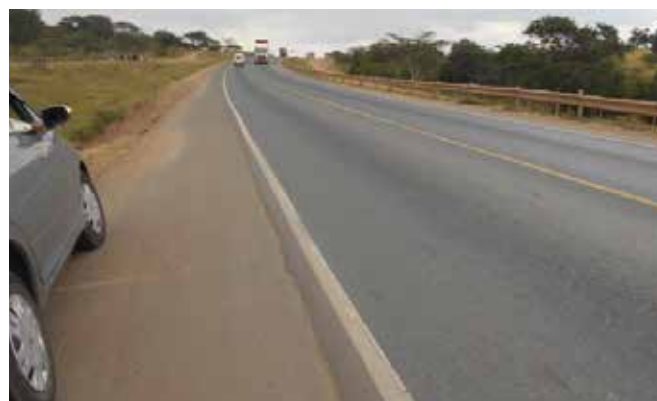
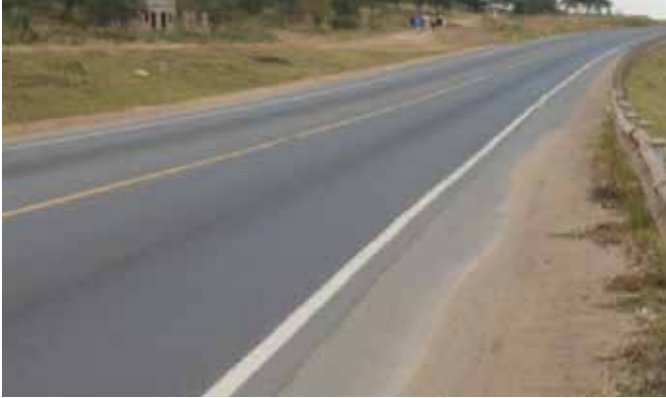
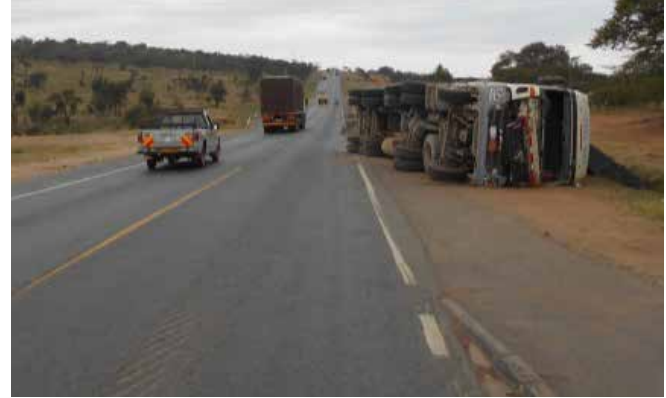
55. Tangi la Maji

This is 0.8 kilometer road section along a straight stretch with depression at the bridge that floods during rainy seasons and a slight bend at another section. There are no road signs and the guard rails are damaged. The main reason for black spot is stalled vehicles on the road during rainy seasons, speeding motorists and careless overtaking. Crashes happen throughout the week but mostly during wet and at night. Vehicles mostly involved in crashes are personal cars (saloons), large buses, and heavy commercial vehicles. Crash victims are taken to Machakos County Referral Hospital.

Picture: Part of Tangi la Maji road section

Engineering - road design/furniture/features	Enforcement - law	Education - Road user awareness
<ul style="list-style-type: none"> • Instal speed limit and hazard signage • Repair guard rail 	<ul style="list-style-type: none"> • Enforce speed limit compliance 	<ul style="list-style-type: none"> • Create awareness on safe driving during the rainy seasons.

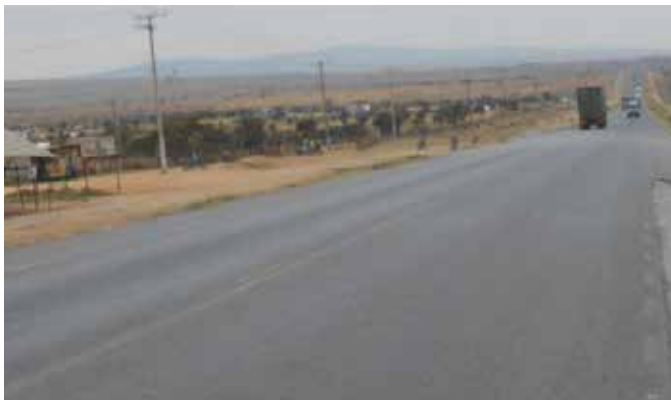
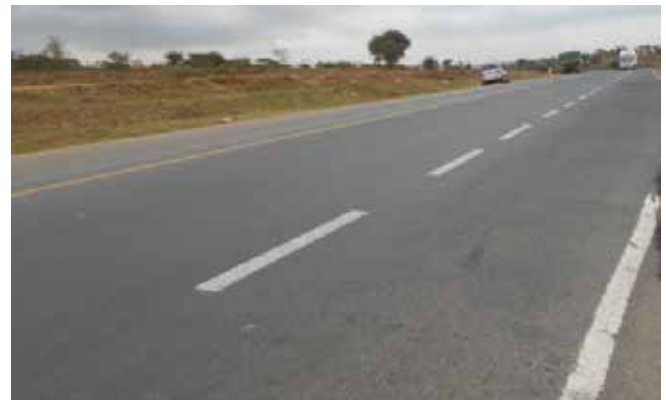
56. Kuata Ndini

This is a 2.6 kilometer road section that has bends on steep slopes with no road signs. The road shoulder is worn out. The reason for the black spot is speeding motorists and careless overtaking. Crashes happen throughout the week and equally in both wet and dry seasons but mostly at night. Vehicles mostly involved in crashes are personal cars (saloons), large buses, and heavy commercial vehicles. Crash victims are taken to Machakos County Referral Hospital.

Picture: Part of Kuata Ndini road section

Engineering - road design/furniture/features	Enforcement - law	Education - Road user awareness
<ul style="list-style-type: none"> • Instal speed limit and hazard signage. • Repair the road shoulder. 	<ul style="list-style-type: none"> • Enforce speed limit compliance. • Mobile Speed camera. 	<ul style="list-style-type: none"> • Create awareness on speeding, careful overtaking and night driving.
