Northern Corridor and Nairobi County Route Hazard Mapping Report

May 2017

Developed by Safe Way Right Way and National Transport and Safety Authority

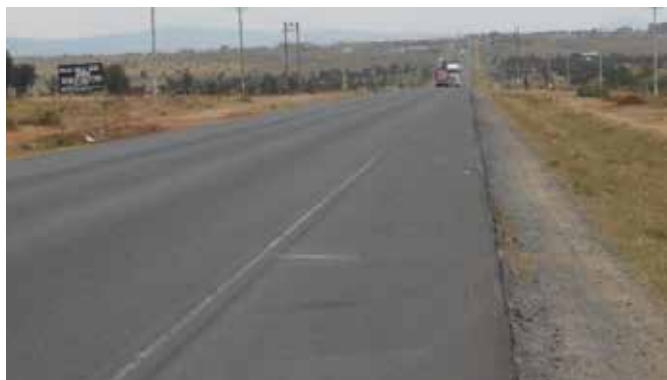
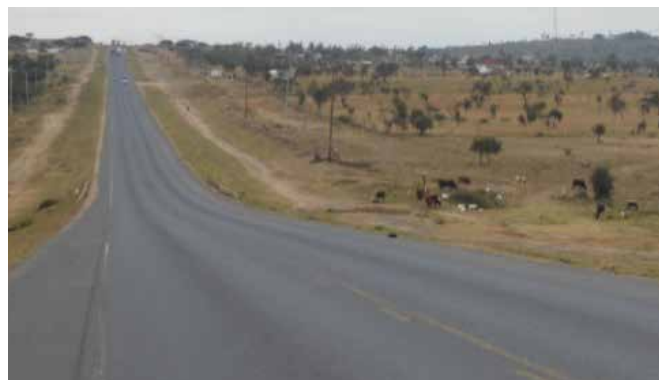
57. Malili-Salama Road

This is a 0.6 kilometer road section on a brow of hill at a steep slope. There are no signs and the road marking is faded. The reason for the black spot is speeding motorists and careless overtaking. Crashes happen throughout the week and equally in both wet and dry seasons but mostly at night. Vehicles mostly involved in crashes are personal cars (saloons), large buses, and heavy commercial vehicles. Crash victims are taken to Machakos County Referral Hospital.

Picture: Part of Malili – Salama road section

Engineering - road design/furniture/features	Enforcement - law	Education - Road user awareness
<ul style="list-style-type: none"> • Instal speed limit and hazard signage. • Repaint the road marking. 	<ul style="list-style-type: none"> • Enforce speed limit compliance. • Speed camera. 	<ul style="list-style-type: none"> • Create awareness on defensive driving especially at night.

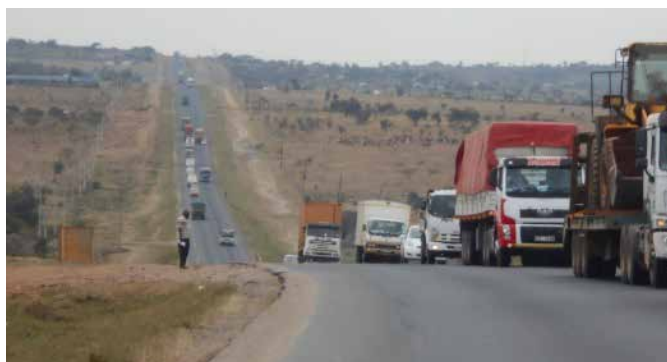
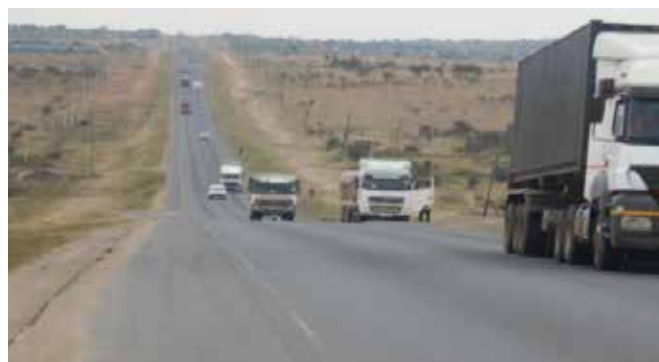
58. Malili

This is 0.4 kilometer road section along a straight stretch at a blind spot at a depression. There are no road signs and the road marking has faded. The reason for the black spot is speeding motorists and a blind spot. Crashes happen throughout the week and equally in both wet and dry seasons but mostly at night. Vehicles mostly involved in crashes are personal cars (saloons), large buses, and heavy commercial vehicles. Crash victims are taken to Machakos County Referral Hospital.

Picture: Part of Malili Area road section

Engineering - road design/furniture/features	Enforcement - law	Education - Road user awareness
<ul style="list-style-type: none"> • Instal speed limit and hazard signage. • Re-mark the road. 	<ul style="list-style-type: none"> • Enforce speed limit compliance. • Speed camera. 	<ul style="list-style-type: none"> • Create awareness on speeding, careful overtaking and night driving.

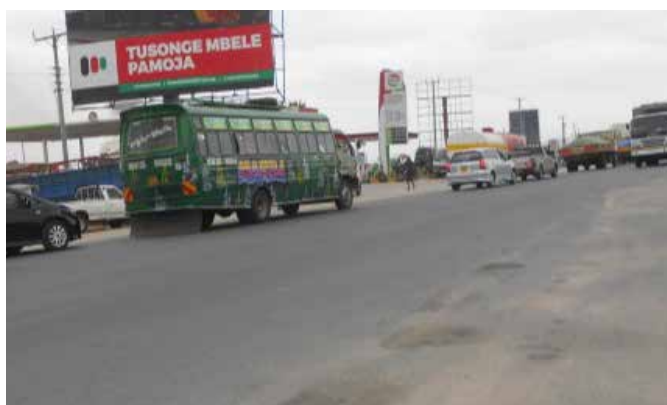
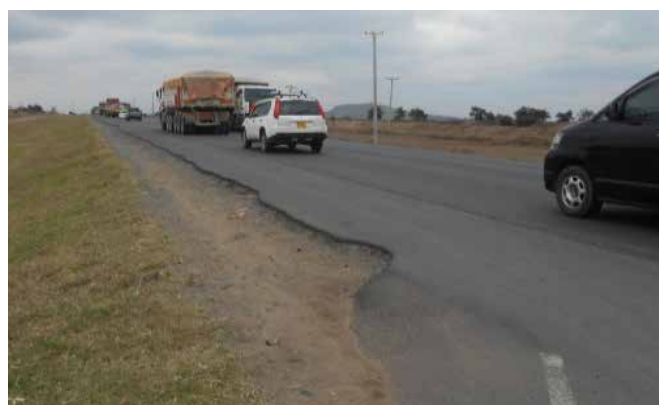
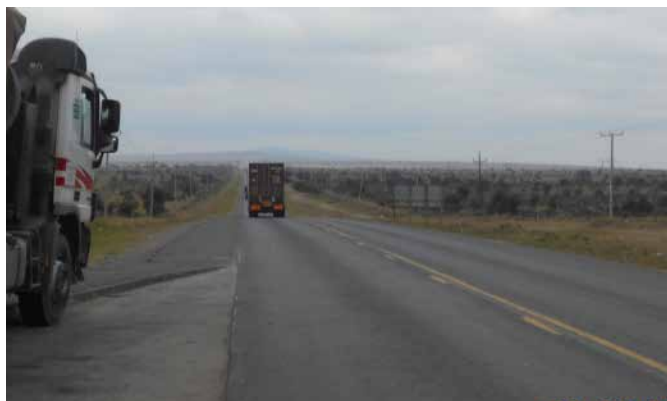
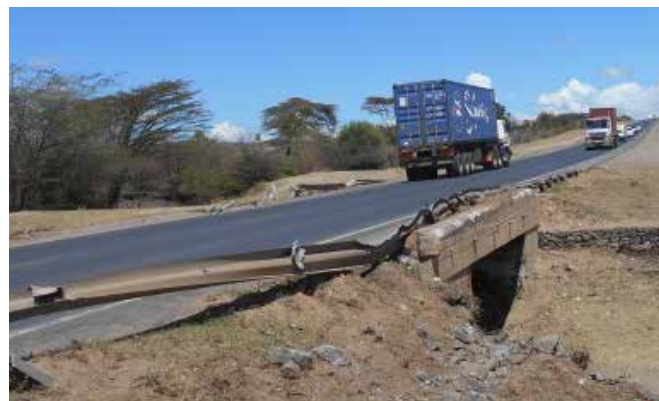
This is a 22.5 kilometer road section that combines 4 sections that were mapped, in 2013, as black spots (Konza Junction, Kapiti Plains, Kapiti and Makutano Bridge). This section has sharp bends long straight stretch with intersections, steep slopes, narrow bridges and market center. The section passes through Kapiti plains, a relative flat long stretch of road. There are a number of slow moving vehicles on the ascent. Most of the road section has faded marking and missing road signs. The guardrail at the bridge is damaged. Makutano Junction also functions a rest stop for long distance truck drivers.

The reason for the black spot is speeding motorist, careless overtaking slow moving vehicles, blind spot corners, and careless entry at Machakos Junction, trucks parked on the roadside and unsafe pedestrian crossing. Crashes happen throughout the week and equally in both wet and dry seasons but mostly at night. Vehicles mostly involved in crashes are personal cars (saloons), large buses, light and medium trucks and heavy commercial vehicles. Crash victims are taken to Machakos County Referral Hospital.

Picture: Part of Konza – Kapiti – Makutano Junction road section

Engineering – road design/furniture/features	Enforcement – law	Education – Road user awareness
<ul style="list-style-type: none"> • Instal speed limit and hazard signage. • Repair damaged guard rail at the bridge. • Repaint the road marking. • Add climbing lanes. 	<ul style="list-style-type: none"> • Enforce speed limit compliance. • Deploy NTSA mobile patrol with speed camera. • Arrest motorists who overlap. 	<ul style="list-style-type: none"> • Educate motorists on dangers of overtaking and blind spots. • Educate pedestrians on safe crossing.

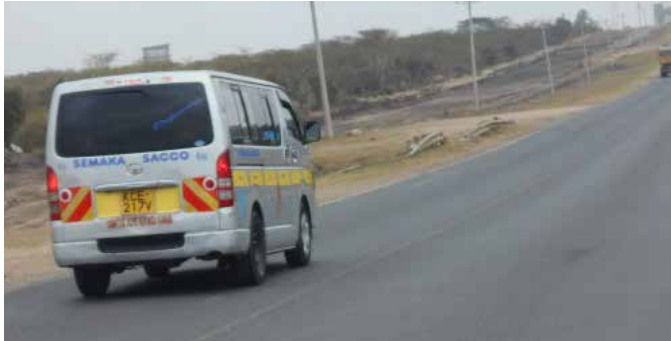
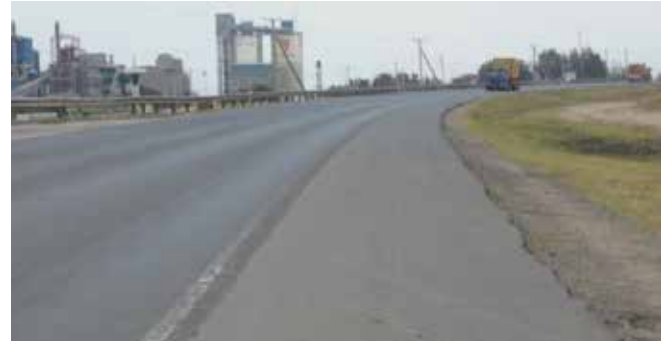
60. Simba Cement Area

This is 2.1 kilometer road section that has a long bend on a steep slope along Simba Cement area. There are slow moving vehicles on the ascent. The main reason for black spot is speeding motorists, careless overtaking, slow moving vehicles tuning into Simba Cement. Crashes happen throughout the week and equally in both wet and dry seasons but mostly during the day. Vehicles mostly involved in crashes are personal cars (saloons), mini buses (PSVs and vans) and heavy commercial vehicles. Crash victims are taken to Machakos County Referral Hospital.

Picture: Part of Simba Cement road section

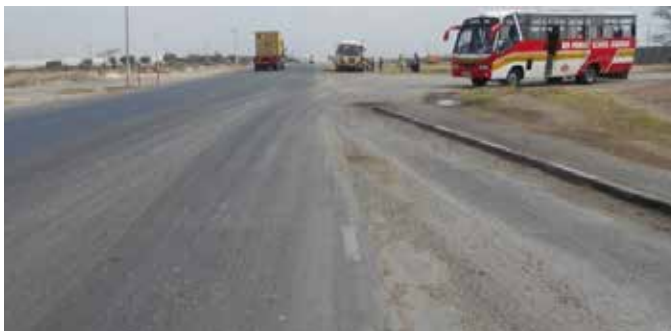
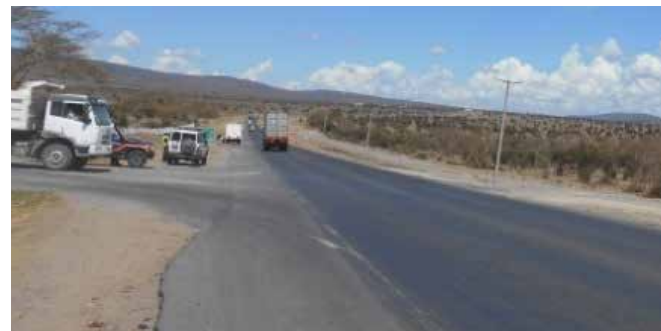
This is a 0.6 kilometer road section along a straight stretch on a steep slope with no guard rails and a blind spot intersection to Lukenya. The road marking is faded and there are no road signs. The reason for the black spot is speeding motorists and careless overtaking; and unsafe pedestrian crossing. Crashes happen throughout the week, in both wet and dry seasons as well as day and night.

Picture: Part of Lukenya Junction road section

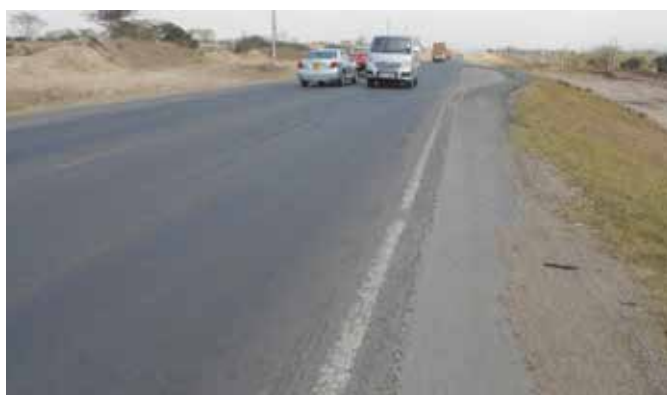
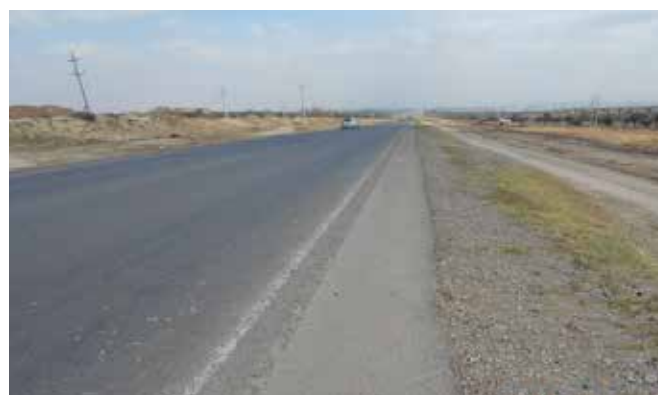
62. Primarosa

This is a new blackspot. It is a 1.9 kilometer road section along a straight stretch on a gentle slope at Primarosa flowers. The reason for the black spot is speeding motorists and cattle crossing. The Daystar University Junction is also unmarked. Crashes happen throughout the week but mostly in dry seasons as cattle cross for water. Also, crashes happen mostly in the daytime. Vehicles mostly involved in crashes are personal cars (saloons), and large buses. Crash victims are taken to Machakos County Referral Hospital and Shalom Hospital.

Picture: Part of Primarosa road section

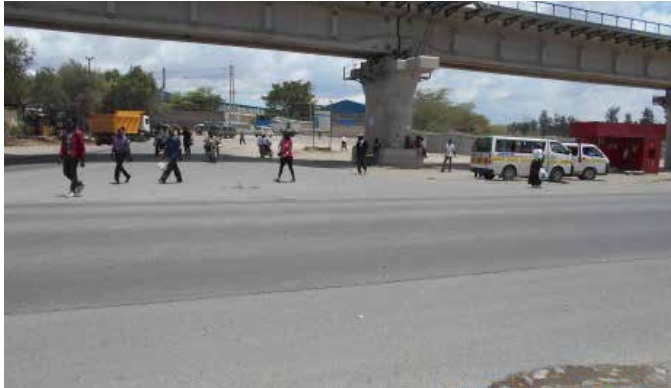
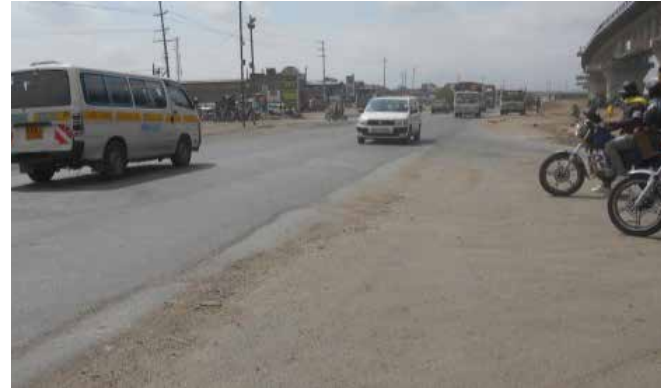
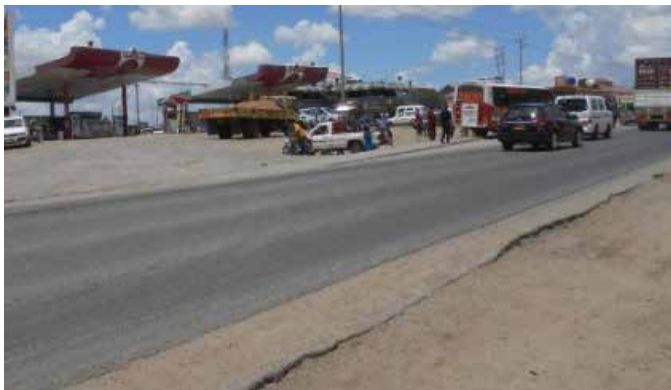
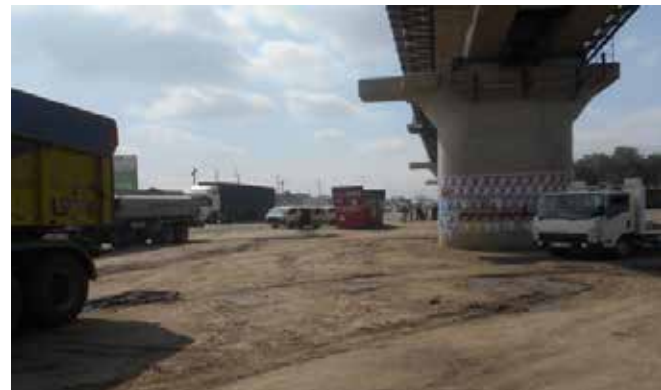
63. Kenya Meat Commission/ Bridge 39 Area

This is a 0.8 kilometer road section with a long bend, a bridge, market center and intersections. The SGR also passes through this section. The road is not marked and signage is missing. The reason for the black spot is speeding motorists, poor visibility at the bends and unsafe pedestrian crossing at undesignated points. Crashes happen throughout the week and in wet and dry seasons but mostly at night. Vehicles mostly involved in crashes are personal cars (saloons), large buses, light and medium trucks and heavy commercial vehicles. Crash victims are taken to Shalom Hospital.

Picture: Part of KMC/Bridge 39 road section

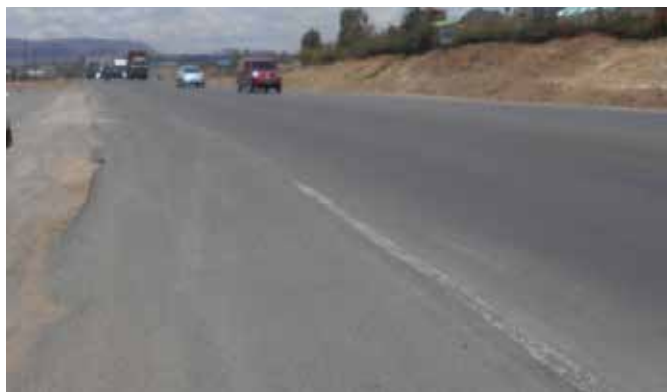
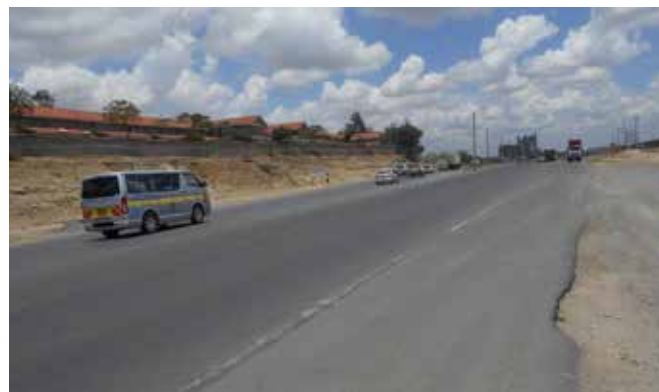
64. Agrovet Lukenya

This is a new blackspots that is a 0.3 kilometer road section along a straight stretch on a gentle slope with no road signs and faded road markings. There is no warning sign to show the end of the dual carriage way. The reason for the black spot is speeding motorists and vehicles missing the right side of the road because the road markings are faded and there are no warning signs. Crashes happen mostly on weekdays at night and in both dry and wet seasons. Vehicles mostly involved in crashes are personal cars (saloons), and light and medium trucks. Crash victims are taken to Shalom Hospital and Machakos County Referral Hospital.

Picture: Part of Agrovet Lukenya road section

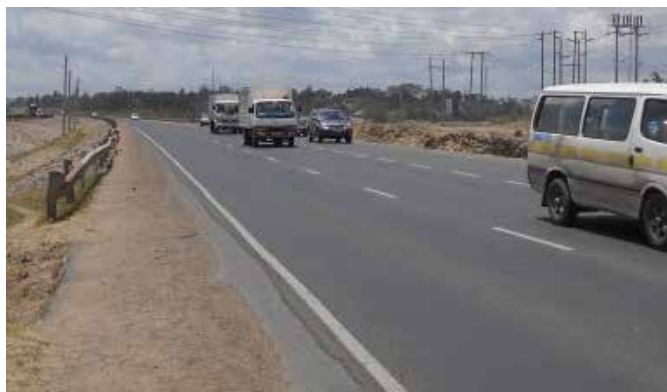
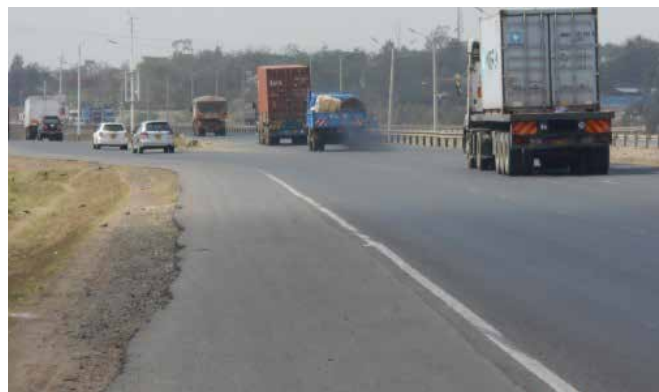
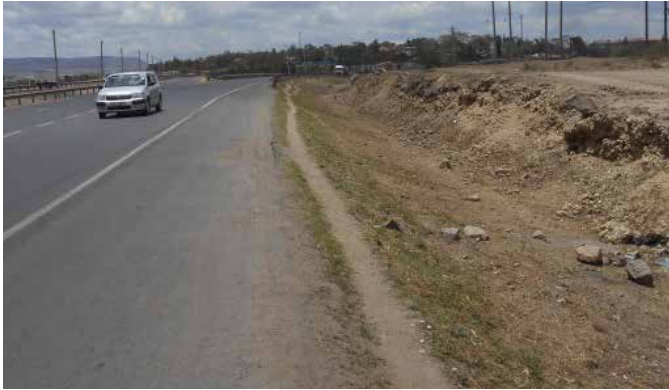
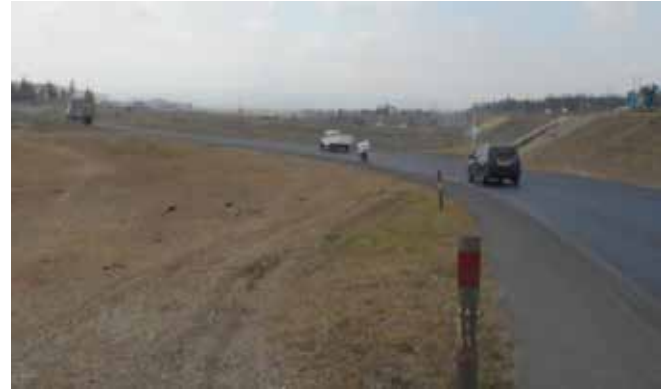
65. Mombasa Cement

This new blackspot is 0.2 kilometers, along a straight stretch at Mombasa Cement on both sides of the dual carriageway. The reason for the black spot is speeding motorists and careless overtaking. Drivers do not use acceleration lanes when joining the highway. Crashes happen throughout the week and in wet and dry seasons mostly during the day. Vehicles mostly involved in crashes are personal cars (saloons), mini buses – (PSVs and vans), and large buses. Crash victims are taken to Shalom Hospital and Machakos County Referral Hospital.

Picture: Part of Mombasa Cement road section

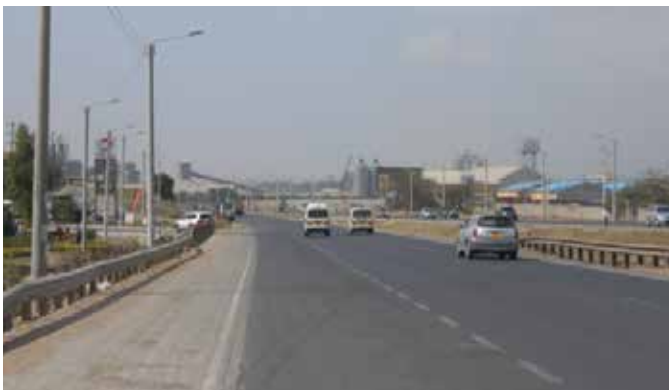
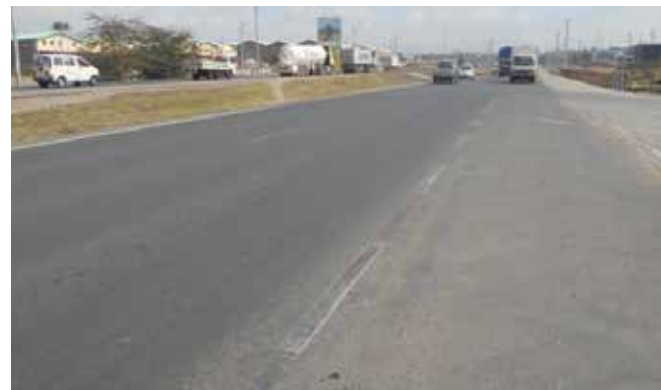
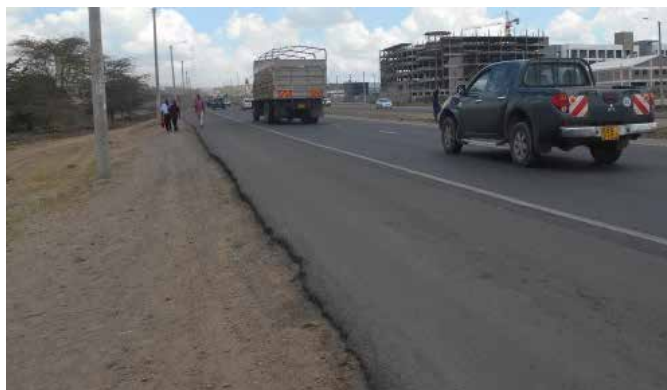
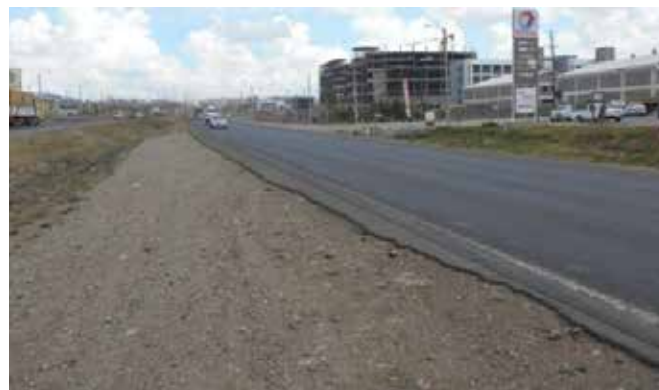
66. Sabaki

This new blackspot is 0.5 kilometers along a straight stretch with no road signs, faded markings and high pedestrian traffic. There are no designated bus stops, the road shoulders are worn out in some sections, and there is no acceleration lane. The reason for the black spot is unsafe pedestrian crossing, undesignated bus stops, speeding motorists and careless overtaking. Crashes happen throughout the week in both wet and dry seasons and throughout the day. Vehicles mostly involved in crashes are personal cars (saloons), mini buses – (PSVs and vans), and heavy commercial vehicles. Crash victims are taken to Shalom Hospital.

Picture: Part of Sabaki road section

Engineering - road design/furniture/features	Enforcement - law	Education - Road user awareness
<ul style="list-style-type: none"> • Instal speed limit signage. • Designate bus stops and pedestrian crossing points. • Consider footbridge. • Have the road marked afresh. 	<ul style="list-style-type: none"> • Enforce speed limit. 	<ul style="list-style-type: none"> • Educate pedestrians on the safe crossing. • Create awareness on speeding and careful overtaking.

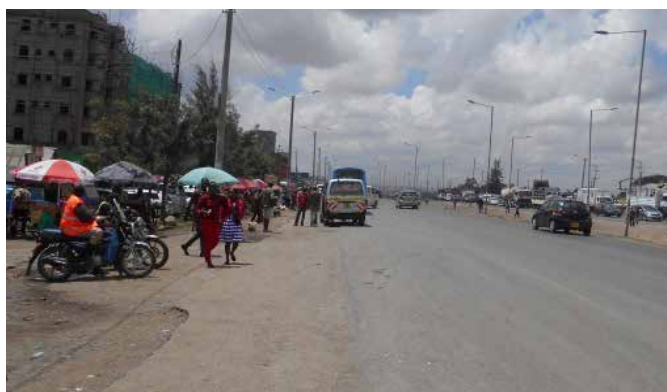
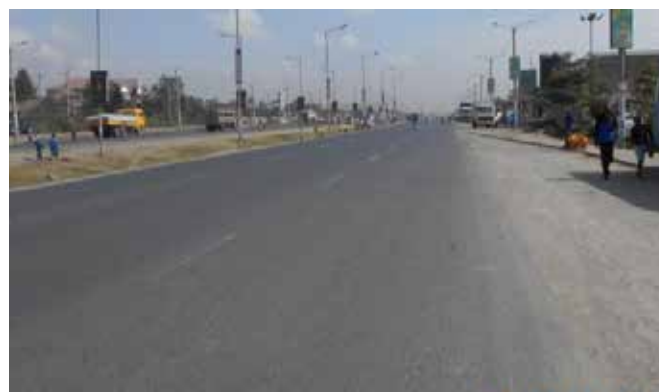
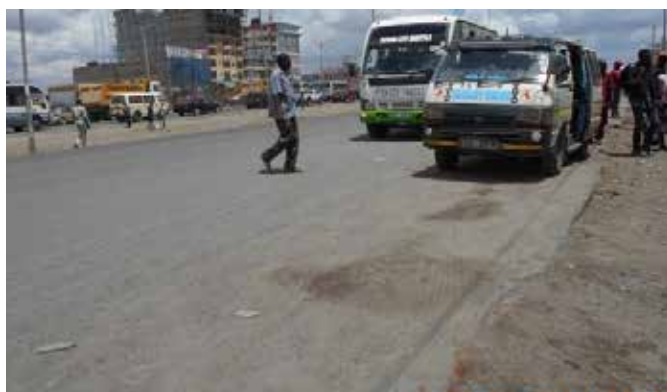
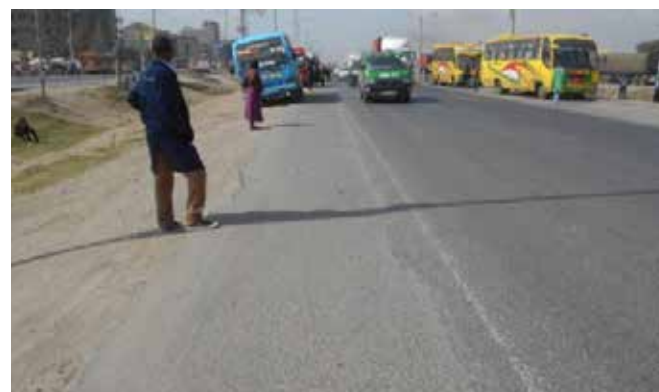
67. Mlolongo Olympic Petrol Station

This new blackspot is 0.4 kilometers along a straight stretch with no road signs or markings and has high pedestrian traffic. There are inadequate designated bus stops and vehicles do not stop for pedestrians to cross. The reason for the black spot is unsafe pedestrian crossing, undesignated bus stops, and speeding motorists. Crashes happen throughout the week in wet and dry seasons, and both day and night time. Vehicles mostly involved in crashes are personal cars (saloons), mini buses – (PSVs and vans), large buses, light and medium trucks, heavy commercial vehicles and motorcycles. Crash victims are taken to Shalom Hospital.

Picture: Part of Mlolongo Olympic Petrol Station road section

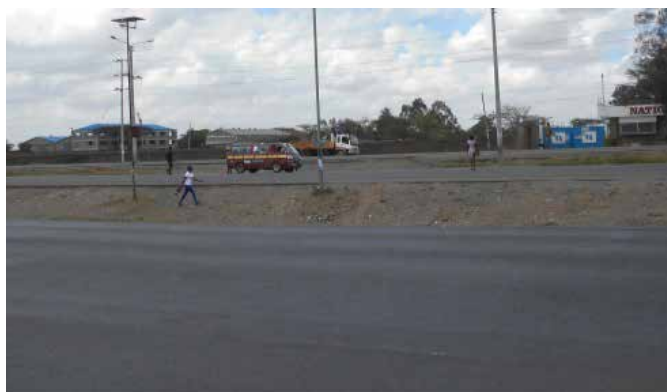
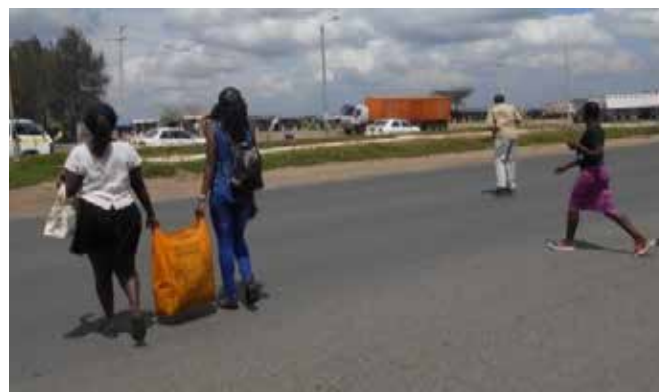
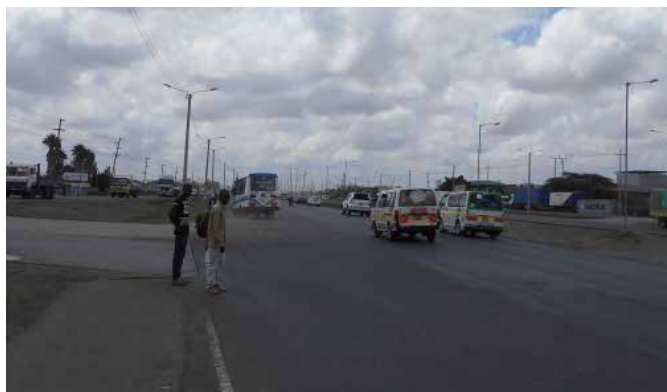
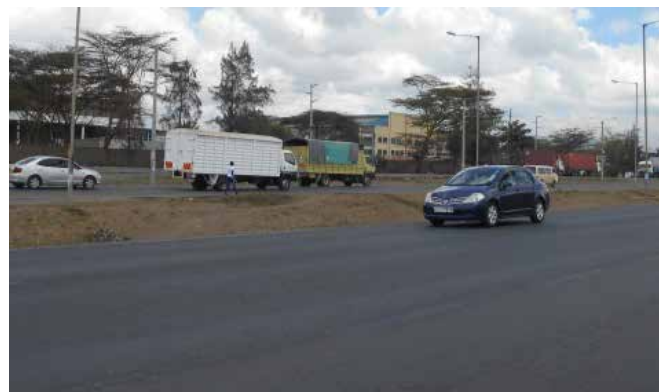
69. Nation Center – Mlolongo

This is a 1.2-kilometer road section on a straight stretch and gentle slope on the dual carriage. The road marking is faded and there are no road signs. Public service vehicles pick and drop passengers away from the designated bus stop. The reason for the black spot is speeding motorists, careless driving by motorcycle riders and unsafe pedestrian crossing at undesignated points. Crashes happen on weekdays and weekends, in dry and wet seasons and during the day and night. Vehicles mostly involved in crashes are personal cars (saloons), mini buses – (PSVs and vans), large buses, light and medium trucks, heavy commercial vehicles and motorcycles. Crash victims are taken to Shalom Hospital.

Picture: Part of Nation Center – Mlolongo road section

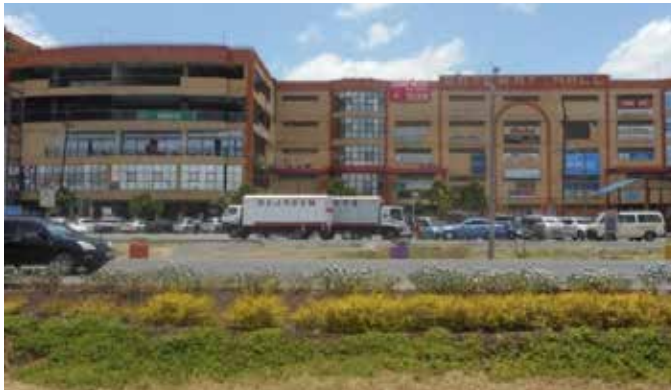
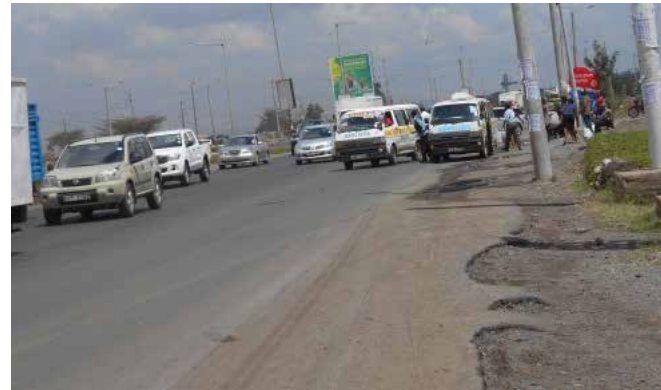
70. Gateway Mall Area

This new blackspot is 0.2 kilometers along a straight stretch with high pedestrian traffic near Gateway Mall on both side of the dual carriageway. There are no designated bus stops; there are intersections, and the road lacks proper marking and signage. The reason for the black spot is unsafe pedestrian crossing, undesignated bus stops, encroaching market and speeding motorists particularly over the weekend. There is no acceleration lane for vehicles joining at the turns. Crashes happen mostly during weekends, in wet and dry seasons and during the day and night time Vehicles mostly involved in crashes are personal cars (saloons), mini buses – (PSVs and vans), large buses, light and medium trucks, heavy commercial vehicles and motorcycles. Crash victims are taken to Shalom Hospital.

Picture: Part of Gateway Mall road section

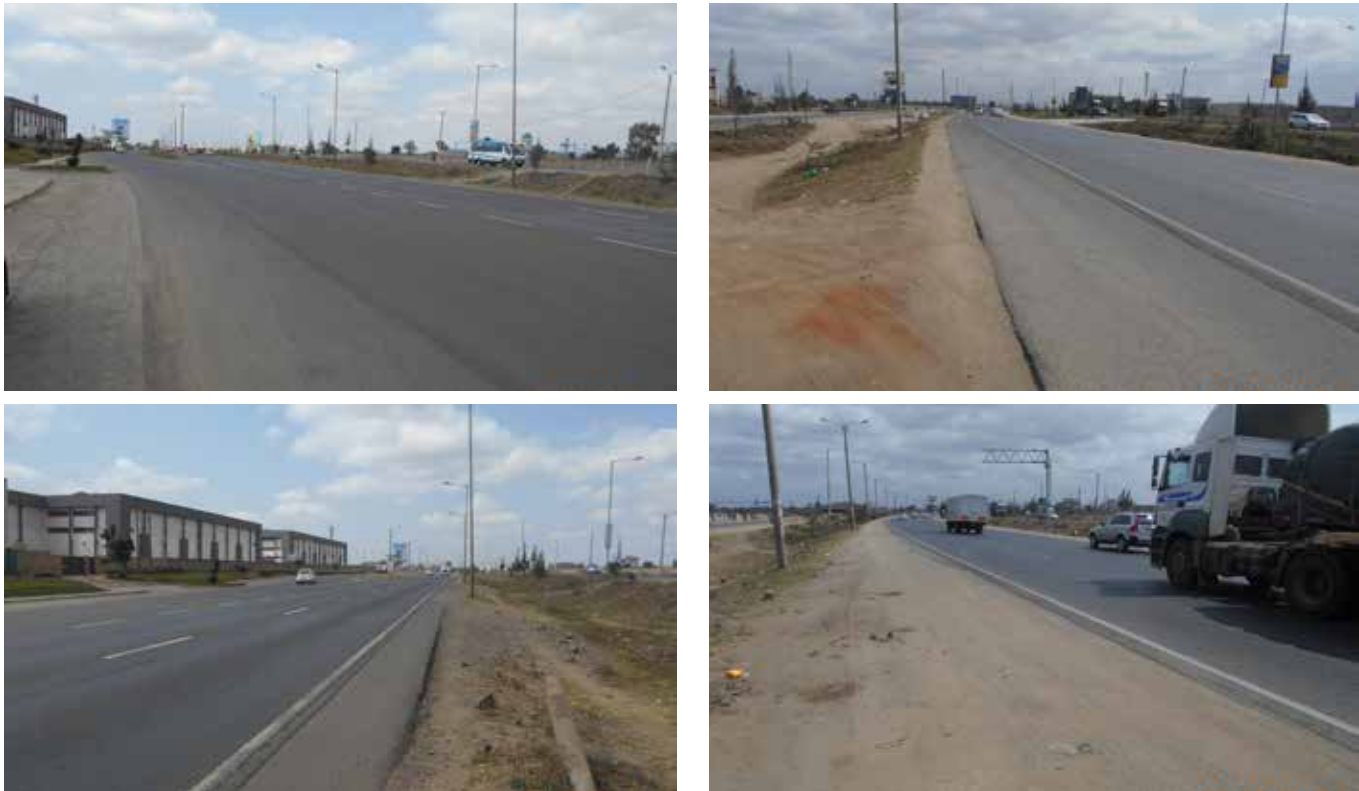
71. Machakos Nairobi Border

This section of the road is on Mombasa Road between Gateway Mall and Kapa Oil Refineries on both sides of the dual carriageway and stretches 0.5 kilometers. The main reason for blackspot is unsafe pedestrian crossing into the surrounding human settlements. There is no designated pedestrian crossing point or footbridge. Crashes happen throughout the week, at night and during the dry season.

Vehicles most involved in crashes are the personal cars (saloons), light and medium trucks, and heavy commercial vehicles. When crashes happen, the victims are taken to Shalom Hospital.

Picture: Part of Machakos Nairobi border road section

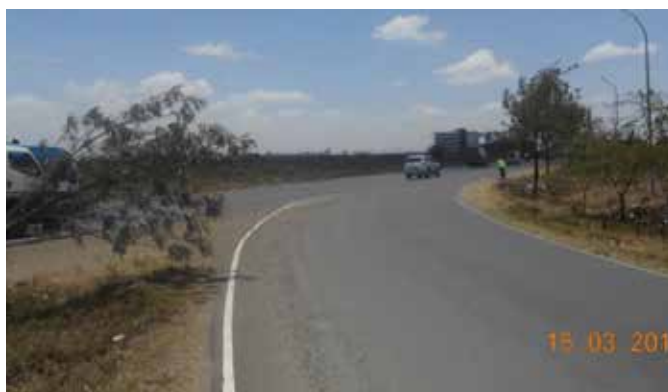
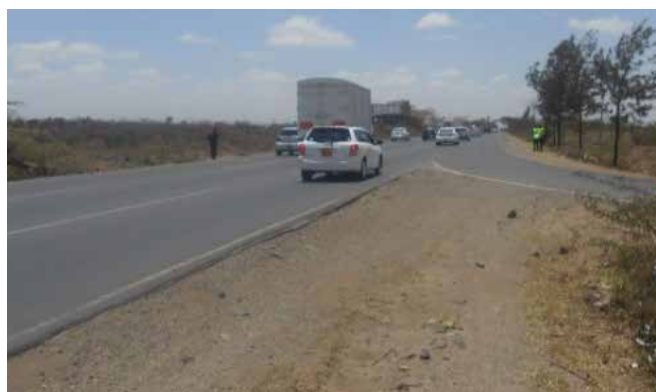
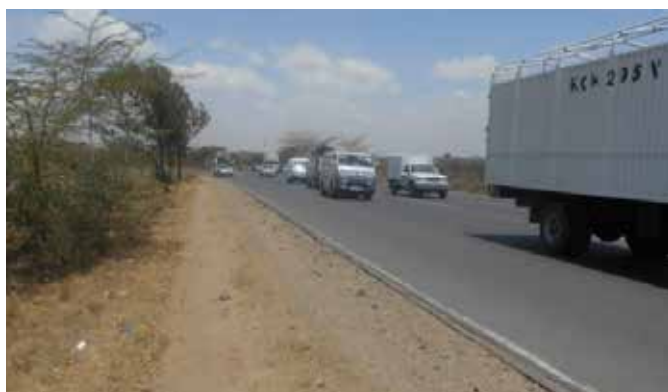
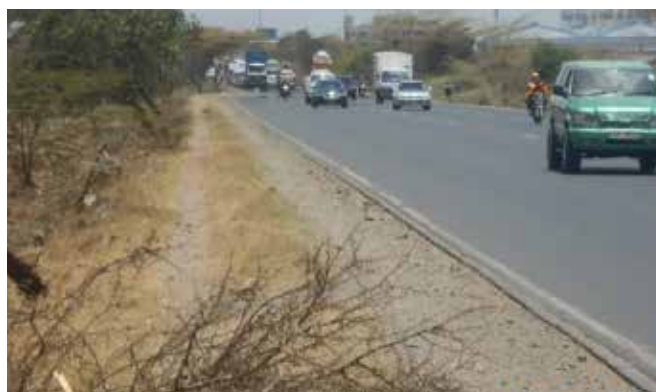
72. JKIA – Airport turn off

This section of the road is situated on Mombasa Road at the turn off where vehicles from Mombasa road heading into town turn to the Airport road, and manifests on both directions of the dual carriage highway and stretches about 0.4 kilometers. The main reasons for blackspot are speeding motorists coupled with careless driving (entry and exit) and missing signage and inadequate road marking. The acceleration lane is not marked from the exit point. Crashes happen throughout the week and mostly during night but during dry seasons. Vehicles most involved in crashes are the personal cars (saloons), light and medium trucks, and heavy commercial vehicles. When crashes happen, the victims are taken to Shalom Hospital.

Picture: Part of JKIA – Airport Turn off road section

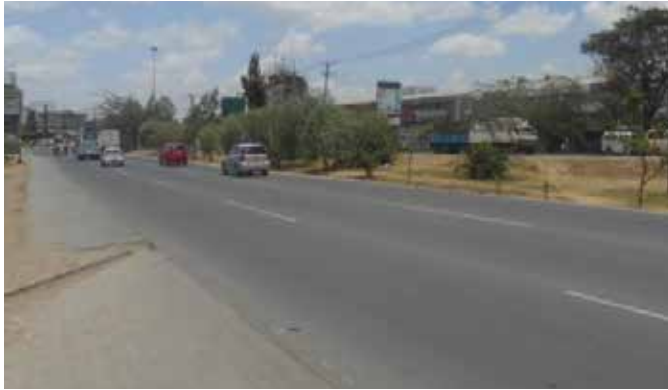
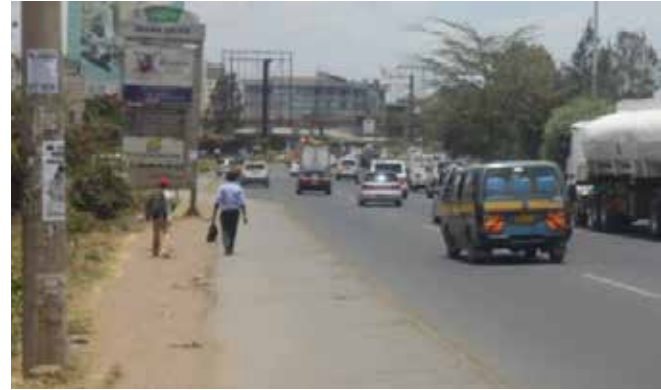
73. Imara Daima Area

This section of the road is situated on Mombasa Road at the turn off to Imara Daima, and manifests on both sides of the dual carriageway and stretches about 300 meters. The main reasons for blackspot are careless driving by motorcycle riders who make illegal turn on the highway. Crashes happen during weekday and mostly during both night and day time but during dry seasons. Vehicles most involved in crashes are the motorcycles. When crashes happen, the victims are taken to Shalom Hospital and Kenyatta National Hospital.

Picture: Part of Imara Daima road section

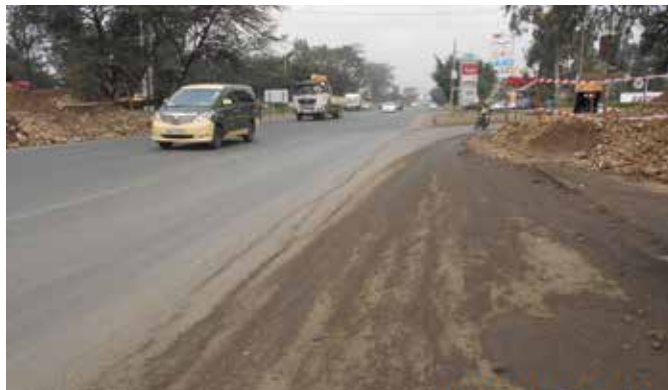
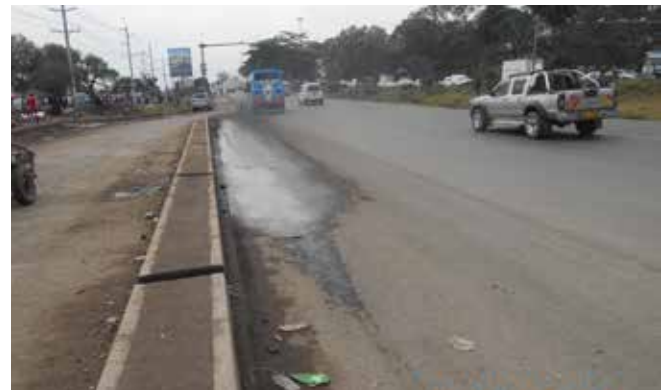
This is a 100-meter road section with an intersection and has a footbridge. The reason for the black spot is speeding motorists, unsafe pedestrian crossing despite presence of a footbridge, and undesignated bus stop on acceleration lane on GM side. Crashes happen mostly during weekend, in both wet and dry seasons as well during both night and day time.

Vehicles mostly involved in crashes are personal cars (saloons), mini buses – (PSVs and vans), large buses, light and medium trucks, heavy commercial vehicles and motorcycles. Crash victims are taken to Kenyatta National Hospital.

Picture: Part of General Motors road section

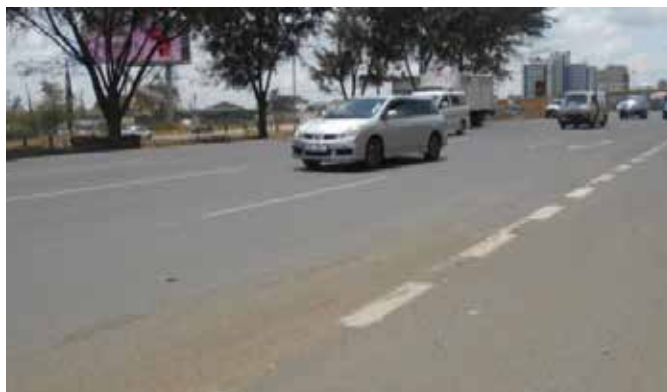
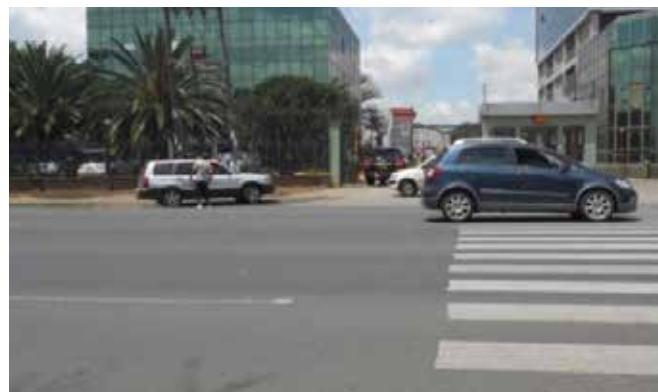
75. Airtel A (from the Overpass towards CBD)

This section of the road is situated on Mombasa Road near Airtel (Parkside Plaza) headquarters on the opposite direction towards Eka Hotel and stretches about 0.8 kilometers. The main reasons for blackspot are speeding motorists, the sharp bend and pedestrian crossing at undesignated points. Many motorists disobey traffic marshals when asked to stop at the pedestrian crossing point. Crashes happen during weekday, both night and day time and during both wet and dry seasons. Vehicles most involved in crashes are personal cars (saloons), mini buses (PSVs and vans), large buses, light and medium trucks, heavy commercial vehicles, motorcycles. When crashes happen, the victims are taken to Kenyatta National Hospital.

Picture: Part of Airport A (Towards CBD) road section

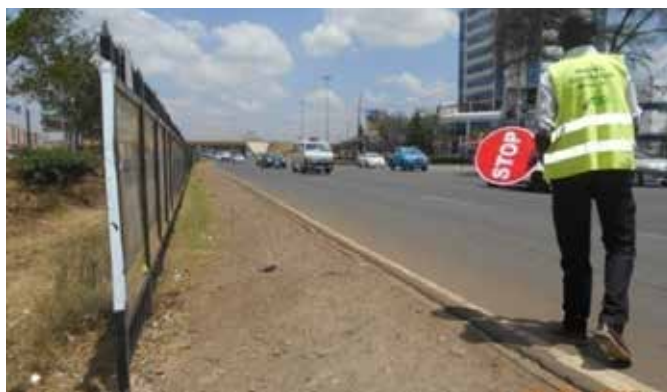
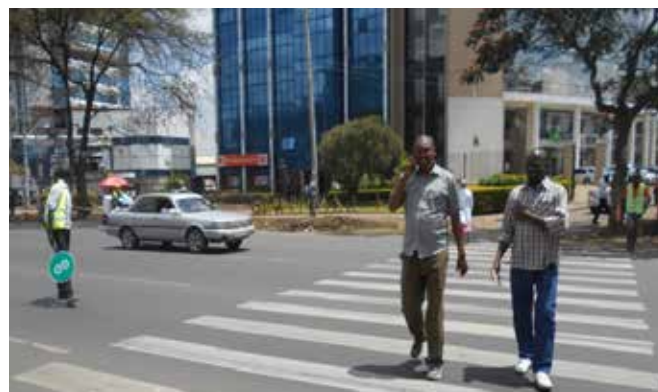
76. Airtel B (from the Overpass towards Mombasa)

This section of the road is situated on Mombasa Road near Airtel (Parkside Plaza) headquarters at the over pass towards the direction to Mombasa and stretches about 0.8 kilometers. The main reasons for blackspot are speeding motorists and unsafe pedestrian crossing. There is a designated pedestrian crossing with a traffic marshal Crashes happen throughout the week and mostly during both night and day time and during both wet and dry seasons. Vehicles most involved in crashes are the personal cars (saloons), mini buses (PSVs and vans), large buses, light and medium trucks, heavy commercial vehicles, motorcycles. When crashes happen, the victims are taken to Kenyatta National Hospital.

Picture: Part of Airtel B (towards Mombasa) road section

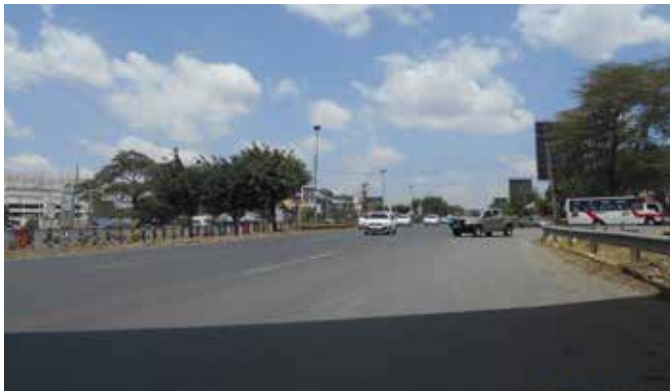
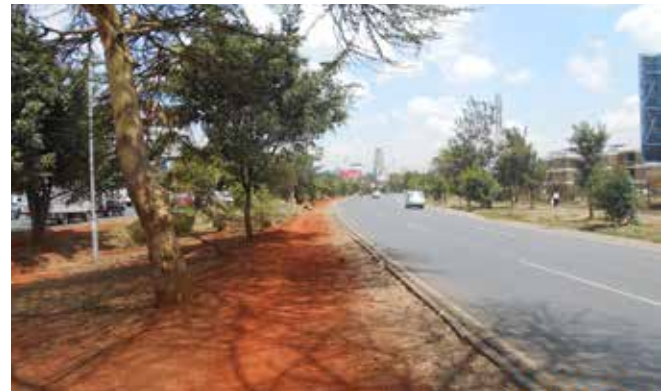
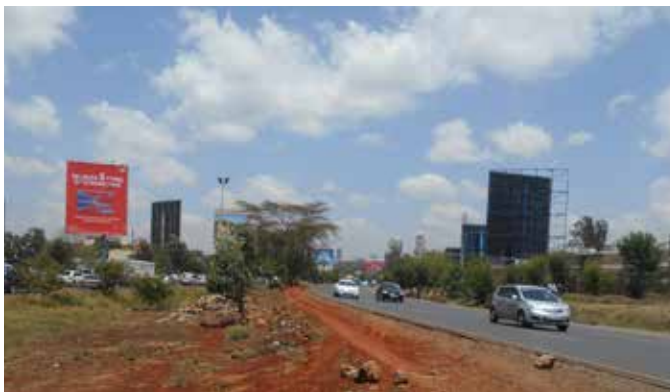
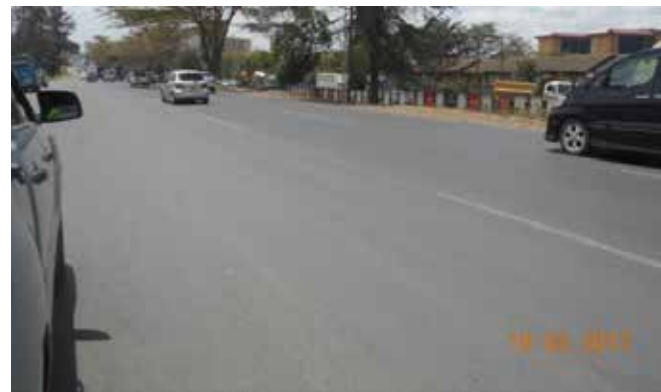
77. Bellevue

This section of the road is situated on Mombasa Road at Bellevue and manifests on both sides of the dual carriageway stretching about 0.9-kilometer. The section is on a long straight stretch, with a junction. The main reasons for blackspot are speeding motorists, the blind spot occasioned by the vegetation at a curve, and inadequate road signage. Crashes happen throughout the week, both night and day time and during both wet and dry seasons. Vehicles most involved in crashes are personal cars (saloons), mini buses (PSVs and vans), large buses, light and medium trucks, heavy commercial vehicles, motorcycles. When crashes happen, the victims are taken to Kenyatta National Hospital.

Picture: Part of Bellevue road section

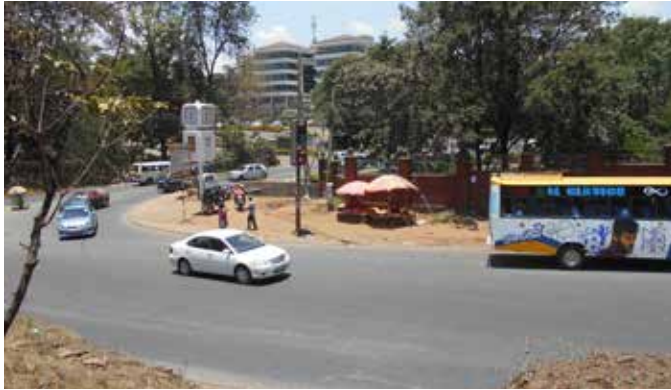
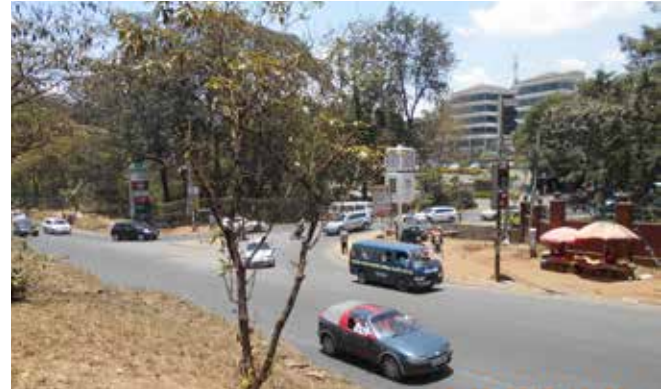
78. Riverside Drive Junction

This section of the road is situated on Waiyaki Way towards Westlands at the junction with Riverside drive, stretching about 200 meters. The main reason for blackspot is road intersection with no give way sign, a high number of pedestrians crossing with no designated crossing points, as well as motorcycle riders crossing the sections to enter or leave the junction of Riverside drive. The road lacks signage and marking. Crashes happen throughout the week, during the day, and in both wet and dry seasons. Vehicles most involved in crashes are personal cars (saloons), and motorcycles. When crashes happen, the victims are taken to MP Shah Hospital and Avenue Hospital.

Picture: Part of Riverside Drive Junction road section

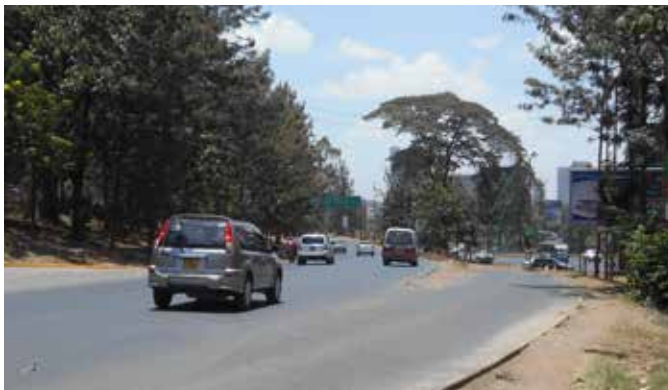
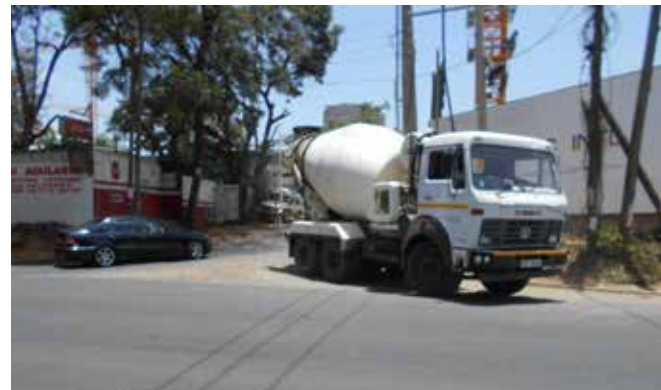
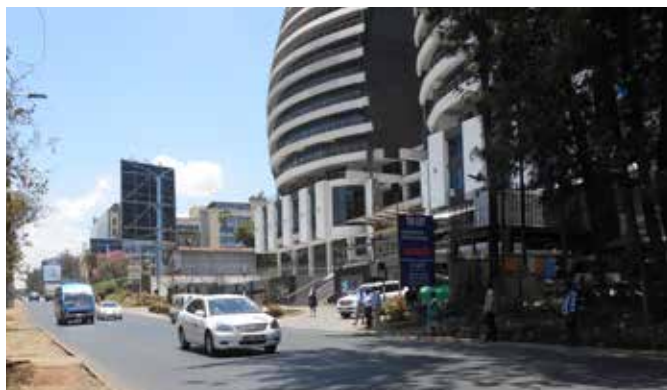
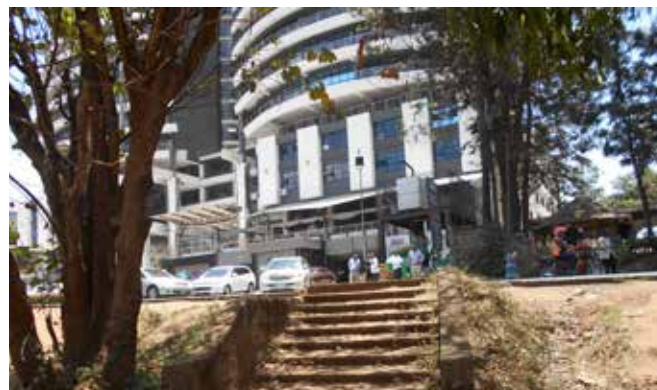
This section of the road is situated on Waiyaki Way in the direction towards the City Center near Villa Rosa Kempinski Hotel stretching about 0.5 kilometers. The main reason for blackspot is a blind spot brought about by the intersection at Chiromo Lane and entry and exit from Villa Rosa. There is a slip road that allows vehicles to join the highway towards Westlands. Motorists travel at excessive speed and change lanes dangerously. There is no proper road signage or marking. There are no designated pedestrian crossing points. There being no designated bus stop, 'matatus' often drop off/pick passengers on the highway.

Crashes happen over weekends and at night, and in both wet and dry seasons. Vehicles most involved in crashes are personal cars (saloons), and motorcycles. When crashes happen, the victims are taken to MP Shah Hospital and Avenue Hospital.

Picture: Part of Villa Rosa Kempinski road section

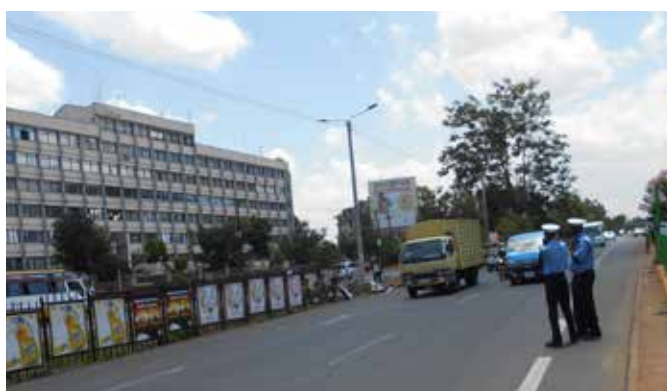
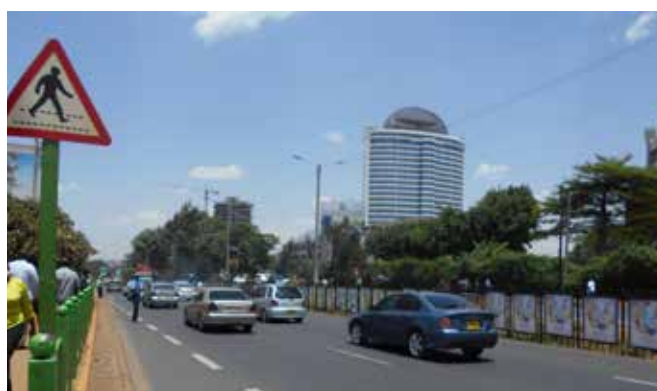
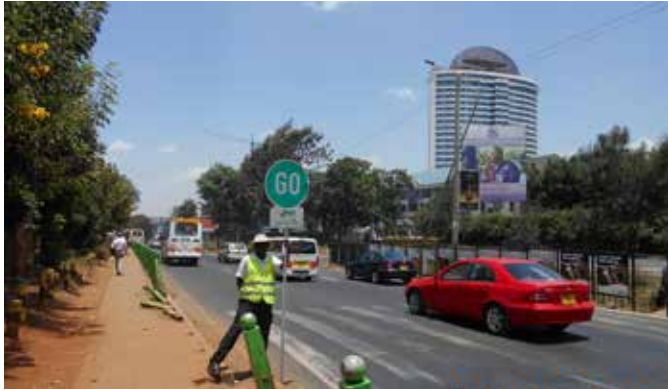
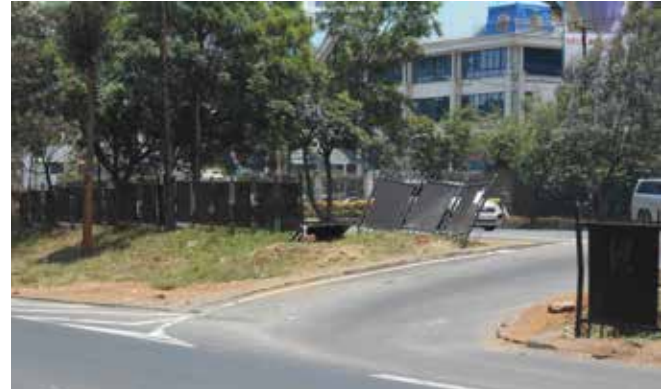
80. Medanta Junction

This section of the road is situated on Waiyaki Way towards City Center near Medanta Africare stretching about 300 meters. The main reasons for blackspot are road intersection, speeding motorists and pedestrian crossing at undesignated points. Vehicles on the highway do not slow down for pedestrians to cross even at the designated crossing point. There is a traffic marshal and well marked crossing point. Crashes happen during weekdays, during the day, and in both wet and dry seasons. Vehicles most involved in crashes are personal cars (saloons), and mini buses (matatus and vans). When crashes happen, the victims are taken to MP Sháh Hospital and Avenue Hospital.

Picture: Part of Medanta Junction road section

Engineering - road design/furniture/features	Enforcement - law	Education - Road user awareness
<ul style="list-style-type: none"> Repair damaged bollards near the pedestrian crossing and pedestrian fence at the turn off. 	<ul style="list-style-type: none"> Ensure matatus use the designated bus stops. Ensure motorists stop for pedestrian. 	<ul style="list-style-type: none"> Educate pedestrians on safe crossing and motorists on giving way to pedestrians.
