Northern Corridor and Nairobi County Route Hazard Mapping Report

May 2017

Developed by Safe Way Right Way and National Transport and Safety Authority

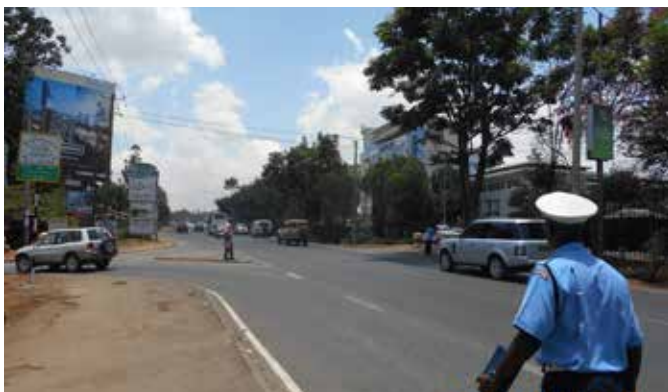
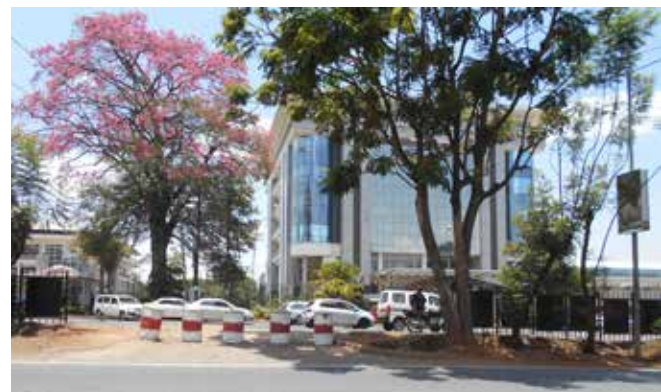
81. Muthangari Drive Junction

This section of the road is situated on Waiyaki Way towards Kangemi near the intersection with Muthangari Drive stretching about 300 meters. The main reasons for the blackspot are pedestrians crossing at undesignated points, reckless motorcycle riders through the barriers, and lack of appropriate road signage. Crashes happen throughout the weeks, both day and night time, and in both wet and dry seasons. Vehicles most involved in crashes are the motorcycles. When crashes happen, the victims are taken to MP Shah Hospital and Avenue Hospital.

Picture: Part of Muthangari Drive Junction road section

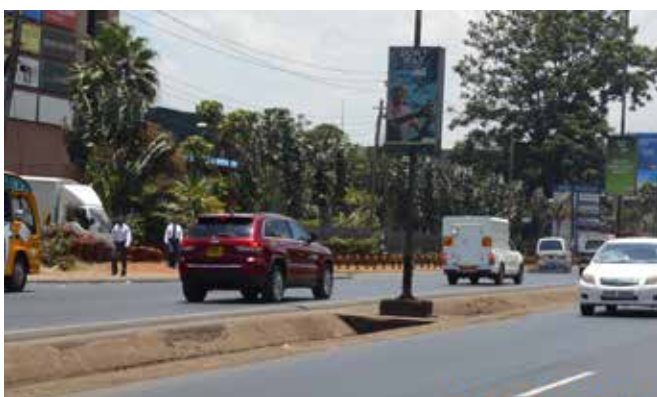
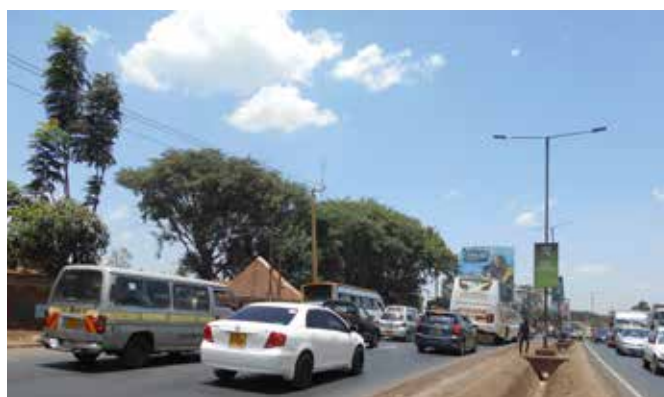
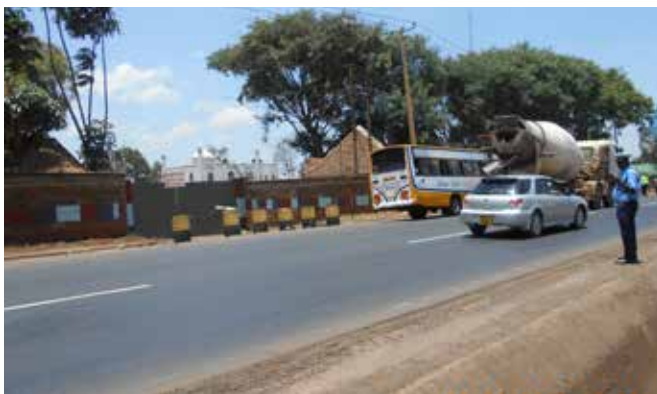
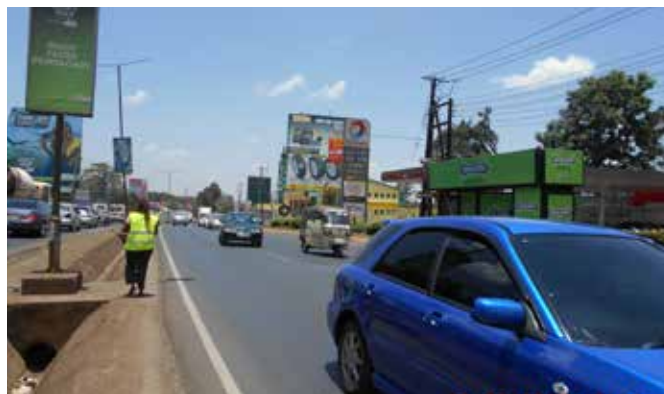
The main reasons for the blackspot are pedestrians crossing at undesignated points, the absence of signage, the road intersection into James Gichuru, the entry into the highway from James Gichuru road and matatus stopping at undesignated bus stop.

Crashes happen during weekdays and at daytime as well as in both wet and dry seasons. Vehicles most involved in crashes are the personal cars (saloons), and mini buses (matatus and vans). When crashes happen, the victims are taken to MP Shah Hospital, Aga Khan and Avenue Hospital.

Picture: Part of Total -ABC Place road section

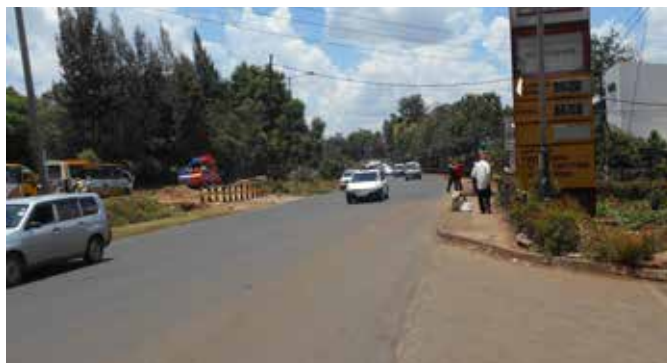
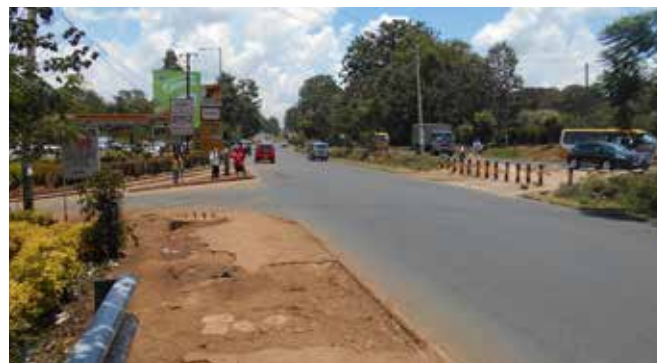
83. Waruku

This is a 0.5 kilometer road section on Waiyaki way manifesting on both directions of the dual carriage way at Waruku with high human traffic. There is a junction. The main hazards are unsafe pedestrian crossing, speeding motorists and an undesignated bus stop. There are neither road signs nor markings. The reason for the black spot is speeding motorists, heavy pedestrian crossing, and undesignated bus stops. Crashes happen throughout the week, through both wet and dry seasons, and mostly at night. Vehicles mostly involved in crashes are personal cars (saloons), mini buses (PSVs, vans) and motorcycles. Crash victims are taken to MP Shah Hospital and St. James Healthcare Center.

Picture: Part of Waruku Area road section

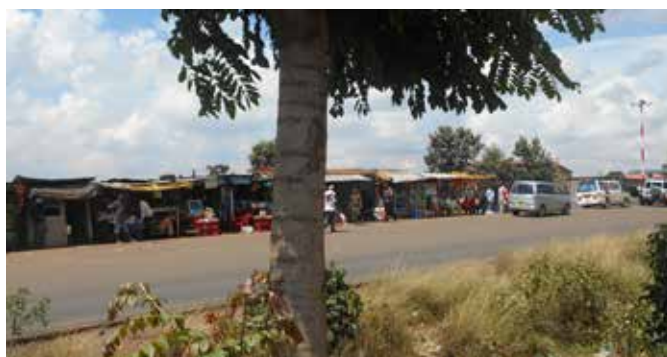
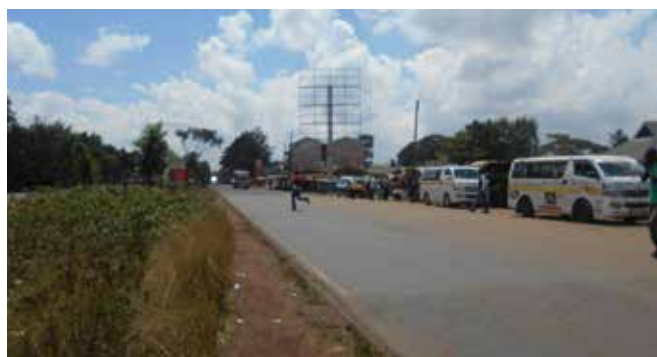
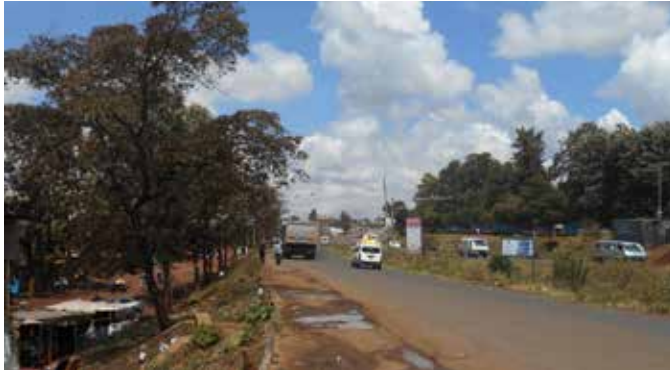
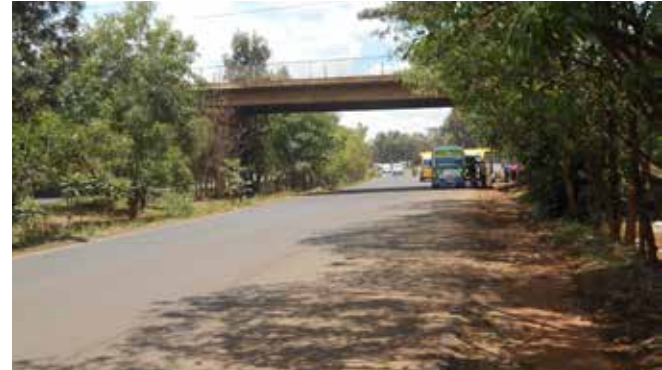
84. Sodom

This is a 0.7 kilometer road section manifesting on both directions of the dual carriage way, across an area with high human traffic. It has junctions and a slight bend. There are undesignated bus stops on both directions of the road, and there are neither road signs nor markings. The reason for the black spot is speeding motorists, unsafe pedestrian crossing, and undesignated bus stops. Vendors selling wares on the side of the road force pedestrians to walk on the road. The trees lining the section also cause poor visibility for road users. Crashes happen throughout the week, during wet and dry seasons, and at all times of the day. Vehicles most involved in crashes are personal cars (saloons), mini buses (PSVs, vans), large buses, light and medium trucks, heavy commercial vehicles and motorcycles. Crash victims are taken to St. James Healthcare Center and Kikuyu Hospital.

Picture: Part of Sodom area road section

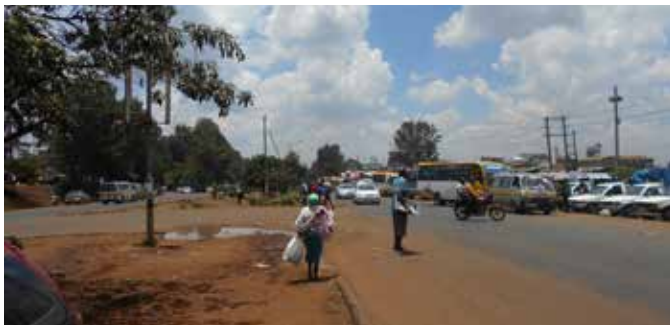
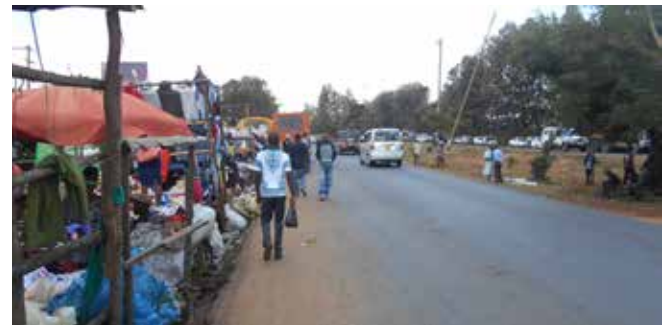
85. Kangemi Market

This is a 50 meter road section across a busy market center with encroachment of the roadside by traders. It has intersection and no speed bumps. It manifests on both sides of the dual carriage way. There are no road signs as well. The reason for the black spot is speeding motorists, heavy pedestrian crossing, and undesignated bus stops. Crashes happen throughout the week in the dry and wet season but mostly at night. Vehicles mostly involved in crashes are personal cars (saloons), mini buses (PSVs, vans), light and medium trucks, heavy commercial vehicles and motorcycles. Crash victims are taken to Kikuyu Mission Hospital

Picture: Part of Kangemi Market road section

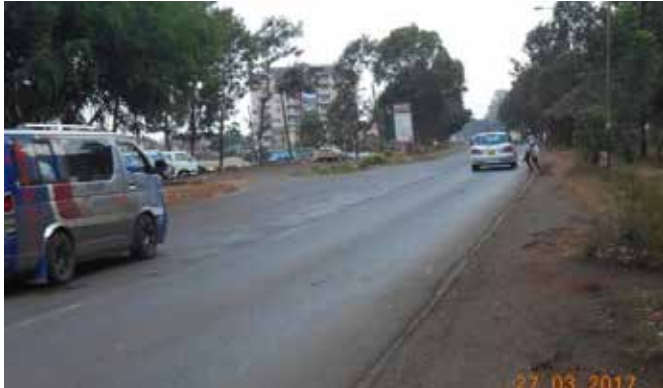
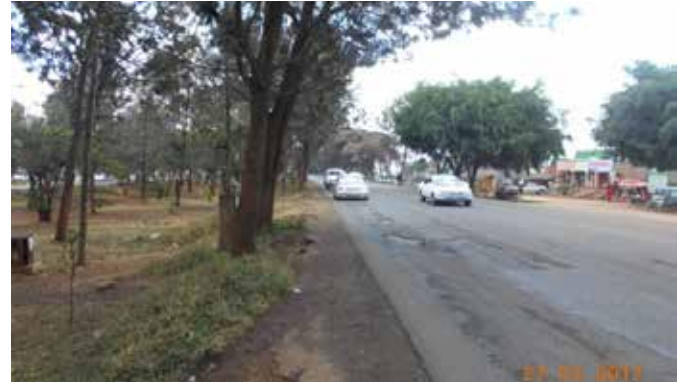
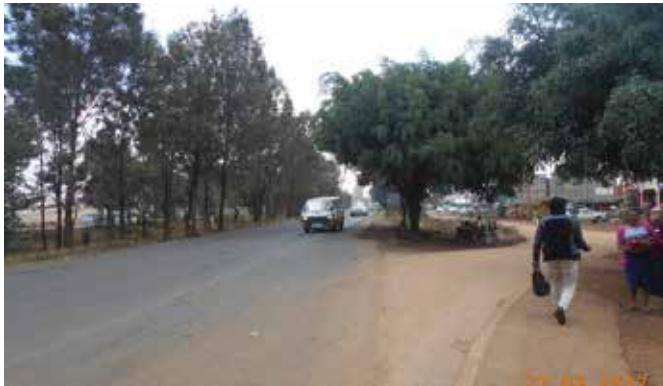
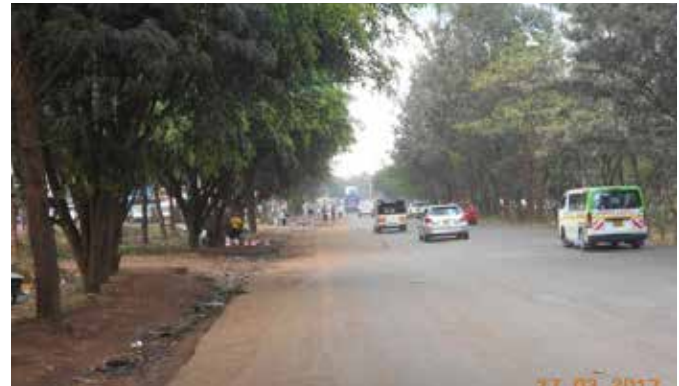
86. Kwa Thiong'o

This is a 150 meter road section on Waiyaki Way along a long straight stretch through Kwa Thiong'o market center. It manifests on both sides of the dual carriageway with no road signs. The reason for the black spot is speeding motorists and pedestrians crossing at undesignated points. Crashes mostly happen over the weekend and at night, as well as in the dry and wet seasons. Vehicles mostly involved in crashes are personal cars (saloons), mini buses (PSVs, vans), and motorcycles. Crash victims are taken to Kikuyu Mission Hospital and AMURT Center.

Picture: Part of Kwa Thiong'o road section

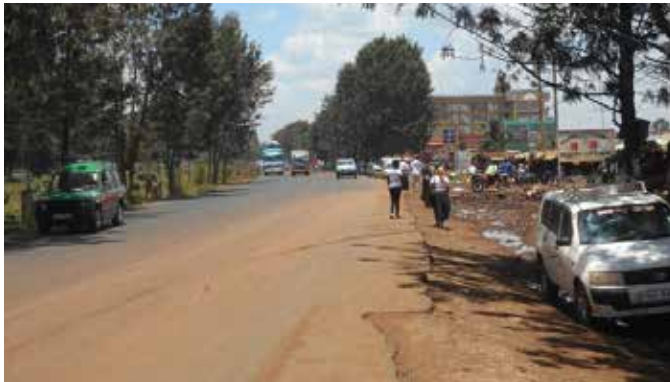
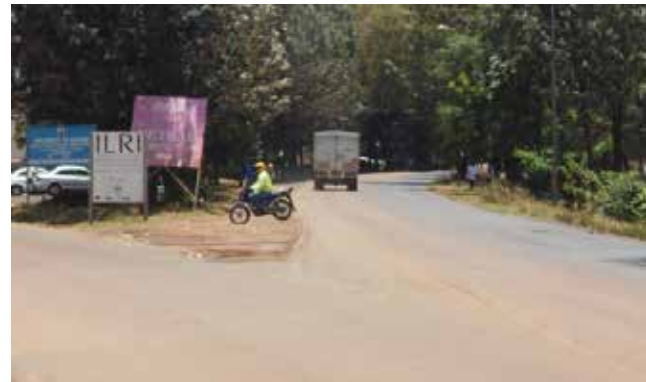
This is an 80 meter road section along Waiyaki Way on one side at Kabete Police that has a bend and tall trees on the side of the road. There are no road signs.

The reason for the black spot is speeding motorists, poor visibility and heavy pedestrian crossing. Crashes occur throughout the week and at all times of the day, especially during the wet season. Vehicles mostly involved in crashes are personal cars (saloons), mini buses (PSVs, vans), and motorcycles. Crash victims are taken to Kikuyu Mission Hospital.

Picture: Part of Kabete Police section

Engineering - road design/furniture/features	Enforcement - law	Education - Road user awareness
<ul style="list-style-type: none"> Designate pedestrian crossing points. Install appropriate road marking and signage. Repair the damaged road shoulder. Clear tree cover to improve line of sight and minimize chance of fatality in the event of a crash. 	<ul style="list-style-type: none"> Enforce the speed limit compliance. 	<ul style="list-style-type: none"> Educate pedestrians on road safety and importance of using designated crossing points.

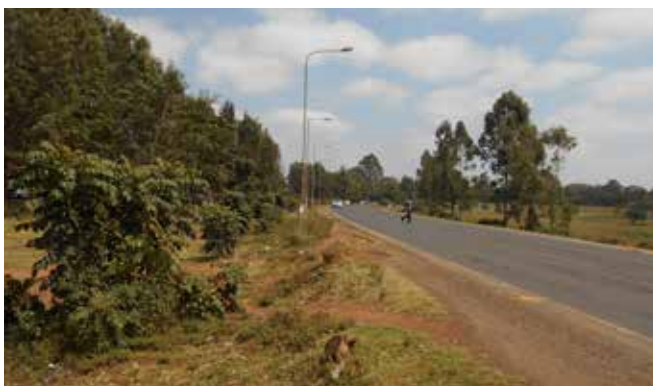
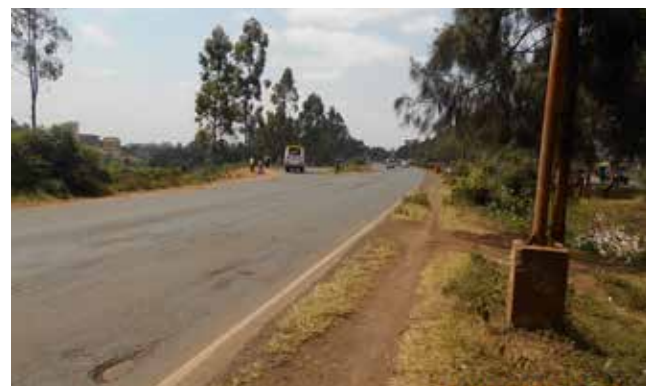
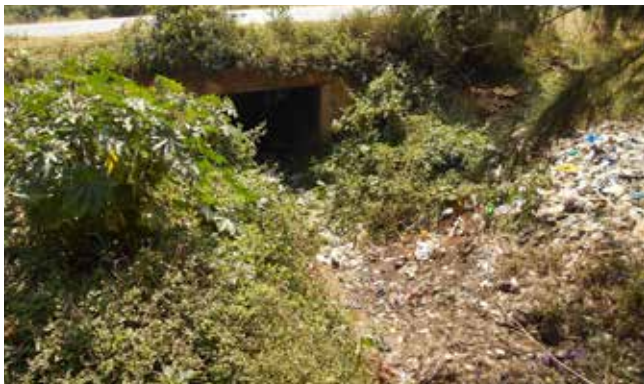
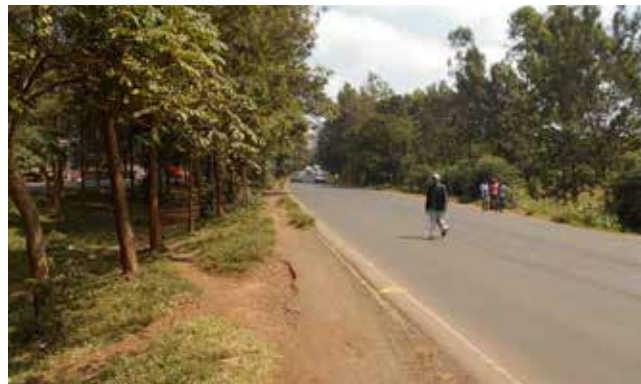
88. Vet Labs Area

This is a 200 meter road section along Waiyaki Way on one side heading to City Center adjacent to Vet Lab fence. There is a bend and tall trees covering both edges of the road. There are no road signs. The reason for the black spot is speeding motorists, poor visibility and heavy pedestrian crossing. Crashes are most common over the weekend at night, and during the wet and dry seasons. Vehicles mostly involved in crashes are personal cars (saloons), mini buses (PSVs, vans), and motorcycles. Crash victims are taken to Kikuyu Mission Hospital.

Picture: Part of Vet Lab road section

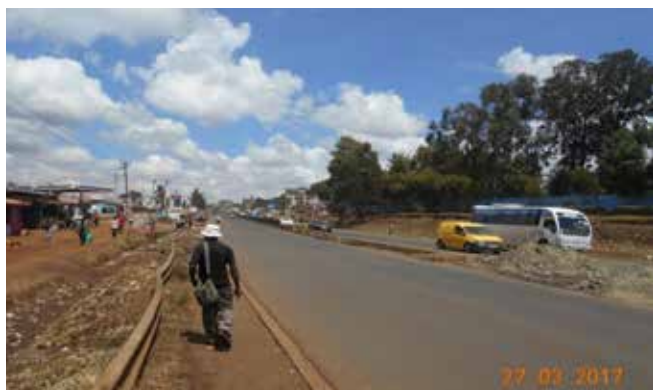
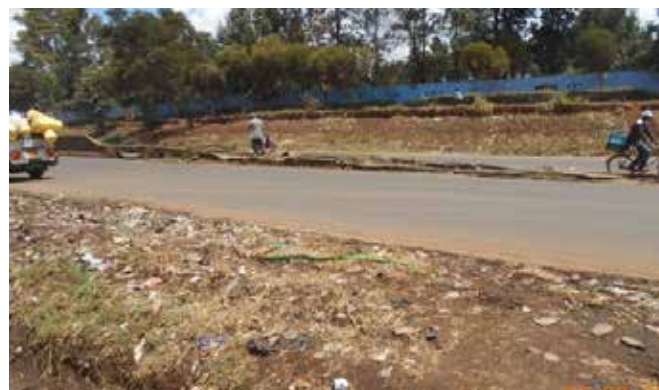
89. Uthiru

This is a 2 kilometer road section at Uthiru area on both sides of the dual carriageway. The section has intersections, a roadside market, with high pedestrian traffic. The road shoulder and guardrails are damaged. The section has some road signs but is unmarked. The reason for the black spot is speeding motorists, unsafe pedestrian crossing, and undesignated bus stops. Crashes mostly occur on weekends at night, and during both the wet and dry seasons. Vehicles mostly involved in crashes are personal cars (saloons), mini buses (PSVs, vans), large buses, light and medium trucks, heavy commercial vehicles, and motorcycles. Crash victims are taken to Kikuyu Mission Hospital.

Picture: Part of Uthiru road section

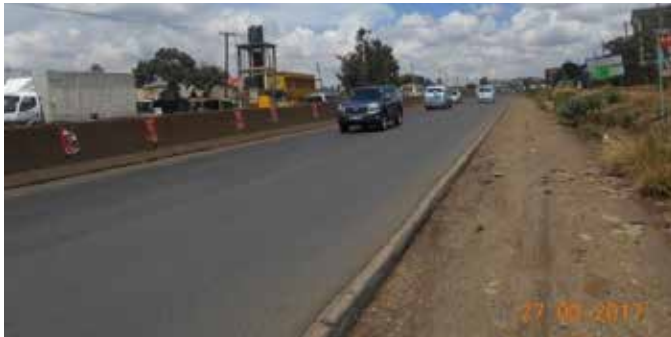
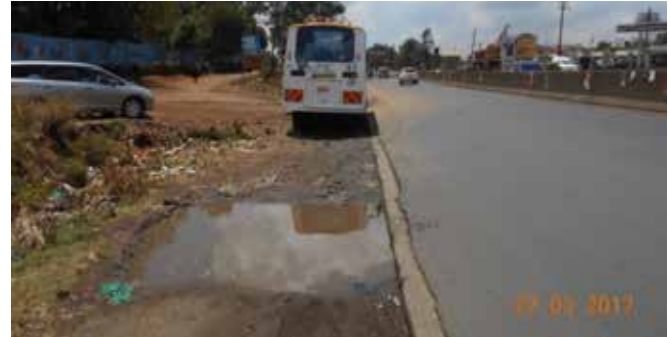
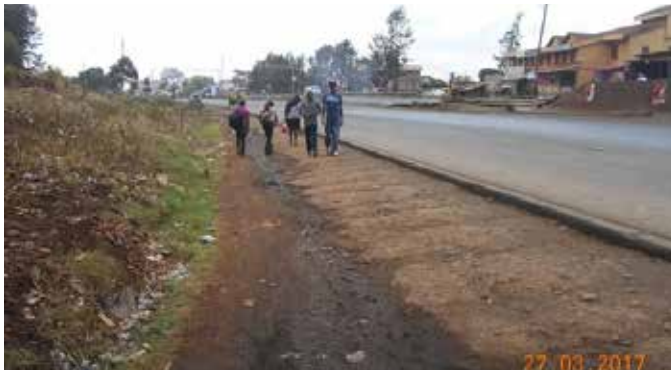
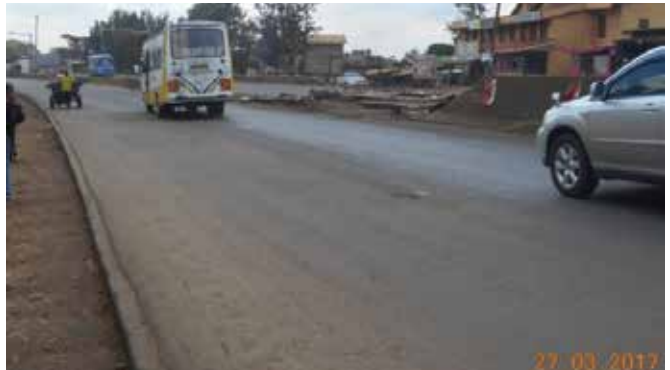
90. Uthiru B

This is a 0.9 kilometer road section at Uthiru B area on Waiyaki Way on both sides of the dual carriageway. The section has high pedestrian traffic including handcarts. The road shoulder and the guardrails are damaged. There are also no road signs and marking. The reason for the black spot is speeding motorists, unsafe pedestrian crossing, and undesignated bus stops. Crashes occur mostly at night on weekends, in both the dry and wet seasons. Vehicles mostly involved in crashes are personal cars (saloons), mini buses (PSVs, vans), large buses, light and medium trucks, heavy commercial vehicles, motorcycles and handcarts. Crash victims are taken to Kikuyu Mission Hospital.

Picture: Part of Uthiru B road section

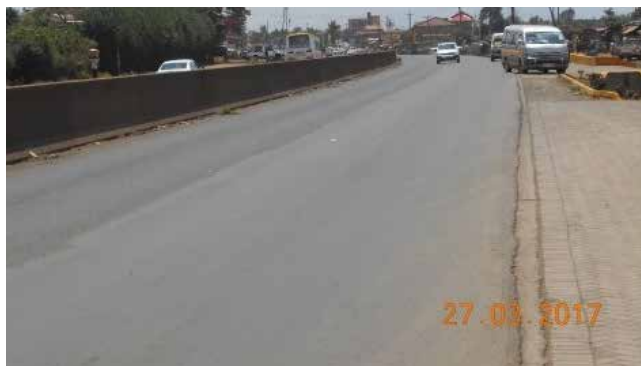
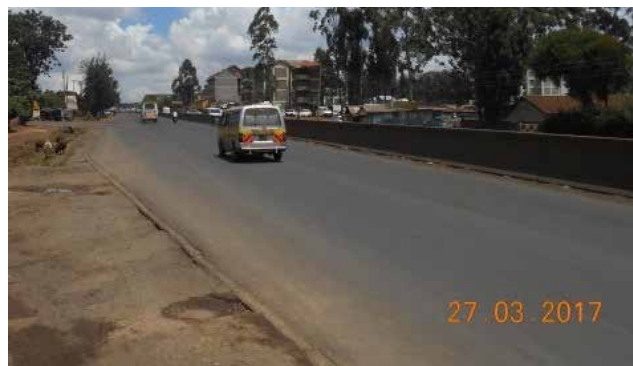
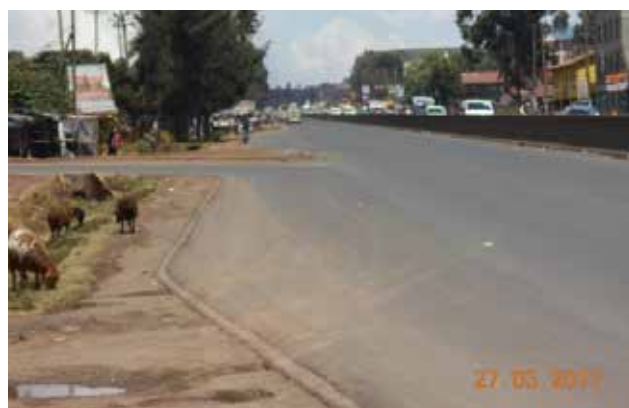
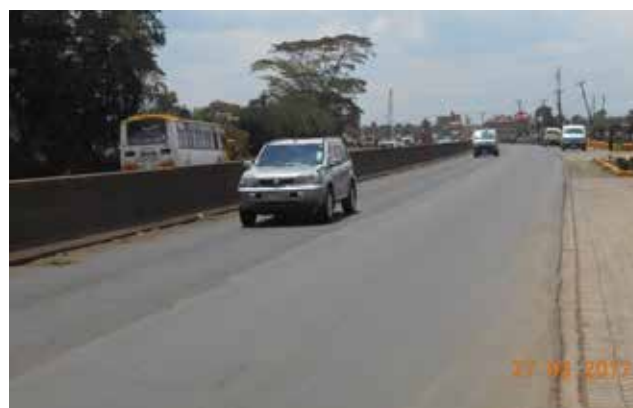
This is a 210 meter road section of Waiyaki Way at Upper Kabete turn off with a bend, through a market center. It has an intersection and there are no road signs. The main reason for black spot is speeding motorists, unsafe pedestrian crossing, and undesignated PSVs stops. Crashes mostly happen during the day throughout the week, in both wet and dry seasons.

Vehicles mostly involved in crashes are personal cars (saloons), mini buses - includes PSVs and vans, and motorcycles. Crash victims are taken to Kikuyu Mission Hospital.

Picture: Part of Area 87 road section

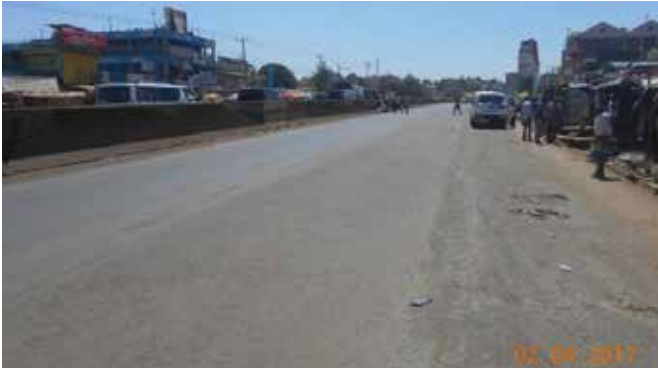
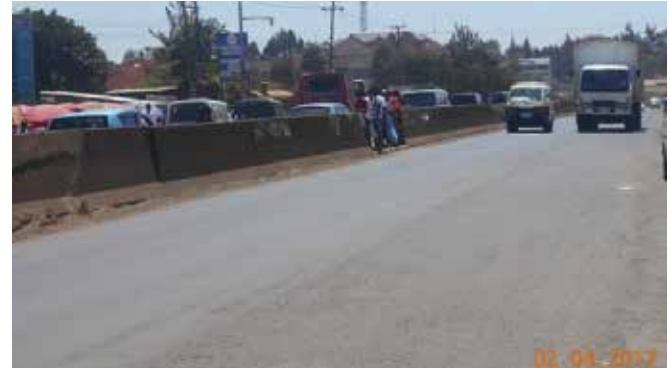
92. Area 87 B

This is a 200 meter road section of Waiyaki way at Area 87 with a bend and intersection. There are no road signs and the median wall is damaged. The main reason for black spot is speeding motorists, unsafe pedestrian crossing, and undesignated bus stops. Crashes mostly happen during the day throughout the week, in the dry and wet seasons. Vehicles mostly involved in crashes are personal cars (saloons), mini buses - includes PSVs and vans, and motorcycles. Crash victims are taken to Kikuyu Mission Hospital.

Picture: Part of Area 87 B road section

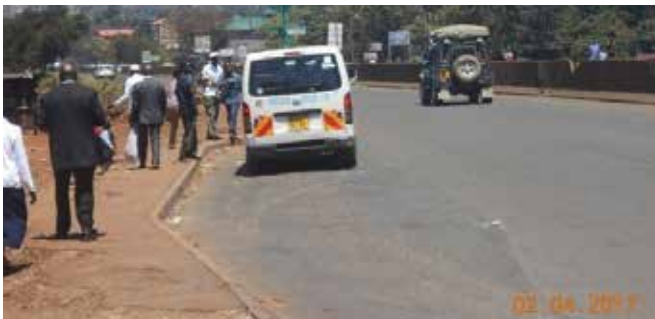
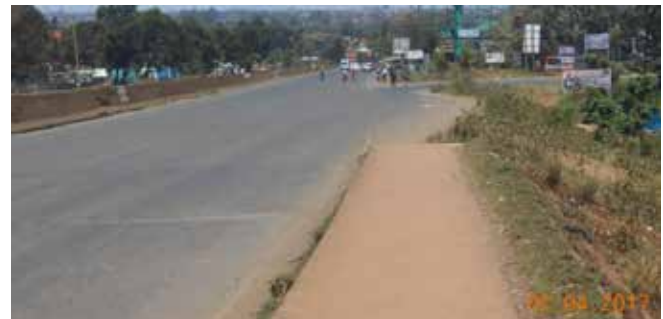
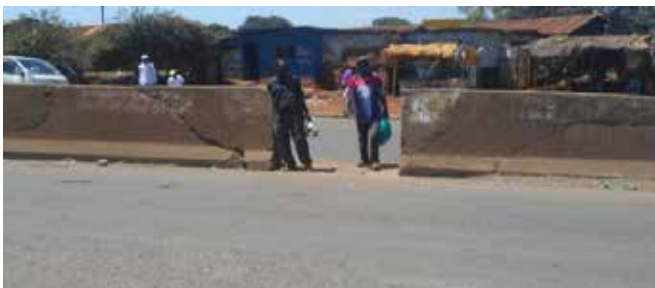
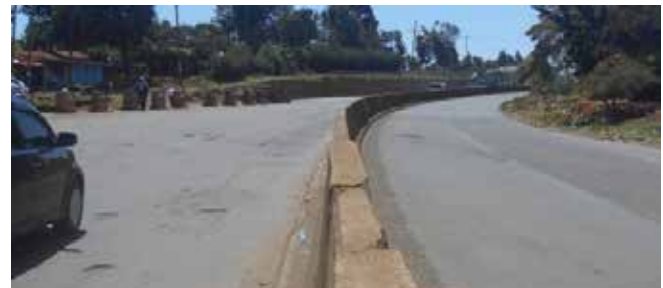
93. Gitaru

This is a 100 meter road section that has a sharp bend on a steep slope, an intersection, a market center and pot holes on one side of the dual carriage way. The median wall is damaged and there are speed limit signs. The reason for the black spot is speeding motorists and unsafe pedestrian crossing. Crashes happen at all hours of the day, throughout the week, and during the wet and dry seasons. Vehicles mostly involved in crashes are personal cars (saloons), mini buses - includes PSVs and vans, large buses, light and medium trucks, heavy commercial vehicles, and motorcycles. Crash victims are taken to Kikuyu Mission Hospital.

Picture: Part of Gitaru road section

Engineering - road design/furniture/features	Enforcement - law	Education - Road user awareness
<ul style="list-style-type: none"> Mark the road. Construct a bus stop. Repair damaged guard rail and median wall. 	<ul style="list-style-type: none"> Enforce speed limit compliance. 	<ul style="list-style-type: none"> Educate pedestrians on safe crossing and motorists on driving safely.

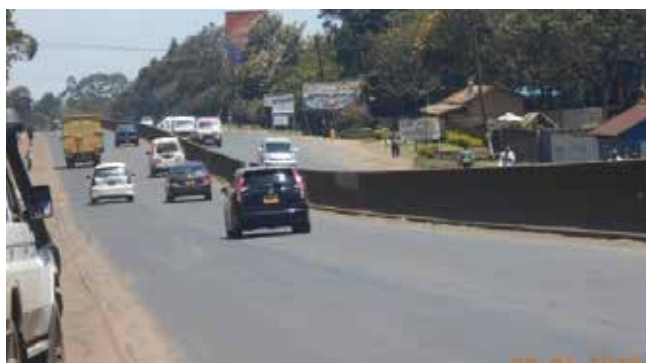
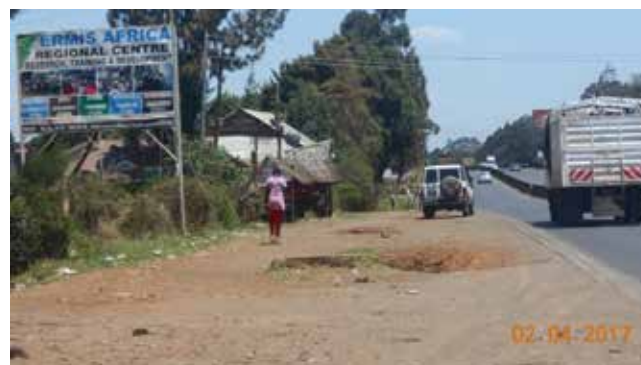
94. Sigona

This is a 100 meter section along a straight stretch on Waiyaki way at Sigona. There are no road signs or markings. The reason for black spot is speeding motorists, undesignated bus stops, and unsafe pedestrian crossing. Crashes happen throughout the week, during the day and night. Vehicles mostly involved in crashes are personal cars (saloons), mini buses - includes PSVs and vans, large buses, light and medium trucks, heavy commercial vehicles, and motorcycles. Crash victims are taken to Kikuyu Mission Hospital.

Picture: Part of Sigona area road section

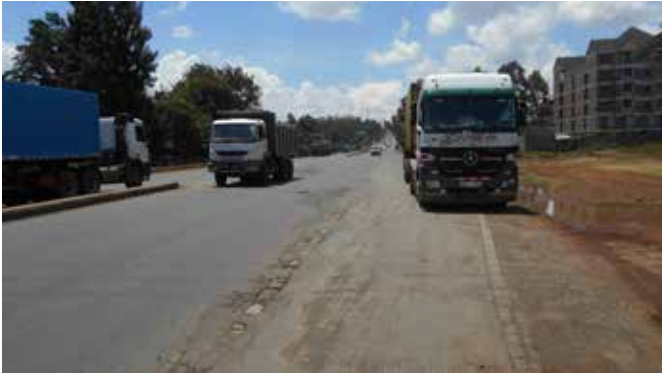
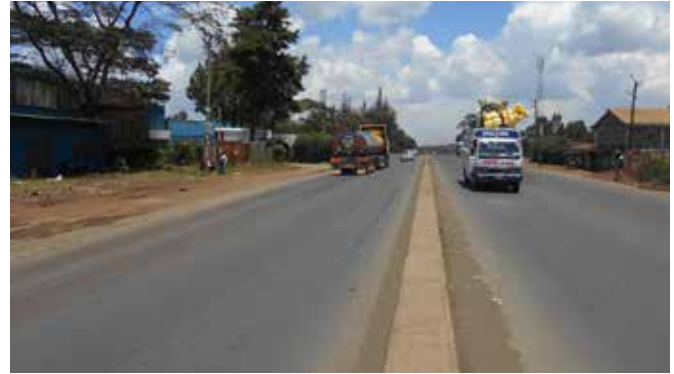
95. Kiambaa

This is a 0.7 kilometer section along a straight stretch on Waiyaki way at Sigona. There are no road signs or markings. The reason for black spot is speeding motorists, undesignated bus stops, and unsafe pedestrian crossing. Crashes happen throughout the week, during the day and night. Vehicles mostly involved in crashes are personal cars (saloons), mini buses - includes PSVs and vans, large buses, light and medium trucks, heavy commercial vehicles, and motorcycles. Crash victims are taken to Kikuyu Mission Hospital.

Picture: Part of Kiimbaa road section

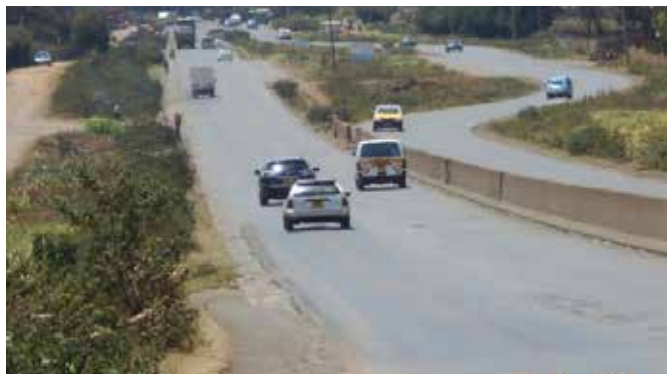
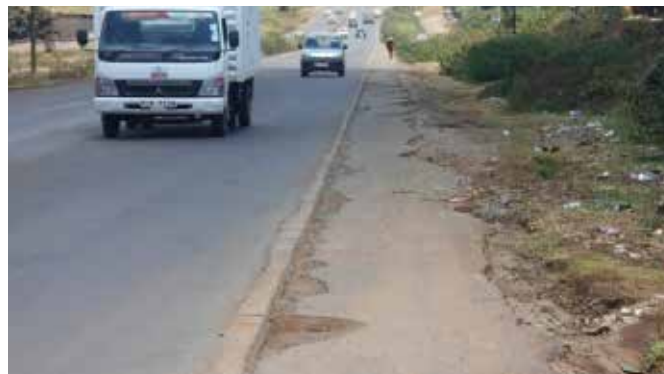
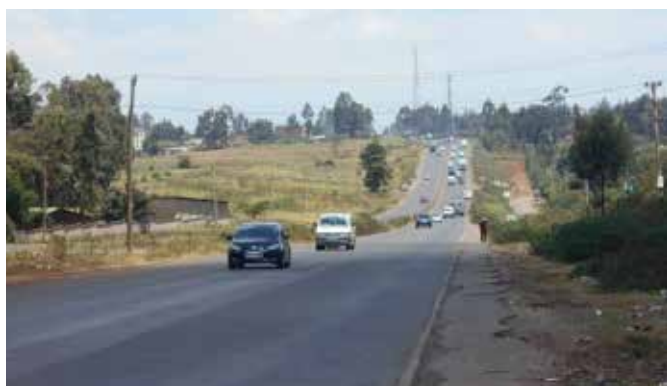
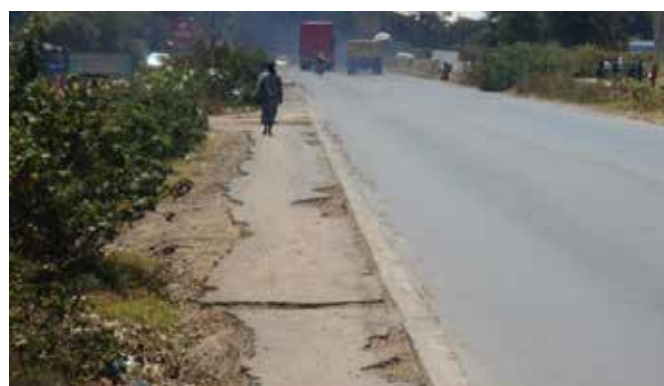
This is a 100 meter section of road along Northern Corridor before Rironi at in both sides of the dual carriageway. It has a straight stretch and curve on a gentle slope with intersections. There are no road signs and markings. The road is uneven with worn out shoulder and potholes.

The key reason for the black spot is speeding motorist and unsafe pedestrian crossing. Crashes happen throughout the week but mostly during daytime in the dry and wet season. Vehicles mostly involved in crashes are personal cars (saloons), mini buses - includes PSVs and vans, and heavy commercial vehicles. Crash victims are taken to Kikuyu Mission Hospital.

Picture: Acre Tano section

Engineering - road design/furniture/features	Enforcement - law	Education - Road user awareness
<ul style="list-style-type: none"> • Instal appropriate road marking. • Erect a speed limit sign. • Repair the road shoulder. • Repair uneven road surface. • Designate pedestrian crossing points. 	<ul style="list-style-type: none"> • Enforce speed limit compliance. 	<ul style="list-style-type: none"> • Educate pedestrians on safe crossing and motorists on driving safely.

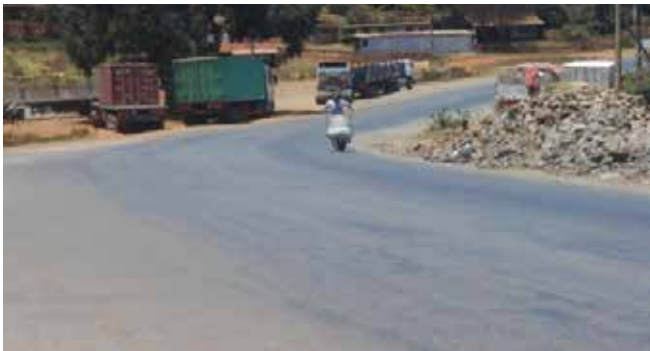
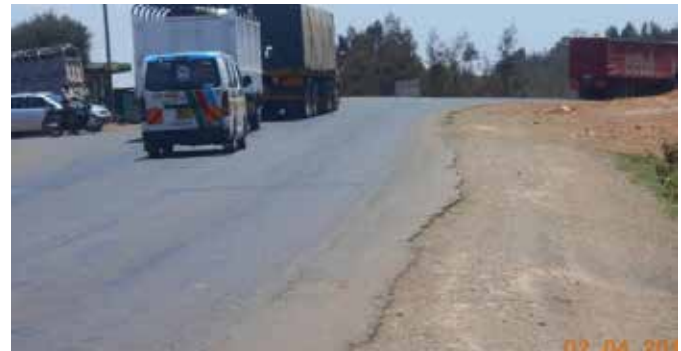
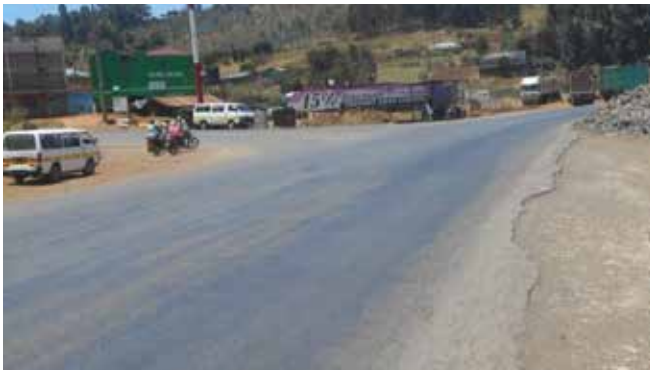
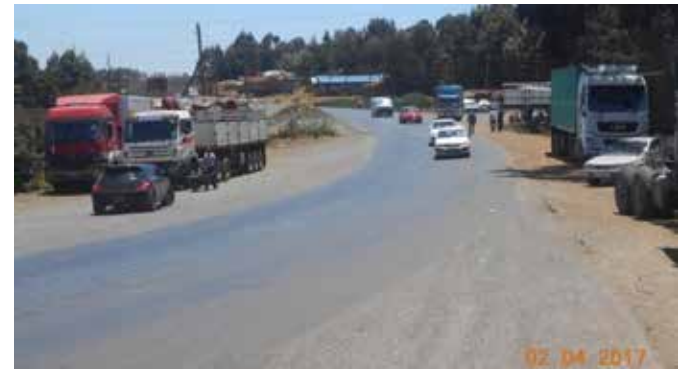
97. Mai Mahiu-Limuru Road Interchange

This is a 0.4-kilometer road section on a straight stretch with interchanges into Mai Mahiu and Limuru. There are neither road markings nor signs. The reason for the black spot is speeding motorists, careless driving and entry into and out of the interchange. There is an undesignated truck stop-over at Matarakwa near a sharp bend. Crashes happen throughout the week and equally during both day and night in the dry and wet season. Vehicles mostly involved in crashes are personal cars (saloons), light and medium trucks, heavy commercial vehicles and motorcycles. Crash victims are taken to AIC Kijabe Hospital.

Picture: Part of Mai Mahiu – Limuru Road Interchange section

Engineering - road design/furniture/features	Enforcement - law	Education - Road user awareness
<ul style="list-style-type: none"> • Instal appropriate road marking and road signage. • Construct a truck stop. • Repair the road shoulder. 	<ul style="list-style-type: none"> • Enforce speed limit compliance. 	<ul style="list-style-type: none"> • Educate drivers on the dangers of undesignated truck stops, speeding and careless entry and exit at the interchange.

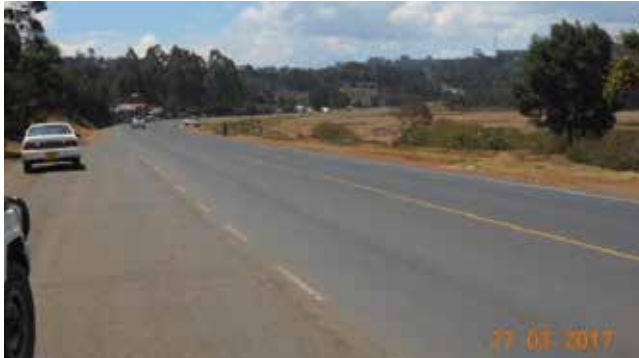
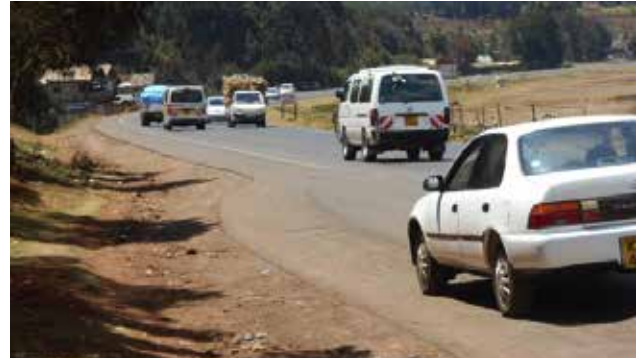
98. Kimende Area

This is 4-kilometer road section towards Naivasha through Kimende area with curves on a gentle slope. There are no road signs. The reason for the black spot is speeding motorists and careless overtaking. Crashes happen throughout the week but mostly during night in the dry and wet season. Vehicles mostly involved in crashes are personal cars (saloons), mini buses - includes PSVs and vans, heavy commercial vehicles and motorcycles. Crash victims are taken to AIC Kijabe Hospital and Kimende Orthodox Mission Hospital.

Picture: Part of Kimende road section

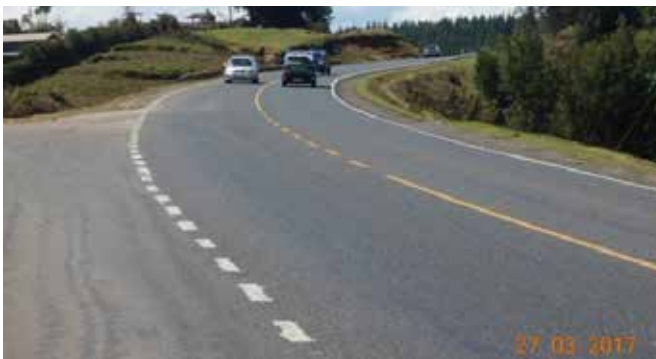
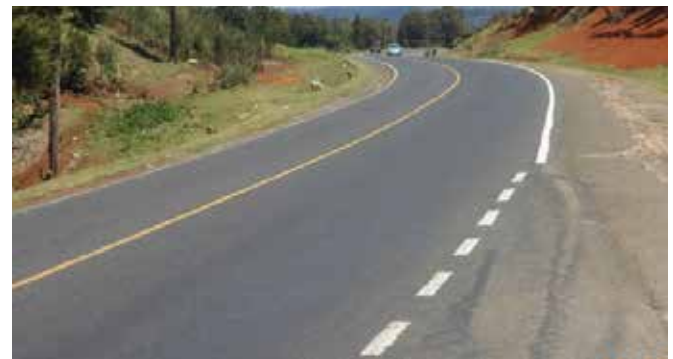
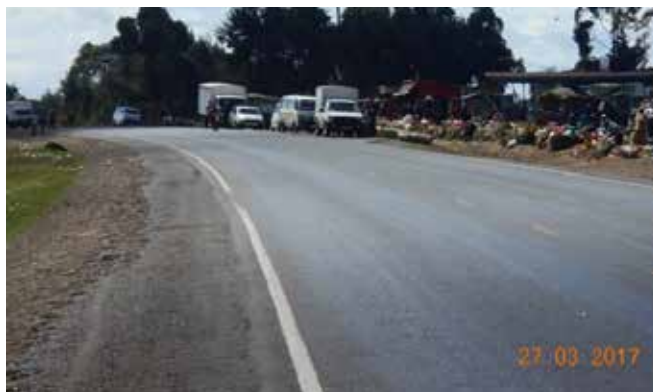
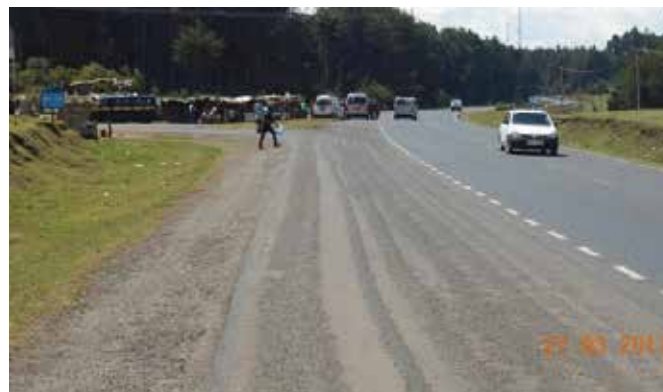
99. Kimende Forest

This is a 0.7 kilometer road section through Kimende forest that has bends and roadside vegetation. There are no road signs. During wet season, the area experiences foggy conditions affecting visibility. The reason for this black spot is speeding motorists and poor visibility during wet season. Crashes happen throughout the week but mostly during the night and during wet seasons. Vehicles mostly involved in crashes are personal cars (saloons), mini buses - including PSVs and vans and heavy commercial vehicles. Crash victims are taken to AIC Kijabe Hospital and Tigoni District Hospital.

Picture: Part of Kimende Forest road section

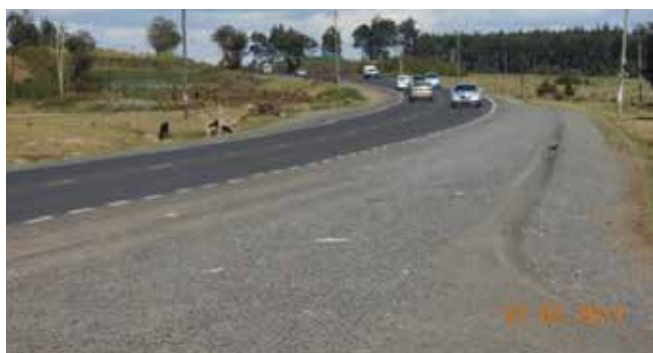
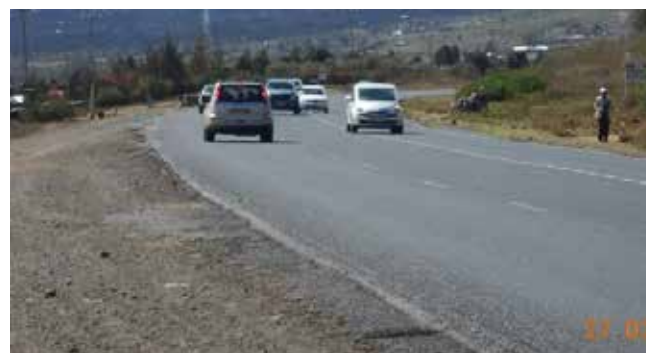
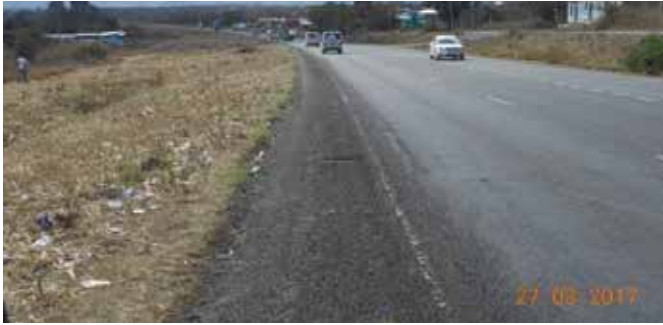
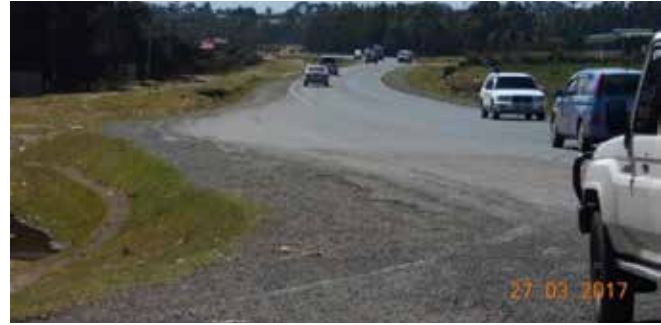
100. Kinungi Steeps

This is a 20.3 kilometer road section through Kinungi area into Naivasha with a series of sharp bends on steep slope, and long straight sections. There are a few road signs at Kinungi and Karai. The reason for the black spot is speeding motorists and careless overtaking. Crashes happen throughout the week but mostly during the night and in wet seasons. In 2016 a fiery crash, on a Saturday night, at Karai claimed over 40 lives. Vehicles mostly involved in crashes are personal cars (saloons), mini buses - includes PSVs and vans, large buses, light and medium trucks, and heavy commercial vehicles. Crash victims are taken to AIC Kijabe Hospital, Naivasha District Hospital and Aga Khan Hospital Medical Center.

Picture: Part of Kinungi Steeps road section

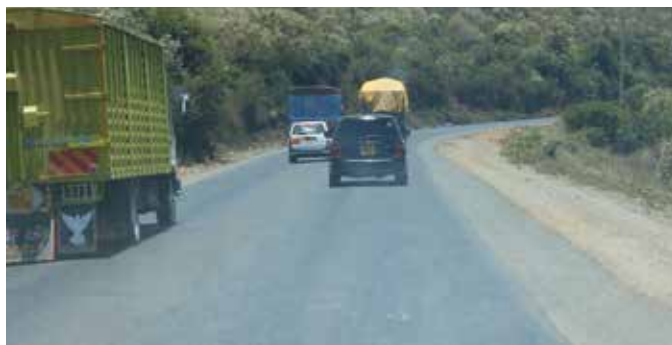
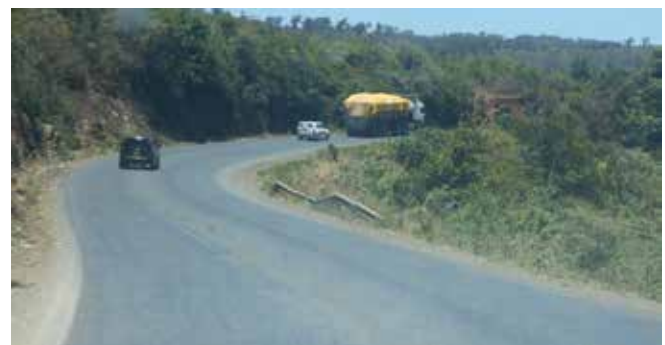
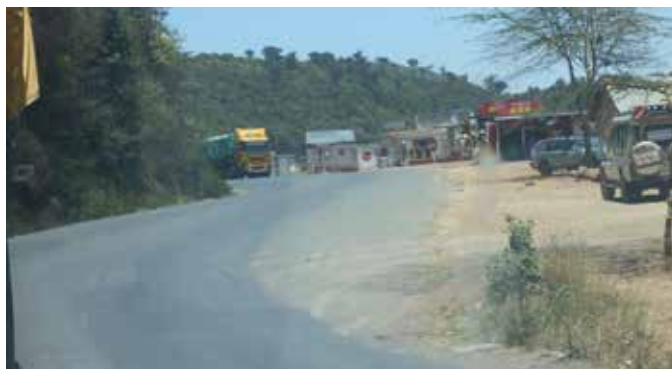
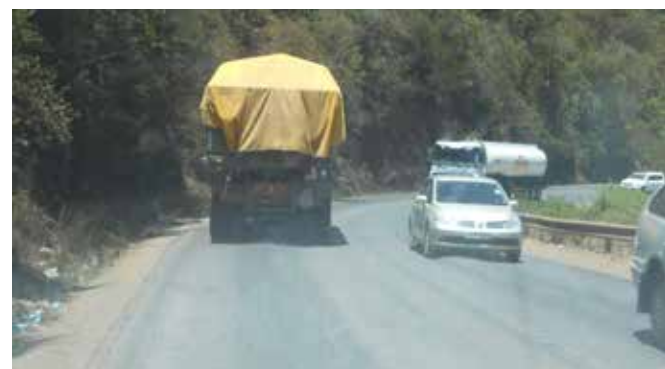
101. Catholic Church-Msikitini

This is a 0.4 kilometer narrow road section heading into Mai Mahiu at the Catholic Church and Msikitini section that has a sharp bend on a very steep slope. The guard rails are damaged. There are no warning signs and the road marking has faded. The reason for the black spot is speeding motorists and careless overtaking. Crashes happen throughout the week but mostly during the night and wet seasons. Vehicles mostly involved in crashes are personal cars (saloons), mini buses - includes PSVs and vans, and heavy commercial vehicles. Crash victims are taken to Naivasha District Hospital

Picture: Part of Catholic Church – Msikitini road section

Engineering - road design/furniture/features	Enforcement - law	Education - Road user awareness
<ul style="list-style-type: none"> • Instal appropriate road signage. • Mark the road. • Repair damaged guard rails. 	<ul style="list-style-type: none"> • Enforce speed limit compliance. 	<ul style="list-style-type: none"> • Educate road users on the danger of careless overtaking and speeding.

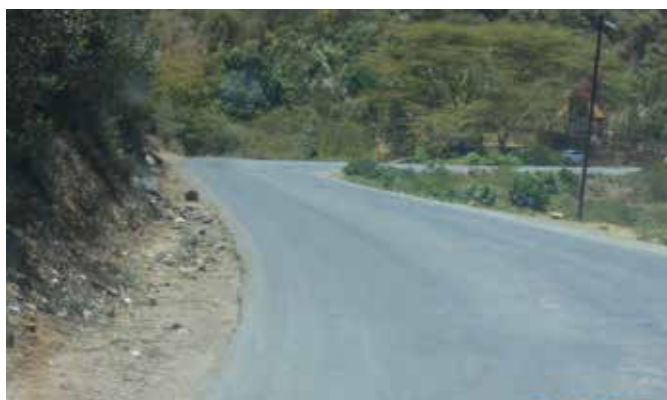
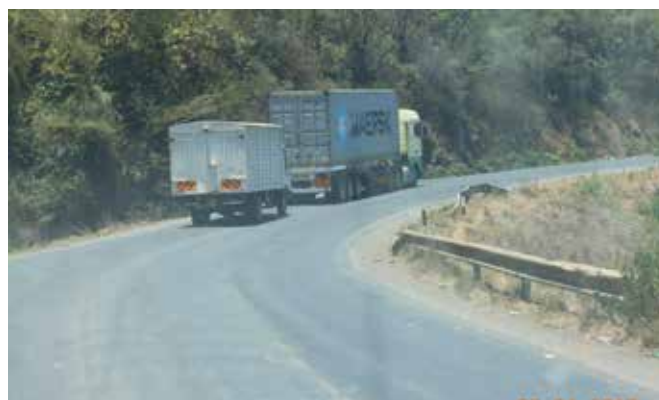
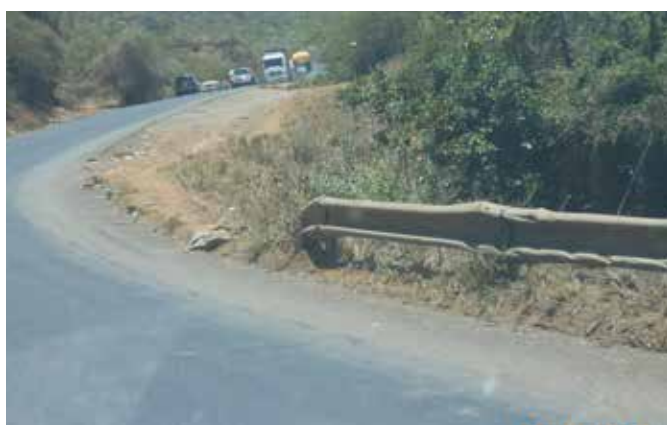
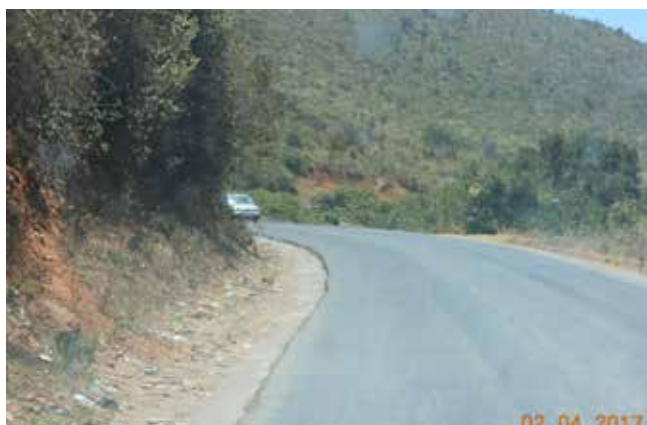
This is a 300 meter road section with a sharp bend on a steep slope on the outskirts of Mai Mahiu town. It has a narrow bridge with damaged guardrails. There are no road markings and signs. The reason for the black spot is careless overtaking and poor visibility due to the bends. Crashes happen throughout the week and through the day and night as well as in both wet and dry seasons.

Picture: Part of Sipemba road section

Engineering - road design/furniture/features	Enforcement - law	Education - Road user awareness
<ul style="list-style-type: none"> • Instal appropriate road signage. • Remark the road. • Repair damaged guard rails. 	<ul style="list-style-type: none"> • Enforce speed limit compliance. 	<ul style="list-style-type: none"> • Educate drivers on the dangers of speeding and careless overtaking.

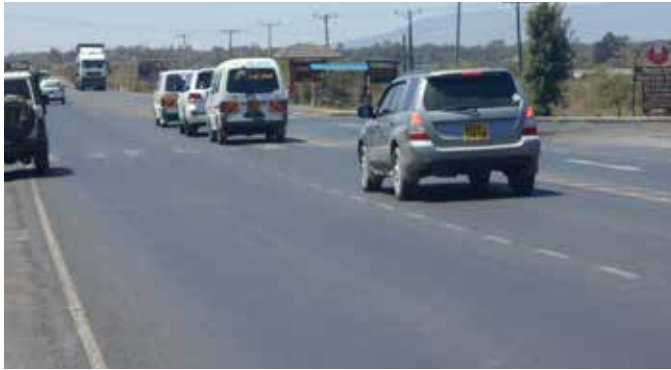
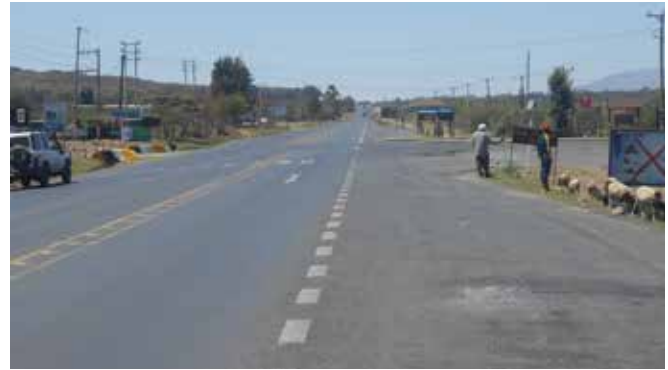
106. Maili Mbili Naivasha

This is a 300 meter road section along a straight stretch on a gentle slope with intersection to Moi South Lake Road. There are no road signs. The reason for the black spot is speeding motorists and careless overtaking. Crashes happen throughout the week, day and night and during both wet and dry seasons. Vehicles mostly involved in crashes are personal cars (saloons), mini buses - includes PSVs and vans, heavy commercial vehicles and motorcycles. Crash victims are taken to Naivasha District Hospital and AIC Kijabe Mission Hospital.

Picture: Part of Maili Mbili Naivasha road section
