Northern Corridor and Nairobi County Route Hazard Mapping Report

May 2017

Developed by Safe Way Right Way and National Transport and Safety Authority

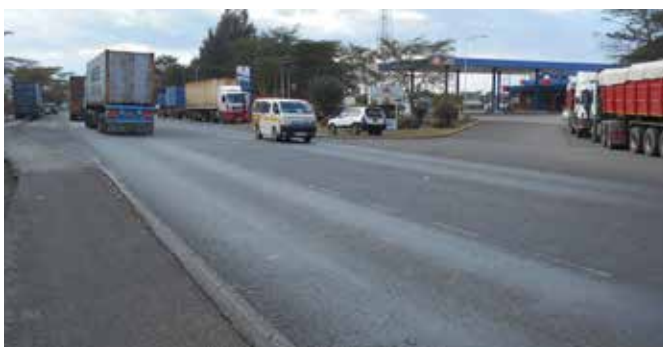
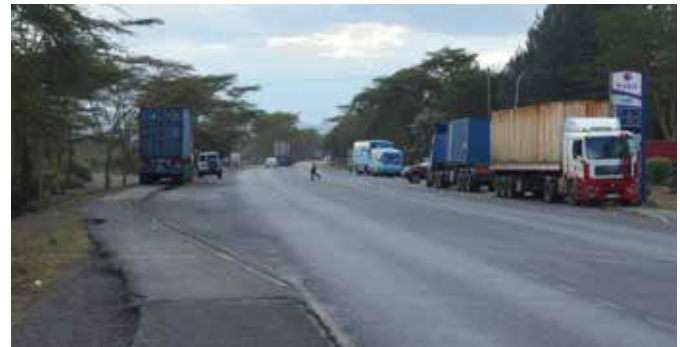
107. Delamere (near Kenol Petrol Station)

This is a 3.1 kilometer road section along a straight stretch passing near Kenol Petrol Station. There signs warning motorists to slow down. The road marking is faded. The reason for the black spot is speeding motorists. Crashes happen throughout the week, during the day and night, and during both wet and dry seasons. Vehicles mostly involved in crashes are personal cars (saloons), light and medium trucks, and heavy commercial vehicles. Crash victims are taken to Naivasha District Hospital.

Picture: Part of Delamere near Kenol road section

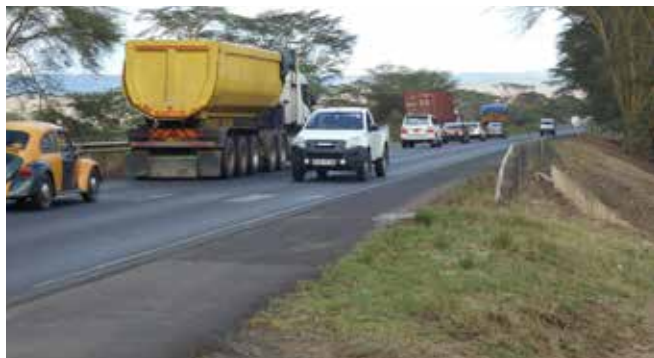
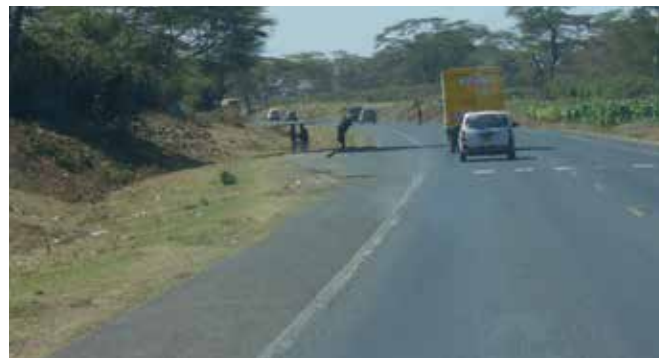
108. Delamare B (Near KCC market)

This is a 0.7 kilometer road section with a bend and a bridge at Delamere near Kenya Cooperative Creameries market. There are no road signs, the road marking is faded and the guardrails at the bridge are damaged. The reason for the black spot is speeding motorists and poor visibility at the bend caused by the tall acacia trees on the road side. Crashes happen throughout the week, during the day and night, and also mostly during wet seasons. Vehicles mostly involved in crashes are personal cars (saloons), light and medium trucks, and heavy commercial vehicles. Crash victims are taken to Naivasha District Hospital and AIC Kijabe Mission.

Picture: Part of Delamare B. road section

Engineering - road design/furniture/features	Enforcement - law	Education - Road user awareness
<ul style="list-style-type: none"> Mark the road. Repair the damaged road section. 	<ul style="list-style-type: none"> Use speed gun to enforce compliance to speed limits. 	<ul style="list-style-type: none"> Educate motorists on driving safely and dangers of speeding.

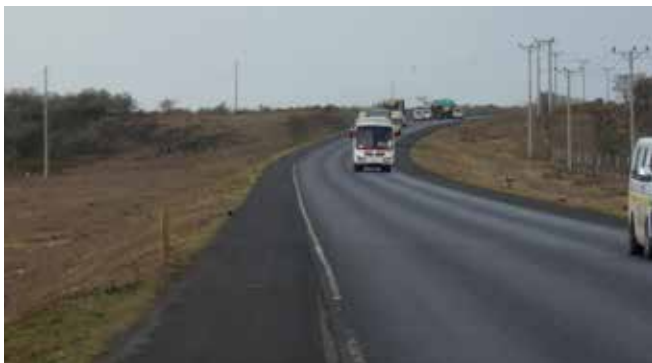
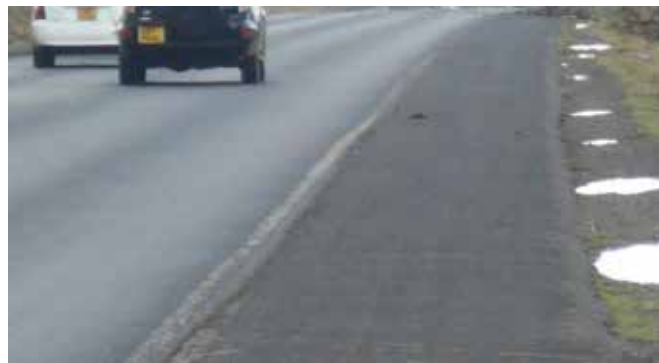
109. Marula Delamere

This is a 1 kilometer road section that has curves on a gentle slope with warning signs. The road marking is faded and is not visible in the dark and during the wet season. The reason for the black spot is speeding motorists and careless overtaking. Crashes happen throughout the week and equally during day and night but mostly during wet seasons. Vehicles mostly involved in crashes are personal cars (saloons), light and medium trucks, and heavy commercial vehicles. Crash victims are taken to Naivasha District Hospital.

Picture: Part of Marula Delamere road section

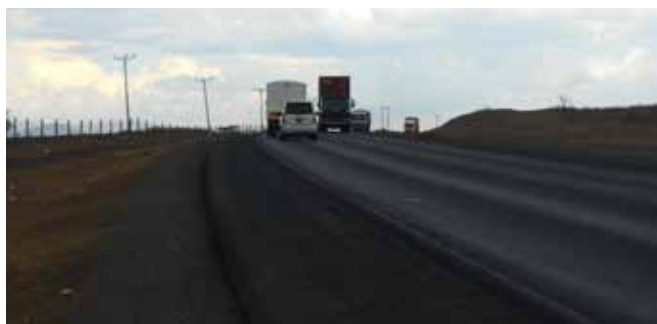
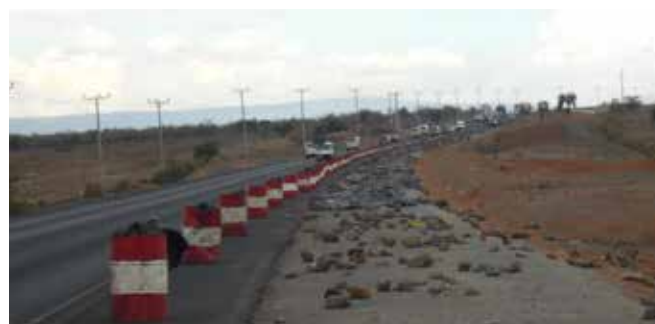
110. Kigio

This is a 3.1 kilometer road section that has sharp bends on a gentle slope, and a brow of a hill in Kigio ranch before the weighbridge. Road construction is ongoing near the weighbridge to expand the road. The road marking is faded and there are no road signs. The reason for the black spot is speeding motorists and careless overtaking. Crashes happen throughout the week and equally during day and night and equally during wet and dry seasons. Vehicles mostly involved in crashes are personal cars (saloons), light and medium trucks, and heavy commercial vehicles. Crash victims are taken to St. Mary's Hospital.

Picture: Part of Kigio road section

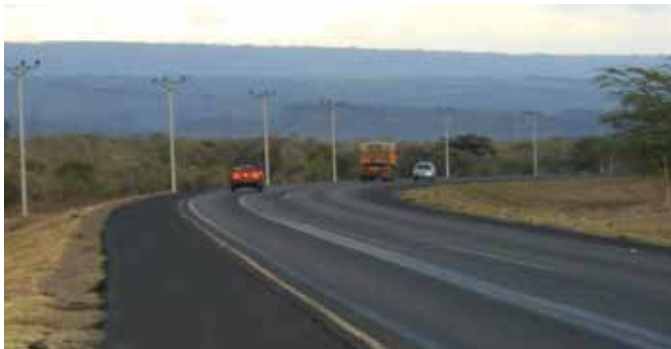
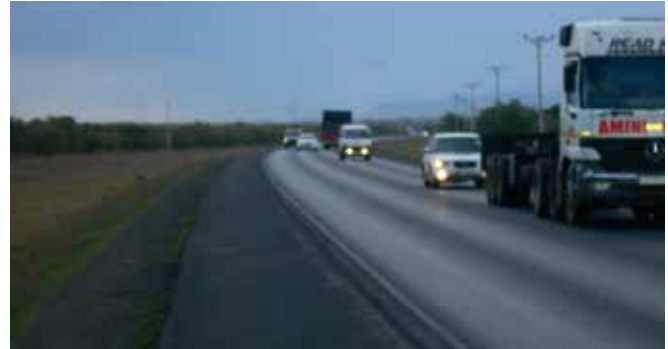
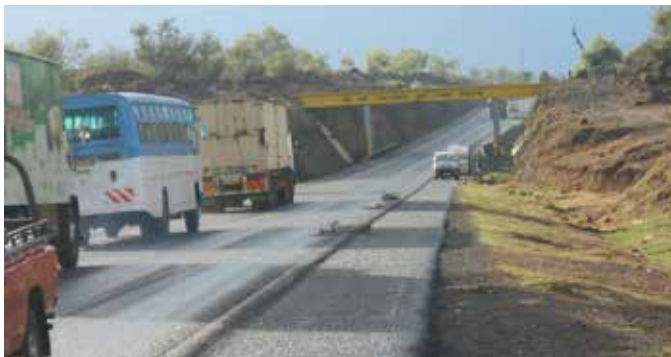
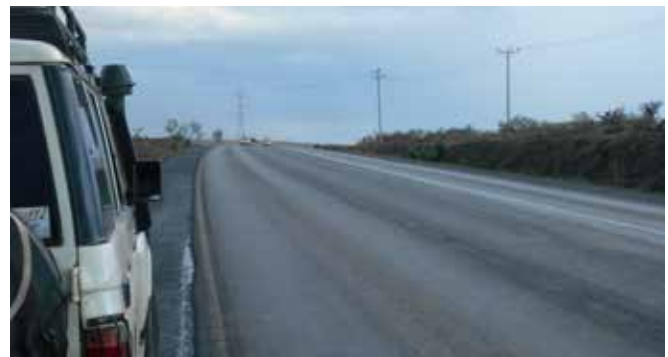
111. Gilgil Railway flyover

This is a 4.3 kilometer road section that has long sharp bends on a gentle slope, a brow of a hill, and a narrow section at the railway fly over. There are a number of cases of drunken driving. The road marking is faded and invisible during the wet season. There is a climbing lane after the footbridge on a blind spot bend where vehicles descending often overtake carelessly. There are no road signs. The reason for the black spot is speeding motorists, drunken driving and careless overtaking. Crashes happen mostly over the weekend, at night and during wet seasons. Vehicles mostly involved in crashes are personal cars (saloons), and heavy commercial vehicles. Crash victims are taken to St. Mary's Hospital.

Picture: Part of Gilgil railway flyover road section

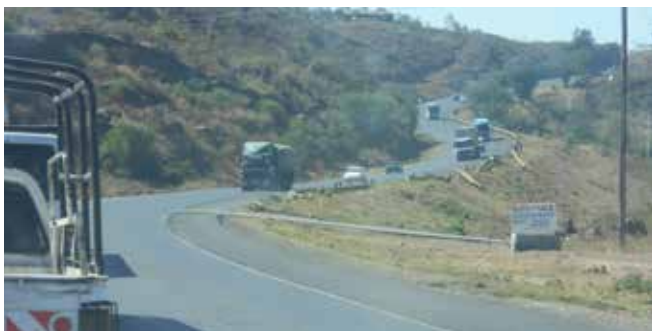
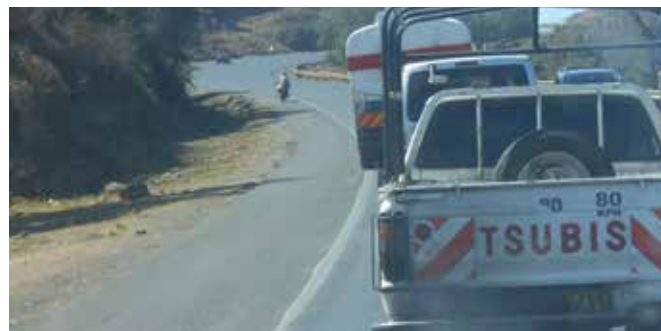
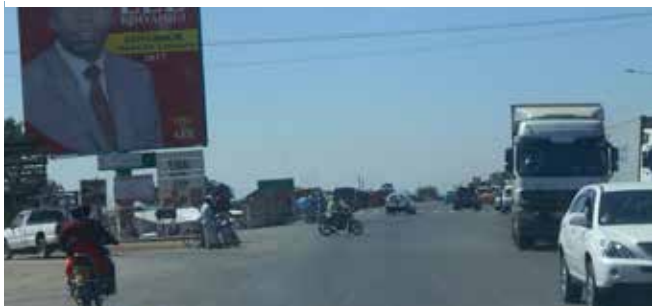
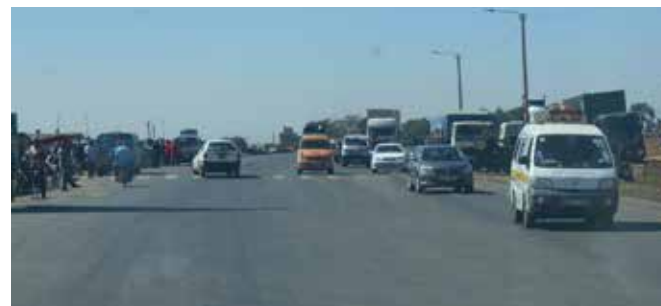
112. Gilgil Junction – St. Mary's Hospital

This is a 7 kilometer road section that has steep slopes on sharp bends, intersections, a busy Kikopey market center and a rest- stop for heavy commercial vehicles. There are no road signs. The reason for the black spot is speeding motorists, careless overtaking, and unsafe pedestrian crossing at the market and hospital junction. Crashes happen throughout the week, both day and night and during both dry and wet seasons. Vehicles mostly involved in crashes are personal cars (saloons), light and medium trucks, heavy commercial vehicles and motorcycles. Crash victims are taken to St. Mary's Hospital.

Picture: Part of Gilgil Junction – St. Mary's Hospital road section

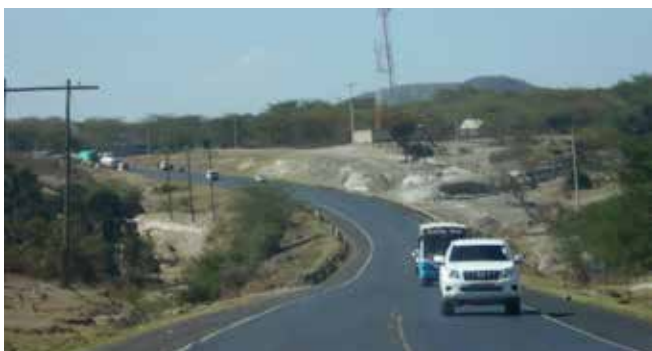
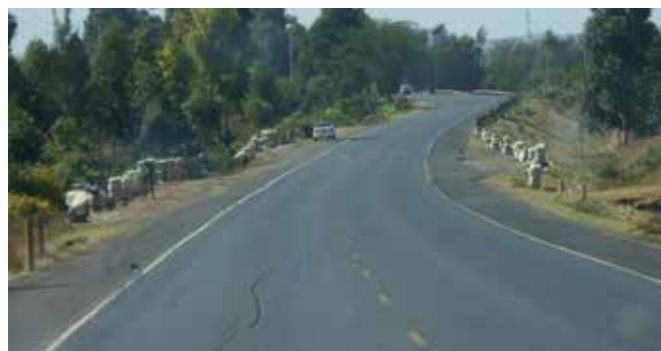
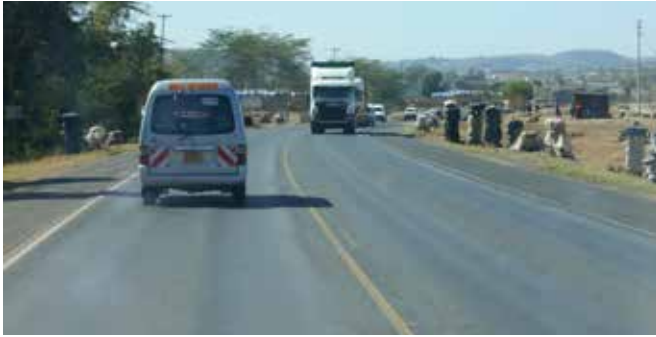
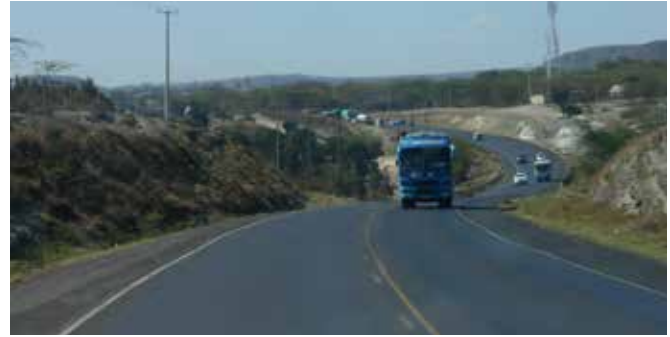
113. Karura – St. Mary's Hospital

This is a 3.5 kilometer road section with steep slopes and bends. There are no road signs and the guardrails are damaged in some sections. There are many roadside traders. The reason for the black spot is speeding motorists and careless overtaking. Crashes happen throughout the week, during the day and night, and in dry and wet seasons. Vehicles mostly involved in crashes are personal cars (saloons), mini buses (PSVs and vans), light and medium trucks, and heavy commercial vehicles. Crash victims are taken to Nakuru Provincial General Hospital and St. Mary's Hospital.

Picture: Part of Karura – St. Mary's Hospital road section

Engineering - road design/furniture/features	Enforcement - law	Education - Road user awareness
<ul style="list-style-type: none"> • Instal appropriate signage. • Repair damaged guard rails. 	<ul style="list-style-type: none"> • Enforce speed limit compliance. 	<ul style="list-style-type: none"> • Educate motorists on the dangers of speeding and careless overtaking.

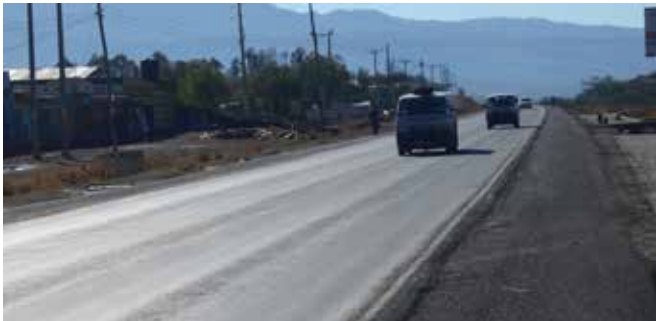
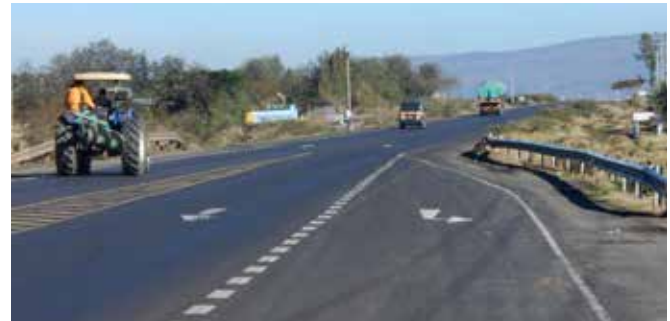
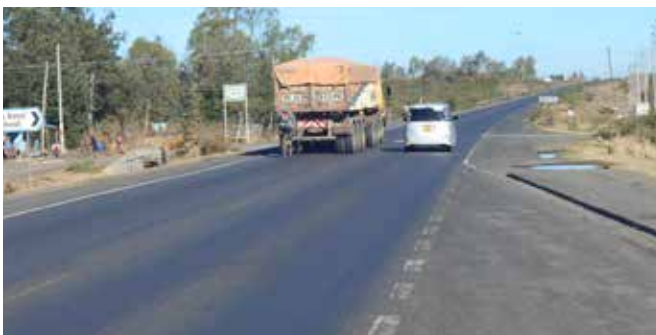
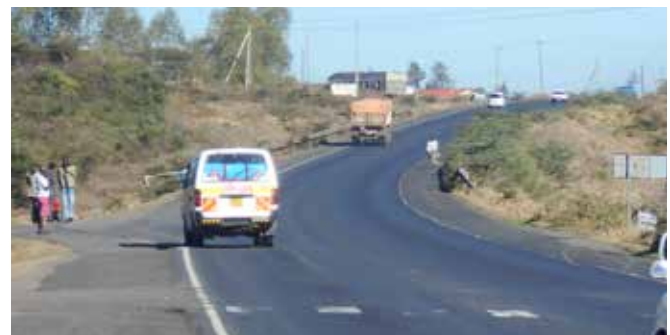
114. Mbaruk Nakuru

This is a 2.7 kilometer road section with a sharp bend on a gentle slope, and a market center. There are no road signs. The reason for the black spot is speeding motorists. Crashes happen throughout the week, during the day and night, and also in the dry and wet seasons. Vehicles mostly involved in crashes are personal cars (saloons), light and medium trucks, and heavy commercial vehicles. Crash victims are taken to Nakuru Provincial General Hospital, Mediheal Hospital, Nakuru and St Mary's Hospital.

Picture: Part of Mbaruk – Nakuru road section

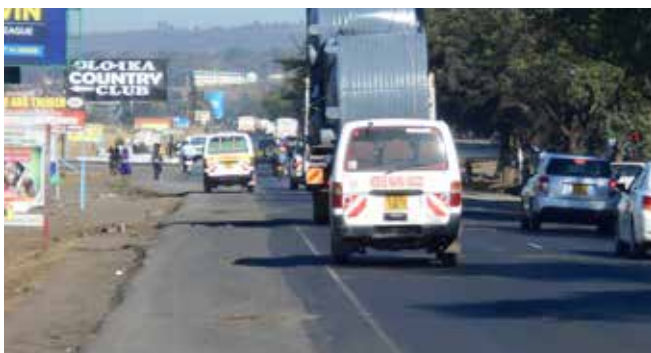
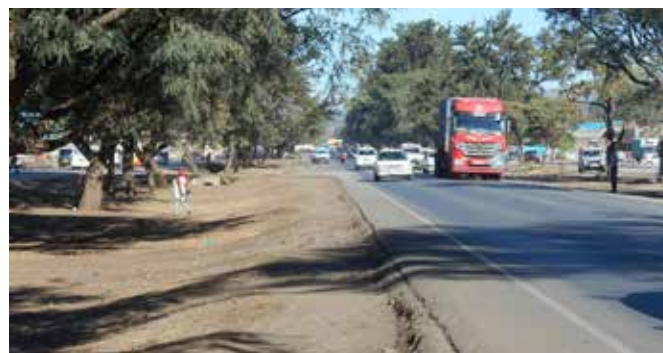
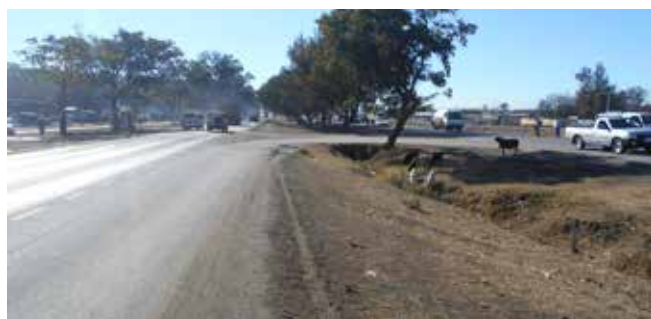
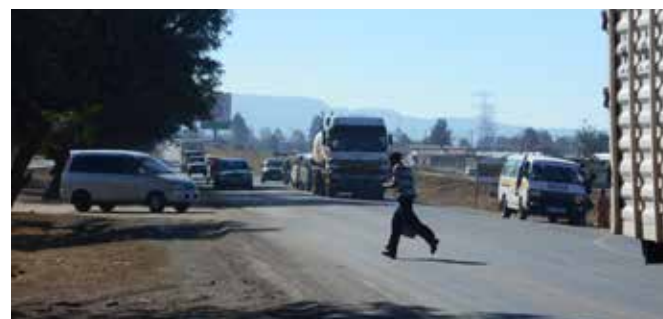
115. Free Area Nakuru

This is a 1.1 kilometer road section into Nakuru town at Free Area, along a straight stretch on gentle slope. It is a dual carriage way, and the blackspot is on both sides. There are no road signs but speed bumps exist. The reason for the black spot is speeding motorists, unsafe pedestrian crossing, and undesignated bus stops. Crashes happen mostly on weekdays but also during the day and night, and in dry and wet seasons. Vehicles mostly involved in crashes are personal cars (saloons), mini buses (PSVs and vans), heavy commercial vehicles and motorcycles. Crash victims are taken to Nakuru War Memorial, Medihealth Hospital, Nakuru and St. Mary's Hospital.

Picture: Part of Free Area road section

Engineering - road design/furniture/features	Enforcement - law	Education - Road user awareness
<ul style="list-style-type: none"> • Instal appropriate signage for bumps, turnings, and hazards. • Construct bus stops. • Designate pedestrian crossings. 	<ul style="list-style-type: none"> • Enforce speed limit compliance. 	<ul style="list-style-type: none"> • Sensitize pedestrians on road safety and motorists on slowing down in this area

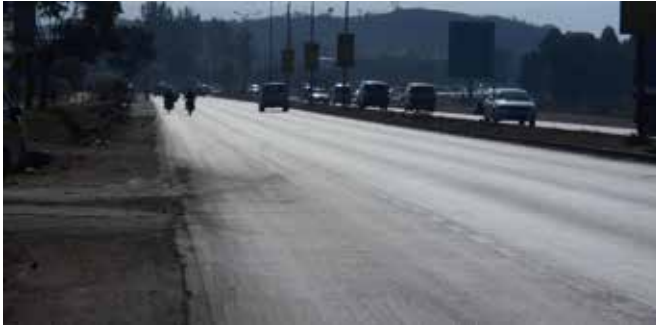
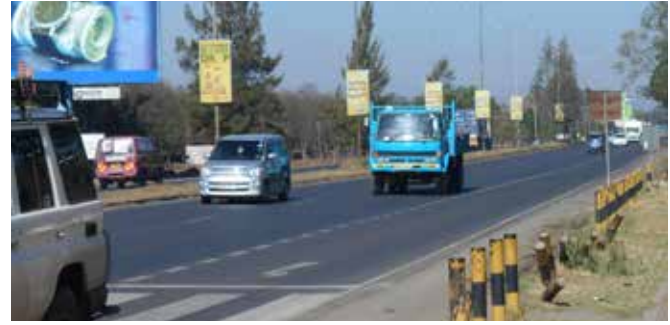
116. State Lodge - Naivas

This is a 1 kilometer road section on the dual carriage along a straight stretch with junctions near the State Lodge and Naivas Supermarket. There are no road signs. The reason for the black spot is unsafe pedestrian crossing, speeding motorists and careless overtaking. Crashes happen mostly on weekdays, during the day and night, and in the dry and wet seasons. . Vehicles mostly involved in crashes are personal cars (saloons), mini buses (PSVs and vans), large buses, and light and medium trucks. Crash victims are taken to Nakuru Provincial General Hospital.

Picture: Part of State lodge - Naivas road section

Engineering - road design/furniture/features	Enforcement - law	Education - Road user awareness
<ul style="list-style-type: none"> • Instal appropriate signage for hazards. • Instal speed bumps and mark faded sections. • Designate more pedestrian crossings. 	<ul style="list-style-type: none"> • Enforce speed limit compliance. 	<ul style="list-style-type: none"> • Sensitize pedestrians on road safety and using designated crossing points. • Educate motorist on safe speed and overtaking.

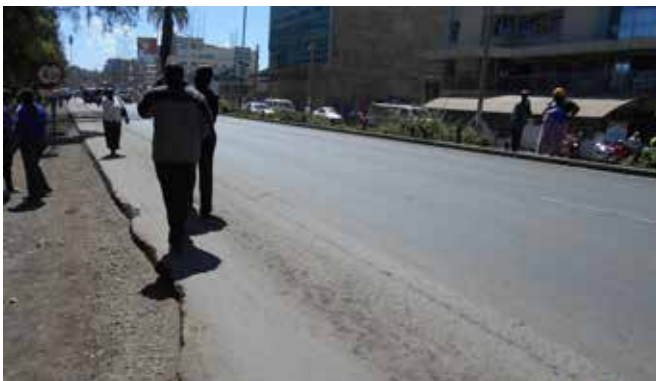
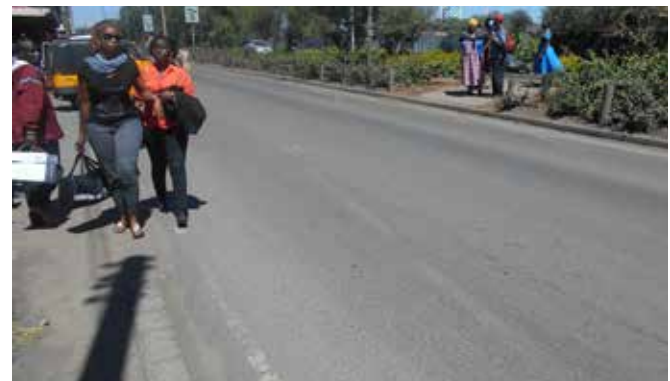
117. Geoffrey Kamau Road

This is a 0.8 kilometer road section on the dual carriage along a straight stretch. There are few road signs and undesignated bus stops. The reason for the black spot is unsafe pedestrian crossing, drunken pedestrians, and speeding motorists. Crashes happen throughout the week, mostly at night, during both the dry and wet seasons. Vehicles mostly involved in crashes are personal cars (saloons), mini buses (PSVs and vans), large buses, and light, medium trucks, heavy commercial vehicles and motorcycles. Crash victims are taken to Nakuru Provincial General Hospital.

Picture: Part of Geoffrey Kamau road section

Engineering - road design/furniture/features	Enforcement - law	Education - Road user awareness
<ul style="list-style-type: none"> • Instal appropriate signage for hazards and speed limit. • Instal speed bumps. • Designate more pedestrian crossings and bus stops. 	<ul style="list-style-type: none"> • Enforce speed limit compliance. • Control PSVs and pedestrians. 	<ul style="list-style-type: none"> • Sensitize pedestrians on road safety and using designated crossing points. • Educate motorist on dangers of speeding

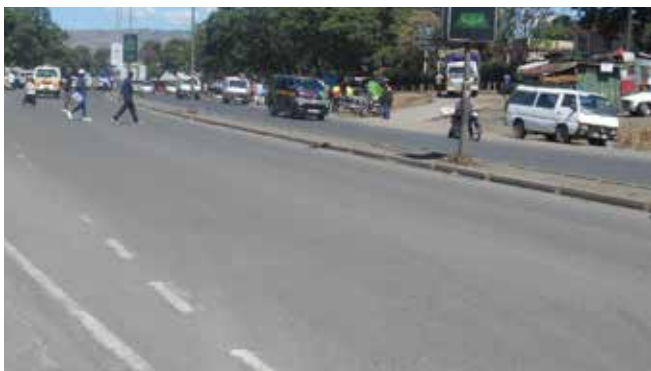
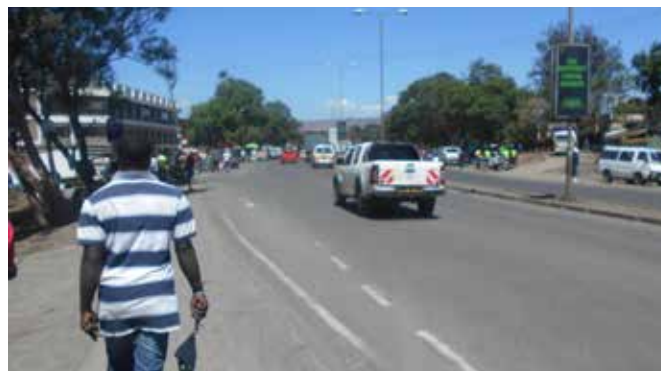
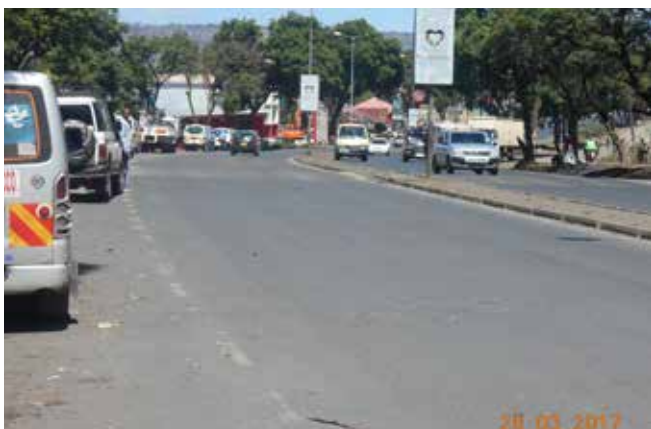
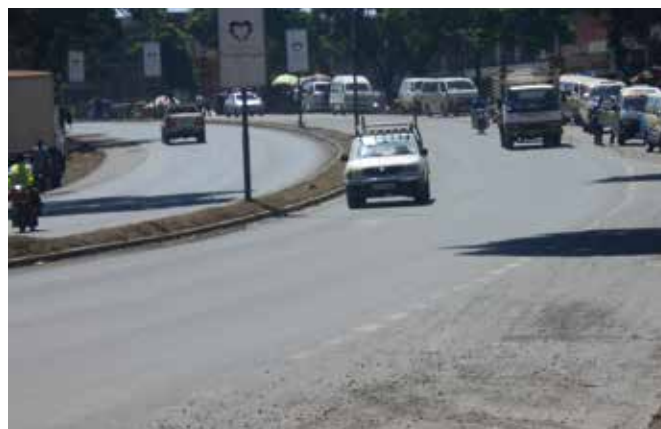
118. Kaloleni Nakuru

This is a 0.5 kilometer road section on the dual carriage along a bend. There are no road signs and it has undesignated bus stops. The reason for black spot is unsafe pedestrian crossing, drunken pedestrians, and speeding motorists. Crashes happen throughout the week mostly at night, and during both dry and wet seasons. Vehicles mostly involved in crashes are personal cars (saloons), mini buses (PSVs and vans), large buses, and light, medium trucks, heavy commercial vehicles and motorcycles. Crash victims are taken to Nakuru Provincial General Hospital and St. Mary's Hospital.

Picture: Part of Kaloleni – Nakuru road section

Engineering - road design/furniture/features	Enforcement - law	Education - Road user awareness
<ul style="list-style-type: none"> • Instal appropriate signage showing hazards and speed limit. • Relocate the bus stop. • Designate pedestrian crossings. • Putting up a footbridge. 	<ul style="list-style-type: none"> • Enforce speed limit compliance. 	<ul style="list-style-type: none"> • Sensitize pedestrians on safe crossing. • Educate motorists on safe speeds looking out for pedestrians especially at night.

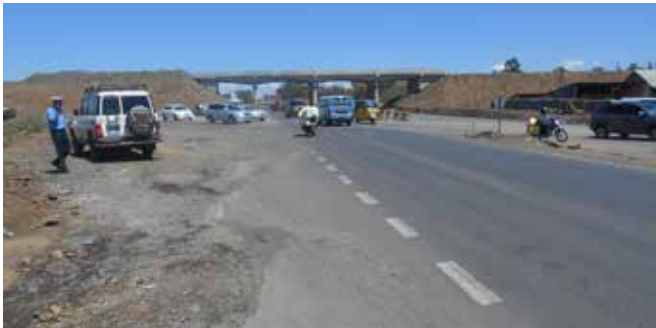
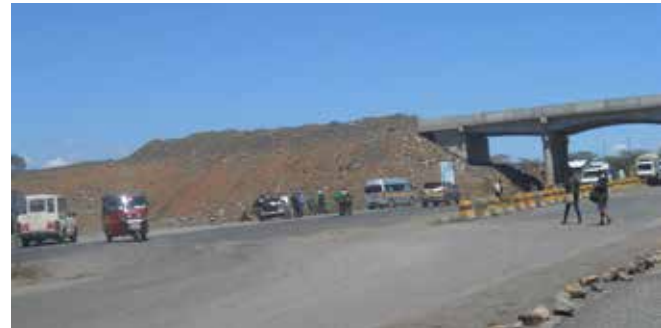
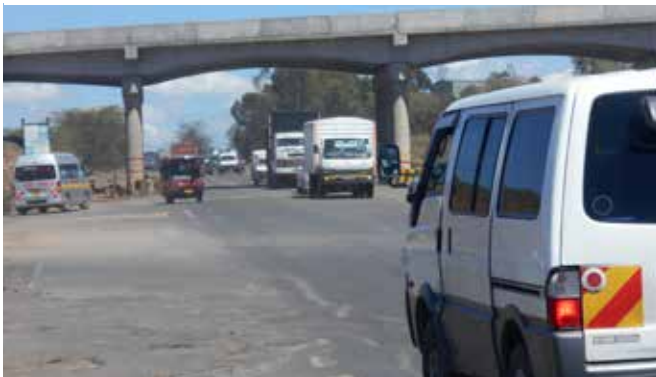
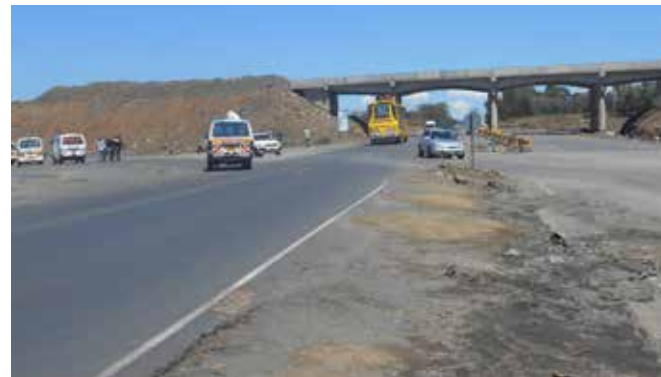
119. Njoro Junction

This is a 1.2-kilometer road section on the dual carriage along a straight stretch with a junction to Njoro. There is an overpass under construction in the area. There are no warning signs. The reason for black spot is speeding motorist, careless overtaking and unsafe pedestrian crossing. This black spot is likely to change once the construction is complete. Crashes happen throughout the week but mostly at night, during both dry and wet seasons. Vehicles mostly involved in crashes are personal cars (saloons), mini buses (PSVs and vans), and heavy commercial vehicles. Crash victims are taken to Nakuru Provincial General Hospital and St Mary's Hospital.

Picture: Part of Njoro Junction road section

Engineering - road design/furniture/features	Enforcement - law	Education - Road user awareness
<ul style="list-style-type: none"> Ensure work site safety is adhered to while construction is ongoing. Instal appropriate signage showing hazards and speed limit during construction. Mark the road once construction is complete. Designate pedestrian crossings. Construct pedestrian walkways. 	<ul style="list-style-type: none"> Enforce speed limit compliance. 	<ul style="list-style-type: none"> Sensitize pedestrian on road safety and motorists to exercise caution while driving through the area under road works.

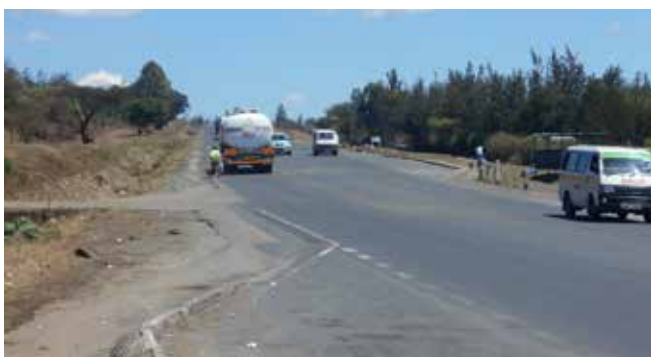
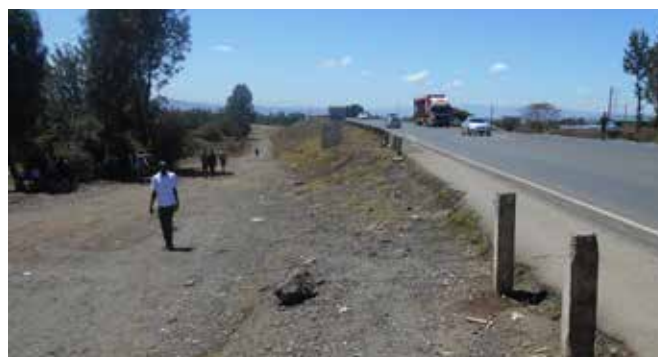
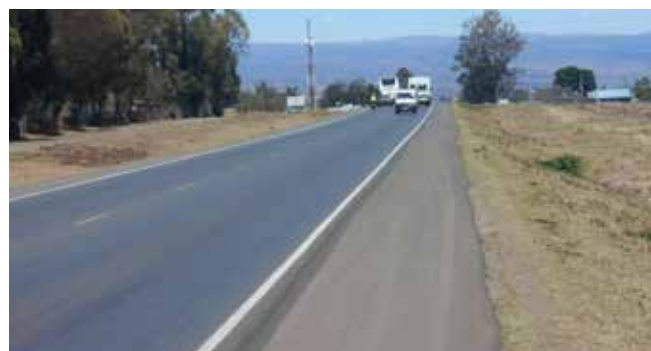
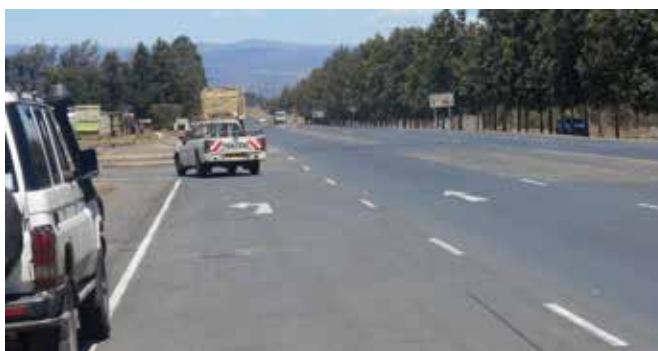
120. Ngata Bridge – Sobea

This is an 8.6 kilometer road section through Ngata Bridge on a gentle slope with intermittent straight road stretches, a series of sharp bends, a bridge, and steep slopes. There are no road signs. The reason for black spot is speeding motorists, careless overtaking on sharp bends and poor visibility due to misty conditions in the wet season. Crashes happen throughout the week but mostly at night and during wet seasons. Vehicles commonly involved in crashes are personal cars (saloons), light and medium trucks, and heavy commercial vehicles. Crash victims are taken to Nakuru Provincial General Hospital and St. Mary's Hospital.

Picture: Part of Ngata Bridge – Sobea road section

Engineering - road design/furniture/features	Enforcement - law	Education - Road user awareness
<ul style="list-style-type: none"> Instal appropriate signage for hazards and speed limit. 	<ul style="list-style-type: none"> Enforce speed limit compliance. 	<ul style="list-style-type: none"> Educate motorists on the risks of speeding, careless overtaking and reduced visibility at night and in misty conditions

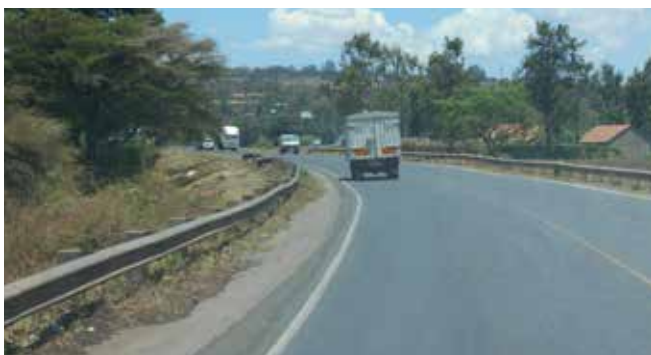
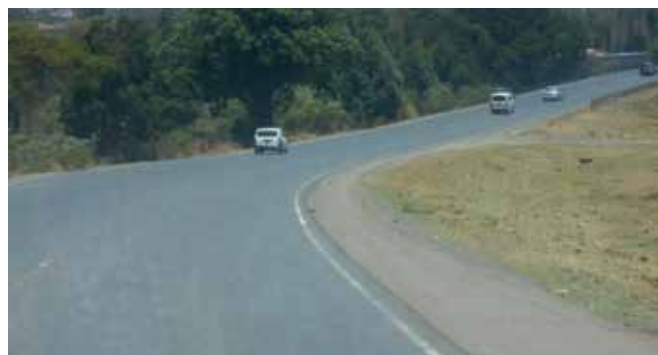
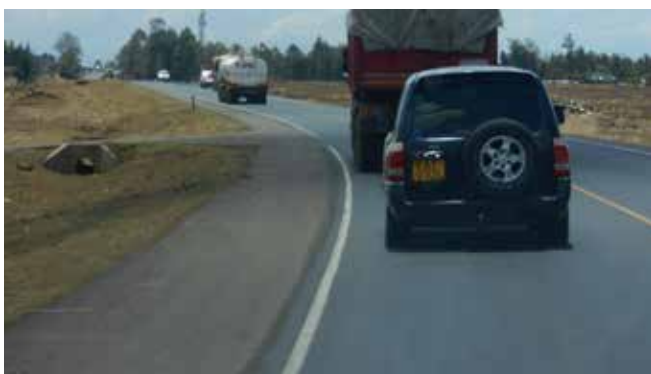
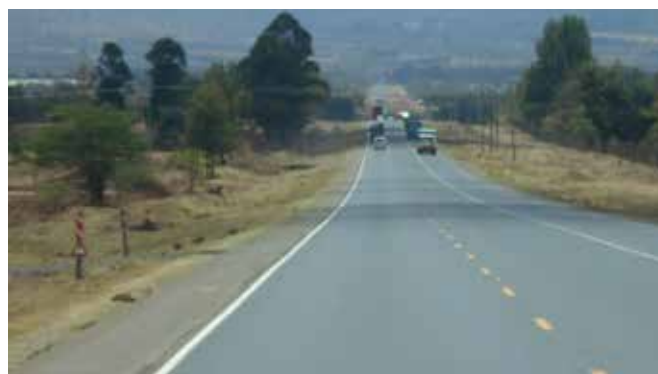
121. Sobeá - Salgaa

This is new black spot on a 9.7 kilometers section of road, through a long straight stretch with a single bend, and brow of a hill. There are slow moving vehicles on the hilly section. Some road sections have cattle crossing. There are no road signs and the road marking has faded. The reason for the black spot is speeding motorists, careless overtaking and unsafe pedestrian crossing. There is inadequate signage. Crashes happen throughout the week but mostly at night and during dry and wet seasons. Vehicles mostly involved in crashes are personal cars (saloons), mini buses (PSVs and vans), large buses, light and medium trucks, and heavy commercial vehicles. Crash victims are taken to Nakuru Provincial General Hospital.

Picture: Part of Sobeá - Salgaa road section

Engineering - road design/furniture/features	Enforcement - law	Education - Road user awareness
<ul style="list-style-type: none"> • Instal appropriate signage showing hazards and speed limit. • Instal a speed camera. 	<ul style="list-style-type: none"> • Enforce speed limit compliance. 	<ul style="list-style-type: none"> • Educate motorists on safe overtaking and danger and dangers of speeding • Educate pedestrians on safe crossing.

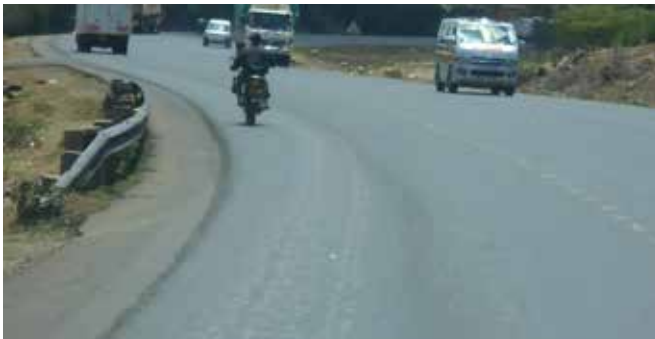
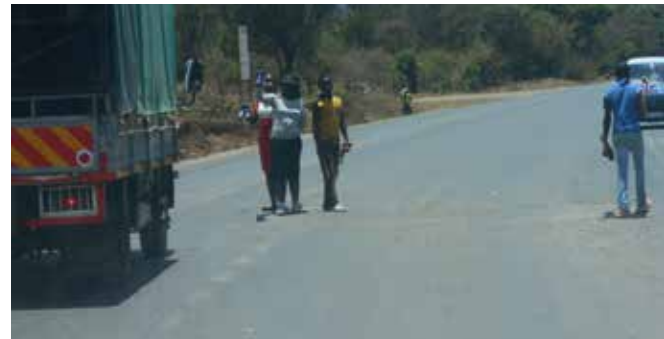
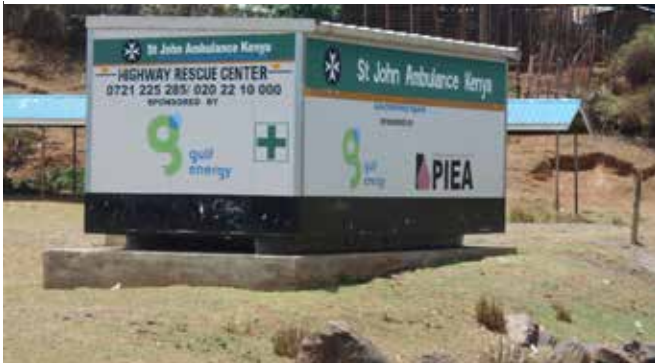
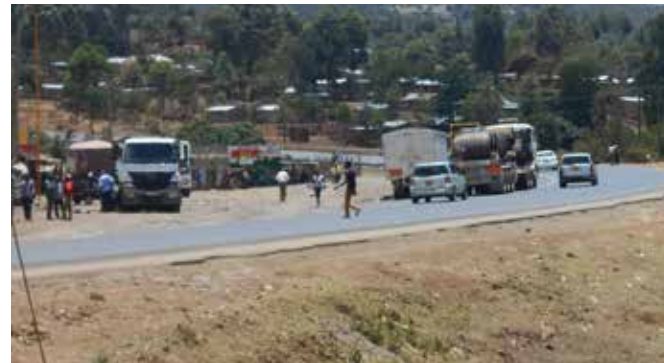
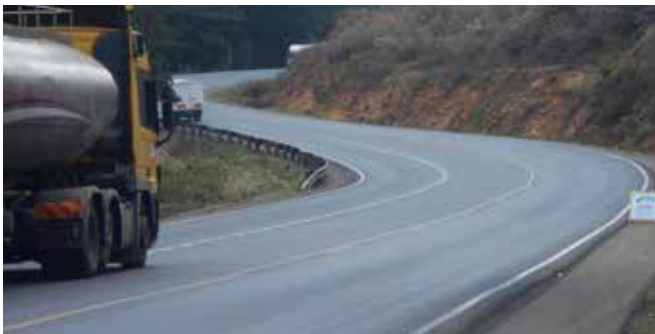
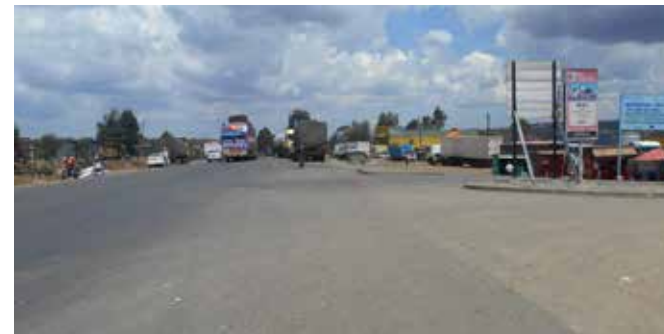
122. Salgaa – GSU Camp

This is a 21 kilometer section of road through a series of sharp bends on steep slopes. There are bridges through Sachanguan area, notorious for one of the worst road crash incident involving a petroleum tanker. The road passes through a forest, and is slippery in wet weather. It also passes on the brow of a hill. There are road signs showing it is a black spot. There are roadside trading points along the road and speed bumps, which are not visible during the night and in wet seasons. There is also an intersection at Kibunja. The reason for the black spot is speeding motorists, careless overtaking and poor visibility due to misty conditions. Crashes happen throughout the week but mostly night and during both wet and dry seasons. Vehicles mostly involved in crashes are personal cars (saloons), mini buses (PSVs and vans), light and medium trucks, and heavy commercial vehicles. Crash victims are taken to Nakuru Provincial General Hospital and Molo Sub-District Hospital. There is a PIEA rescue center located in Salgaa.

Picture: Part of Salgaa – GSU Camp road section

Engineering - road design/furniture/features	Enforcement - law	Education - Road user awareness
<ul style="list-style-type: none"> • Instal appropriate signage showing hazards and speed limit. • Mark the speed bumps with reflectors for visibility at night and in wet seasons. • Repaint the speed bumps. • Designate pedestrian crossing points. 	<ul style="list-style-type: none"> • Enforce speed limit compliance. • Enforce lane compliance. • Relocate roadside traders. 	<ul style="list-style-type: none"> • Sensitize long distance drivers on dangers of free- wheeling • Sensitize roadside traders on road safety. • Educate motorists on risks of speeding and reckless overtaking in bad weather and at night.

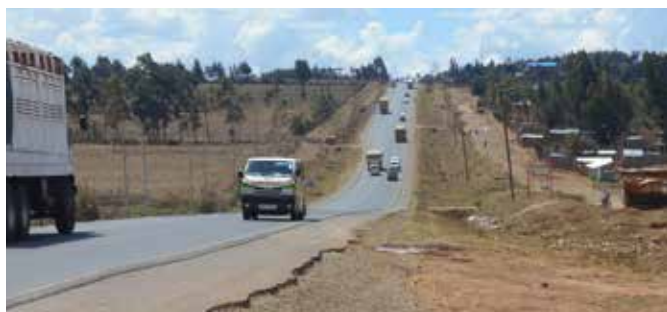
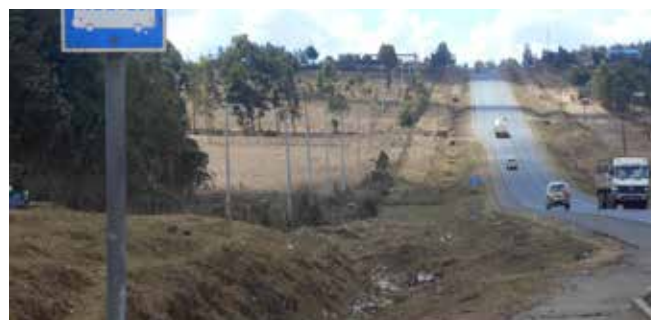
123. Jogoo Area - Mau Summit

This is a new blackspot on a 1-kilometer road section with a brow of a hill and a steep slope with a junction. It passes through Jogoo roadside market. There are no road signs and the road marking has faded. The reason for the black spot is unsafe pedestrian crossing, speeding motorists, careless overtaking, and poor visibility. Crashes happen throughout the week but mostly at night and equally during wet and dry seasons. Vehicles mostly involved in crashes are personal cars (saloons), mini buses (PSVs and vans), and heavy commercial vehicles. Crash victims are taken to Nakuru Provincial General Hospital and Londiani Hospital.

Picture: Part of Jogoo Mau Summit road section

Engineering - road design/furniture/features	Enforcement - law	Education - Road user awareness
<ul style="list-style-type: none"> • Instal appropriate signage for hazards and speed limit. • Designate pedestrian crossing points. 	<ul style="list-style-type: none"> • Enforce speed limit compliance. 	<ul style="list-style-type: none"> • Sensitize pedestrians on road safety. • Educate motorists on dangers of speeding and careless overtaking at night and in bad weather

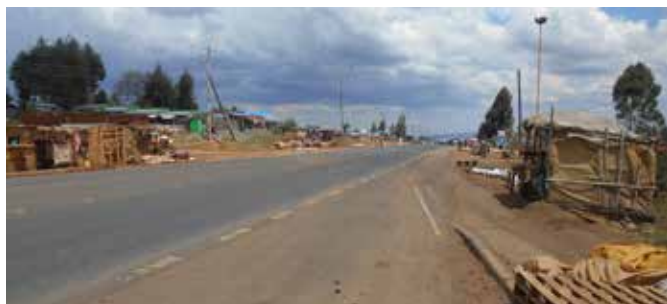
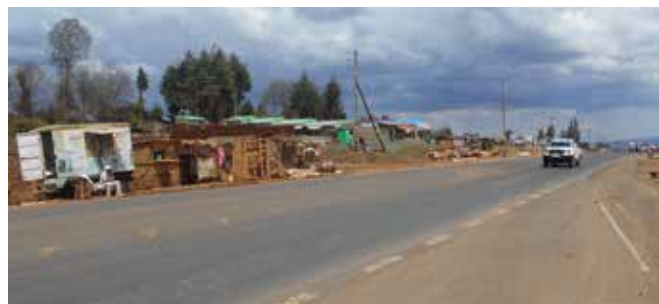
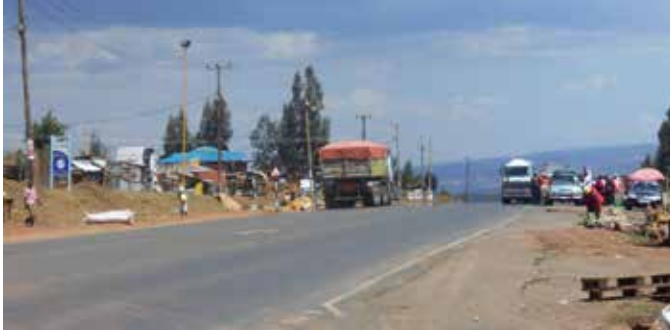
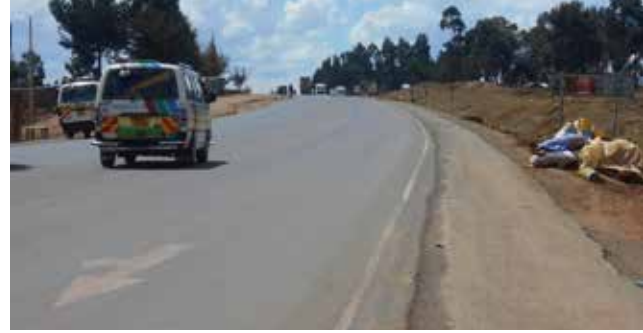
This is a new blackspot on a 0.9 kilometer road section with a steep slope and a junction. It passes through a roadside market at Total Mau Summit. The intersection is currently under construction to create an overpass and has speed bumps. There are no road signs. The reason for the black spot is unsafe pedestrian crossing, drunken pedestrian and inadequate road signage and marking, occasioned by ongoing construction. Crashes happen throughout the week but mostly at night and during both wet and dry seasons.

Vehicles mostly involved in crashes are personal cars (saloons), mini buses (PSVs and vans), large buses, light and medium trucks, and heavy commercial vehicles. Crash victims are taken to Nakuru Provincial General Hospital.

Picture: Part of Jogoo Centre-Mau Summit (Total) Junction road section

Engineering - road design/furniture/features	Enforcement - law	Education - Road user awareness
<ul style="list-style-type: none"> • Instal appropriate signage for hazards and speed limit. • Designate pedestrian crossing points. • Ensure work site safety is adhered to by all construction site workers. • Instal signage to guide motorists while construction is ongoing. 	<ul style="list-style-type: none"> • Enforce speed limit compliance. • Relocate the bars at the junction to reduce cases of drunken pedestrians. 	<ul style="list-style-type: none"> • Sensitize pedestrians on road safety and motorists on driving safely especially at night.

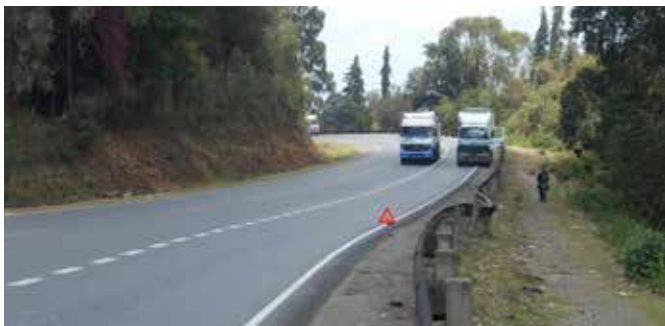
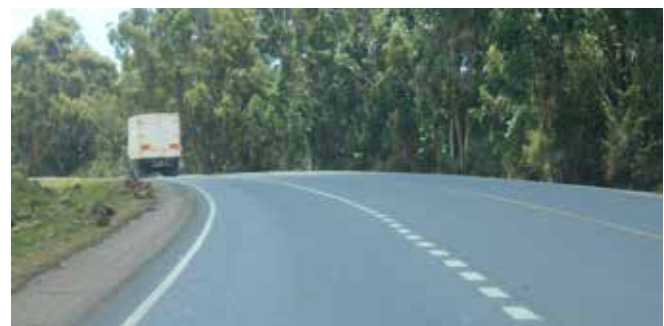
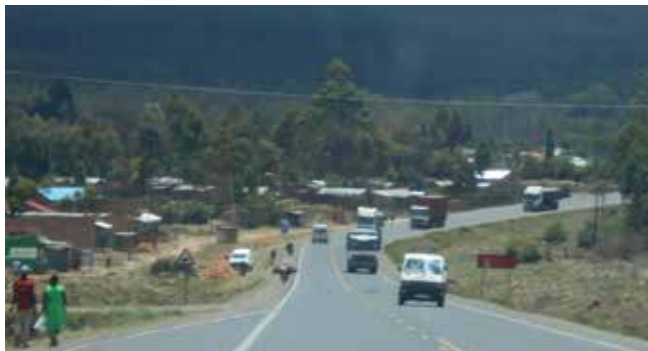
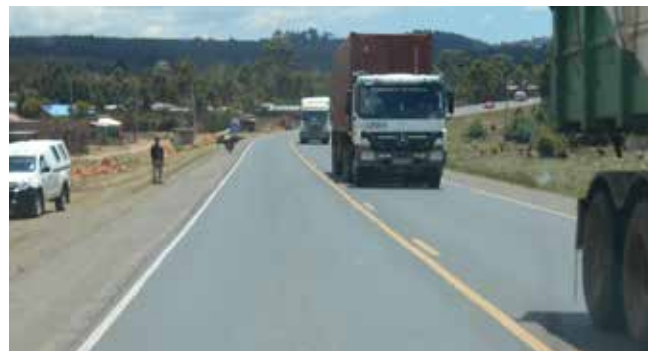
125. GSU Camp

This is a 1.4-kilometer road section on a steep slope and has sharp bends. There are no road signs and the guardrails are damaged. The reason for the black spot is speeding motorists, careless overtaking, and poor visibility. Crashes happen throughout the week but mostly night, and also during wet and dry seasons. Vehicles mostly involved in crashes are personal cars (saloons), light and medium trucks, and heavy commercial vehicles. Crash victims are taken to Molo Sub County Hospital.

Picture: Part of GSU Camp road section

Engineering - road design/furniture/features	Enforcement - law	Education - Road user awareness
<ul style="list-style-type: none"> • Instal appropriate signage for hazards and speed limit. • Repair damaged guardrails. • Trim the trees to improve visibility. 	<ul style="list-style-type: none"> • Enforce speed limit compliance. 	<ul style="list-style-type: none"> • Educate motorists on the dangers of speeding and careless overtaking especially at night.

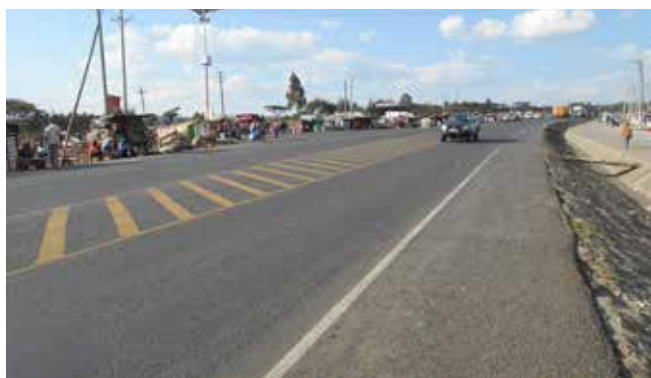
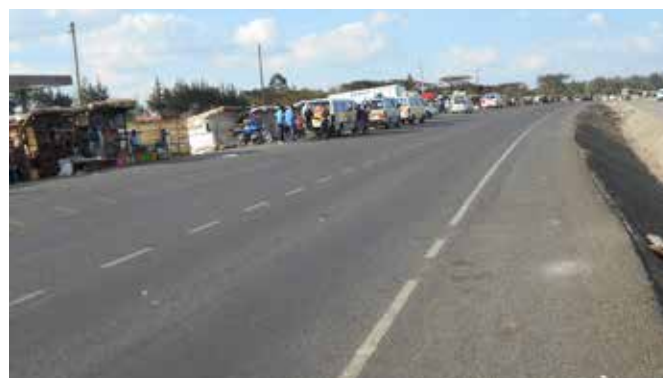
126. Londiani Junction

This is 0.7-kilometer road section along a straight stretch passing through a roadside market center at Londiani junction. It has intersections. There are no road signs. The reason for the black spot is speeding motorists and unsafe pedestrian crossing at undesignated points near the roadside market. Crashes happen throughout the week but mostly at night and during wet and dry seasons. Vehicles mostly involved in crashes are personal cars (saloons), heavy commercial vehicles and motorcycles. Crash victims are taken to Kericho County Hospital.

Picture: Part of Londiani junction road section

Engineering - road design/furniture/features	Enforcement - law	Education - Road user awareness
<ul style="list-style-type: none"> • Instal appropriate signage for hazards and speed limit. • Construct a market away from the road to stop encroachment on the road reserve. 	<ul style="list-style-type: none"> • Enforce speed limit compliance. 	<ul style="list-style-type: none"> • Sensitize pedestrians near the market on safe crossing • Educate motorist on the dangers of speeding and careless overtaking

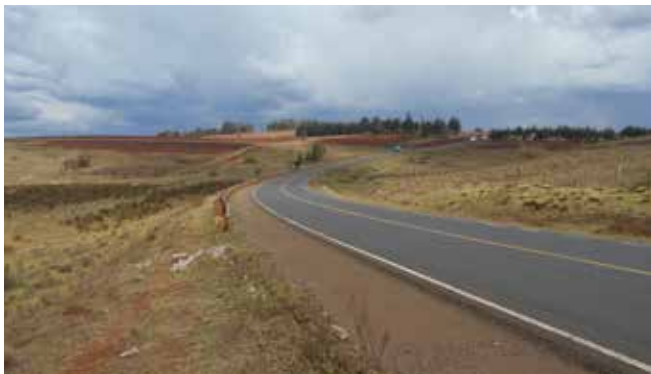
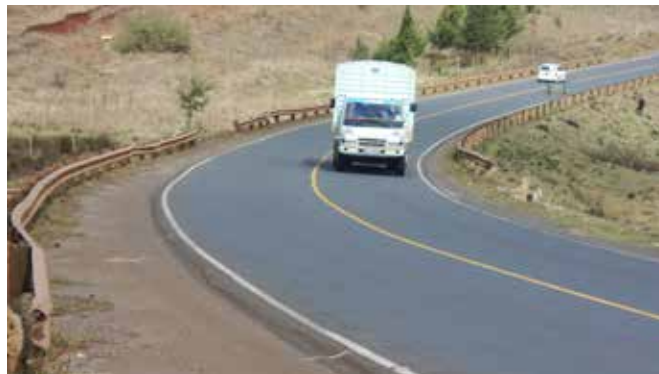
128. Gatarakwa - Kichinjio

This is a new blackspot on a 2.5-kilometer road section with a steep slope, a narrow bridge and a sharp bend at Gatarakwa. The guardrails are damaged. The reason for the black spot is speeding motorists, and careless overtaking. Crashes happen throughout the week but mostly at night and during wet seasons. Vehicles commonly involved in crashes are personal cars (saloons), mini buses (PSVs and vans), and heavy commercial vehicles. Crash victims are taken to Eldama Ravine Hospital.

Picture: Part of Gatarakwa - Kichinjio road section

Engineering - road design/furniture/features	Enforcement - law	Education - Road user awareness
<ul style="list-style-type: none"> • Instal appropriate signage for hazards and speed limit. • Repair damaged guard rail. 	<ul style="list-style-type: none"> • Enforce speed limit compliance. 	<ul style="list-style-type: none"> • Educate motorists on the dangers of speeding and careless overtaking especially at night and during the rainy season.
