Northern Corridor and Nairobi County Route Hazard Mapping Report

May 2017

Developed by Safe Way Right Way and National Transport and Safety Authority

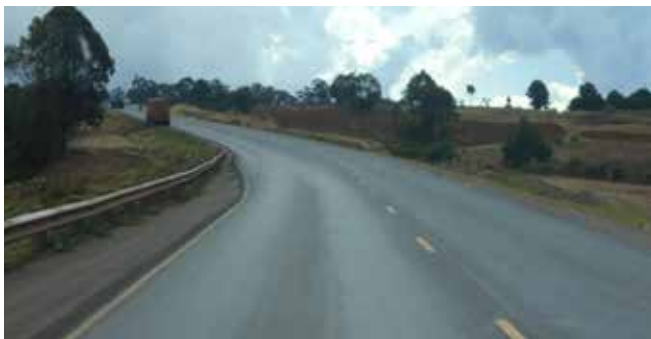
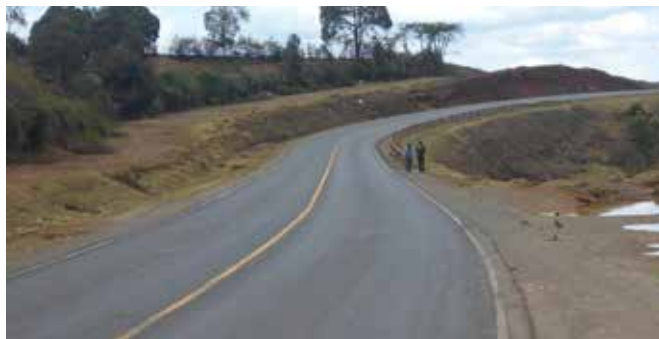
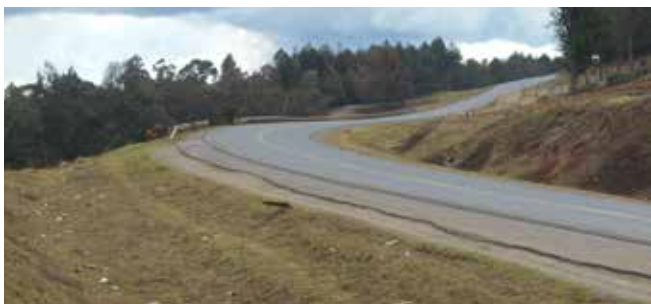
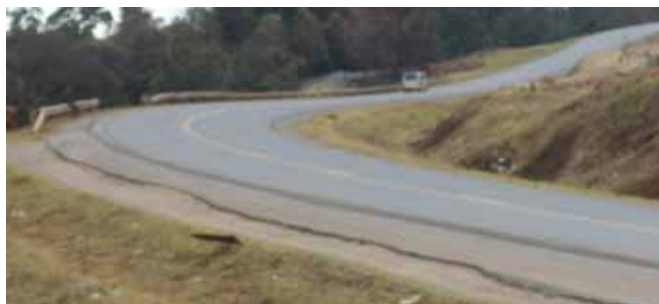
129. Equator-King'ero

This is a 1 kilometer road section on a steep slope with sharp bend. The guardrails are damaged and there are no road signs. The reason for the black spot is speeding motorists, slippery road surface and poor visibility. Crashes happen throughout the week but mostly at night and during wet seasons. Vehicles mostly involved in crashes are personal cars (saloons), mini buses (PSVs and vans), and heavy commercial vehicles. Crash victims are taken to Eldama Ravine Hospital.

Picture: Part of Equator Kingero road section

Engineering - road design/furniture/features	Enforcement - law	Education - Road user awareness
<ul style="list-style-type: none"> • Instal appropriate signage for hazards and speed limit. • Repair damaged guard rail. 	<ul style="list-style-type: none"> • Enforce speed limit compliance. 	<ul style="list-style-type: none"> • Educate motorists on the dangers of speeding especially at night and during the rainy season.

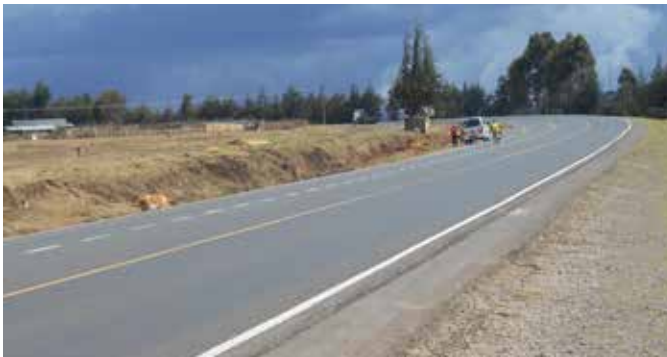
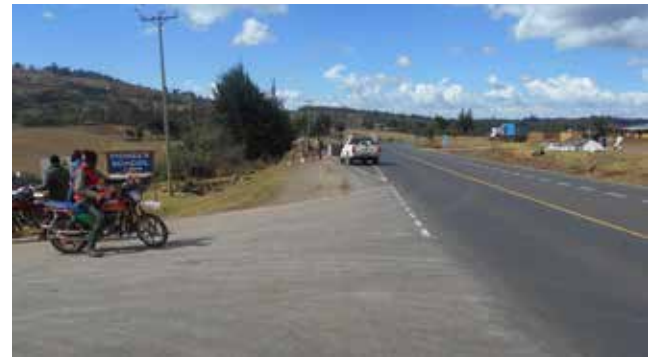
130. Kahoya (near Muchorwe Junction)

This is a 1.4-kilometer road section that has a sharp bend on a gentle slope. There are no road signs. The reason for the black spot is speeding motorists. Crashes happen throughout the week but mostly the night and in wet seasons. Vehicles mostly involved in crashes are personal cars (saloons), mini buses (PSVs and vans), and heavy commercial vehicles. Crash victims are taken to Eldama Ravine Hospital

Picture: Part of Kahoya near Muchorwe Junction road section

Engineering - road design/furniture/features	Enforcement - law	Education - Road user awareness
<ul style="list-style-type: none"> • Instal appropriate signage showing hazards and speed limit. 	<ul style="list-style-type: none"> • Enforce speed limit compliance. 	<ul style="list-style-type: none"> • Educate motorists on the dangers of speeding especially at night.

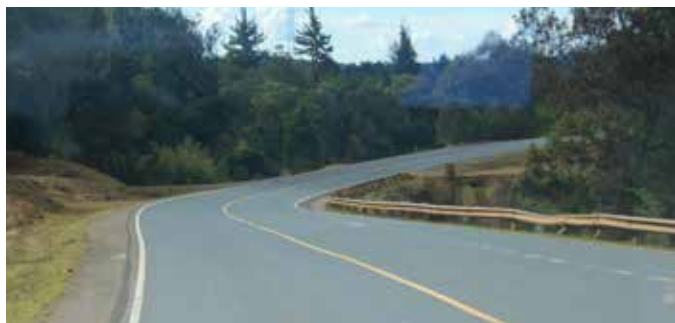
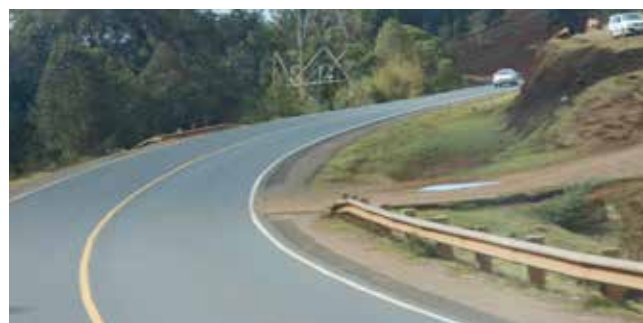
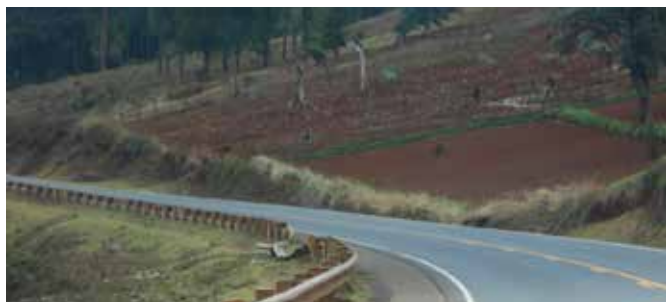
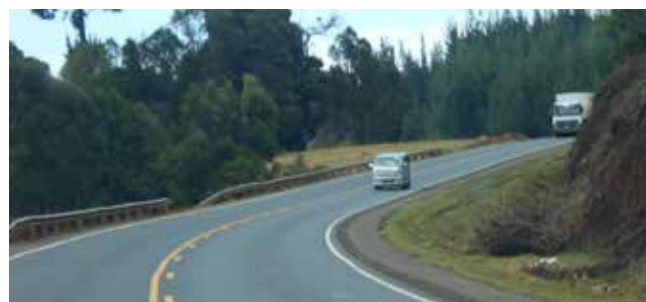
131. Kahoya B Area

This is a 0.4 kilometer road section with a sharp bend on a gentle slope with no speed bumps. There are no road signs. The reason for the black spot is speeding motorists. Crashes happen throughout the week but mostly at night and during wet seasons. Vehicles frequently involved in crashes are personal cars (saloons), mini buses (PSVs and vans), and heavy commercial vehicles. Crash victims are taken to Eldama Ravine Hospital and Moi Teaching and Referral Hospital.

Picture: Part of Kahoya B area road section

Engineering – road design/furniture/features	Enforcement – law	Education – Road user awareness
<ul style="list-style-type: none"> • Instal appropriate signage showing hazards and speed limit. 	<ul style="list-style-type: none"> • Enforce compliance to speed limits. 	<ul style="list-style-type: none"> • Educate road users on the risks of speeding and careless overtaking especially at night

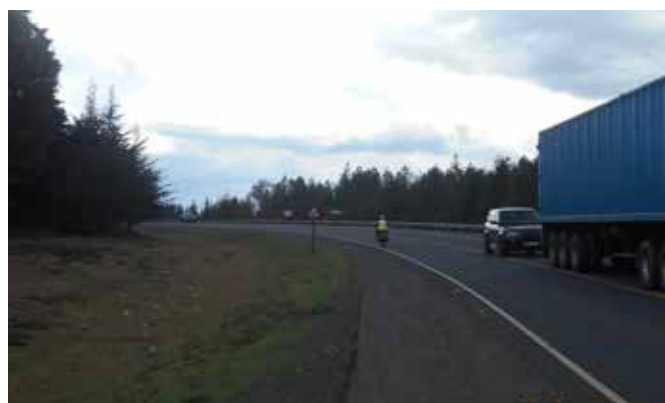
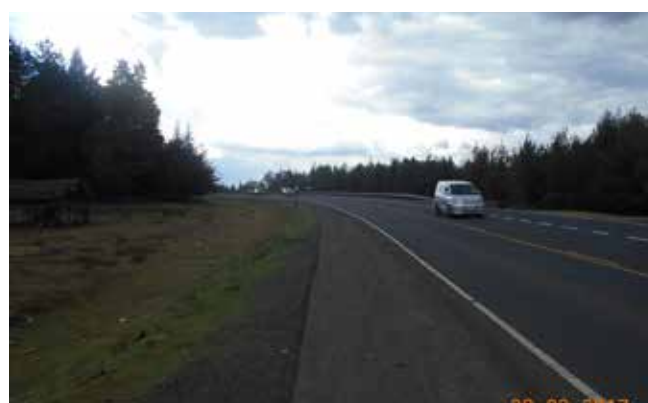
132. Kahoya near Timboroa

This is a 1-kilometer road section with sharp bends on a gentle slope. There are some road signs. The reason for the black spot is speeding motorists, poor visibility due to mist in the wet season, and careless overtaking. Crashes happen throughout the week but mostly at night and during wet seasons. Vehicles mostly involved in crashes are light and medium trucks and heavy commercial vehicles. Crash victims are taken to Eldama Ravine Hospital and Moi Teaching and Referral Hospital.

Picture: Part of Kahoya near Timboroa road section

Engineering - road design/furniture/features	Enforcement - law	Education - Road user awareness
<ul style="list-style-type: none"> • Instal additional signage for hazards and speed limit. 	<ul style="list-style-type: none"> • Enforce speed limit compliance. 	<ul style="list-style-type: none"> • Educate pedestrians on the dangers of speeding and careless overtaking especially in rainy season.

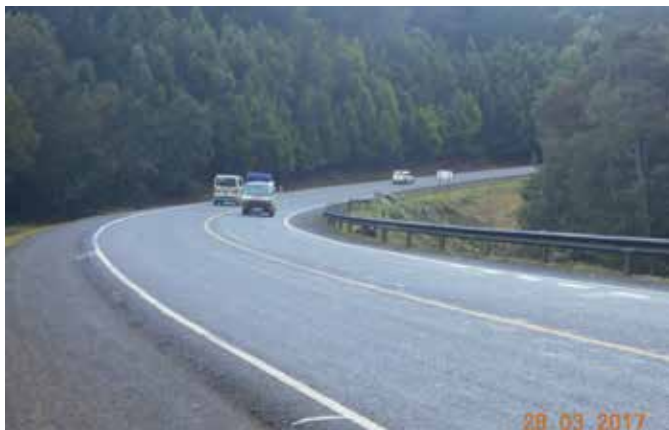
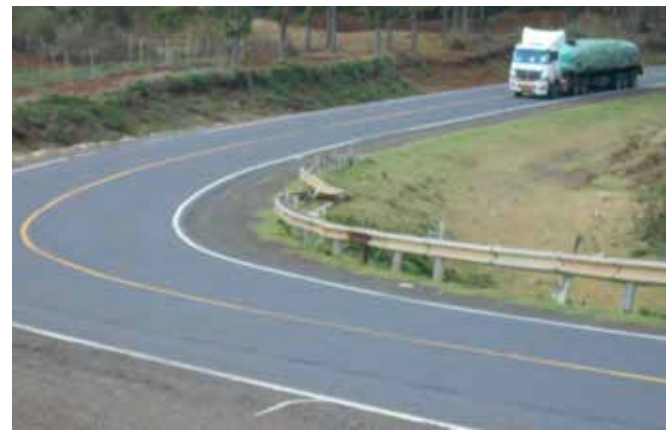
133. Timboroa Danger

This is 0.8-kilometer road section with sharp bends on a gentle slope heading into Timboroa. There are no road signs and the guardrails are damaged. The reason for black spot is speeding motorists and careless overtaking. Crashes happen throughout the week during day and night, and mostly during wet seasons. Vehicles typically involved in crashes are personal cars (saloons), mini buses (PSVs and vans), light and medium trucks and heavy commercial vehicles. Crash victims are taken to Burnt Forest

Picture: Part of Timboroa Danger road section

Engineering - road design/furniture/features	Enforcement - law	Education - Road user awareness
<ul style="list-style-type: none"> • Instal appropriate signage for hazards and speed limit. • Repair damaged guard rail. 	<ul style="list-style-type: none"> • Enforce speed limit compliance. 	<ul style="list-style-type: none"> • Educate road users on the dangers of speeding and careless overtaking in bad weather

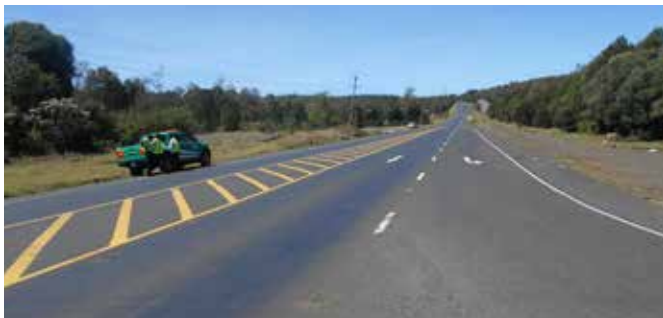
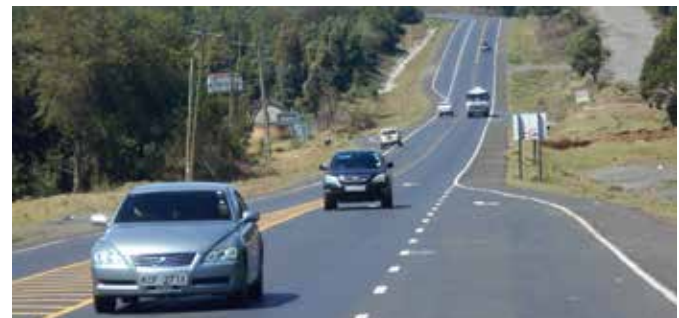
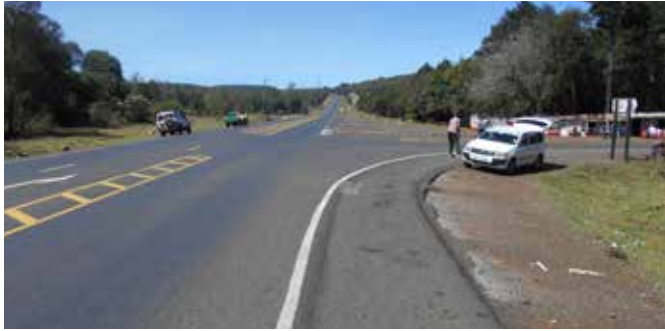
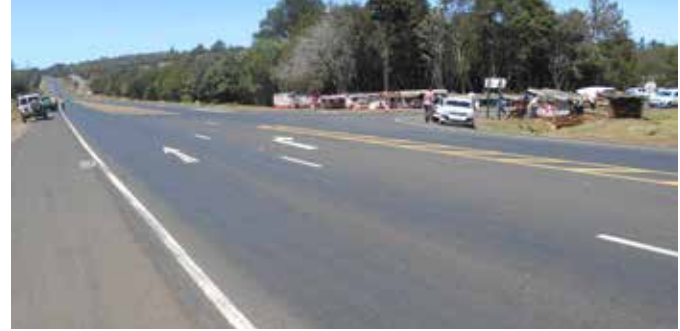
135. Nabkoi Junction

This is a 300-meter road section on a steep slope with an intersection. The reason for black spot is speeding motorists on a blind spot and careless entry into the main road at the intersection. Crashes happen throughout the week but mostly at night and during wet seasons. Vehicles mostly involved in crashes are personal cars (saloons), mini buses (PSVs and vans), large buses and heavy commercial vehicles. Crash victims are taken to Moi Teaching and Referral Hospital.

Picture: Part of Nabkoi Junction road section

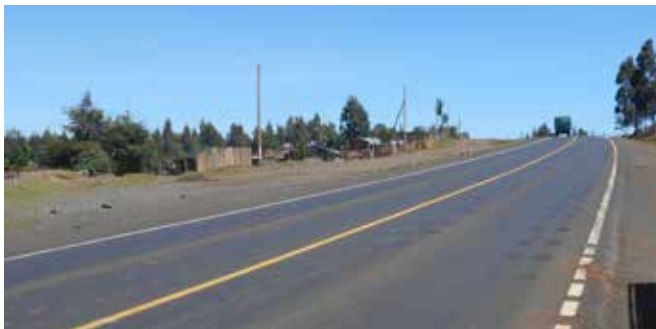
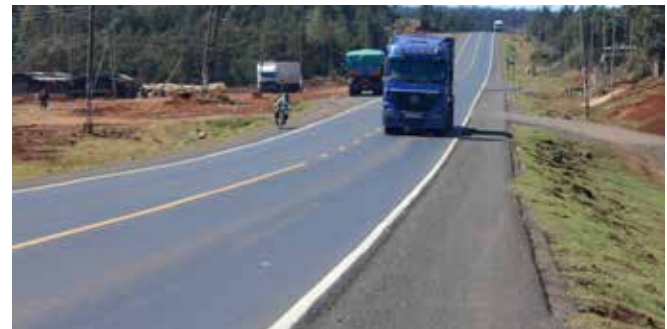
136. Ngong Trading Center

This is a new blackspot on a 0.6 kilometer road section with a steep slope and passes through Ngong trading center. There is inadequate road signage. The reasons for the black spot are speeding motorists and freewheeling. Crashes happen mostly over weekday and at night but equally during both dry and wet seasons. Vehicles mostly involved in crashes are heavy commercial vehicles. Crash victims are taken to Moi Teaching and Referral Hospital.

Picture: Part of Ngong Trading Center road section

Engineering - road design/furniture/features	Enforcement - law	Education - Road user awareness
<ul style="list-style-type: none"> Erect speed limit signage. 	<ul style="list-style-type: none"> Enforce speed limit compliance. 	<ul style="list-style-type: none"> Educate and sensitize truck drivers on dangers of speeding and freewheeling. Motorists should be especially careful at night.

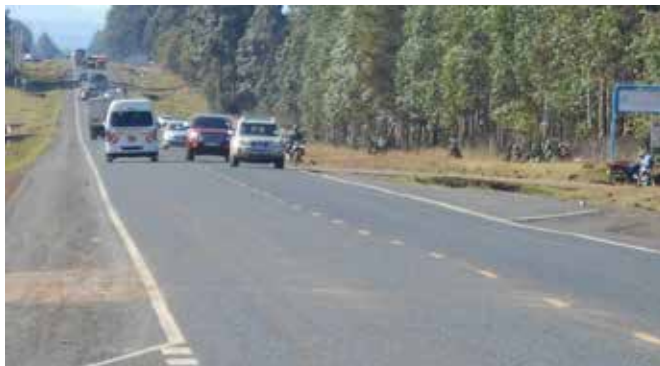
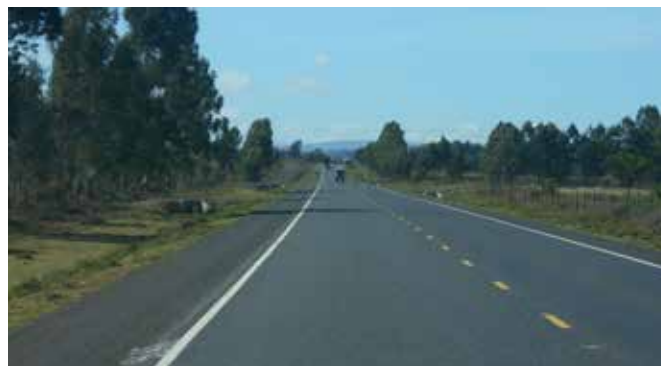
This is 1.1-kilometer road section along a straight stretch on a gentle slope. There are no road signs. There are speed bumps at the end of the black spot. The road section also has a sharp bend. The reason for the black spot is speeding motorists and careless overtaking. Crashes happen throughout the week but mostly at night and during wet seasons.

Vehicles mostly involved in crashes are personal cars (saloons), mini buses (PSVs and vans), large buses, and light and medium trucks. Crash victims are taken to Moi Teaching and Referral Hospital.

Picture: Part of Kapchebii - Cheptiret road section

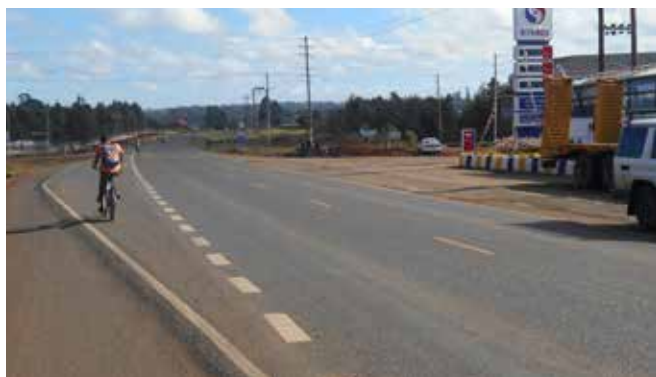
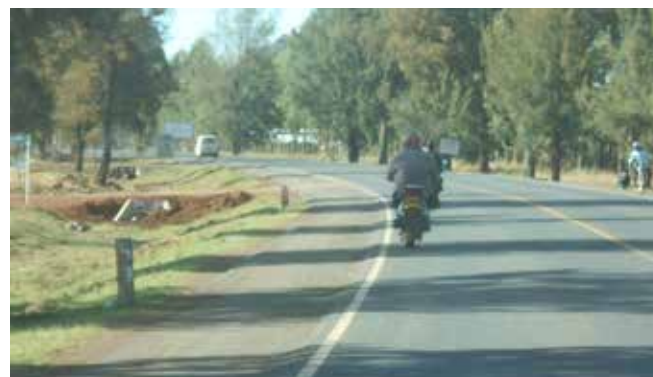
139. Cheplaskei - Starbex

This is a new blackspot is a 6.5-kilometer road section along a straight stretch. The road section has a gentle slope, sharp bends and road intersections. The reason for the black spot is speeding motorist and careless overtaking. There is a rumble strip at the bend. Crashes happen mostly over weekend and at night but during both dry and wet seasons. Vehicles mostly involved in crashes are personal cars (saloons), mini buses (PSVs and vans), and heavy commercial vehicles. Crash victims are taken to Moi Teaching and Referral Hospital and Mediheal Hospital.

Picture: Part of Cheplaskei - Starbex road section

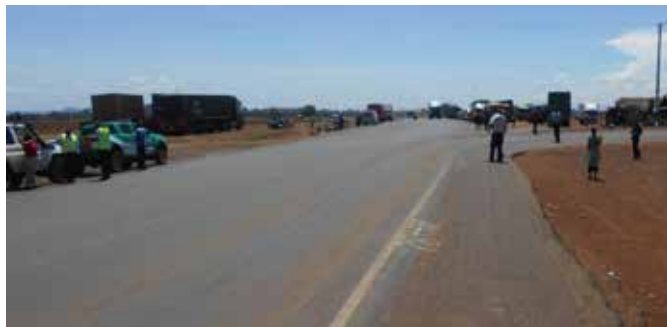
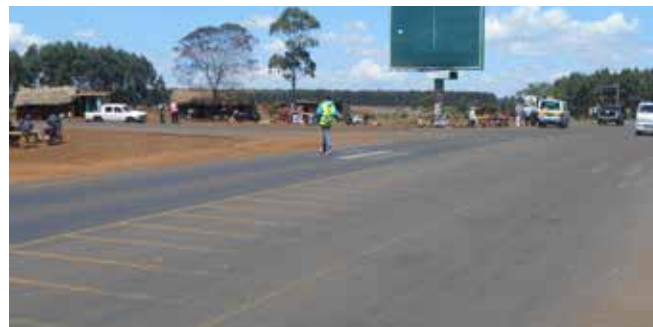
141. M̃reba-M̃aili Tisa Junction

This is a 2.5 kilometer road section along a stretch on a steep slope with a junction. There are no road signs. The reason for the black spot is speeding motorist and careless driving. Crashes happen throughout the week but mostly at night and in both dry and wet seasons. Vehicles mostly involved in crashes are personal cars (saloons), and heavy commercial vehicles. Crash victims are taken to Moi Teaching and Referral Hospital and Mediheal Hospital.

Picture: Part of M̃reba – M̃aili Tisa Junction road section

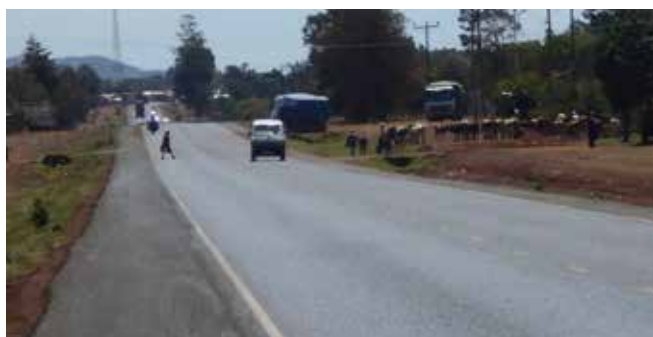
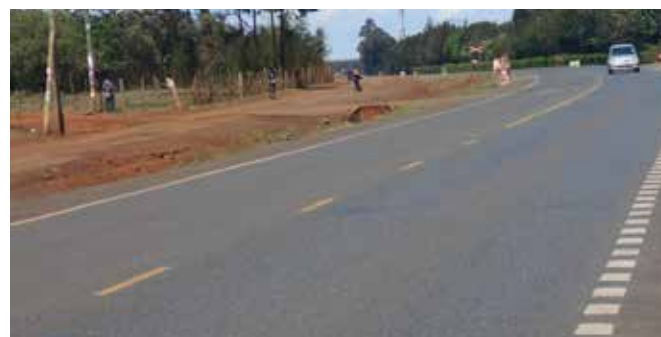
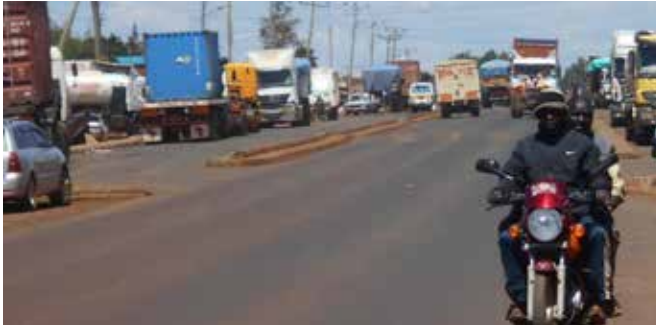
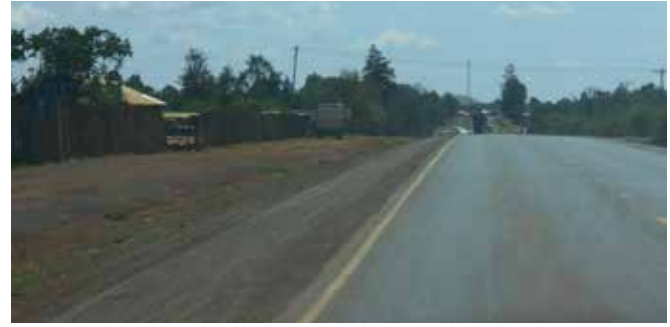
This is a 1.4 kilometer road section with a straight stretch on a gentle slope near Jua Kali market center and a sharp bend near Duka Moja. The only road sign on this section is the junction ahead sign. The reason for the black spot is speeding motorists, unsafe pedestrian crossing at undesignated locations and careless bodaboda riders. Crashes happen throughout the week but mostly at night and during wet seasons. Vehicles mostly involved in crashes are personal cars (saloons), mini buses (PSVs and vans) and motorcycles.

Crash victims are taken to Moi Teaching and Referral Hospital and Mediheal Hospital. There is a designated truck stop-over at Jua Kali.

Picture: Part of Duka Moja – Jua Kali road section

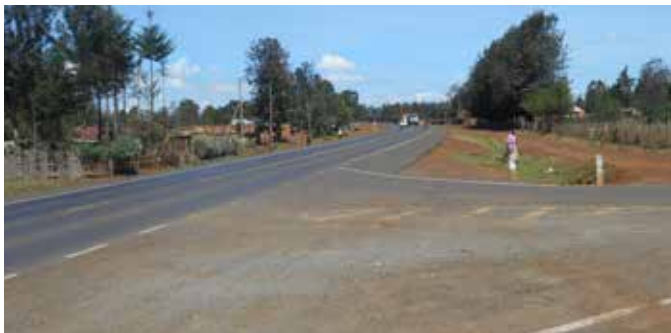
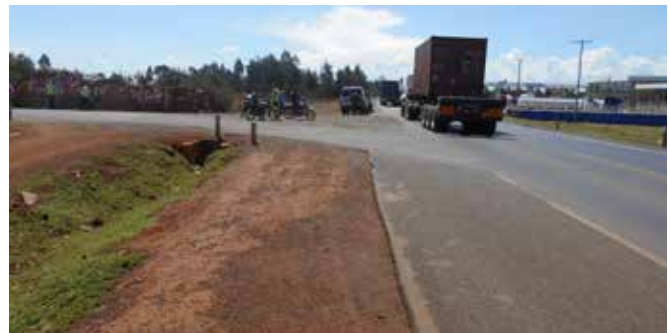
143. Sugoi Junction – Tumaini – Kaplong

This is a 1.8-kilometer road section with a sharp bend on a gentle slope with a slight depression, through a market center and road junction. There are no road signs. The reason for black spot is speeding motorists and unsafe pedestrian crossing at undesignated points. Crashes happen throughout the week but mostly at night and during wet seasons. Vehicles mostly involved in crashes are personal cars (saloons), heavy commercial vehicles and motorcycles. Crash victims are taken to

Picture: Part of Sugoi junction – Tumaini road section

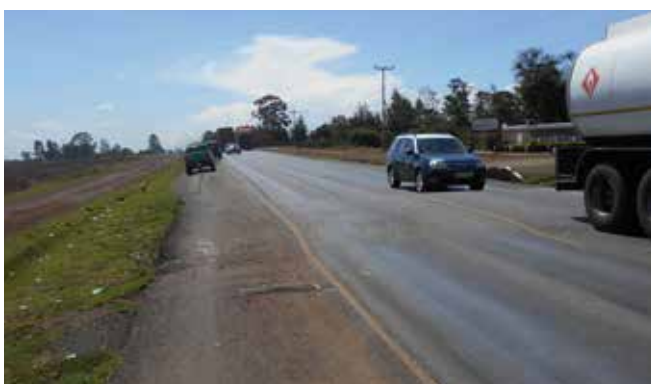
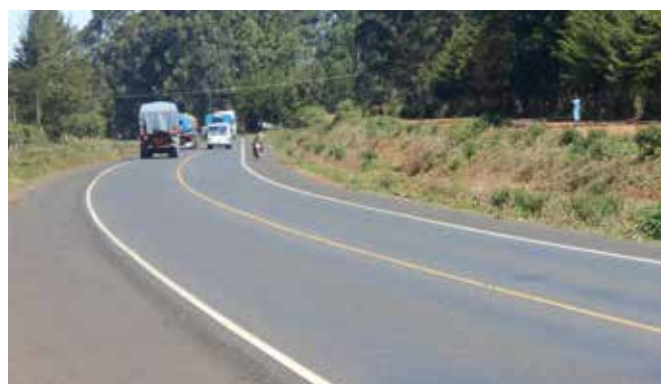
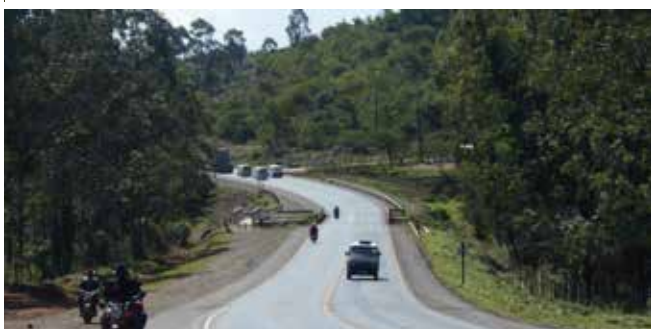
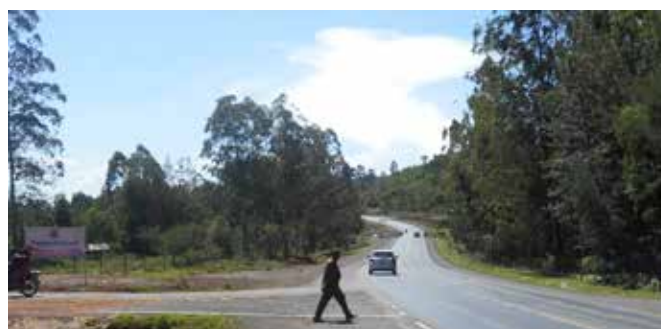
144. Kemco-Turbo

This 6.2-kilometer road section has sharp bends on steep slopes, and tall vegetation at some sections of the road and a bridge into Turbo town. There are no road signs. The reason for the black spot is speeding motorists and poor visibility due to the bends and vegetation along the road. Crashes happen throughout the week but mostly at night and during wet seasons. Vehicles mostly involved in crashes are personal cars (saloons), and heavy commercial vehicles. Crash victims are taken to Moi Teaching and Referral Hospital and Mediheal Hospital. There exists a designated truck stop-over point at Turbo.

Picture: Part of Kemco - Turbo road section

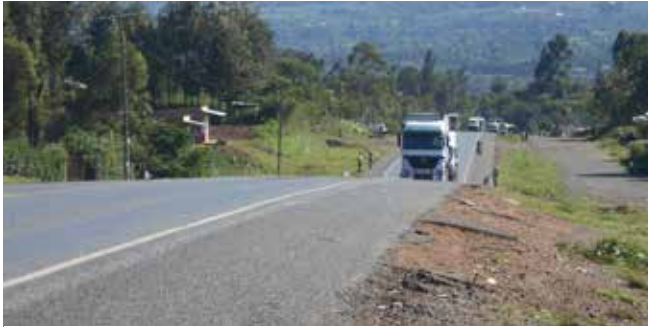
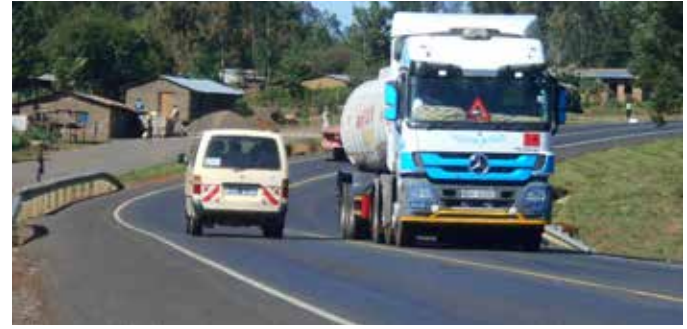
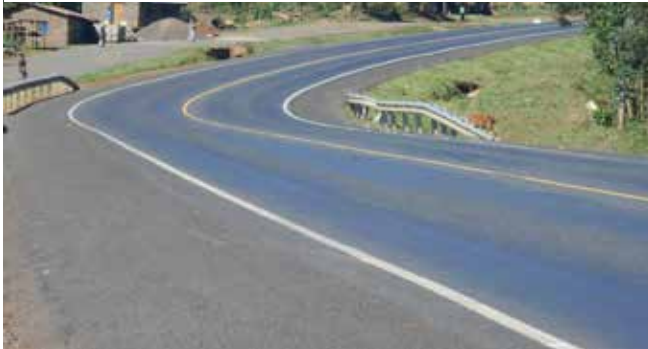
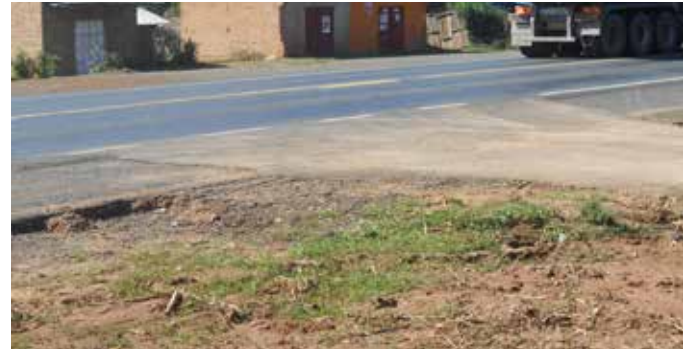
146. Stage Muge – Kipkaren

This is a 4-kilometer road section through Stage Muge to Kipkaren shopping center on a steep slope with sharp bends. There is a bridge at Kipkaren River. There are no road signs. A railway bridge crosses above the road. The reason for black spot is unsafe pedestrian crossing, careless motorcycle riders, speeding motorists and careless overtaking. Crashes happen mostly over weekend but equally at both day and night, and during both dry and wet seasons. Vehicles mostly involved in crashes are personal cars (saloons), and heavy commercial vehicles. Crash victims are taken to Lumakanda Sub County Hospital and Murgusi Hospital.

Picture: Part of Stage Muge - Kipkaren road section

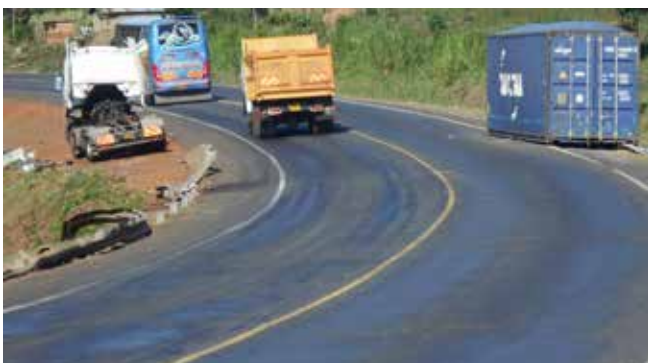
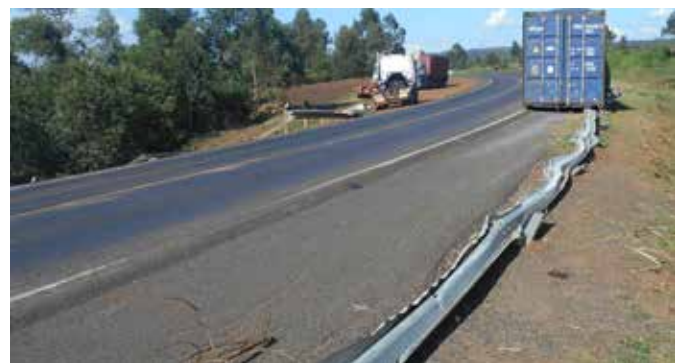
147. Mabanga Bridge

This is a new blackspot on a 0.7 kilometers road section with a steep slope, sharp bend and a bridge at Mabanga River. There are no road signs. The reason for the black spot is speeding motorists, careless driving and careless motorcycle and bicycle riders on the steep. The guardrails at the bridge are damaged. Crashes happen throughout the week but at night, and during both dry and wet seasons. Vehicles mostly involved in crashes are personal cars (saloons), heavy commercial vehicles, motor cycles and bicycles. Crash victims are taken to Lumakanda Sub County Hospital.

Picture: Part of Stage Mabanga Bridge road section

Engineering - road design/furniture/features	Enforcement - law	Education - Road user awareness
<ul style="list-style-type: none"> • Instal signage for hazards and speed limit. • Repair damaged guard rail. 	<ul style="list-style-type: none"> • Enforce speed limit compliance. 	<ul style="list-style-type: none"> • Educate cyclists on road safety. • Create awareness on speeding and careful driving at night.

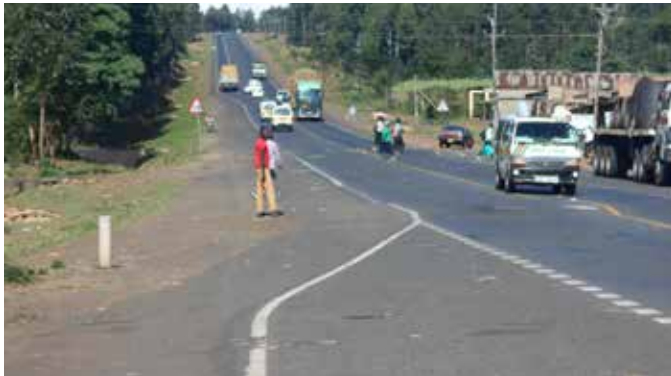
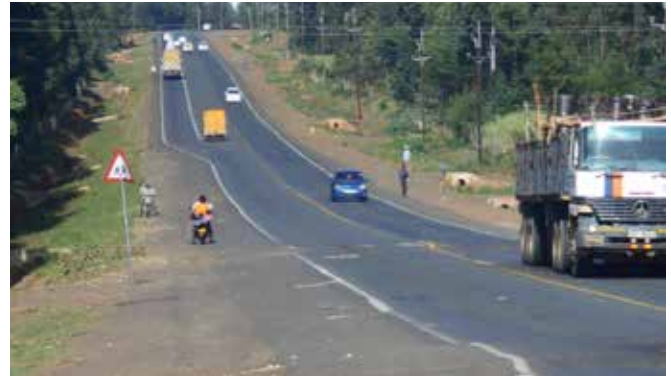
148. Mukhonje-Maturu

This is a 1.3-kilometer road section with a sharp bend on a steep slope and through Maturu trading center. Maturu primary and secondary schools are located on this road section. There is a children's' crossing sign and a speed bump but the rest of this road lacks signage. The reason for the black spot is speeding motorists, unsafe pedestrian traffic crossing at undesignated points. There are many cases of freewheeling trucks and the speed bumps are only at the market center. Crashers occur throughout the week, day and night and also during dry and rainy seasons. Vehicles mostly involved in crashes are personal cars (saloons), and heavy commercial vehicles. Crash victims are taken to Webuye Sub County Hospital.

Picture: Part of Mukhonje - Maturu road section

Engineering - road design/furniture/features	Enforcement - law	Education - Road user awareness
<ul style="list-style-type: none"> • Instal signage for hazards and speed limit. • Have a speed bump on the steep slope and near the school. 	<ul style="list-style-type: none"> • Enforce speed limit compliance 	<ul style="list-style-type: none"> • Create awareness among motorists on speeding and safe crossing. • Train school pupils on road safety.

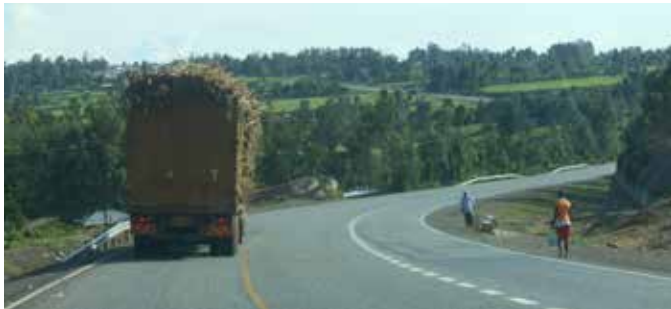
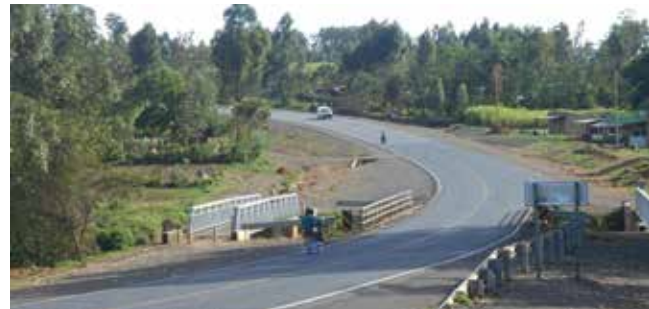
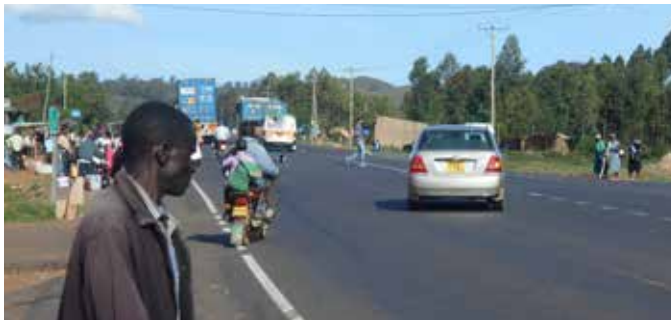
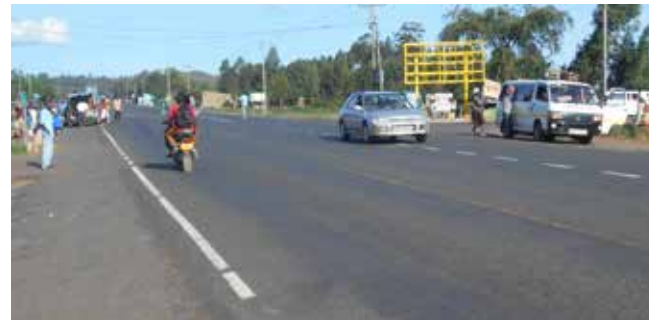
149. Lwandeti- Chimoi - Kaburengo

This 6.3-kilometer road section has sharp bends on steep slopes, bridges, brow of the hill and crosses through Chimoi Market Center. The road is fairly well marked but has no road signs. The reason for the black spot is speeding motorists, freewheeling on the steep slope, careless overtaking and poor visibility at the sharp bends as well as unsafe pedestrian crossing at and near the market centers. Crashes happen during the week, day and night and in both dry and wet seasons. Vehicles mostly involved in crashes are personal cars (saloons), and heavy commercial vehicles. Crash victims are taken to Webuye Sub County Hospital.

Picture: Part of Lwandeti – Chimoi – Kaburengo Area road section

Engineering - road design/furniture/features	Enforcement - law	Education - Road user awareness
<ul style="list-style-type: none"> • Instal signage for hazards and speed limit. • Instal speed bumps on the steep slope and at Chimoi center. 	<ul style="list-style-type: none"> • Enforce speed limit compliance. 	<ul style="list-style-type: none"> • Sensitize pedestrians on safe crossing. • Sensitize truck drivers on dangers of freewheeling and speeding.

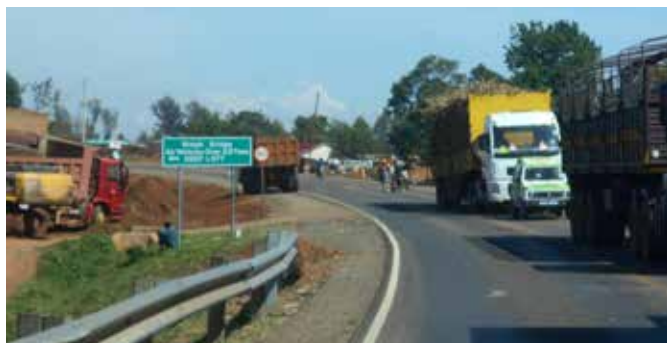
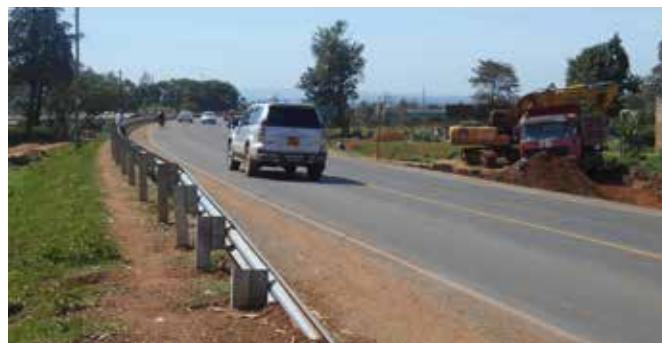
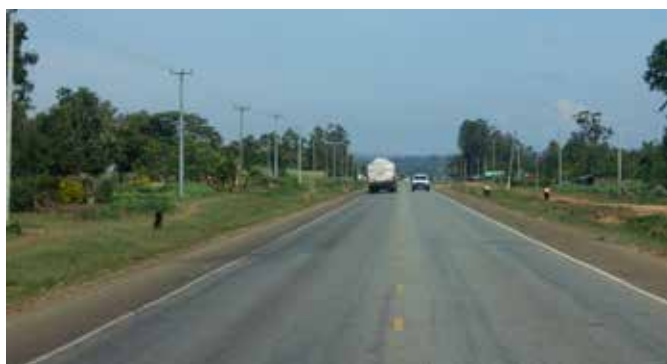
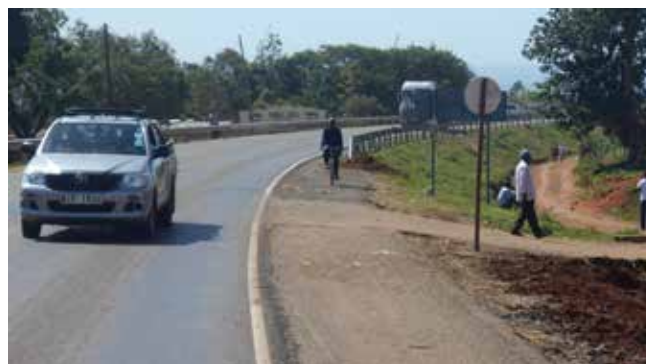
150. Matulo-Matisi Bridge

This is a 3.1-kilometer road section on a straight stretch with a gentle slope bridge and is near a weighbridge. The reason for the black spot is speeding motorists and loss of vehicle control due to freewheeling. Crashes happen during the week, day and night and in both dry and wet seasons. Vehicles mostly involved in crashes are personal cars (saloons), and motorcycles. Crash victims are taken to Webuye Sub County Hospital.

Picture: Part of Matulo – Matisi bridge area road section

Engineering - road design/furniture/features	Enforcement - law	Education - Road user awareness
<ul style="list-style-type: none"> Instal signage warning of the hazards. 	<ul style="list-style-type: none"> Enforce speed limit compliance. 	<ul style="list-style-type: none"> Sensitize truck drivers on dangers of freewheeling and speeding.

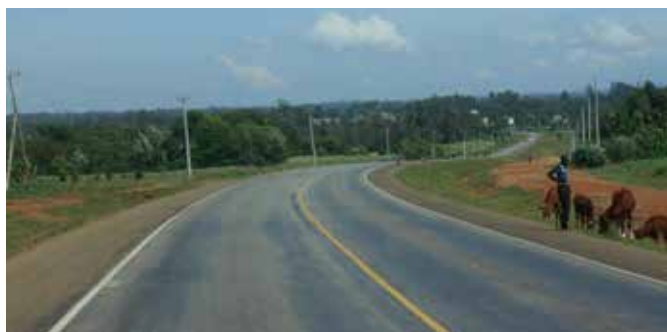
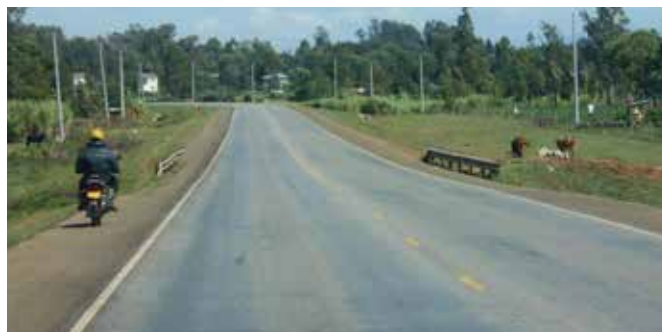
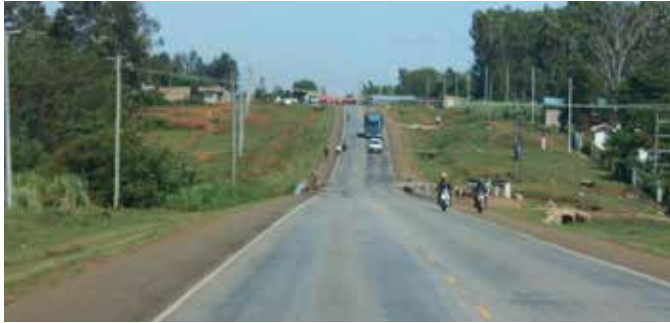
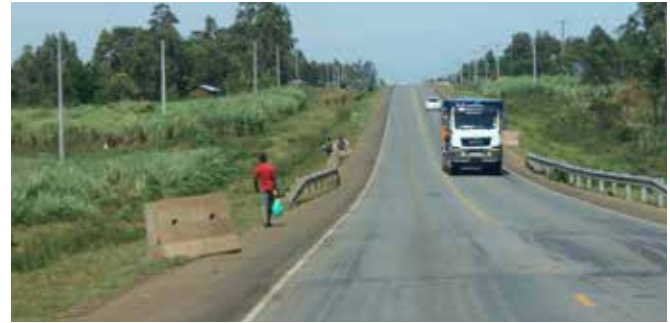
151. Misanga

This is a 1.8-kilometer road section along a straight stretch and smooth bend but on a slope with a depression. There sections has brow of a hill. The reason for the black spot is speeding motorists and careless overtaking. The road is also slippery during wet season. Crashes happen during the week, daytime and in both dry and wet seasons. Vehicles mostly involved in crashes are personal cars (saloons), heavy commercial vehicles, and motorcycles. Crash victims are taken to Bungoma Level 5 Hospital.

Picture: Part of Misanga road section

Engineering - road design/furniture/features	Enforcement - law	Education - Road user awareness
<ul style="list-style-type: none"> • Instal signage for hazards and speed limit. • Consider speed bumps. 	<ul style="list-style-type: none"> • Enforce speed limit compliance. 	<ul style="list-style-type: none"> • Create awareness on dangers of speeding and safe overtaking. Motorists should be especially careful at night

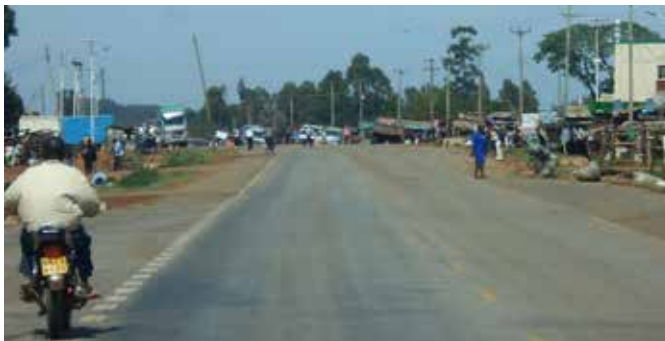
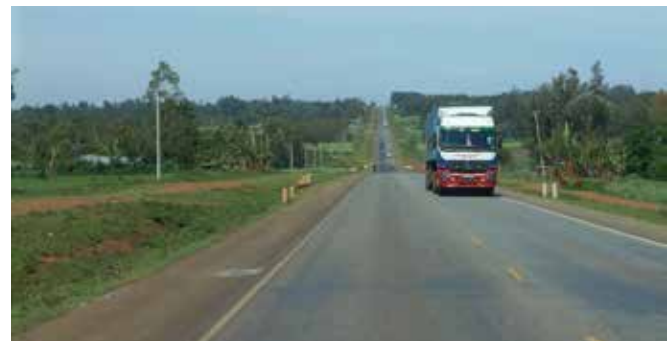
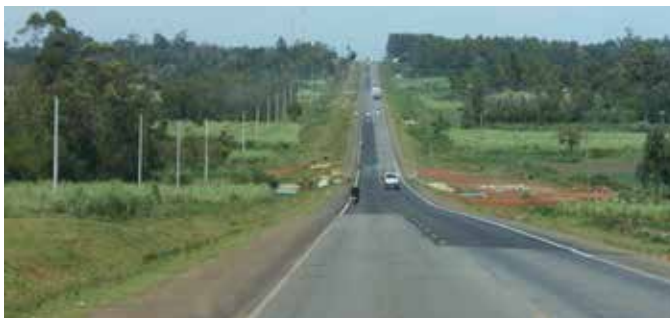
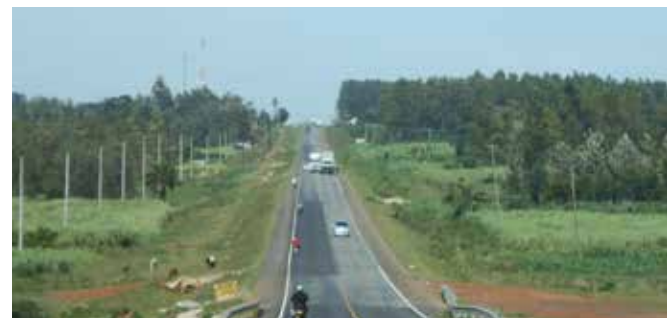
152. Matokelo-Bukembe Bridge

This is a 3-kilometers road section along a straight stretch on a steep slope with a bridge. There is also a roadside market developing. There are no road signs. The reason for the black spot is unsafe pedestrian crossing, speeding motorists and careless overtaking. Crashes happen throughout the week, day and night, and in both dry and wet seasons. Vehicles mostly involved in crashes are personal cars (saloons), heavy commercial vehicles, and motorcycles. Crash victims are taken to Bungoma

Picture: Part of Matokelo - Bukembe road section

Engineering - road design/furniture/features	Enforcement - law	Education - Road user awareness
<ul style="list-style-type: none"> • Instal signage for hazards and speed limit. • Consider speed bumps. • Designate pedestrian crossing points near the market. 	<ul style="list-style-type: none"> • Enforce speed limit compliance. • Ensure traders do not encroach on the road. 	<ul style="list-style-type: none"> • Sensitize pedestrian and motorcycle riders on road safety. • Create awareness among motorists on safe speeds and careful overtaking.

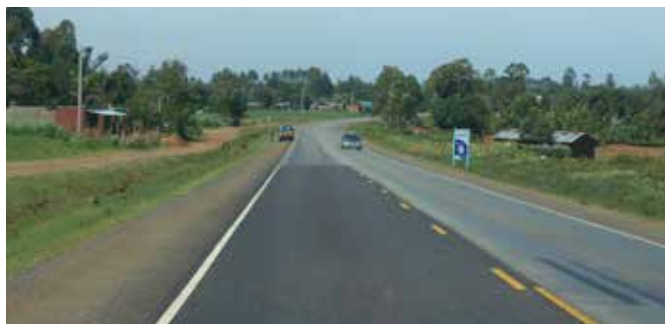
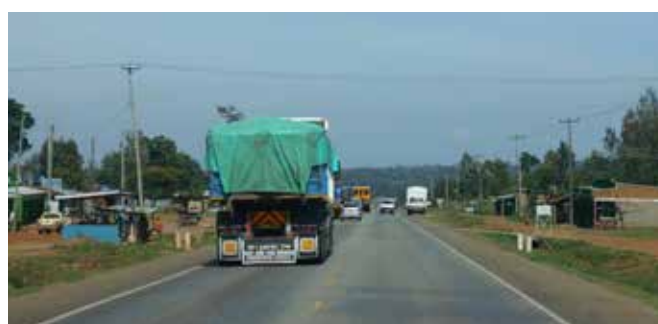
This is a 1.5-kilometer road section with a bend on a steep slope and bridge. There are no road signs. The reason for the black spot is speeding motorists and careless overtaking. Crashes happen throughout the week, day and night, and in both dry and wet seasons.

Vehicles mostly involved in crashes are personal cars (saloons), mini buses (PSVs and vans) and heavy commercial vehicles.

Picture: Part of Mabanga road section

Engineering - road design/furniture/features	Enforcement - law	Education - Road user awareness
<ul style="list-style-type: none"> • Instal signage for hazards and speed limit. • Designate pedestrian crossing points. 	<ul style="list-style-type: none"> • Instal a speed camera. • Enforce speed limit compliance. 	<ul style="list-style-type: none"> • Educate motorists on speeding and careful overtaking. • Educate pedestrians on safe crossing.

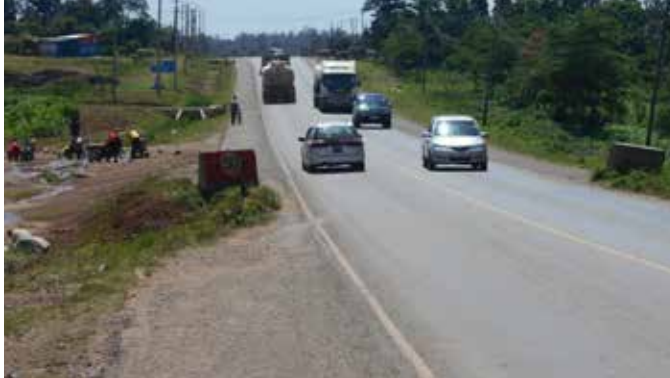
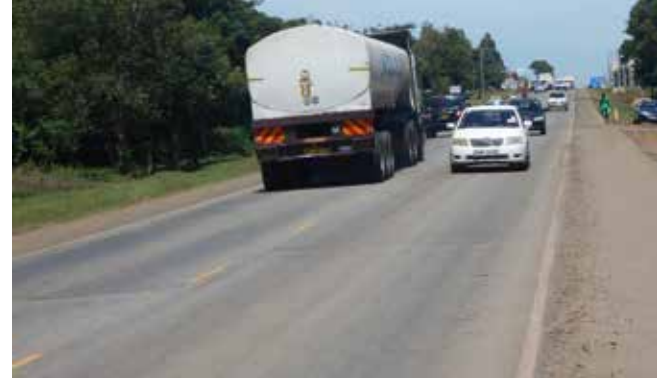
154. Mabanga-Sikata

This is a 3 kilometer road section along a straight stretch on a steep slope with a bridge, bend and intersection. There are no road signs. The reason for the black spot is speeding motorists, careless motorcycle riders and careless overtaking. Crashes happen mostly over the weekend and at night, but equally during both dry and wet seasons. Vehicles mostly involved in crashes are heavy commercial vehicles and motorcycles. Crash victims are taken to Bungoma Level 5 Hospital.

Picture: Part of Mabanga - Sikata road section

Engineering - road design/furniture/features	Enforcement - law	Education - Road user awareness
<ul style="list-style-type: none"> • Instal appropriate signage for hazards and speed limit. 	<ul style="list-style-type: none"> • Enforce speed limit compliance. • Consider speed camera. 	<ul style="list-style-type: none"> • Sensitize motorcycle riders on road safety. • Create awareness on dangers of speeding and careless overtaking.

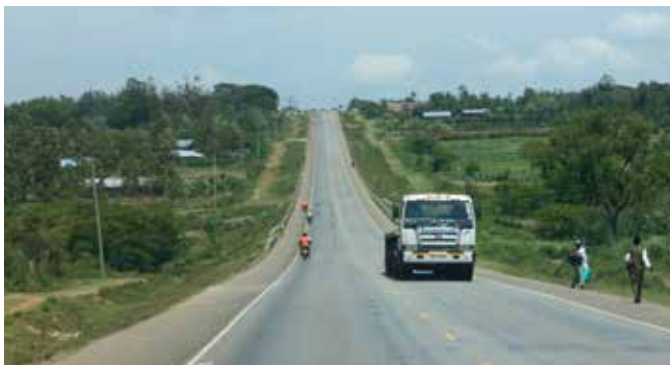
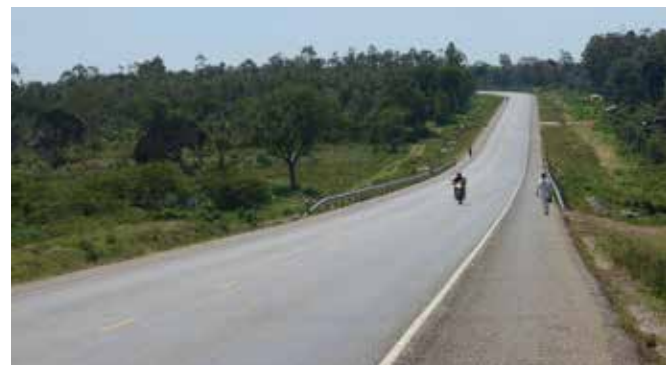
155. Kimwanga Bridge

This is a 1.5 kilometer road section that has a bend on a straight stretch with gentle slope and a bridge. The guardrail at the bridge is damaged and there are no road signs. The reason for the black spot is speeding motorists on a blind spot at the bridge. Crashes happen throughout the week but at daytime, and equally during both dry and wet seasons. Vehicles mostly involved in crashes are personal cars (saloons), mini buses (PSVs and vans), large buses, and heavy commercial vehicles.

Picture: Part of Kimwanga Bridge road section

Engineering - road design/furniture/features	Enforcement - law	Education - Road user awareness
<ul style="list-style-type: none"> • Instal appropriate signage for hazards and speed limit. • Repair damaged guardrail. 	<ul style="list-style-type: none"> • Enforce speed limit compliance. 	<ul style="list-style-type: none"> • Create awareness so that motorists slow down and do not overtake at the bridge.

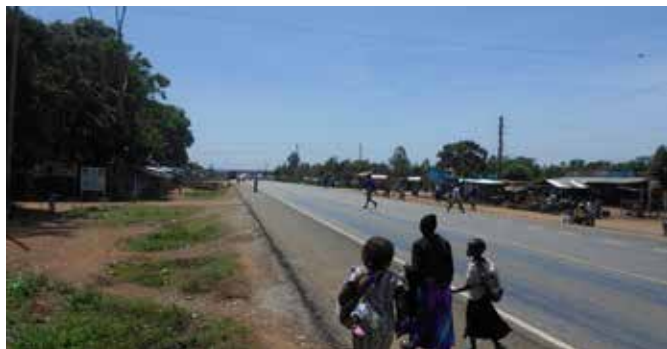
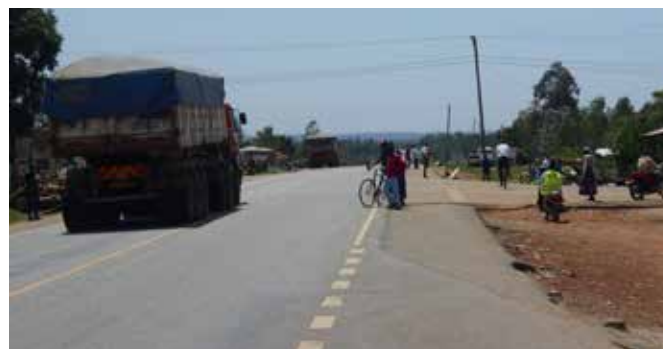
156. Kimaeti-Malakisi Junction

This is a 400-meter road section with intersection and market center. There are no road signs. The reason for the black spot is speeding motorists, unsafe pedestrian crossing and careless motorcycle riders crossing the main road from the junctions. Crashes happen throughout the week, day and night, and in both dry and wet seasons. Vehicles mostly involved in crashes are personal cars (saloons), mini buses (PSVs and vans), and heavy commercial vehicles. Crash victims are taken to Bungoma Level 5 Hospital and Busia County Referral Hospital.

Picture: Part of Kimaeti - Matisi road section

Engineering - road design/furniture/features	Enforcement - law	Education - Road user awareness
<ul style="list-style-type: none"> • Instal appropriate signage for hazards and speed limit. • Designate pedestrian crossing points. 	<ul style="list-style-type: none"> • Enforce speed limit compliance. 	<ul style="list-style-type: none"> • Educate pedestrian and motorcycle riders on road safety. • Create awareness on safe speed and careful overtaking.

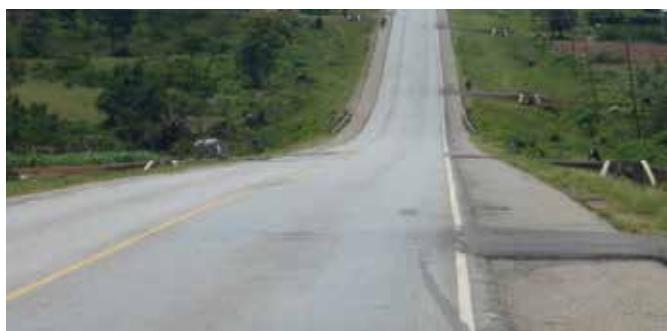
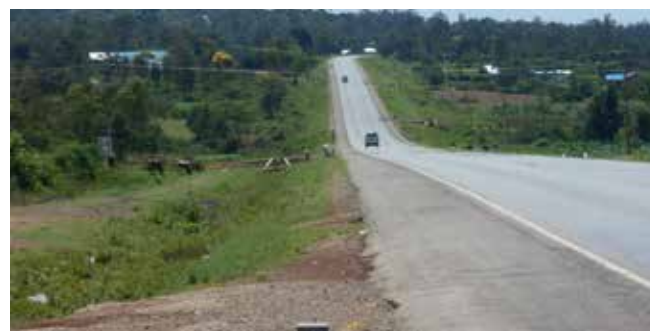
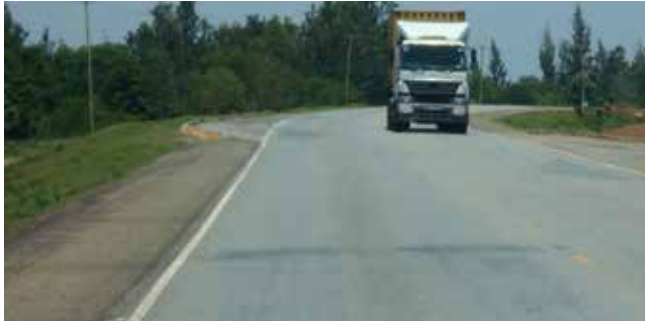
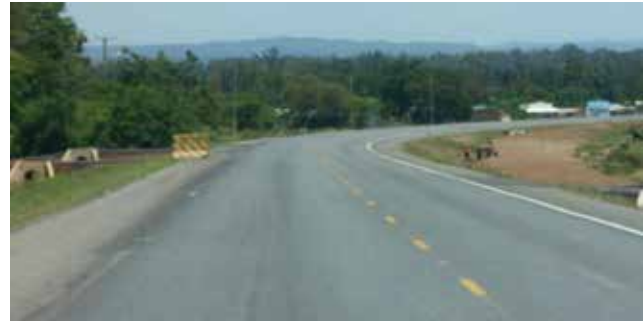
157. Koteko

This is a 0.5-kilometer road section with a bend on gentle slope. There are no road signs. The reason for the black spot is speeding motorists. Crashes happen throughout the week, day and night, in both dry and wet seasons. Vehicles mostly involved in crashes are personal cars (saloons), mini buses (PSVs and vans), and heavy commercial vehicles. Crash victims are taken to Bungoma Level 5 Hospital and Busia County Referral Hospital.

Picture: Part of Koteko road section

Engineering - road design/furniture/features	Enforcement - law	Education - Road user awareness
<ul style="list-style-type: none"> Instal appropriate signage for hazards and speed limit. 	<ul style="list-style-type: none"> Enforce speed limit compliance. 	<ul style="list-style-type: none"> Educate motorists on the dangers of speeding.
