Northern Corridor and Nairobi County Route Hazard Mapping Report

May 2017

Developed by Safe Way Right Way and National Transport and Safety Authority

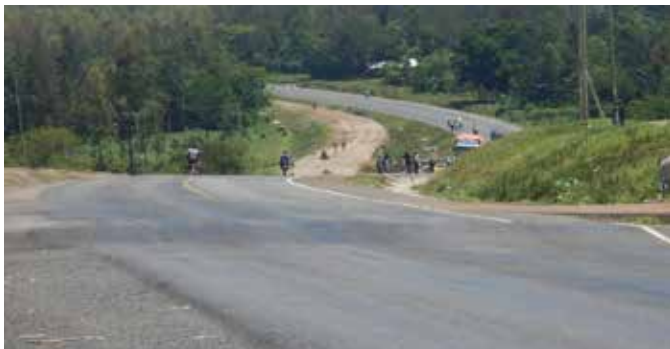
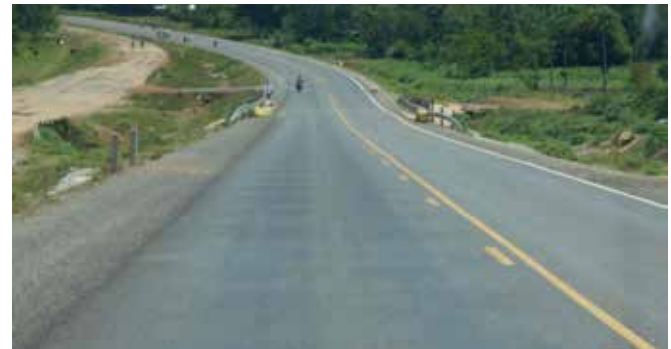
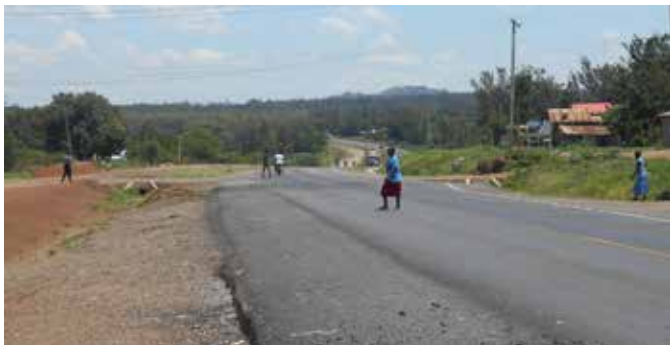
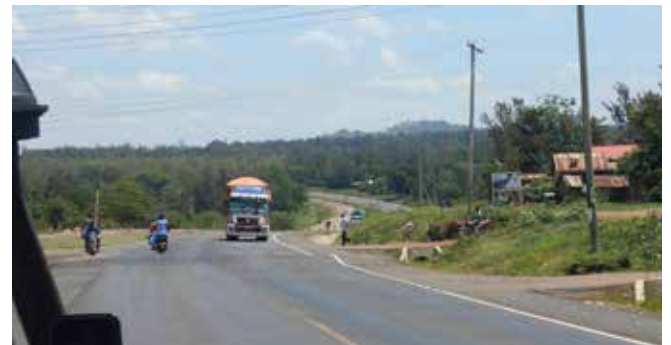
158. Koteko-Kocholia

This 3.4-kilometer road section has sharp bends on a steep slope. There are no road signs. The reason for the black spot is speeding motorists and careless overtaking at bends. Crashes happen throughout the week, day and night, and during dry and wet seasons. Vehicles mostly involved in crashes are personal cars (saloons), mini buses (PSVs and vans), and heavy commercial vehicles. Crash victims are taken to Busia County Referral Hospital. There is a truck stop-over point at Koteko.

Picture: Part of Koteko - Kocholia road section

Engineering - road design/furniture/features	Enforcement - law	Education - Road user awareness
<ul style="list-style-type: none"> • Instal appropriate signage for hazards and speed limit. • Mark the bump and designate pedestrian crossing points. 	<ul style="list-style-type: none"> • Enforce speed limit compliance. 	<ul style="list-style-type: none"> • Create awareness on speeding and careful overtaking especially on the sharp bends.

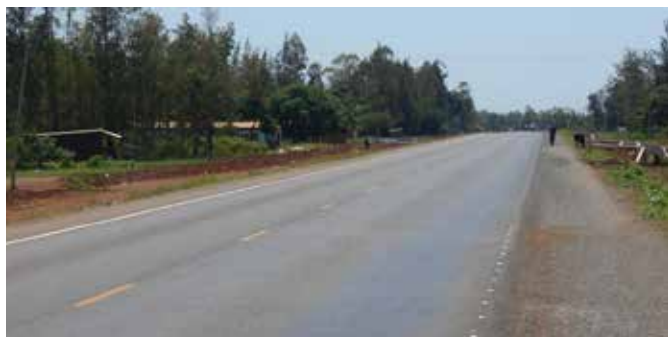
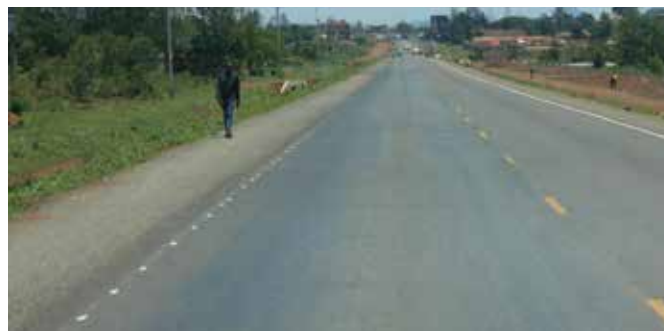
159. Ikapalok-Malaba

This is a 1.4 kilometer road section along a straight stretch on a gentle slope and no speed bumps. There are no road signs. The reason for the black spot is speeding motorists and unsafe pedestrian crossing. Crashes happen throughout the week, day and night, and during dry and wet seasons. Vehicles mostly involved in crashes are personal cars (saloons), mini buses (PSVs and vans), and heavy commercial vehicles. Crash victims are taken to Busia County Referral Hospital. There is an undesignated truck stop-over point at Malaba.

Picture: Part of Ikapalok - Malaba road section

Engineering - road design/furniture/features	Enforcement - law	Education - Road user awareness
<ul style="list-style-type: none"> • Instal appropriate signage for hazards and speed limit. • Designate pedestrian crossing points. 	<ul style="list-style-type: none"> • Enforce speed limit compliance. 	<ul style="list-style-type: none"> • Sensitize pedestrians on road safety. • Educate motorists on the dangers of speeding.

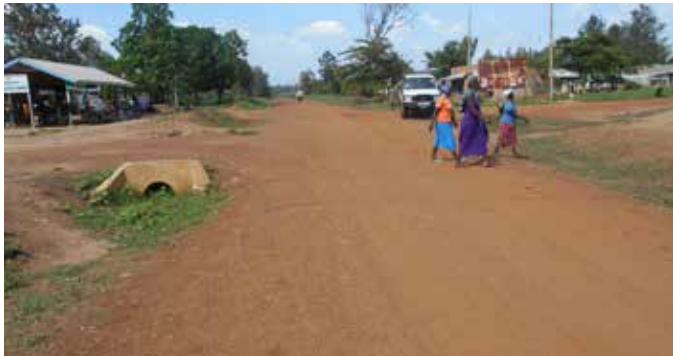
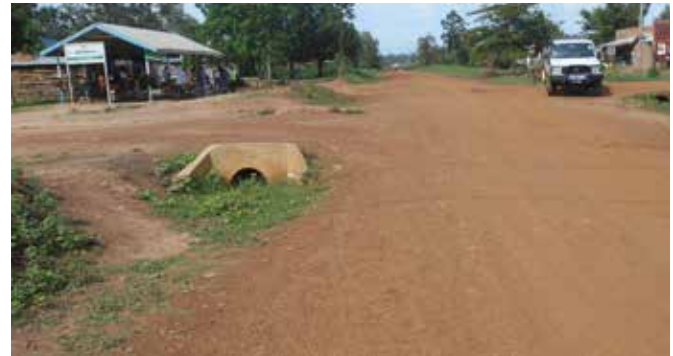
This is a new black spot on a 0.7-kilometer road section. This road links Malaba and Busia town and is not on the Northern Corridor. The section crosses through Likoli market center. The road surface is not paved and there are no road signs.

The reason for the black spot is unsafe pedestrian crossing. Crashes happen throughout the week, day and night, and during dry and wet seasons. Vehicles mostly involved in crashes are motorcycles. Crash victims are taken to Busia County Referral Hospital.

Picture: Part of Malaba – Busia (C43-Likoli) road section

Engineering – road design/furniture/features	Enforcement – law	Education – Road user awareness
<ul style="list-style-type: none"> • Instal appropriate signage for hazards and speed limit. 	<ul style="list-style-type: none"> • Enforce speed limits after installation of road signs. 	<ul style="list-style-type: none"> • Sensitize motorcycle riders and pedestrians on road safety. • Motorist should be cautious when driving through Likoli.

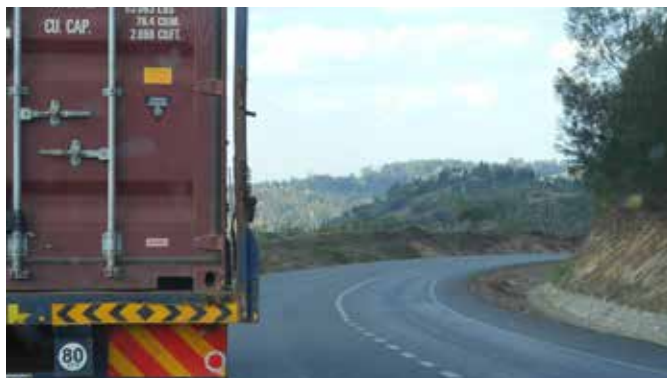
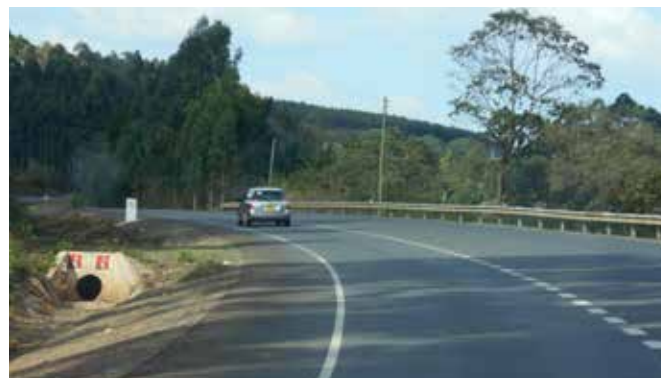
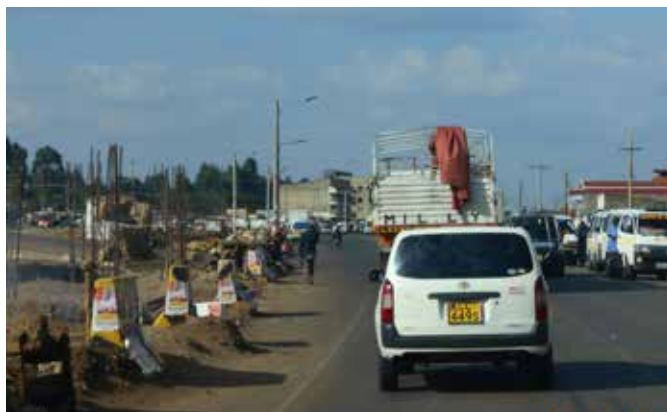
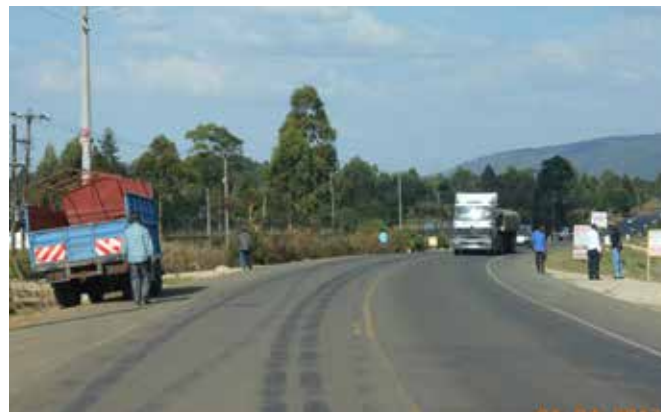
162. Chepsir Area

This is a 4.3-kilometer road section with steep slopes and sharp bends. It passes through Chepsir Market Center. The road is fairly well marked but there are no road signs. The reason for the black spot is speeding motorists and careless overtaking, unsafe pedestrian crossing and undesignated bus stops. Crashes happen throughout the week but mostly at daytime, and equally during both dry and wet seasons. Vehicles mostly involved in crashes are personal cars (saloons), mini buses (PSVs and vans), heavy commercial vehicles and motorcycles. Crash victims are taken to Kericho County Referral Hospital and Siloam Hospital.

Picture: Part of Chepsir road section

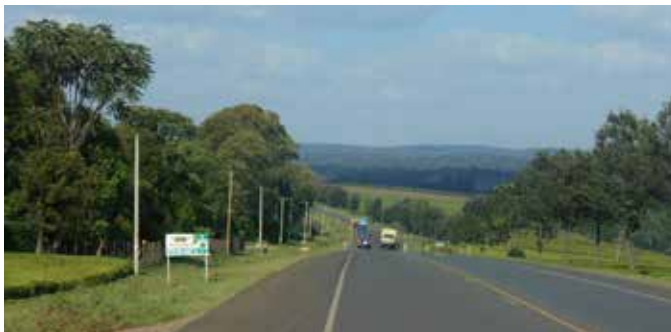
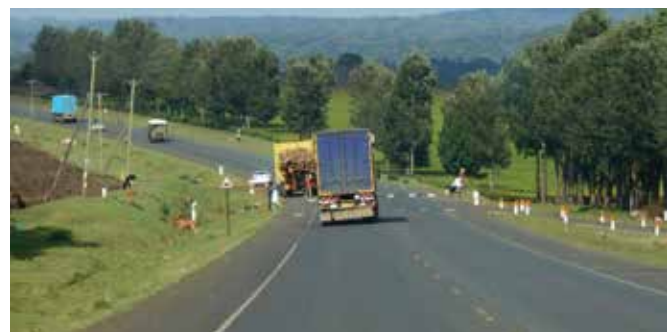
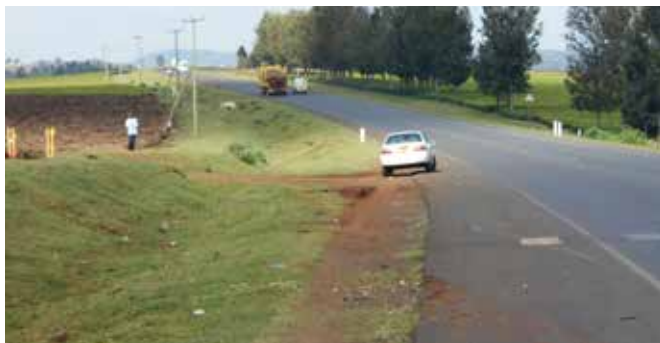
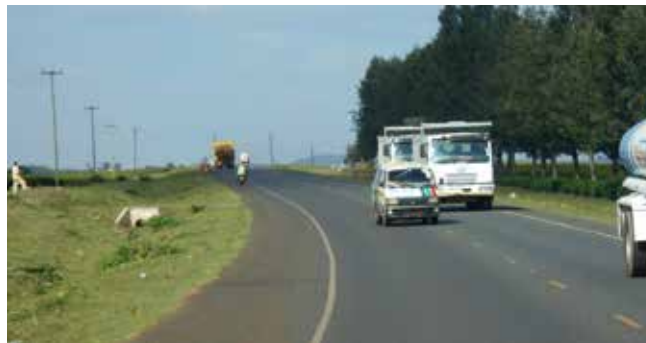
This is a 0.5 kilometer road section on a steep slope, with a bend and intersection and is well marked but missing vital road signage. The reason for the black spot is speeding motorists. There is a speed bump in the section but often motorists go over it at high speeds. Crashes happen throughout the week, day and night, and during dry and wet seasons.

Vehicles mostly involved in crashes are personal cars (saloons), mini buses (PSVs and vans), and light and medium trucks. Crash victims are taken to Kericho County Referral Hospital and Siloam Hospital.

Picture: Part of Chagaik road section

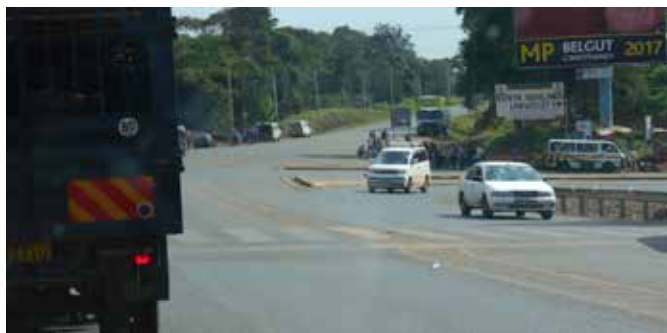
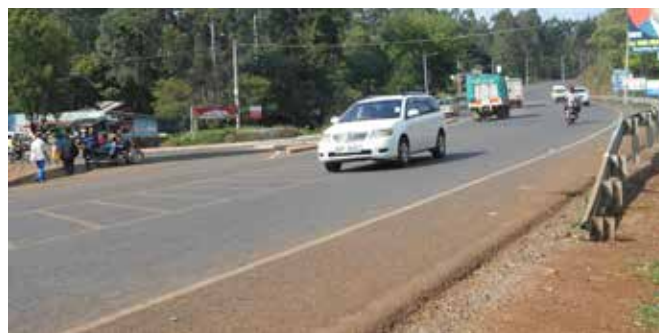
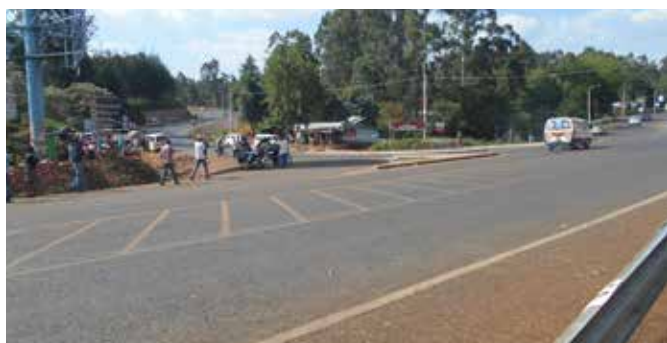
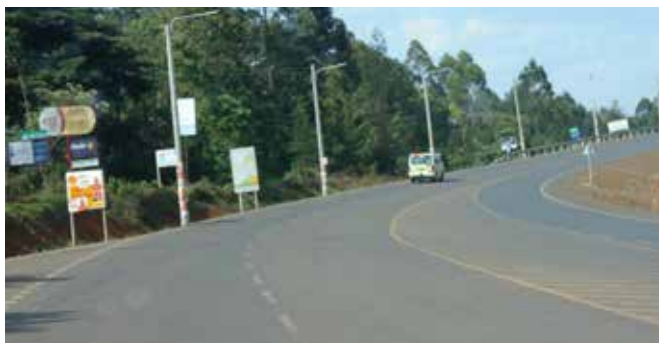
165. Chepkolon Junction

This is a 200-meter road section on a steep slope with a bend, no traffic signs. It crosses at the intersections to Kisumu and Kisii. The reason for the black spot is speeding motorists and careless entry from the intersection. There are also careless motorcycle riders especially at the intersection. Crashes happen throughout the week, at night, and during dry and wet seasons. Vehicles mostly involved in crashes are personal cars (saloons), mini buses (PSVs and vans), large buses, light and medium trucks, heavy commercial vehicles and motorcycles. Crash victims are taken to Kericho County Referral Hospital and Siloam Hospital.

Picture: Part of Chepkolon Junction road section

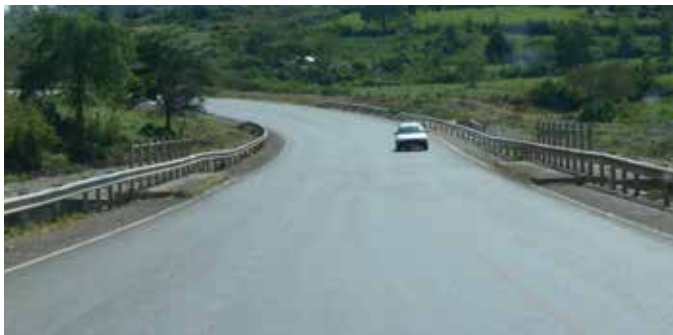
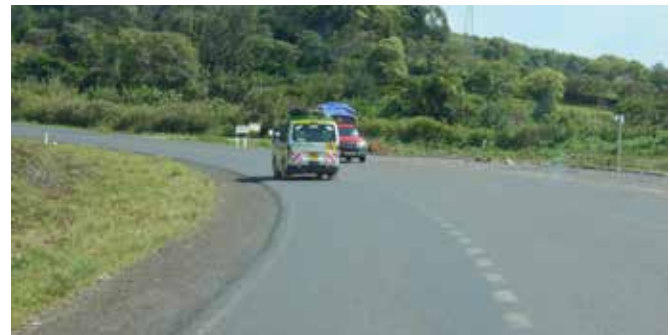
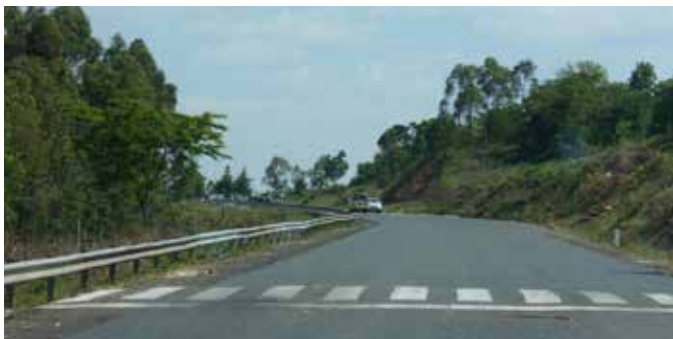
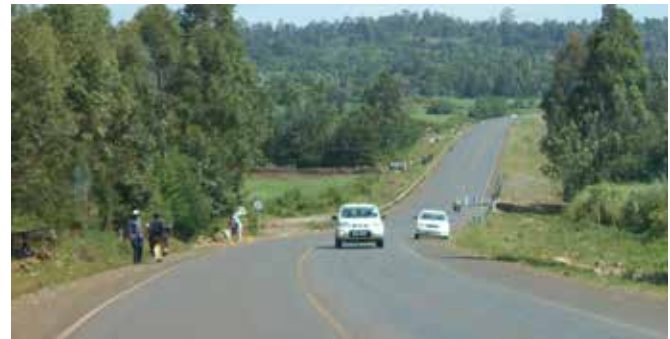
This is a 9.8-kilometer road section with a series of sharp bends on steep slopes and a bridge. The road is during wet season. The bends have guardrails, there are speed bumps but vehicles speed over them. The road is well marked and has some traffic signs.

The reason for the black spot is speeding motorists, poor visibility at the sharp bends, slippery surface in wet conditions and careless overtaking. Crashes happen throughout the week, day and night, and during dry and wet seasons. Vehicles mostly involved in crashes are personal cars (saloons), light and medium trucks, and heavy commercial vehicles. Crash victims are taken to Kericho County Referral Hospital and Siloam Hospital.

Picture: Part of Kaitui – Soliat Corner road section

Engineering - road design/furniture/features	Enforcement - law	Education - Road user awareness
<ul style="list-style-type: none"> • Instal signage for the blackspot, slippery road, and speed limit. • Repair the damaged guard rails. 	<ul style="list-style-type: none"> • Enforce speed limit compliance. 	<ul style="list-style-type: none"> • Sensitize motorists on road safety. • Create awareness so that motorists maintain safe speeds and overtake carefully especially at the sharp bends, at night and in wet seasons.

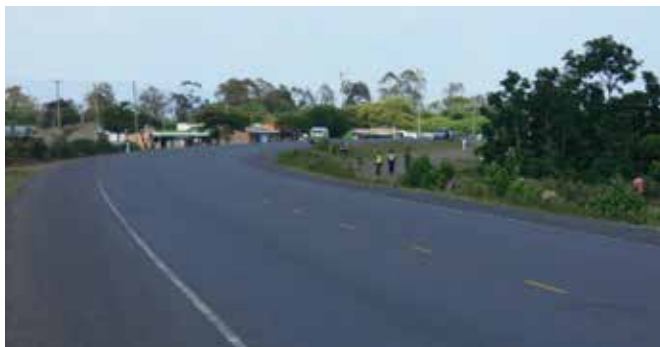
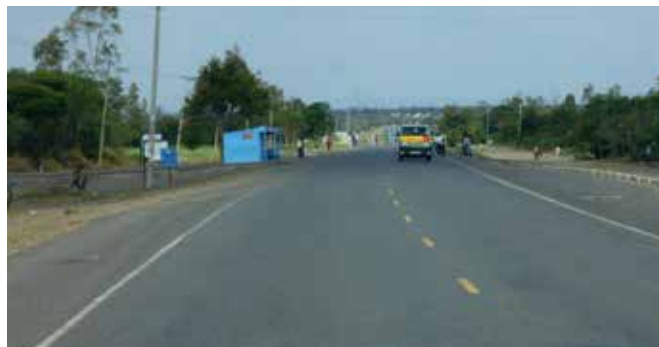
167. Ogwedhi

This is a 250-meter road section on a straight stretch near Ogwedhi market center. The reason for black spot is speeding motorists and unsafe pedestrian crossing. Crashes happen throughout the week, day and night, and during dry and wet seasons. Vehicles mostly involved in crashes are personal cars (saloons), large buses, and heavy commercial vehicles. Crash victims are taken to Jaramogi Oginga Odinga Referral Hospital.

Picture: Part of Ogwedhi road section

Engineering - road design/furniture/features	Enforcement - law	Education - Road user awareness
<ul style="list-style-type: none"> • Instal road signs. • Designate pedestrian crossing points. 	<ul style="list-style-type: none"> • Enforce speed limit compliance. 	<ul style="list-style-type: none"> • Sensitize pedestrians on safe crossing. • Create awareness on the dangers of speeding.

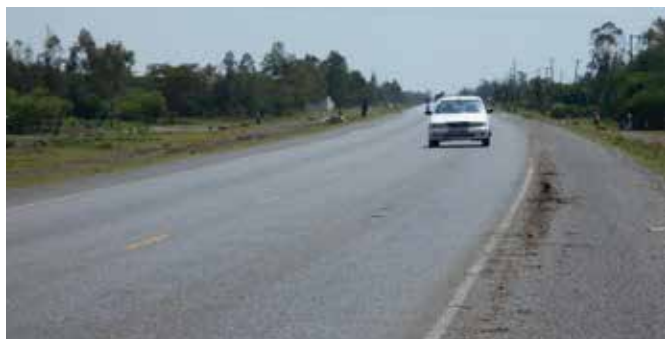
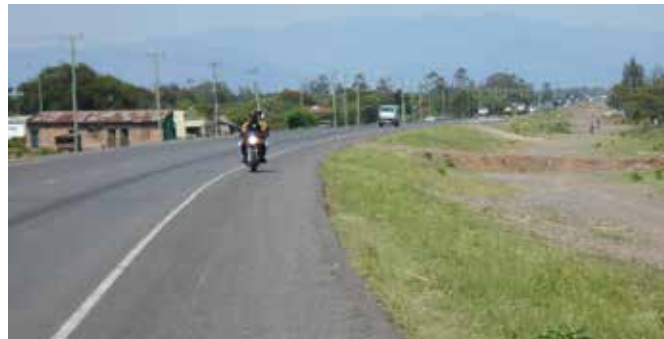
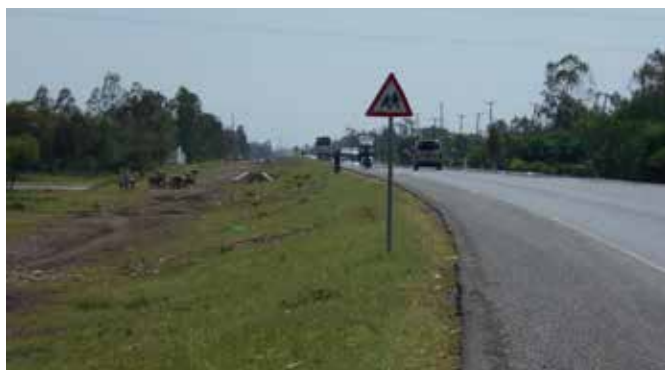
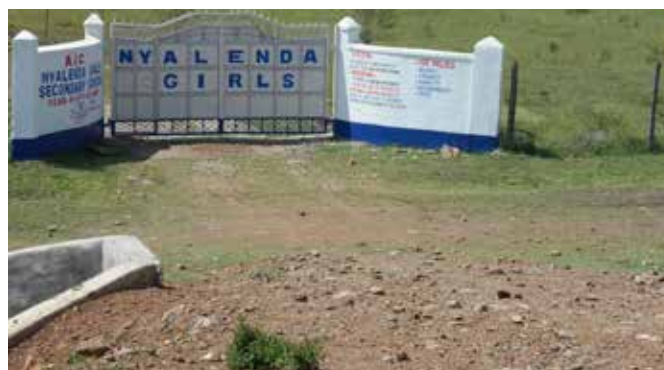
168. Otho

This is a new blackspot on a 3.2-kilometer road section with a straight stretch and a bend. It passes through Otho market center. The reason for black spot is unsafe pedestrian crossing and speeding motorists. Crashes happen throughout the week, day and night, and during dry and wet seasons. Vehicles mostly involved in crashes are personal cars (saloons), mini buses (PSVs and vans), and motorcycles. Crash victims are taken to Jaramogi Oginga Odinga Referral Hospital.

Picture: Part of Otho road section

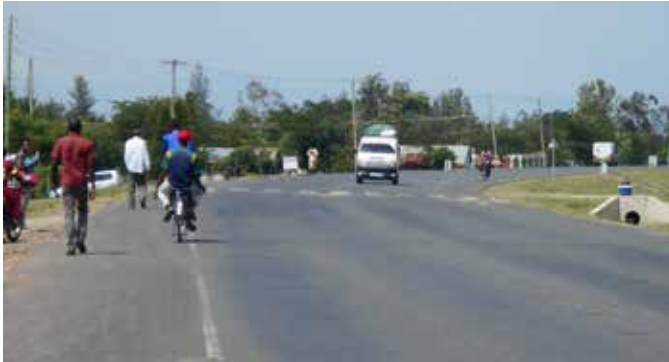
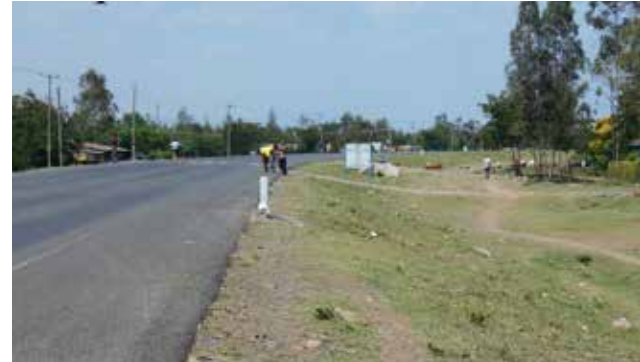
169. Boya

This is a new blackspot on a 300-meter road section with a sharp bend on a gentle slope. It passes through Boya market center. There are no road signs. The reason for black spot is unsafe pedestrian crossing and speeding motorists. Crashes happen throughout the week, day and night, and during dry and wet seasons. Vehicles mostly involved in crashes are personal cars (saloons), and motorcycles. Crash victims are taken to Ahero Sub- District Hospital and Jaramogi Oginga Odinga Referral Hospital.

Picture: Part of Boya road section

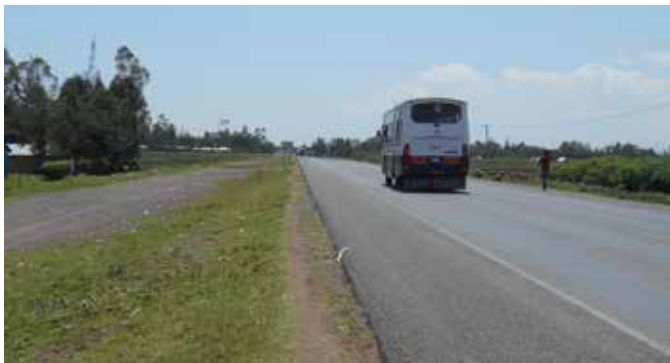
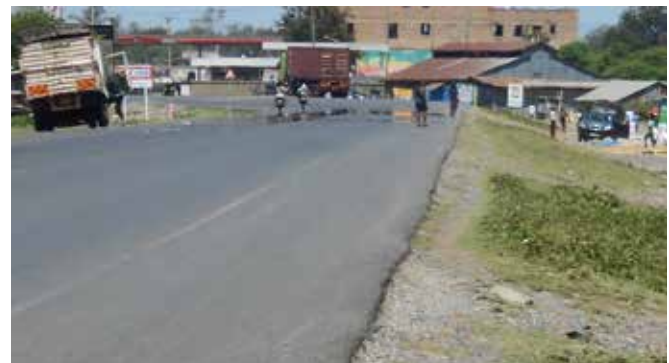
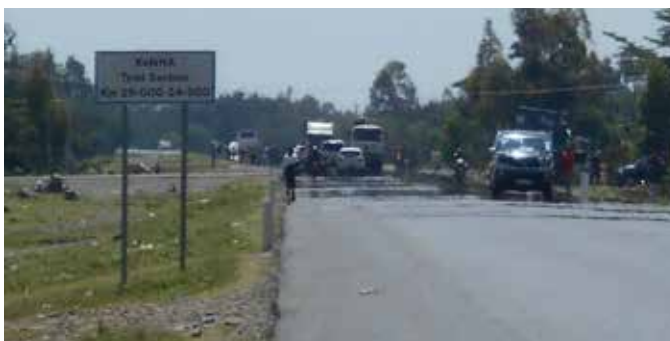
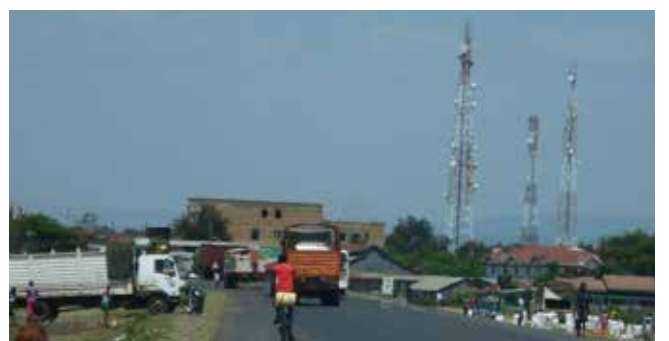
170. Ahero at Deliverance Church

This is a new blackspot on a 300-meter road section at a straight stretch and has a sharp bend. It passes through Ahero town center. There is no adequate signage in this section. The reason for black spot is unsafe pedestrian crossing and speeding motorists. Crashes happen throughout the week and, both day and night, as well as in both dry and wet seasons. Vehicles mostly involved in crashes are personal cars (saloons), and motorcycles. Crash victims are taken to Ahero Nyando County Hospital and Jaramogi Oginga Odinga Referral Hospital.

Picture: Part of Ahero at Deliverance Church road section

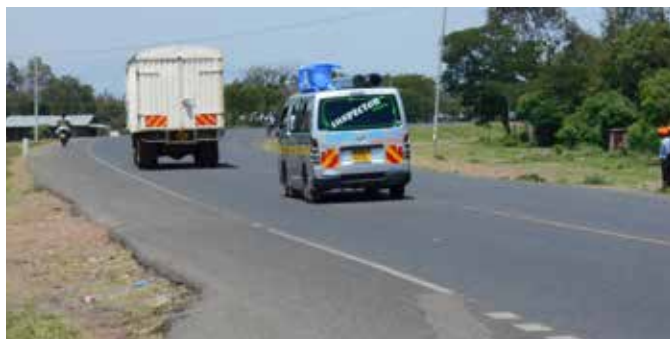
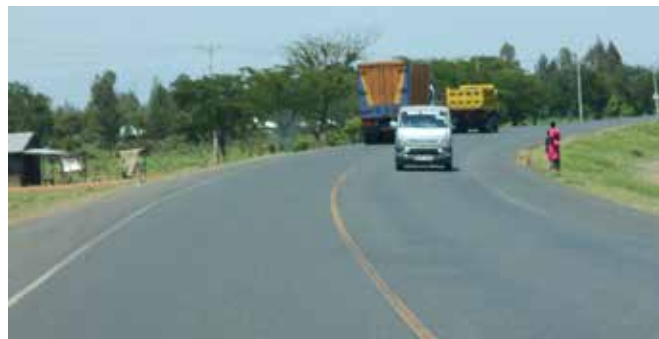
171. Lela-Ogwedhi-Kagogo

This 0.8-kilometer road section has a bend on a steep slope, a straight stretch and passes through a market center. The reason for the black spot is speeding motorist and careless overtaking. Crashes happen throughout the week, day and night, and during dry and wet seasons. Vehicles mostly involved in crashes are personal cars (saloons), large buses, and heavy commercial vehicles. Crash victims are taken to Jaramogi Oginga Odinga Referral Hospital.

Picture: Part of Lela – Ogwedhi - Kagogo road section

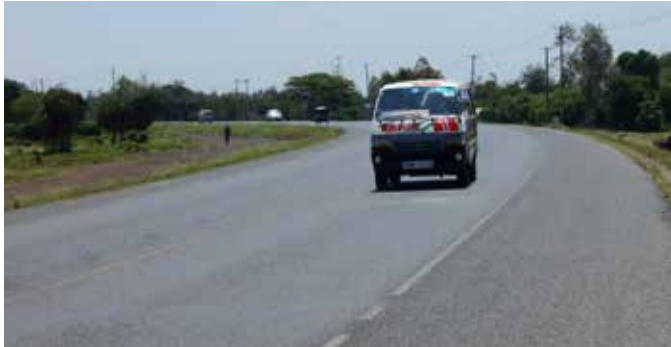
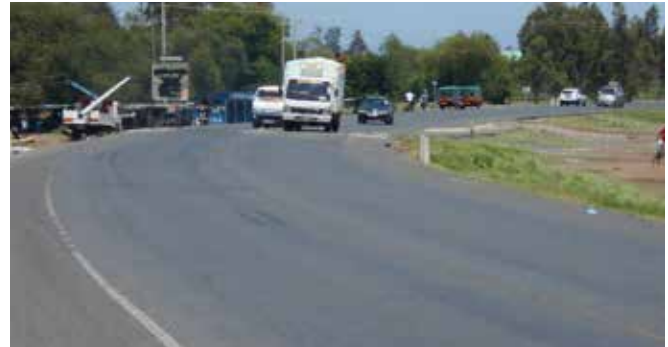
172. Namba Kogana

This 0.4-kilometer road section has a sharp bend. The reason for black spot is speeding motorist and poor visibility due to the sharp bend. There is one bump in this section. Crashes happen throughout the week, day and night, and during dry and wet seasons. Vehicles mostly involved in crashes are mini buses (PSVs and vans), and heavy commercial vehicles. Crash victims are taken to Jaramogi Oginga Odinga Referral Hospital.

Picture: Part of Namba Kogana road section

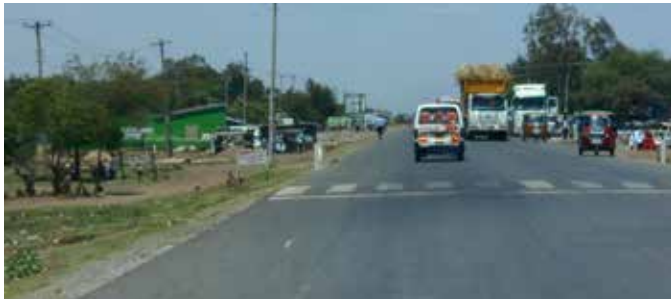
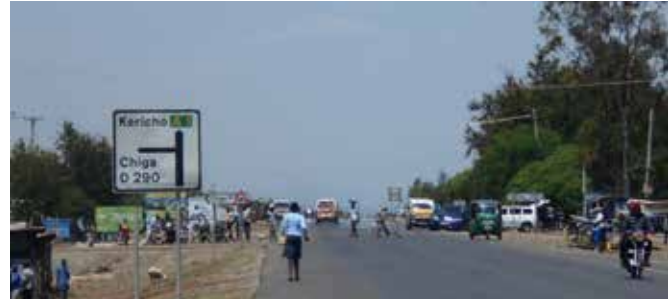
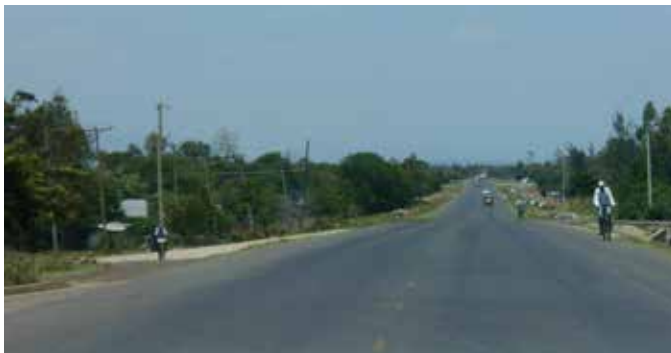
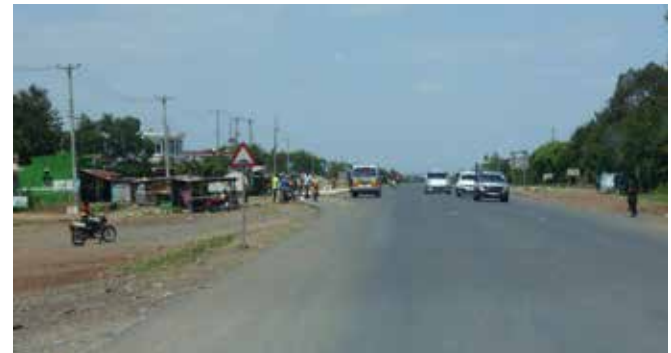
173. Koyuga-Rabour

This is a 1.1-kilometer road section along a straight stretch and gentle slope, has speed bumps and intersections, and passes through Rabuor market. The road marking is fading. The reason for the black spot is speeding motorists, unsafe pedestrian crossing at Rabuor market and children crossing from the nearby schools. Crashes happen throughout the week, day and night, and during dry and wet seasons. Vehicles mostly involved in crashes are personal cars (saloons), mini buses (PSVs and vans), and motorcycles. Crash victims are taken to Jaramogi Oginga Odinga Referral Hospital.

Picture: Part of Koyuga - Rabuor road section

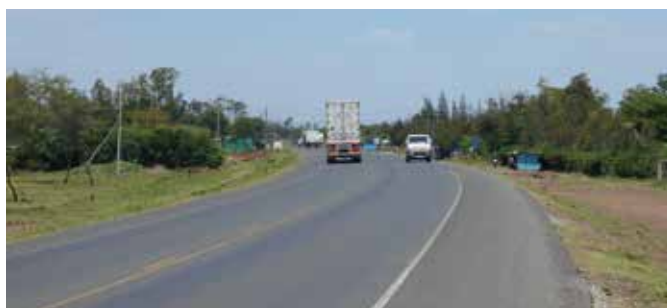
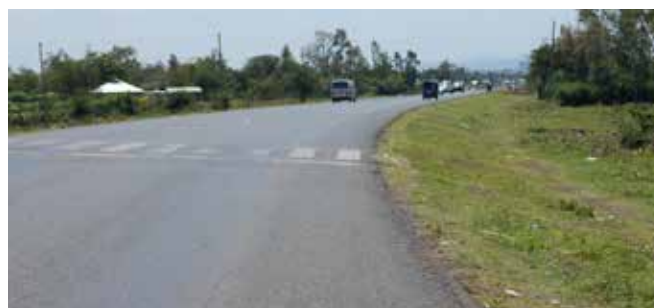
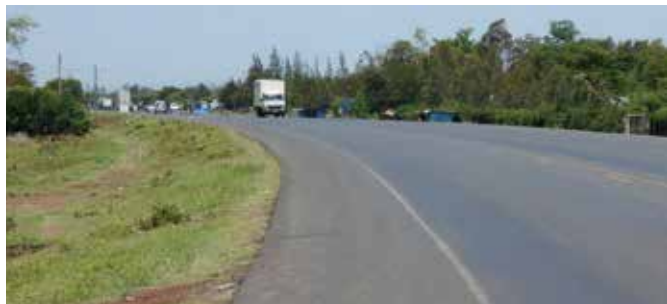
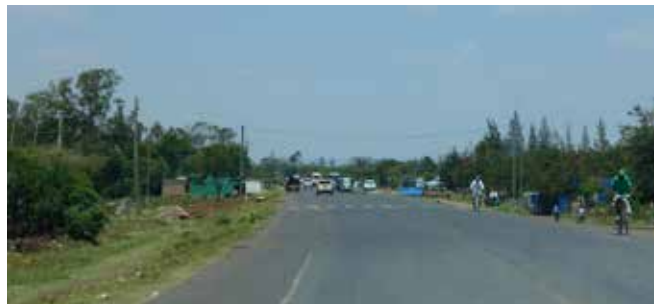
174. Alendu

This is a 1.3-kilometer section on a straight stretch with sharp bend and a market center. The reason for black spot is speeding motorist, and unsafe pedestrian crossing along the road and at the market center. The section has speed bumps, which do not slow down vehicles. Crashes happen throughout the week, day and night, and during dry and wet seasons. Vehicles mostly involved in crashes are personal cars (saloons), mini buses (PSVs and vans), and heavy commercial vehicles. Crash victims are taken to Jaramogi Oginga Odinga Referral Hospital.

Picture: Part of Alendu road section

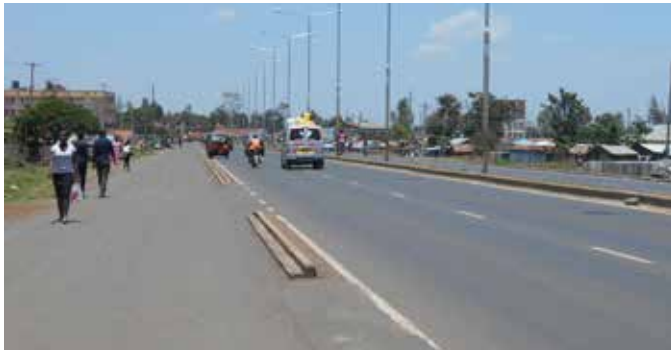
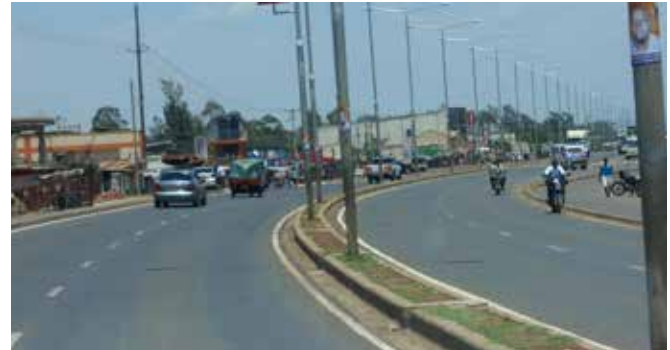
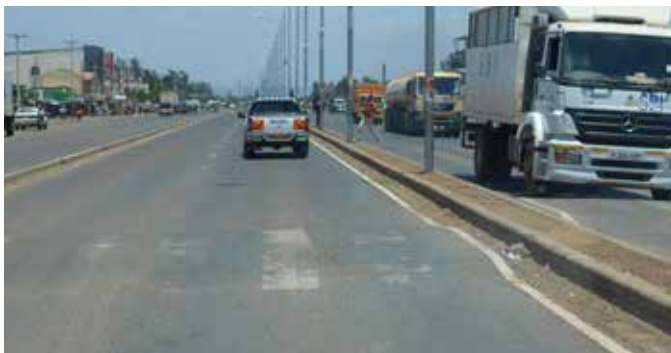
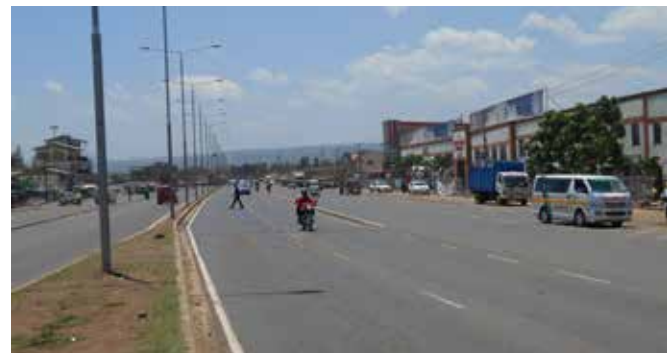
175. Nyamasaria

This is a new blackspot on a 2.4-kilometer road section at Nyamasaria along a straight stretch. It also has a bend. A part of this road section is a dual carriageway. There are no designated pedestrians crossing points. The traffic signs are installed high up on the street light poles and are not visible to motorists. There are speed bumps erected in the section. There is a high density of people due to the settlements and trading center at Nyamasaria. The reason for the black spot is unsafe pedestrian crossing, careless motorcycle riders, and a market that has encroached on the roadside. Crashes happen throughout the week, day and night, and during dry and wet seasons. Vehicles mostly involved in crashes are personal cars (saloons), mini buses (PSVs and vans), and motorcycles. Crash victims are taken to Jaramogi Oginga Odinga Referral Hospital.

Picture: Part of Nyamasaria road section

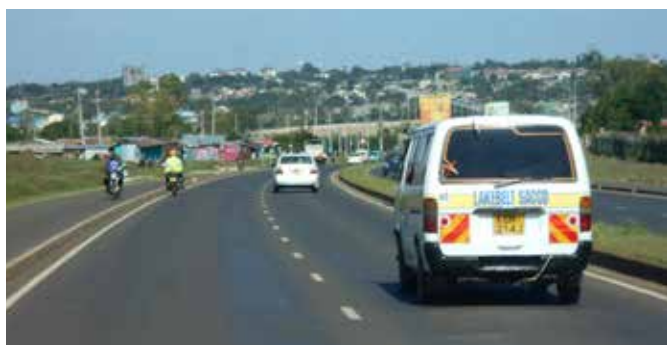
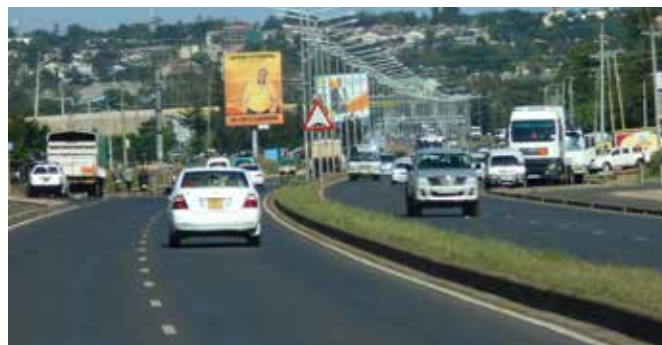
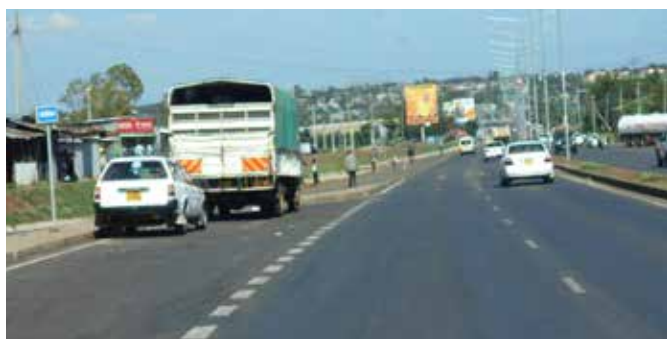
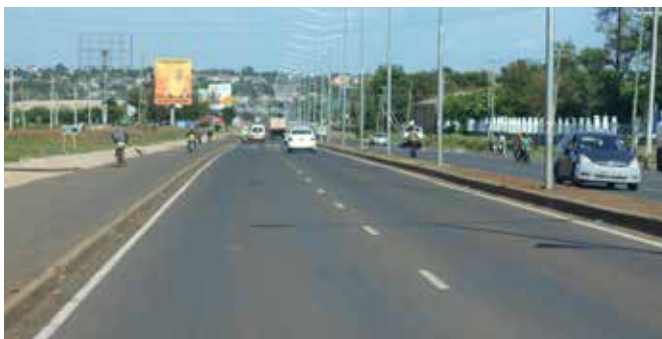
176. Kisumu Airport

This is a 0.7-kilometer road section near Kisumu Airport along a straight stretch with a bend and through an industrial area with informal settlements and intersections. The reason for the black spot is speeding motorists, careless driving and entry from the intersection (motorists and motorcycle riders) as well as unsafe pedestrian crossing at undesignated points. There is a speed bump but is not adequate. Crashes happen throughout the week, day and night, and during dry and wet seasons. Vehicles mostly involved in crashes are personal cars (saloons), mini buses (PSVs and vans), heavy commercial vehicles, and motorcycles. Crash victims are taken to Jaramogi Oginga Odinga Referral Hospital.

Picture: Part of Kisumu Airport area road section

Engineering - road design/furniture/features	Enforcement - law	Education - Road user awareness
<ul style="list-style-type: none"> • Instal adequate signage for road hazards and speed limit. • Designate pedestrian crossing point. • Put up a footbridge. • Erect a guard rail to control unsafe movement by pedestrians and motorcyclists. 	<ul style="list-style-type: none"> • Enforce speed limit compliance and safe crossing by pedestrians. 	<ul style="list-style-type: none"> • Sensitize pedestrians on safe crossing • Sensitize motorcycle and 'tuk tuk' riders on road safety. • Create awareness among motorists on the dangers of speeding.

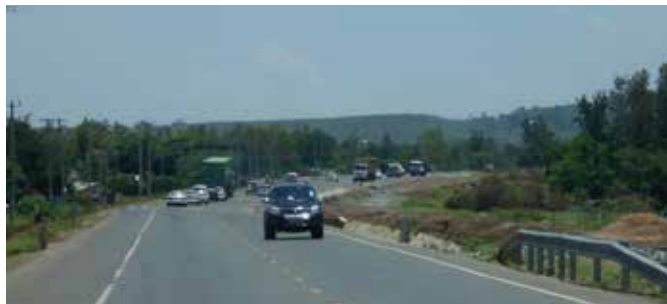
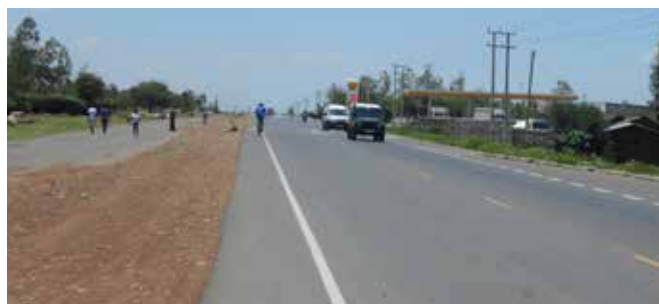
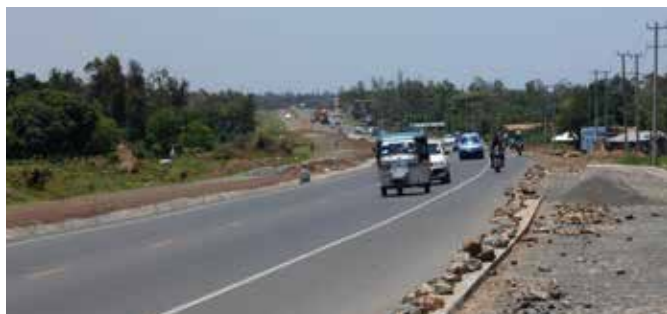
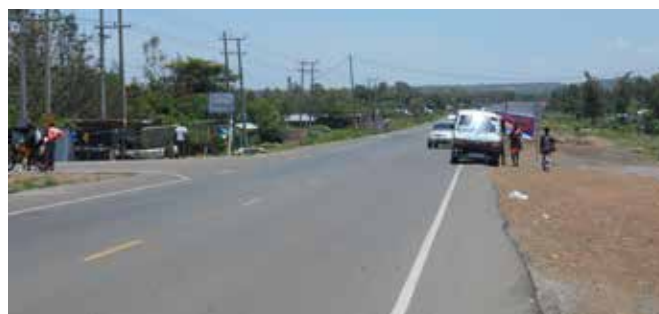
178. Tieng're Junction

This is a new blackspot on 2.3-kilometer road section near the Otonglo area of the highway along a straight stretch with a sharp bend at a gently sloping section. The section has intersections, speed bumps, but lacks adequate road signs. There are also loose chippings still on the road used to construct the drainage. The reason for the black spot is unsafe pedestrian crossing, speeding motorists and careless entry from the junction by motorcycle riders. Crashes happen equally over weekend and weekday but mostly at day time, as well as equally during both dry and wet seasons. Vehicles mostly involved in crashes are personal cars (saloons), mini buses (PSVs and vans), heavy commercial vehicles and motorcycles. Crash victims are taken to Jaramogi Oginga Odinga Referral Hospital.

Picture: Part of Tieng're Junction area road section

Engineering - road design/furniture/features	Enforcement - law	Education - Road user awareness
<ul style="list-style-type: none"> • Instal signage for the hazard and speed limit. • Designate pedestrian crossing points • Remove the lose chippings. 	<ul style="list-style-type: none"> • Enforce speed limit compliance. 	<ul style="list-style-type: none"> • Sensitize pedestrians on road safety • Sensitize motorcycle riders and pedestrians on safe speed and careful entry on to the main road.

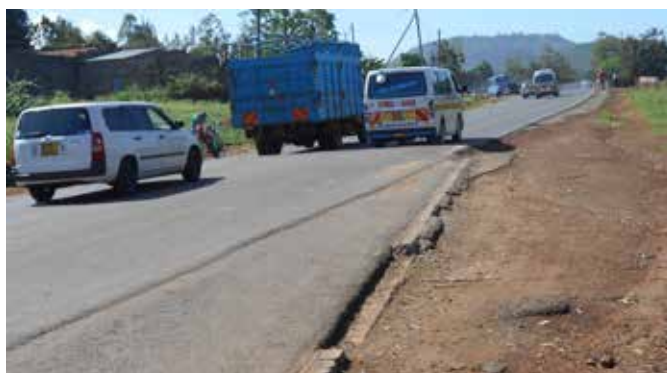
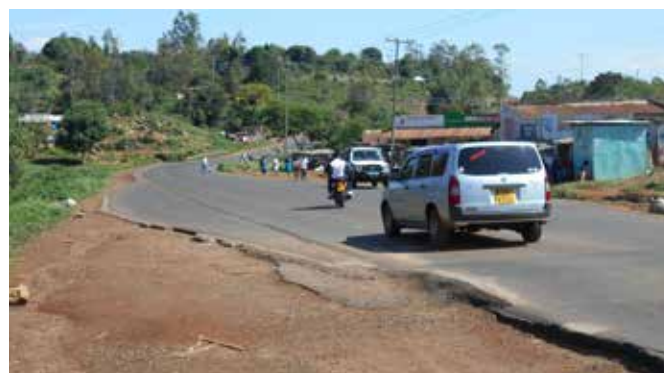
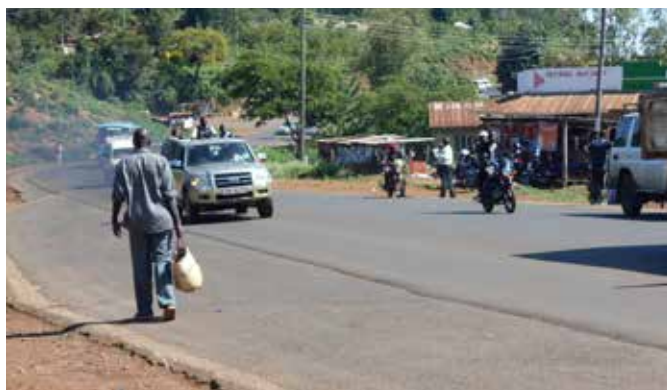
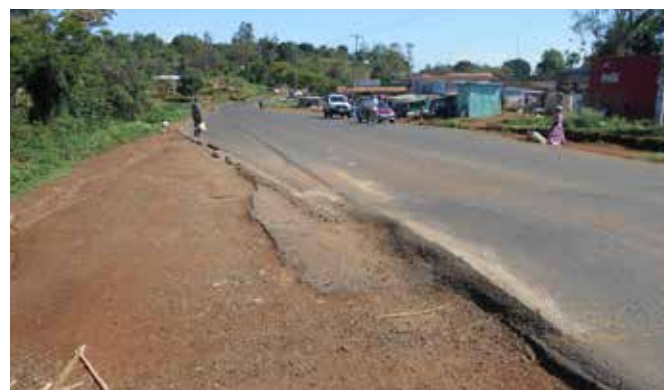
179. Daraja Mbili

This is a 0.7 kilometer road section with a bridge at a sharp bend, a steep slope, a market center and intersections. The road shoulder is worn out, markings are faded and there is no road signage. There is an unmarked speed bump that is dangerous at night and during wet season. The reason for the black spot is speeding motorists, unsafe pedestrian crossing, and head on collisions due to careless overtaking. Crashes happen throughout the week, day and night, and during dry and wet seasons. Vehicles mostly involved in crashes are personal cars (saloons), mini buses (PSVs and vans), and heavy commercial vehicles. Crash victims are taken to Jaramogi Oginga Odinga Referral Hospital.

Picture: Part of Daraja Mbili road section

Engineering - road design/furniture/features	Enforcement - law	Education - Road user awareness
<ul style="list-style-type: none"> • Instal signage for the hazard and speed limit. • Mark the road appropriately, particularly the speed bump. • Designate pedestrian crossing points. • Repair road shoulders. 	<ul style="list-style-type: none"> • Enforce speed limit compliance. 	<ul style="list-style-type: none"> • Sensitize on road safety. • Sensitize pedestrians and motorcyclists on road safety. • Create awareness on careful overtaking and dangers of speeding.

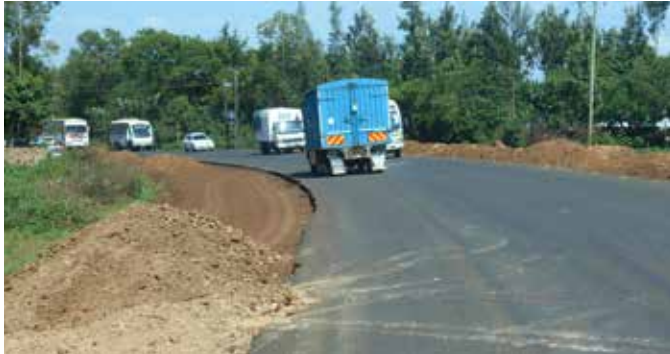
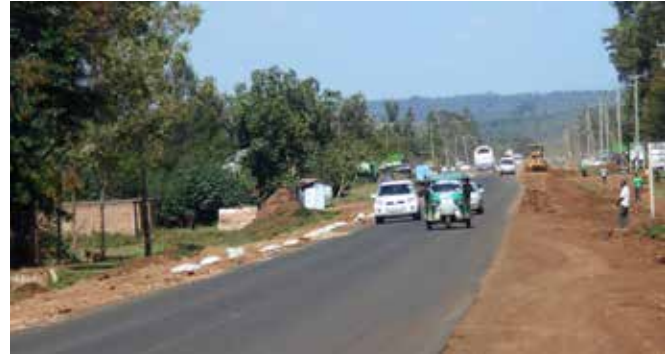
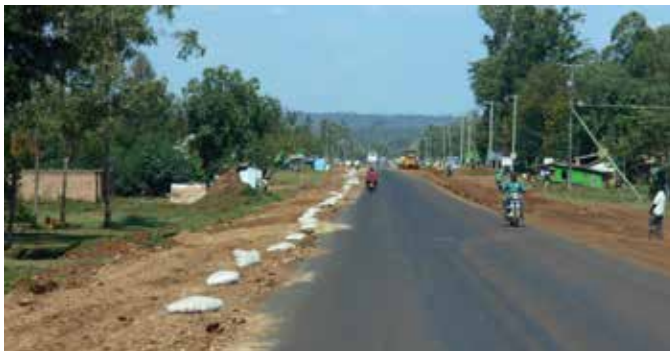
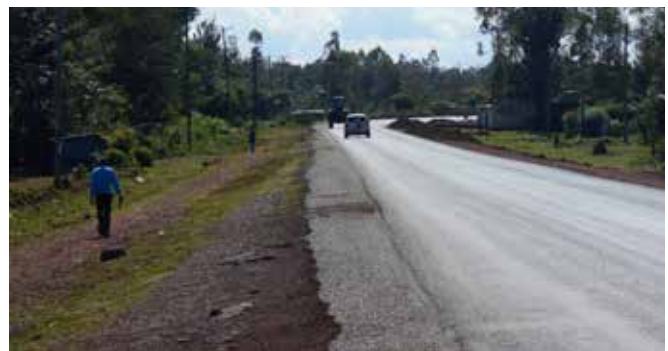
180. Chulaimbo

This is 1.8-kilometer road section with a sharp bend on a gentle slope and a straight stretch, through Chulaimbo market center. The road is not marked and does not have signage. Repair work has started on the road shoulder. The reason for the black spot is speeding motorists and unsafe crossing by pedestrians. Crashes happen throughout the week, day and night, and during dry and wet seasons. Vehicles mostly involved in crashes are mini buses (PSVs and vans), and heavy commercial vehicles. Crash victims are taken to Jaramogi Oginga Odinga Referral Hospital.

Picture: Part of Chulaimbo road section

Engineering - road design/furniture/features	Enforcement - law	Education - Road user awareness
<ul style="list-style-type: none"> • Instal signage for the hazard and speed limit. • Mark the road appropriately and erect a speed bump near the schools and trading center. • Designate pedestrian crossing points. • Complete repair of the road shoulder. 	<ul style="list-style-type: none"> • Enforce speed limit compliance. 	<ul style="list-style-type: none"> • Educate motorists on the dangers of speeding. • Train school pupils on road safety. • Sensitize motorcycle riders and pedestrians on road safety.

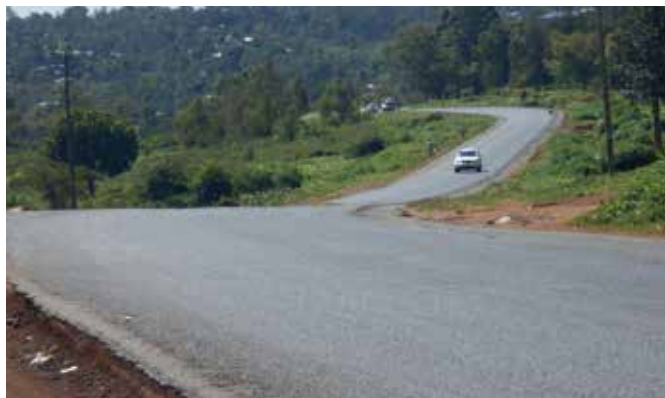
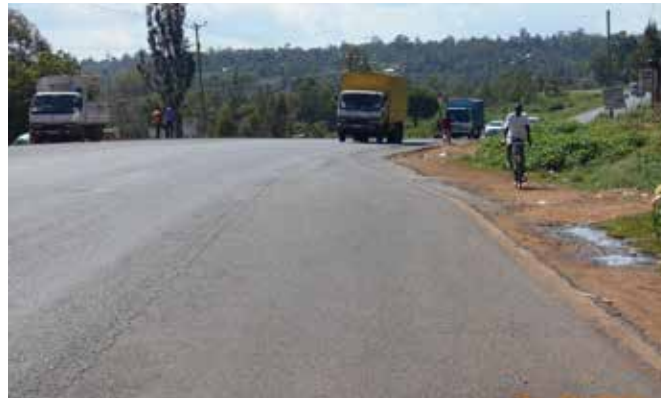
181. Lela

This is a 200-meter road section with a sharp bend on a steep slope through Lela market. The road is not marked and does not have signage and bumps. The road shoulder is worn out and missing in some sections. The reason for the black spot is speeding motorists and unsafe pedestrian crossing. Crashes happen throughout the week, day and night, and during dry and wet seasons. Vehicles mostly involved in crashes are personal cars (saloons), mini buses (PSVs and vans), and heavy commercial vehicles. Crash victims are taken to Vihiga District Hospital and Jaramogi Oginga Odinga Referral Hospital.

Picture: Part of Lela road section

Engineering - road design/furniture/features	Enforcement - law	Education - Road user awareness
<ul style="list-style-type: none"> • Instal signage for the hazard and speed limit. • Mark the road, designate pedestrian crossing points and erect bumps at Lela market. • Repair the road shoulder. 	<ul style="list-style-type: none"> • Enforce speed limit compliance. 	<ul style="list-style-type: none"> • Create awareness on dangers of speeding and unsafe crossing by pedestrians.

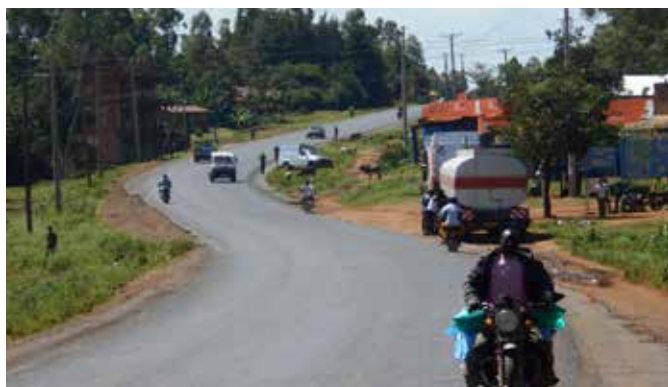
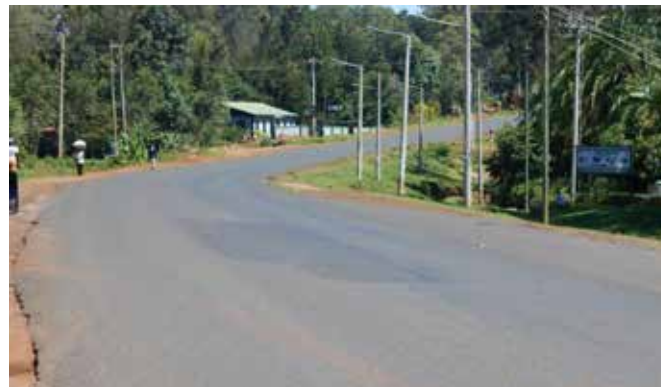
182. Ebukasami Coptic Church

This is a 300-meter road section along sharp bends, intersection, and no speed bumps. The road not marked, lacks road signs and the road shoulder is worn out. The reason for the black spot is speeding motorists. Crashes happen throughout the week, day and night, and during dry and wet seasons. Vehicles mostly involved in crashes are personal cars (saloons), mini buses (PSVs and vans), and heavy commercial vehicles. Crash victims are taken to Vihiga District Hospital.

Picture: Part of Ebukasami Coptic Church road section

Engineering - road design/furniture/features	Enforcement - law	Education - Road user awareness
<ul style="list-style-type: none"> • Instal signage for the hazard and speed limit. • Mark the road and repair road shoulder. • Erect speed bumps and designate pedestrian crossing points. 	<ul style="list-style-type: none"> • Enforce speed limit compliance. 	<ul style="list-style-type: none"> • Create awareness on the dangers of speeding. • Educate motorcyclists on road safety.
