Northern Corridor and Nairobi County Route Hazard Mapping Report

May 2017

Developed by Safe Way Right Way and National Transport and Safety Authority

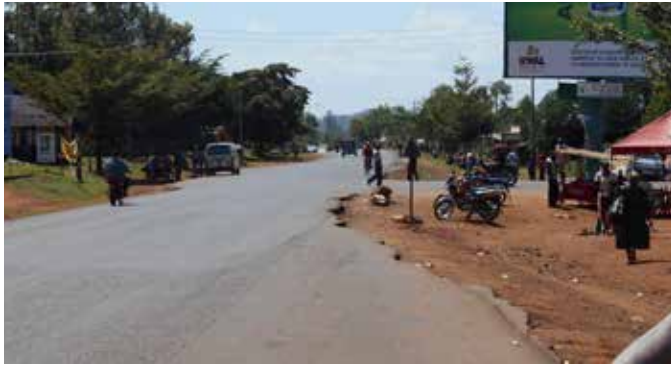
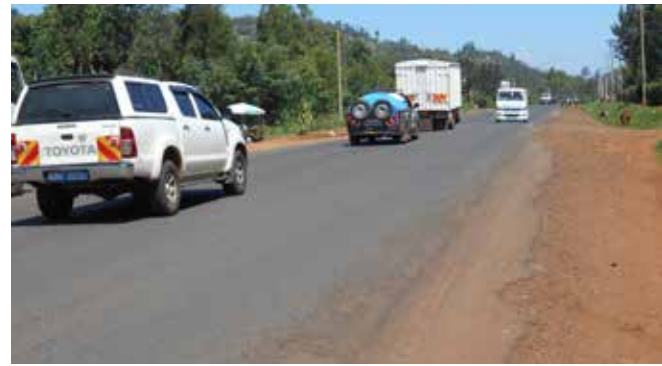
183. Ebukasami

This is a 300-meter road section on a straight section with an intersection at Ebukasami market center. There are no road signs, the road is not marked, the shoulder is worn out and there is a speed bump with no marking. The reason for the black spot is speeding motorists, unsafe pedestrian crossing, and careless motorcycle riders. Crashes happen throughout the week, day and night, and during dry and wet seasons. Vehicles mostly involved in crashes are personal cars (saloons), mini buses (PSVs and vans), heavy commercial vehicles, and motorcycles. Crash victims are taken to Vihiga District Hospital and Emuhaya Health Center.

Picture: Part of Ebukasami road section

Engineering - road design/furniture/features	Enforcement - law	Education - Road user awareness
<ul style="list-style-type: none"> • Instal signage for the hazard and speed limit. • Mark the road appropriately. • Ensure the speed bump is marked. • Repair road shoulder. • Designate pedestrian crossing points. 	<ul style="list-style-type: none"> • Enforce speed limit compliance. 	<ul style="list-style-type: none"> • Educate pedestrian on safe crossing. • Create awareness among motorists on the dangers of speeding. • Train motorcyclists on road safety.

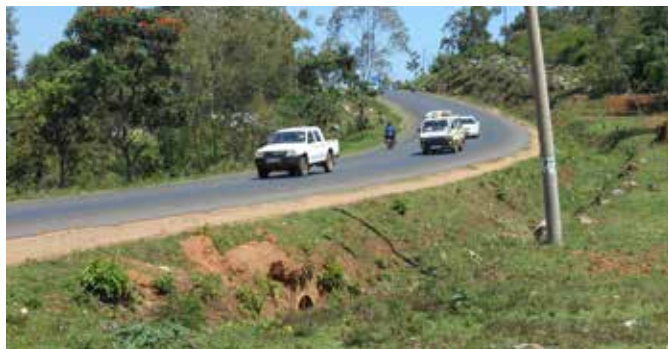
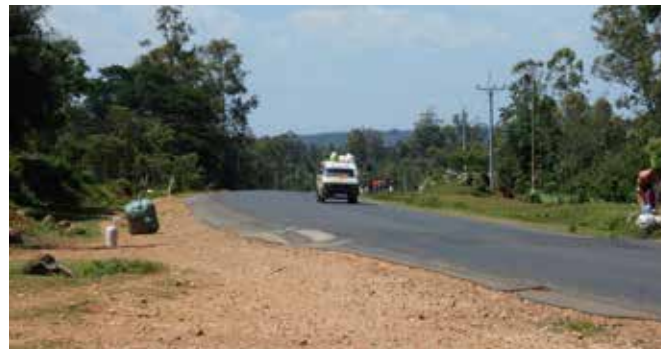
184. Esibila (before the Market Center)

This 300-meter road section has a gentle slope and sharp bend. This section has no road signs, marking and road shoulder is worn out. There is a speed bump, which is not marked at the end of the section. The reason for the black spot is speeding motorist, and poor visibility at the bend. Crashes happen throughout the week, daytime, and during dry and wet seasons. Vehicles mostly involved in crashes are personal cars (saloons), mini buses (PSVs and vans), and heavy commercial vehicles. Crash victims are taken to Vihiga District Hospital and Emuhaya Health Center.

Picture: Part of Esibila road section

Engineering - road design/furniture/features	Enforcement - law	Education - Road user awareness
<ul style="list-style-type: none"> • Instal signage for the hazards and speed limit. • Mark the road appropriately. • Mark the speed bump and repair the road shoulder. 	<ul style="list-style-type: none"> • Enforce speed limit compliance. 	<ul style="list-style-type: none"> • Create awareness on the dangers of speeding and careful overtaking on the sharp bend.

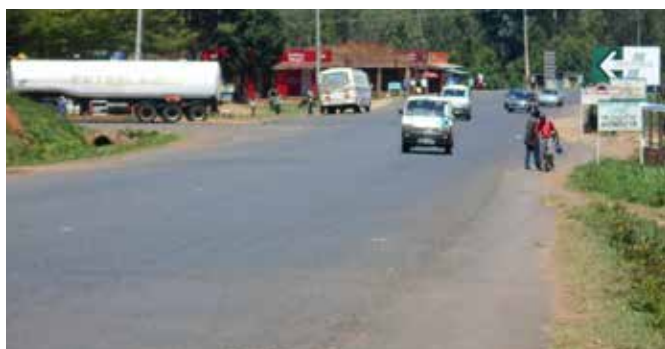
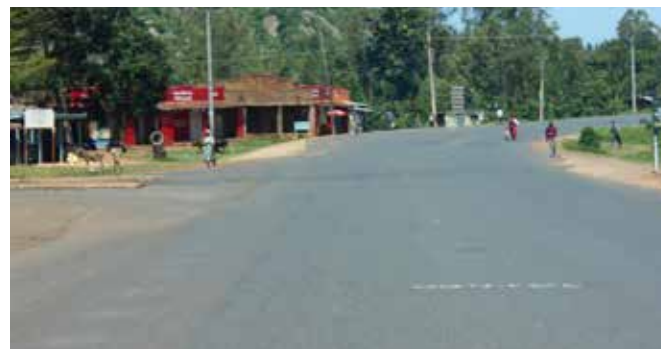
185. Esibila (near Esibila Center & Esibila Primary School).

This is a 100-meter road section on a straight stretch with a gentle slope at Esibila market with an intersection. Esibila Primary school is located in this black spot. This section has no road signs and marking. The reason for the black spot is speeding motorists, unsafe pedestrian crossing and poor visibility at the bend. Crashes happen throughout the week, day and night, and during dry and wet seasons. Vehicles mostly involved in crashes are personal cars (saloons), mini buses (PSVs and vans), and heavy commercial vehicles. Crash victims are taken to Vihiga District Hospital, Ugunja District Hospital and Emuhaya Health Center.

Picture: Part of Esibila B road section

Engineering - road design/furniture/features	Enforcement - law	Education - Road user awareness
<ul style="list-style-type: none"> • Instal signage for the hazard and speed limit. • Mark the road appropriately. • Designate pedestrian crossing points and erect bumps. 	<ul style="list-style-type: none"> • Enforce speed limit compliance. 	<ul style="list-style-type: none"> • Sensitize pedestrians and Esibila primary school children on road safety. • Create awareness on the dangers of speeding and careful driving at the bend.

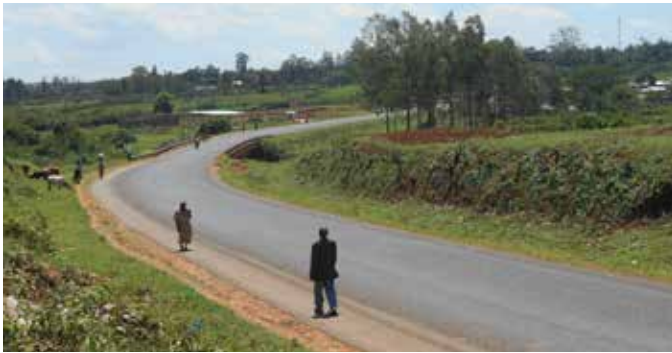
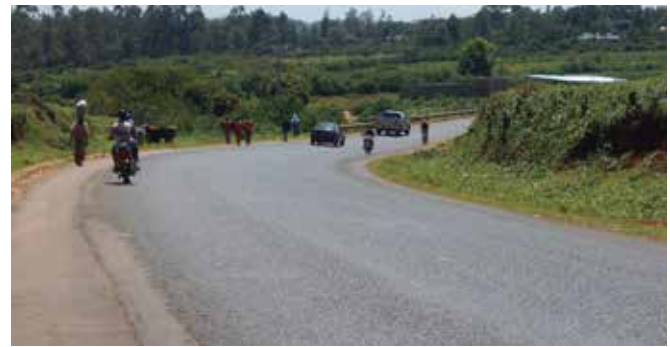
186. Ulumbi – Lwanda

This is a 1.1-kilometer road section along a straight stretch with a bridge at a sharp bend. There is no road signage and the road is not marked. The reason for black spot is speeding motorists and careless overtaking. Crashes happen throughout the week, day and night, and during dry and wet seasons. Vehicles mostly involved in crashes are personal cars (saloons), mini buses (PSVs and vans), and heavy commercial vehicles. Crash victims are taken to Maseno Mission Hospital and Emuhaya Health Center.

Picture: Part of Ulumbi - Lwanda road section

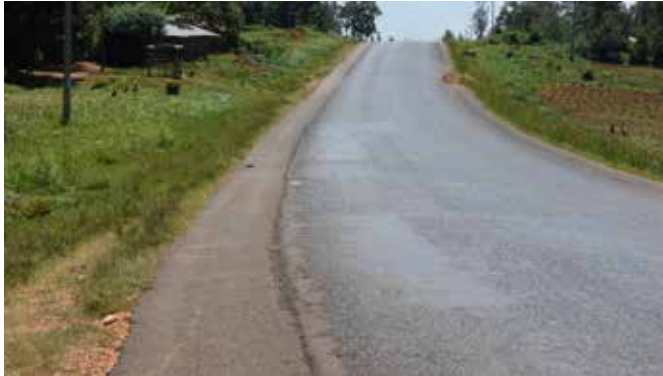
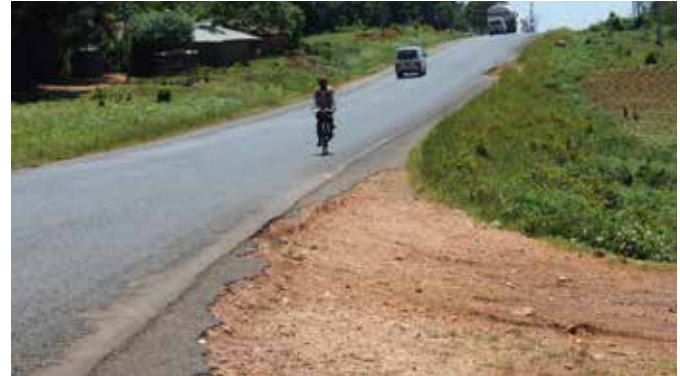
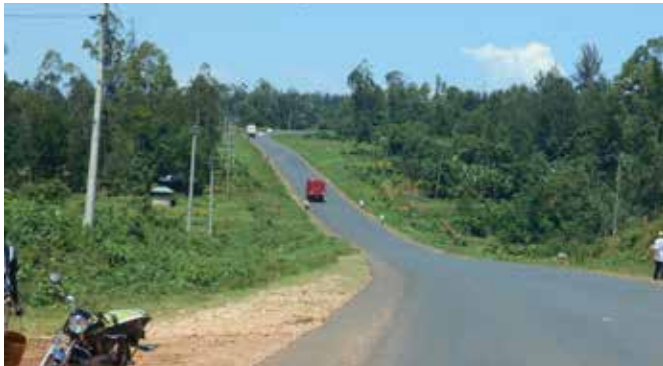
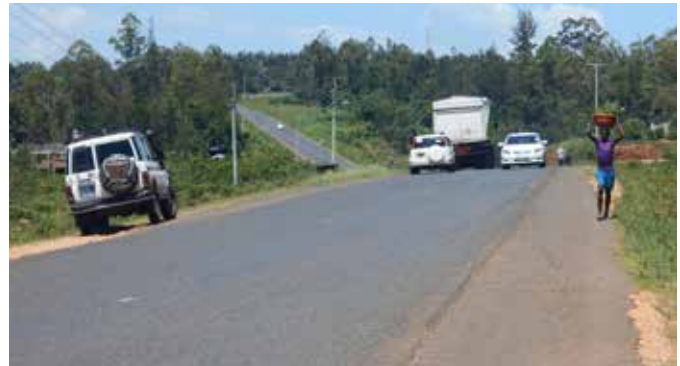
187. Ulumbi Junction

This is a 0.6-kilometer road section along a straight stretch with an intersection. This section does not have road signage and the road shoulder is damaged in some sections. The reason for black spot is speeding motorists and careless overtaking. Crashes happen throughout the week, at night, and during dry and wet seasons. Vehicles mostly involved in crashes are personal cars (saloons), mini buses (PSVs and vans), large buses, light and medium trucks, heavy commercial vehicles and motorcycle. Crash victims are taken to Maseno Mission Hospital and Vihiga District Hospital.

Picture: Part of Ulumbi Junction road section

Engineering - road design/furniture/features	Enforcement - law	Education - Road user awareness
<ul style="list-style-type: none"> • Instal signage for the hazard (steep descent) and speed limit. • Mark the road. 	<ul style="list-style-type: none"> ☐ Enforce speed limit compliance 	<ul style="list-style-type: none"> • Create awareness among motorists on speeding and careful overtaking especially at night.

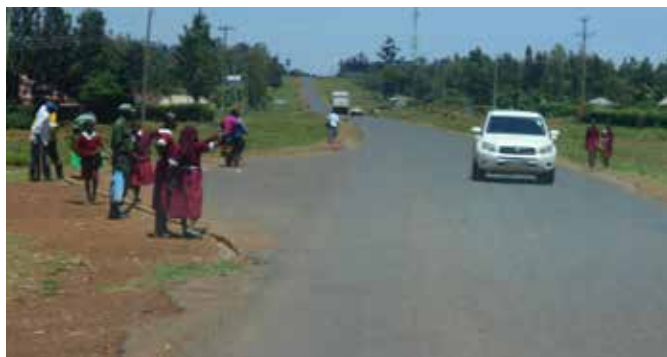
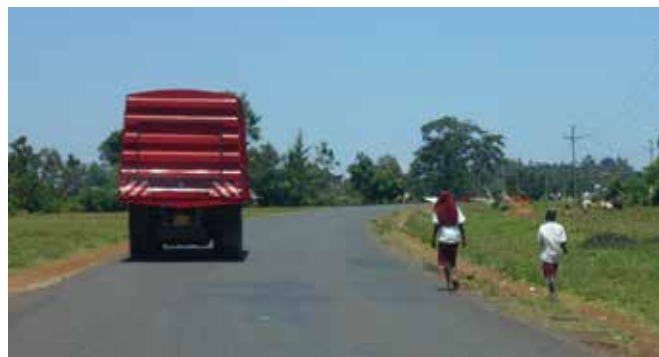
This is a 1.8-kilometer road section along a straight stretch, with a slight bend on a gentle slope and has intersection. The road is not marked and does not have road signs. The reason for the black spot is speeding motorists and unsafe crossing by pedestrians. Crashes happen throughout the week, day and night, and during dry and wet seasons.

Picture: Part of Lana road section

Engineering - road design/furniture/features	Enforcement - law	Education - Road user awareness
<ul style="list-style-type: none"> • Instal signage for the hazard and speed limit. • Mark the road appropriately. • Erect speed bumps and designate pedestrian crossing points. 	<ul style="list-style-type: none"> • Enforce speed limit compliance 	<ul style="list-style-type: none"> • Sensitize pedestrians on road safety and motorists on dangers of speeding. • Train school children on road safety.

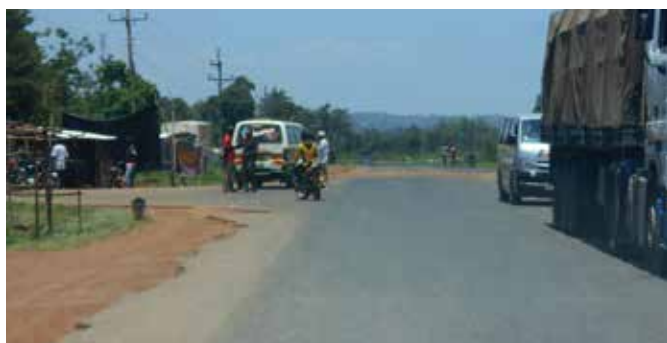
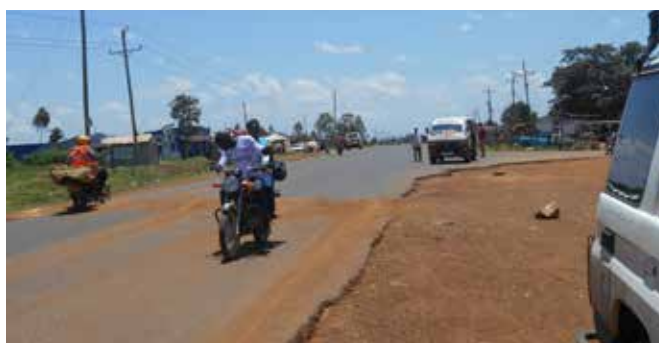
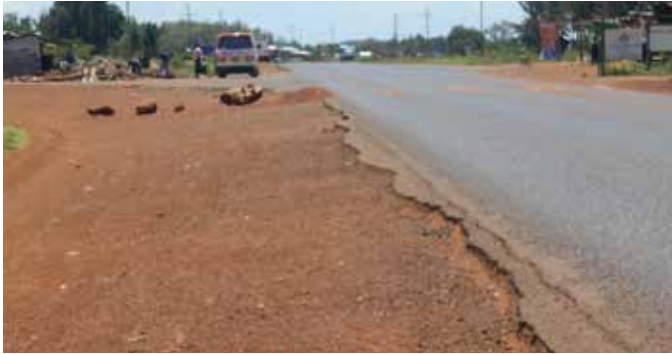
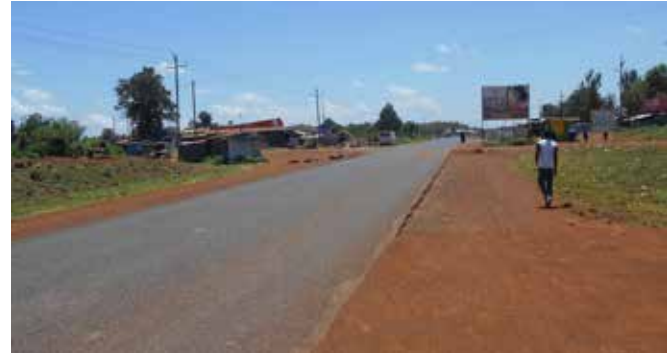
190. Madea Area

This is a 2.9 kilometer road section through a busy market center with intersections and no speed bumps. This section has no road signage and the road shoulder is damaged. Madea residents have put up temporary speed bumps. The reason for the black spot is speeding motorists and unsafe pedestrian crossing. Crashes happen throughout the week, at night, and during dry and wet seasons. Vehicles mostly involved in crashes are personal cars (saloons), heavy commercial vehicles and motorcycle. Crash victims are taken to Maseno Mission Hospital.

Picture: Part of Madea road section

Engineering - road design/furniture/features	Enforcement - law	Education - Road user awareness
<ul style="list-style-type: none"> • Instal signage for the hazard and speed limit. • Mark the road. • Designate pedestrian crossing points and erect speed bumps. • Repair damaged road shoulder. 	<ul style="list-style-type: none"> • Enforce speed limit compliance. 	<ul style="list-style-type: none"> • Sensitize pedestrians and motorcycle riders on road safety. • Create awareness on the dangers of speeding.

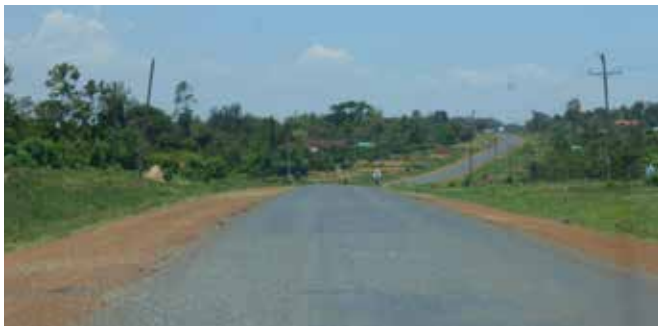
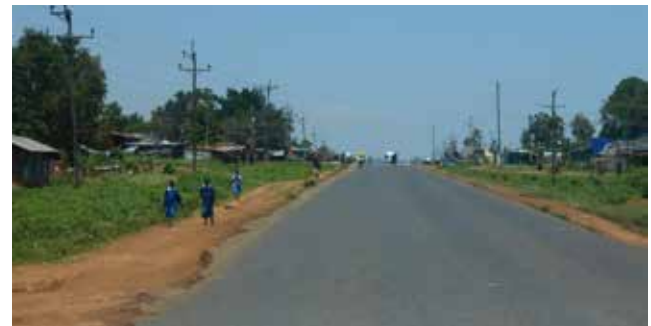
191. Simenya – Sidindi

This is a 2.1 kilometer road section along a straight stretch on a steep slope and passes through a market center. This section has a worn out road shoulder and no road signs. The reason for the black spot is speeding motorists and unsafe pedestrian crossing including children. Crashes happen throughout the week, day and night, and during dry and wet seasons. Vehicles mostly involved in crashes are personal cars (saloons), mini buses (PSVs and vans), large buses, light and medium trucks, and heavy commercial vehicles. Crash victims are taken to Maseno Mission Hospital and Rangala Mission Hospital.

Picture: Part of Simenya - Sidindi road section

Engineering - road design/furniture/features	Enforcement - law	Education - Road user awareness
<ul style="list-style-type: none"> • Instal signage for the hazard and speed limit. • Mark the road appropriately. • Designate pedestrian crossing point. • Repair damaged road shoulder. 	<ul style="list-style-type: none"> • Enforce speed limit compliance. 	<ul style="list-style-type: none"> • Sensitize pedestrians and motorcycle riders on road safety. • Train school children on road safety. • Educate motorists on the dangers of speeding.

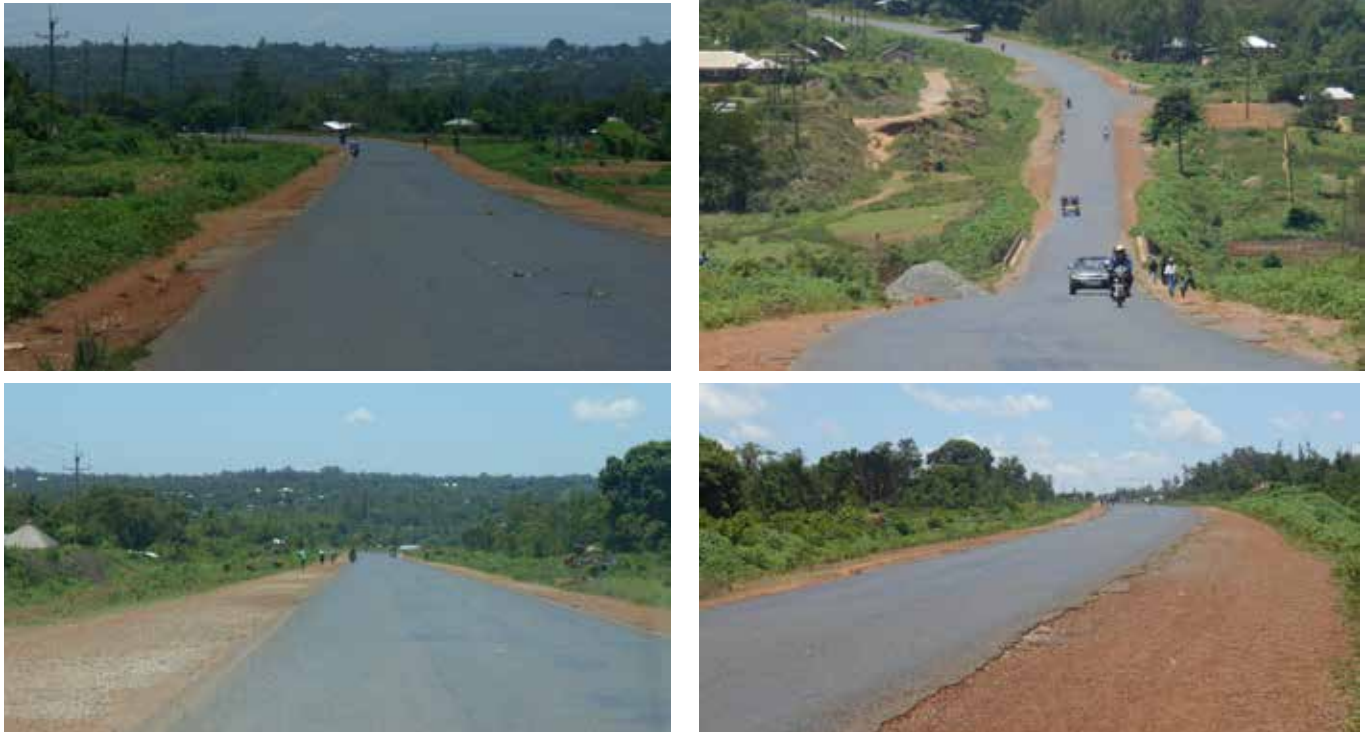
This is a 2.4-kilometer road section on a steep slope with bends and a bridge. The road is not marked and lacks road signs. The road shoulder is damaged. The reason for black spot is speeding motorists.

Picture: Part of Naam Nzoia road section

Engineering - road design/furniture/features	Enforcement - law	Education - Road user awareness
<ul style="list-style-type: none"> • Instal signage for the hazard and speed limit. • Mark the road appropriately. • Repair damaged road shoulder 	<ul style="list-style-type: none"> • Enforce speed limit compliance 	<ul style="list-style-type: none"> • Create awareness on dangers of speeding especially at night

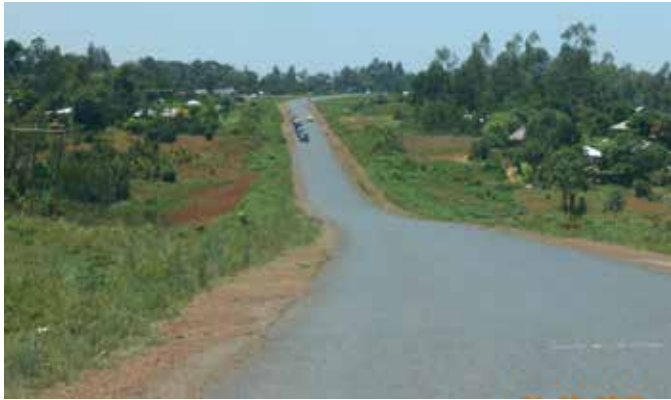
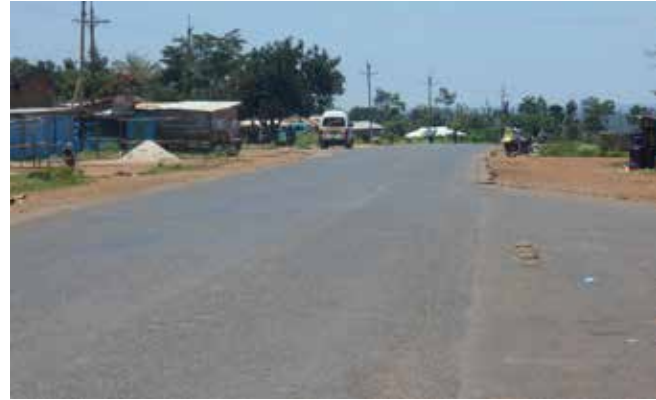
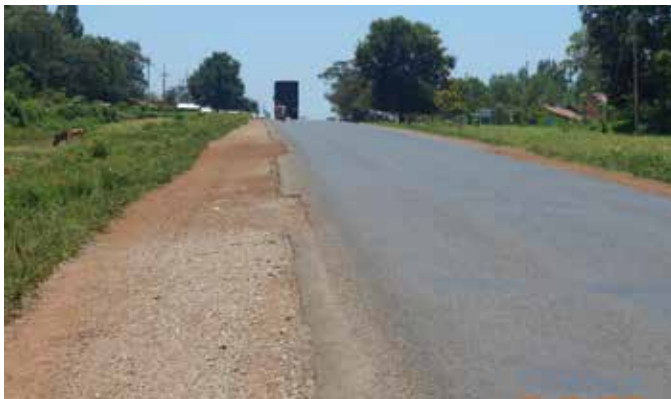
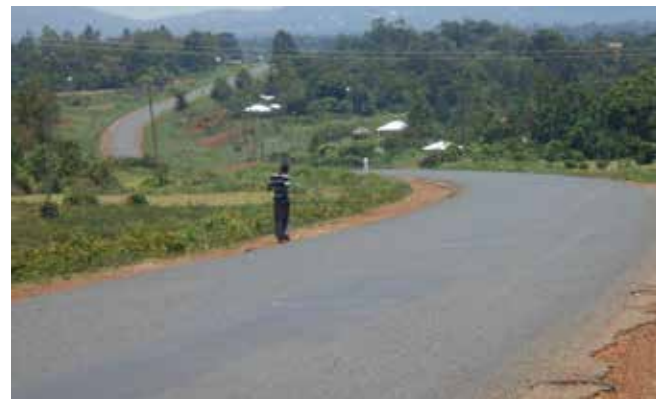
194. Ligega-Ugunja

This is a 1.4-kilometer road section on a straight section between Ligega and Ugunja steep slope. This road section is unmarked; road shoulder is damaged and lacks road signs. The reason for the black spot is speeding motorists and careless overtaking. Crashes happen throughout the week, at night, and during dry and wet seasons. Vehicles mostly involved in crashes are personal cars (saloons), mini buses (PSVs and vans), large buses, light and medium trucks, heavy commercial vehicles and motorcycles. Crash victims are taken to Yala Sub County Hospital.

Picture: Part of Ligegā - Ugunja road section

Engineering – road design/furniture/features	Enforcement – law	Education – Road user awareness
<ul style="list-style-type: none"> • Instal signage for the hazard and speed limit. • Mark the road appropriately. • Repair damaged road shoulder 	<ul style="list-style-type: none"> • Enforce speed limit compliance 	<ul style="list-style-type: none"> • Sensitize motorcycle riders on road safety • Create awareness on speeding and careful overtaking

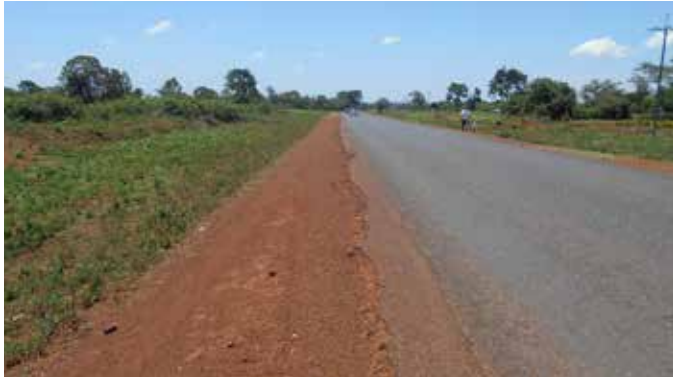
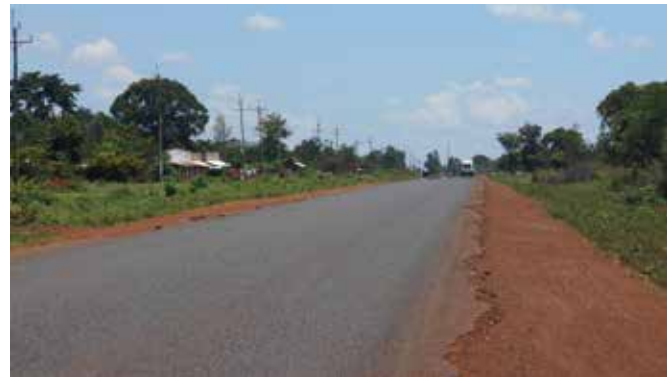
196. Nyamwanga

This is a 0.8-kilometer road section along a straight stretch near Nyamwanga market center. There are no speed bumps. The road is unmarked, lacks road signs and the road shoulder is damaged. The reason for black spot is speeding motorists and pedestrians crossing at undesignated points. Crashes happen throughout the week, day and night, and during dry and wet seasons. Vehicles mostly involved in crashes are personal cars (saloons), mini buses (PSVs and vans), heavy commercial vehicles and motorcycles. Crash victims are taken to Ugunja Sub County Hospital.

Picture: Part of Nyamwanga road section

Engineering - road design/furniture/features	Enforcement - law	Education - Road user awareness
<ul style="list-style-type: none"> • Instal signage for the hazard and speed limit. • Mark the road appropriately. • Erect a speed bump and designate pedestrian crossing points. • Repair damaged road shoulder. 	<ul style="list-style-type: none"> • Enforce speed limit. 	<ul style="list-style-type: none"> • Educate motorists on the dangers of speeding. • Sensitize motorcycle riders on road safety. • Train pedestrians on road safety.

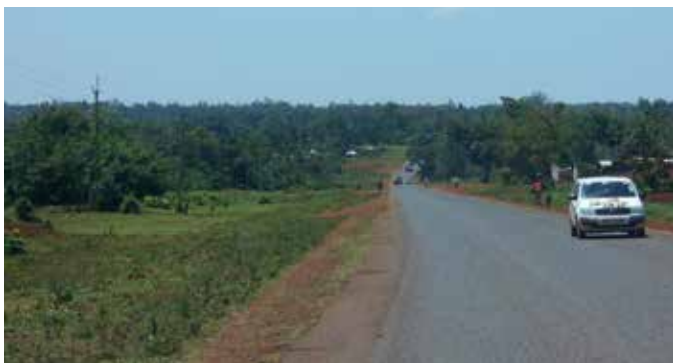
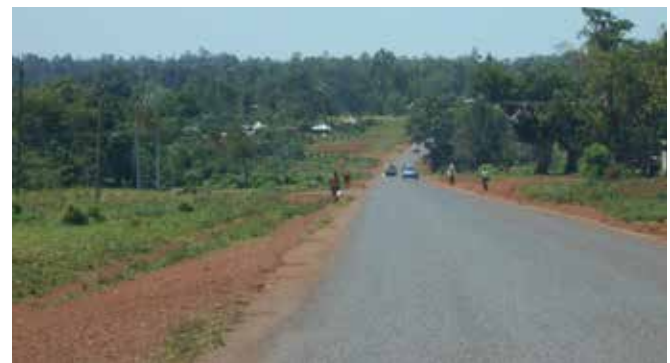
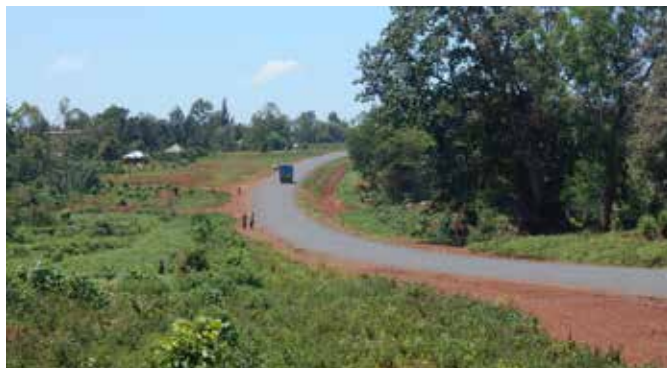
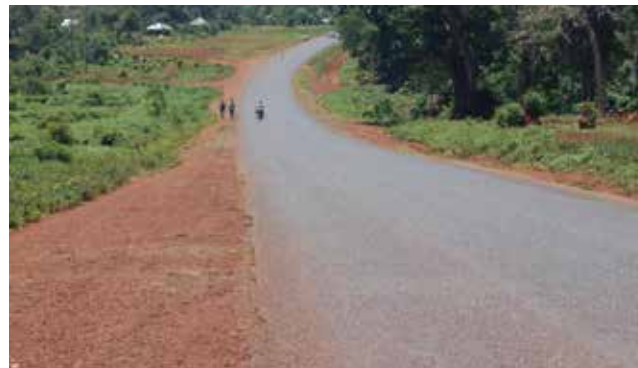
197. Rakite

This is a 0.8-kilometer road section along a straight stretch on a steep slope, near Rakite a market center. This road section is unmarked and lacks road signs. The reason for black spot is speeding motorists, unsafe pedestrian crossing at the market center. Crashes happen throughout the week, day and night, and during dry and wet seasons. Vehicles mostly involved in crashes are personal cars (saloons), mini buses (PSVs and vans), and heavy commercial vehicles. Crash victims are taken to Ugunja Sub County Hospital and Busia County Referral Hospital.

Picture: Part of Rakite road section

Engineering - road design/furniture/features	Enforcement - law	Education - Road user awareness
<ul style="list-style-type: none"> • Instal signage for the hazard and speed limit. • Mark the road. • Designate pedestrian crossing points with bumps at Rakite. 	<ul style="list-style-type: none"> • Enforce speed limit compliance. 	<ul style="list-style-type: none"> • Create awareness on speeding and safe crossing.

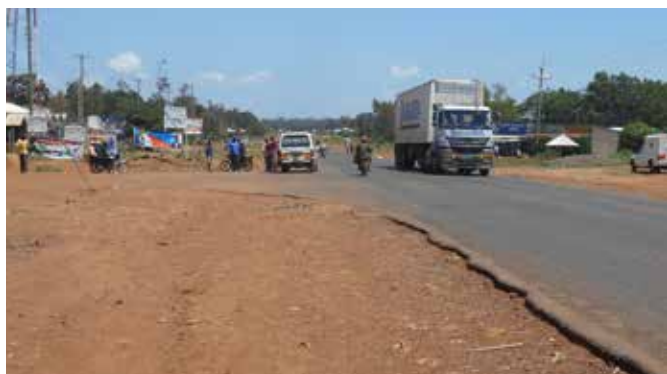
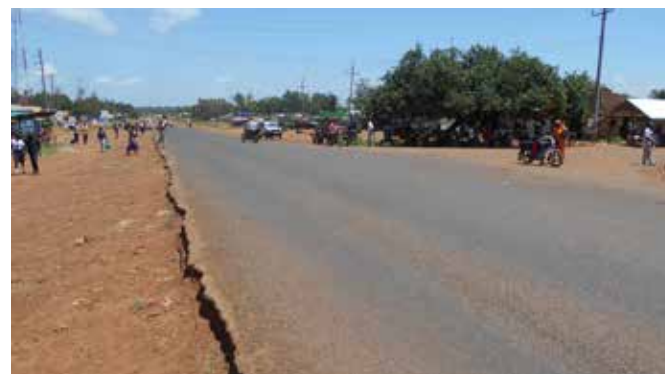
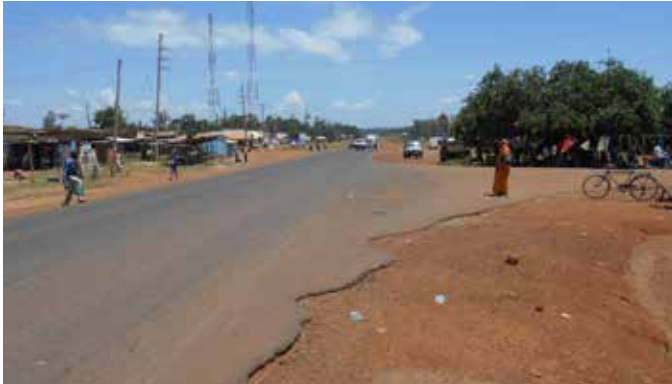
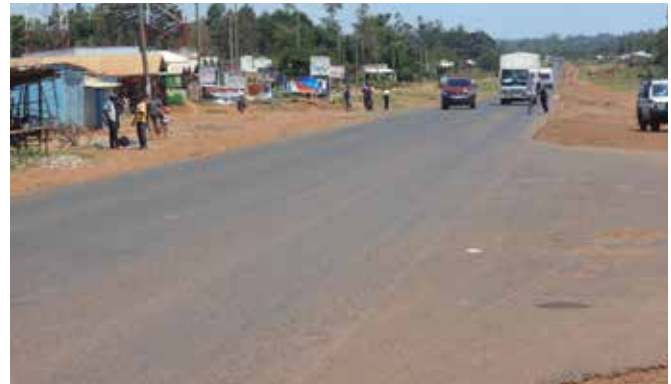
198. Matayos

This is a 400-meter road along a straight stretch near Matayos market center with intersection to Mumias and Bungoma. There are no road signs, the shoulder is worn out and the road is unmarked. The reason for the black spot is unsafe pedestrian crossing, speeding motorists and careless overtaking. Crashes happen throughout the week, at night, and during dry and wet seasons. Vehicles mostly involved in crashes are personal cars (saloons), mini buses (PSVs and vans), heavy commercial vehicles and motorcycles. Crash victims are taken to Busia County Referral Hospital.

Picture: Part of Matayos road section

Engineering - road design/furniture/features	Enforcement - law	Education - Road user awareness
<ul style="list-style-type: none"> • Instal signage for the hazard and speed limit. • Mark the road appropriately. • Repair the damaged road shoulder. • Have a speed bump and designate pedestrian crossing points at Matayos market. 	<ul style="list-style-type: none"> • Enforce speed limit compliance. 	<ul style="list-style-type: none"> • Sensitize pedestrians on safe crossing and motorcycle riders on road safety. • Create awareness on speeding, careful crossing and safe overtaking especially at night.

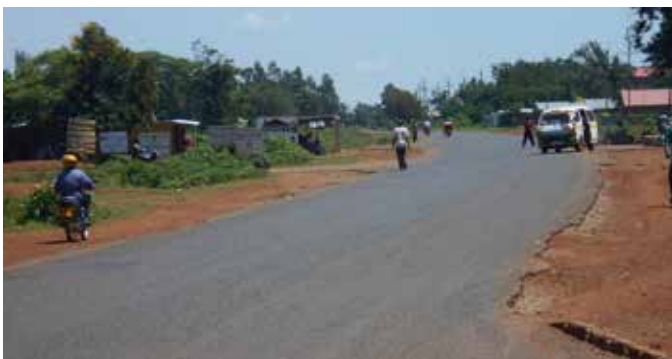
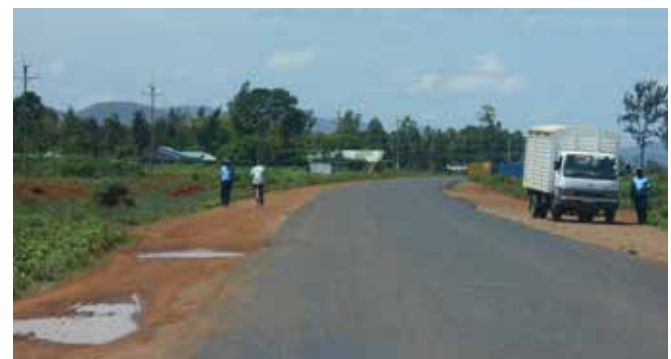
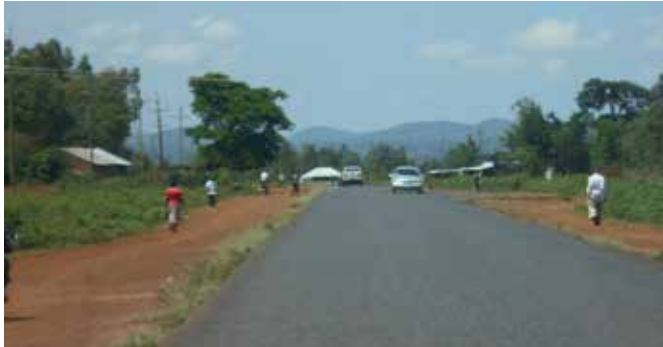
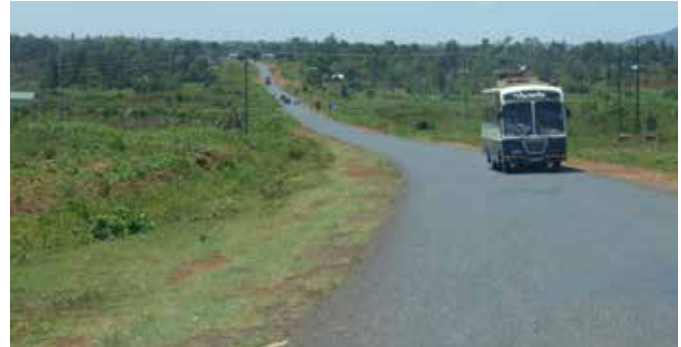
199. Mundika

This is a 3.8-kilometer road section with a sharp bend on gentle slope and through Mundika market. This section is unmarked and does not have road signage. The reason for the black spot is speeding motorists and pedestrian crossing unsafely. Crashes happen throughout the week, at night, and during dry and wet seasons. Vehicles mostly involved in crashes are mini buses (PSVs and vans), and heavy commercial vehicles. Crash victims are taken to Busia County Referral Hospital.

Picture: Part of Mundika road section

Engineering - road design/furniture/features	Enforcement - law	Education - Road user awareness
<ul style="list-style-type: none"> • Instal signage for the hazard and speed limit. • Mark the road and repair the shoulders. • Designate pedestrian crossing points. 	<ul style="list-style-type: none"> • Enforce speed limit compliance. 	<ul style="list-style-type: none"> • Educate motorist on the dangers of speeding especially at night. • Educate pedestrians on safe crossing.

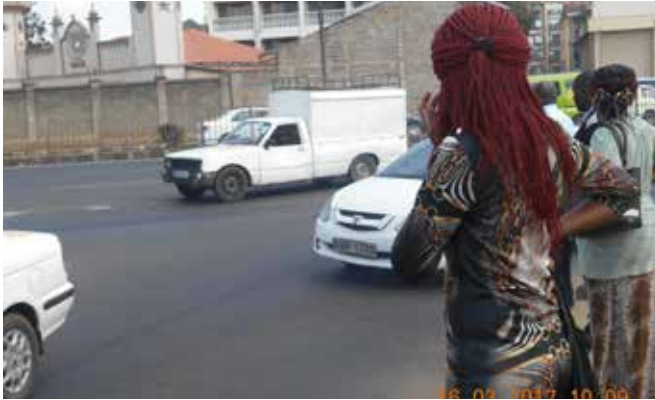
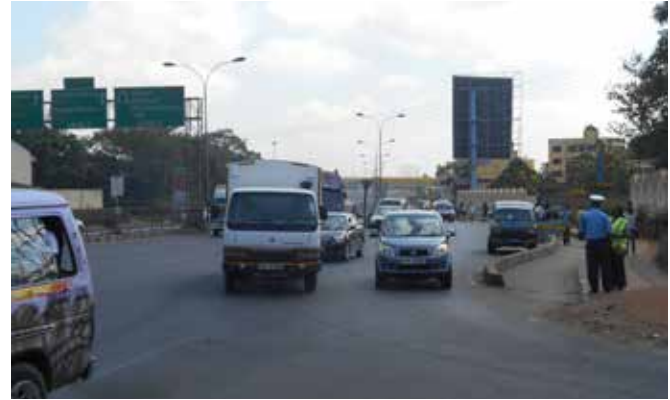
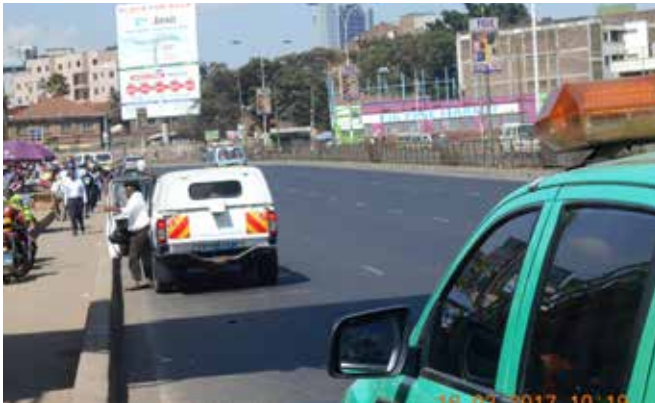
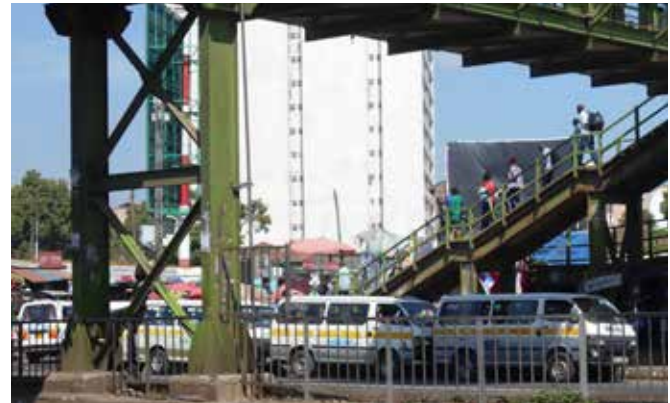
The first black spot on the highway is located between Ngara bus stop and Guru Nanak Hospital, covers both directions of the dual carriageway, and is about 1.1 kilometers. The hazards identified are road intersections, which act as blind spot when joining in or exiting the highway, high density of pedestrians crossing from Ngara Market, residential places and bus stops. There is also inadequate signage and some road sections are not marked. Vehicles, particular PSVs have created undesigned bus stops near the overpass. Pedestrians are hit while trying to cross over the guardrails. In some cases like the Ngara bus stop, PSVs, pick and drop off passengers on the highway, who in turn jump over the guardrails instead of using the footbridge.

Picture: Part of Guru Nanak road section

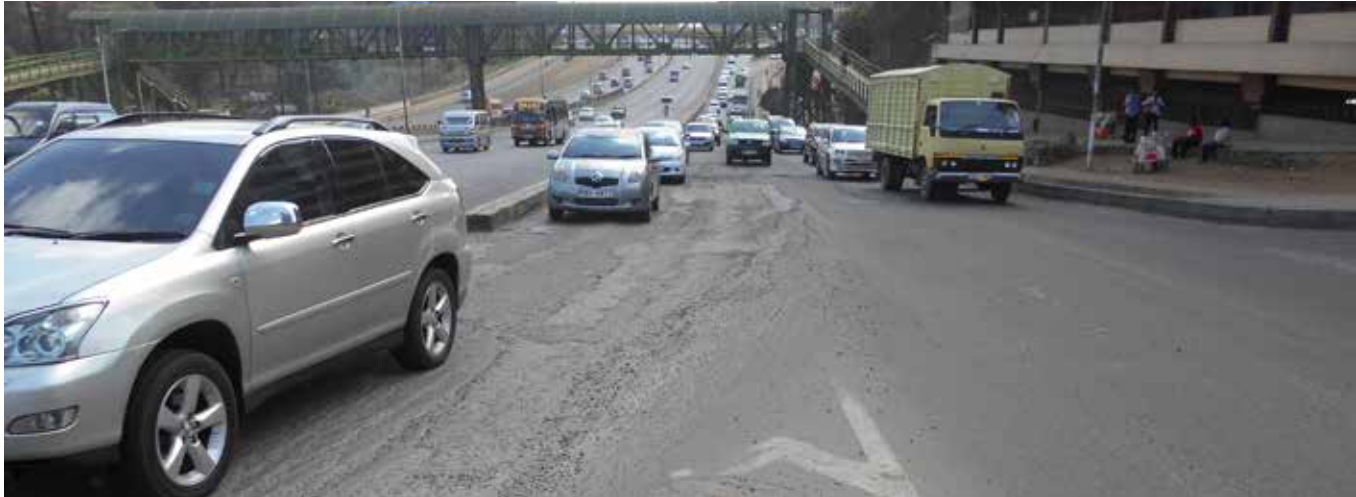
2. Kwa Kirima Footbridge

This is a 0.7-kilometer blackspot located near the Kirima flats with a footbridge and manifests in both directions of the dual carriage way. Badly designed intersections and driver behavior are the main hazards. On the route towards Nairobi CBD, vehicles from Kiambu road join the highway from the service lane at a blind spot junction. On the opposite direction, vehicles exiting the highway present a hazard. Most crashes occur throughout the week but during the early mornings and in dry and wet seasons. Personal cars (saloons), mini buses (PSVs and vans), and large buses are the types of vehicles most involved. When crashes happen, victims are taken to Guru Nanak and Kenyatta Hospital

Picture: Part of Kwa Kirima road section

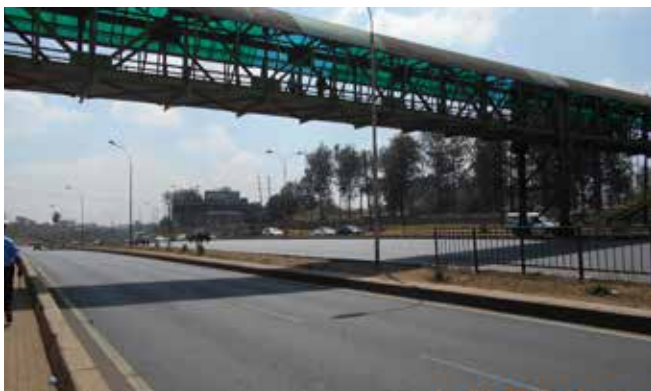
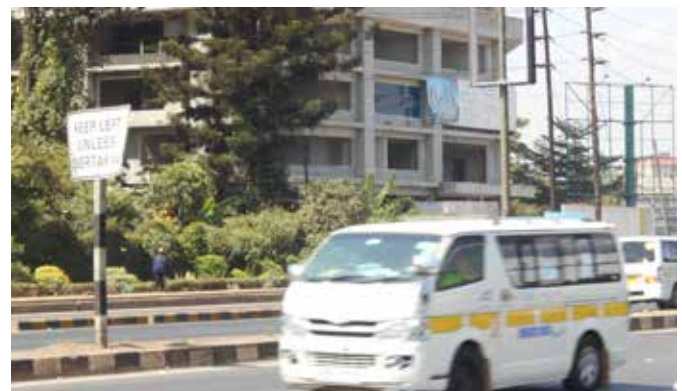
3. Muthaiga Police Footbridge

This is located near the Muthaiga Police Station and Mathari Hospital section and extends 200 meters on both sides of the dual carriageway. There is a footbridge already located here. The main hazard is unsafe pedestrians crossing. Pedestrians ignore using the footbridge and cross at undesigned points with some crossing under the footbridge. PSVs also drop off and pick up passengers on the highway. Crashes happen mostly on weekdays, during the day and night and in all seasons. Most vehicles involved in crashes are personal cars (saloons), mini buses (PSVs and vans), and large buses. When crashes happen, victims are taken to Guru Nanak and Kenyatta Hospital.

Picture: Part of Muthaiga Police road section

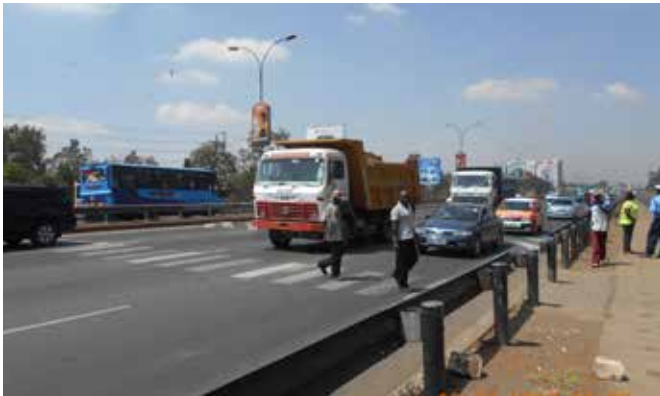
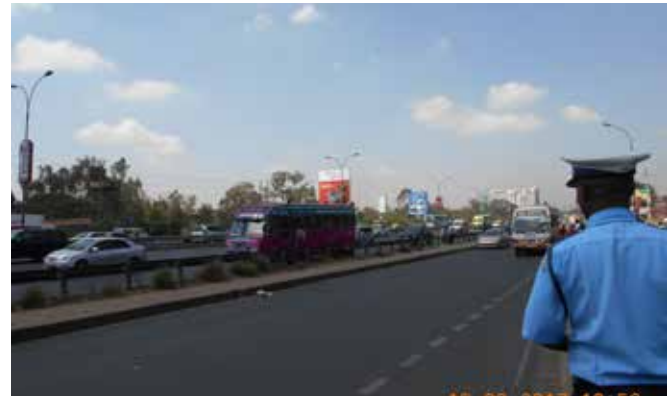
This black spot is located on the highway at Drive Inn near Kenya School of Monetary Studies (KSMS) and stretches 120 meters in both directions of the dual carriageway. The black spot is on both sides of the highway. The major hazard is the speed bump and unsafe pedestrians crossing at undesignated points. Most motorists do not stop for pedestrians at the speed bump. Crashes happen both day and night throughout the week but mostly during the wet season.

Picture: Part of KSMS road section

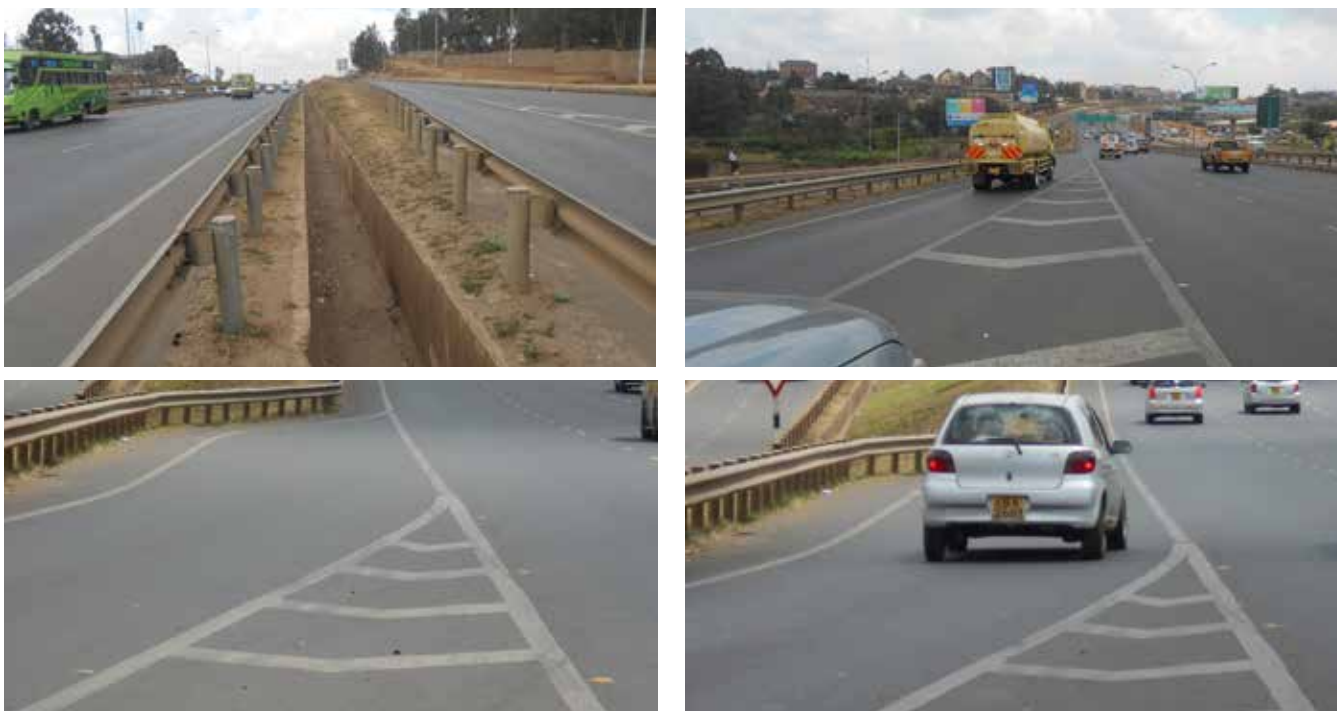
The blackspot is situated near the GSU headquarters and Roasters flyover, a distance of about 0.4 kilometers on both sides of the dual carriageway. The direction towards Thika has an exit and entry point while the direction towards CBD has an exit point. Unsafe use of the exits has led to crashes attributed to speeding. The section has slight bend, a depression at the river and an exit immediately you start to ascend. Crashes happen throughout the week, both night and day time and in the dry and

Picture: Part of GSU Drift road section

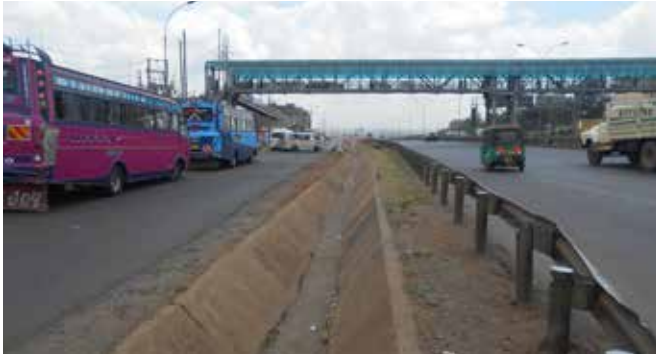
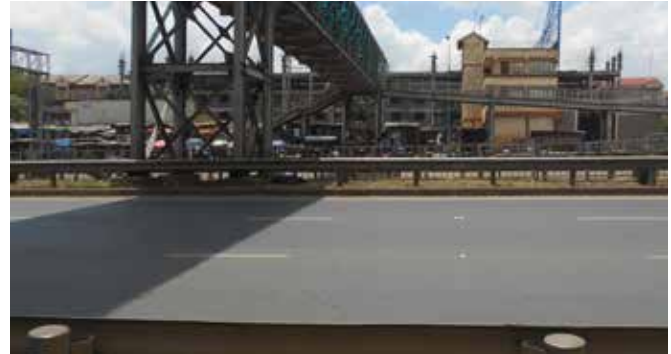
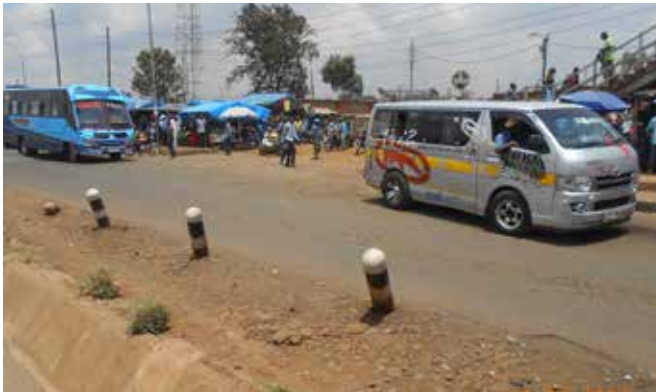
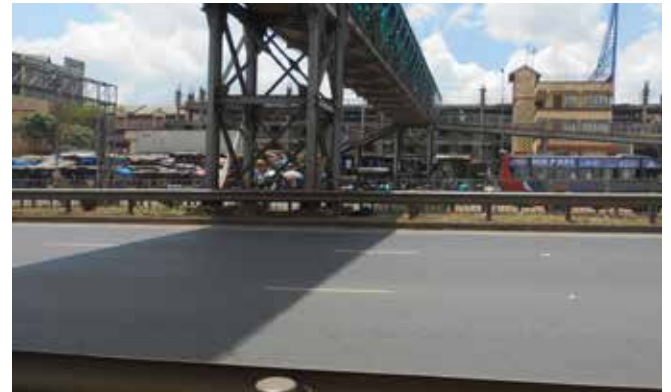
6. Roysambu near the footbridge

This black spot is located near the Roysambu footbridge and extends 100 meters in both directions of the dual carriageway. The major hazard is pedestrians not using the footbridge when crossing the road. The heavy presence of pedestrians is due to the nearby shopping mall (Thika Road Mall), market stalls and undesignated bus stop. The bollards on the section are also damaged. Crashes happen throughout the week and both day and night and equally in both dry and wet seasons. Vehicles most involved in crashes are personal cars (saloons) and mini buses (PSVs and vans). When crashes happen, victims are taken to Kenyatta National Hospital or Uhai Neema Hospital.

Picture: Part of Roysambu road section

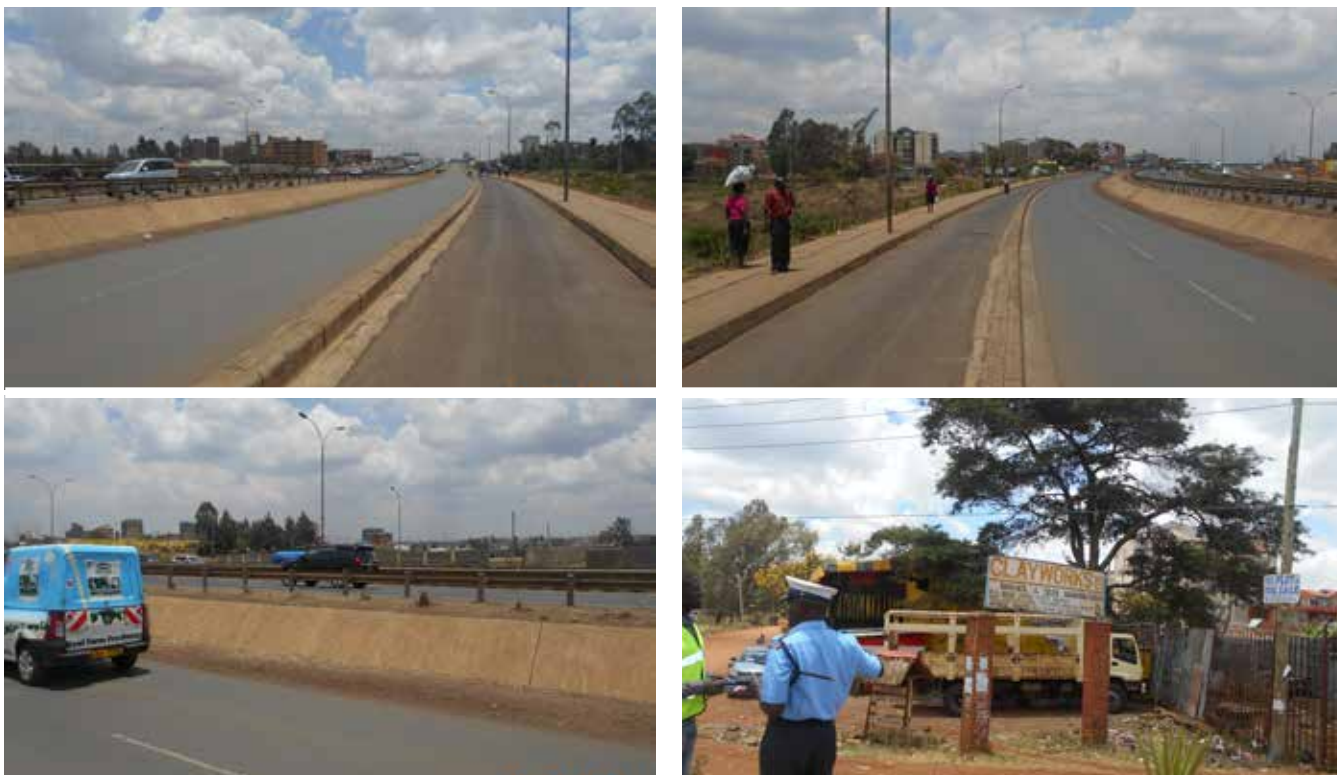
This is located near Githurai 45 section on both directions of the dual carriageway and extends a distance of about 0.4 kilometers. The main hazards are the sharp bend, and speeding motorists. Most crashes happen due to careless change of lanes and speeding motorists in both directions of the highway.

Picture: Part of Caster Mill road section

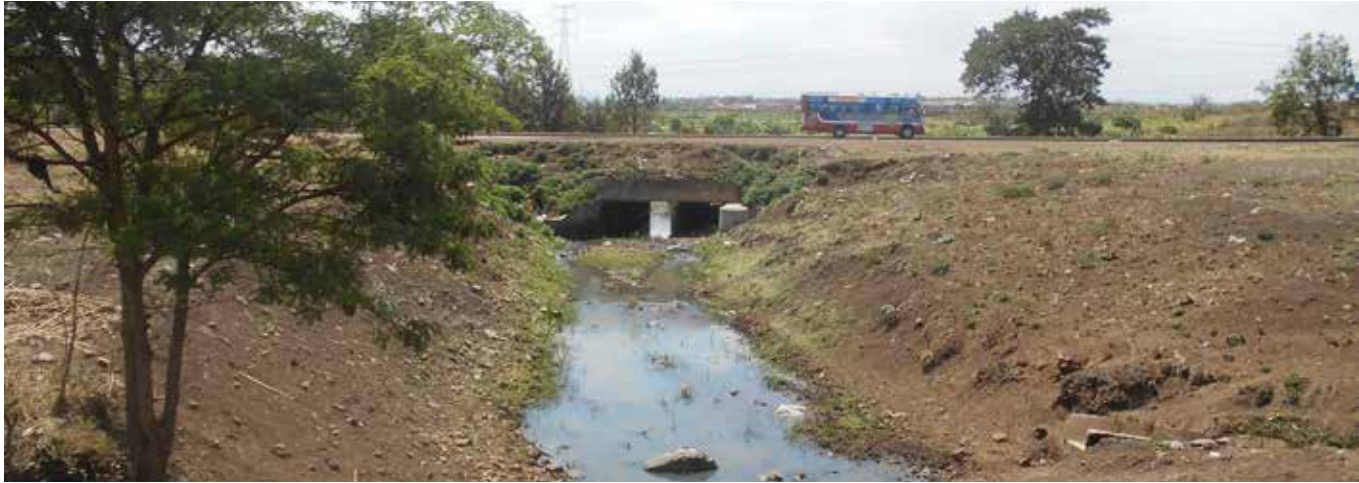
This black spot is located at River Kamiti Bridge just after Kenyatta University on both directions of the dual carriageway and extends about 100 meters. The main hazards here are the lack of adequate signage and road marking to show the presence of a river. The bridge does not have guardrails. Crashes are common throughout the week, all through the day and during both dry and wet seasons.

Picture: Part of River Kamiti road section (delete/ replace one photo)
