Northern Corridor and Nairobi County Route Hazard Mapping Report

May 2017

Developed by Safe Way Right Way and National Transport and Safety Authority

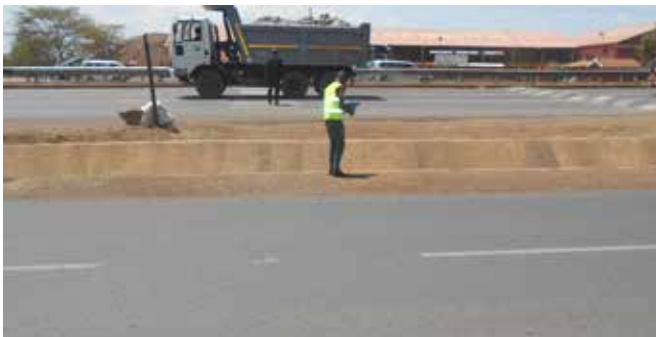
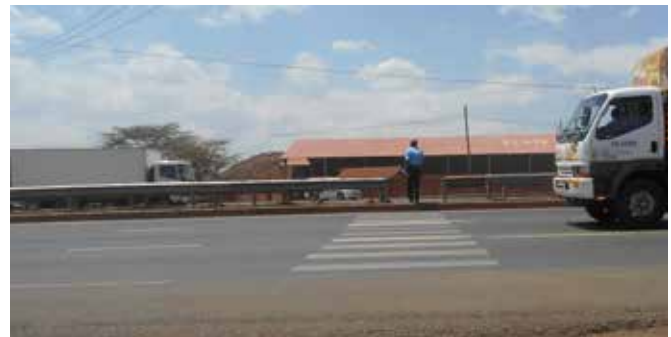
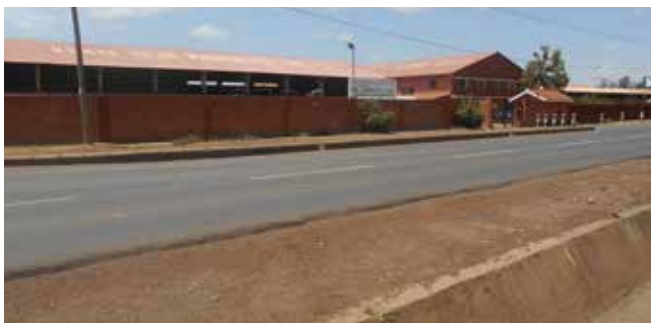
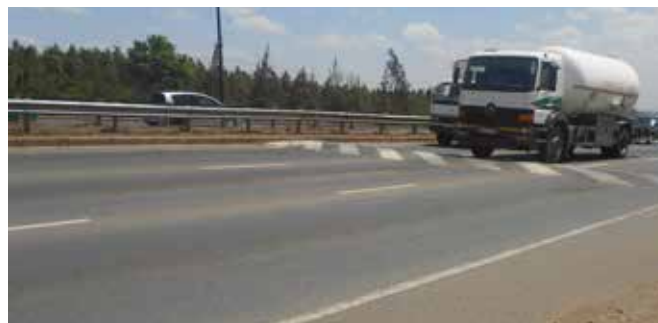
This section is near the Clayworks Products Kenya and extends a distance of about 100 meters in both directions of the dual carriageway. There are speed bumps on the highway; but no bumps on the service lanes where motorists tend to speed.

There is unsafe pedestrian crossing into the nearby factories (Clayworks and Brookside) and no proper signage or road markings. Most crashes that happen on the service lanes involve pedestrians. Crashes happen throughout the week, both night and day and during both dry and wet seasons. Vehicles most involved in crashes are personal cars (saloons), mini buses (PSVs and vans), large buses, light and medium trucks, heavy commercial vehicles, and motorcycles. Victims of crashes are taken to Ruiru Sub District Hospital.

Picture: Part of Clayworks road section

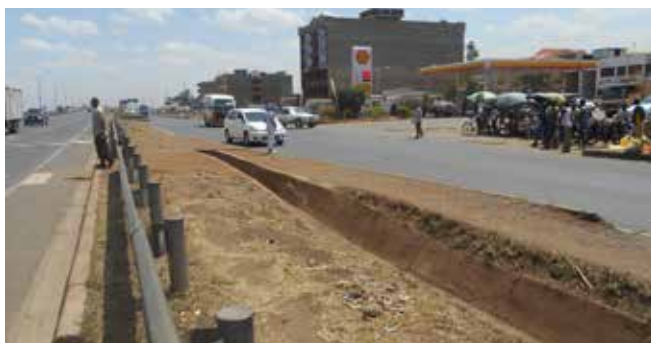
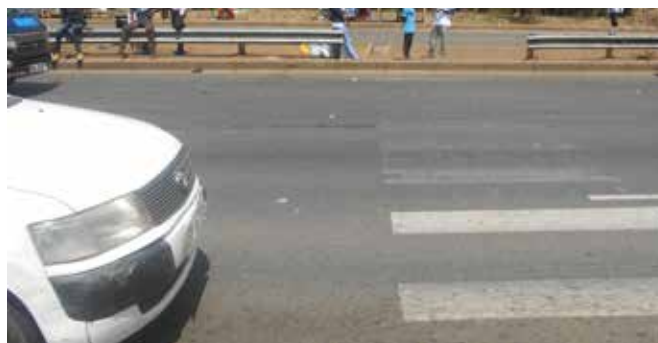
This black spot section is in Ruiru just after the underpass at Eastern Bypass and extends for about 100 meters on both directions of the dual carriage highway. The service lanes have no speed bumps where motorists tend to speed.

Pedestrians cross unsafely at undesignated points. The speed bumps on the highway are worn out and so motorists speed over them. The section also lacks inadequate road marking, signage and street lighting. Crashes happen throughout the week, and throughout the day as well as equally during both dry and wet seasons. Vehicles most involved in crashes are personal cars (saloons), mini buses (PSVs and vans), large buses, light and medium trucks, heavy commercial vehicles, and motorcycles. Crash victims are taken to Ruiru Sub District Hospital.

Picture: Part of Kihanguro road section

Engineering - road design/furniture/features	Enforcement - law	Education - Road user awareness
<ul style="list-style-type: none"> Erect signs and street lights. Repair the worn out speed bumps. Put up a footbridge. Designate bus stops on the service lanes. 	<ul style="list-style-type: none"> Enforce speed limits. 	<ul style="list-style-type: none"> Educate passengers on how to cross safely.

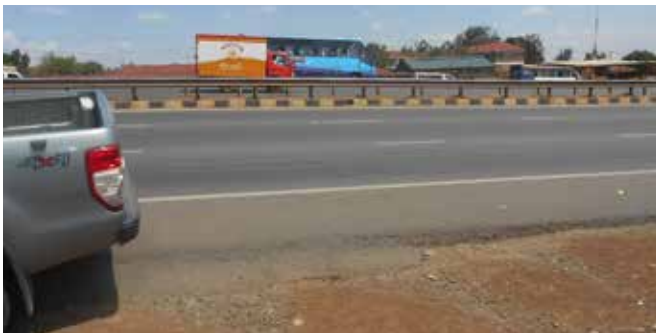
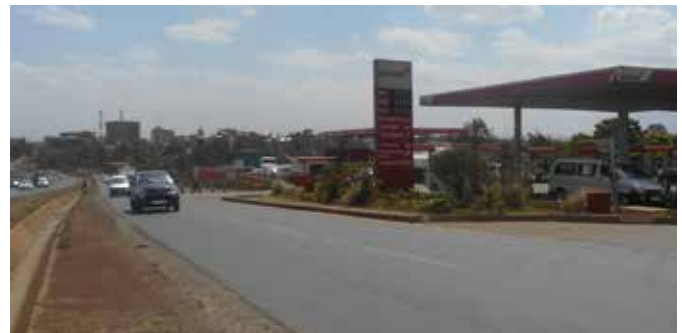
11. Essar (Wakario)

This black spot is located in Ruiru near Kenyatta University Ruiru Campus and extends for about 150 meters on both directions of the dual carriageway. The main hazard is the unsafe pedestrian crossing and the lack of a footbridge on both directions of the highway. Crashes happen throughout the week and day as well as equally during both dry and wet seasons. Vehicles involved in crashes are personal cars (saloons), mini buses (PSVs and vans), large buses, light and medium trucks, heavy commercial vehicles, and motorcycles. Crash victims are taken to Ruiru Sub District Hospital.

Picture: Part of Essar (Wakario) road section

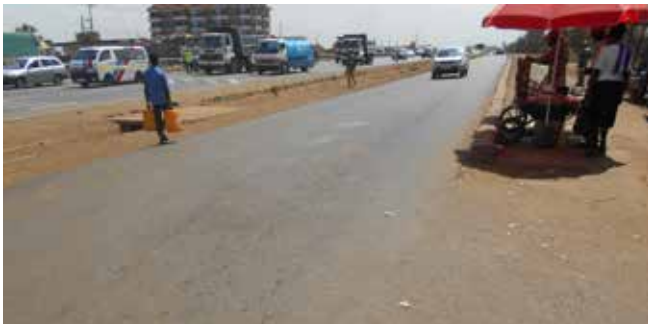
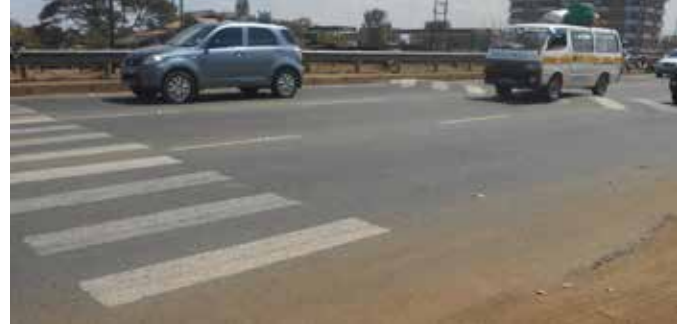
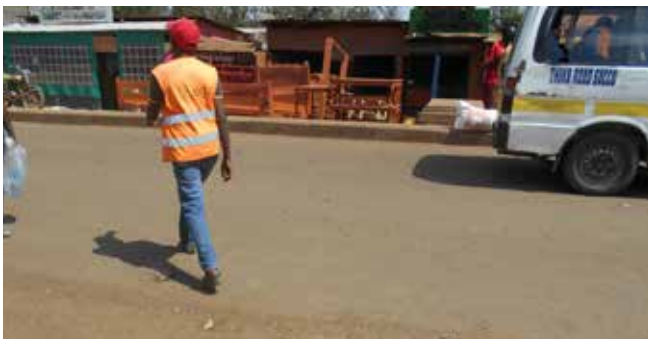
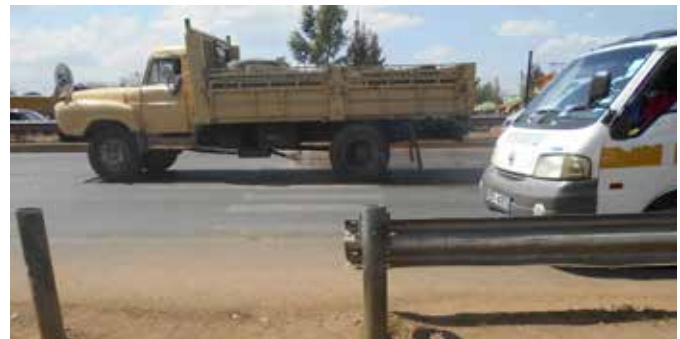
12. Toll Station

This black spot section is located at the Highway Toll Station and extends about 400 meters on both directions of the dual carriage highway. The hazards include unsafe pedestrian crossing and cattle crossing. The guardrails are damaged and there is encroachment by kiosks on the pedestrian footpath. Crashes happen throughout the week, and day as well during both dry and wet seasons. Vehicles involved in crashes are personal cars (saloons), mini buses (PSVs and vans), large buses, light and medium trucks, heavy commercial vehicles, and motorcycles. Crash victims are taken to Ruiru Sub District Hospital.

Picture: Part of Toll Station road section

Engineering - road design/furniture/features	Enforcement - law	Education - Road user awareness
<ul style="list-style-type: none"> Erect bumps on the service lane and pedestrian crossing points Repair damaged guard rail. 	<ul style="list-style-type: none"> Clear encroachment on the pedestrian foot path by traders. 	<ul style="list-style-type: none"> Create awareness on safe crossing.

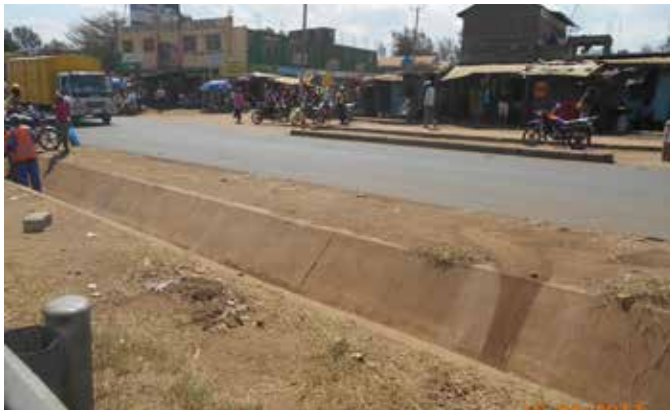
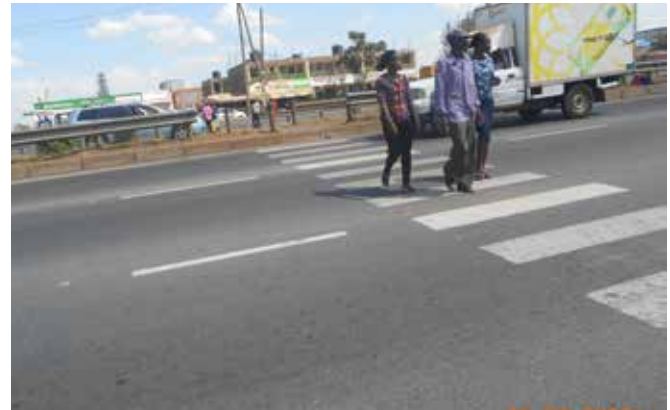
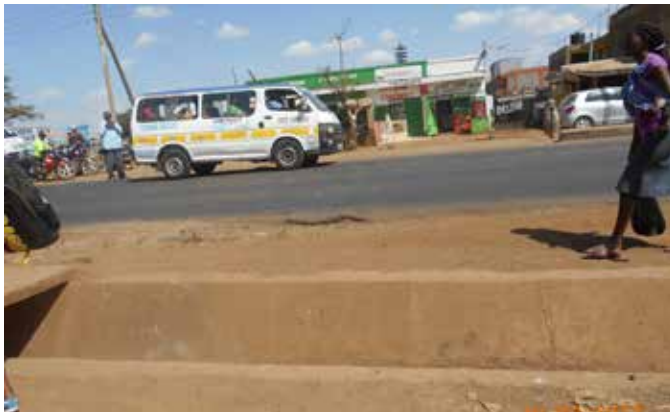
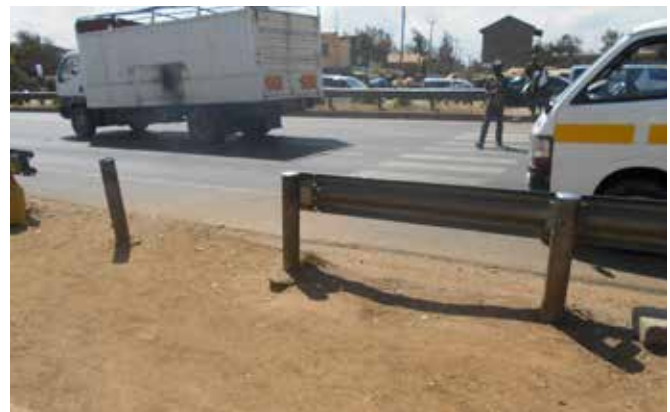
This is located near the High Point bus stop in Juja and extends about 200 meters on both sides of the dual carriageway. Main hazards include unsafe pedestrian crossing, and lack of pedestrian crossing signs. There is inadequate lighting and the road marking have faded in some sections.

Picture: Part of High Point road section

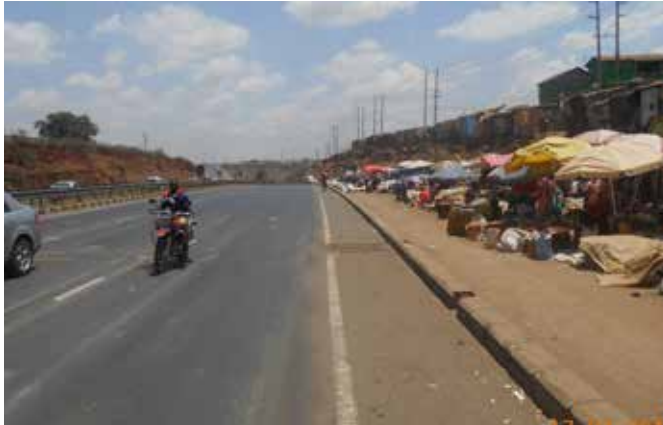
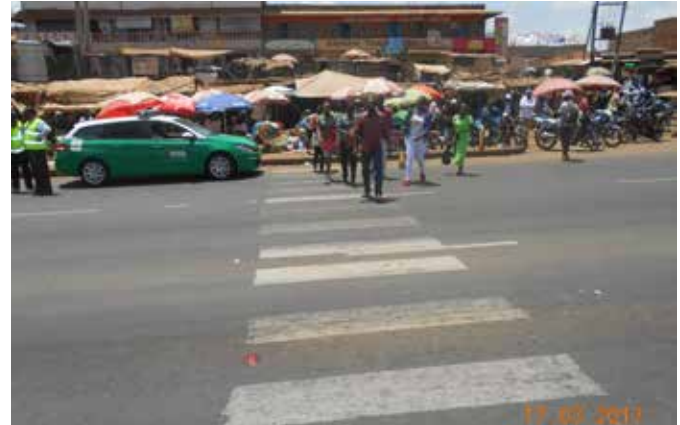
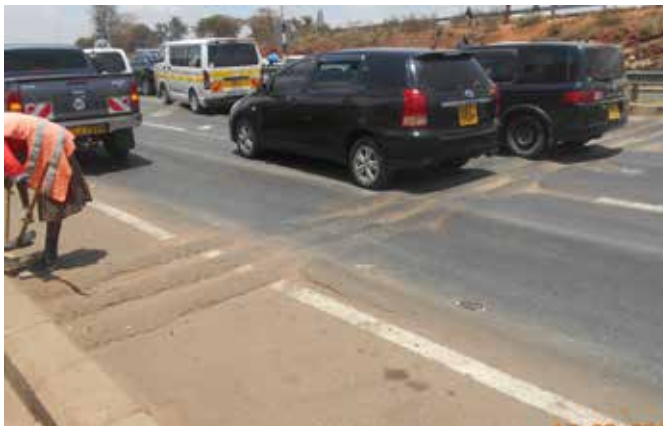
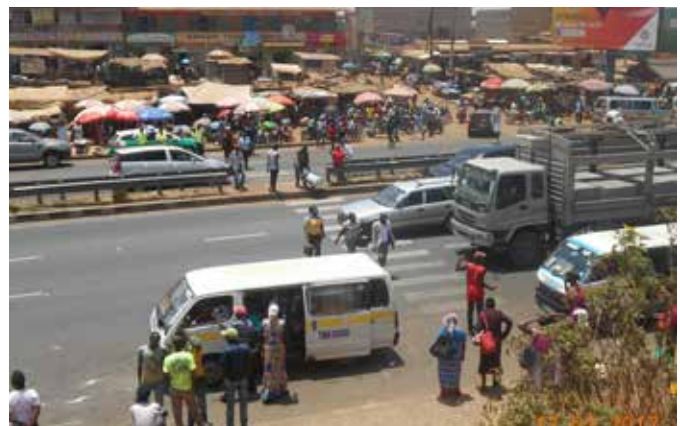
This section of the road is at Witeithie center and extends 200 meters on both directions of the dual carriage highway. The hazards include unsafe pedestrian crossing from the market center, reckless motorcyclists, and undesignated bus stop. Crashes happen throughout the week and day and during both dry and wet seasons.

Picture: Part of Witeithie road section

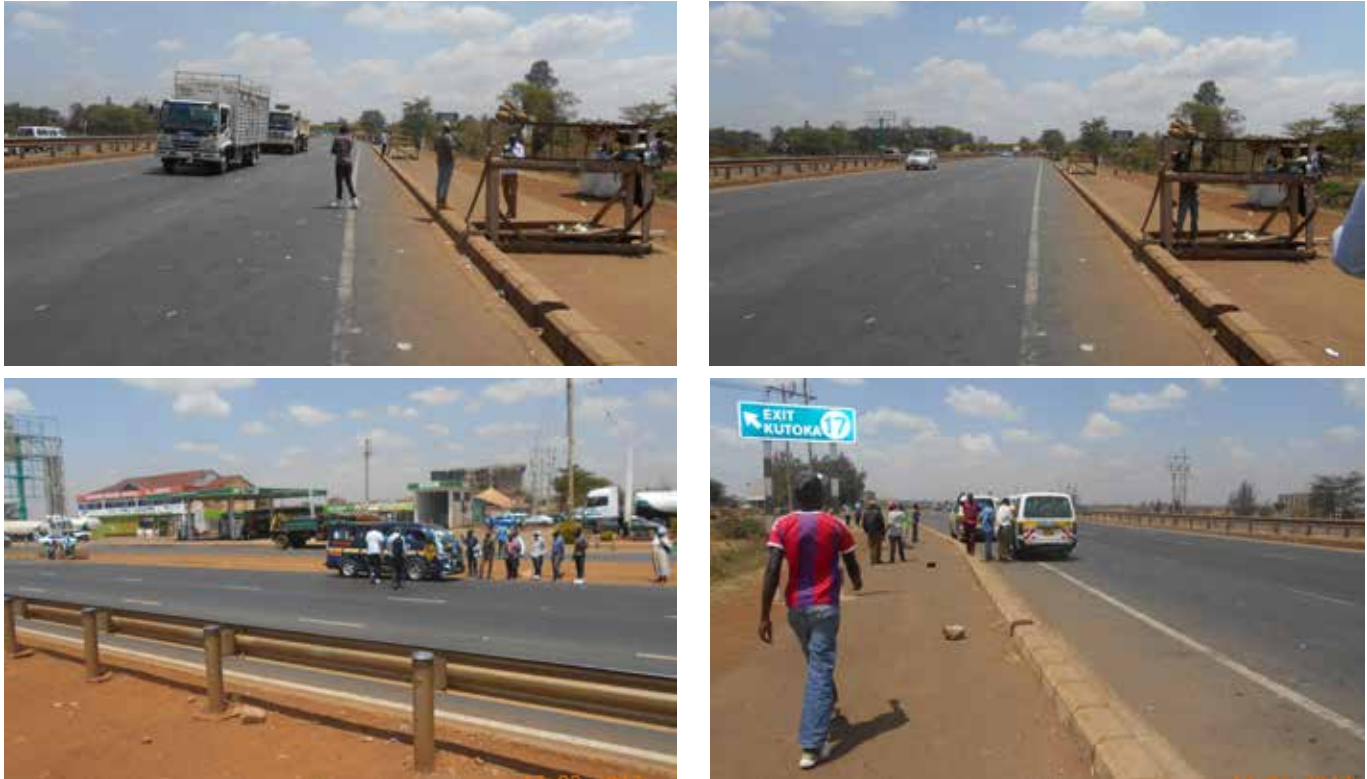
15. Jomoko

This black spot section is located at Jomoko area and is 300 meters on both directions of the dual carriageway. The main hazards include unsafe pedestrian crossing, undesignated bus stop and encroachment by traders on the road side. Crashes happen throughout the week and day as well as equally during both dry and wet seasons. Vehicles involved in crashes are personal cars (saloons), mini buses (PSVs and vans), large buses, light and medium trucks, heavy commercial vehicles, and motorcycles. Crash victims are taken to Thika Level 5 hospital.

Picture: Part of Jomoko road section

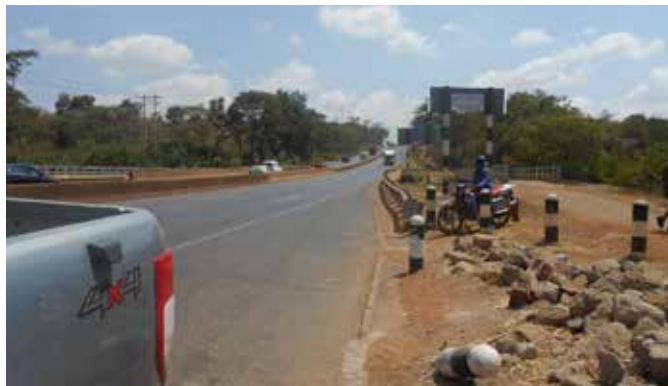
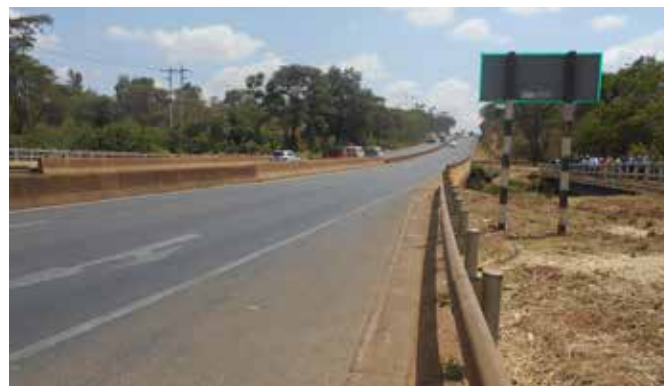
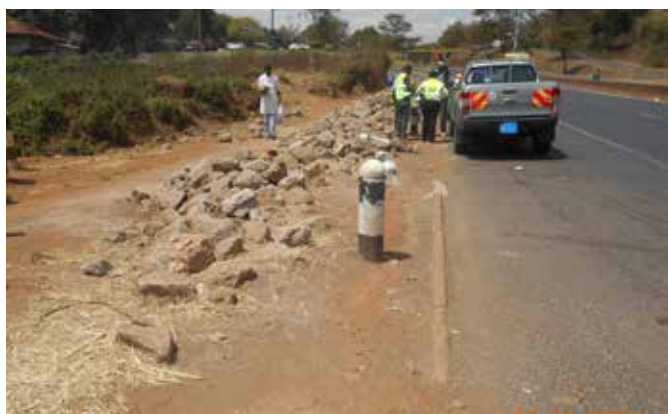
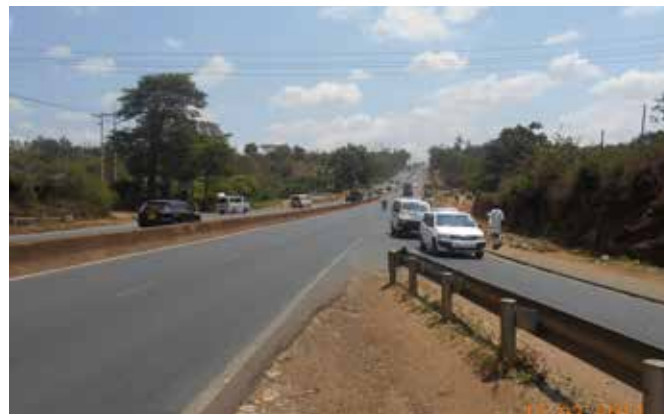
Picture: Part of Blue Post road section

This section is near the Blue Post Hotel Thika and extends 1.1 kilometer in both directions of the dual carriageway. The hazards include a drift, speeding motorists, undesignated bus stops on the highway, careless motorcycle riders. The bollards and road shoulder are damaged. Crashes happen throughout the week and day as well as during both dry and wet seasons.

Vehicles involved in crashes are personal cars (saloons), mini buses (PSVs and vans), large buses, light and medium trucks, heavy commercial vehicles, and motorcycles. Crash victims are taken to Thika Level 5 Hospital.

Engineering - road design/furniture/features	Enforcement - law	Education - Road user awareness
<ul style="list-style-type: none"> Erect speed bumps. Repair bollards. 	<ul style="list-style-type: none"> Enforce speed limits. Discourage use of illegal bus stops. 	<ul style="list-style-type: none"> Encourage safe crossing and lower speeds.

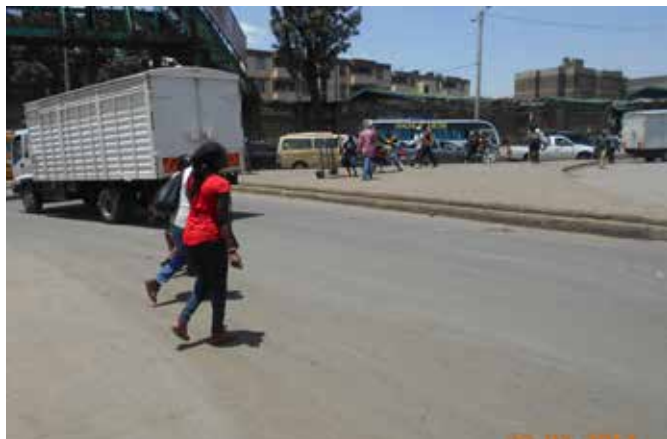
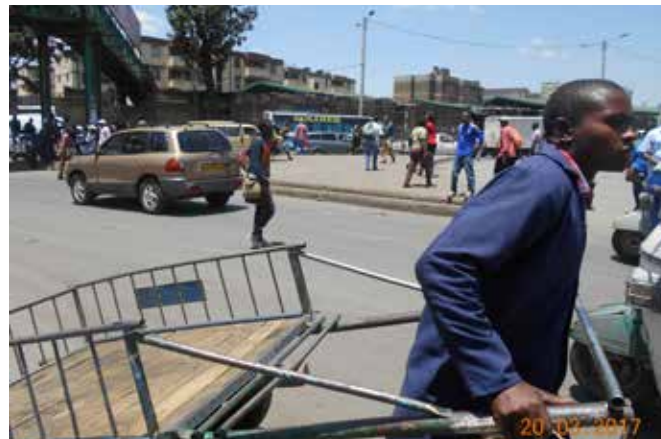
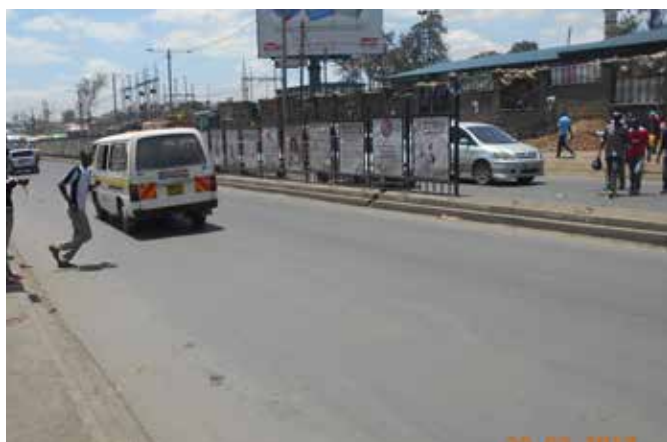
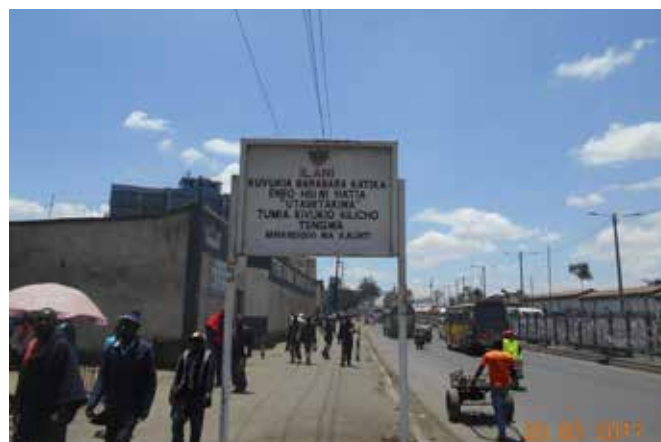
Picture: Part of Landhies Road section

This black spot section is located at the Landhies Road in the section adjacent to Muthurwa market and bus station and extends about 0.5 kilometers on both directions of the dual carriageway. The main hazards include unsafe pedestrian, encroachment on road banks by traders. There are two foot bridges that have been taken over by street families who harass pedestrians, forcing them to cross on the road. The hand cart pushers from Muthurwa market also cross unsafely and move against traffic. Gaps in the pedestrian fence encourage unsafe crossing. Crashes happen throughout the week and day as well as during both dry and wet seasons.

Vehicles most involved in crashes are personal cars (saloons), mini buses (PSVs and vans), large buses, light and medium trucks, heavy commercial vehicles, motorcycles and hand carts. When crashes happen, the victims are taken to Kenyatta National Hospital.

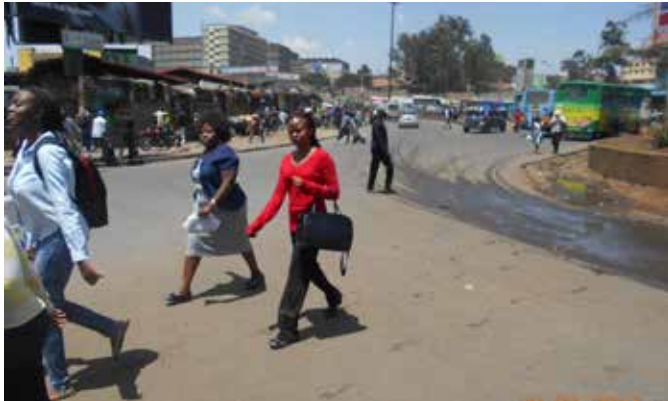
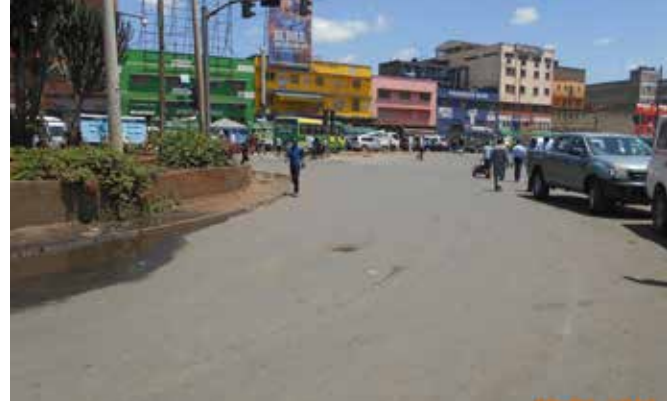
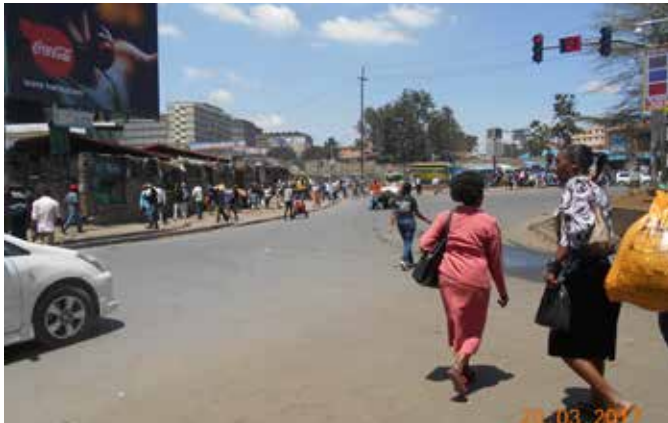
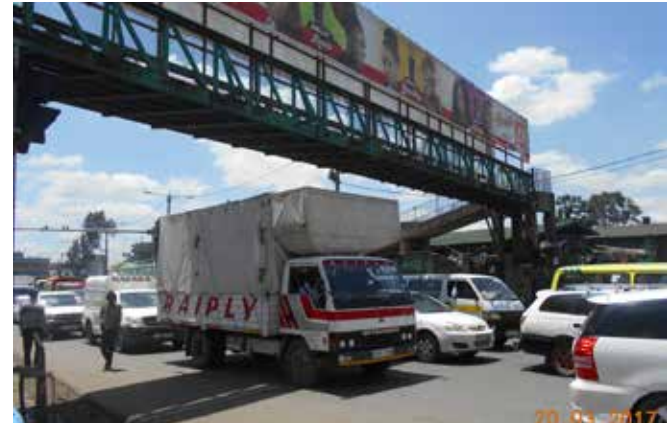
Picture: Part of Landhies – Kamukunji roundabout road section

This section is located at the Landhies Road-Kamukunji roundabout and extends the length of the roundabout. The main hazards include unsafe pedestrians crossing from the market and bus station. The pedestrians also cross unsafely on the roundabout, motorcycles ignore traffic rules, and handcarts from Muthurua market cross in all directions without regard to safety. Crashes happen throughout the week and day as well as during both dry and wet seasons. Vehicles most involved in crashes are personal cars (saloons), mini buses (PSVs and vans), large buses, light and medium trucks, heavy commercial vehicles, motorcycles, and hand carts. When crashes happen, the victims are taken to Kenyatta National Hospital.

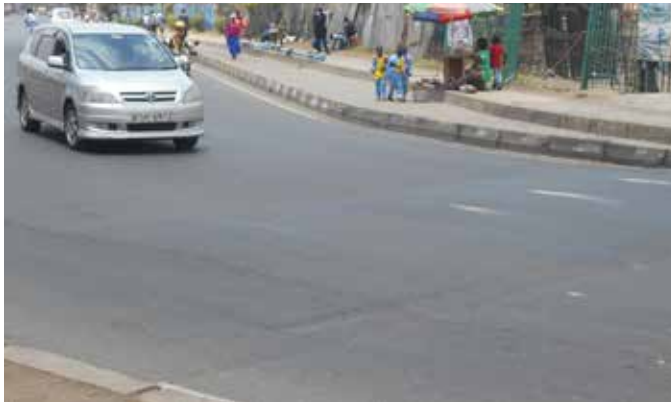
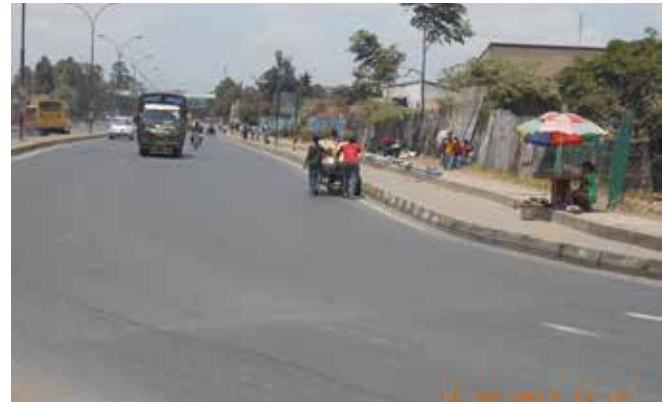
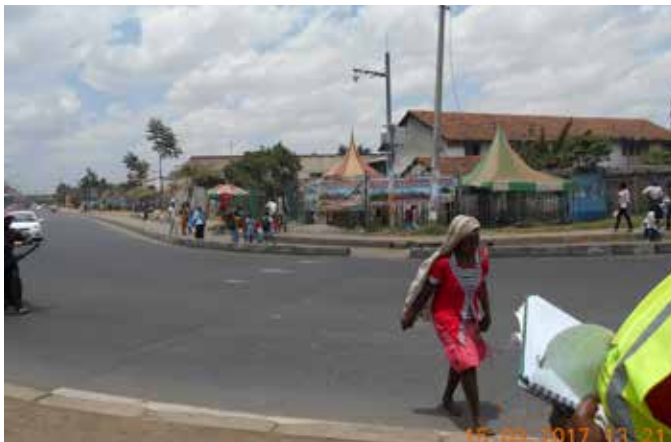
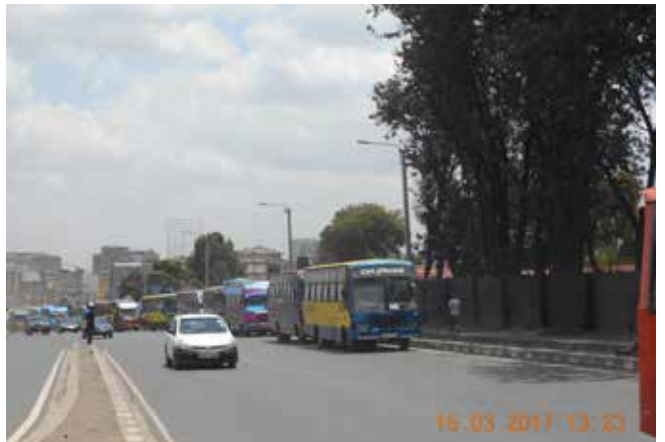
Picture: Part of Kariokor Market Bump road section

This section is located on Ring Road in Ngara adjacent to Kariokor market and extends about 100 meters. The main hazards include speeding motorists, inadequate road signs and a speed bump with faded marking. The speed bump is not marked and is often not visible at night to motorists. Crashes happen throughout the week, day and night, as well as during both dry and wet seasons. Vehicles most involved in crashes are personal cars (saloons), mini buses (PSVs and vans), large buses, and light and medium trucks. When crashes happen, the wounded are taken to Guru Nanak Hospital.

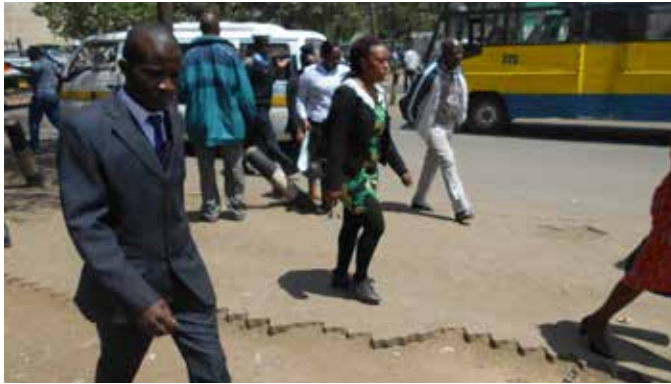
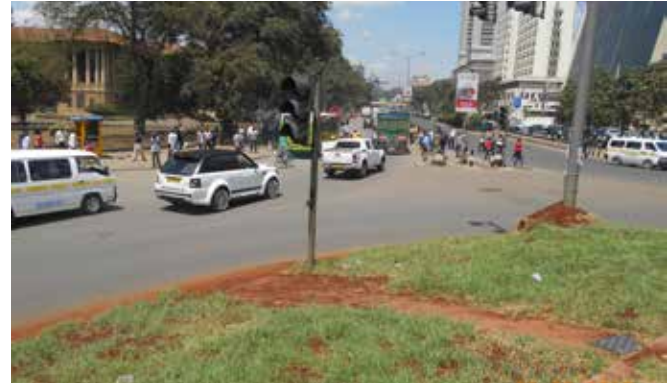
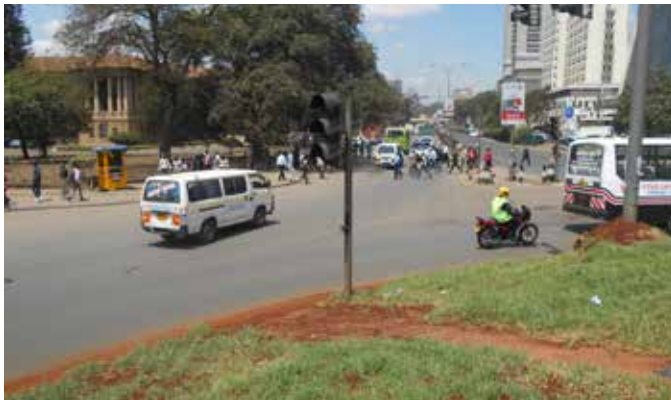
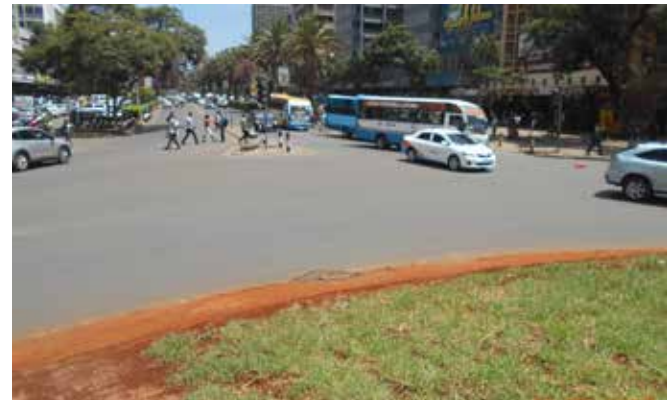
Picture: Part of Haile-Selassie roundabout section

This section is located on Haile Selassie Avenue at the Railways roundabout adjacent to the Bus stop and Railways Corporation and extends the length of the roundabout. The main hazard is unsafe pedestrian crossing. There is a high human traffic estimated at over 20,000 people in the morning and evening from the railway station and the bus stop. Crashes happen mostly during the weekday and morning hours of the daytime during both dry and wet seasons. Vehicles most involved in crashes are the mini buses (PSVs and vans), and large buses. When crashes happen, the victims are taken to Kenyatta National Hospital.

Engineering - road design/furniture/features	Enforcement - law	Education - Road user awareness
<ul style="list-style-type: none"> Construct a footbridge that crosses the roads at the railways roundabout. Mark pedestrian crossing areas. Repair the foot path. 	<ul style="list-style-type: none"> Enforce safe crossing. 	<ul style="list-style-type: none"> Create awareness on safe crossing.

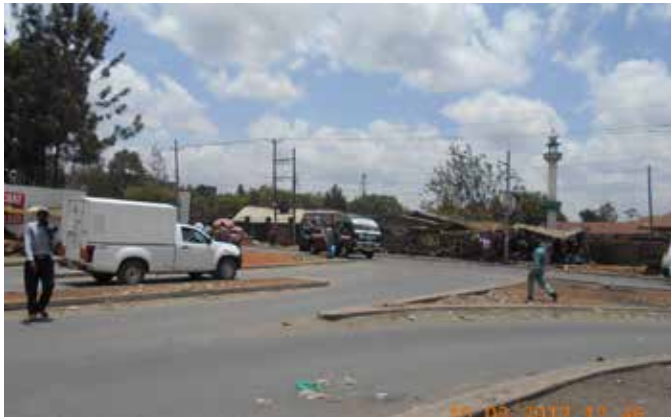
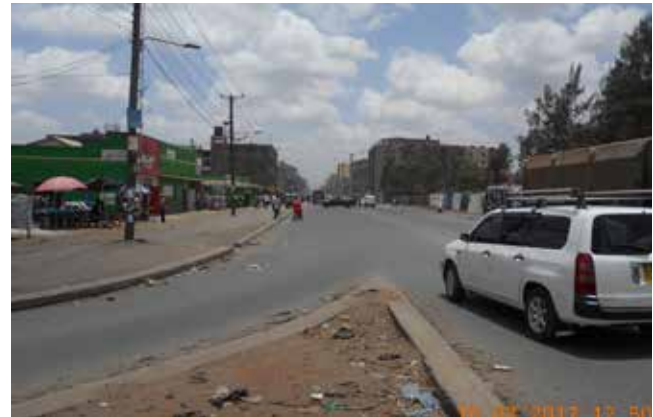
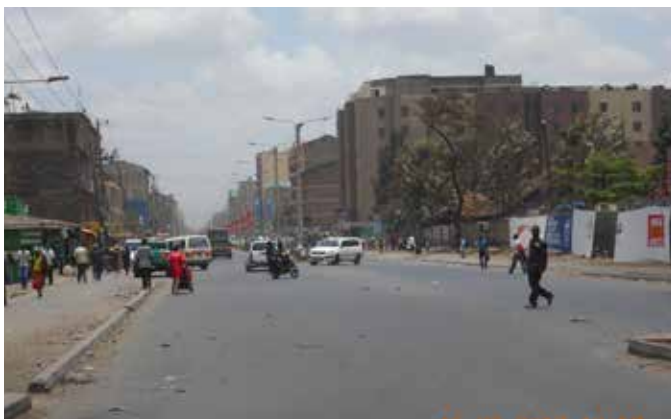
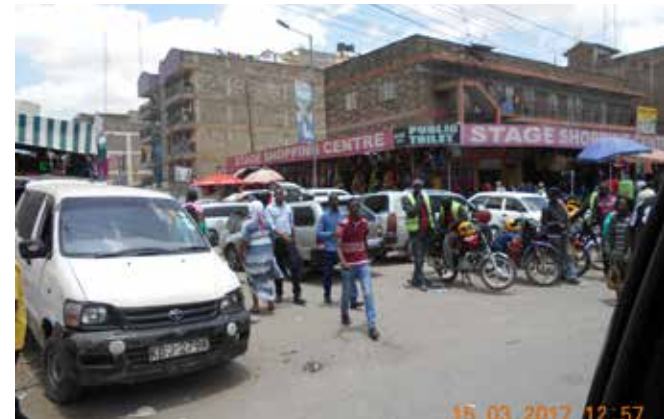
Picture: Part of St. Teresa Junction road section

This section stretches about 1.4 kilometers from the junction of Eastleigh First Avenue to St Teresa Junction on Juja Road, to the roundabout at 13th street. The main hazards are the road intersections, which act as blind spots, unsafe pedestrian crossing due to presence of schools and other facilities at St Teresa Center, high number of careless motorcyclist, and the poor construction of the junction that allows vehicles to make dangerous U-turns. There are no designated pedestrian crossing points on the busy road. Crashes happen throughout the week and day as well as during both dry and wet seasons. Vehicles most involved in crashes are personal cars (saloons), mini buses (PSVs and vans), and motorcycles. When crashes happen, the victims are taken to MSF Clinic.

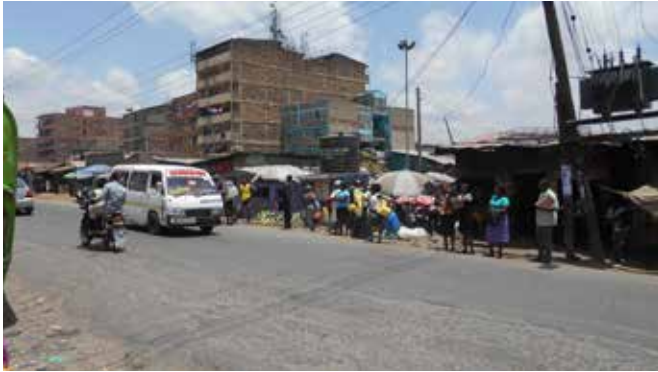
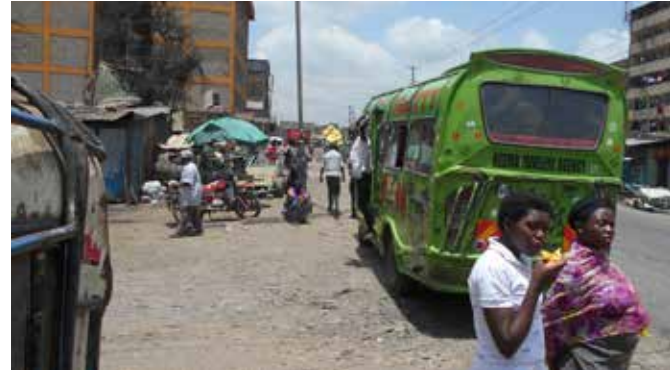
Picture: Part of Oilibya road section (show the petrol station)

This section stretches about 0.1 kilometers along Juja road near Oilibya petrol station. The main hazards are unsafe pedestrian crossing, undesignated bus stops and inadequate road signage and marking. There are no speed bumps to slow down motorists and no designated crossing points for pedestrians. There are many drunken pedestrians on this section. Most crashes happen throughout the week, but mostly at night, and in both dry and wet seasons. Vehicles most involved in crashes are the mini buses (PSVs and vans). When crashes happen, the victims are taken to MSF Clinic.

Engineering - road design/furniture/features	Enforcement - law	Education - Road user awareness
<ul style="list-style-type: none"> • Create bus stops. • Designate pedestrian crossings. • Instal and mark speed bumps. • Ensure appropriate signage and marking is in place. • Repair worn out road shoulders. 	<ul style="list-style-type: none"> • Enforce speed limits once signage is in place. 	<ul style="list-style-type: none"> • Educate pedestrians on safe crossing. • Educate motorists to slow down in populated areas.

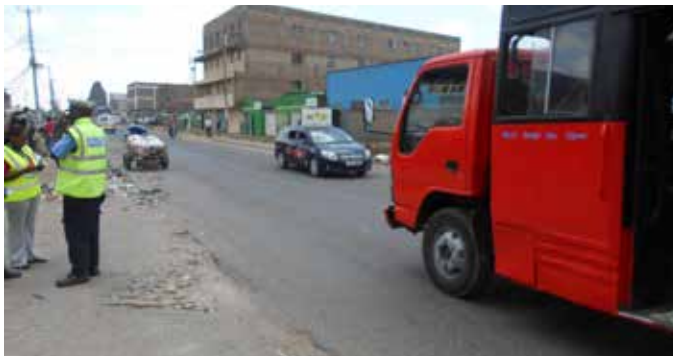
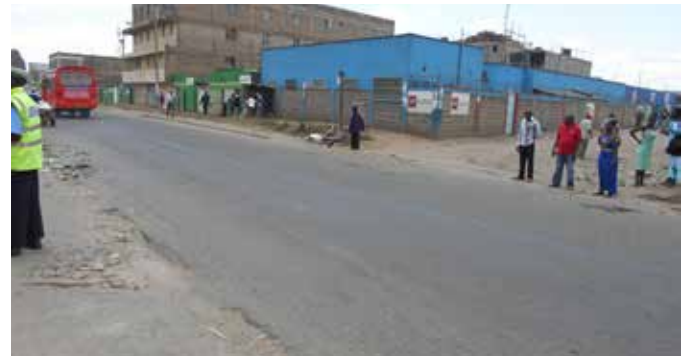
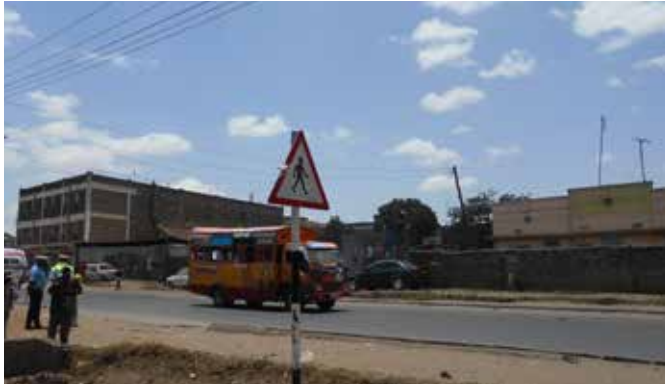
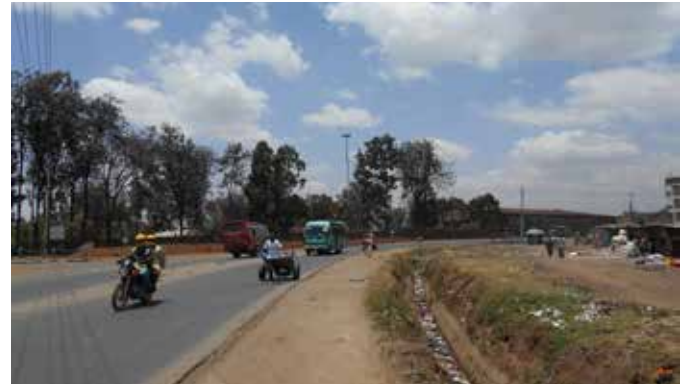
Picture: Part of Kiboro Primary road section

This section stretches 0.7 kilometers along Juja road and is adjacent to Kiboro primary school. The main hazards are the unsafe pedestrian crossing with the added human traffic due to presence of a school and inadequate road signage and markings. There are no speed bumps to slow down motorists, no designated crossing points for pedestrians and PSVs stop at undesignated bus stops on the road. Crashes happen throughout the week, but mostly at night, and equally in both dry and wet seasons. Vehicles most involved in crash are mini buses (PSVs and vans). When crashes happen, the victims are taken to MSF Clinic.

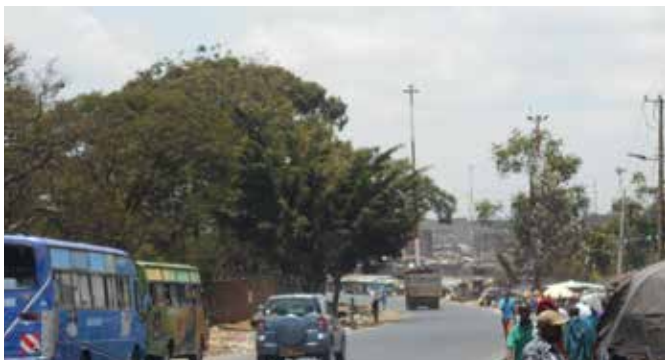
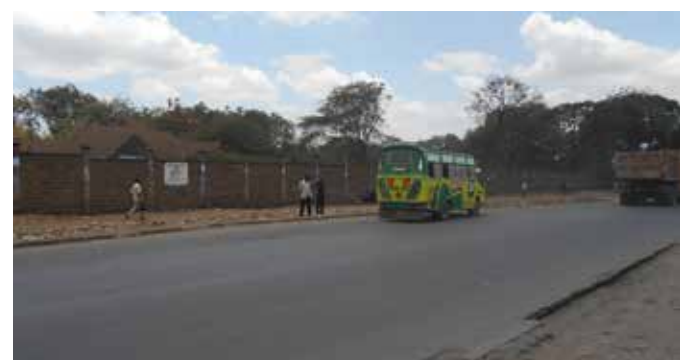
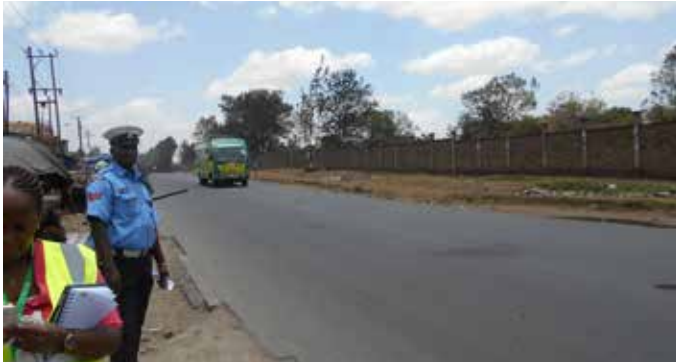
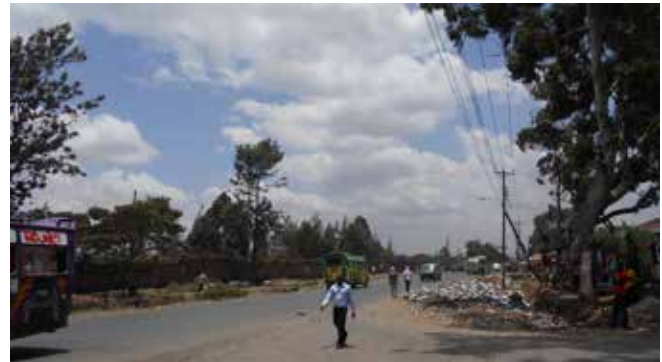
Picture: Part of Mathare No. 10 road section

This section stretches about 0.6 kilometers along Juja Road in the section adjacent to Mathare No. 10 bus stage. The main hazards are the unsafe pedestrian crossing and inadequate road signage and markings. There are no speed bumps to slow down motorists, no designated crossing points for pedestrians, and no designated bus stop. Most crashes happen throughout the week, but mostly during the day time and evening, and in both dry and wet seasons. Vehicles most involved in crashes are mini buses (PSVs and vans). When crashes happen, the victims are taken to MSF Clinic.

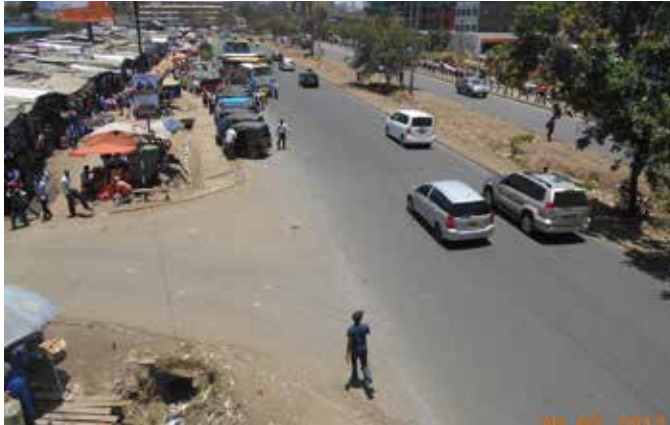
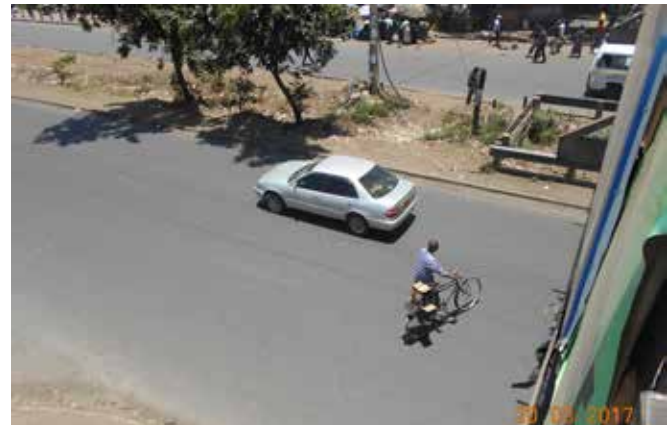
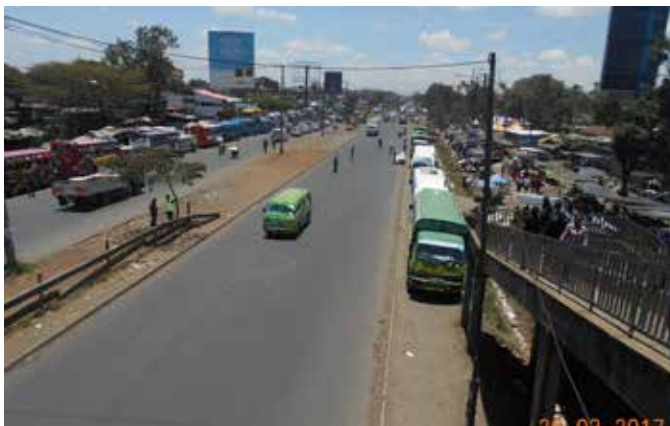
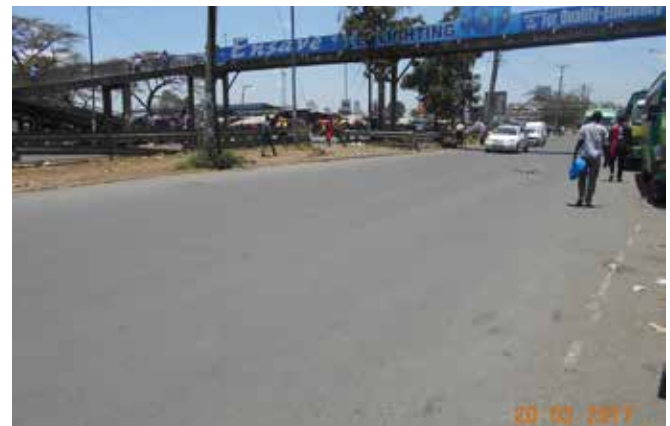
Picture: Part of Burma Footbridge road section

This section stretches about 0.1 kilometers along Jogoo Road in the section near Burma footbridge. The main hazards are unsafe pedestrian crossing and speeding motorists. Pedestrians do not use the footbridge and there is encroachment on the road sides by traders. There are also many careless motorcyclists crossing the road. Crashes happen throughout the week, both day and night, as well as during both dry and wet seasons.

Vehicles most involved in crash are personal cars (saloons), mini buses (PSVs and vans), large buses, light and medium trucks, heavy commercial vehicles, and motorcycles. When crashes happen, the victims are taken to Kenyatta National Hospital.

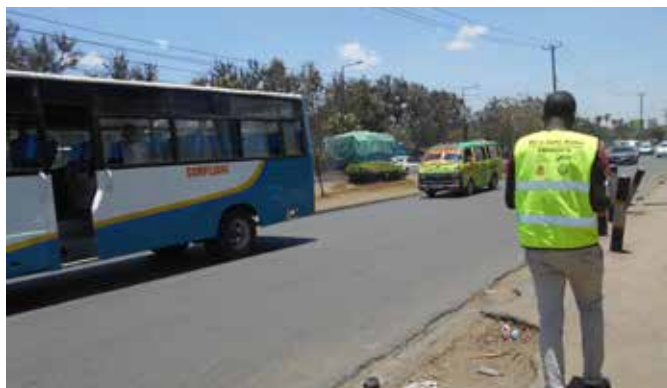
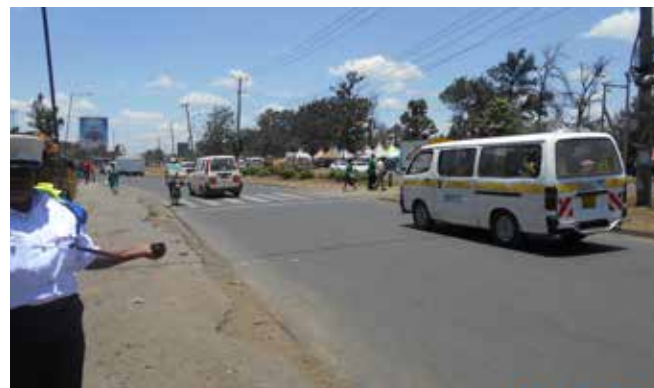
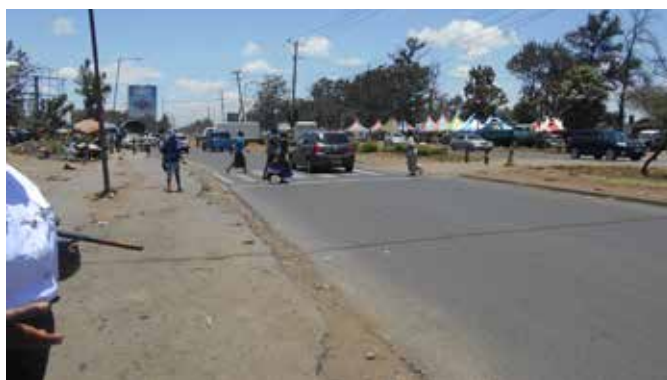
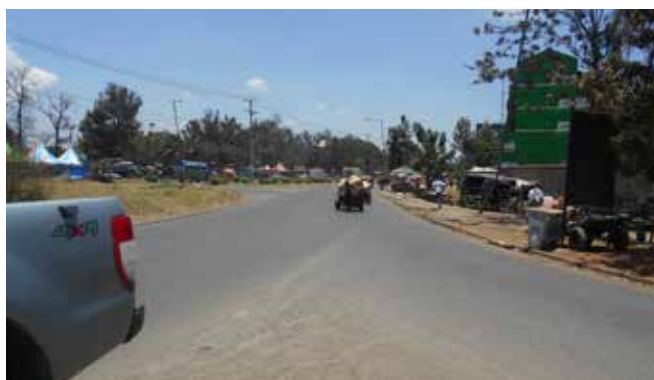
Picture: Part of Rikana road section

This section stretches about 0.1 kilometers along Jogoo road near Rikona Enterprises. There is a designated pedestrian crossing point but the road is unmarked. The main hazard is speeding motorists. Motorists do not obey the designated speed limit on this road section. Crashes happen throughout the week, both day and night, as well during both dry and wet seasons. Vehicles most involved in crash are personal cars (saloons), mini buses (PSVs and vans), large buses, light and medium trucks, heavy commercial vehicles and motorcycles. When crashes happen, the victims are taken to Kenyatta National Hospital.

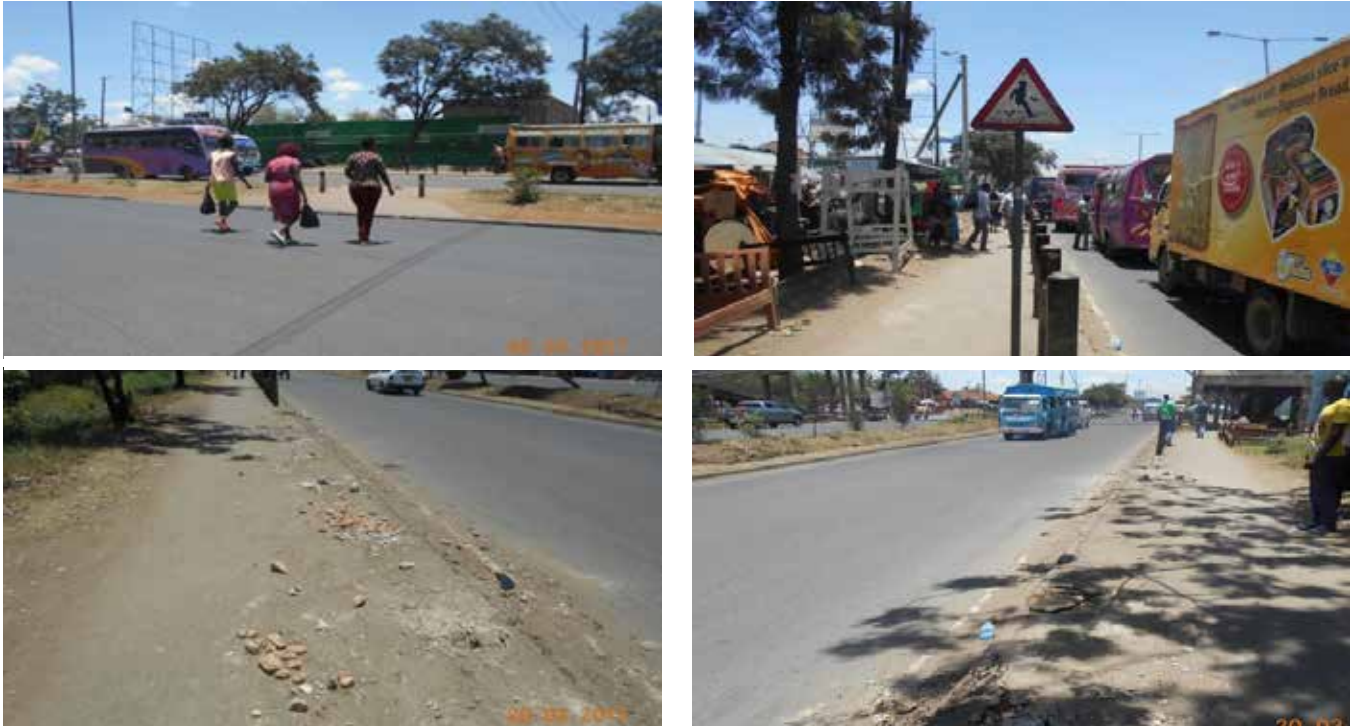
Picture: Part of Uchumi Supermarket road section

This section stretches about 0.3 kilometers on Jogoo road in the section near Uchumi Super market towards Donholm. The main hazards are unsafe pedestrian crossing and speeding motorists. Motorists do not slow down at the pedestrian crossing, and pedestrians cross the road at all points away from the designated pedestrian crossing.

Even though there is a footbridge, many pedestrians do not use it. Crashes happen throughout the week, both day and night, as well as during both dry and wet seasons. Vehicles most involved in crash are personal cars (saloons), mini buses (PSVs and vans), large buses, light and medium trucks, and motorcycles. When crashes happen, the victims are taken to Kenyatta National Hospital.
