Northern Corridor and Nairobi County Route Hazard Mapping Report

May 2017

Developed by Safe Way Right Way and National Transport and Safety Authority

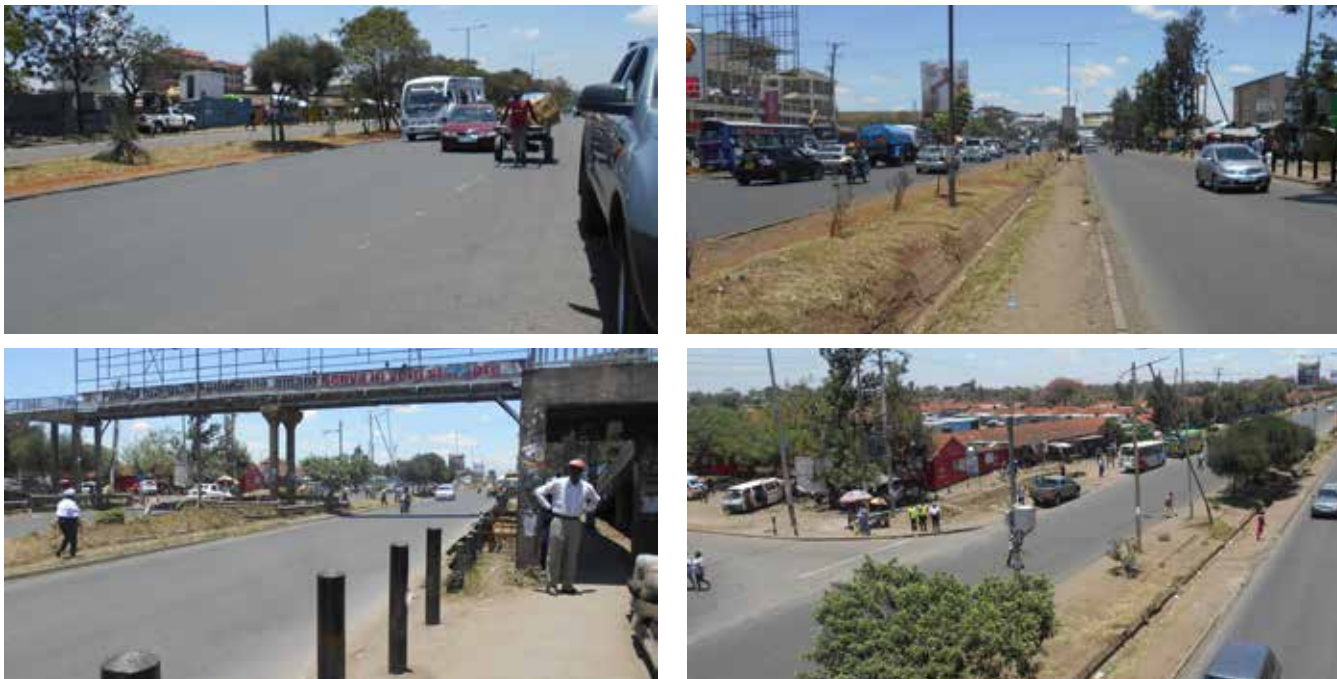
Picture: Part of Uchumi Junction road section

This section stretches about 0.7 kilometers along Jogoo road in the section at the Uchumi Supermarket Junction towards Nyayo Stadium. The main hazards are unsafe pedestrian crossing and speeding motorists. Motorists do not slow down at the pedestrian crossing and pedestrian cross the road at all points away from the designated pedestrian crossing. Even though there is a footbridge, pedestrian ignore and cross under the bridge. Crashes happen throughout the week, both day and night and during both dry and wet seasons. Vehicles most involved in crash are personal cars (saloons), mini buses (PSVs and vans), large buses, light and medium trucks, and motorcycles. When crashes happen, the victims are taken to Kenyatta National Hospital or Metropolitan Hospital Buru Buru.

Engineering - road design/furniture/features	Enforcement - law	Education - Road user awareness
<ul style="list-style-type: none"> Erect guard rails to keep away pedestrian crossing on all road points. NB - There are now bumps and signage courtesy to a protest by St. Anne's primary pupils on 14 June 2017 	<ul style="list-style-type: none"> Enforce speed limit and pedestrian right of way at the crossing point. Arrest pedestrian crossing unsafely. 	<ul style="list-style-type: none"> Educate pedestrians on safe crossing. Educate motorists on slowing down for pedestrians.

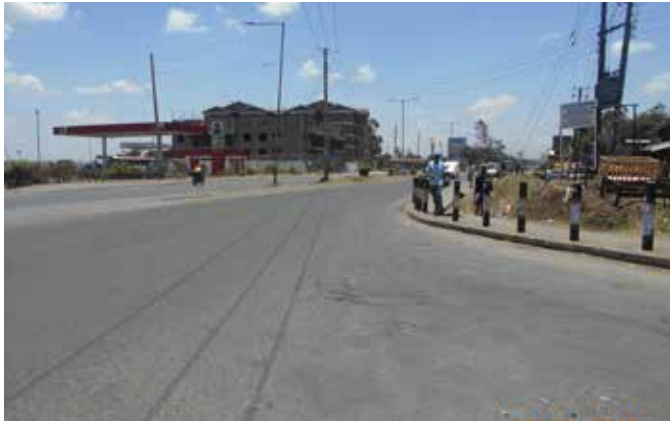
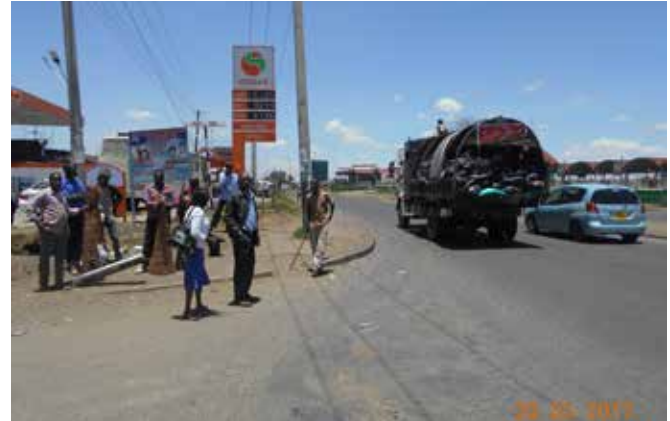
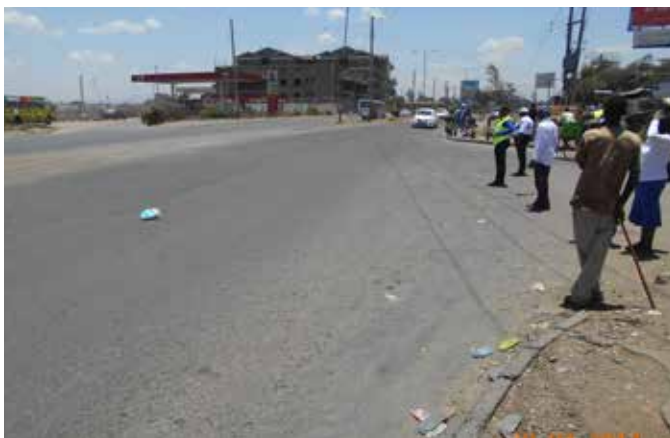
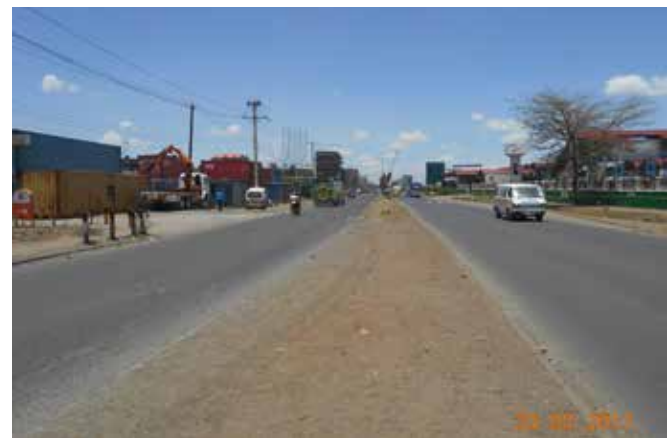
Picture: Part of Hamza/Mogas road section

This section stretches 400 meters along Jogoo Road at the junction near Mogas petrol station and Hamza road on the way to Donholm. The main hazards are speeding motorists, inadequate road signage and damaged road infrastructure. Crashes happen throughout the week, both day and night as well as during both dry and wet seasons. Vehicles most involved in crash are personal cars (saloons), mini buses (PSVs and vans), large buses, light and medium trucks, heavy commercial vehicles, and motorcycles. When crashes happen, the victims are taken to Kenyatta National Hospital or Metropolitan Hospital Buru Buru.

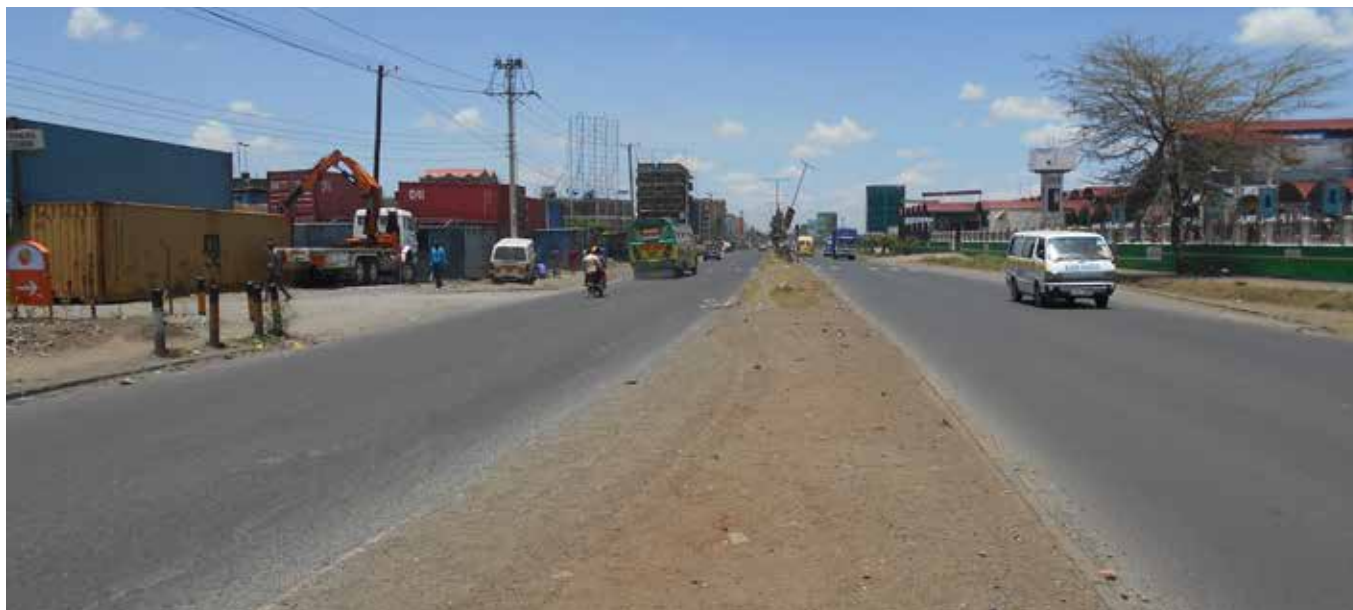
Picture: Part of Hamza road section

This section stretches about 0.4 kilometers along Jogoo road at the bend near Mogas petrol station and Hamza road on the opposite direction heading towards Nyayo Stadium adjacent to Makadara railway station. The main hazards are speeding motorists and roadside encroachment. Crashes happen throughout the week, both day and night and during both dry and wet seasons. Vehicles most involved in crash are personal cars (saloons), mini buses (PSVs and vans), large buses, light and medium trucks, heavy commercial vehicles and motorcycles. When crashes happen, the victims are taken to Kenyatta National Hospital and Mama Lucy Kibaki Hospital.

Engineering - road design/furniture/features	Enforcement - law	Education - Road user awareness
<ul style="list-style-type: none"> • Repair and maintain the traffic light signal. • Repair the road bank. • Mark the road. • Instal bumps to slow down vehicles near the designated pedestrian crossing. 	<ul style="list-style-type: none"> • Enforce speed limits. 	<ul style="list-style-type: none"> • Educate motorist on safe speeds and careful entry to the main road.

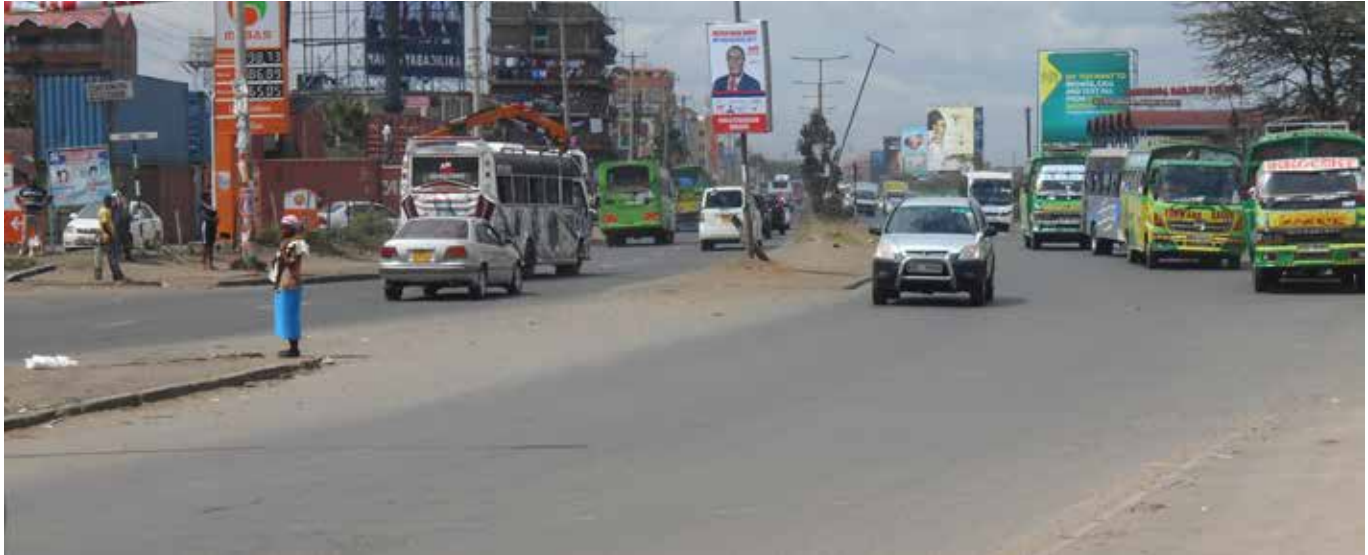
Picture: Part of Hamza Oryx road section

This section stretches about 100 meters along Jogoo road near the Oryx Hotel. The main hazards are the inadequate road signage and the steep section with a drift and an intersection. The existing signs are damaged and worn out and are not visible. Motorists often tend to speed due to the descent. Crashes happen throughout the week, at both day and night but mostly during the wet season. Vehicles most involved in crashes are personal cars (saloons), mini buses (PSVs and vans), large buses, light and medium trucks, heavy commercial vehicles and motorcycles. When crashes happen, the victims are taken to Kenyatta National Hospital and Mama Lucy Kibaki Hospital.

Engineering - road design/furniture/features	Enforcement - law	Education - Road user awareness
<ul style="list-style-type: none"> • Instal speed bumps. • Repair damaged road signage. • Mark the road. 	<ul style="list-style-type: none"> • Enforce speed limits. 	<ul style="list-style-type: none"> • Educate drivers on the need to slow down especially during rainy season.

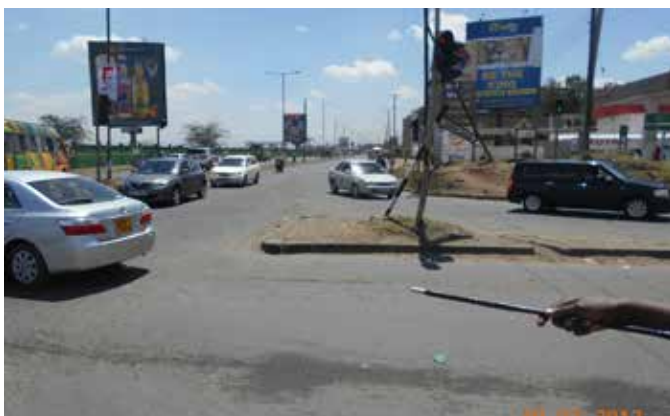
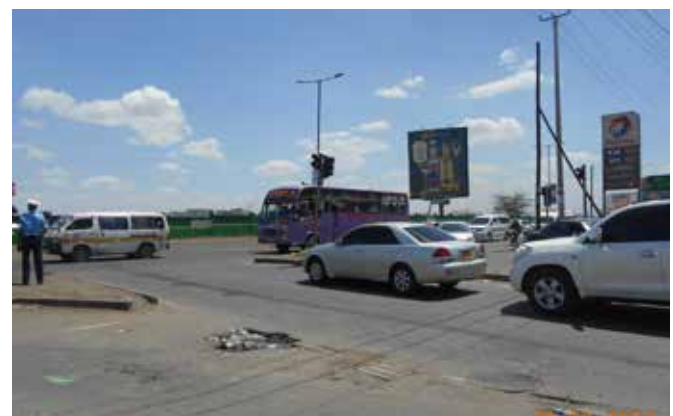
Picture: Part of Rabai Road junction section

This section stretches about 0.2 kilometers along Jogoo Road at the Rabai Road junction near a Total petrol station. The main hazards are speeding motorists and the damaged road infrastructure. Most crashes happen throughout the week, both night and day, and in both dry and wet seasons. Vehicles most involved in crash are Personal cars (saloons), mini buses (PSVs and vans), large buses, light and medium trucks, heavy commercial vehicles and motorcycles. When crashes happen, the victims are taken to Kenyatta National Hospital.

Engineering - road design/furniture/features	Enforcement - law	Education - Road user awareness
<ul style="list-style-type: none"> Repair the traffic lights. Repair bollards. Replace missing manhole covers. 	<ul style="list-style-type: none"> Enforce obedience to traffic lights. 	<ul style="list-style-type: none"> Educate motorists on safe speed and careful entry to Jogoo road from Rabai Road.

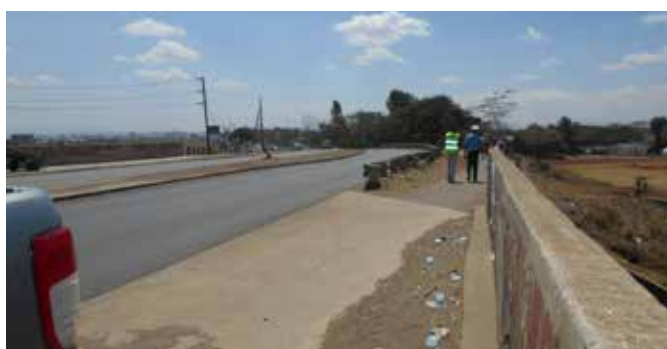
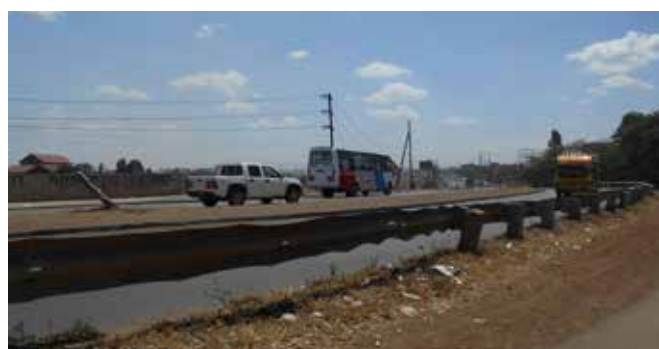
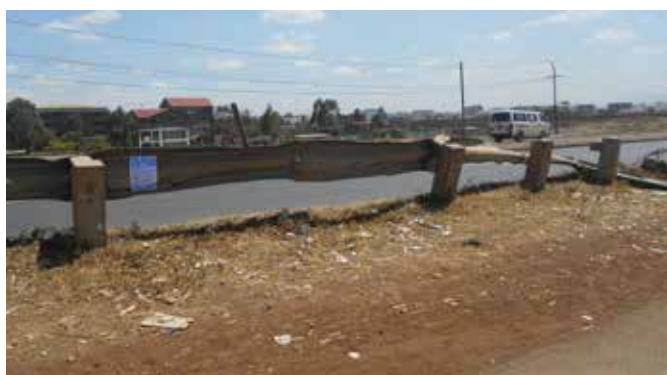
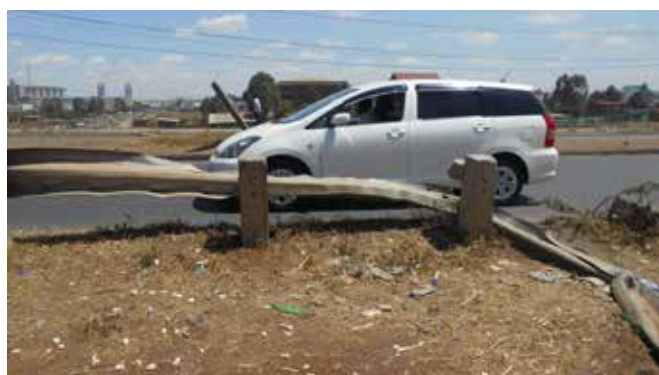
Picture: Part of Jogoo Road flyover road section

This section stretches about 250 meters along Jogoo Road at the flyover of the railways. The main hazards are sharp bend and speeding motorists. There is a sharp bend at the bridge with no signage. Motorists speed and PSVs drive in the wrong direction at night. Most crashes happen throughout the week but mostly at night, and in both wet and dry seasons. Vehicles most involved in crash are personal cars (saloons), mini buses (PSVs and vans). When crashes happen, the victims are taken to Kenyatta National Hospital.

Engineering - road design/furniture/features	Enforcement - law	Education - Road user awareness
<ul style="list-style-type: none"> Instal speed bumps or rumble strips to slow down motorists. Repair damaged guard rails. Instal sign showing sharp bend ahead. 	<ul style="list-style-type: none"> Arrest speeding motorists and PSVs that drive on the wrong side. 	<ul style="list-style-type: none"> Educate motorists on the need to observe traffic rules and drive safely.

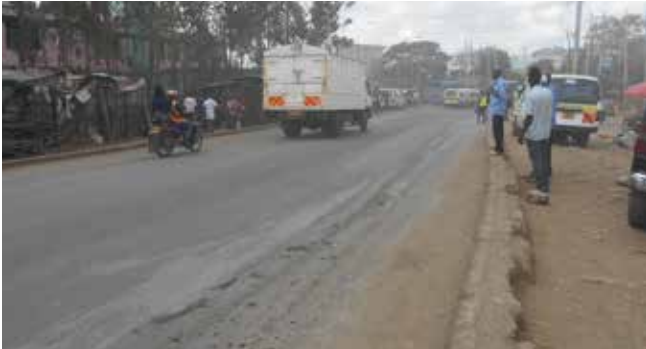
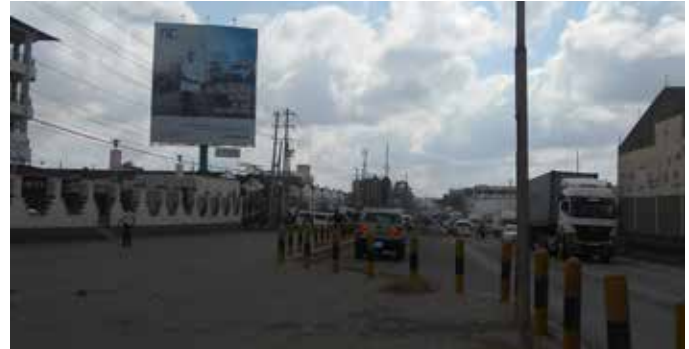
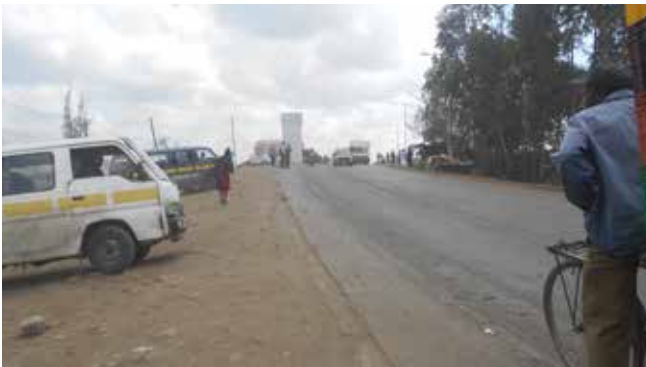
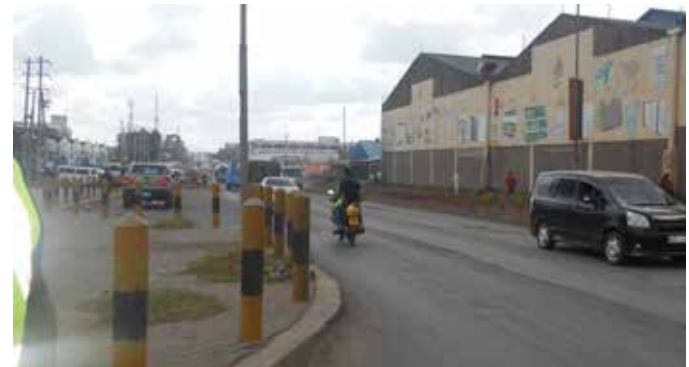
Picture: Part of Lunga Lunga Road section

This section stretches about 3.2 kilometers along Lunga Lunga Road and stretches from Mamba/Mareba bus stop to near the Donholm railway subway. The main hazards are pedestrian crossing, a steep road with a sharp bend, inadequate road markings and signage, and damaged road infrastructure. Motorcycles overlap on the road. The road side has been encroached by traders. There is a steep drift around Sinai bus stop and heavy human traffic from the slum areas. Most crashes happen throughout the week and both night and day as well as in dry and wet seasons. Vehicles most involved in crashes are personal cars (saloons and motorcycles). When crashes happen, the victims are taken to Kenyatta National Hospital and Mama Lucy Hospital.

Engineering - road design/furniture/features	Enforcement - law	Education - Road user awareness
<ul style="list-style-type: none"> • Provide adequate road signage. • Mark the road. • Construct pedestrian walk ways. • Designate pedestrian crossing points. 	<ul style="list-style-type: none"> • Presence of Traffic Police to enforce road safety and remove defective vehicles. 	<ul style="list-style-type: none"> • Educate motorcycles riders on road safety.

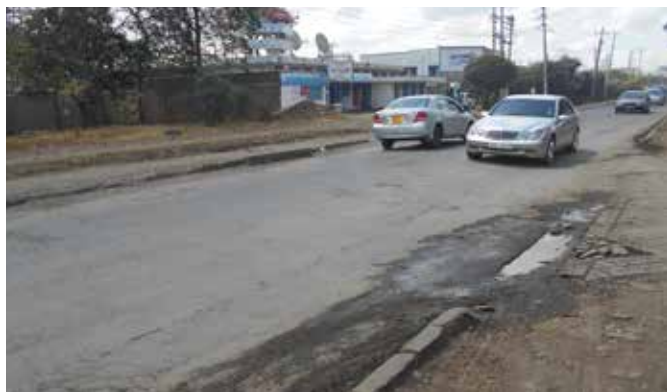
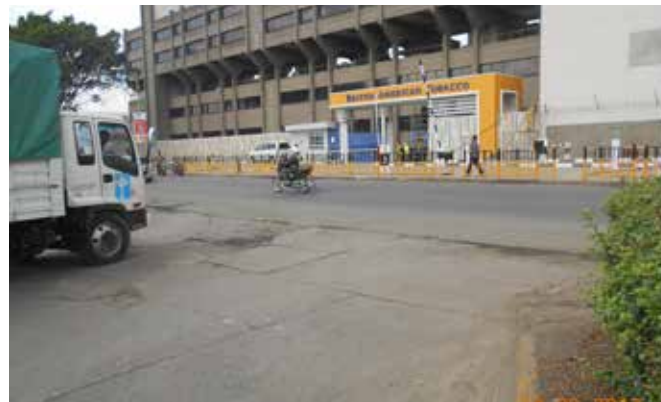
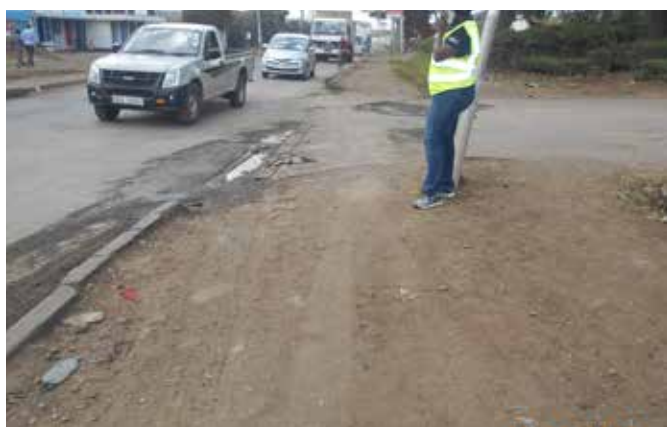
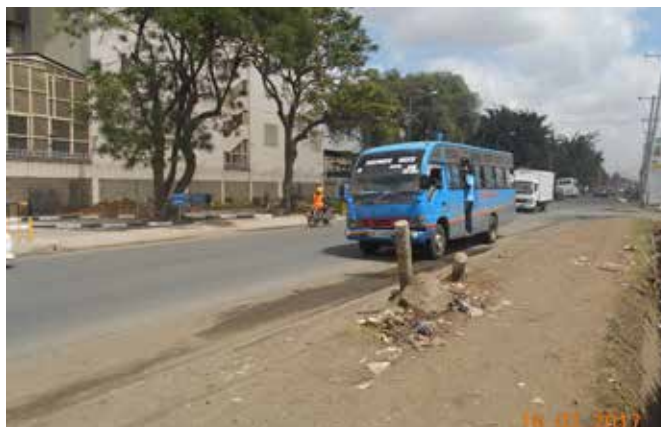
Picture: Part of Likoni Road section

This section stretches 0.4 kilometers along Likoni Road from BAT to Viwandani. The main hazards are pedestrian crossing, narrow road section and the presence of potholes. Pedestrians cross unsafely, motorcyclists drive carelessly and the road is narrow with no lighting for safe use at night. Most crashes happen during weekday during the daytime, in both wet and dry seasons. Vehicles most involved in crash are personal cars (saloons), mini buses (PSVs and vans), large buses, light and medium trucks, heavy commercial vehicles, motorcycles, and peddle cycles. When crashes happen, the victims are taken to Kenyatta National Hospital or Mama Lucy Hospital.

Engineering - road design/furniture/features	Enforcement - law	Education - Road user awareness
<ul style="list-style-type: none"> • Provide adequate road signage and have the road marked appropriately. • Construct pedestrian crossing points and walk ways. • Instal street lighting. • Repair and widen the road. 	<ul style="list-style-type: none"> • Enforce respect for traffic rules. 	<ul style="list-style-type: none"> • Educate motorcycles riders and other road users on road safety.

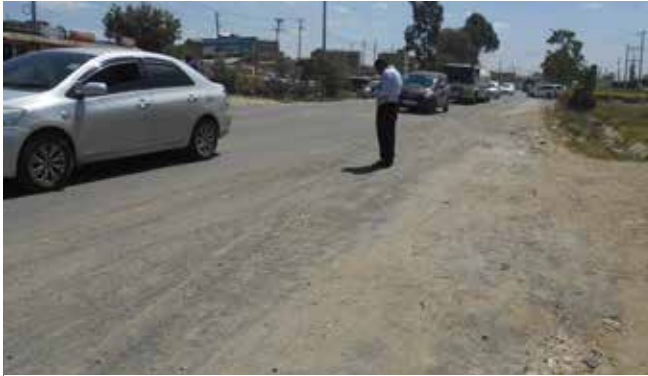
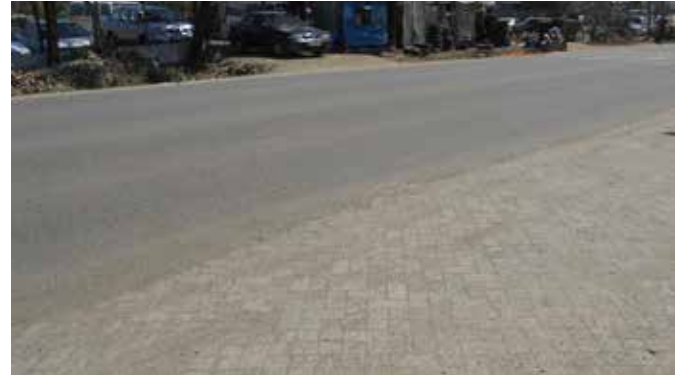
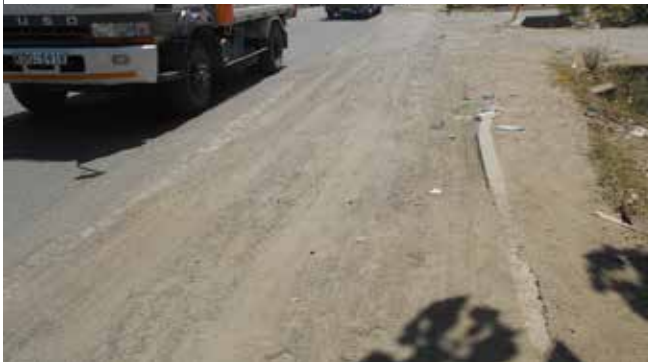
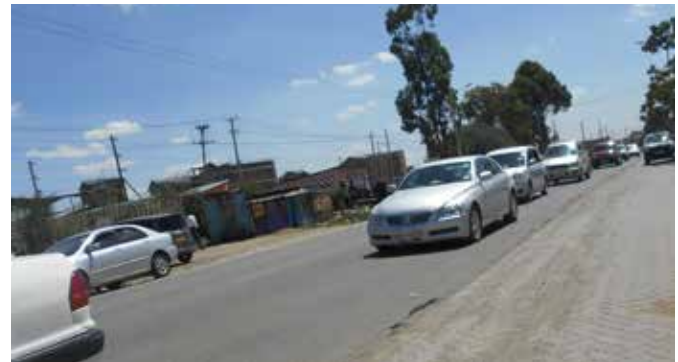
Picture: Part of East Capital road section

This black spot section of the road on Kangundo Road at East Capital apartment's measures 200 meters. The main reason for blackspot is unsafe pedestrian crossing from the many residential areas in this area with no designated pedestrian crossing points. Crashes happen throughout the week, mostly during the night and in both wet and dry seasons. Vehicles most involved in crashes are the personal cars (saloons), mini buses (PSVs and vans), large buses, light and medium trucks, heavy commercial vehicles, motorcycles, and peddle cycles. When crashes happen, the victims are taken to Mama Lucy Hospital.

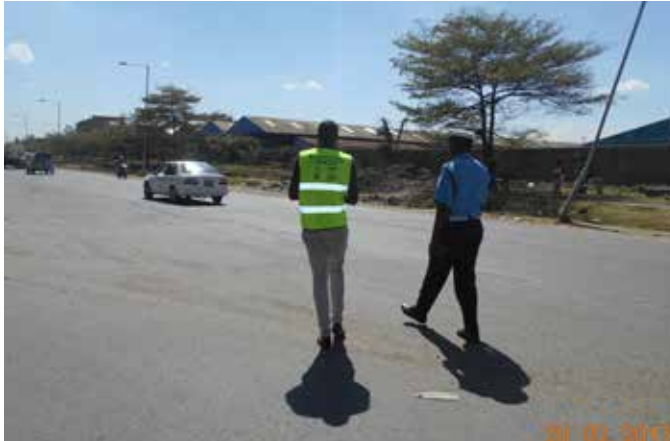
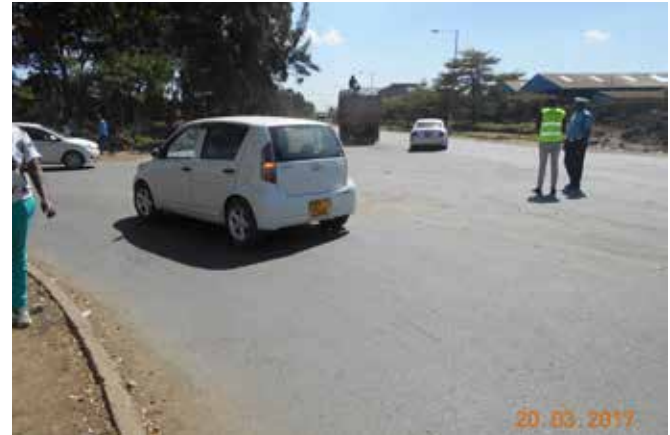
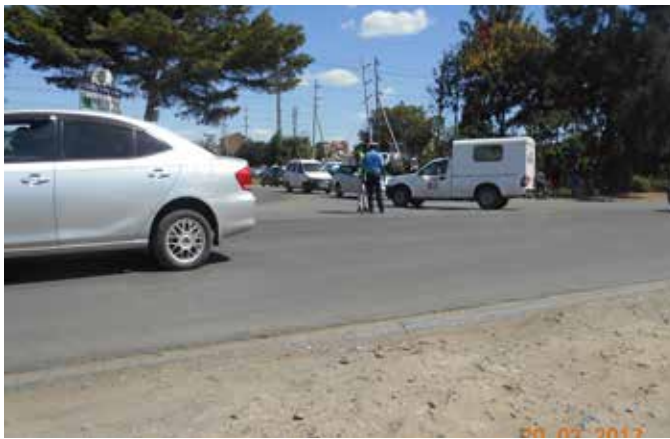
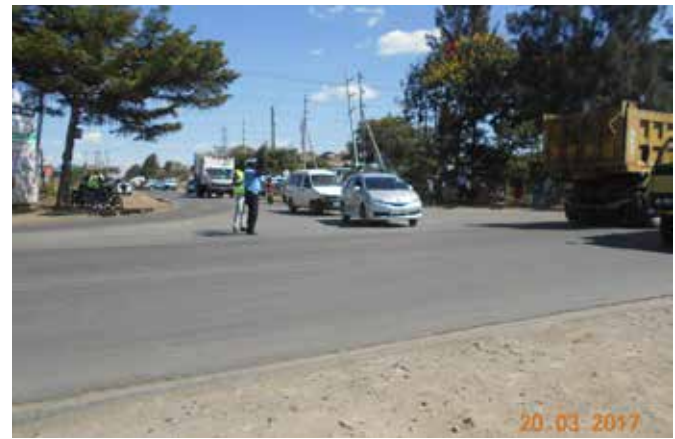
Picture: Part of Kangundo – Kayole Spine Road section

This black spot is situated on Kangundo Road at the junction with Kayole Spine road stretching about 200 meters. The main reasons for blackspot are the speeding motorists, coupled with a road intersection with inadequate signage and road marking.

There are also cases of drunk driving due to the presence of the entertainment joints and pedestrian crossing in undesignated points. Crashes happen during the weekend, mostly during night and during both wet and dry seasons. Vehicles most involved in crashes are the personal cars (saloons), and motorcycles. When crashes happen, the victims are taken to Mama Lucy Hospital.

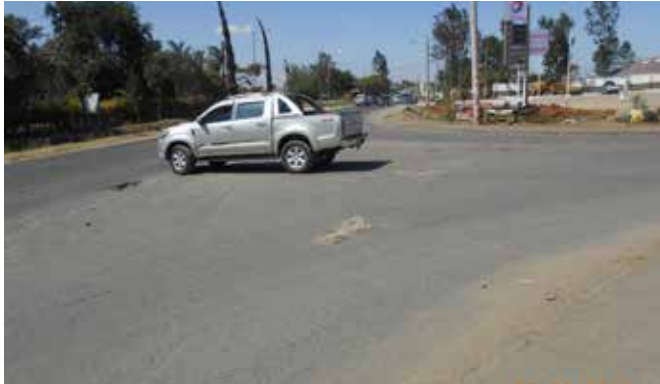
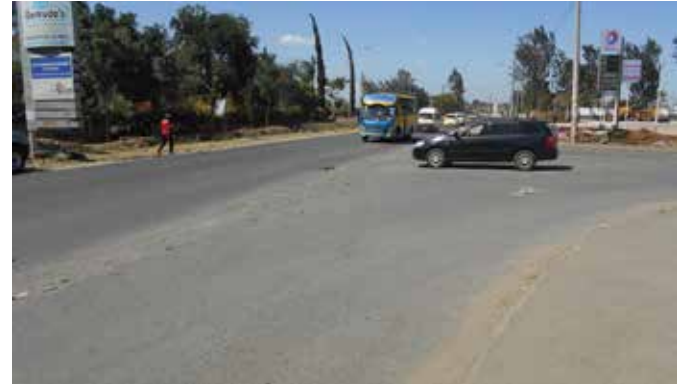
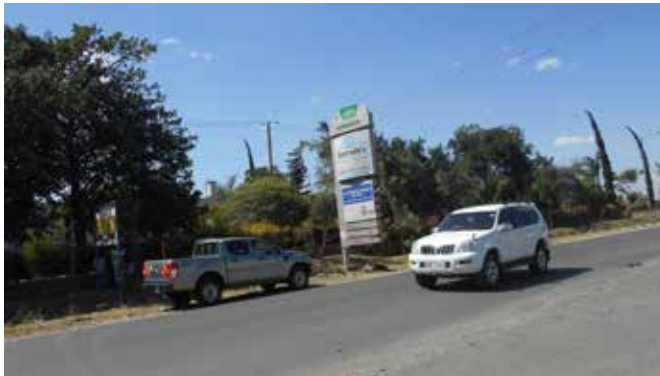
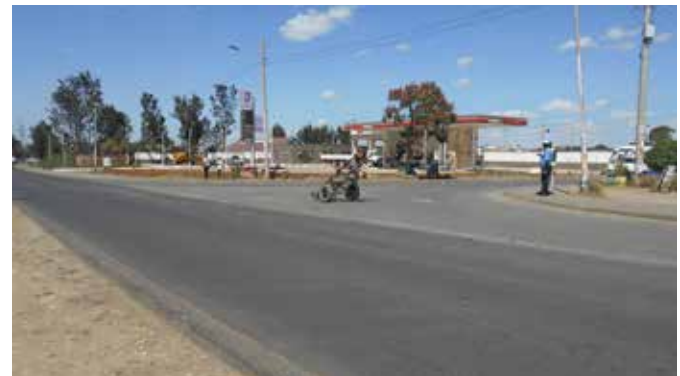
Picture: Part of Komarock –Kangundo Road – Junction

This section of the road is situated on Kangundo Road at the junction with Komarock road stretching about 0.7 kilometers. There is a Total petrol station on this road. The main reasons for blackspot are the blind spot at the road intersection, inadequate signage and missing road marking. There is also no street lighting making visibility at night very poor. Crashes happen during weekdays and both in the night and day time and during both wet and dry seasons. Vehicles most involved in crashes are the personal cars (saloons), mini buses (PSVs and vans) and motorcycles. When crashes happen, the victims are taken to Mama Lucy Hospital.

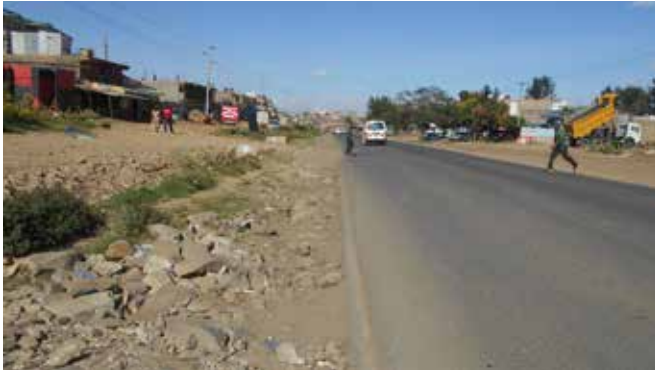
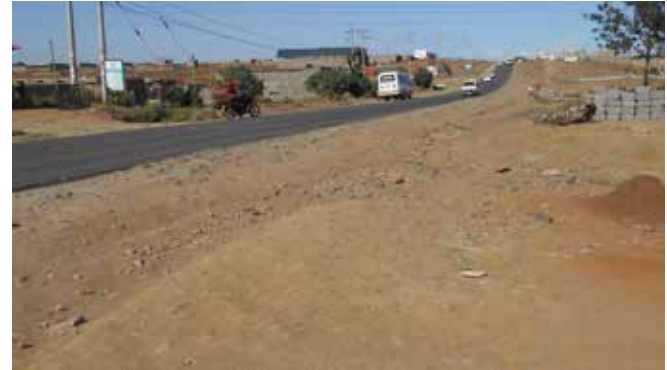
Picture: Part of Slaughter road section

This section of the road is situated on Kangundo Road in the Kayole Slaughter section stretching about 0.8 kilometers. The main reasons for blackspot are speeding motorists, pedestrians crossing at undesignated points and coupled with presence of entertainment joints with many cases of drunk driving and drunken pedestrians. Crashes happen during weekdays and at night during both wet and dry seasons. Vehicles most involved in crashes are the personal cars (saloons) and motorcycles. When crashes happen, the victims are taken to Mama Lucy Hospital.

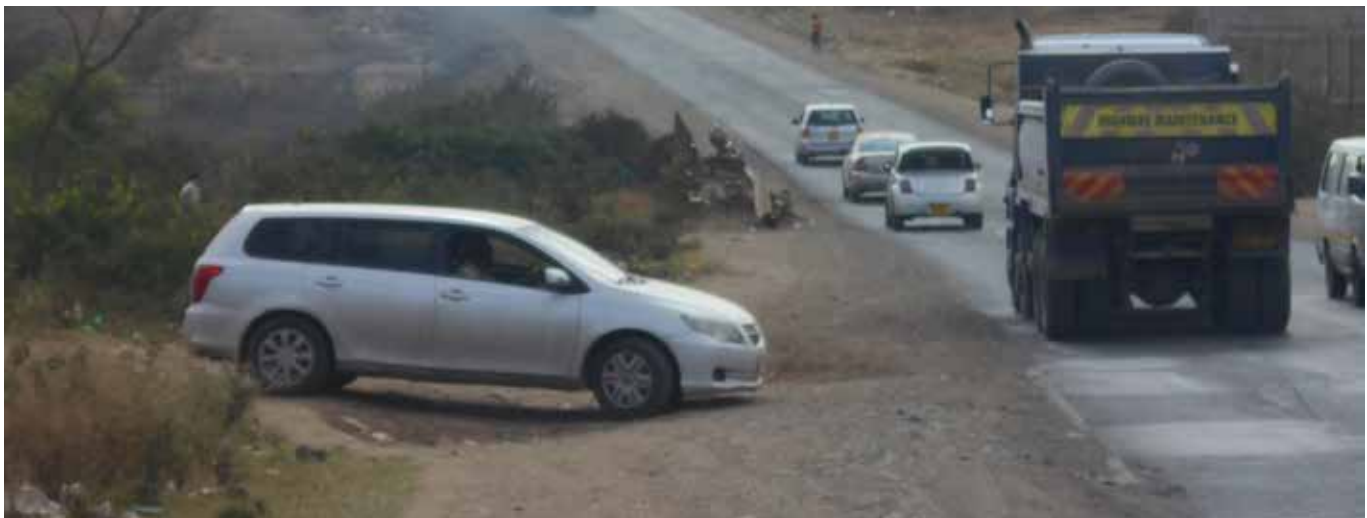
Picture: Part of Njiru Kangundo road section

This section of the road is situated on Kangundo Road near Njiru shopping center stretching about 0.5 kilometers. The main reasons for blackspot are speeding motorists and pedestrians crossing at undesignated points and coupled with presence of entertainment joints. Many cases of drunk driving and drunken pedestrians have been reported to the police. Crashes happen throughout the weeks both night and day time but mostly during dry seasons.

Vehicles most involved in crashes are personal cars (saloons), mini buses (PSVs and vans), large buses, light and medium trucks, heavy commercial vehicles, and motorcycles. When crashes happen, the victims are taken to Mama Lucy Hospital and Ruai Family Hospital.

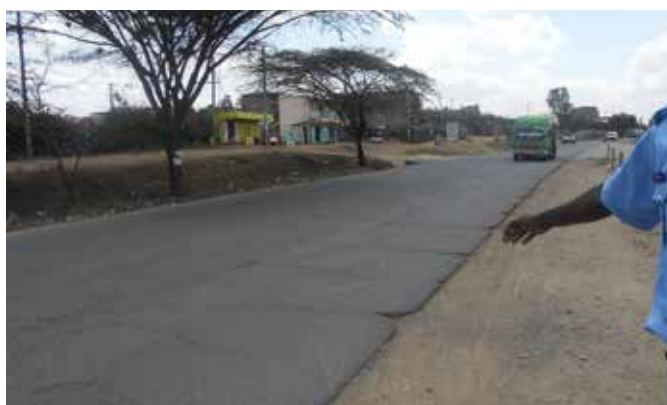
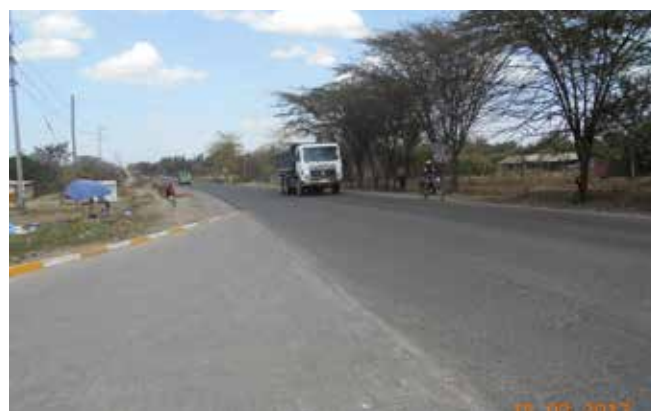
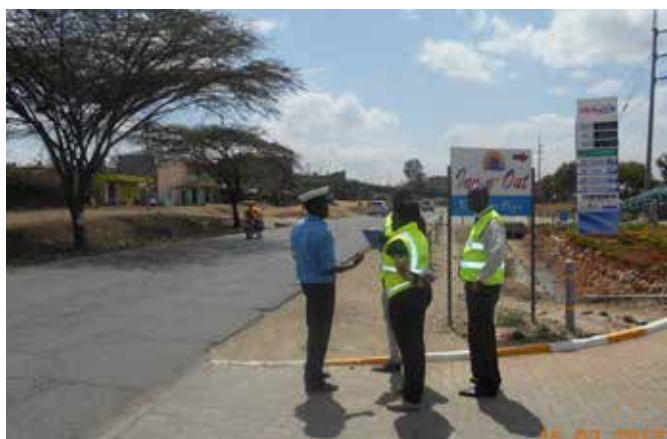
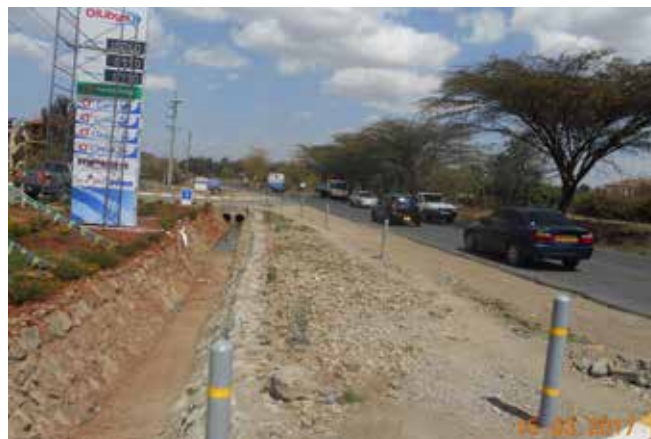
Picture: Part of Kona Mbaya road section

This section of the road is situated on Kangundo Road near Ruai Corner Mbaya farm stretching 400 meters. There is an Oilbya petrol station on this section. The main reason for blackspot is speeding motorists at a blind spot. Crashes happen during weekdays and at night, and mostly during dry seasons. Vehicles most involved in crashes are the light and medium trucks, heavy commercial vehicles, heavy commercial vehicles, and motorcycles. When crashes happen, the victims are taken to Mama Lucy Hospital and Ruai Family Hospital.

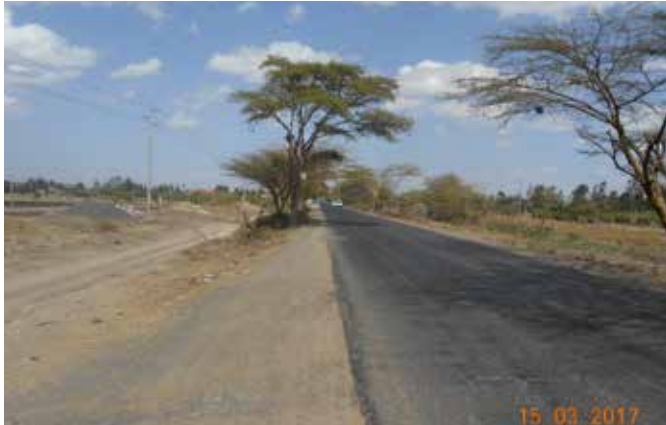
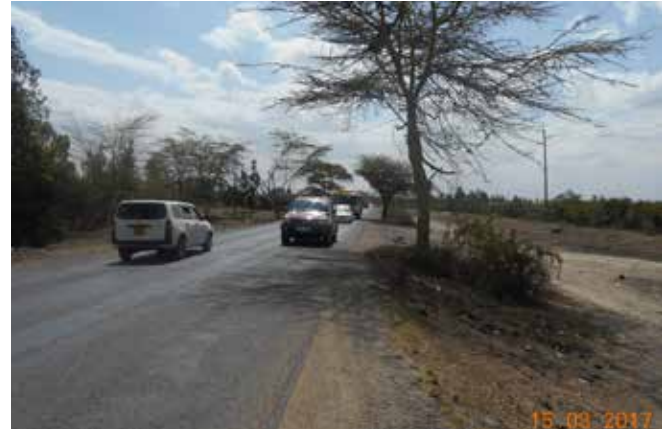
Picture: Part of Kangundo Road No. 26 road section

This section of the road is situated on Kangundo Road on a straight narrow road towards the last stopping points for PSVs on route number 26, near Total Kamala petrol station. The section is 2.6 kilometers long. The main reasons for blackspot are speeding motorists on a narrow straight road section. The acacia trees have reduced visibility and often motorists are involved while overtaking. There being no designated bus stop, 'PSVs' make illegal stops on the road and obstruct traffic. Crashes happen throughout the week, both night and day, but mostly during the dry season. Vehicles most involved in crashes are personal cars (saloons), mini buses (PSVs and vans), light and medium trucks, heavy commercial vehicles, and motorcycles. When crashes happen, the victims are taken to Mama Lucy Hospital and Ruai Family Hospital.

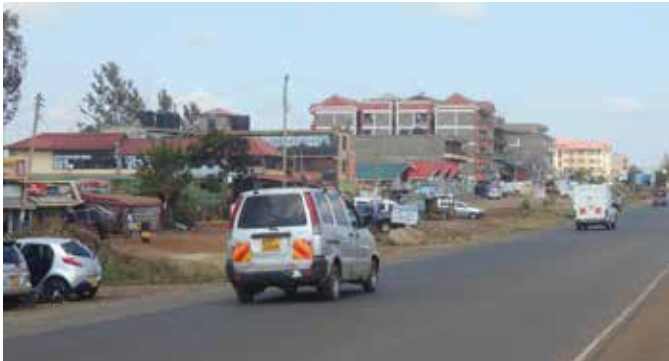
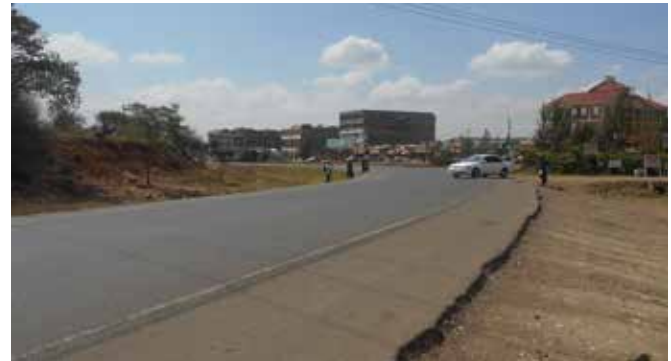
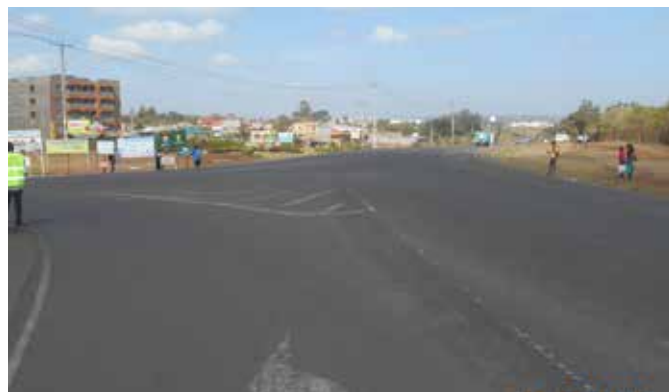
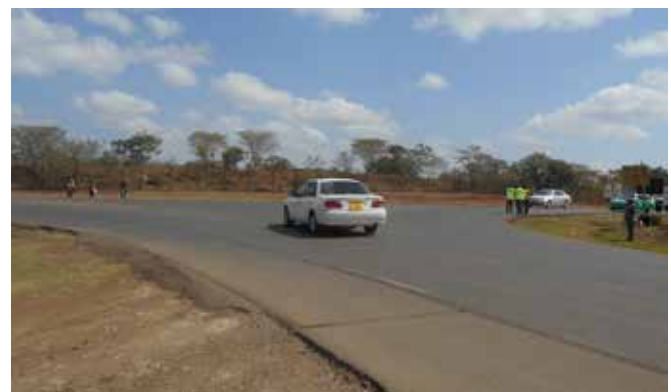
Picture: Part of Eastern Bypass Junction road section

This section of the road is situated at the junction of Eastern Bypass and Ruiru Kamiti road and is 100 meters long. The main reasons for blackspot is unsafe pedestrians crossing, missing road signage, bill boards that obstruct view, faded road markings and undesignated bus stops. The many entertainment joints in the area increase the human traffic over the weekend. Crashes happen mostly during weekends, at night and in both dry and wet seasons. Vehicles most involved in crashes are the personal cars (saloons), motorcycles, and peddle cycles. When crashes happen, the victims are taken to Ruiru Sub District Hospital, Nazareth Hospital or Twendo Hospital.

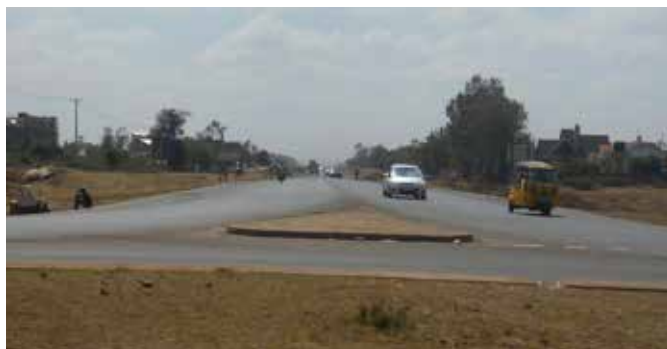
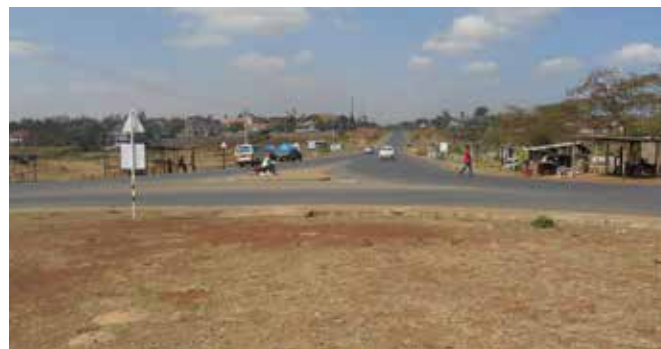
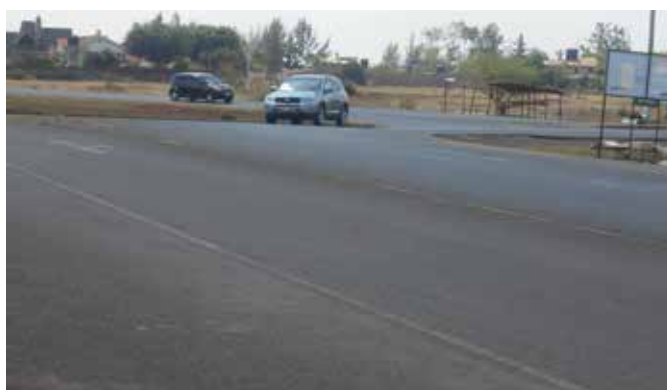
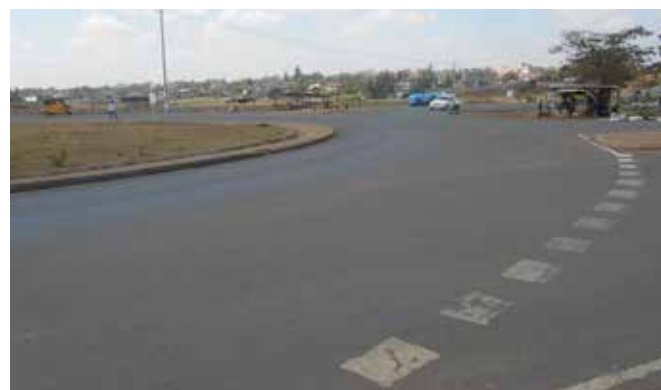
Picture: Part of Membley Roundabout road section

This section of the road is situated at the Membley roundabout where the Eastern Bypass and Northern Bypass meet, and stretches the length of the roundabout. The main reason for blackspot is the blind spot (poor line of sight), and. There are speed bumps and the roundabout curves towards the Northern Bypass. Crashes happen throughout the week, both night and day time as well as in both dry and wet seasons. Vehicles most involved in crashes are the personal cars (saloons), mini buses (PSVs and vans), large buses, light and medium trucks, heavy commercial vehicles, motorcycles, and peddle cycles. When crashes happen, the victims are taken to Ruiru Sub District Hospital, Nazareth Hospital or Twendo Hospital.

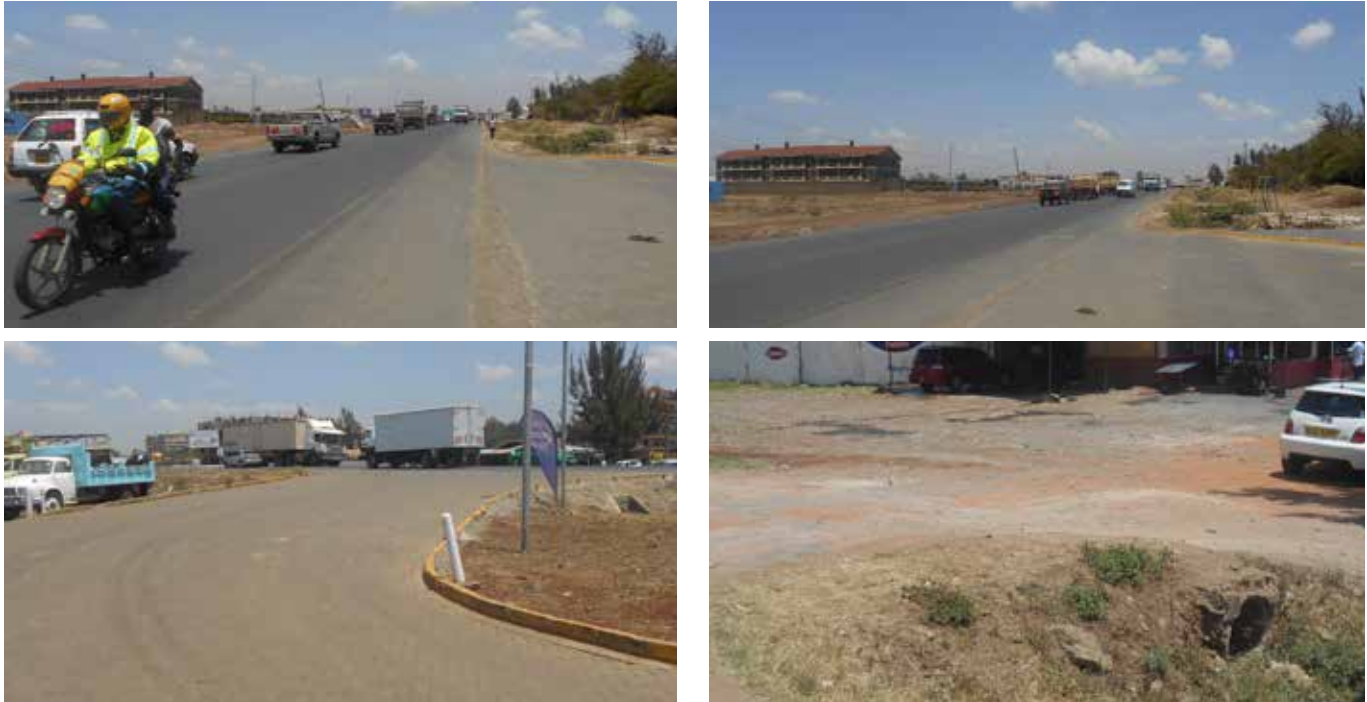
Picture: Part of Delta Petrol Station road section

This section of the road is situated on the Ruai bypass and Delta Petrol station on the Eastern Bypass, and stretches about 1.1 kilometers. The main reason for blackspot is the speeding motorists and the high presence of entertainment joints that have led to an increase in cases of drunken driving. The section is a straight stretch with no speed limit signs. Motorists overlap on this section of the road. This is a densely populated area with high human traffic. Crashes happen throughout the week, during night and day time as well as in both dry and wet seasons. Vehicles most involved in crashes are the personal cars (saloons), mini buses (PSVs and vans), light and medium trucks, heavy commercial vehicles, and motorcycles. When crashes happen, the victims are taken to Ruiru Sub District Hospital.

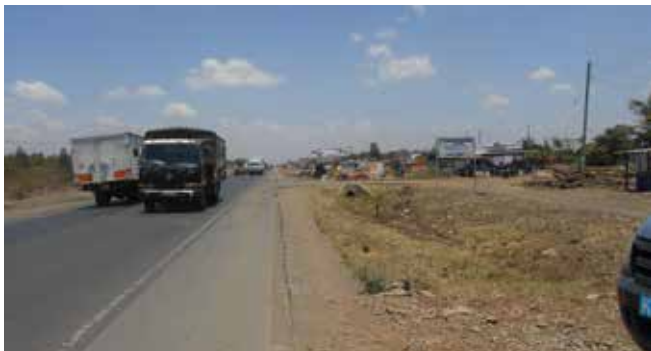
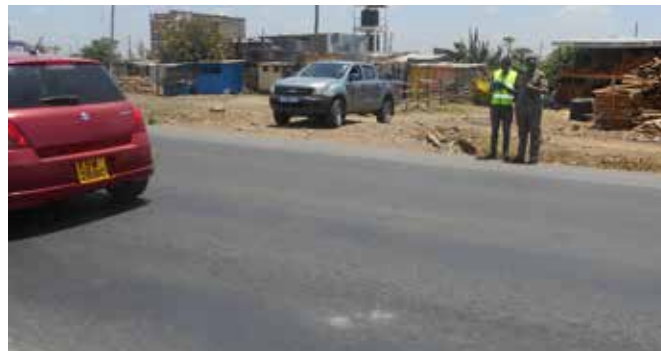
Picture: Part of Mitikenda road section

This section of the road is situated on the Eastern Bypass in Mitikenda area and stretches about 2.2 kilometers. The main reason for blackspot is speeding motorists and the presence of entertainment joints that have led to increase in cases of drunken driving coupled with unsafe pedestrian crossing. Crashes happen throughout the week, both night and day time and in both dry and wet seasons. Vehicles most involved in crashes are the personal cars (saloons), mini buses (PSVs and vans), light and medium trucks, large buses, heavy commercial vehicles, and motorcycles. When crashes happen, the victims are taken to Ruiru Sub District Hospital.

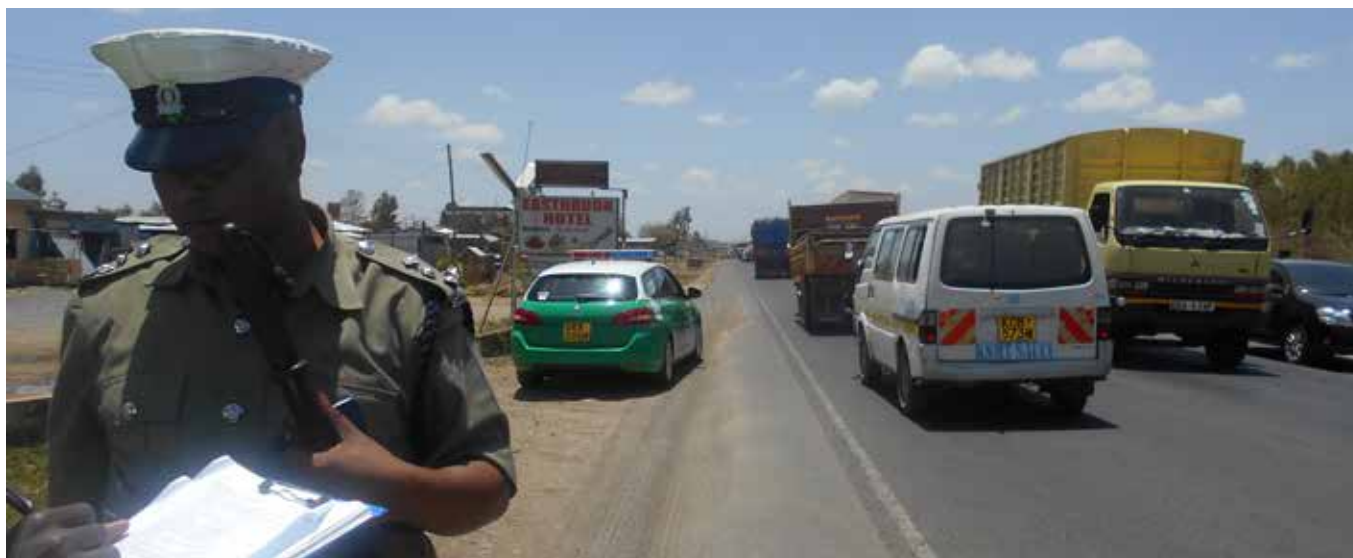
Picture: Part of Charles Lwanga road section

This section of the road is situated on the Eastern Bypass in the Charles Lwanga area and stretches about 1.2 kilometers. The main reason for blackspot is the speeding motorists, the high presence of entertainment joints with increased cases of drunken driving, and unsafe pedestrian crossing. There are no designated pedestrian crossing points, and the section being straight, motorists tend speed. Crashes happen throughout the week and equally at both night and day time but mostly during dry seasons. Vehicles most involved in crashes are the personal cars (saloons), mini buses (PSVs and vans), large buses, light and medium trucks, heavy commercial vehicles, and motorcycles. When crashes happen, the victims are taken to Mama Lucy Hospital and Ruai Family Hospital.
