Northern Corridor and Nairobi County Route Hazard Mapping Report

May 2017

Developed by Safe Way Right Way and National Transport and Safety Authority

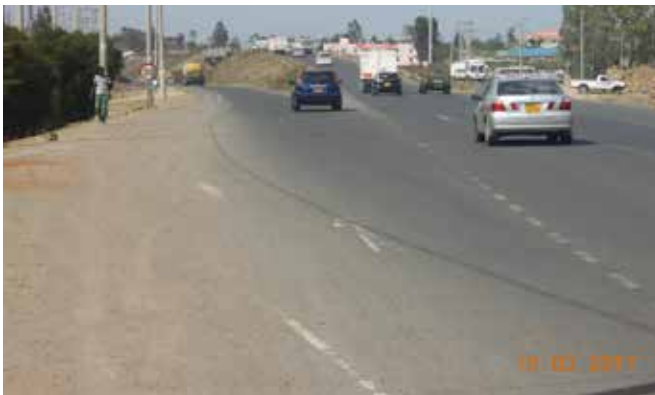
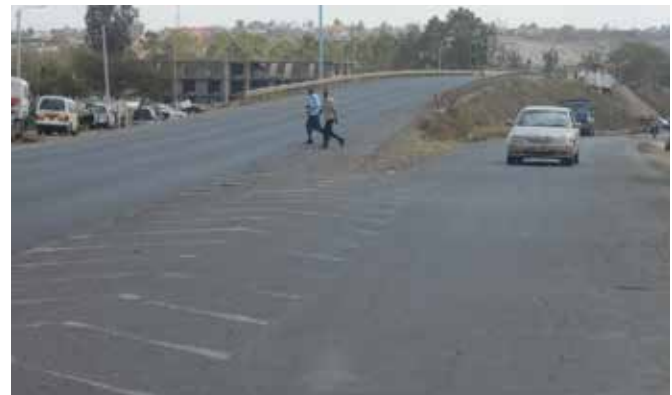
Picture: Part of Ruai Bypass road section

This section of the road is situated on the Eastern Bypass at the overpass on Kangundo Road and stretches 0.7 kilometers. The main reason for blackspot is the speeding motorists coupled with inadequate road marking and road signage. Crashes happen throughout the week, both night and day time and in both dry and wet seasons. Vehicles most involved in crashes are the personal cars (saloons), mini buses (PSVs and vans), large buses, light and medium trucks, and heavy commercial vehicles. When crashes happen, the victims are taken to Mama Lucy Hospital or Ruai Family Hospital.

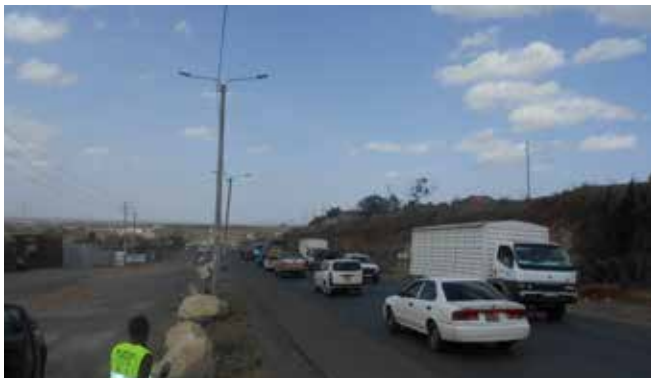
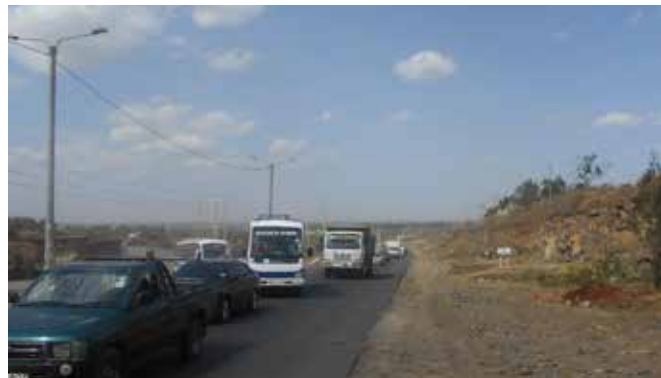
Picture: Part of Triples O's road section

This section of the road is situated the Eastern Bypass near Triple O's Club and stretches about 0.8 kilometers. The main reason for blackspot is the speeding motorists, presence of many bars and restaurants with increased cases of drunken driving, freewheeling vehicles on the slope and careless overtaking by motorists. Crashes happen throughout the week but mostly at night and in dry seasons. Vehicles most involved in crashes are the personal cars (saloons) mini buses (PSVs and vans), light and medium trucks, and heavy commercial vehicles. When crashes happen, the victims are taken to Mama Lucy Hospital, Komarock or Bliss GVS Hospital.

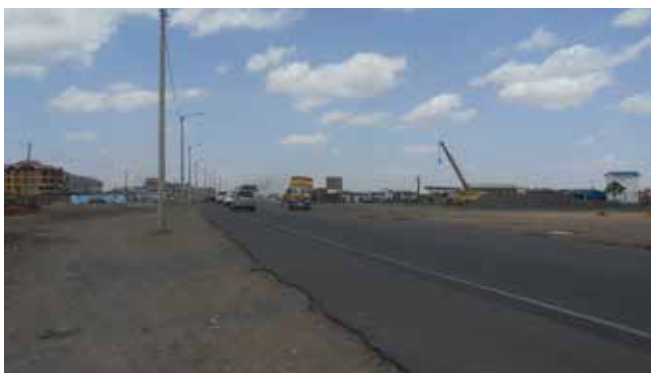
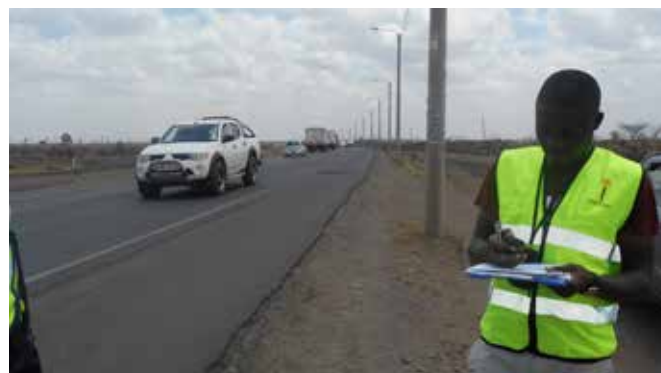
Picture: Part of GSU Camp road section

This section of the road is located on the Eastern Bypass near GSU Camp and is 0.7 kilometers long. The main reason for blackspot is the speeding motorists. Crashes happen throughout the week, at night and during dry seasons.

Vehicles most involved in crashes are the personal cars (saloons), mini buses (PSVs and vans), light and medium trucks, and heavy commercial vehicles. When crashes happen, the victims are taken to Mama Lucy Hospital, or Shalom Hospital.

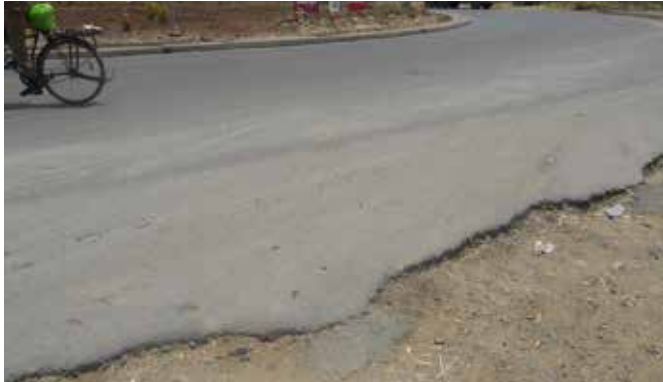
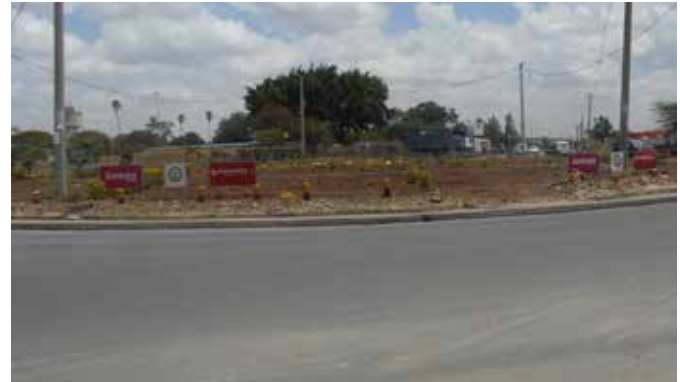
Picture: Part of North Airport road section

This section of the road is between Eastern bypass and Airport North Road and stretches about 400 meters. The main reasons for the blackspot is the blind spot (poor visibility) at the roundabout and inadequate road marking and signage. Crashes happen mostly during weekdays and mostly at night and in dry seasons. Vehicles most involved in crashes are the personal cars (saloons), mini buses (PSVs and vans), light and medium trucks, and heavy commercial vehicles. When crashes happen, the victims are taken to Mama Lucy Hospital, or Shalom Hospital.

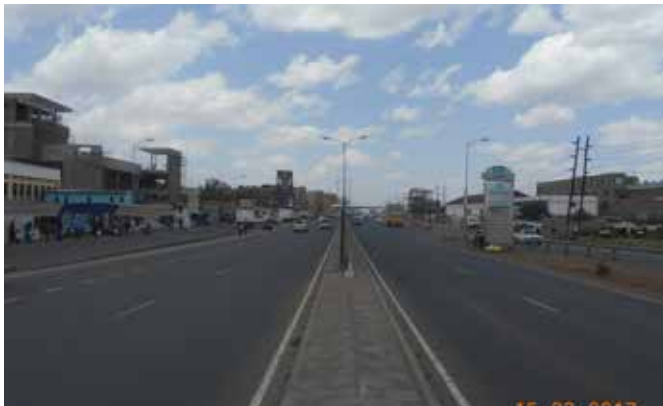
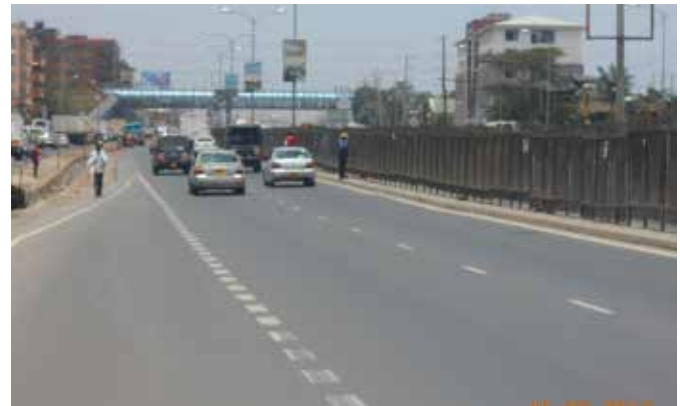
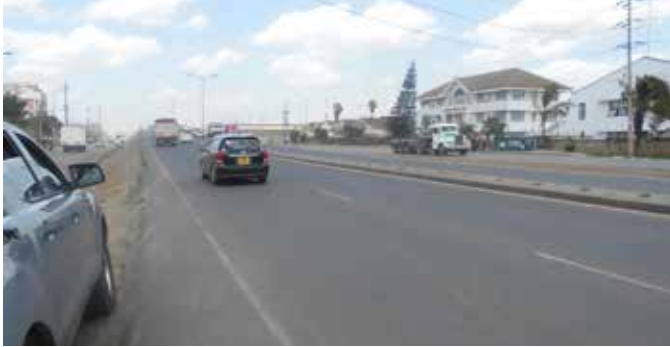
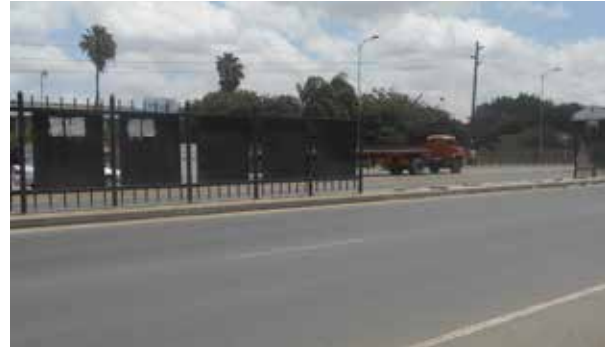
52. Airport North Road

This section of the road is between City Cabanas Hotel and Taj Mall, a stretch of 1.2 kilometers on both sides of the dual carriageway. There is a foot bridge and pedestrian fence. The main reason for blackspot is unsafe pedestrian crossing and reckless motorcycle riders. Crashes happen throughout the week and both day and night but mostly in dry seasons. Vehicles most involved in crashes are personal cars (saloons), light and medium trucks, and motorcycles. When crashes happen, the victims are taken to Kenyatta National Hospital, or Shalom Hospital.

Picture: Part of Airport North road section

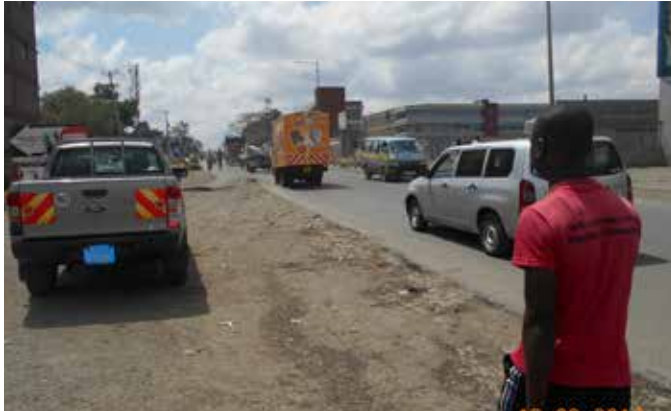
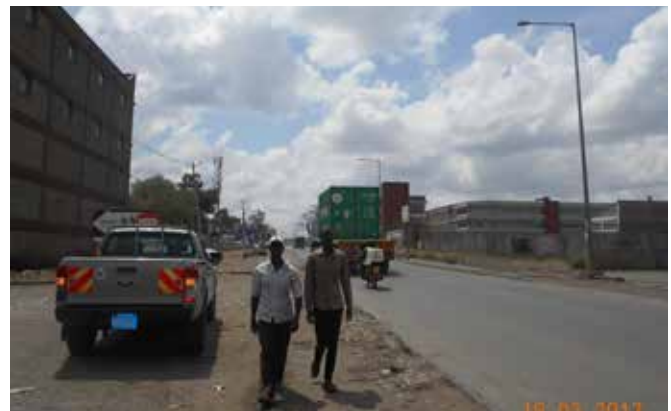
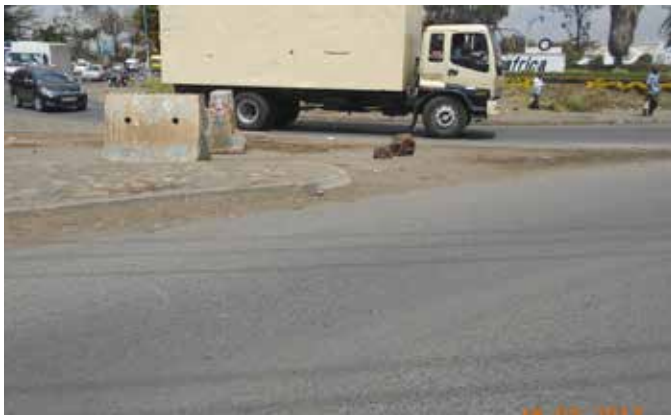
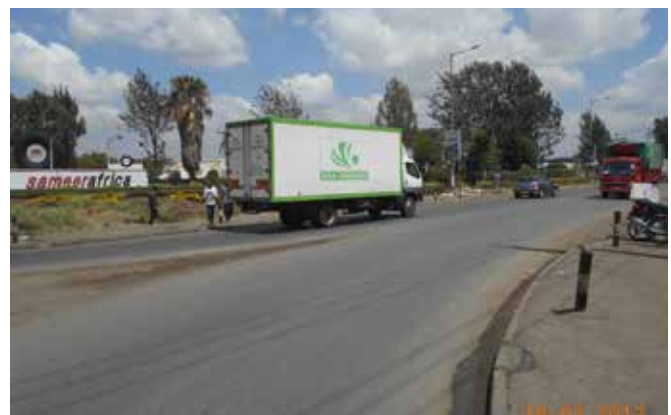
53. Enterprise Road (Road A)

This section of the road is between Road A bus stage and General Motors, a stretch of 1.8 kilometers. The main reason for blackspot is unsafe pedestrian crossing, inadequate road markings and missing road signage. This road section is under construction. There is high human traffic from the informal settlements, the use of inappropriate materials for road furniture, reckless motorcycle riders and pedestrian walking on the main road because there are no footpaths. Crashes happen throughout the week, daytime and in both dry and wet seasons. Vehicles most involved in crashes are personal cars (saloons), motorcycles and pedal cyclist. When crashes happen, the victims are taken to Kenyatta National Hospital or Mama Lucy Hospital.

Picture: Part of Enterprise Road (Road A) road section

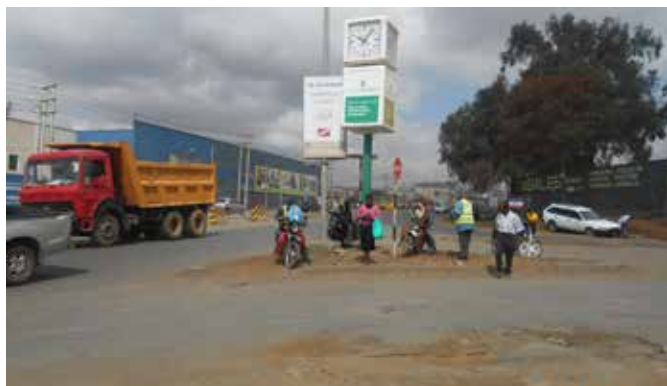
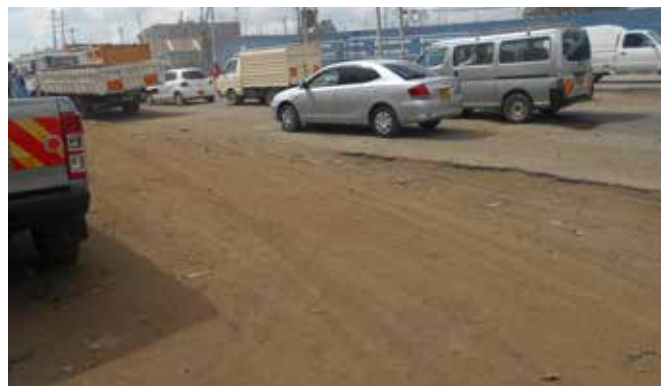
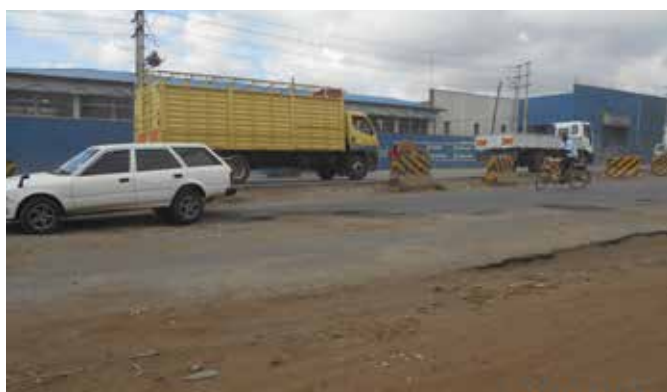
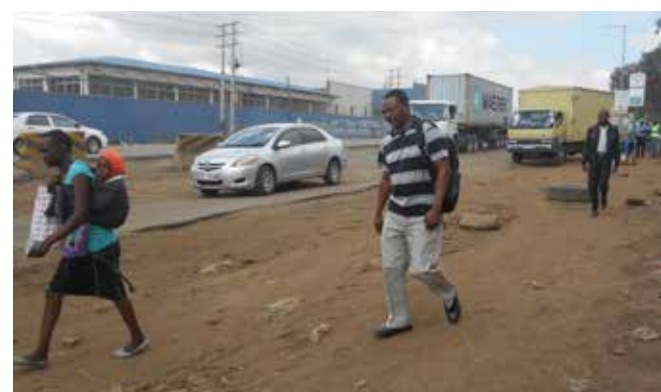
54. Enterprise Road (Kayaba)

This 0.7 kilometers section is situated on Enterprise Road in Mukuru Kayaba informal settlement area. The main reason for blackspot is unsafe pedestrian crossing and the many potholes on the road. Human traffic from Mukuru Kayaba walks on the road due to lack of walkways. The road has many pot holes and undesignated bus stops. Crashes happen mostly on weekday and at day time but equally in both dry and wet seasons. Vehicles most involved in crashes are the personal cars (saloons), and mini buses (PSVs and vans). When crashes happen, the victims are taken to Kenyatta National Hospital.

Picture: Part of Enterprise Road (Kayaba) road section

Engineering - road design/furniture/features	Enforcement - law	Education - Road user awareness
<ul style="list-style-type: none"> Designate bus stops and pedestrian crossing points. Repair the road to remove pot holes. Mark the road. Instal signage and street lights. 	<ul style="list-style-type: none"> Control PSVs. 	<ul style="list-style-type: none"> Educate road users on safe crossing.

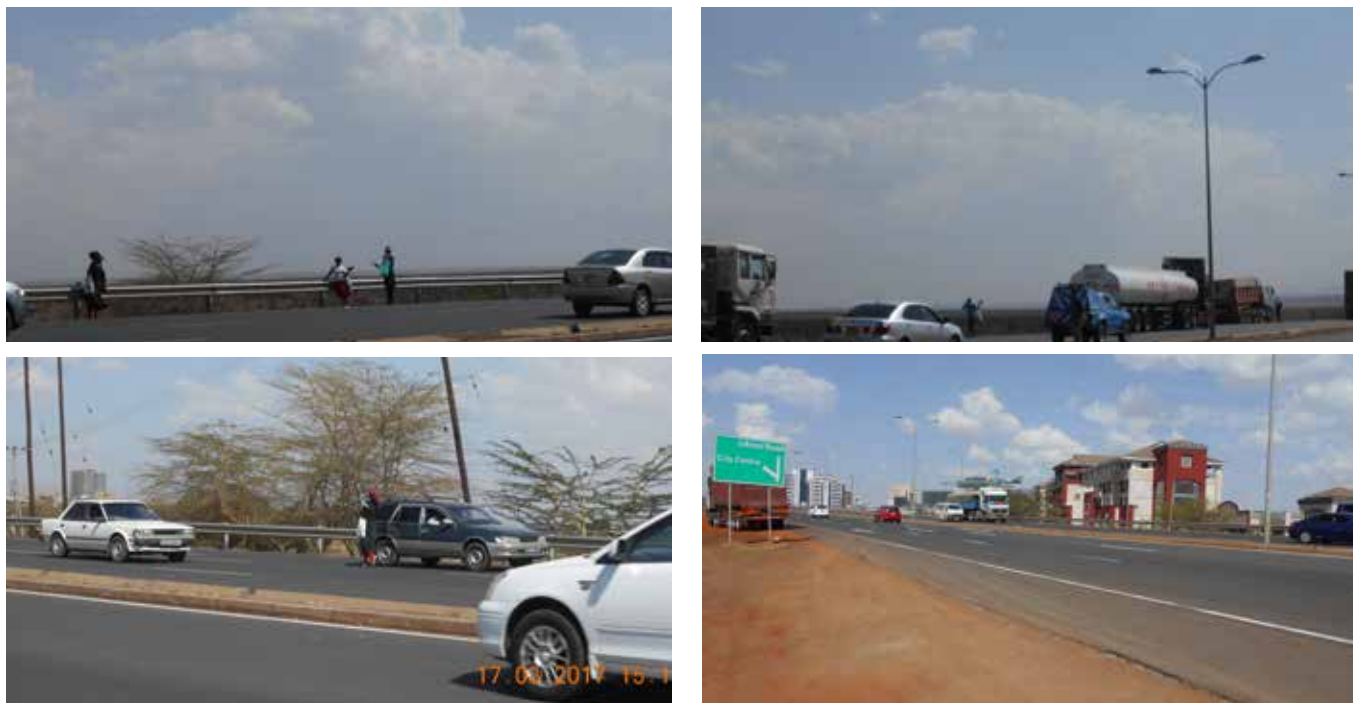
55. Ole Sereni underpass

This 200 meters road is located near Ole Sereni hotel towards Langata. The road is well marked with good signage. The main hazard is speeding motorists. There are many hawkers on this section at the interchange. Crashes happen mostly during the weekday and in both wet and dry seasons but mostly during daytime. Vehicles most involved in crash are personal cars (saloons), light and heavy commercial vehicles. Crash victims are taken to Mater Hospital or Nairobi West Hospital.

Picture: Part of Ole Sereni Bypass road section

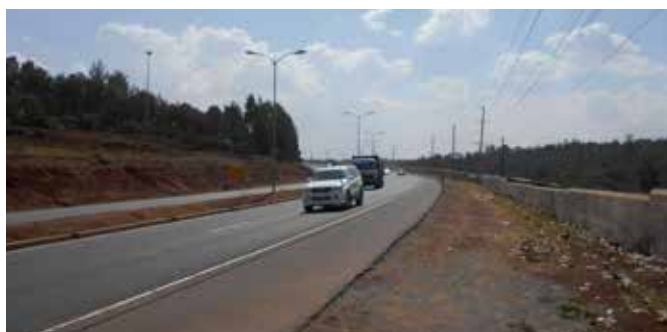
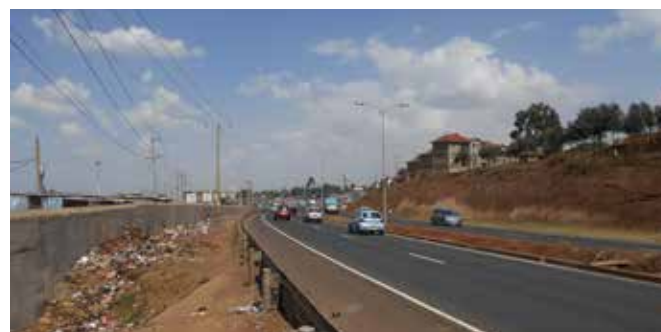
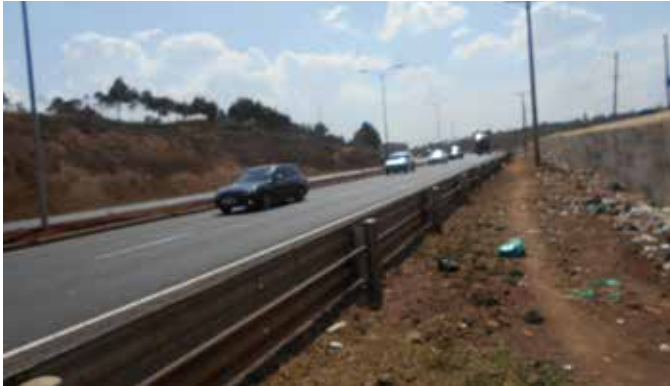
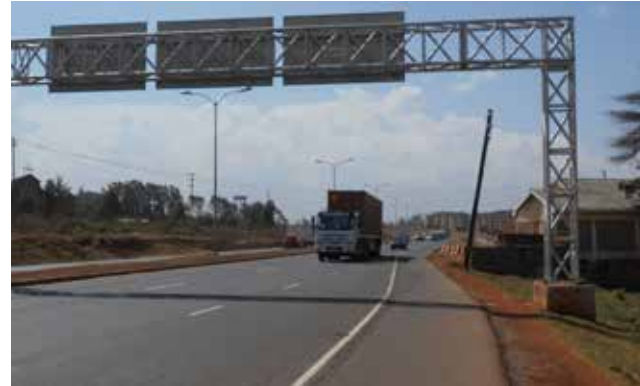
56. Southern Bypass near Langata Road Interchange

This section of the road is on the southern bypass starting from the Langata road interchange to just before entry into Ngong Forest stretching 2.2 kilometer on both directions of the dual carriage way. The road is well marked. The main reason for blackspot is unsafe pedestrian crossing. Crashes happen mostly during the weekday and at night and in both dry and wet seasons. Vehicles most involved in crash are personal cars (saloons), as well as light and heavy commercial vehicles. When crashes happen, the victims are taken to St. Mary's Langata Hospital.

Picture: Part of Southern Bypass at Langata Road Interchange road section

Engineering - road design/furniture/features	Enforcement - law	Education - Road user awareness
<ul style="list-style-type: none"> • Instal pedestrian fence all through to restrict pedestrian crossing. 	<ul style="list-style-type: none"> • Ensure pedestrian use the underpass foot paths. 	<ul style="list-style-type: none"> • Educate pedestrians on the need to use designated crossings.

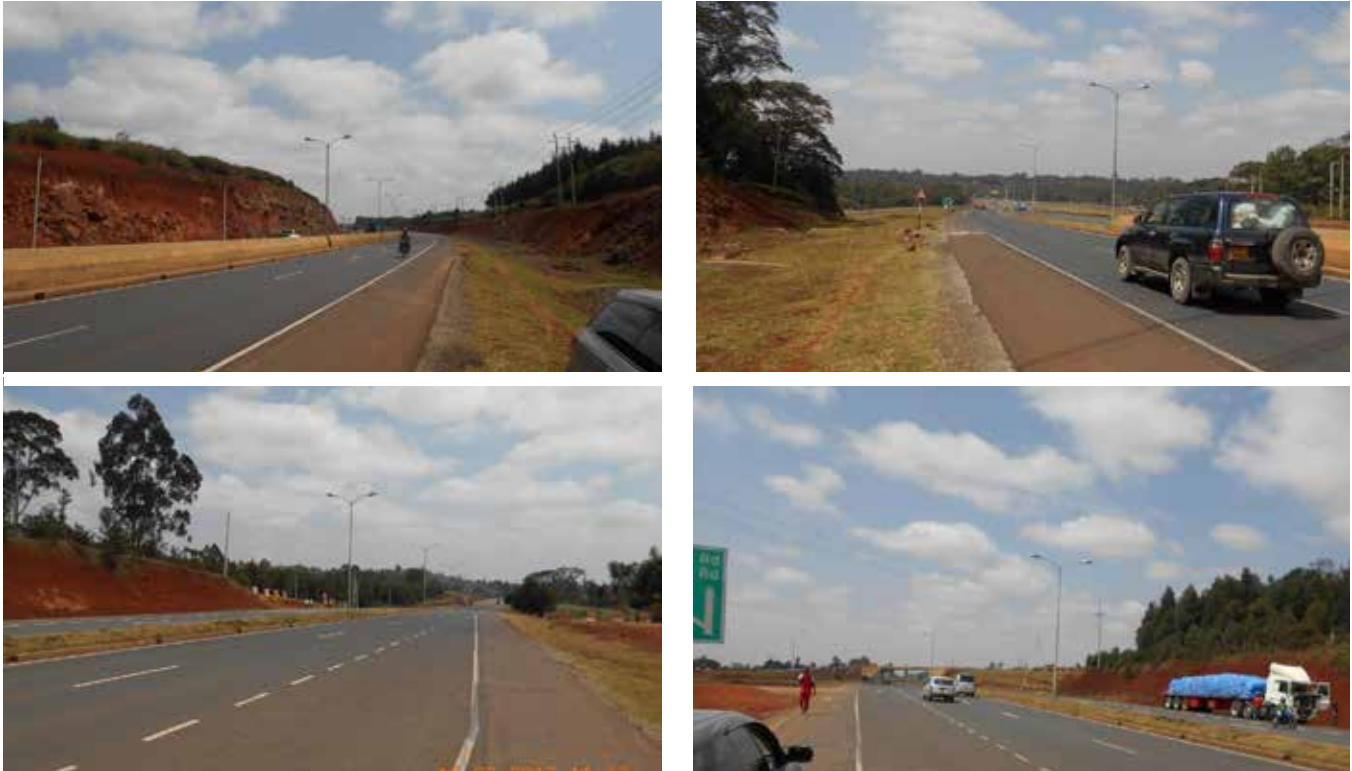
57. Southern bypass near Dagoretti-Karen

This section of the road stretches a distance of 3.8 kilometers along Karen Dagoretti section of the Southern bypass towards Mombasa Road. The main reasons for blackspot are the sharp bend and speeding motorists. There is also no road signage. Crashes happen mostly during the weekday and at night and in both dry and wet seasons. Vehicles most involved in crash are the personal cars (saloons), as well as light and heavy commercial vehicles. When crashes happen, the victims are taken to Karen or Kikuyu Hospital.

Picture: Part of Southern Bypass near Dagoretti road section

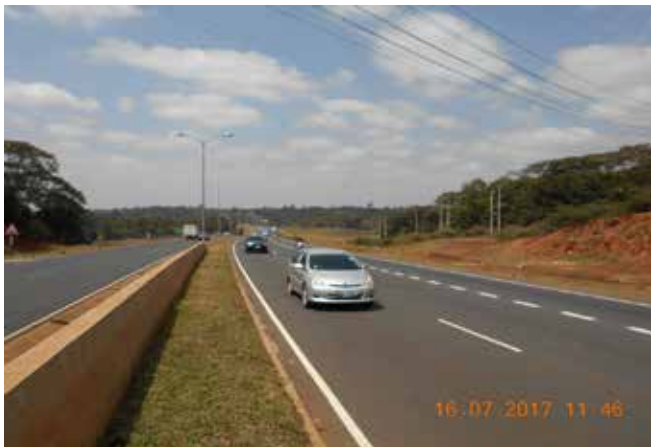
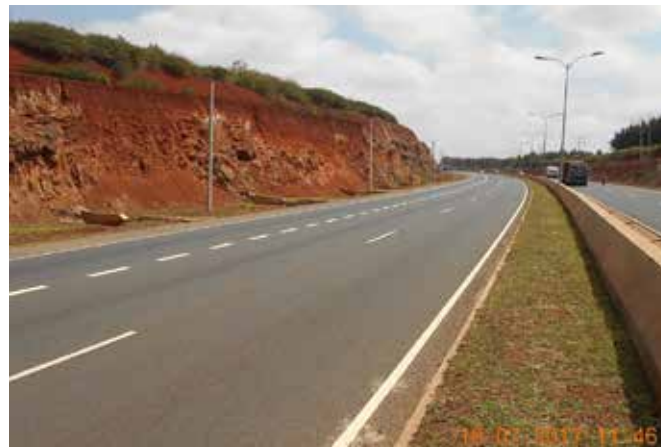
58. Southern Bypass near Dagoretti-Karen

This section of the road is on stretches for 4 kilometers long on the Karen-Dagoretti section of the Southern bypass towards the Northern Corridor. The main reasons for blackspot are the sharp bends and speeding motorists. There is also no road signage. Crashes happen mostly during the weekday at night and during both dry and wet seasons. Vehicles most involved in crashes are personal cars (saloons), light trucks, and heavy commercial vehicles. When crashes happen, the victims are taken to Karen Hospital or Kikuyu Hospital.

Picture: Part of Southern Bypass near Dagoretti road section

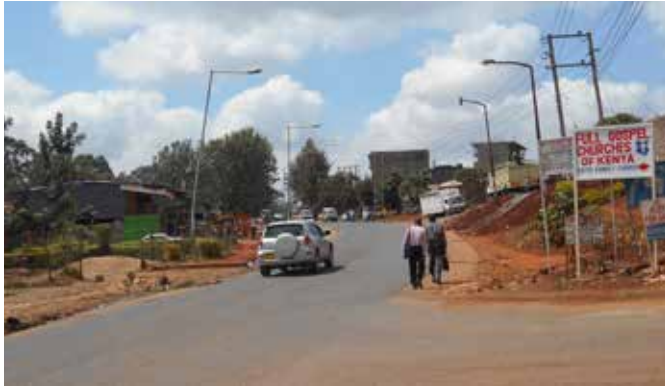
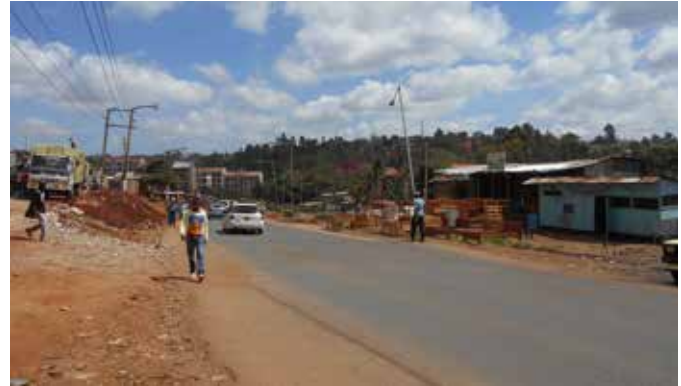
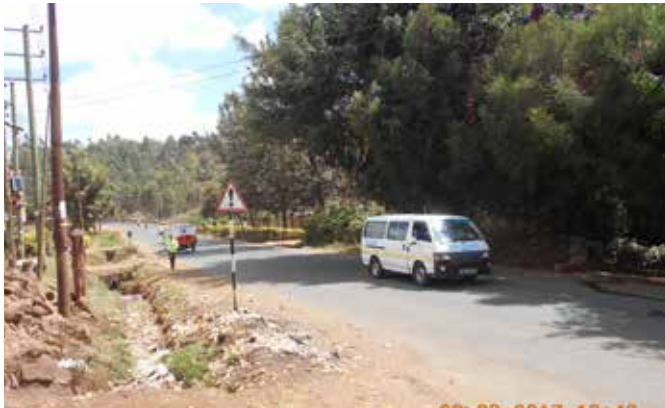
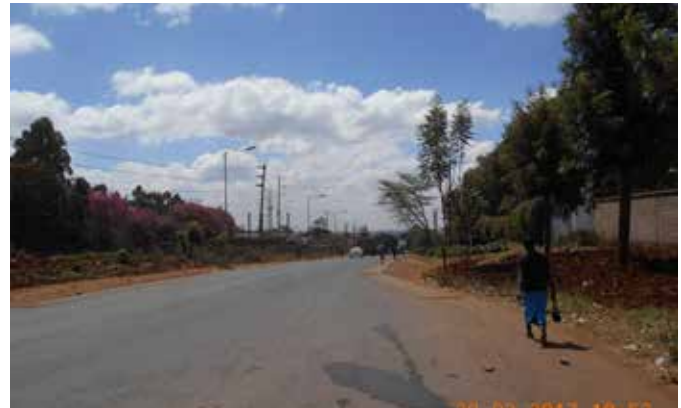
59. Nduaru section

This section of the road stretches 2.4 kilometers along the Naivasha Road. The main reasons for the blackspot are the sharp bends, a sharp descent, unsafe pedestrian crossing, poor visibility due to the tall trees along the road, blind spots, and no road marking. Crashes happen throughout the week but at daytime and equally in both dry and wet seasons. Vehicles most involved in crashes are personal cars (saloons), mini buses (PSVs and vans), and light and medium trucks. When crashes happen, the victims are taken to Melchizedek or Mid Hill Hospital.

Picture: Part of Nduaru road section

Engineering - road design/furniture/features	Enforcement - law	Education - Road user awareness
<ul style="list-style-type: none"> • Instal the missing road signs and marking. • Instal designated bus stops and pedestrian crossing points. • Cut trees to improve visibility. 	<ul style="list-style-type: none"> • Enforce speed limits. 	<ul style="list-style-type: none"> • Educate motorists to drive carefully in the road sections with poor visibility, pedestrians and blind spots.

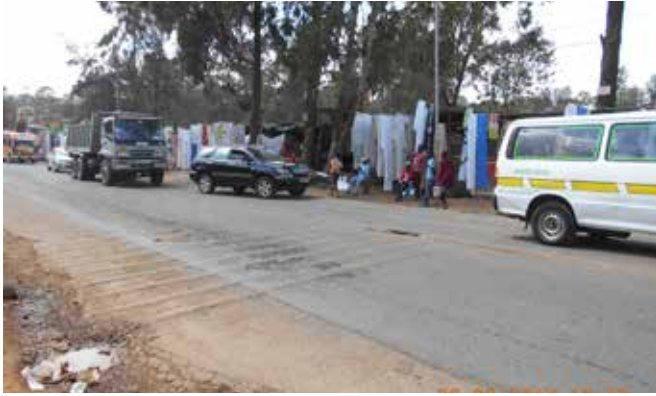
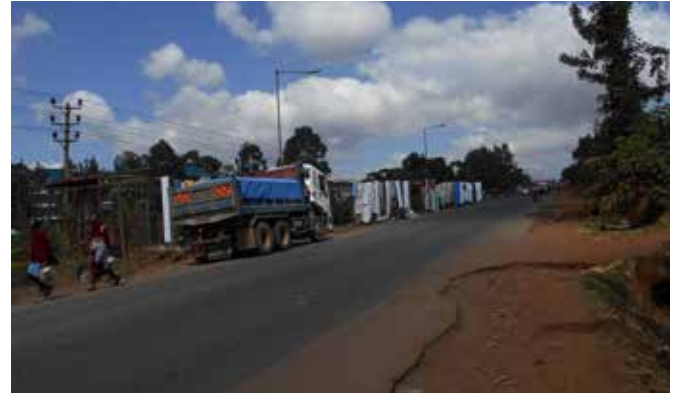
60. Kawangware Deliverance Church section

This section of the road is 100 meters long on Naivasha road near Kawangware Deliverance Church Junction. The main reasons for blackspot are PSVs stopping on the road to pick and drop passengers, and often overlap. There are no designated crossing points for pedestrian and motorcyclist ride carelessly. There are also traders selling tents along the road and creating visual obstruction. The main hazard is unsafe pedestrian crossing, lack of designated path for motorcyclist, slow moving vehicles, no road signage and no road markings. Crashes happen mostly during the weekday and at daytime but equally during both dry and wet seasons. Vehicles most involved in crash are mini buses (PSVs and vans), large buses, light and medium trucks, and motorcycles. When crashes happen, the victims are taken to Melchizedek Hospital.

Picture: Part of Kawangware Deliverence Church road section

Engineering - road design/furniture/features	Enforcement - law	Education - Road user awareness
<ul style="list-style-type: none"> Repaint road markings and instal road signs. Create a designated bus stop. Expand the road and repair damaged sections. 	<ul style="list-style-type: none"> Remove traders from the road side. Re-direct lorries to use alternative route as some sections are very steep. 	<ul style="list-style-type: none"> Train motorcyclists on defensive riding. Educate pedestrian on safe crossing.

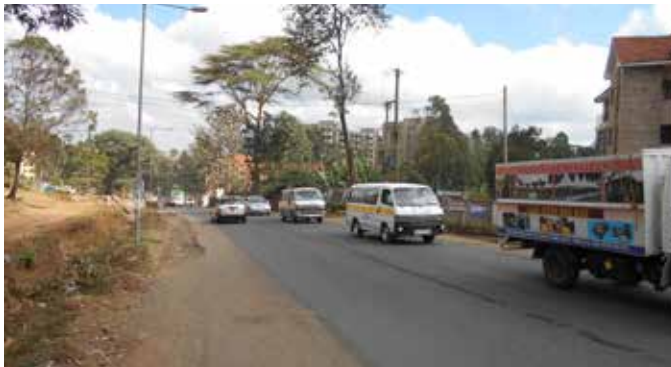
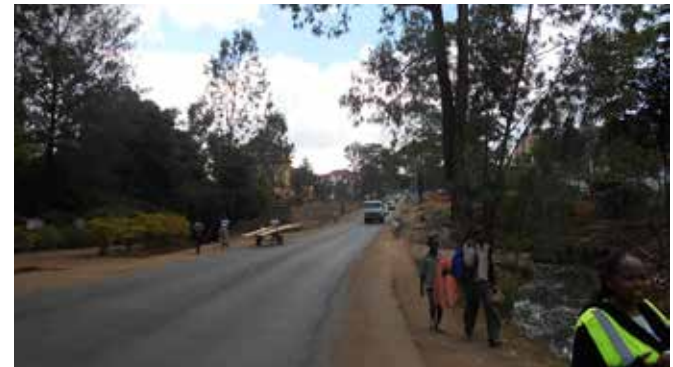
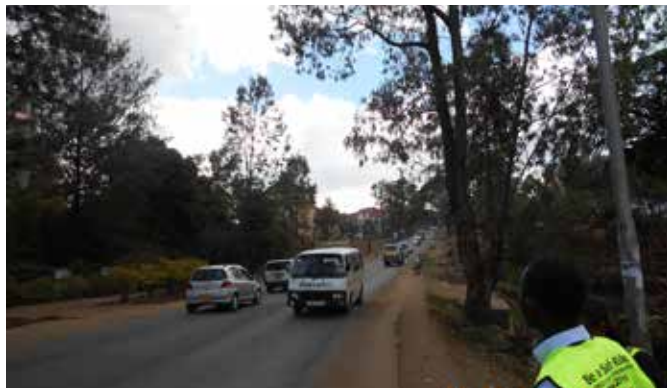
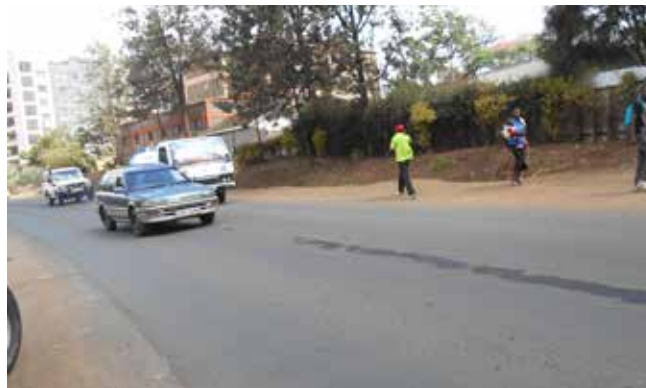
61. Melchizedek Hospital section

This section of the road is 300 meters long on Naivasha road near Melchizedek Hospital. The main reasons for blackspot are speeding motorists on a descent, undesignated bus stops, and no road marking. The road shoulder is damaged. Crashes happen mostly during the weekday but equally both day and night and in both dry and wet seasons. Vehicles most involved in crashes are personal cars (saloons), mini buses (PSVs and vans), large buses, light trucks, and heavy commercial vehicles. When crashes happen, the victims are taken to Melchizedek Hospital.

Picture: Part of Melchizedek road section

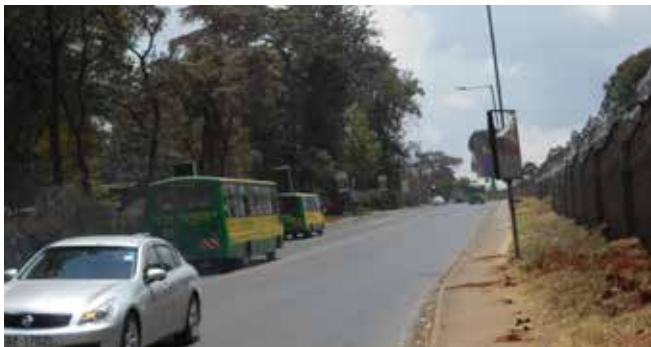
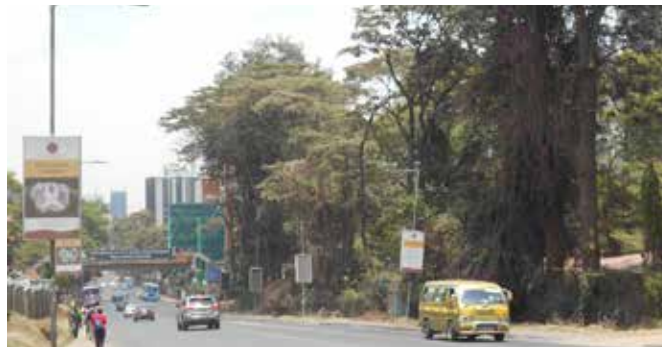
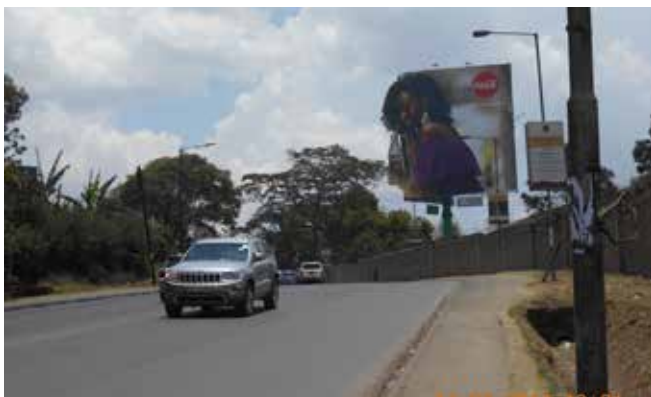
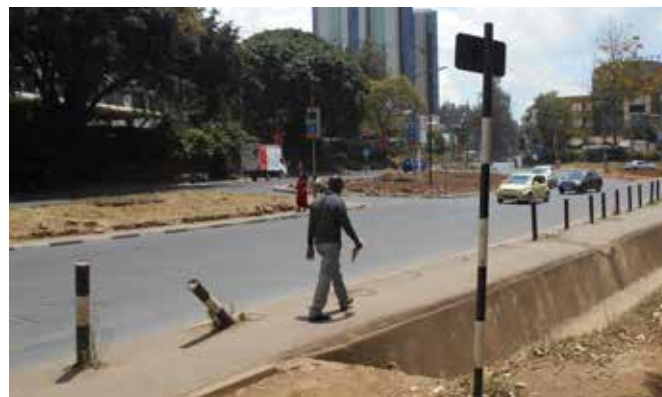
62. Valley Road section

This section of the road stretches for 1 kilometer along Valley Road starting near Department of Defense where the road starts to slope to the point where Valley Road joins Kenyatta Avenue. The main reason for blackspot is speeding motorists on the sharp bend and the steep slope. There are also no road markings and signage at the end of the black spot near integrity center.

There is a foot bridge that is not used by pedestrians. Vehicles make dangerous illegal turn at the Chancery. Crashes happen throughout the week at day and night and during both dry and wet seasons. Vehicles most involved in crash are the personal cars (saloons), mini buses (PSVs and vans), large buses, motorcycles. When crashes happen, the victims are taken to Kenyatta National Hospital.

Picture: Part of Valley road section (same comments as map 33)

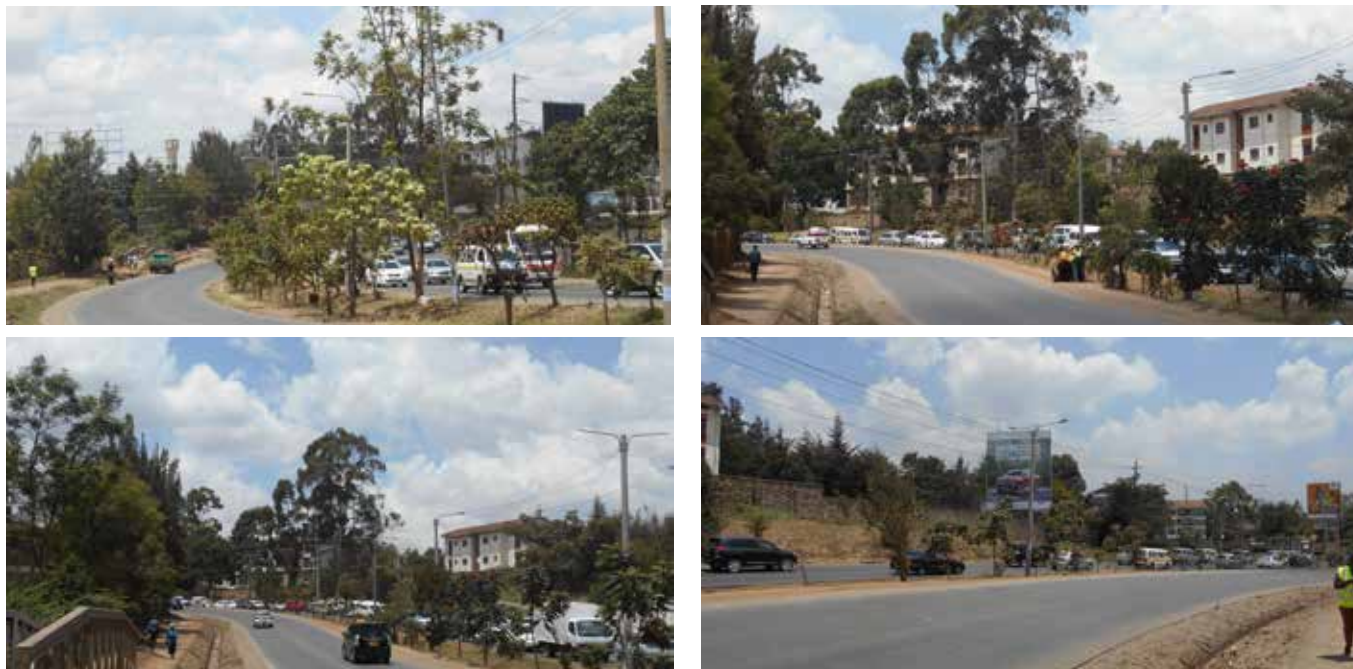
63. Mbagathi Flats

This section of the road is situated near Mbagathi flats stretching about 300 meters on both directions of the dual carriageway. The reason for black spot is unsafe pedestrian crossing, a sharp bend with no warning sign and poor visibility due to the vegetation. There is a depression at the river; the residential area does not have a bus stop. Crashes happen throughout the week, both night and day time as well as in both wet and dry seasons. Vehicles most involved in crash are personal cars (saloons), and mini buses (PSVs and vans) as well as light trucks. When crashes happen, the victims are taken to Kenyatta National Hospital or Mbagathi (IDH) Hospital.

Picture: Part of Mbagathi Flats road section

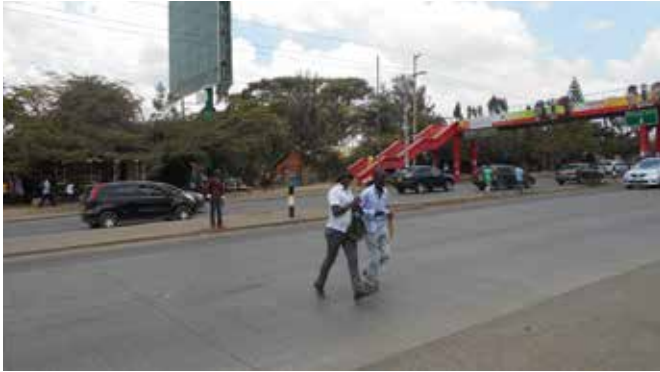
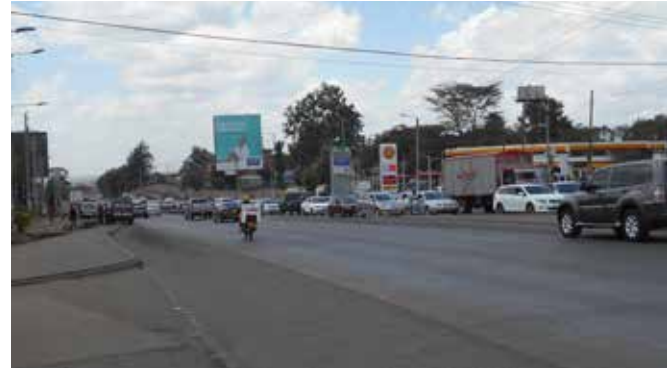
64. Mbagathi Footbridge

This section of the road is situated near the turn into Kenyatta Market and Ngumo estate at the footbridge stretching about 200 meters in both directions of the dual carriage way. The reason for black spot is unsafe pedestrian near the footbridge, damaged road infrastructure – road signage, speeding motorists, encroaching road bank, motorcyclist crossing at undesignated sections, inadequate road signs and no road marking. Crashes happen throughout the week, both night and day time and in both wet and dry seasons. Vehicles most involved in crash are personal cars (saloons), mini buses (PSVs and vans) and light trucks. When crashes happen, the victims are taken to Kenyatta or Mbagathi (IDH) Hospital and in rare cases to the Defense Forces Memorial Hospital.

Picture: Part of Mbagathi Footbridge road section

Engineering - road design/furniture/features	Enforcement - law	Education - Road user awareness
<ul style="list-style-type: none"> Repair the footbridge. Construct a pedestrian fence. Road marking and signage needed. 	<ul style="list-style-type: none"> Enforce use of footbridge. Enforce speed limits. 	<ul style="list-style-type: none"> Educate pedestrians on importance of using the footbridge.

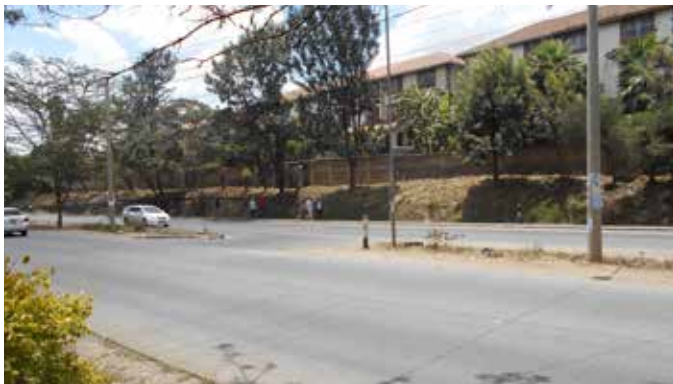
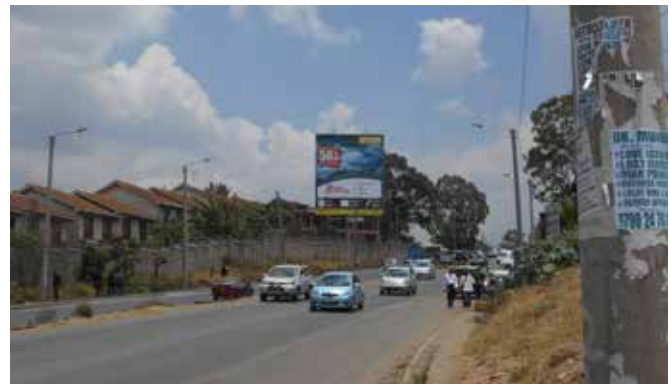
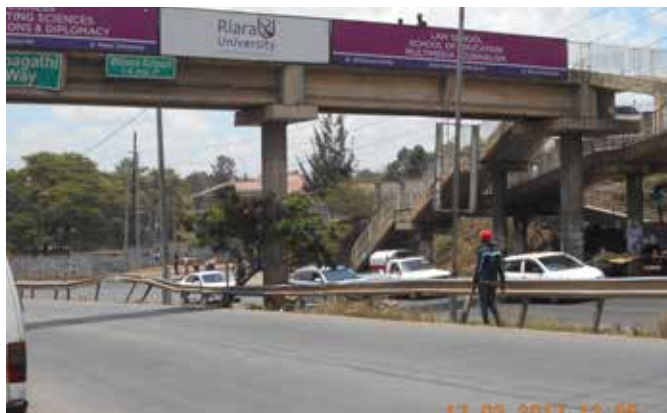
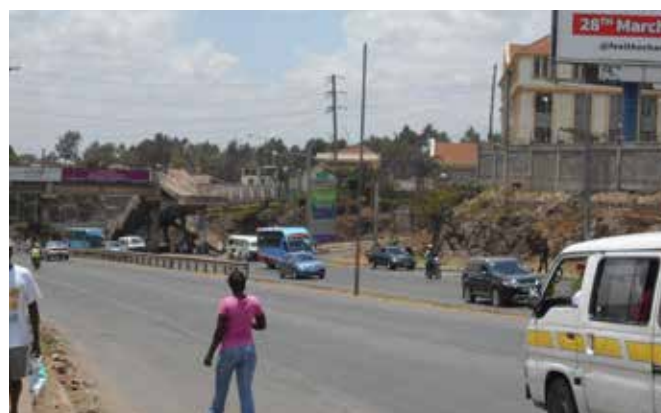
65. Riara University

This section of the road is situated near Riara University along the Nyayo Highrise and has a bridge at the river and a sharp bend. The black spot stretches 700 meters in both directions of the dual carriageway. The reason for black spot is pedestrian crossing at undesignated points ignoring using the footbridge, the sharp bend on a steep sloping, speeding motorists, undesignated bus stops by PSVs, and damaged guardrails. Crashes happen throughout the week, both night and day time and in both wet and dry seasons. Vehicles most involved in crashes are the personal cars (saloons), and mini buses (PSVs and vans) as well as light trucks. When crashes happen, the victims are taken to Kenyatta National Hospital or Mbagathi (IDH) Hospital.

Picture: Part of Riara University road section

Engineering - road design/furniture/features	Enforcement - law	Education - Road user awareness
<ul style="list-style-type: none"> • Instal pedestrian fence through the whole section. • Create bus stop at Nyayo Highrise. • Repair the guardrails. 	<ul style="list-style-type: none"> • Enforce use of footbridge. • Ensure PSVs use the designated bus stop. • Speed limit enforcement. 	<ul style="list-style-type: none"> • Educate pedestrians on use of footbridge. • Educate drivers on safe speed.

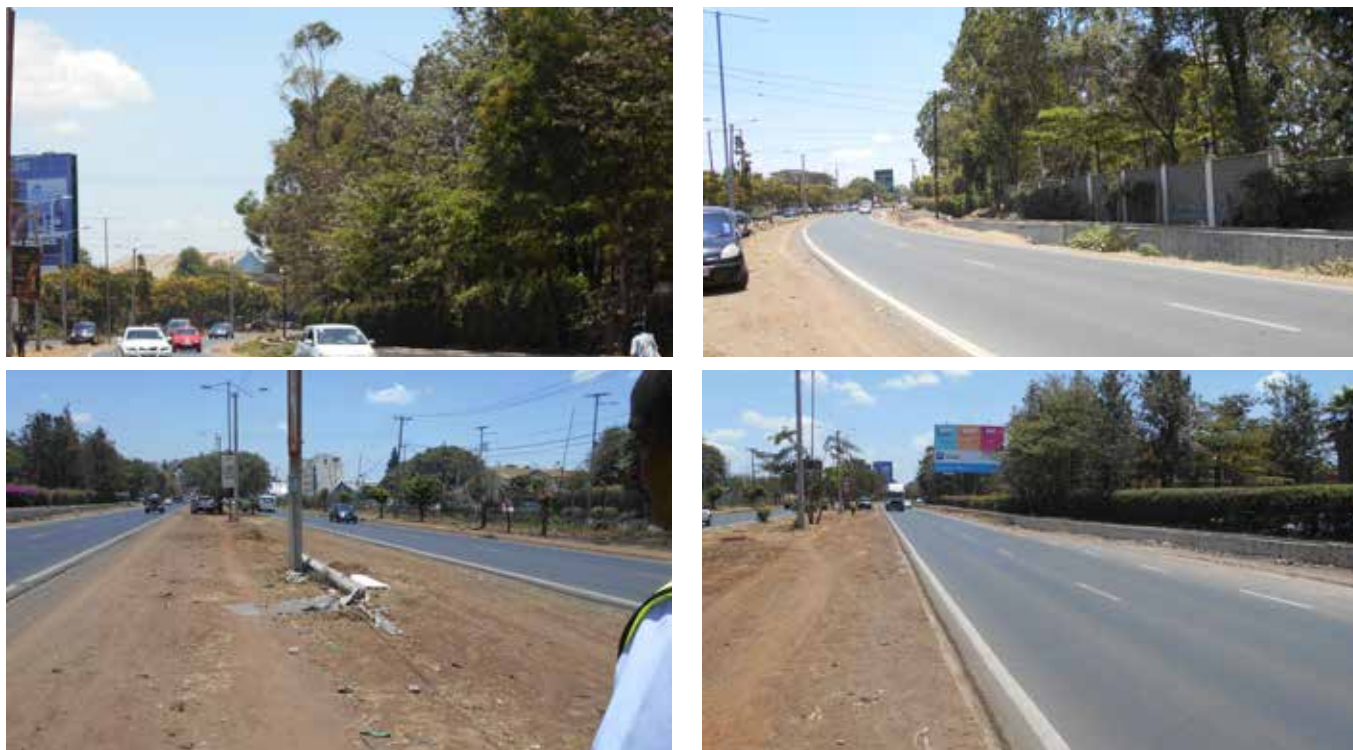
66. Sunshine School section

This section is near the Sunshine school opposite Wilson Airport on the side of the dual carriage towards CBD and is 400 meters long. The reason for black spot is the sharp bend and speeding motorists. Crashes happen throughout the week but mostly at night, and in both dry and wet seasons. Vehicles most involved in crash are the personal cars (saloons), and mini buses (PSVs and vans). When crashes happen, the victims are taken to Langata Hospital.

Picture: Part of Sunshine School road section

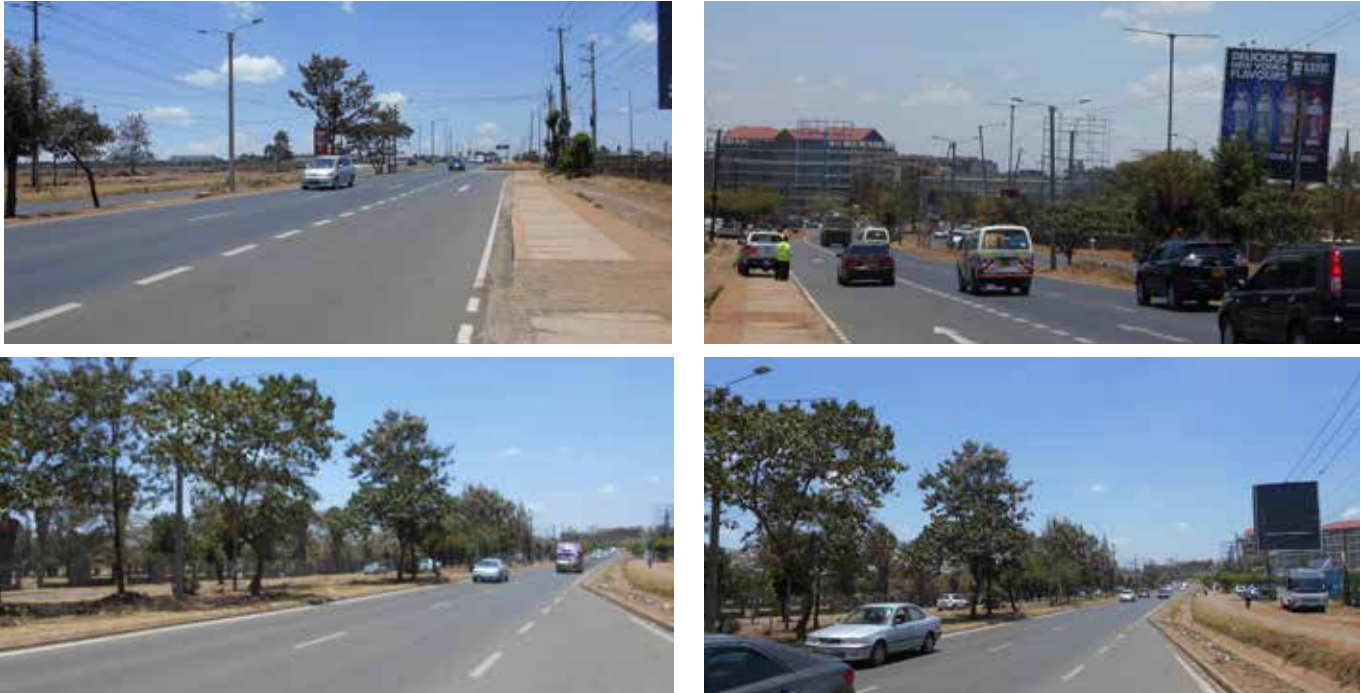
This section is at the Langata road Southern bypass interchange stretching from the entry from Carnivore for about 1 kilometer on both directions of the dual carriage road. The main hazard is unsafe pedestrian, motorcyclist and pedal cyclist crossing. There are no speed limit signage, no designated bus stops, and reckless motorcyclist crossing on all points of the road. There are no pedestrian crossing signs or markings.

Crashes happen throughout the week but mostly during the day and during both dry and wet seasons. Vehicles most involved in crash are the personal cars (saloons). When crashes happen, the victims are taken to Langata Hospital.

Picture: Part of Langata Road Southern Bypass Interchange road section

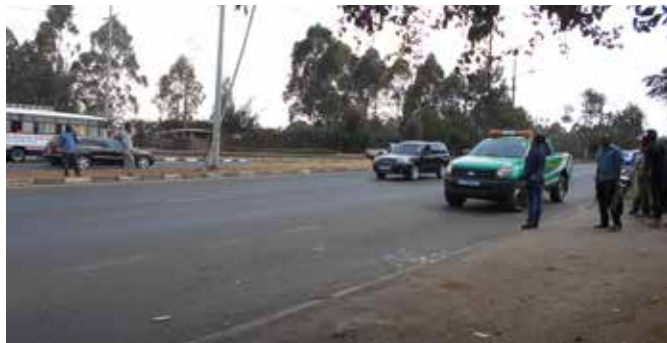
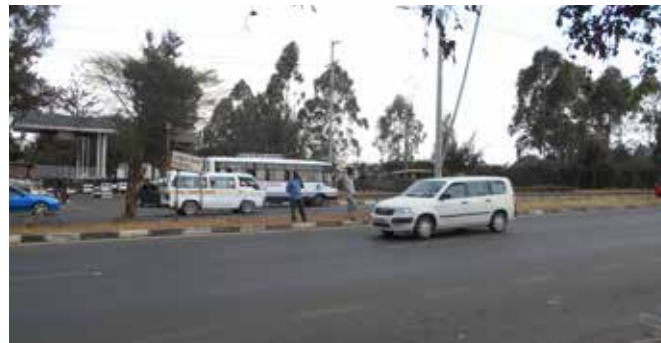
68. Kenya Wildlife Services (KWS)

This section stretches from the Langata Barracks gate to the KWS gate on the side of the dual carriage a distance of 0.6 kilometers. The main hazard is unsafe pedestrian crossing and there are no designated crossing areas. Crashes happen throughout the week, at night, and equally during both dry and wet seasons. Vehicles most involved in crash are personal cars (saloons) and mini buses mostly PSVs. When crashes happen, the victims are taken to Langata Hospital or St. Mary's Lang'ata Hospital.

Picture: Part of KWS road section
