Northern Corridor and Nairobi County Route Hazard Mapping Report

May 2017

Developed by Safe Way Right Way and National Transport and Safety Authority

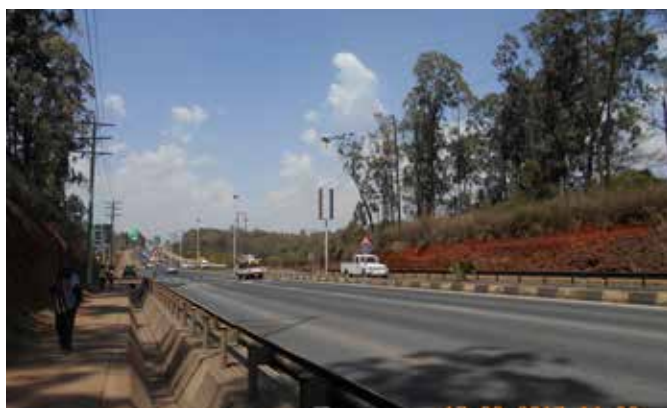
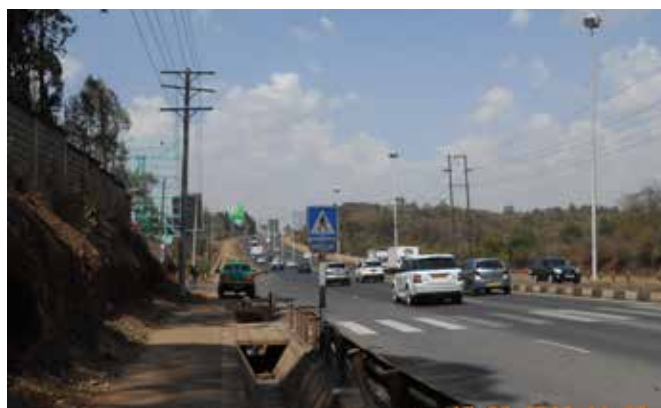
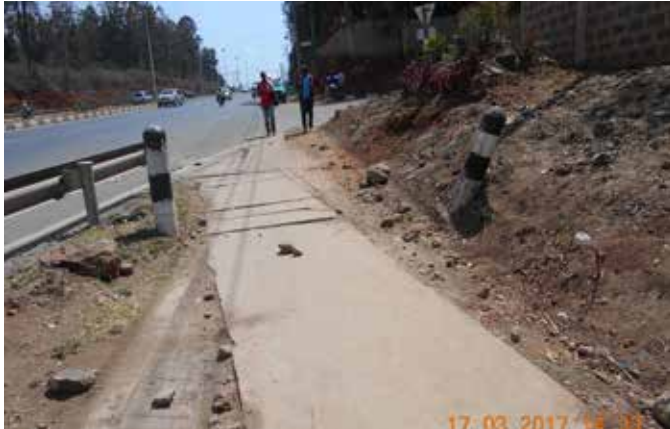
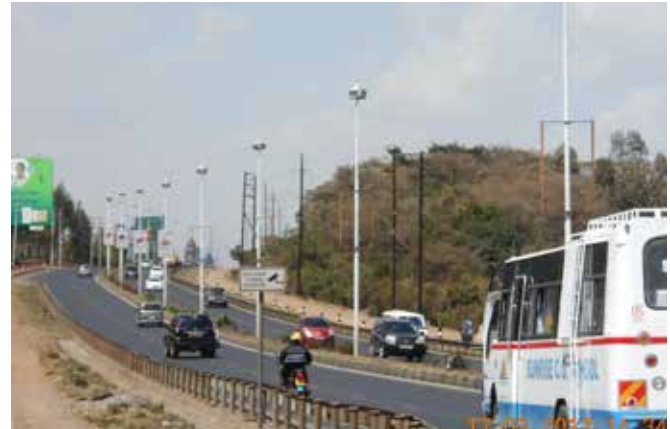
This section is near the KWS Clubs headquarters just before the junction to Magadi road, a stretch of 200 meters on both sides of the dual carriageway. The main hazard is pedestrian crossing at undesignated points. PSVs also use the pedestrian lane to avoid traffic at the bumps.

Crashes happen mostly during the weekday, both day and night, and in both dry and wet seasons. Vehicles most involved in crash are the personal cars (saloons) and mini buses mostly PSVs. When crashes happen, the victims are taken to Langata Hospital or St. Mary's Langata.

Picture: Part of KWS Clubs road section

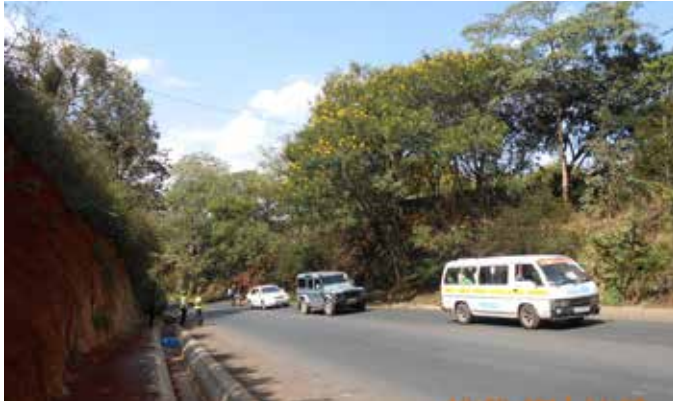
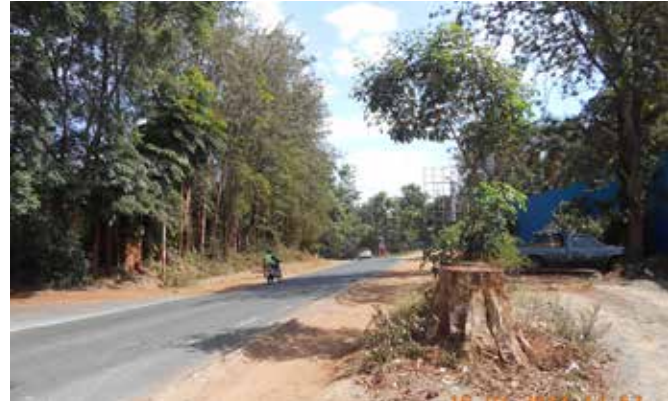
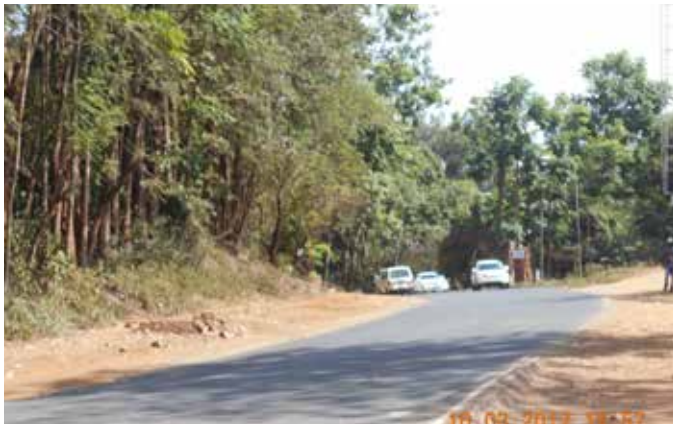
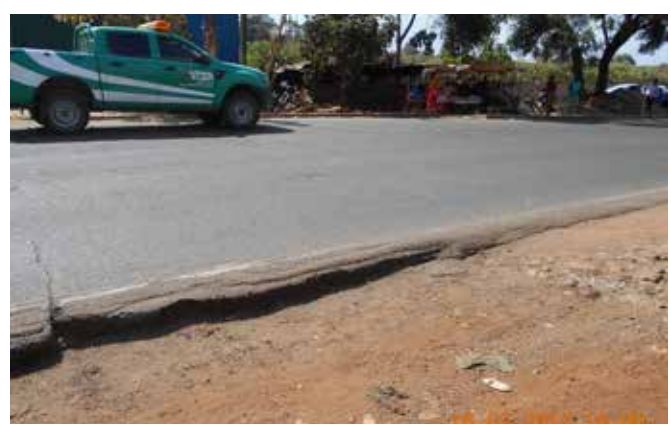
70. Village Market -Roselyn Riviera –Red Hill Road

This section of the road stretches for about 0.9 kilometer along the Limuru Road starting from the section near Roselyn Riviera Mall up to the intersection at Red Hill Road. Road construction is ongoing at the entrance of the Village Market and near the entrance of Runda Estate. The main reasons for blackspot are the sharp bends and the steep slope, missing road signage, and heavy traffic to Two Rivers, Roselyn Riviera and Village Market. In some sections the road shoulder is missing or damaged. Crashes happen mostly during weekday and at night but equally in both dry and wet seasons.

Picture: Part of Village Market road section

Engineering - road design/furniture/features	Enforcement - law	Education - Road user awareness
<ul style="list-style-type: none"> • Complete road works. • Instal road signs and markings. • Construct the road shoulders. 	<ul style="list-style-type: none"> • Enforce speed limits. 	<ul style="list-style-type: none"> • Create awareness on road hazards.

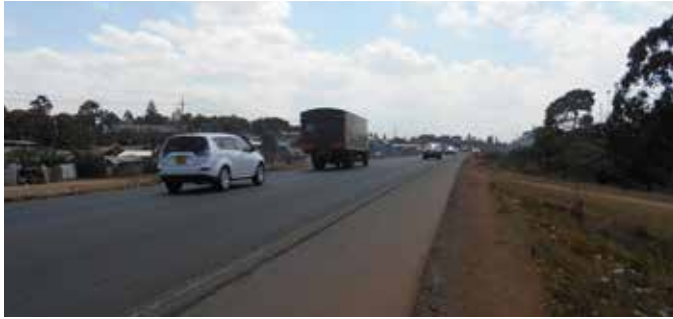
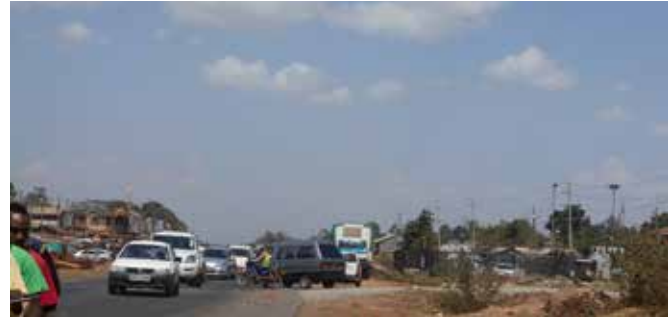
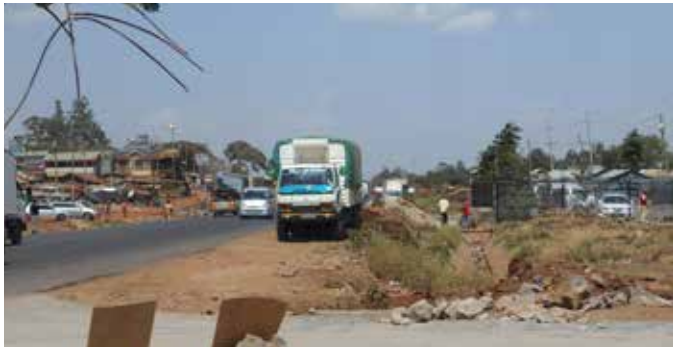
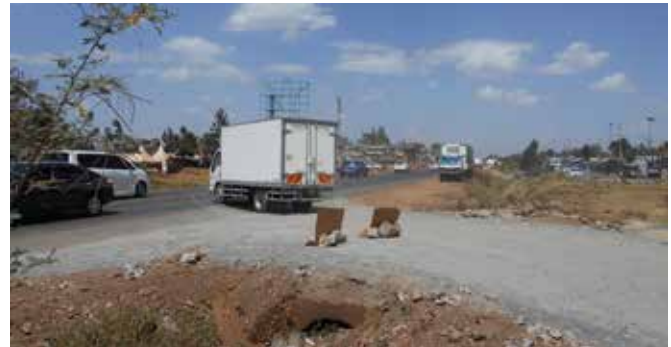
71. PCEA Githogoro (Beulah)

This section of the road is situated near PCEA Githogoro on the Northern Bypass and stretches about 800 metres. The hazards are unsafe pedestrian crossing, inadequate road signage and no road marking. The main reason for blackspot are the pedestrian crossings coupled with drunk pedestrians, there are no designated bus stops, and the speed bumps are not standardized and lack any road sign or marking. There are also no designated pedestrian crossing points. Crashes happen mostly during the weekend and at night and during both dry and wet seasons. Vehicles most involved in crashes are the personal cars (saloons), and light and medium trucks. Crash victims are taken to Kiambu Level 4 Hospital.

Picture: Part of PCEA Githogoro road section

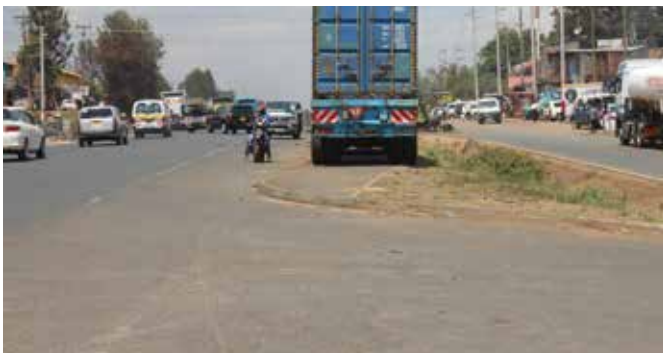
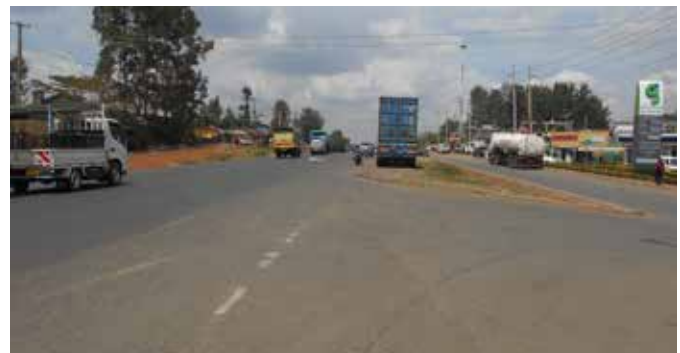
This section of the road is situated at Marurui area on the Northern Bypass, and stretches about 200 meters. The hazards are speeding motorists, unsafe pedestrian crossing, faded road marking and no road signage. The main reason for blackspot is the confusion at the Gulf petrol station area where trailers obstruct motorists joining the main road from the petrol station. Crashes happen throughout the week but mostly at night and in both dry and wet seasons.

Picture: Part of Marurui road section

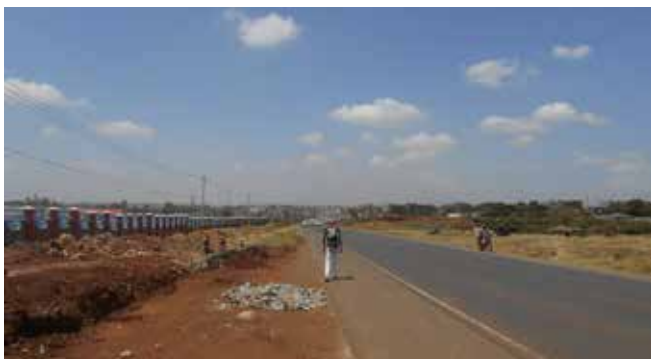
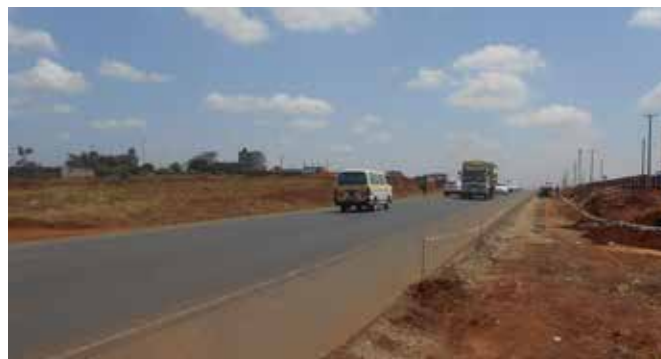
73. Kamae

This section of the road is situated near Kamae Center on the Northern Bypass and stretches about 800 meters. The hazards are pedestrian, cattle crossing, and speeding motorist. The main reason for blackspot is pedestrian crossing in all points and coupled with speeding motorist. Crashes happen throughout the, both day and night as well as in both dry and wet seasons. Vehicles most involved in crashes are personal cars (saloons), mini buses (PSVs and vans), large buses, light and medium trucks, heavy commercial vehicles, and motorcycles. When crashes happen, the victims are taken to Kahawa West Hospital and Kenyatta University Hospital.

Picture: Part of Kamae road section

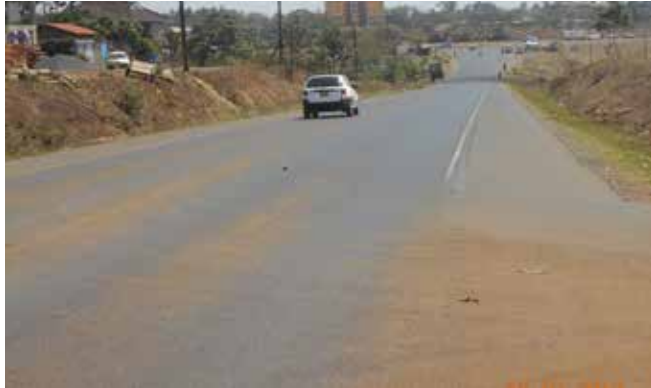
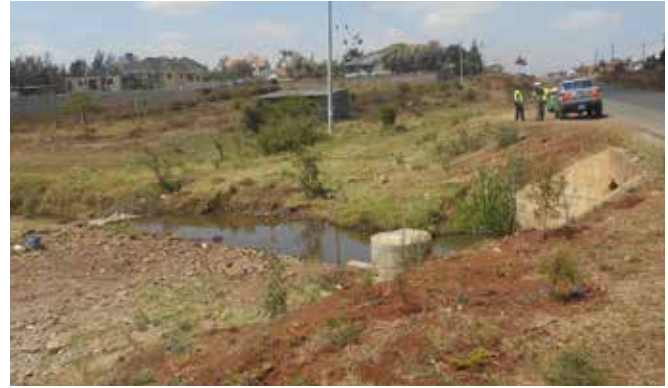
74. Membley Drift

This section of the road is situated at the drift near Membley estate on the Northern Bypass and stretches about 300 meters. The hazards are the steep slope, inadequate road signage and marking, damaged infrastructure and badly designed speed bumps. The main reason for blackspot is the missing guard rails at the river, inadequate signage, the presence of car wash at the river with vehicles turning in and out of the road, and poorly constructed bumps. Crashes happen throughout the week but mostly at night and in both dry and wet seasons. Vehicles most involved in crashes are the personal cars (saloons), mini buses (PSVs and vans), large buses, light and medium trucks, heavy commercial vehicles, motorcycles, and peddle cycles. When crashes happen, the victims are taken to Ruiru Sub District Hospital, Nazareth Hospital or Twendo Hospital.

Picture: Part of Membley Drift road section
