March 1, 2023

## Harbortown SB326 Inspection Report

WJE No. 2022.3823

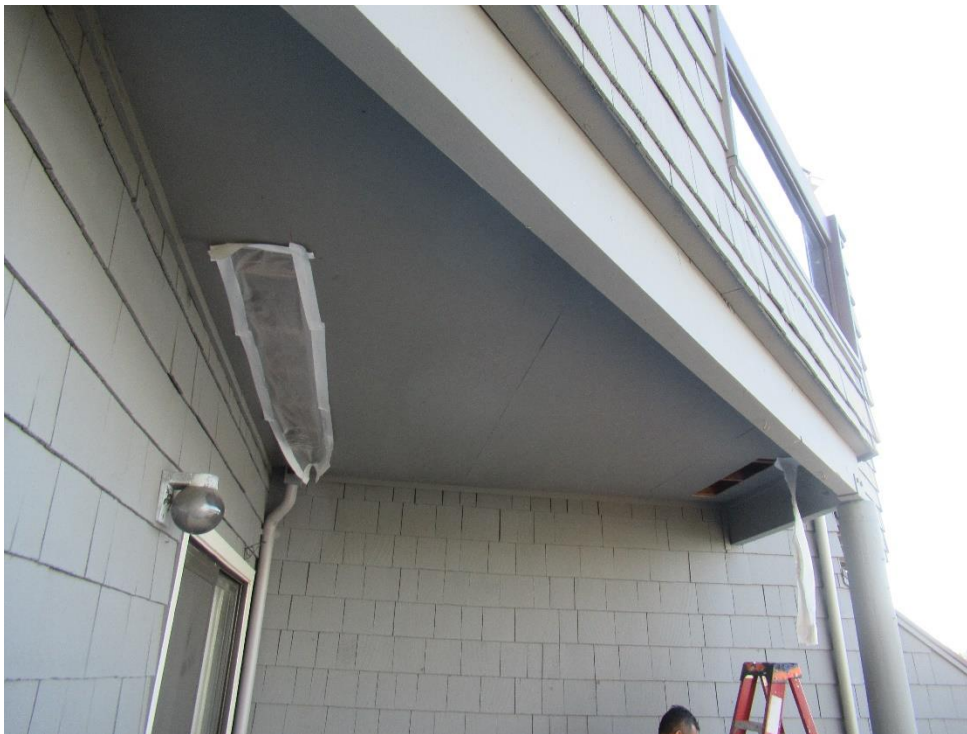
Figure 11. Inspection openings at unit deck not over garage with concealed framing.

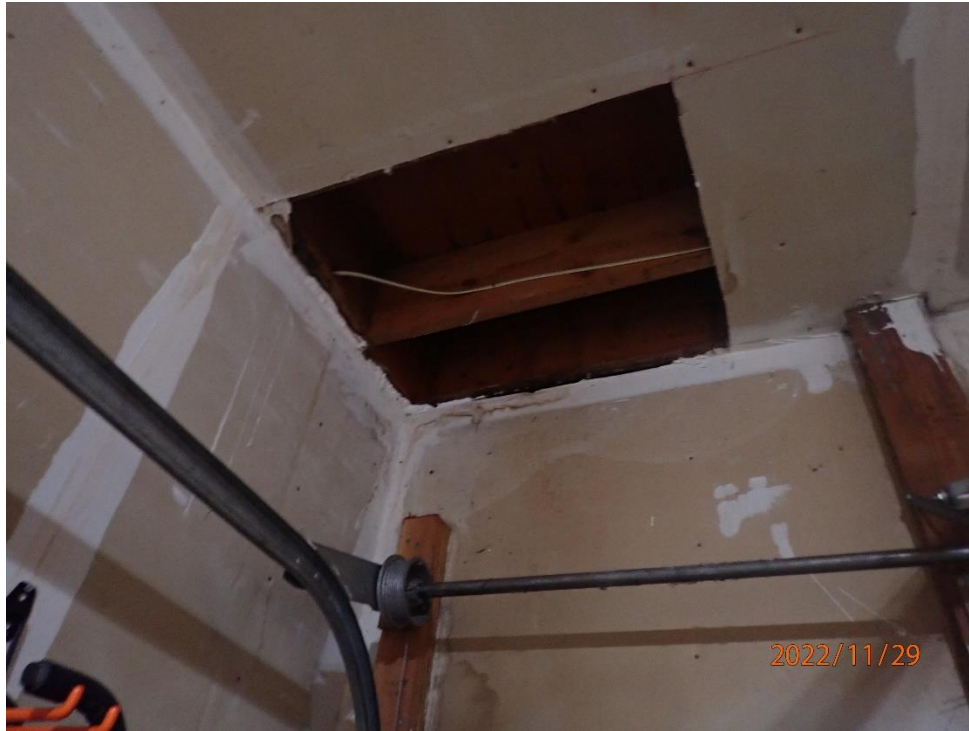
Figure 12. Inspection opening in garage ceiling.

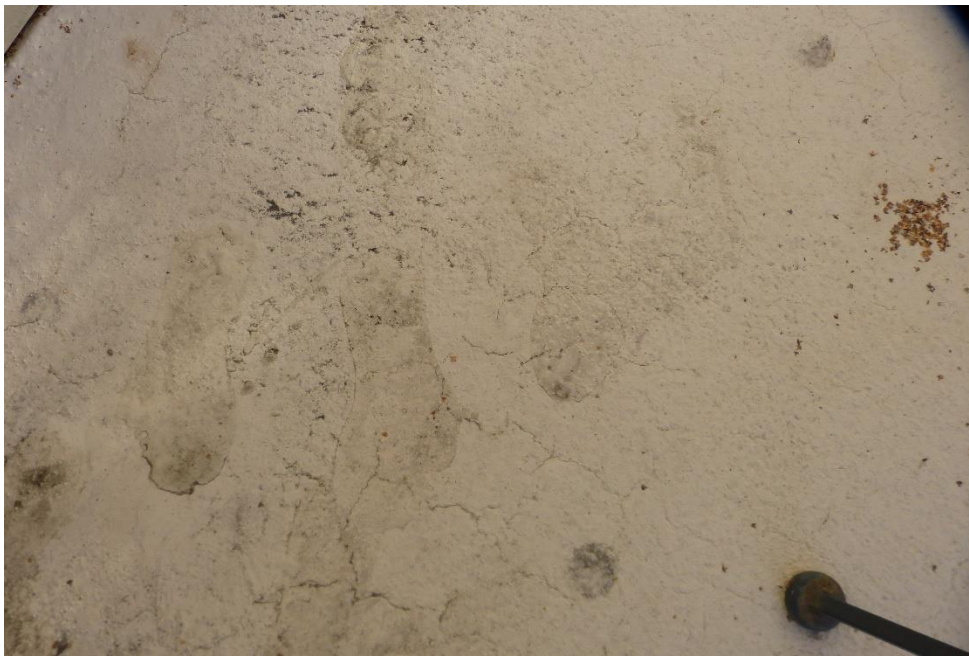
Figure 19. Distress to overcoating on exposed waterproofing.

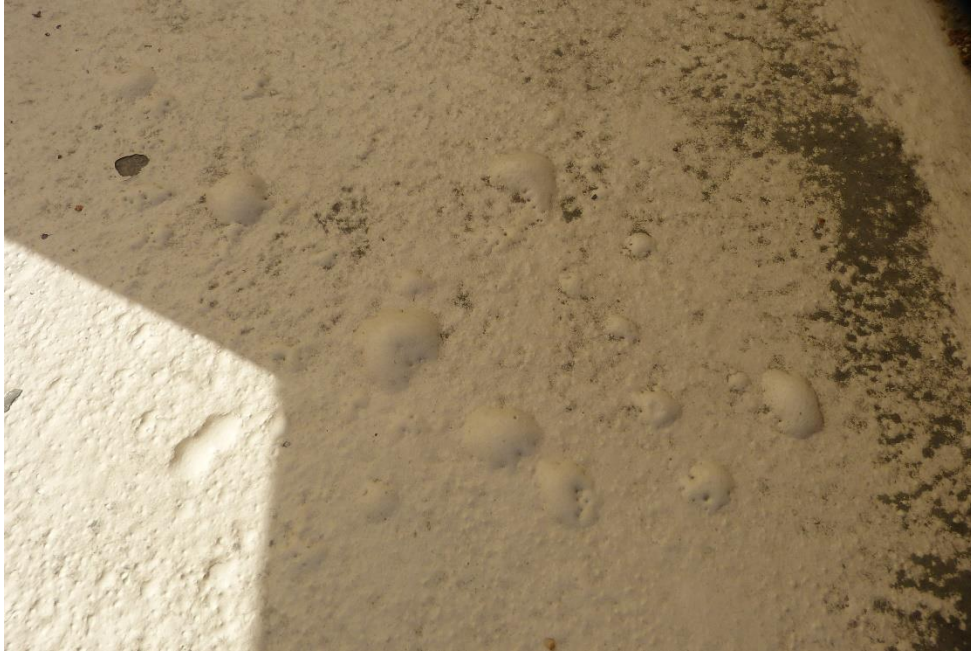
Figure 20. Distress to overcoating on exposed waterproofing.

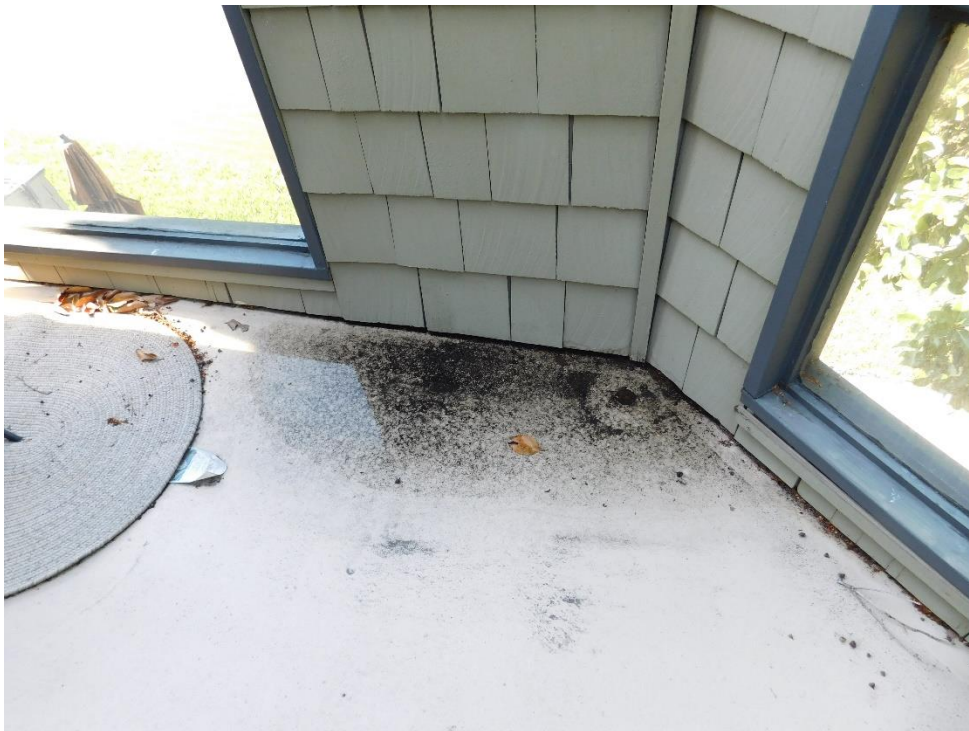
Figure 23. Ponding water at drain location.

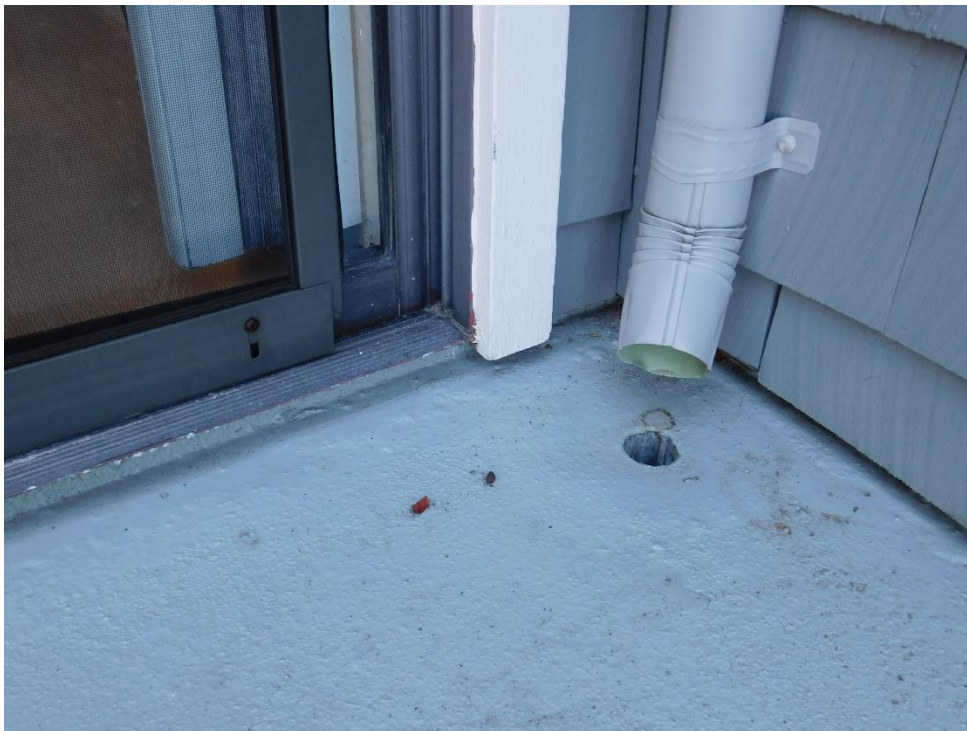
Figure 25. Downspout to roof than drains onto second floor deck.

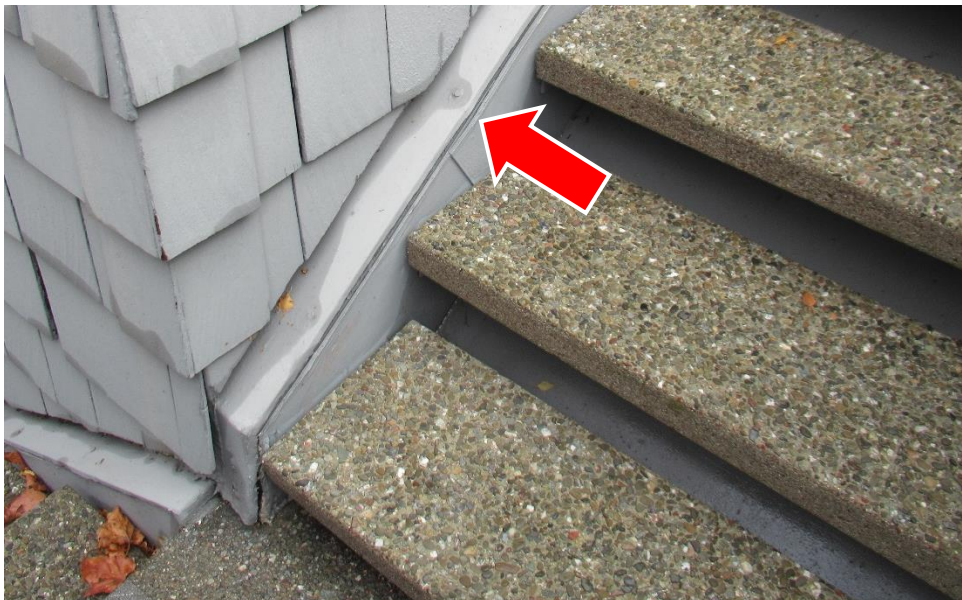
Damage or disruption of the stair cladding was observed at five locations. At 933 Shoreline (Building 25) it was observed that a portion of the stair cladding has moved out of position, allowing water to access the garage wall framing at about mid-height on the garage wall (the stair wraps around the corner of the garage) (Figure 54). This appeared to be a local condition that might relate to differential settlement.

Figure 54. Stringer cladding out of position, allowing water intrusion.
