Harbortown

San Mateo, CA

INVASIVE BUILDING REVIEW

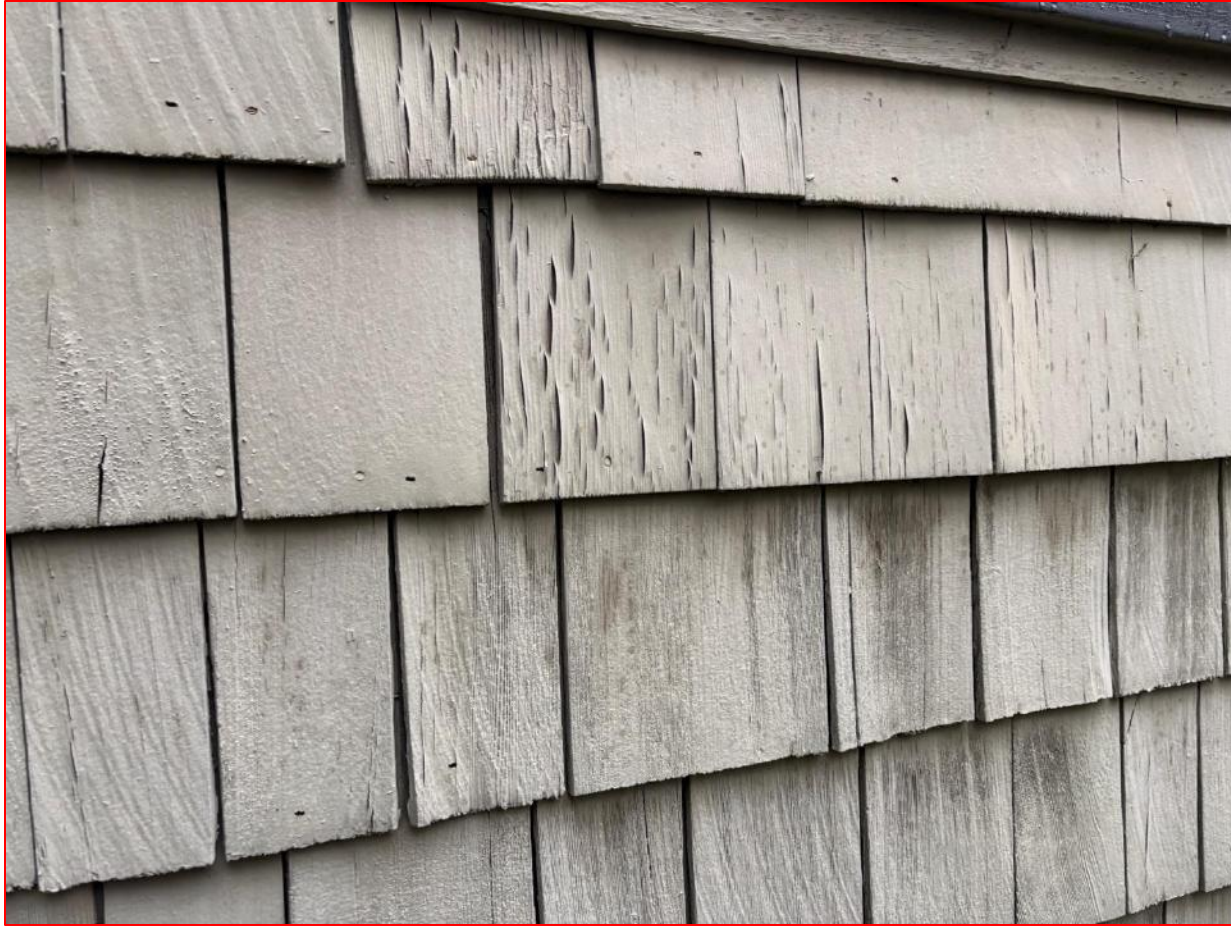
Adhesion and Coating Failures - Pervasive

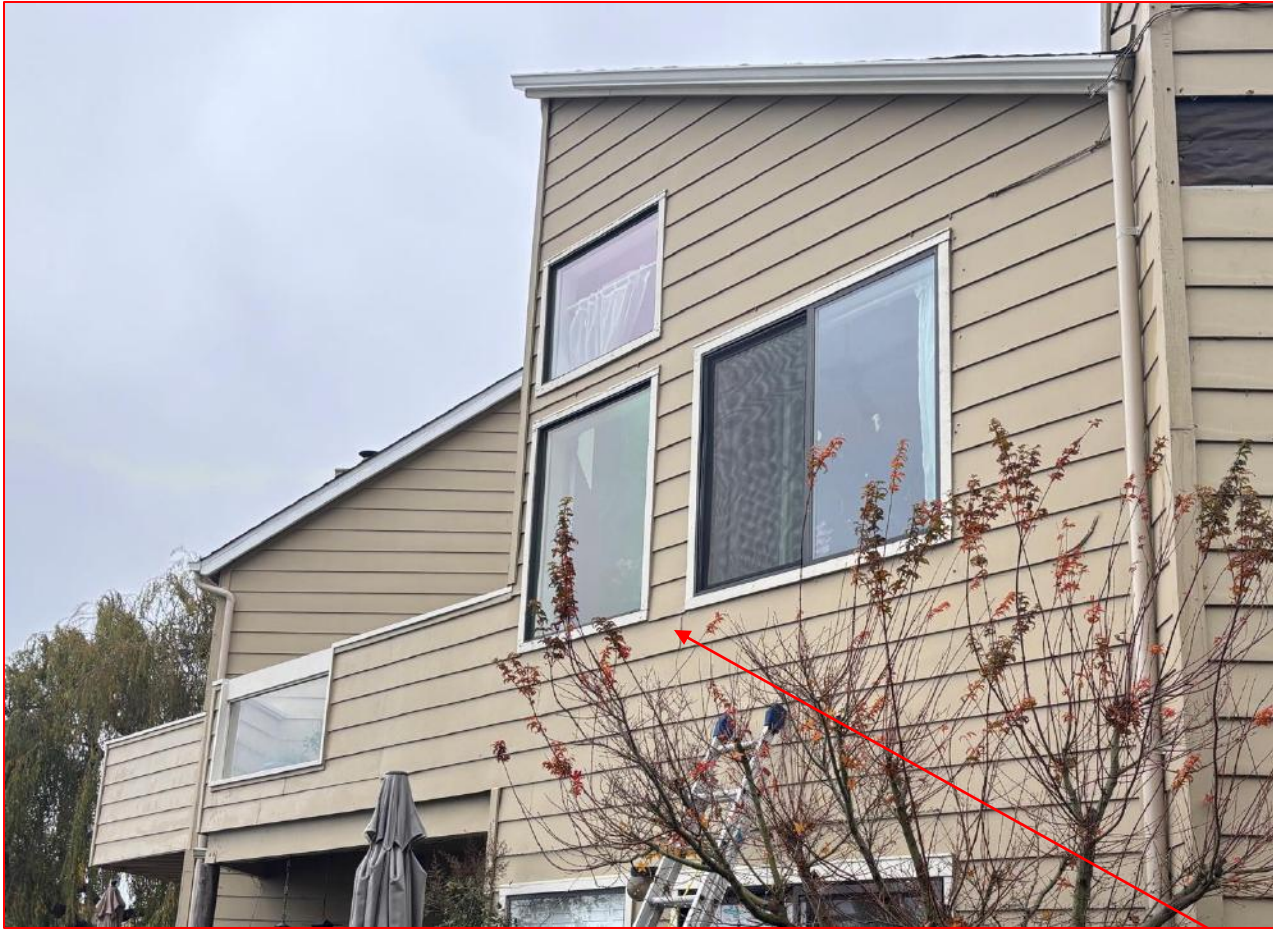
Typical Updated Flanged Window Installation, Aged WRB, and Existing Flashing Sequences. Noted Felt Paper WRB, Jamb Flashing, and Sill Flashing

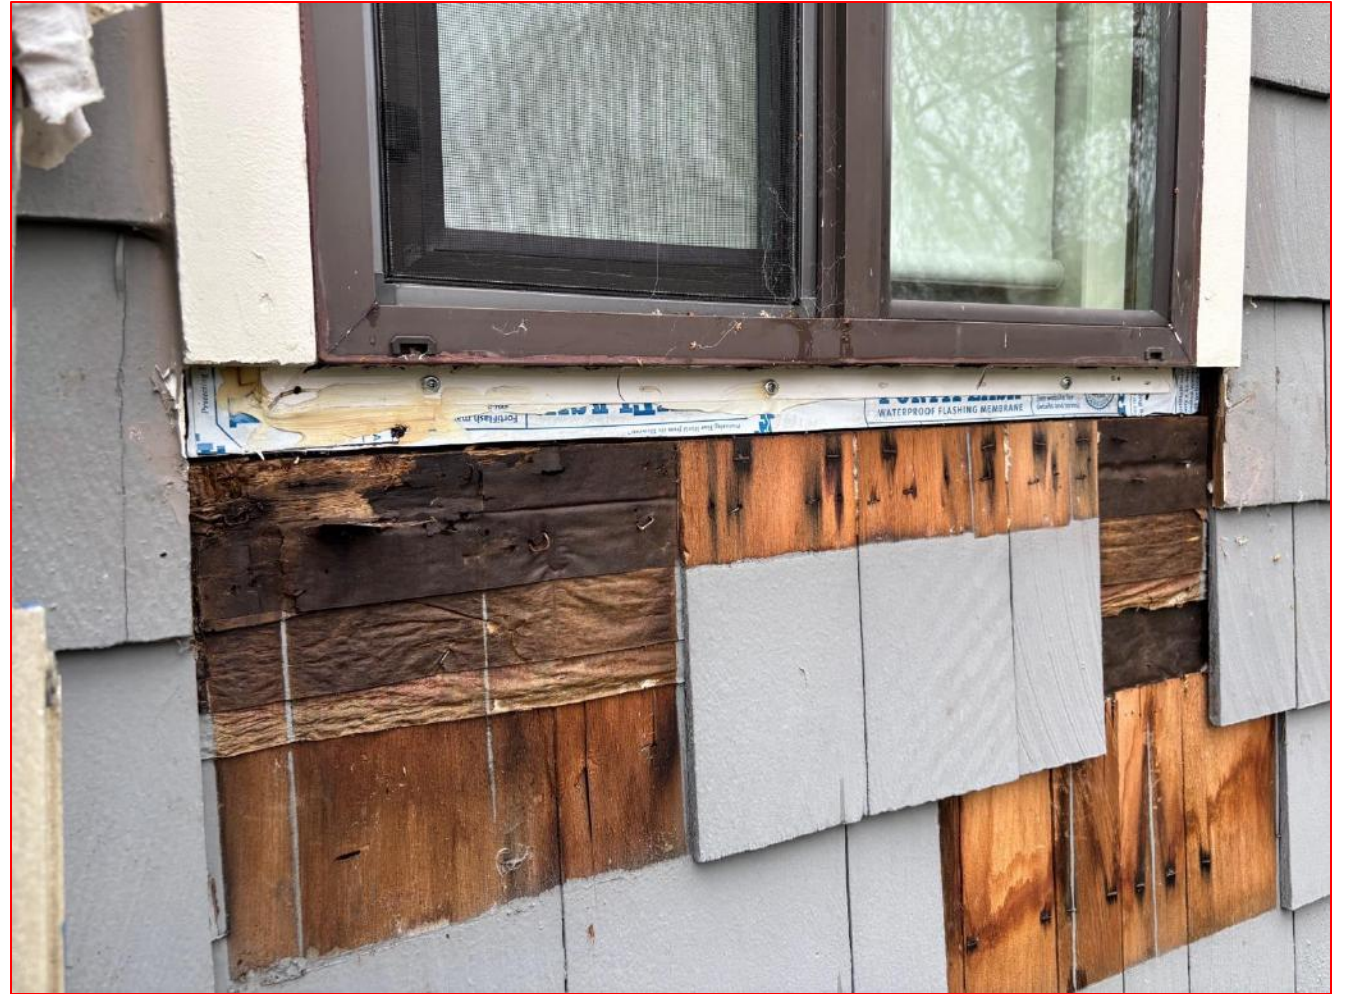
Typical Updated Flanged Window Installation, Aged WRB, and Existing Flashing Sequences. Noted Felt Paper WRB, Jamb Flashing, and Sill Flashing

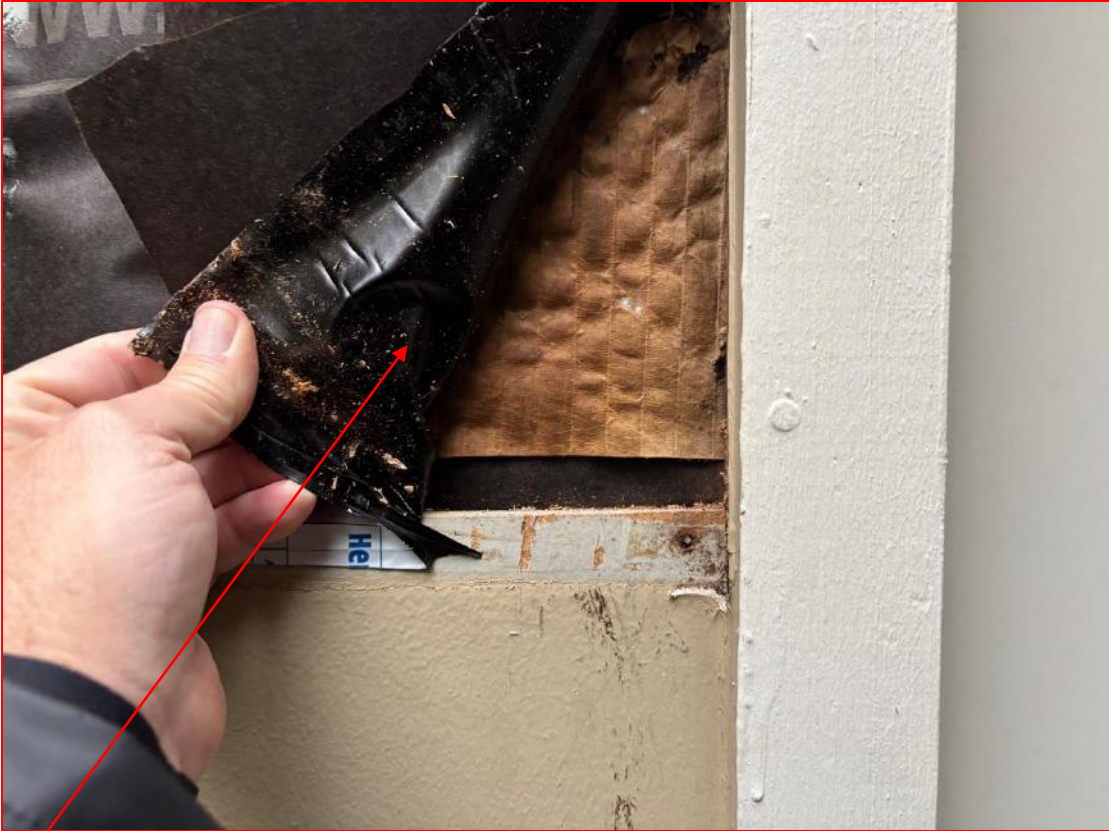
Noted updated “Spot” repaired lap siding, trim, membrane flashing, and WRB – Noted additional sealant added to WRB fastener heads.

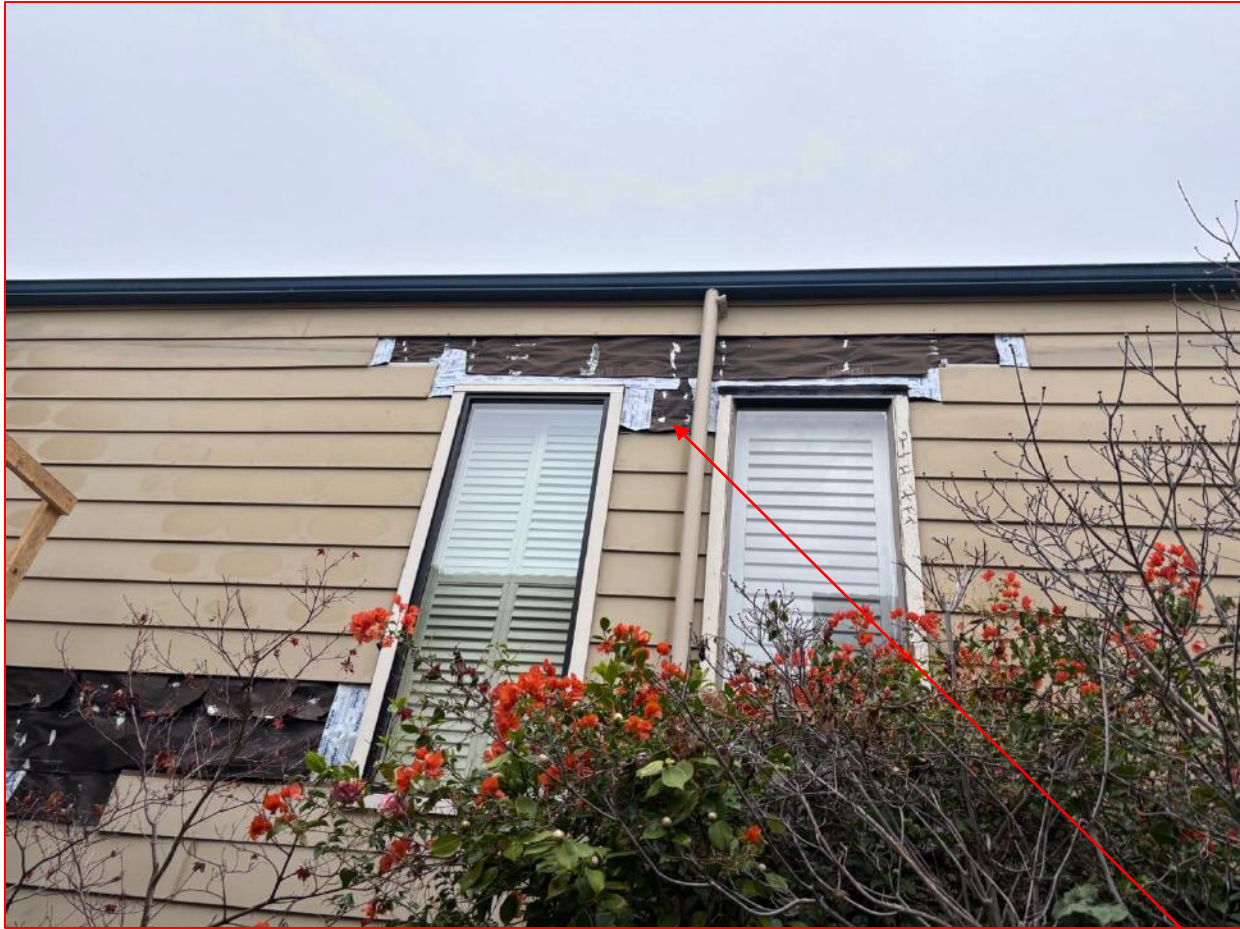
Updated "Spot" repaired WRB, Window flashing, and original aged and worn Felt Paper WRB
