Pepys Power & Hypergreening

Supplementary Material 2

Home Consultation Reports

BENCE HOUSE

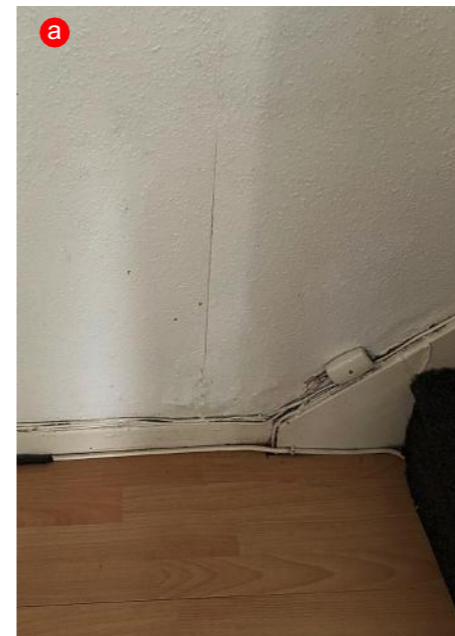
(d) The access to the original entrance and stair from the ground floor corridor has been blocked off (that corridor is inaccessible). (a) There is evidence of damp ingress and damage from this space through the ground floor wall. Occupant has advised that the injected cavity wall insulation undertaken a few years ago is not effective. (c) They have applied a layer of rigid insulation (polystyrene?) to the inside face of the kitchen wall. It seems this is primarily an effort to address a radiant cold surface in winter. Some evidence of paint peeling at corner of ceiling to external wall in master bedroom but occupant has not noticed condensation. Occupant reports cold floor to kitchen/living lower level, assumed to be uninsulated solid construction. Occupant reports issues with double glazing units blown/condensation between glass, but hard to see on a warm day.

Damp ingress along partition with access corridor

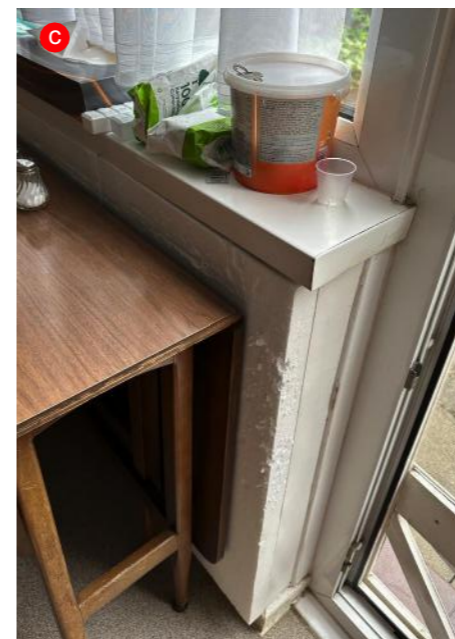
DIY internal insulation to address thermal discomfort in winter

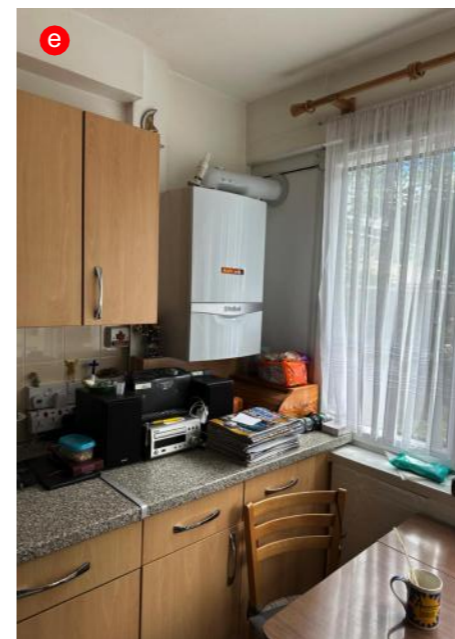
Gas boiler in kitchen with flue to garden

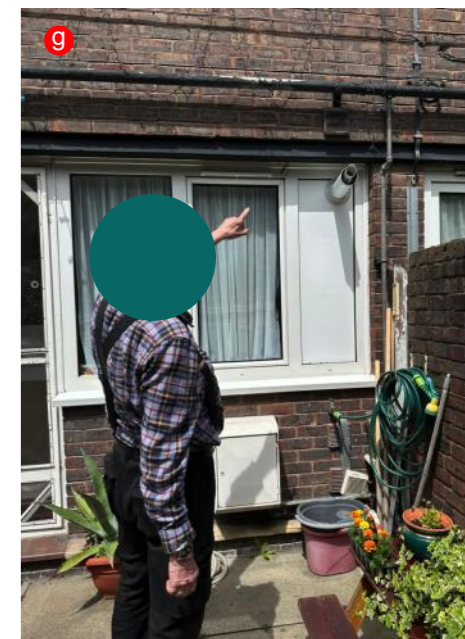
Garden elevation with boiler flue, MVHR intake/extract and gas meter

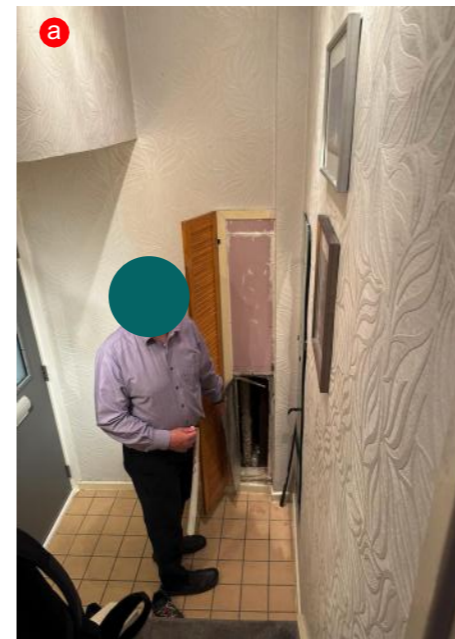
(a) As with other similar flats, there is a service riser in the entrance lobby hallway at the party wall with the neighbouring flat. This has been a source of leaks and issues but not currently any live problems to report.

Service riser and access panel in entrance lobby

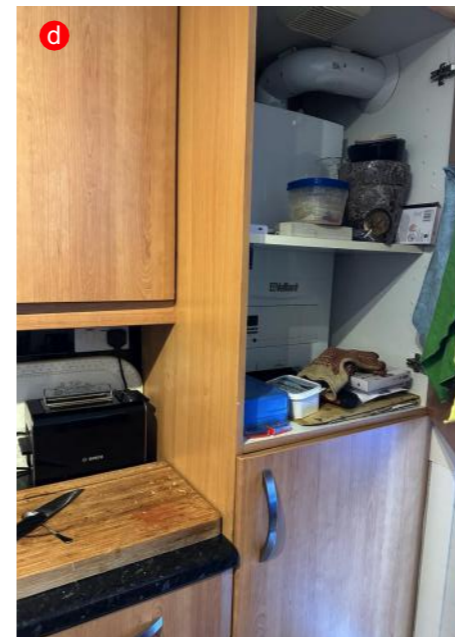
Gas boiler in kitchen with flue to external terrace

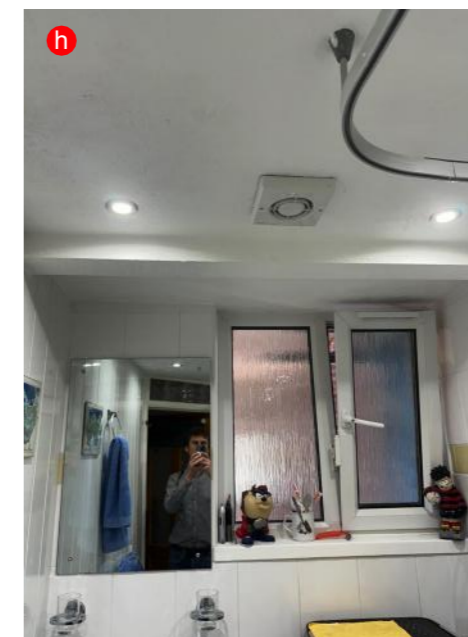
Window to third external elevation and extract fan to exterior in bathroom

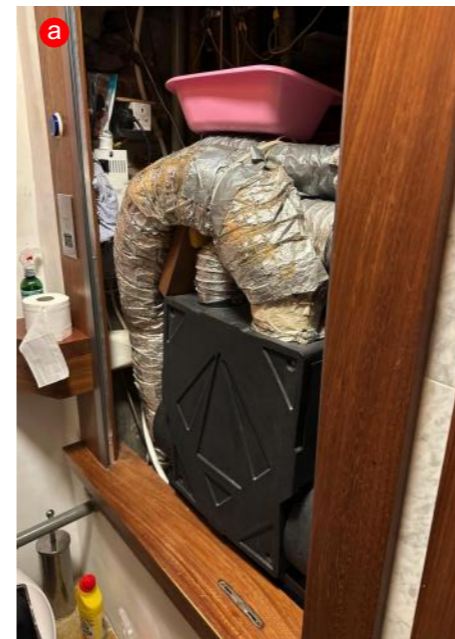
(a, d) MVHR installed in 1997 by local authority with leaseholder oversight, ducting is discreet, filters and unit maintained by occupant, supply and extract to outside in living room floor; poorly installed flexible ducting with lots of kinks, foil has delaminated; filters 'hoovered out' by occupant every few years, not replaced; no summer bypass.

MVHR unit and ventilation ducts in WC service duct

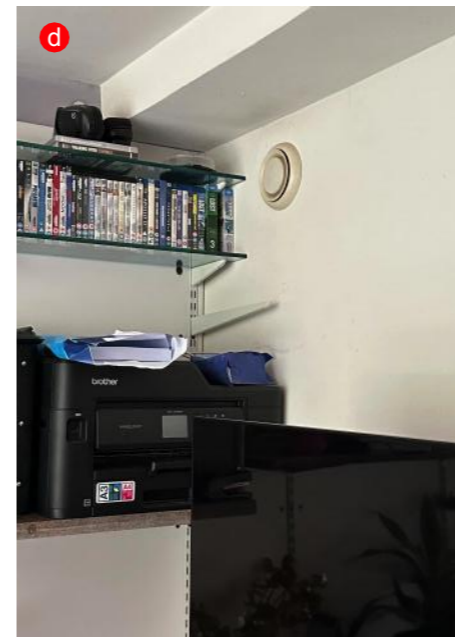
Active supply air register in living room

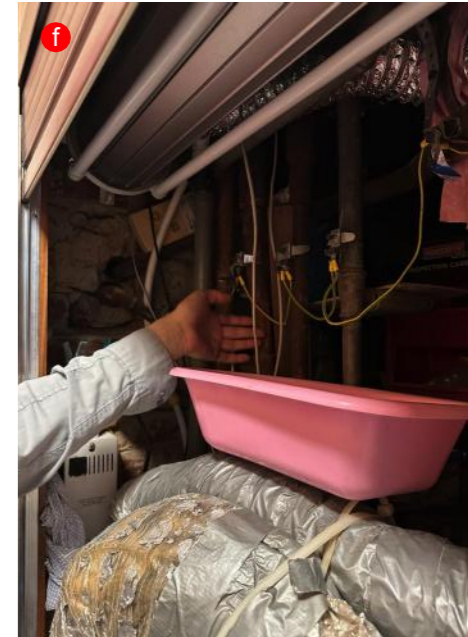
Historic district heating system pipework, now defunct

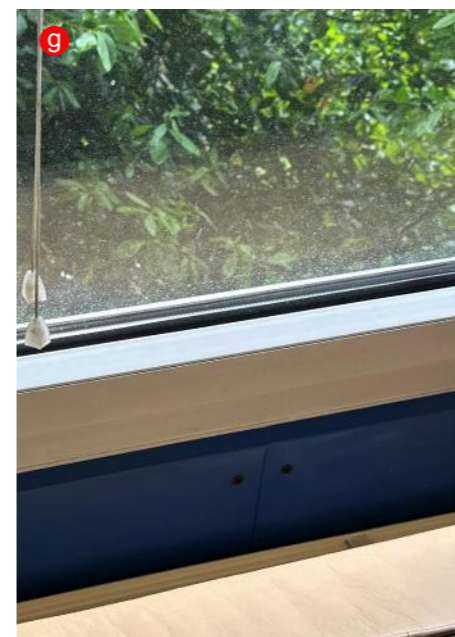
(g) The panelling under the ground window in the living room can be removed for future inspection of wall buildup. Occupant says it is poor quality block work with injected cavity wall insulation

Panelling in living room is easily removable for future inspection

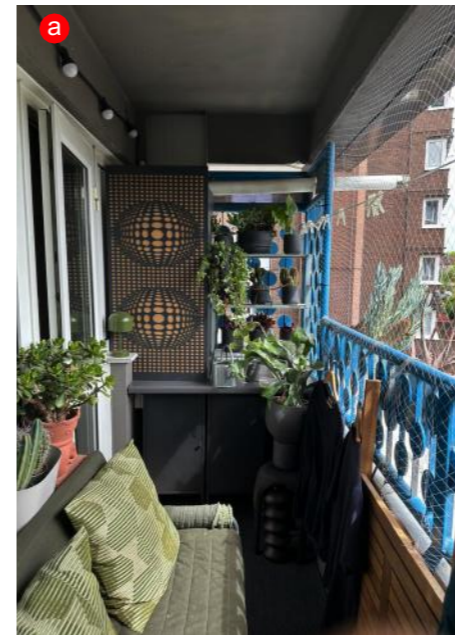
External cabinet on terrace housing gas Combi boiler

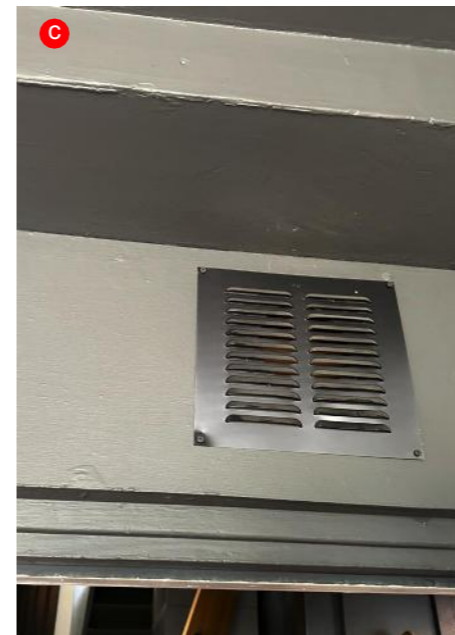
Ventilation grille, defunct (no mechanical ventilation in property)

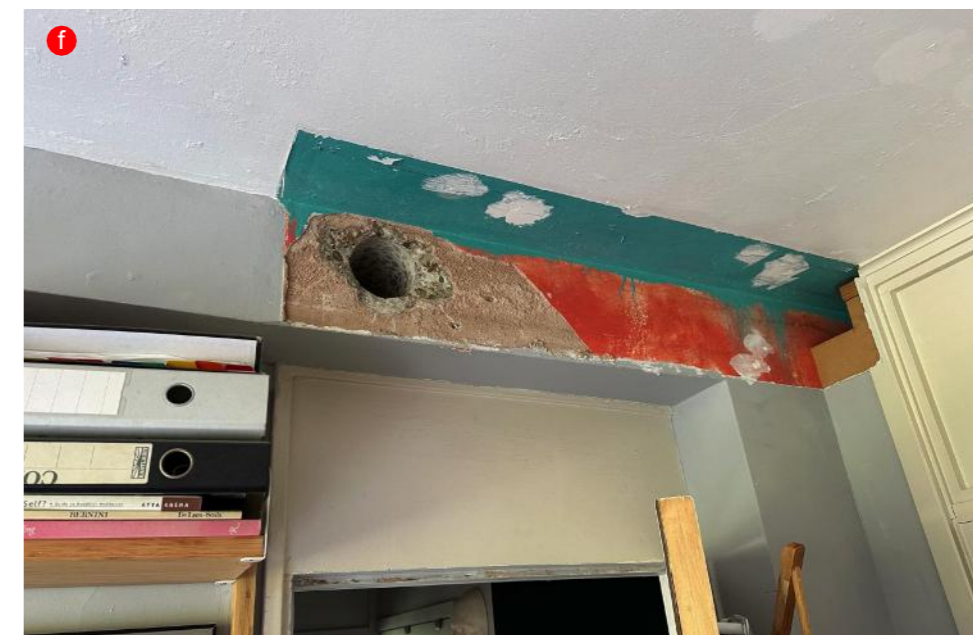
Remnant of historic service distribution, stripped out during renovation

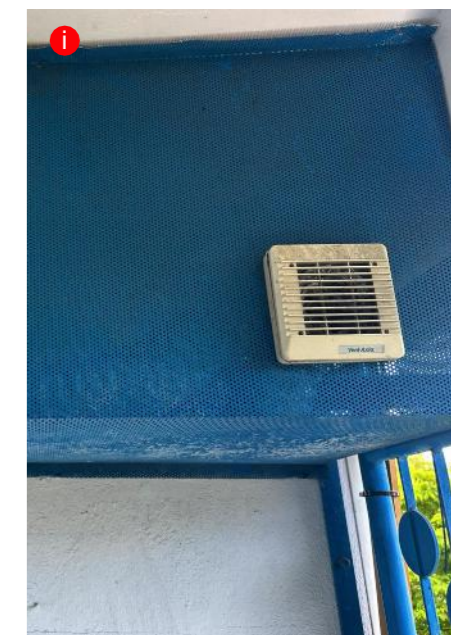
MVHR external air register in service cage at external terrace

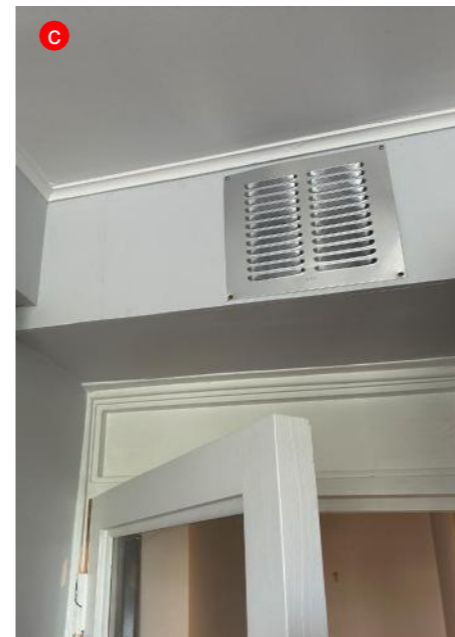
Defunct ventilation grille, ventilation installation has been stripped out

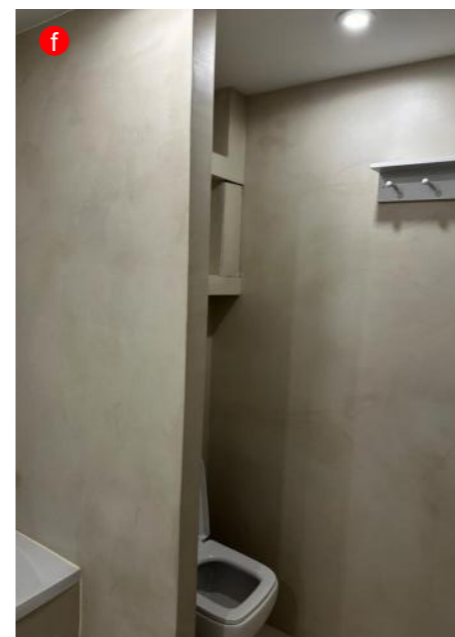
WC with no extract ventilation

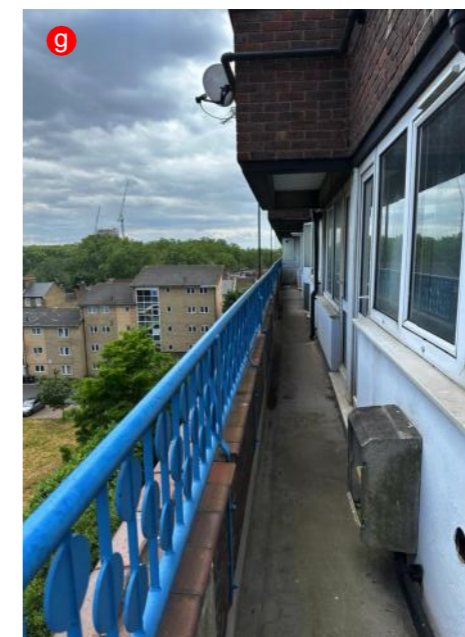
6th floor escape balcony roof forms part of building envelope at living room ceiling

6th floor escape balcony running over living room

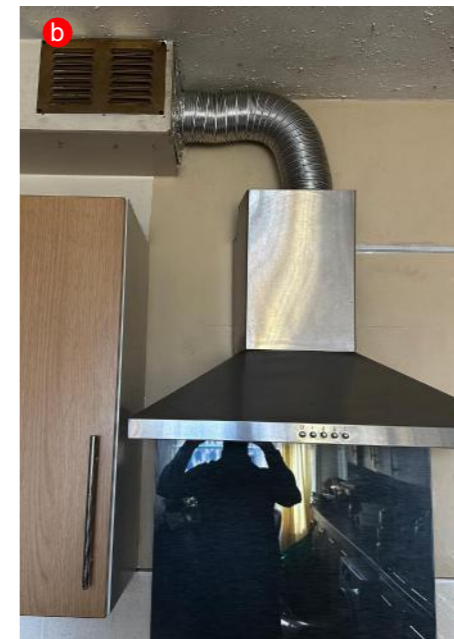
Kitchen extract potentially running into MVHR unit

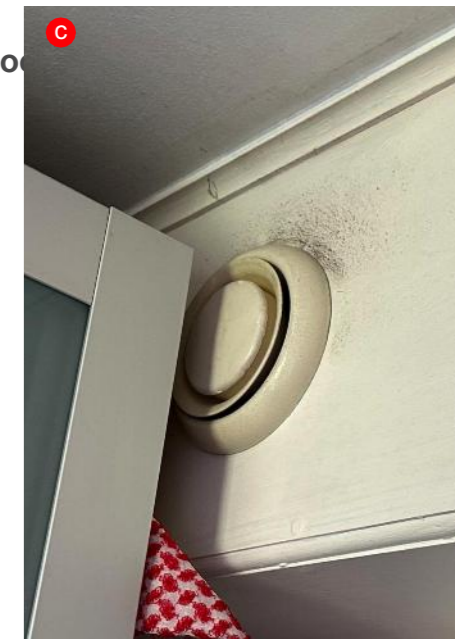
Supply air register with evidence of dirt/mould discharge

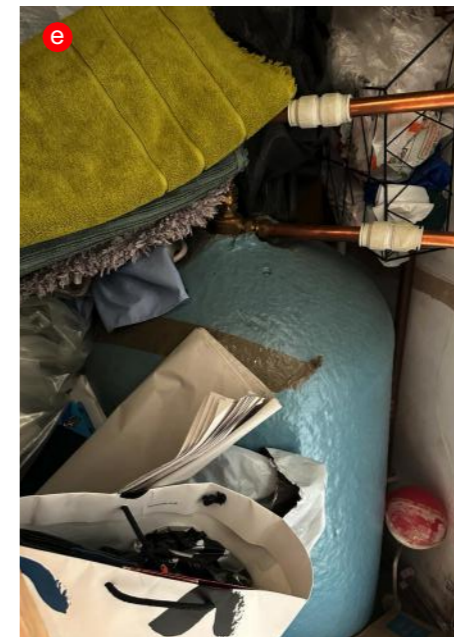
Hot water tank in hallway cupboard

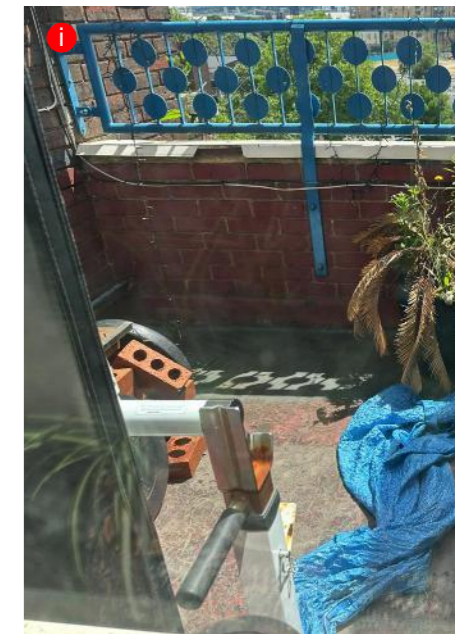
Kitchen terrace with poor drainage issues
