# Fast Curing, Surface Tolerant, Abrasion Resistant System for Patch Repairs

# 1818

Belzona 1818 is a fast curing, surface tolerant, abrasion resistant system ideal for patch repairs on surfaces subject to high erosion and abrasive environments.

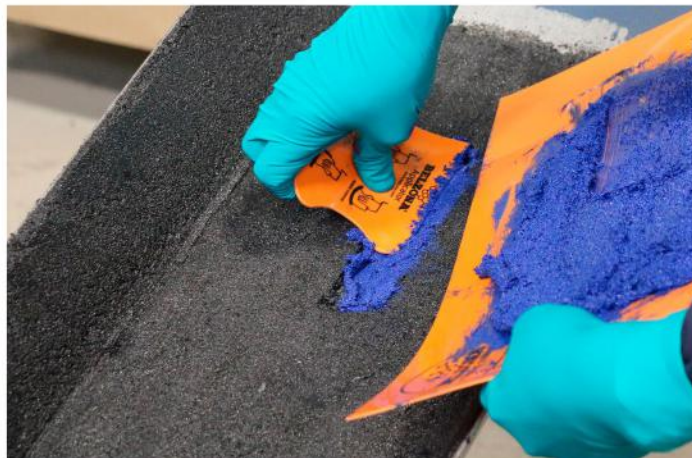
As shown in the image above, Belzona 1818 is ideally suited for patch repairs where a rapid return to service is required.
