## TEST REPORT No. 8109

Product Desc.: Armalon NG / Armatrans Vinyl Flooring

Result	Class
AS 4586:2013 (Amendment No. 1)	Slip resistance classification of new pedestrian surface materials, Appendix D: OIL-WET INCLINING PLATFORM TEST METHOD Corrected mean overall acceptance angle:	9°	R 9

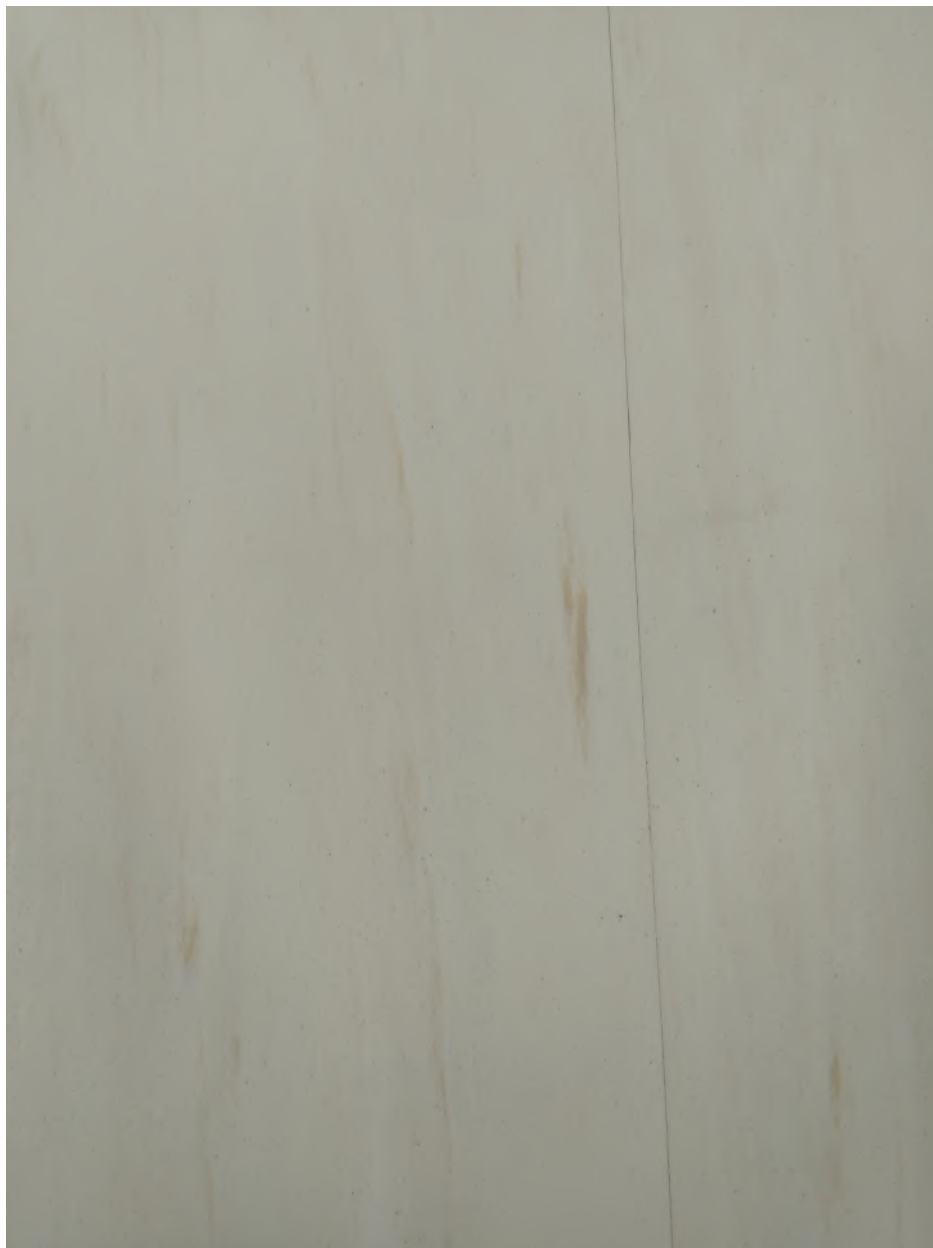
PHOTOS:

REPORT NO: 8109  
ISSUE DATE: 30 July 2018  
MANUFACTURER: Armstrong Flooring  
PRODUCT DESC: Armalon NG / Armatrans Vinyl Flooring
