March 1, 2023

## Harbortown SB326 Inspection Report

WJE No. 2022.3823

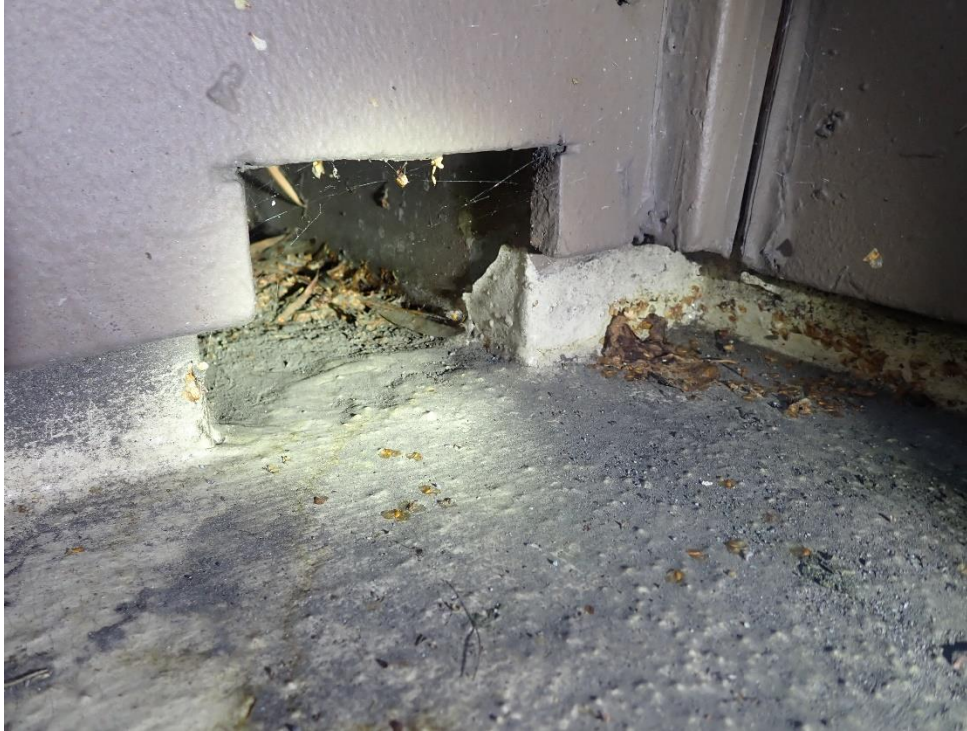
Figure 24. Scupper with reverse slope.
