Harbortown

San Mateo, CA

INVASIVE BUILDING REVIEW

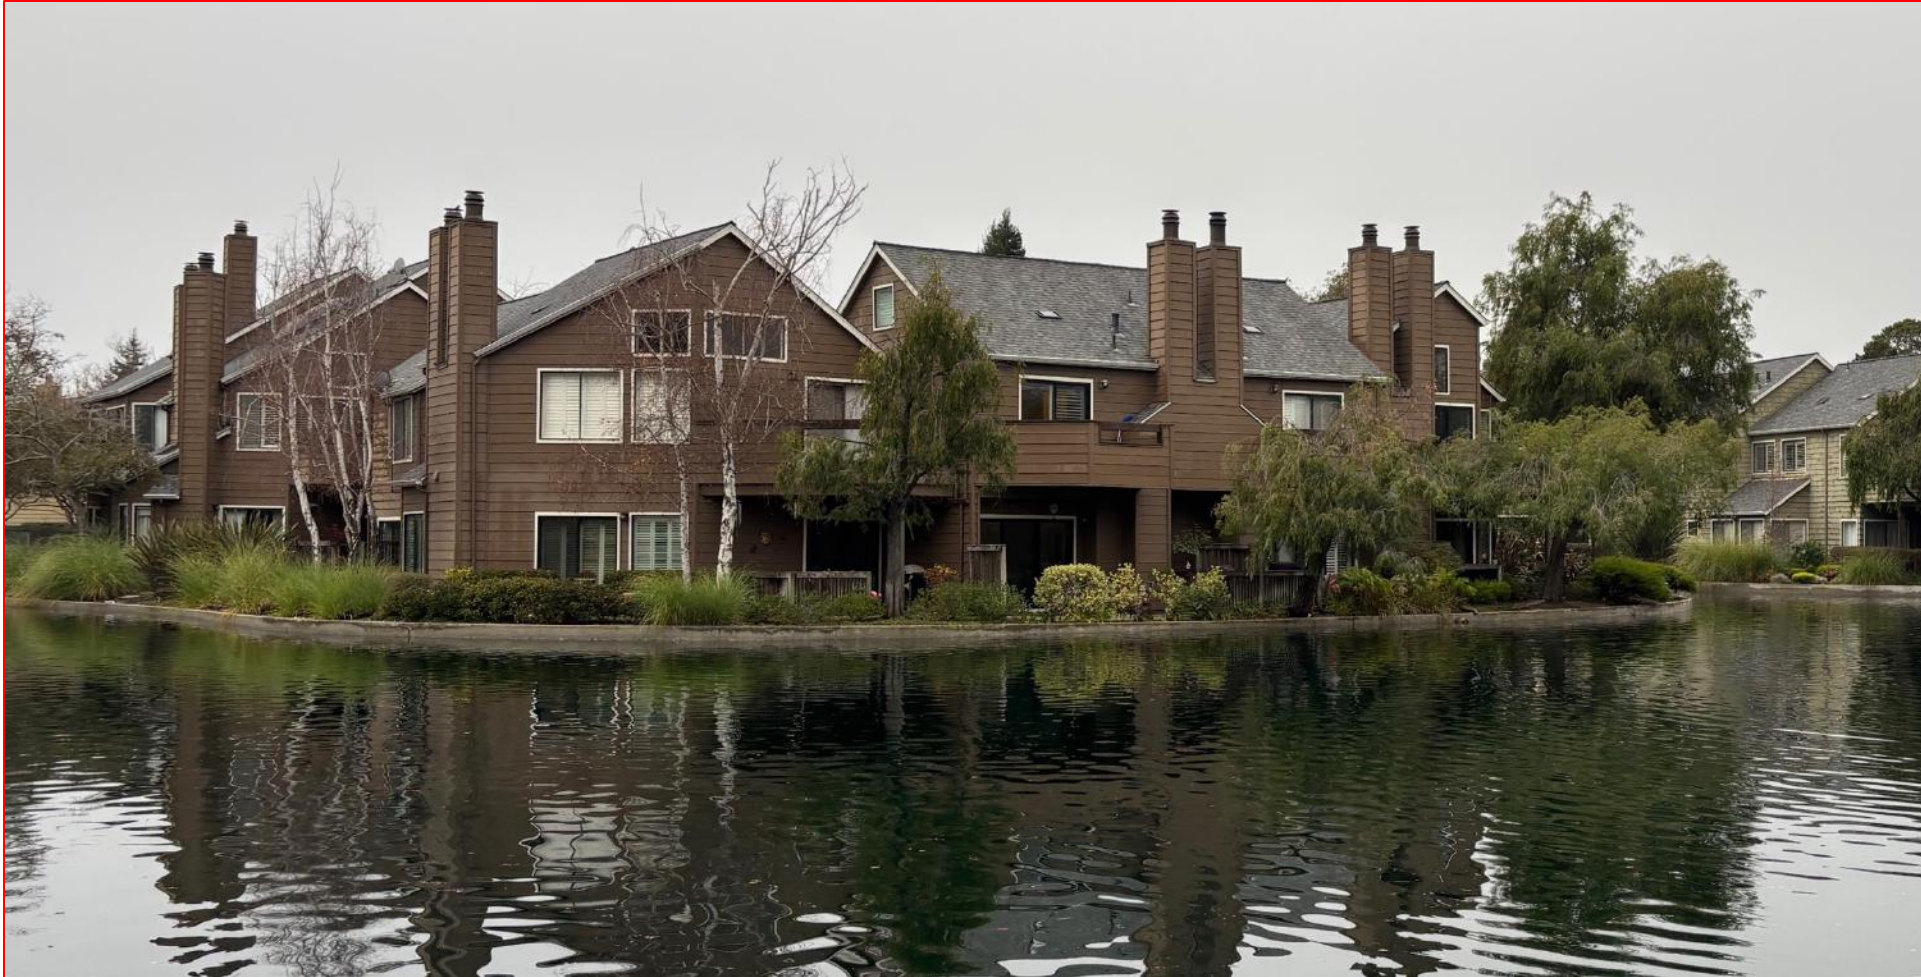
Aged and Worn Painted Lap Siding and Shingles, Painted Wood and PVC trim, Wood Framed Decks, Wood Decking, Composite Decking, Glass Panel and Wood Capped Railings, Masonry Decks, Synthetic Roof Membrane, Updated Architectural Asphalt Shingles, Vinyl and Metal Flanged Windows and Patio Doors

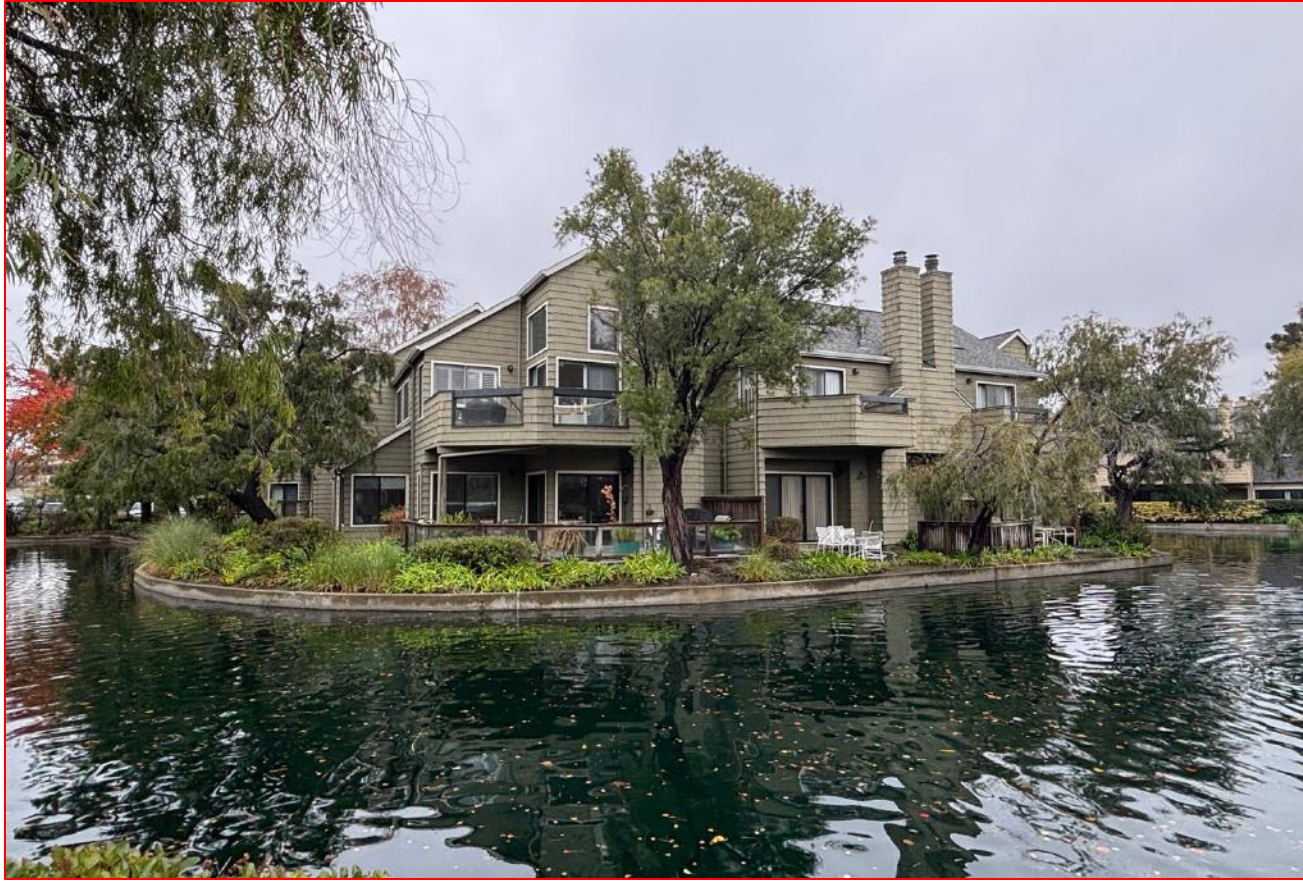
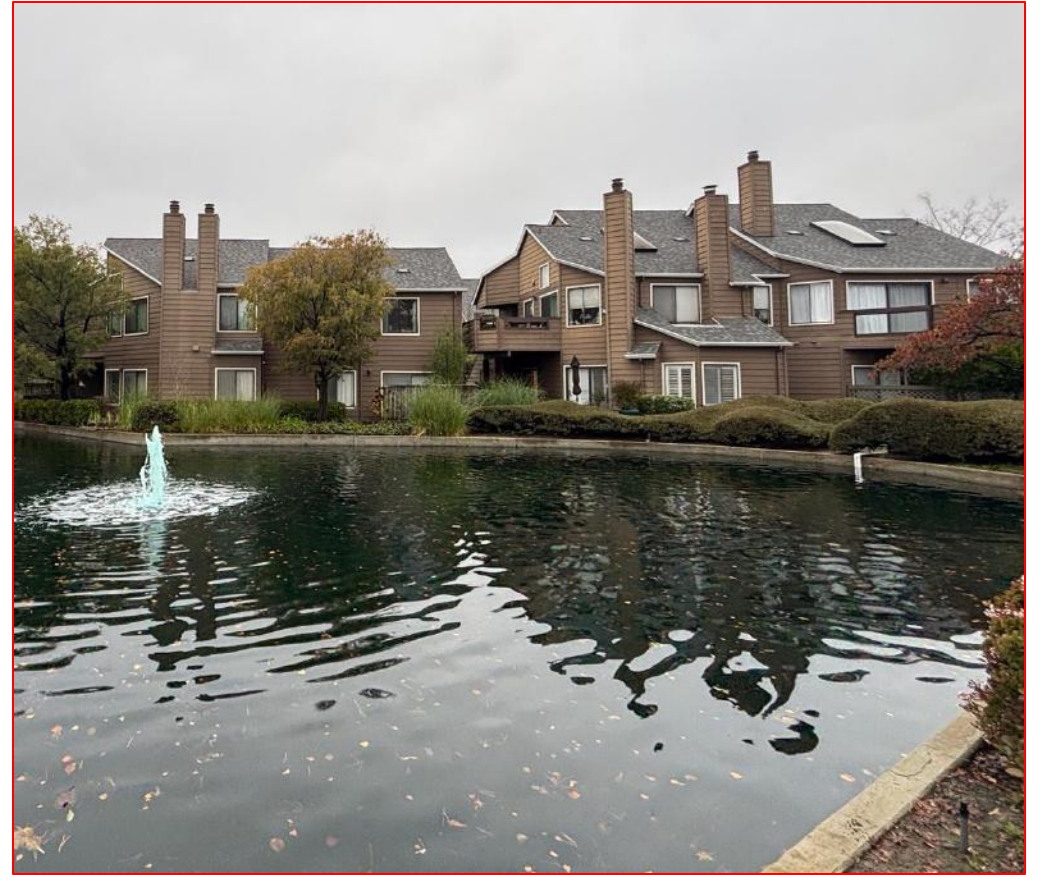
Aged and Worn Painted Lap Siding and Shingles, Painted Wood and PVC trim, Wood Framed Decks, Wood Decking, Composite Decking, Glass Panel and Wood Capped Railings, Masonry Decks, Synthetic Roof Membrane, Updated Architectural Asphalt Shingles, Wood Fences, Wood Trellis, Vinyl, Wood, and Metal Flanged Windows, Patio & Utility Doors

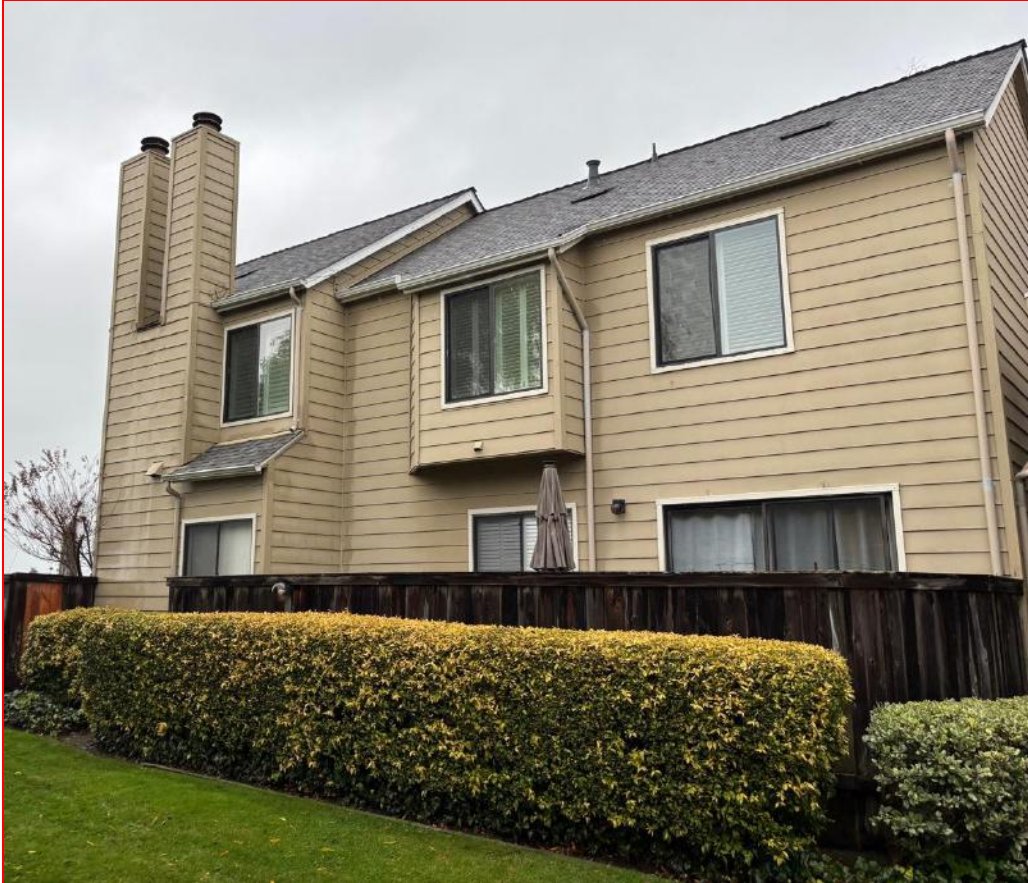
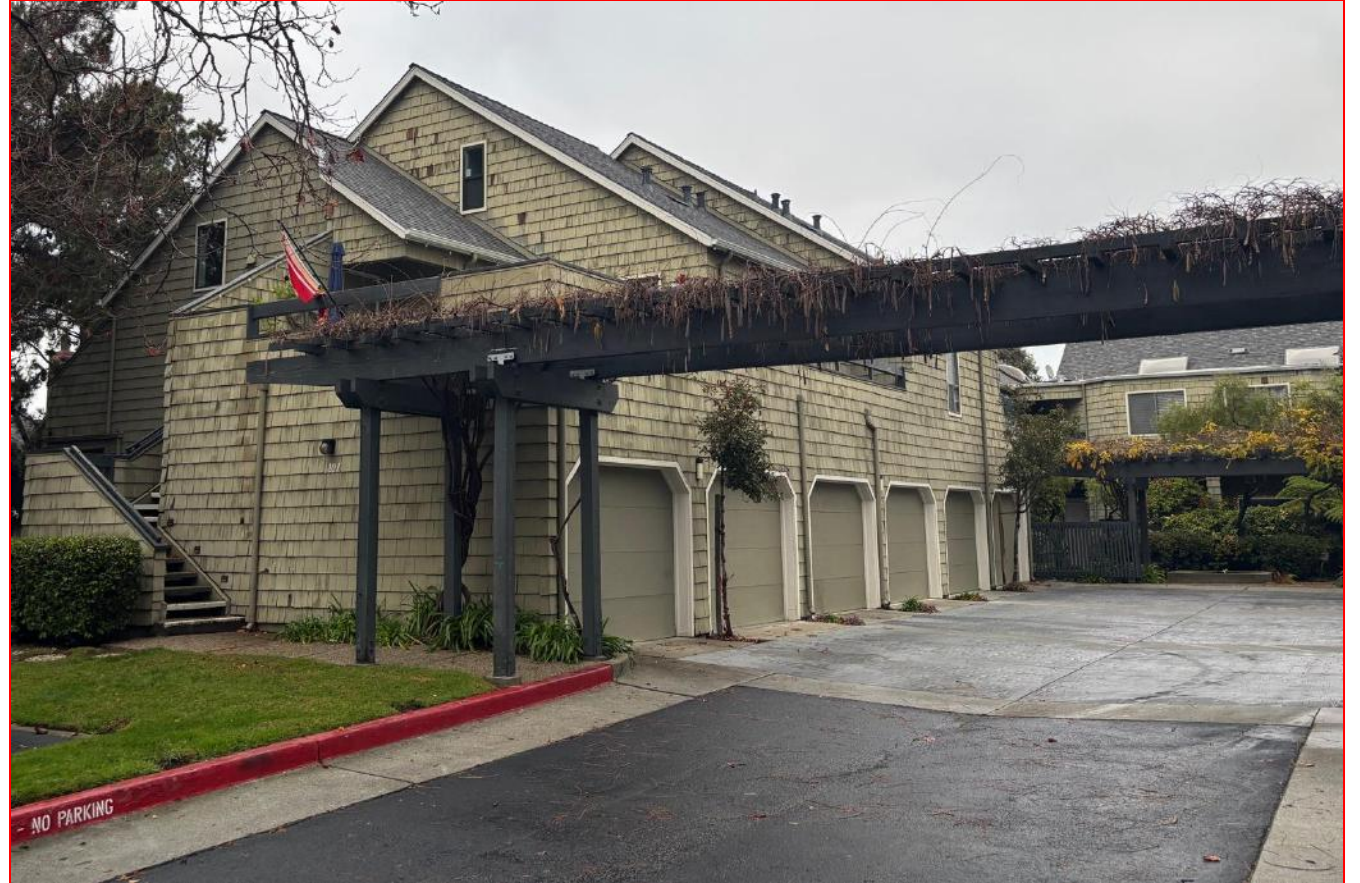
Aged and Worn Painted Lap Siding and Shingles, Painted Wood and PVC trim, Wood Framed Decks, Wood Decking, Composite Decking, Glass Panel and Wood Capped Railings, Masonry Decks, Synthetic Roof Membrane, Updated Architectural Asphalt Shingles, Wood Fences, Wood Trellis, Vinyl, Wood, and Metal Flanged Windows, Patio & Utility Doors

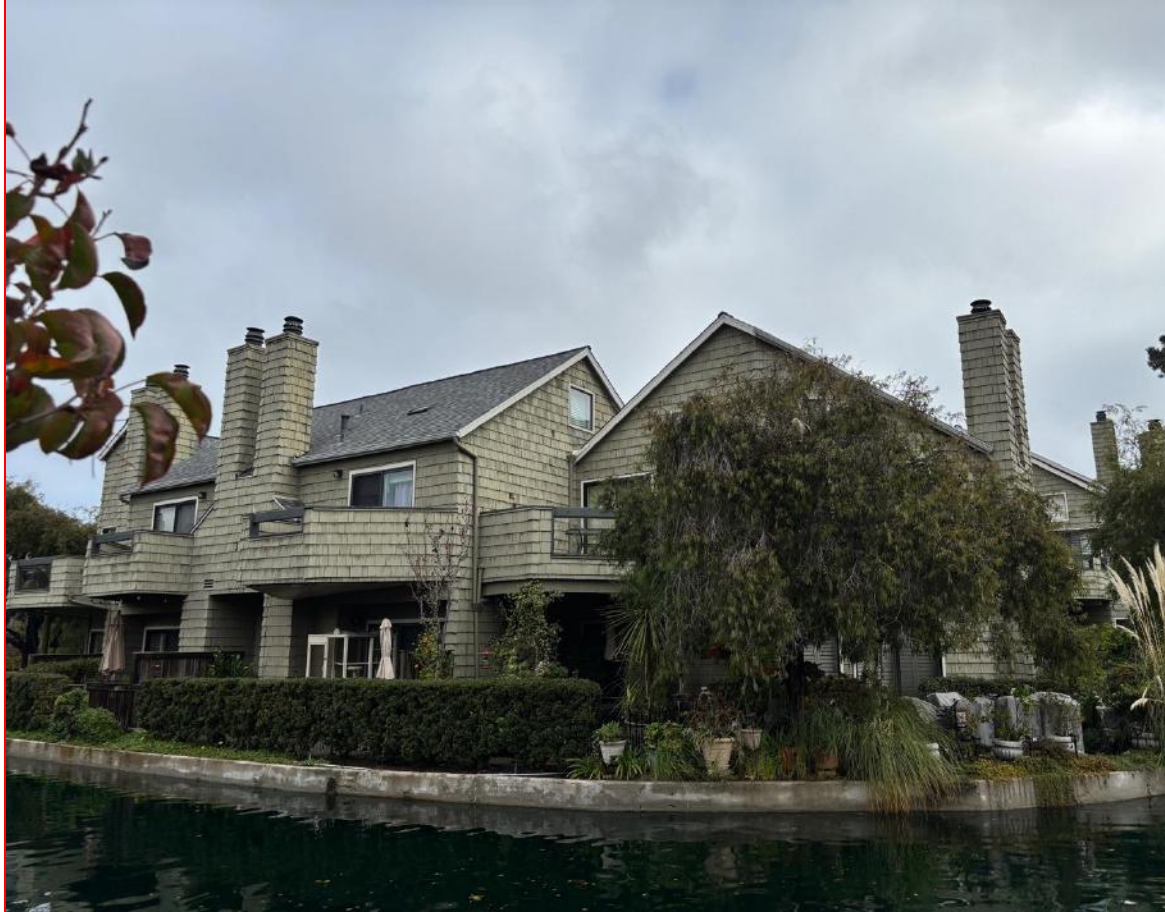
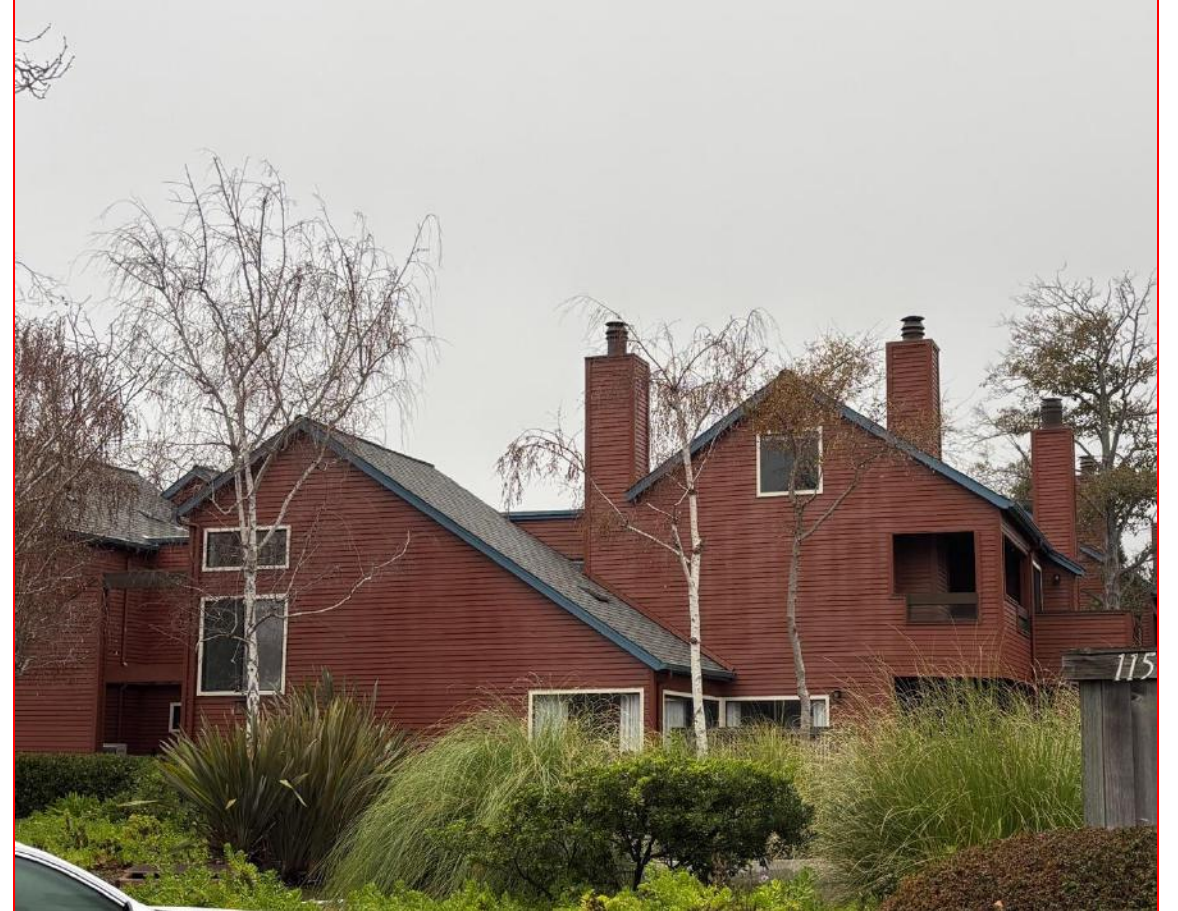
Aged and Worn Painted Lap Siding and Shingles, Painted Wood and PVC trim, Wood Framed Decks, Wood Decking, Composite Decking, Glass Panel & Wood Capped Railings, Masonry Decks, Synthetic Roof Membrane, Updated Architectural Asphalt Shingles, Wood Fences, Wood Trellis, Vinyl, Wood, and Metal Flanged Windows, Patio & Utility Doors

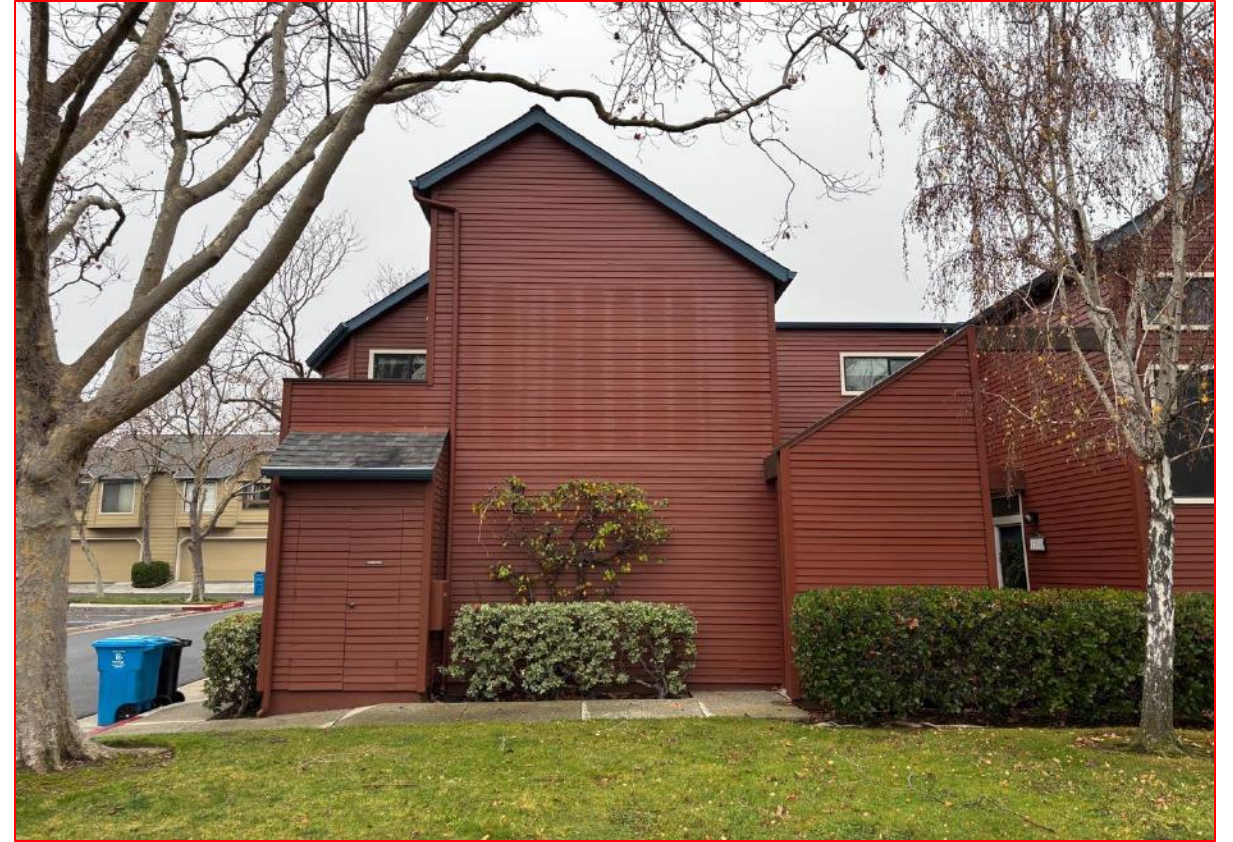
Spot Repaired Aged and Worn Painted Wood Siding. Noted signs of moisture transfer, blistering paint, peeling paint, UV degraded, decayed with visible signs of top grain eroded surfaces

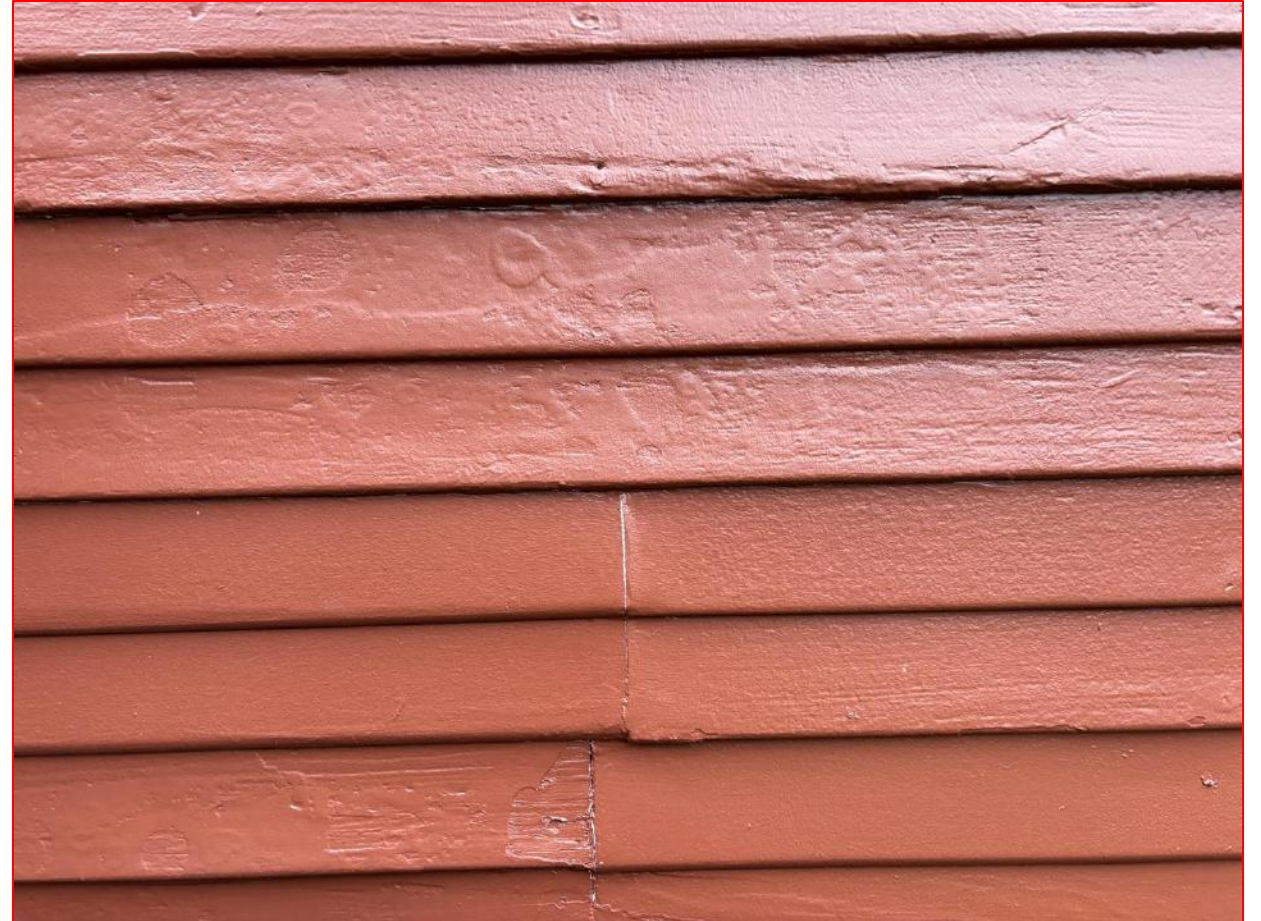
Visible Adhesion and Coating Failures on recently painted wood siding surfaces - Pervasive

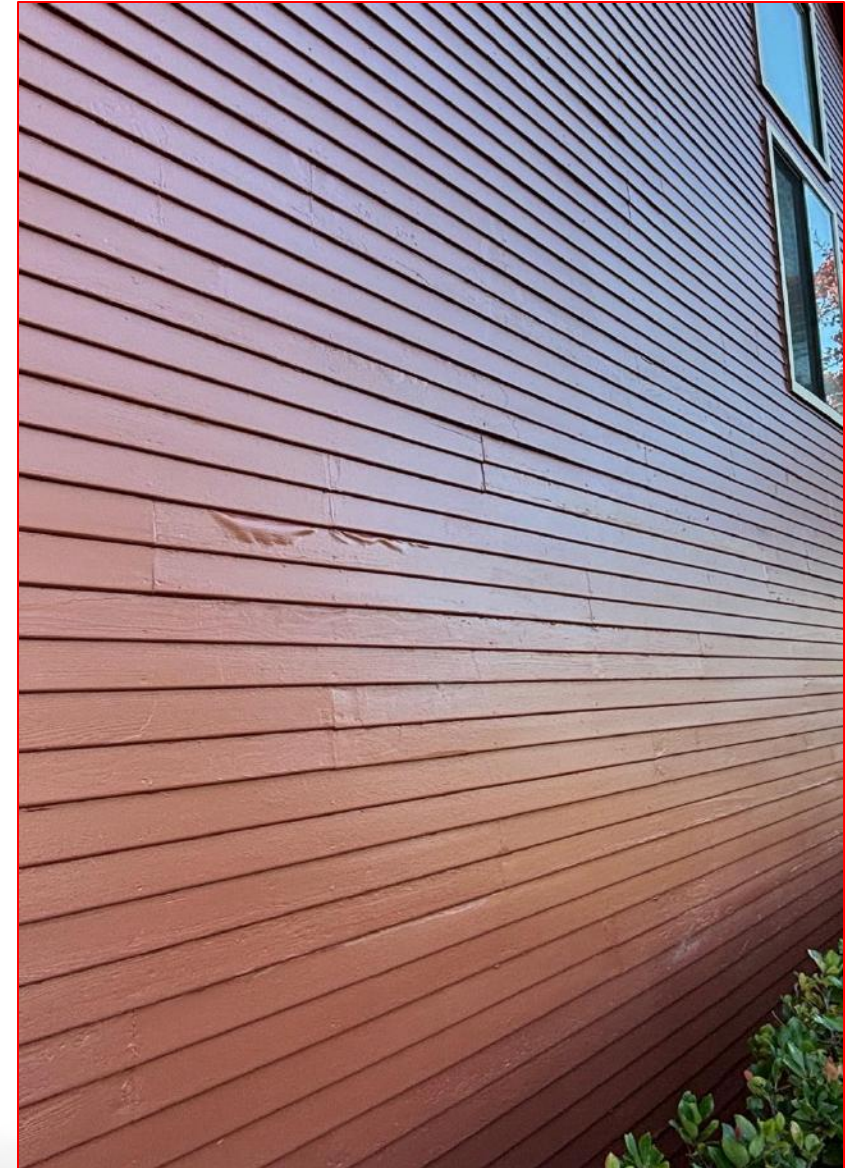
Noted recently painted wood siding surfaces with visible blisters, peeling, bubbles, and marked repairs

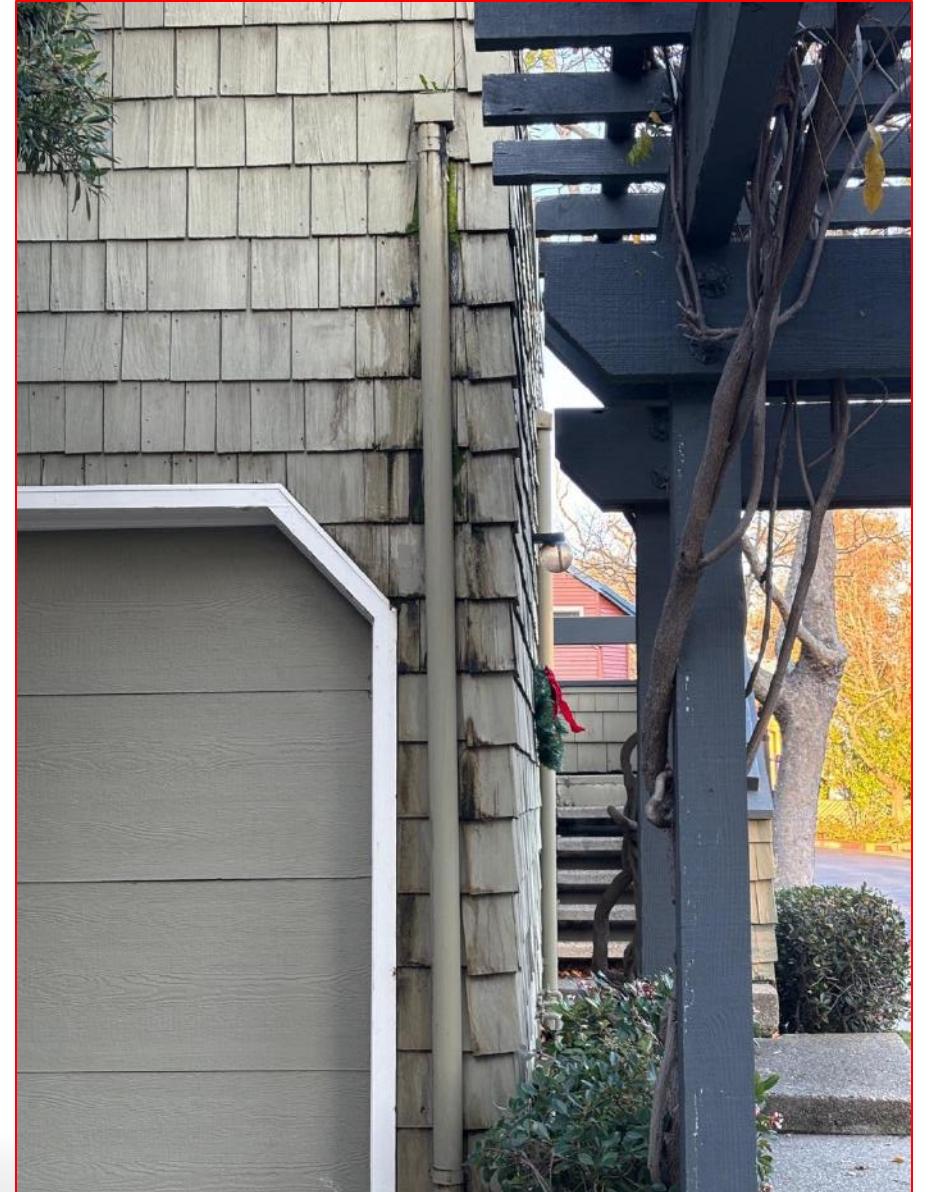
Cupped, Curled, and Decayed Wood Shingles - Pervasive

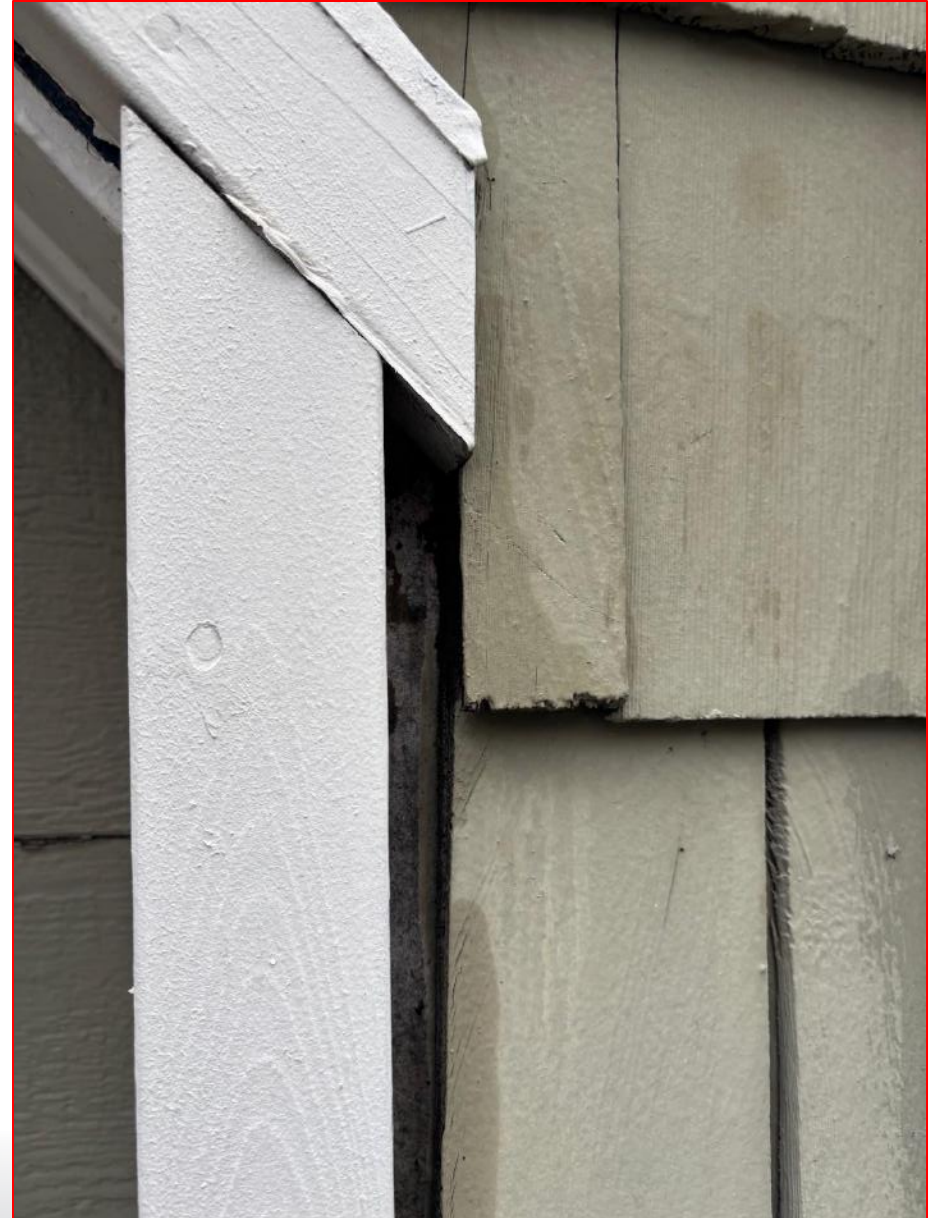
Adhesion and coating failures on shingles and visible gaps exposing sheathing

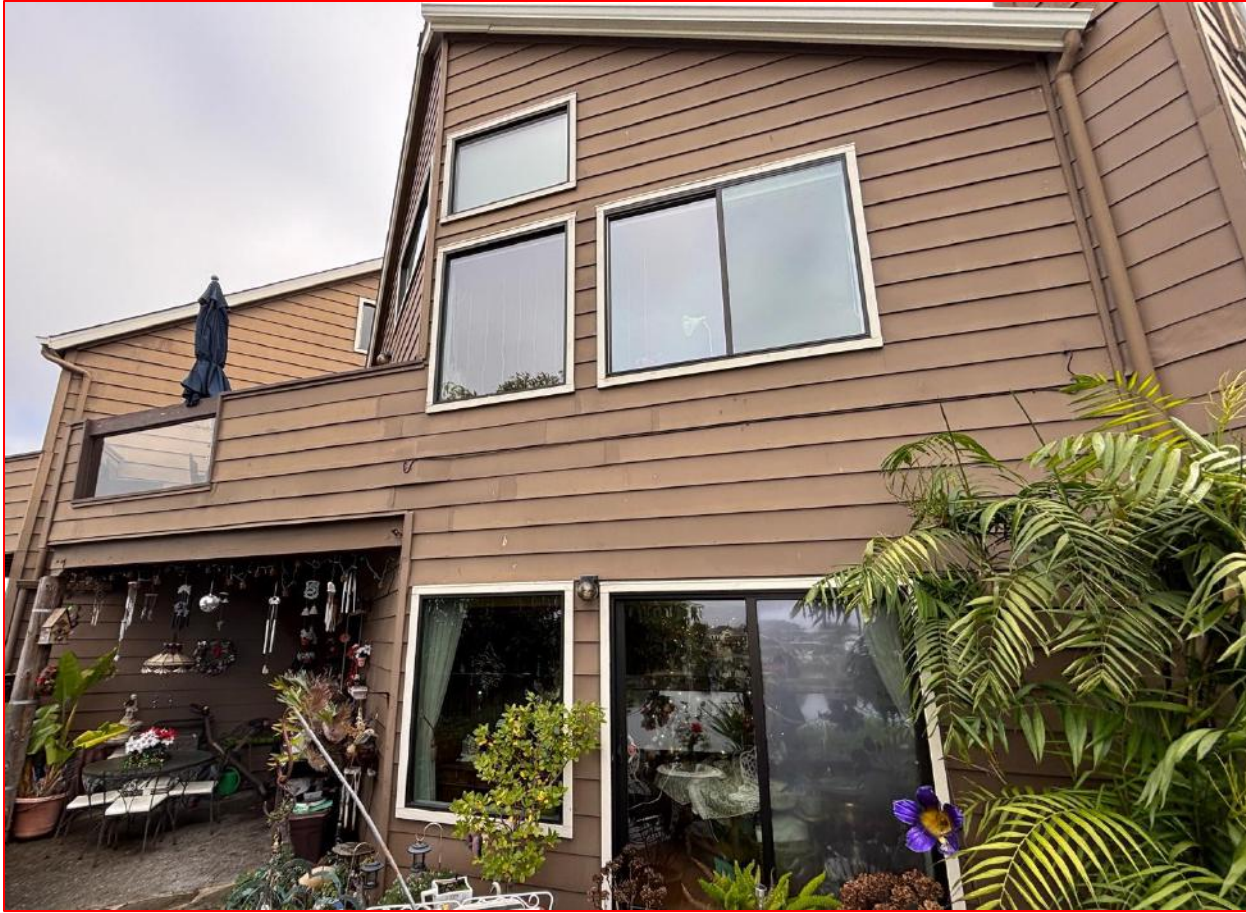
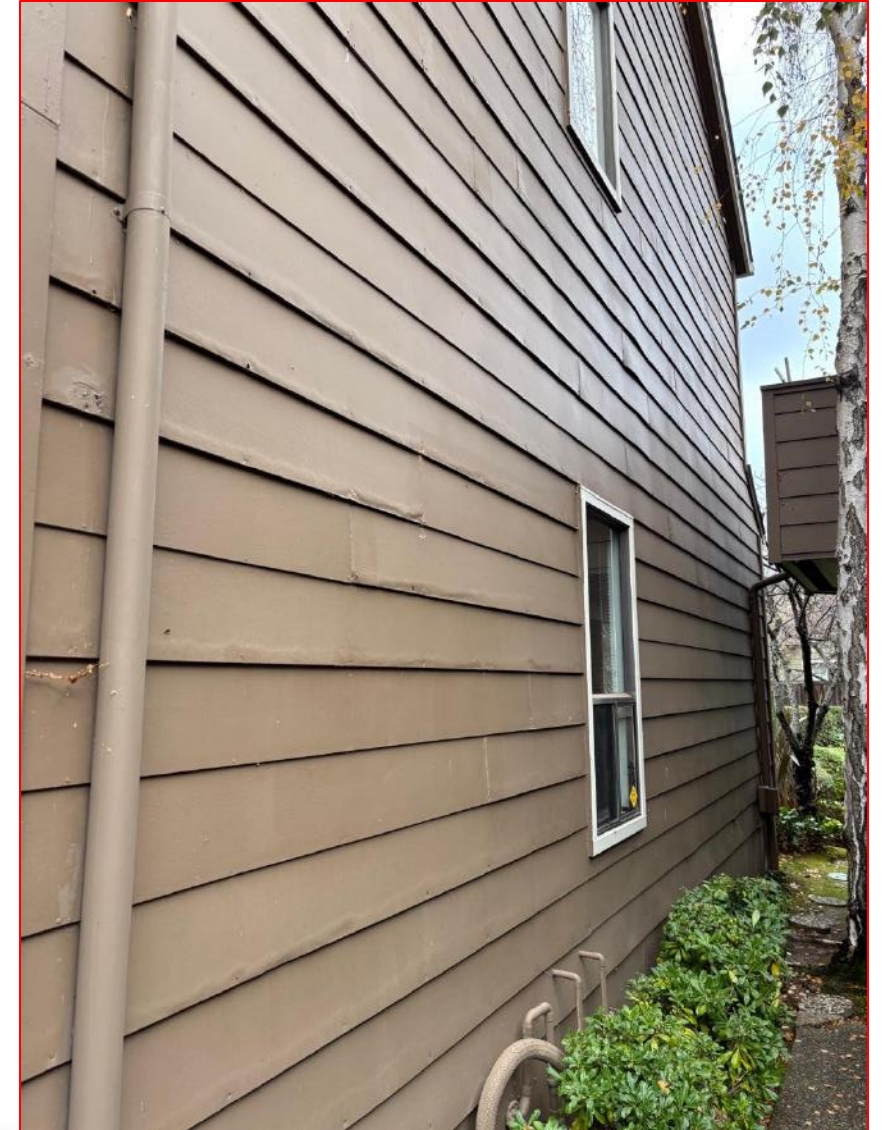
Aged and Worn "Masonite Compressed Fiber" Lap Siding.
Noted moisture damage and coating failures - Pervasive

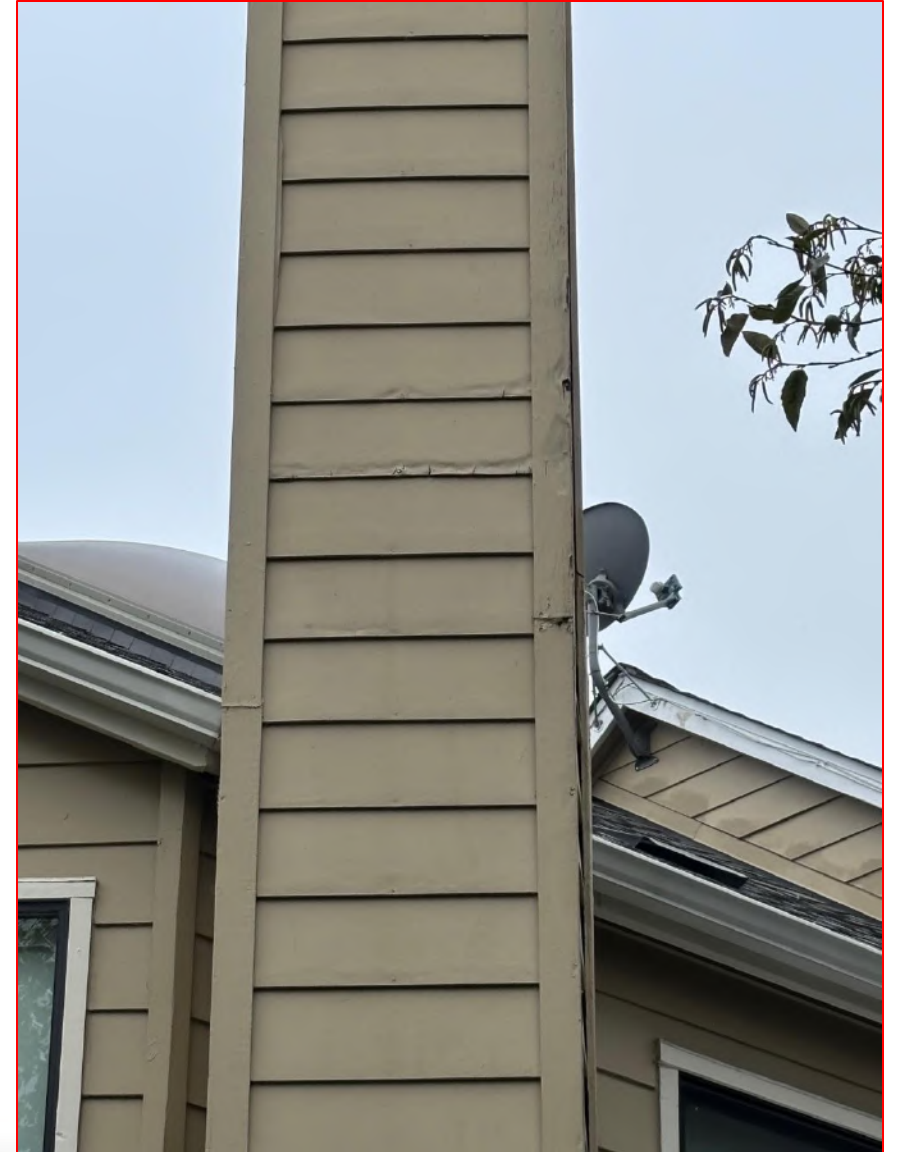
Noted moisture-damaged and deteriorated lap siding below numerous windows and balcony transitions.

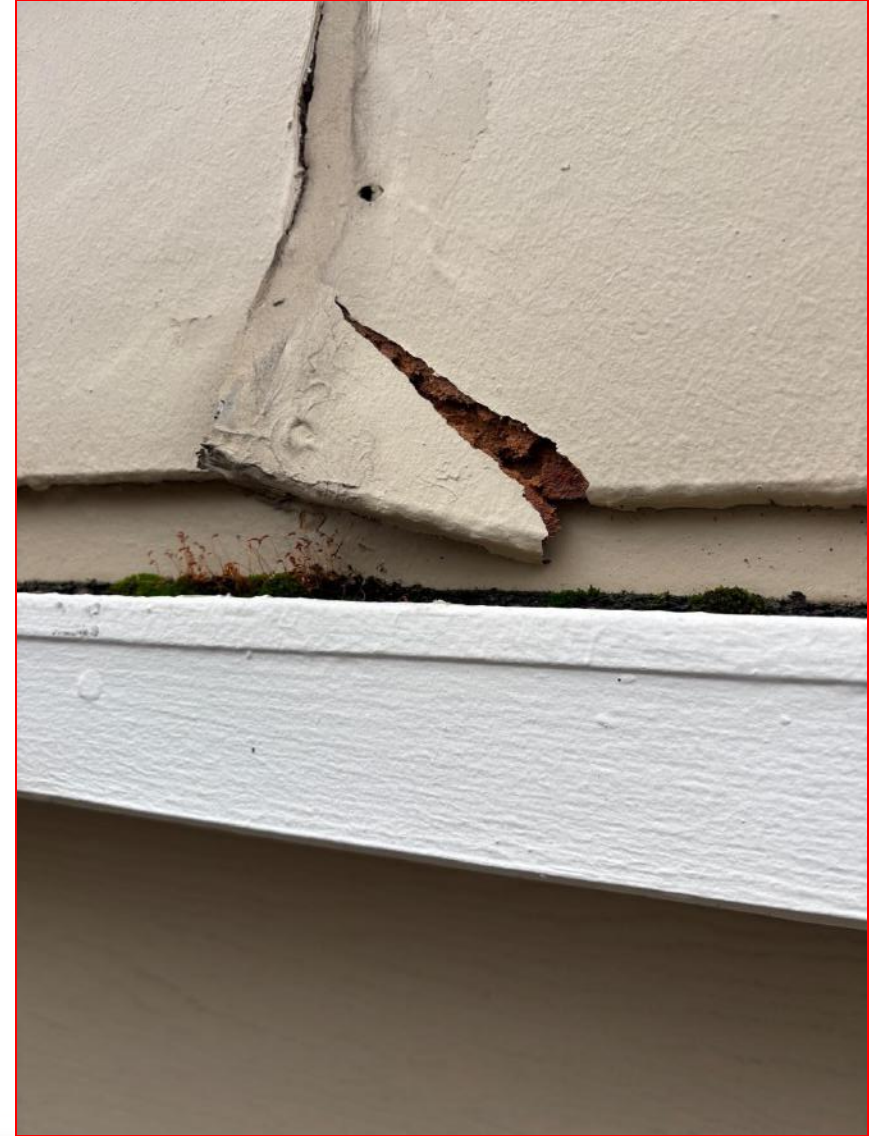
Noted moisture-damaged and deteriorated lap siding - Pervasive

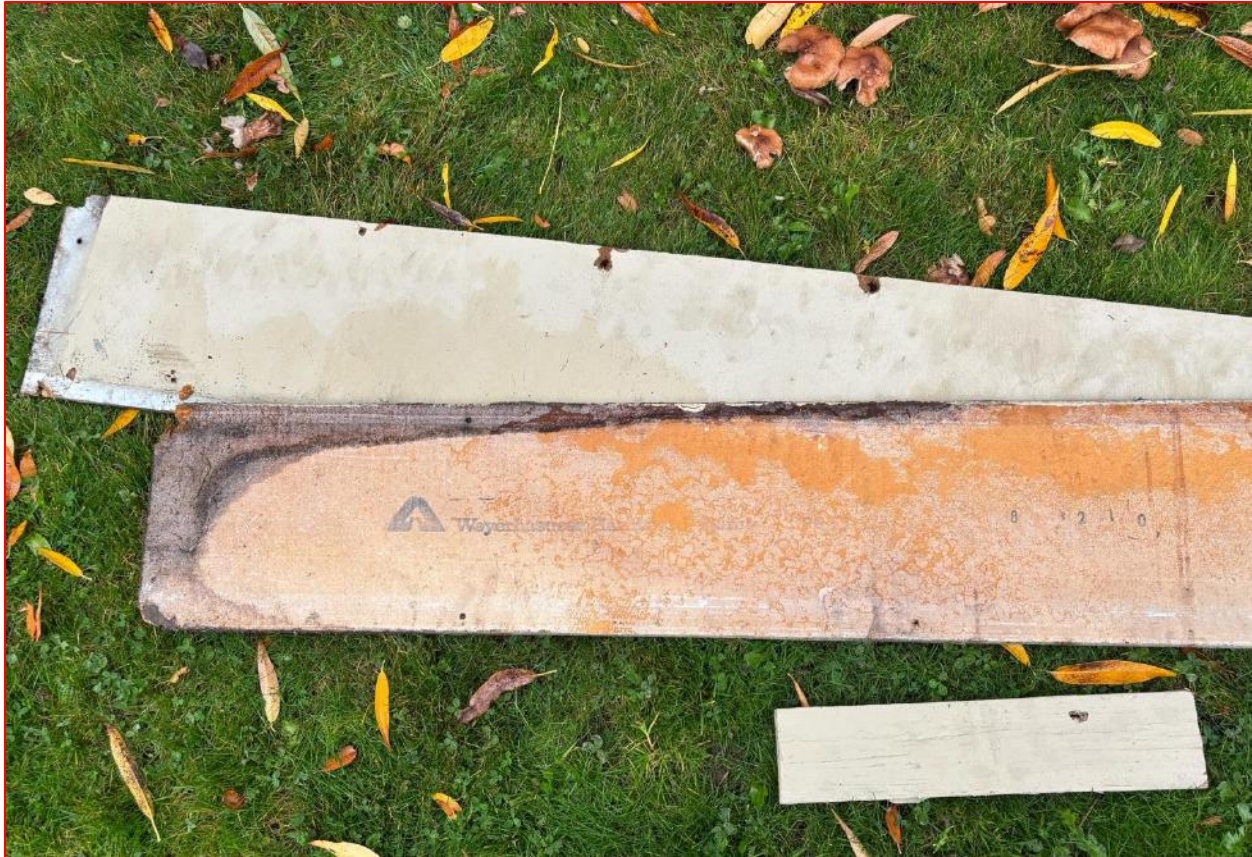
Existing aged and worn wood fiber lap siding. Noted excessive moisture saturation, damage, spot repair, and UV faded coatings. Pervasive

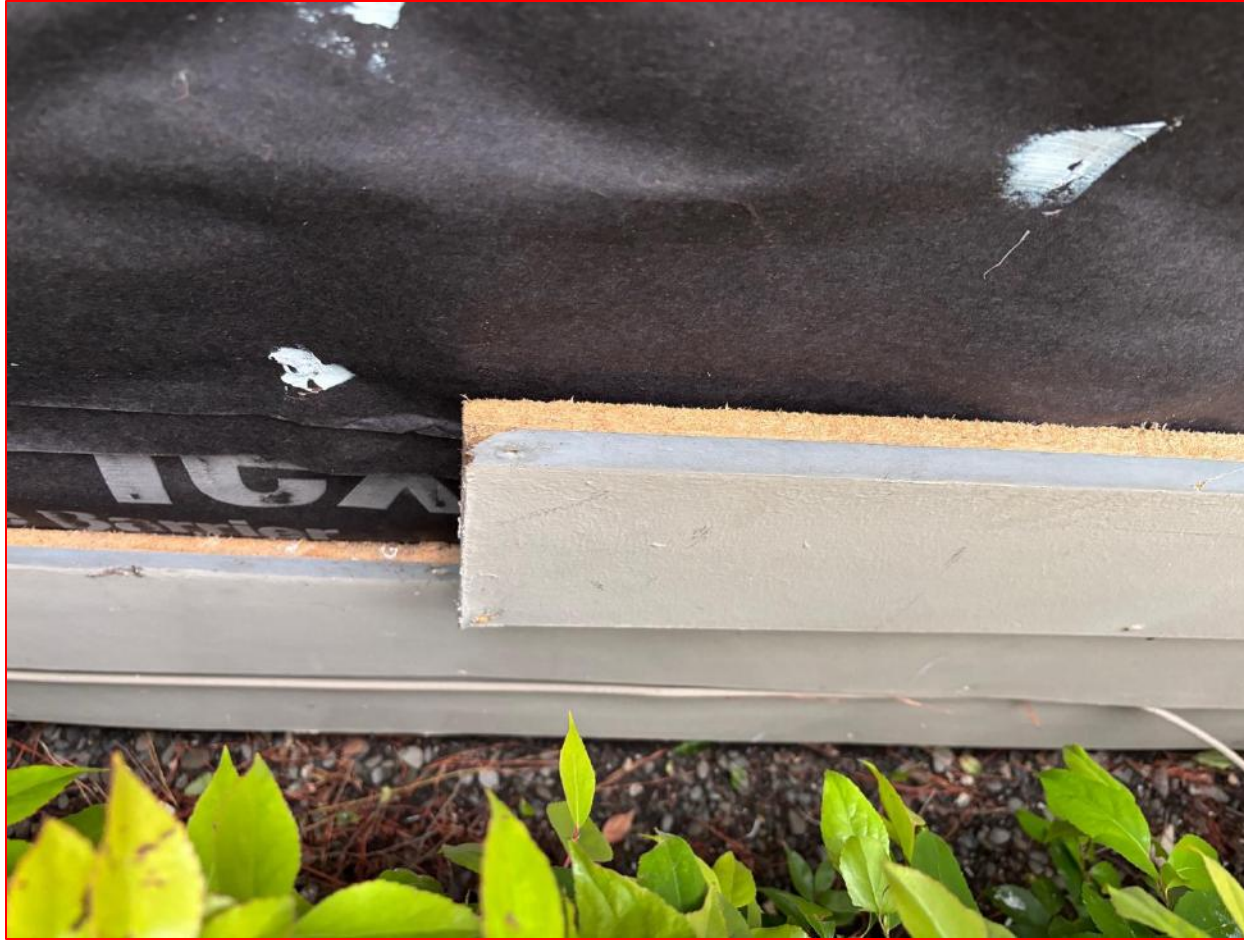
Spot repair locations of aged and worn compressed fiber siding. Note swelled siding and rusting fasteners

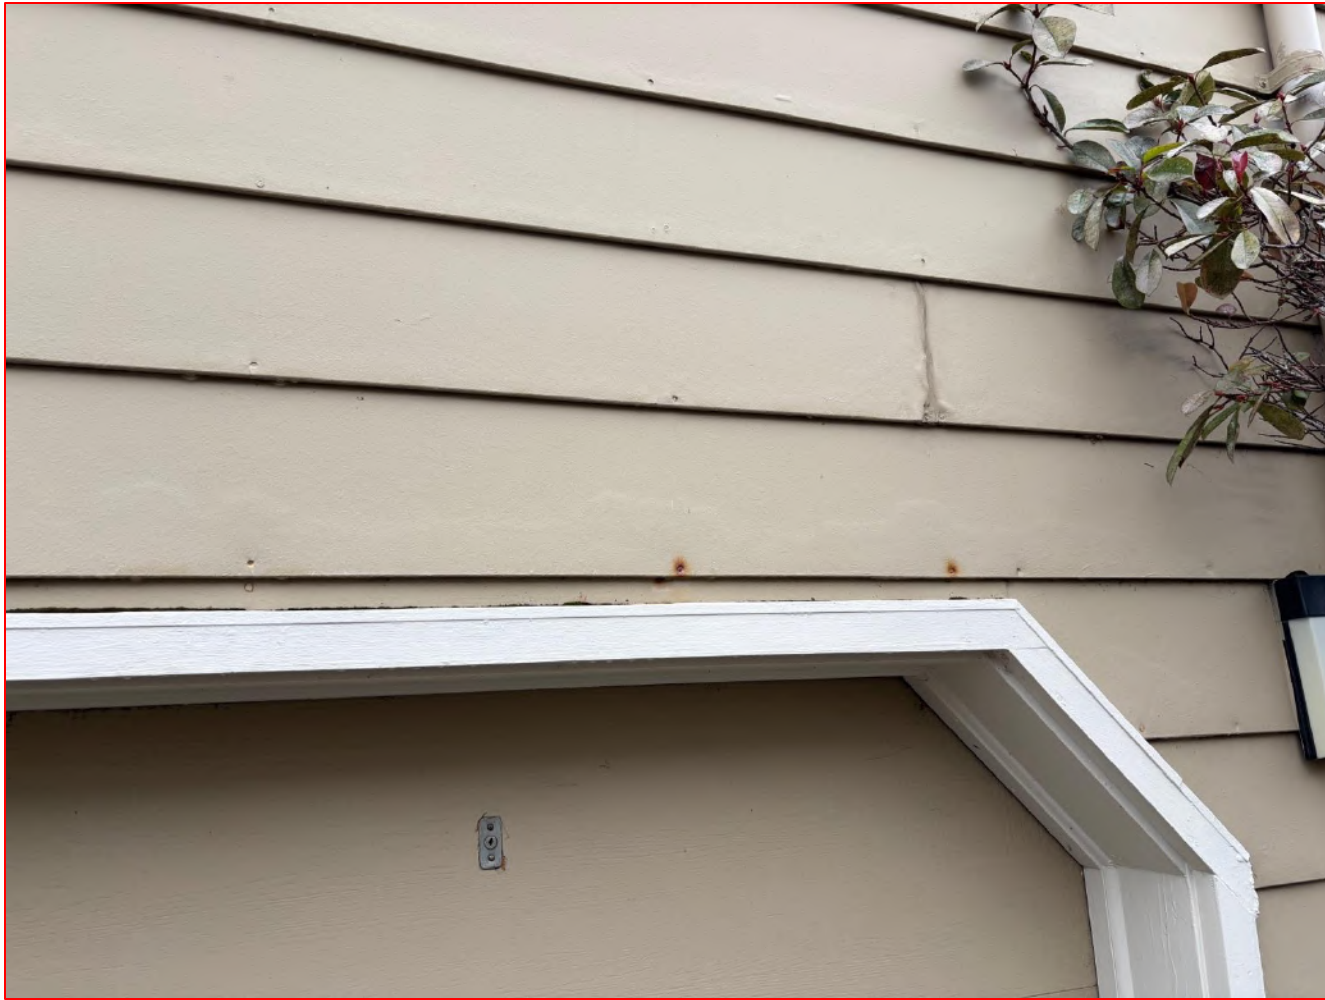
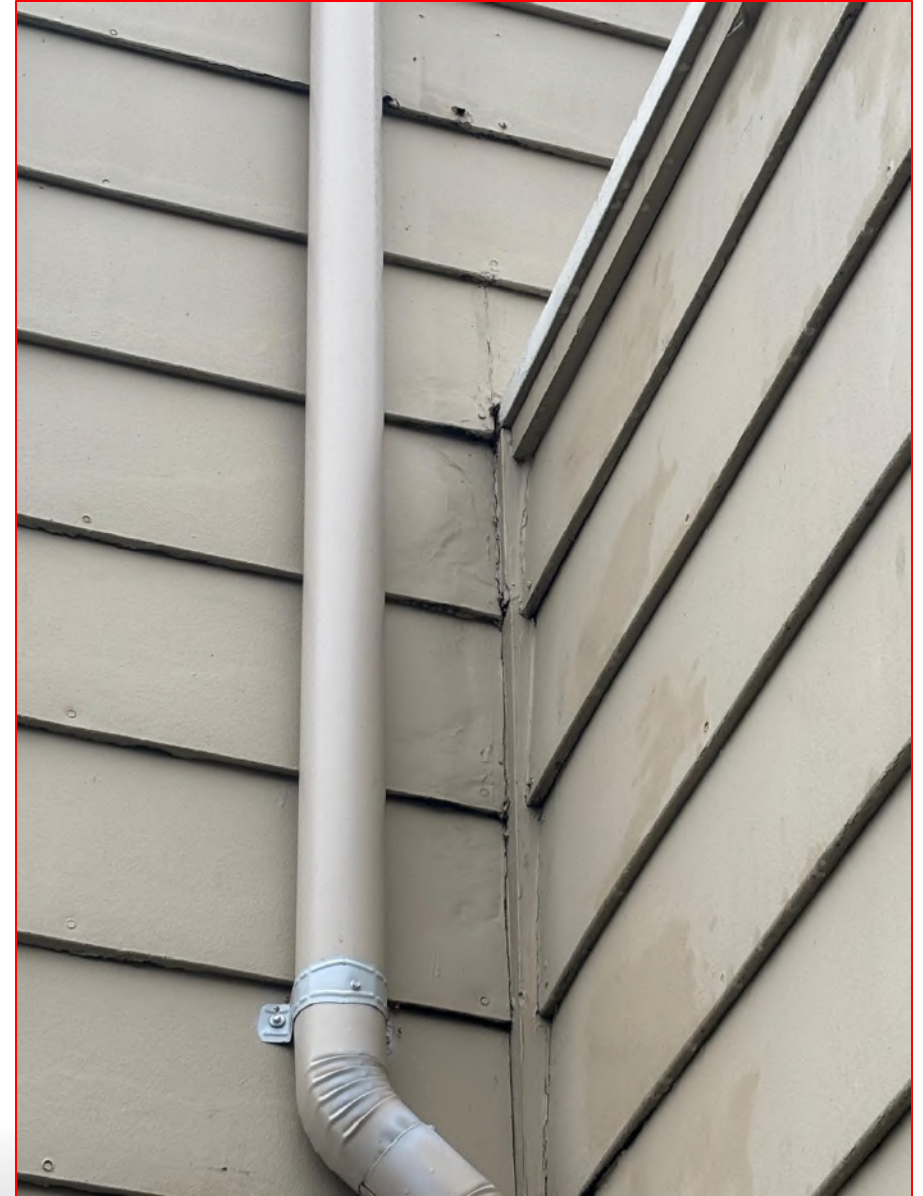
Visible moisture and signs of water intrusion above and below transitions. Pervasive
