Harbortown

San Mateo, CA

INVASIVE BUILDING REVIEW

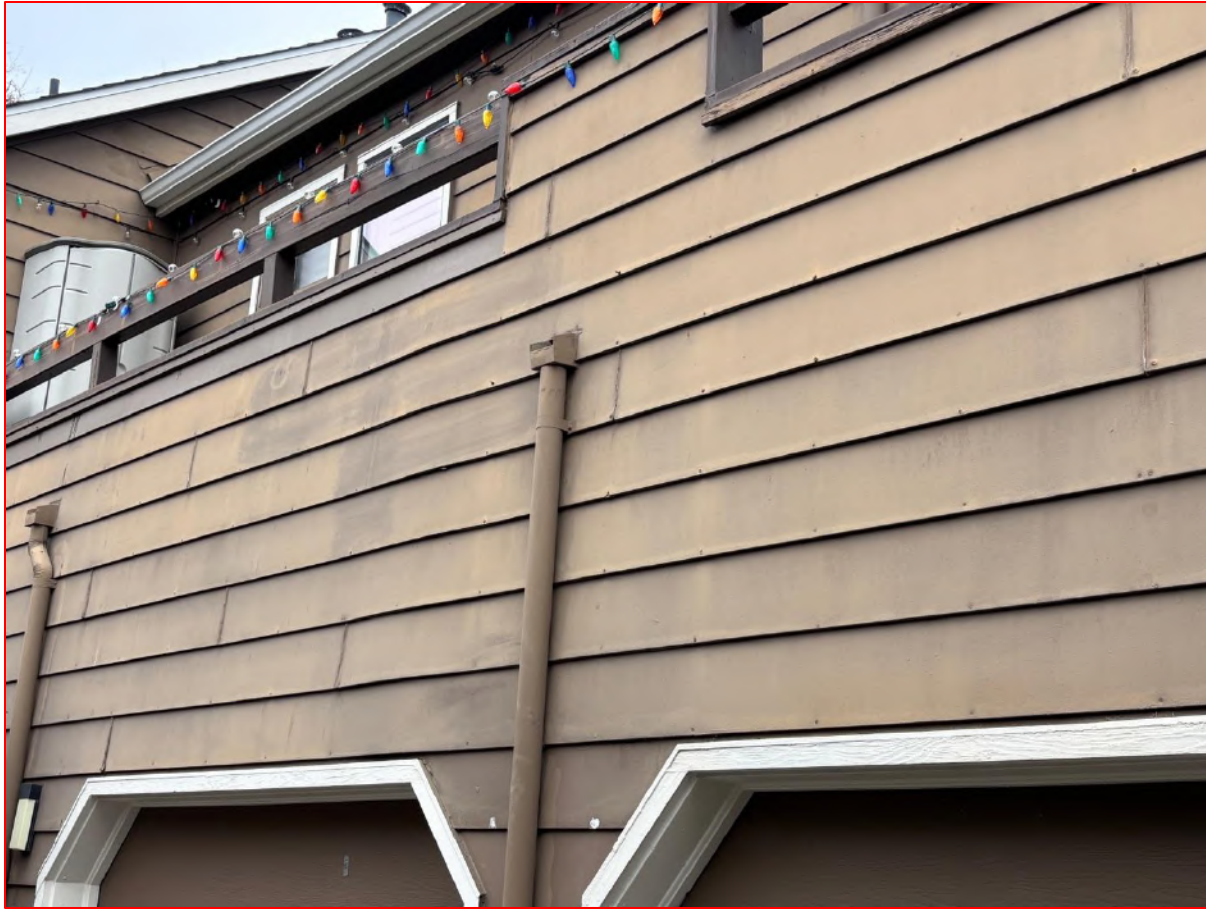
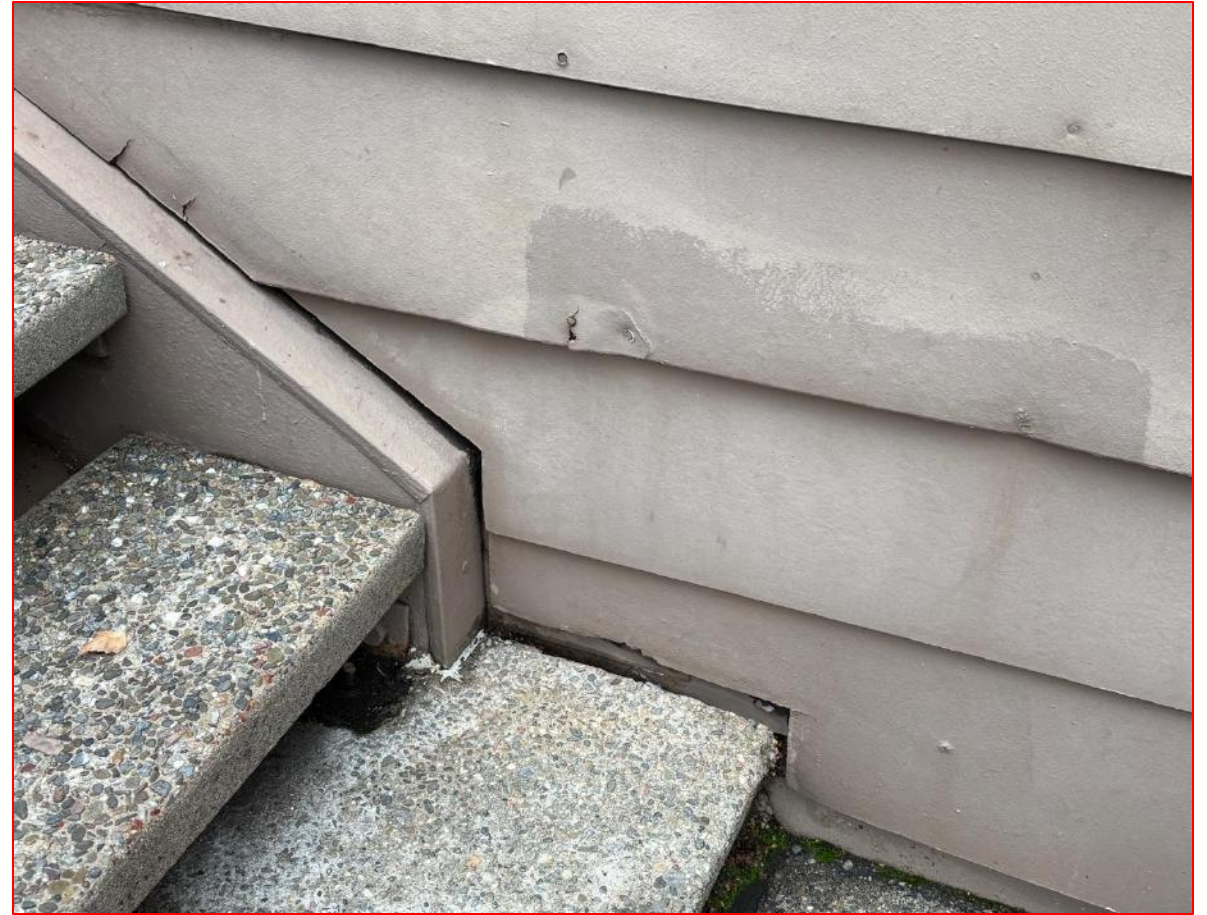
Aged and Worn lap siding. Swelled, damp, deteriorated, damaged siding, and UV Faded Coatings - Pervasive

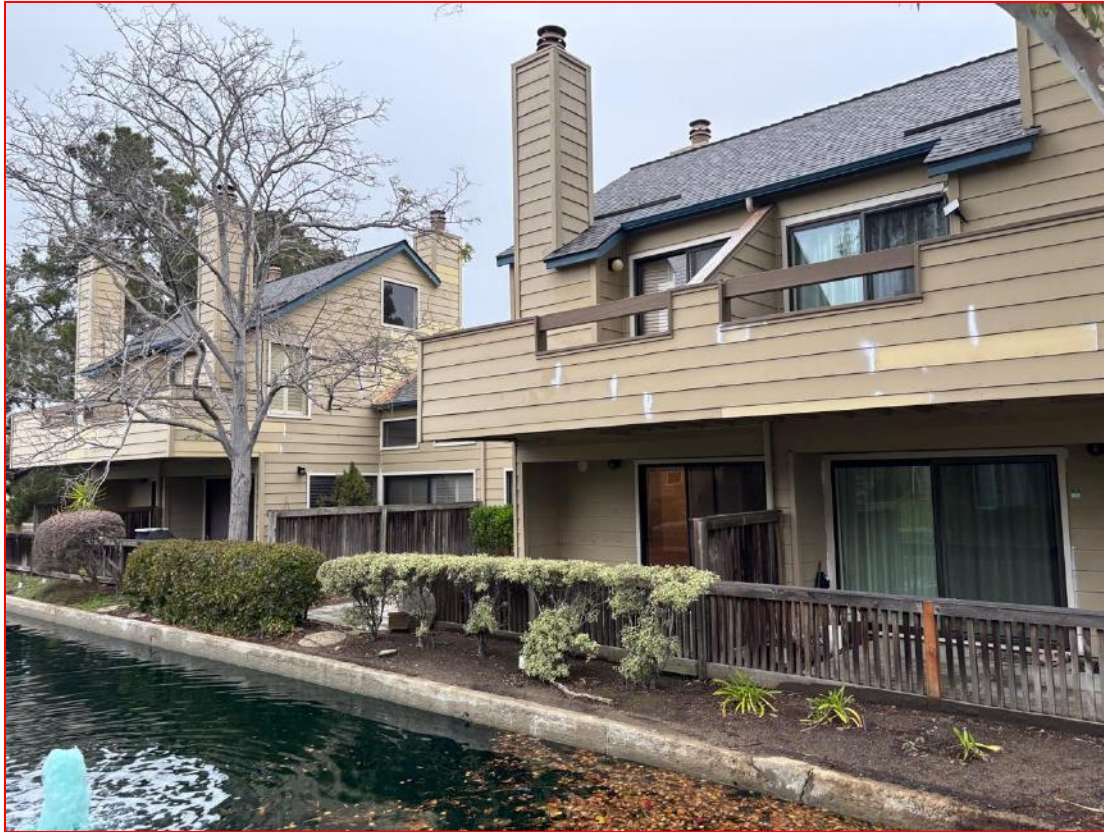
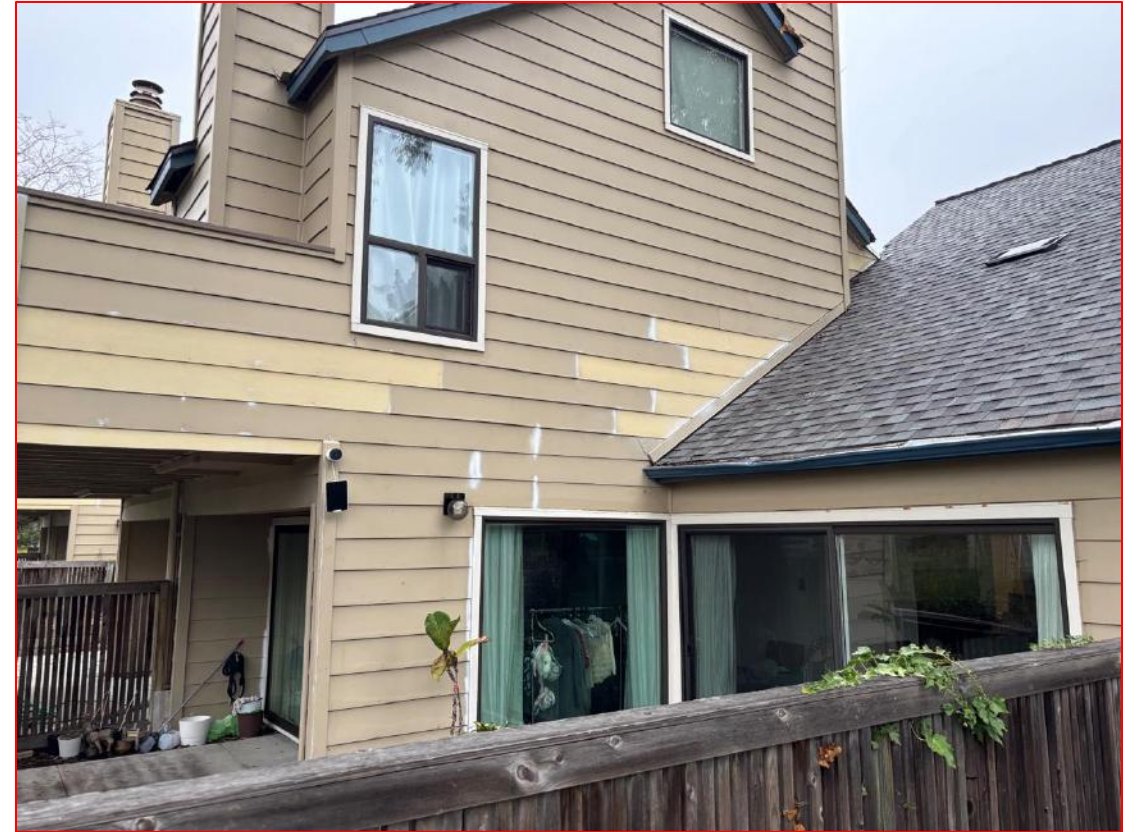
Recent "Spot" Repaired Lap Siding

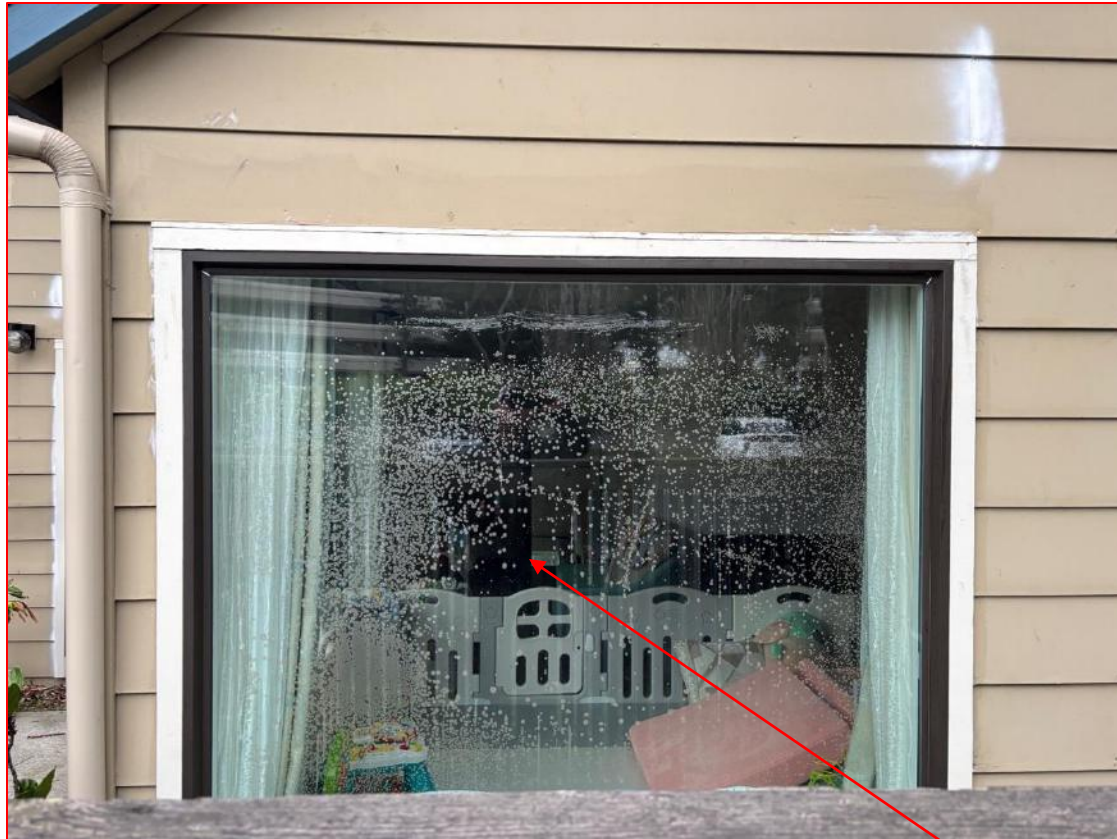
Aged and Worn Windows. Noted numerous failing seals, gaskets, screens, and frames. Pervasive

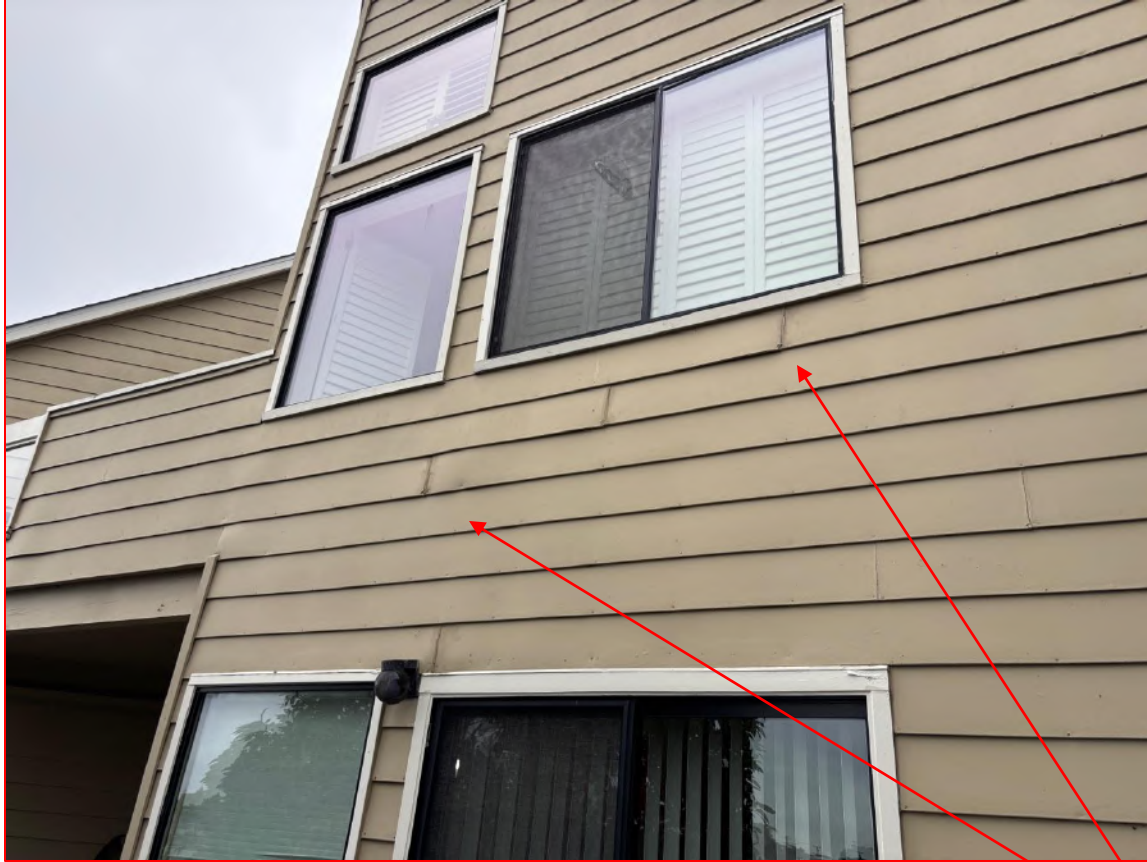
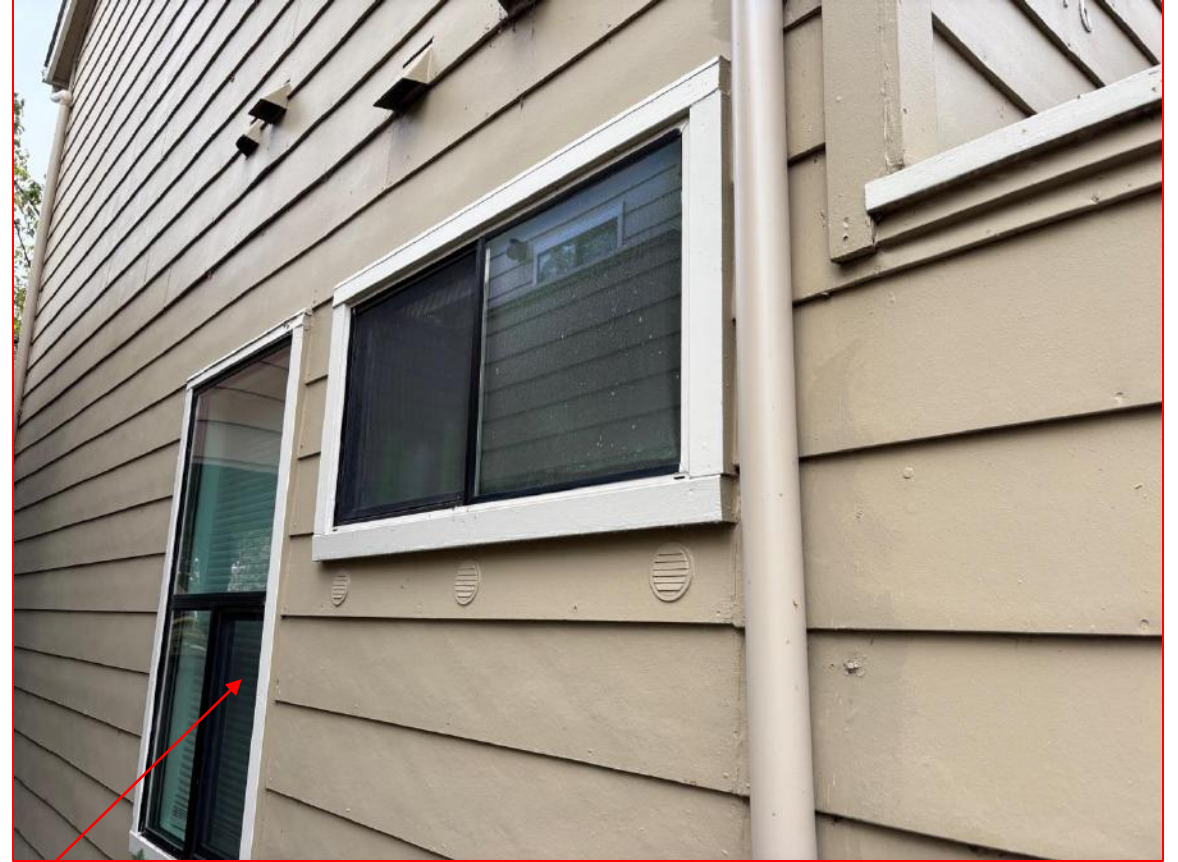
Aged and Updated Flanged Windows with signs of moisture penetration behind the lap siding - Pervasive

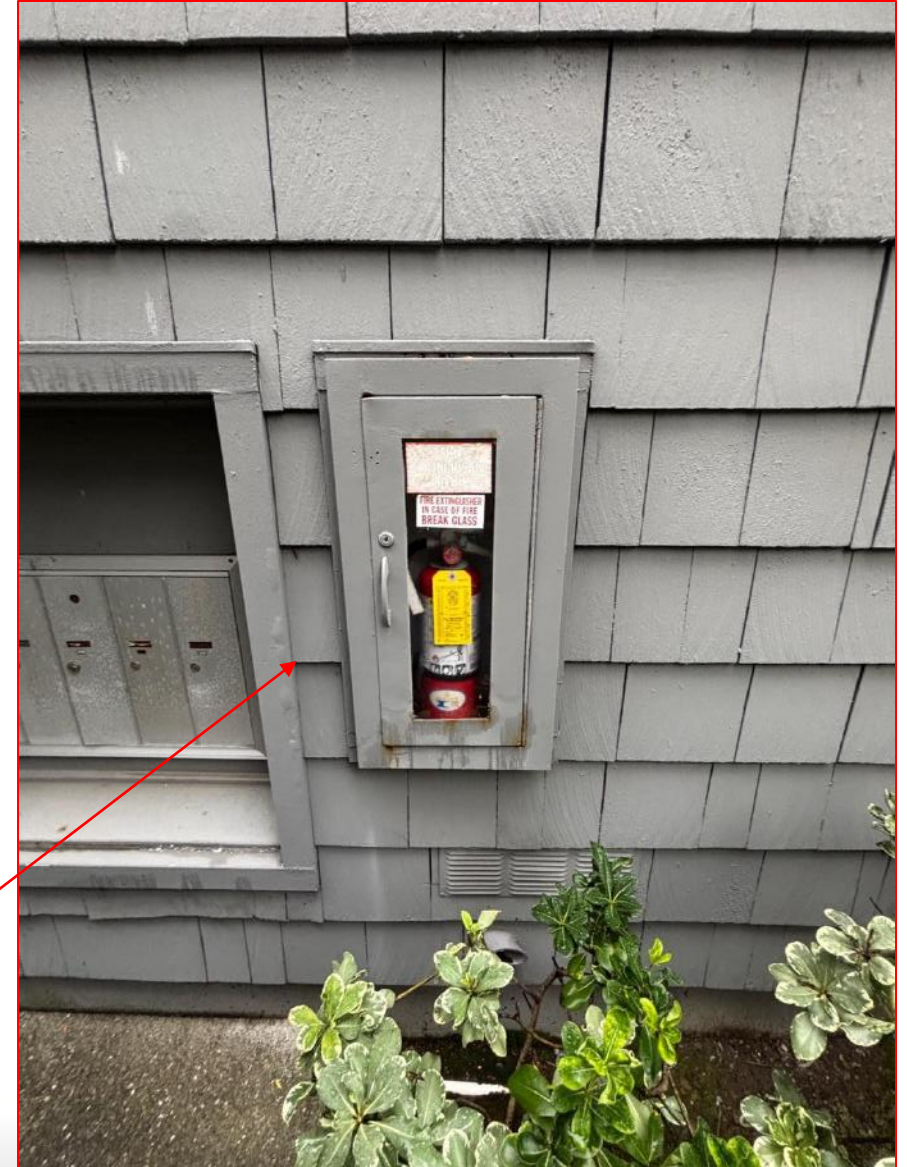
Aged, Worn, Weathered, and UV Degraded deck coating, and common area mailboxes, utility doors, and extinguisher boxes

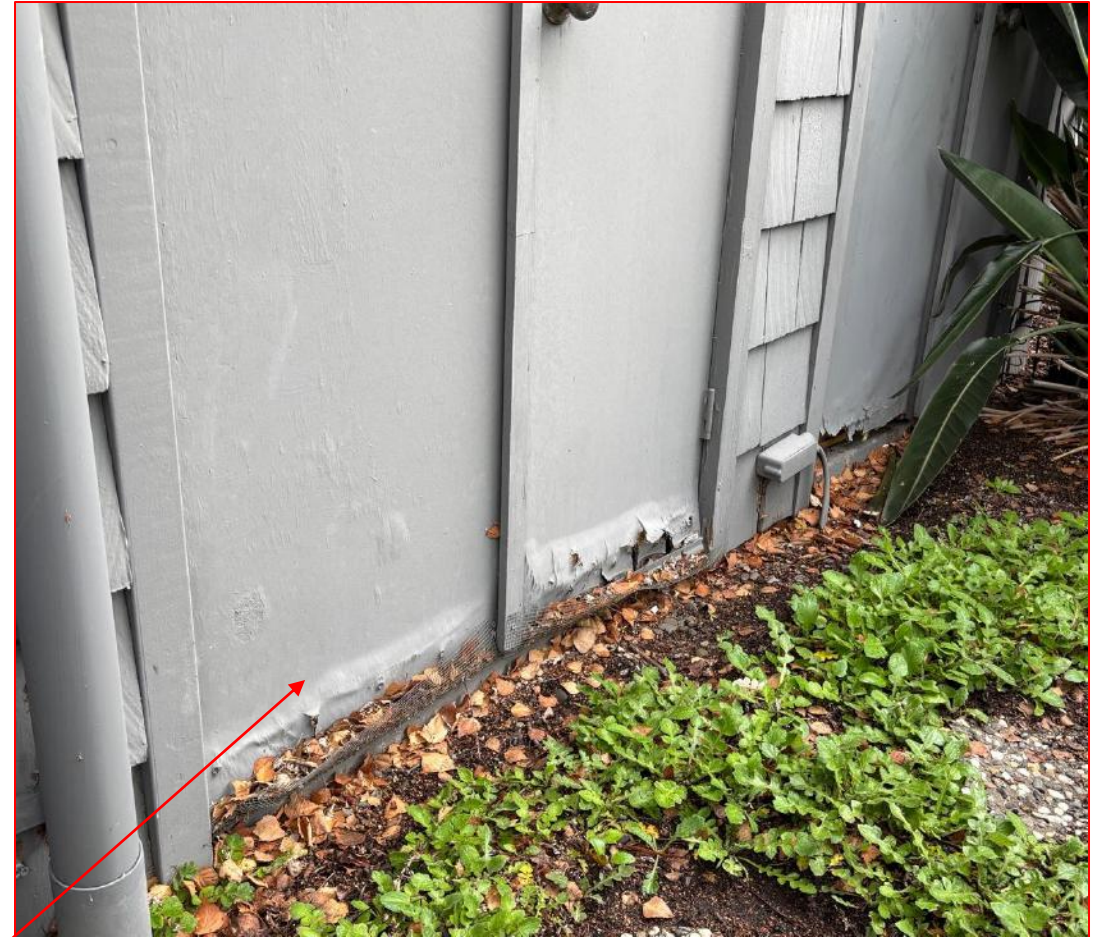
Aged, Worn, Weathered, and UV Degraded Utility Doors.
Pervasive

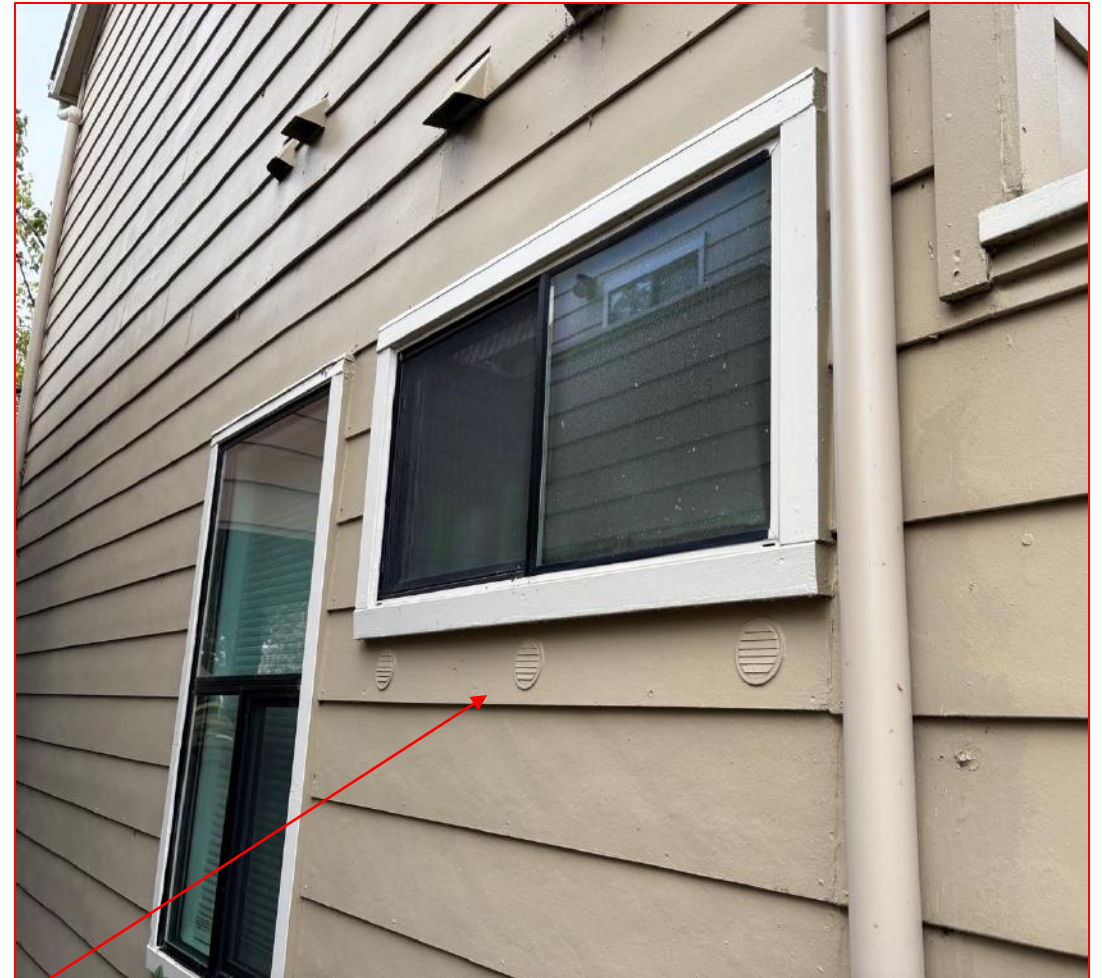
Aged, Worn, and Varying types of vents at high moisture locations and wall cavities. Noted many were clogged and painted closed

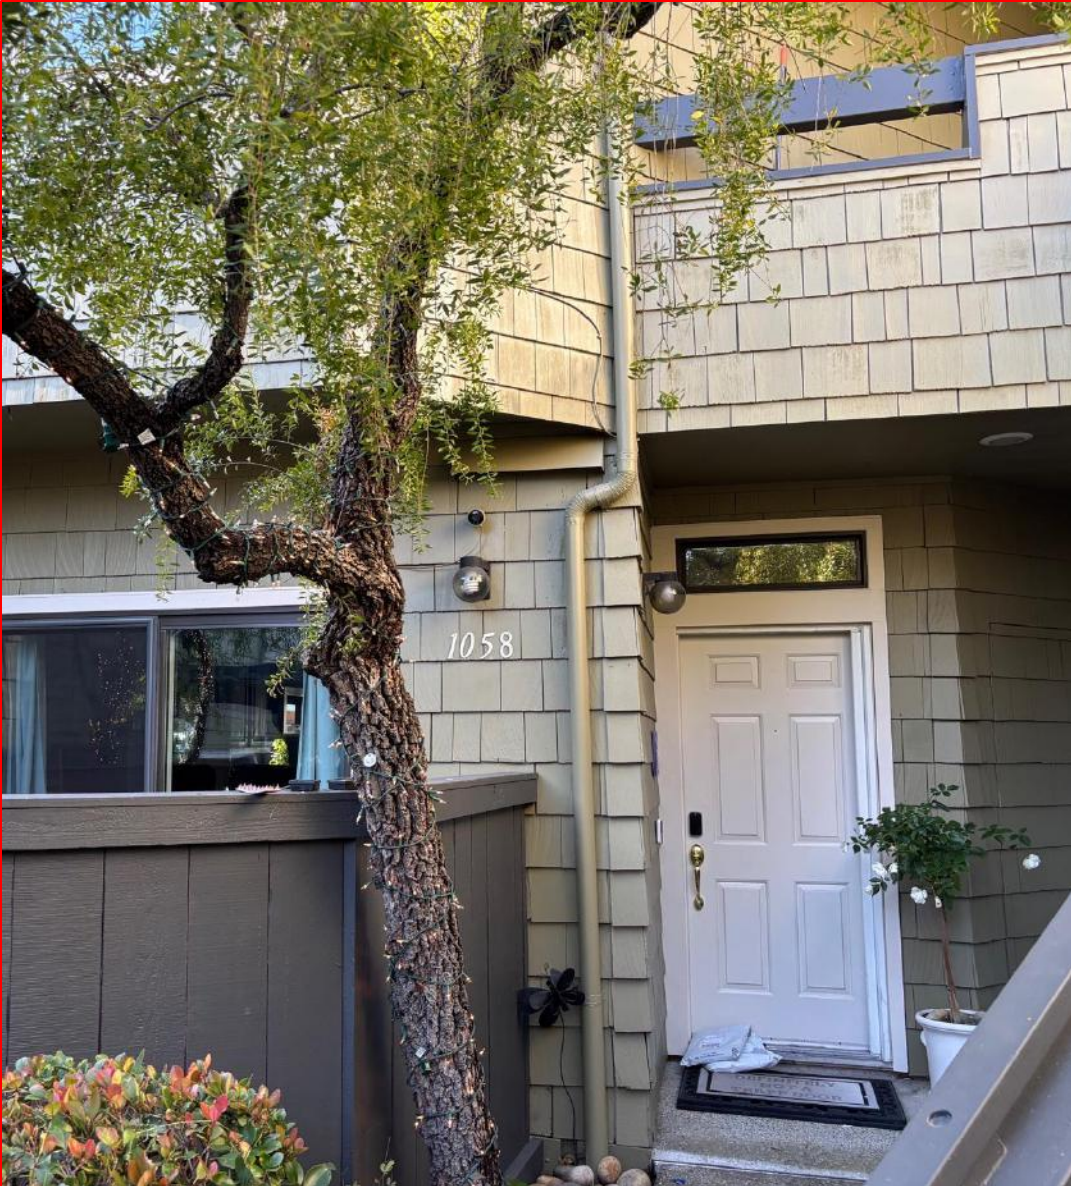
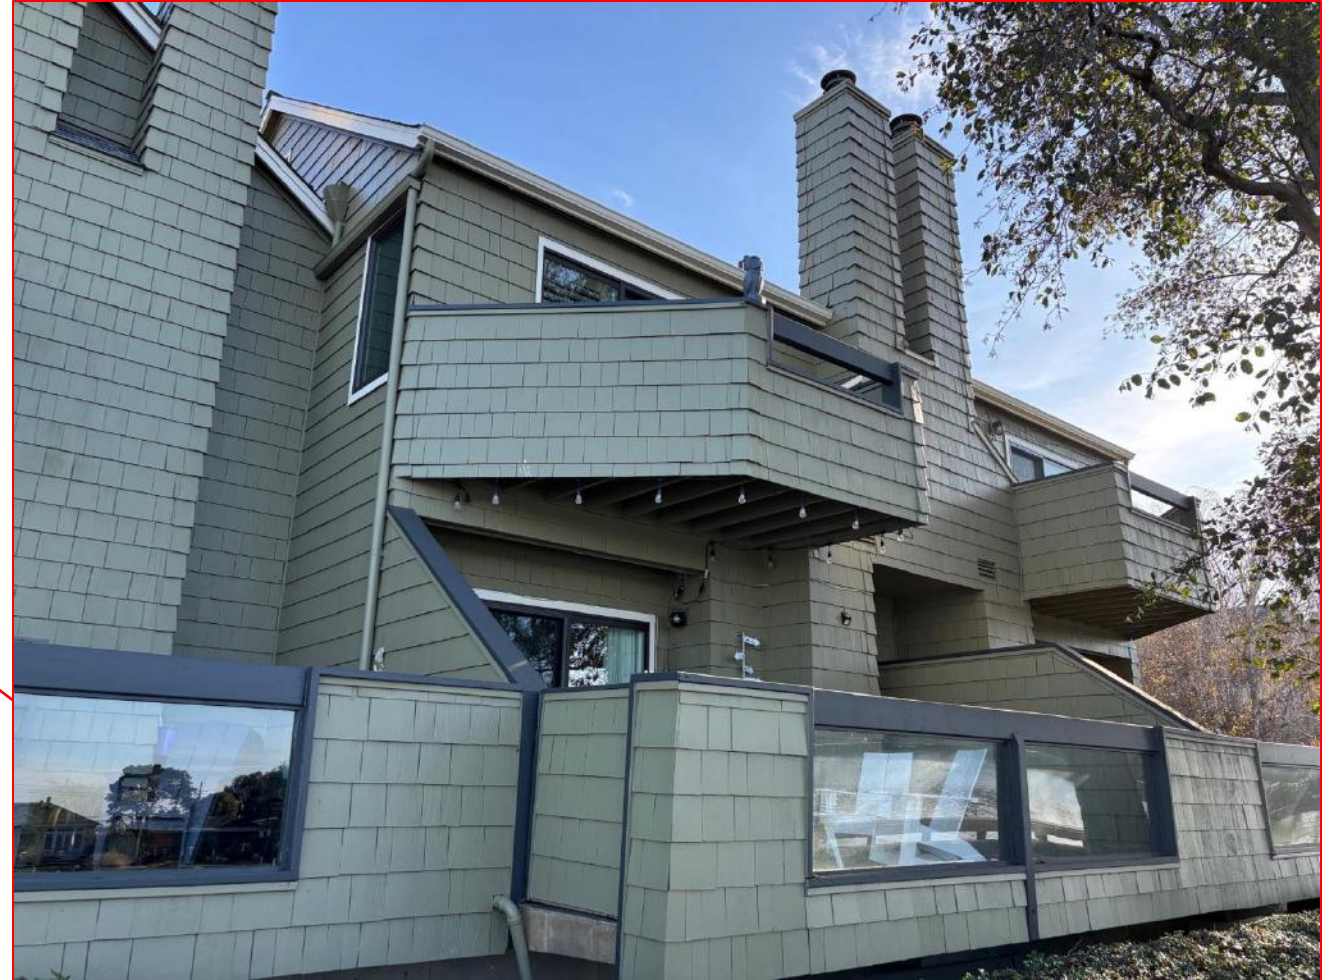
Recently spot repaired and painted wood shingles and building trim.

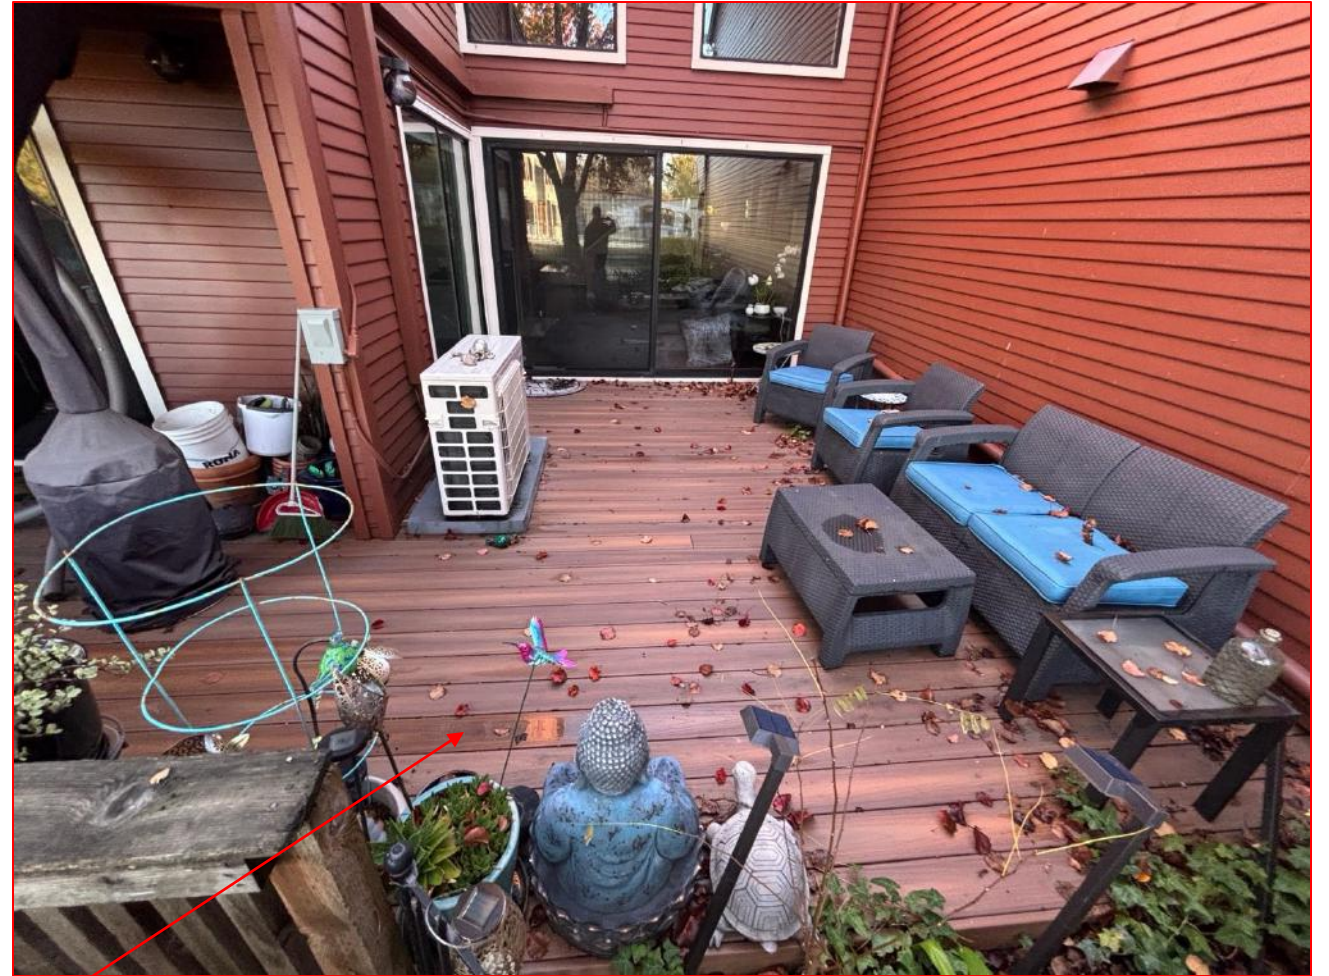
Aged and Worn Wood Decks and Wood Fences. Updated composite decks and recently painted buildings.

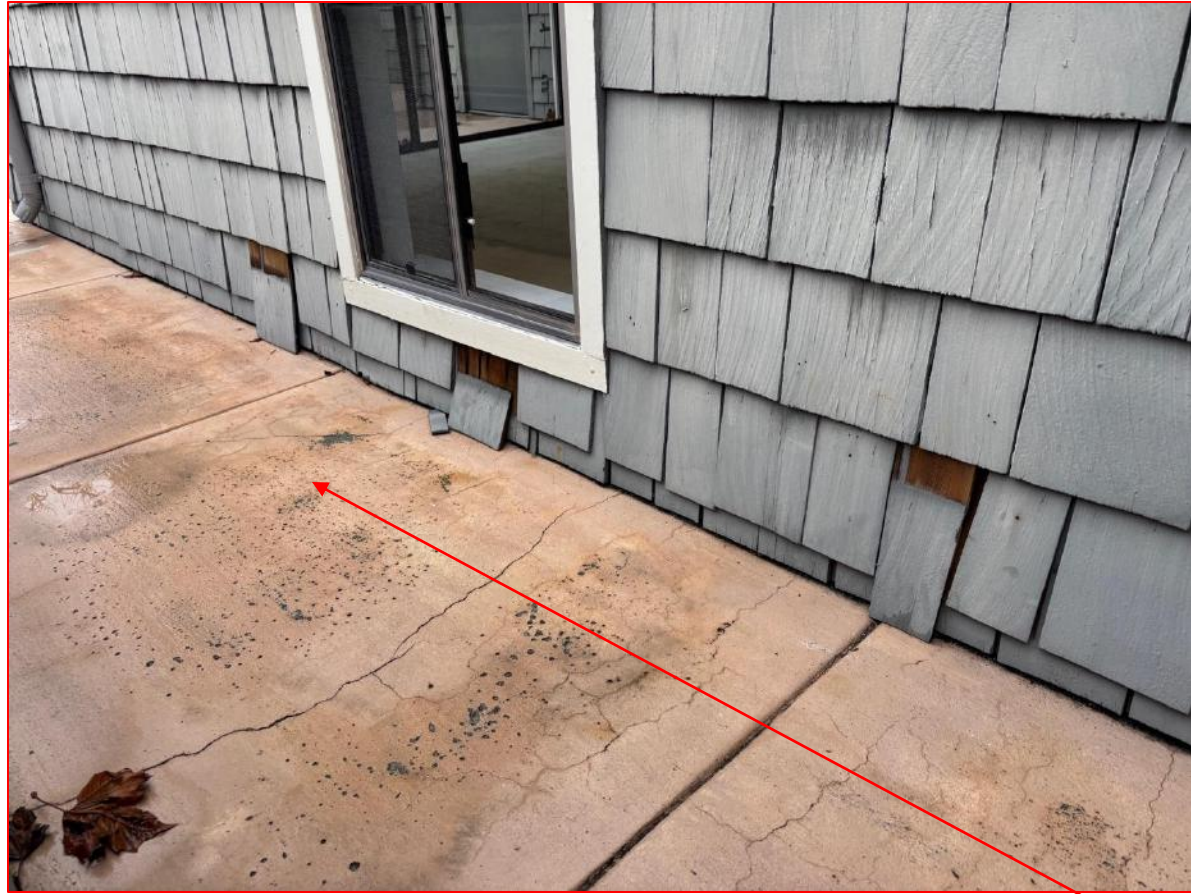
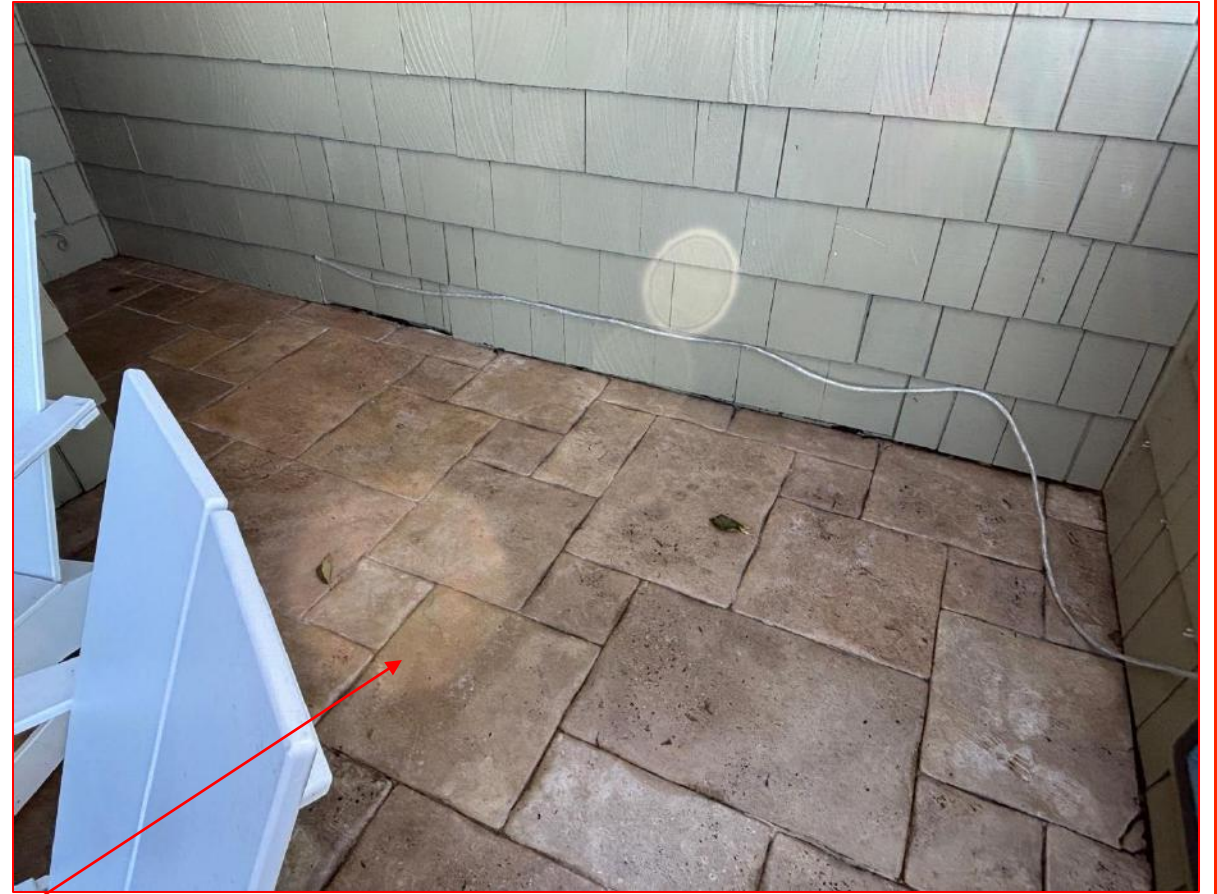
Aged, worn, and weathered balcony surface coatings. Noted varied updated ceramic tile and applied floor coatings.

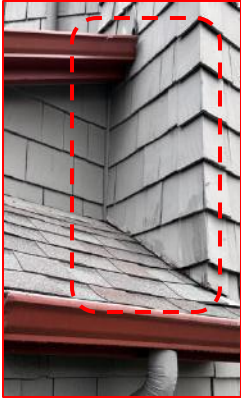
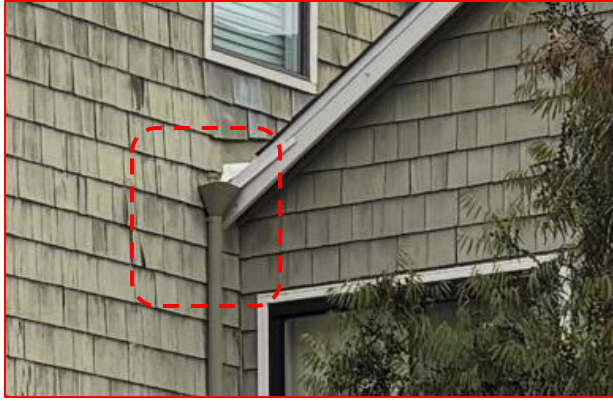
Noted roofing was not installed with “kick outs” or wall diverter flashings. Please note “Kick Outs” will help keep water away and/or from getting behind siding and into the structure of the building.

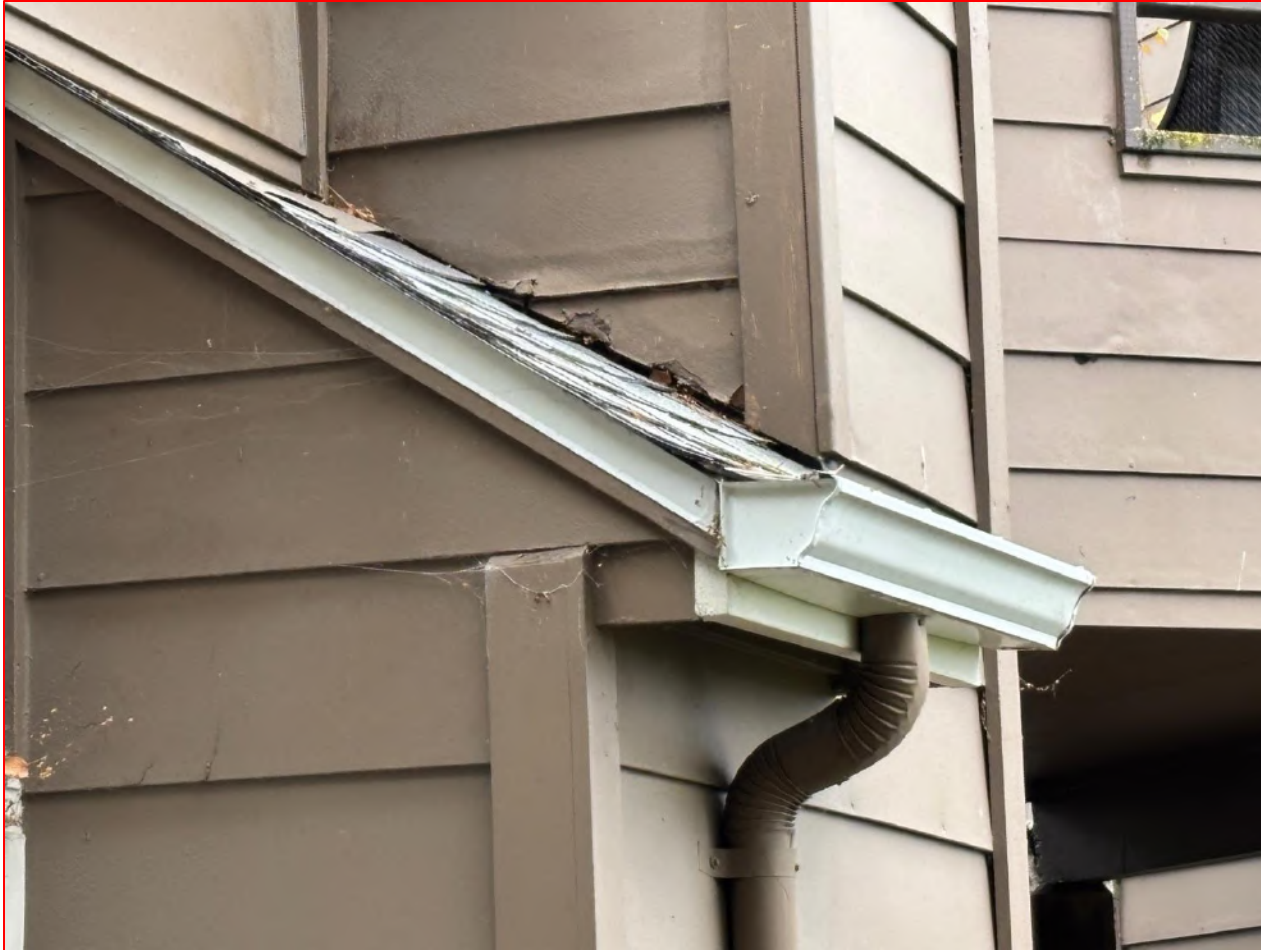
Typical Front roof-to-wall transition at chimneys, and deck railing transitions.

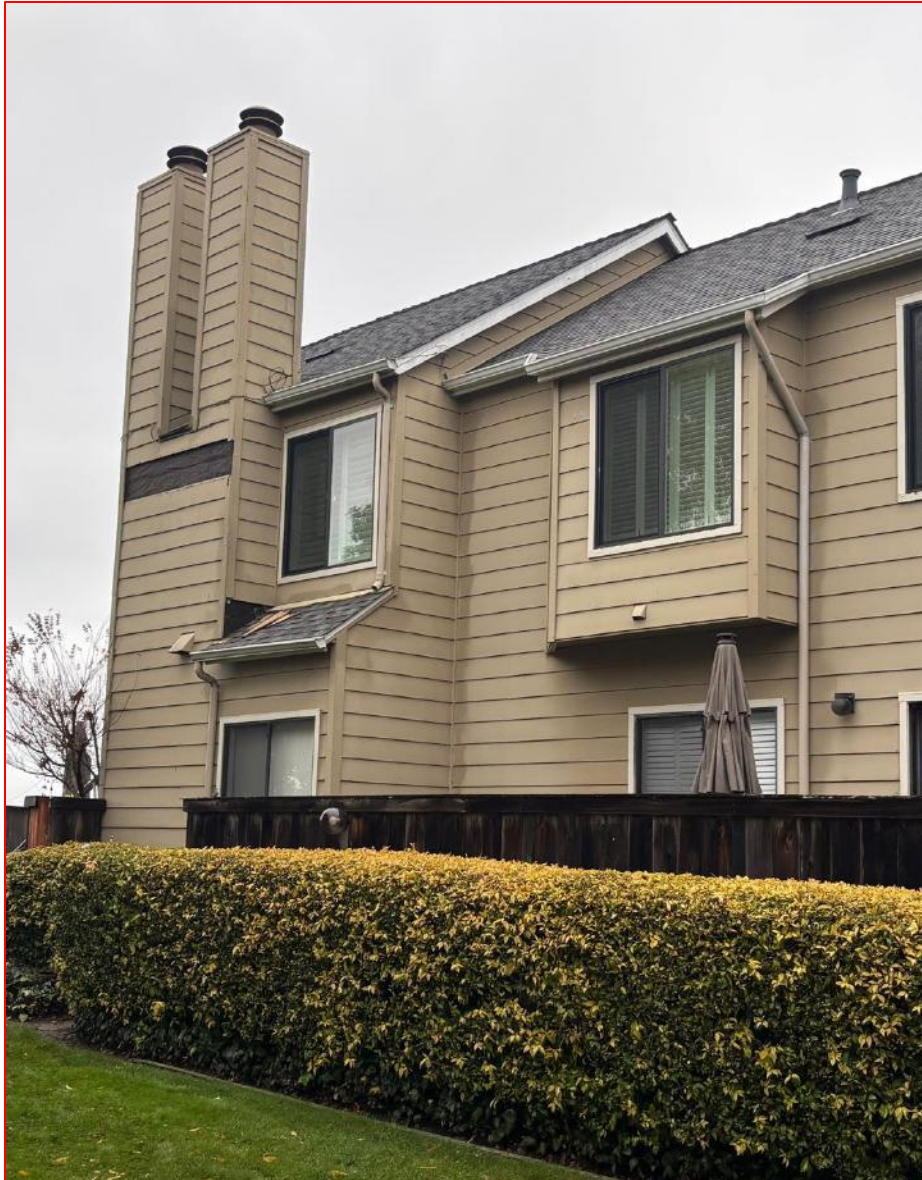
Front roof-to-wall transition. Noted Tyvek WRB System and Grace Installed incorrectly over cedar shingles with – Poor Sequencing

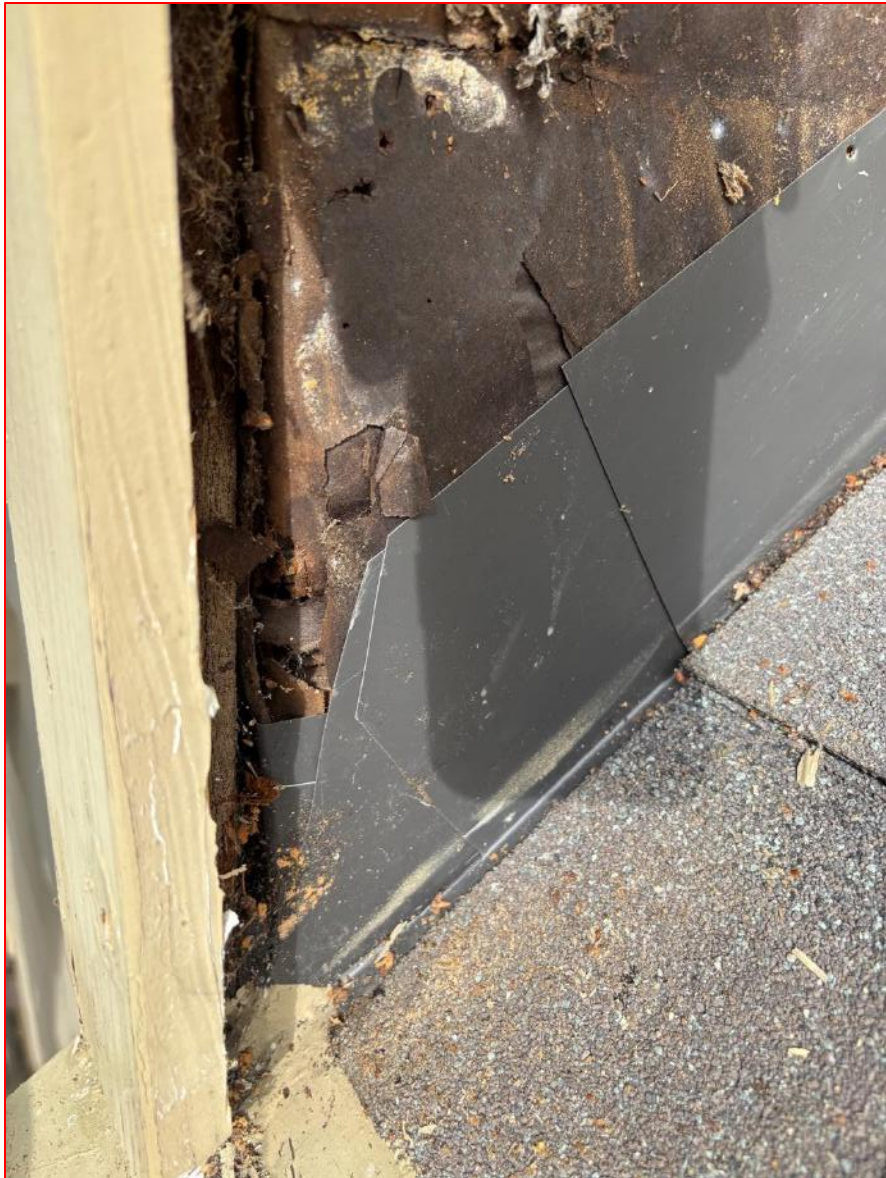
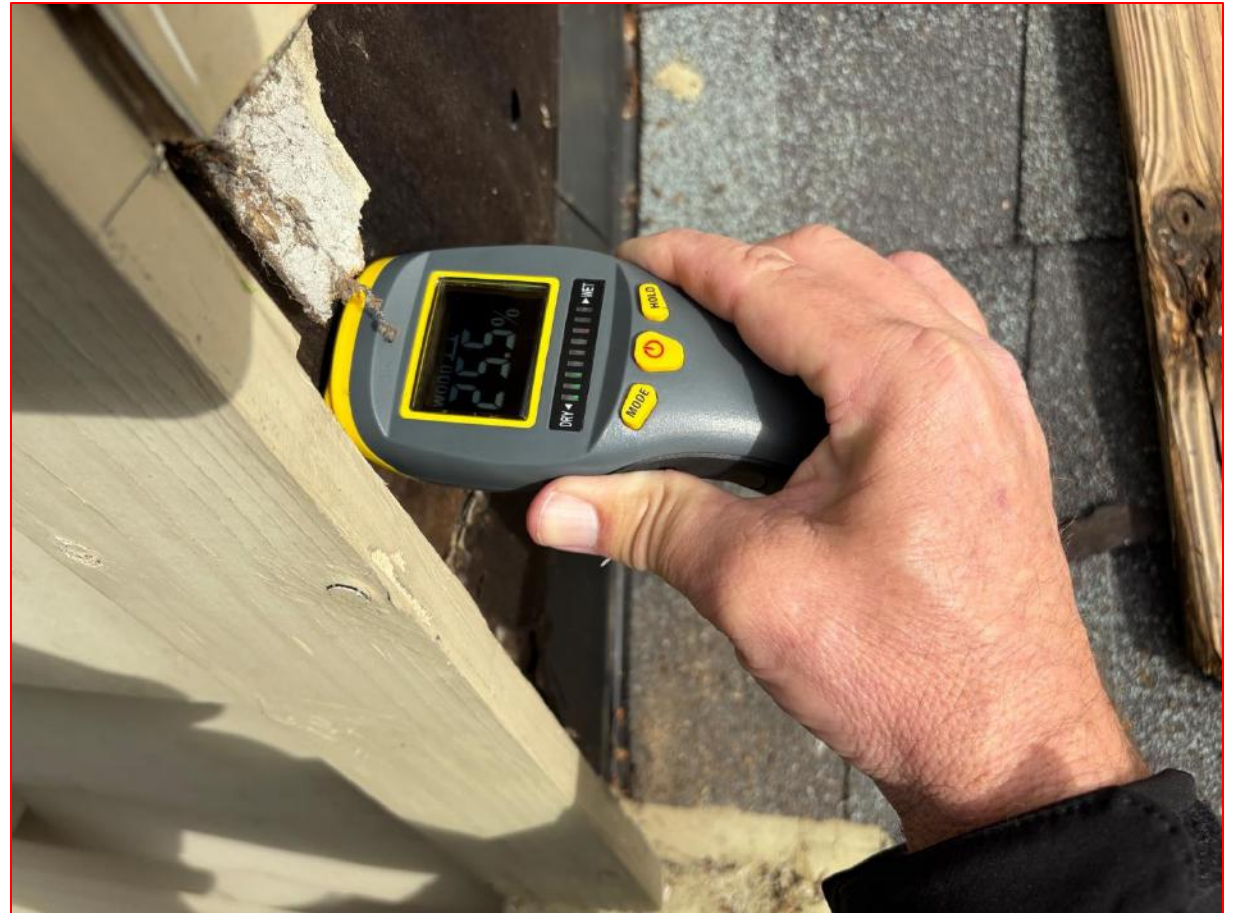
Typical transitions at Chimney Boxes. Noted aged and worn felt paper WRB and lack of membrane flashing at the roof-to-wall transitions. Detected elevated moisture readings at the base of the chimneys inspected

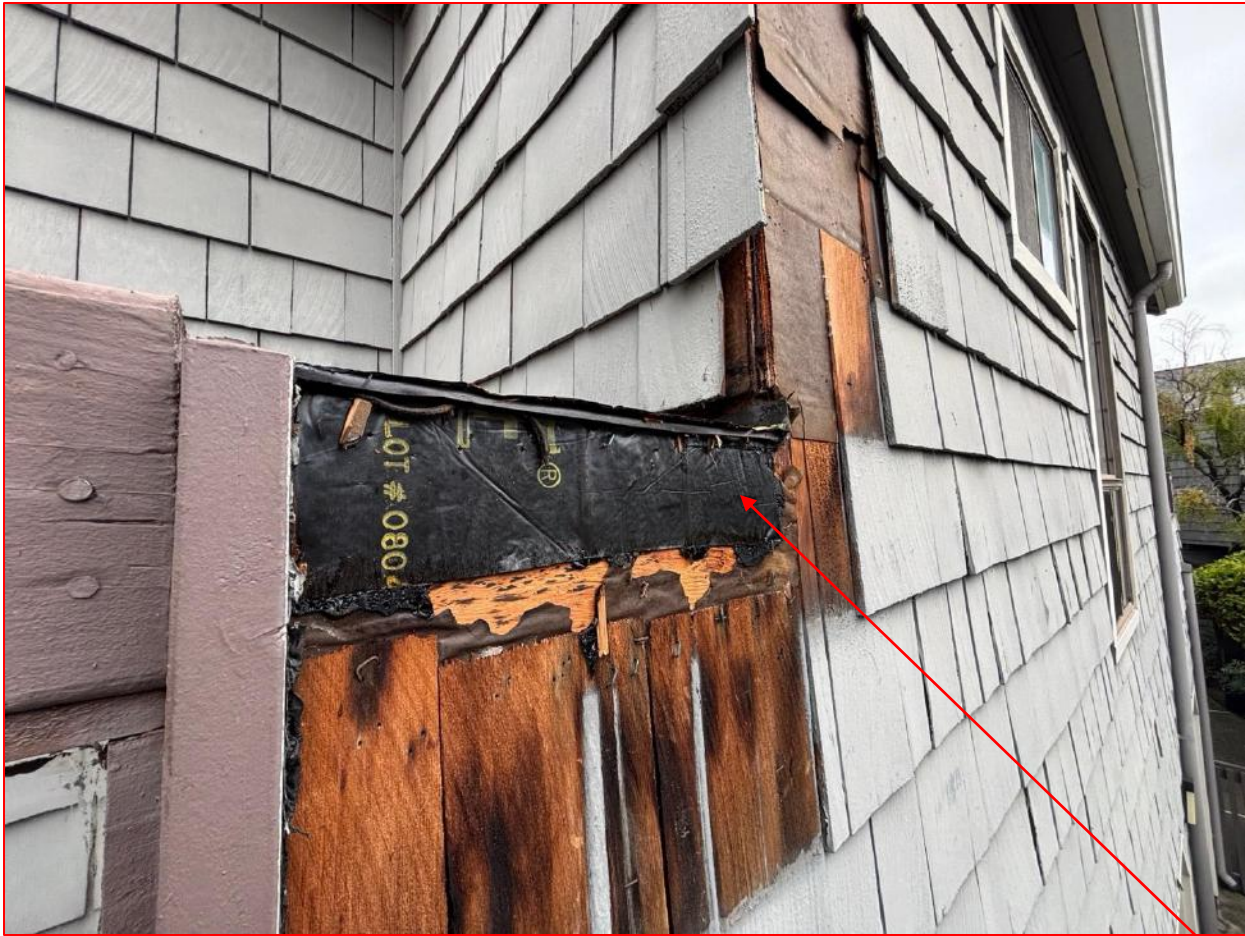
Typical deck-to-wall transition. Noted spot repaired flashing and aged and worn felt paper WRB. Detected elevated moisture readings. Please Note: Moisture readings of 12% and Less can be considered to be "Dry"
