Harbortown

San Mateo, CA

INVASIVE BUILDING REVIEW

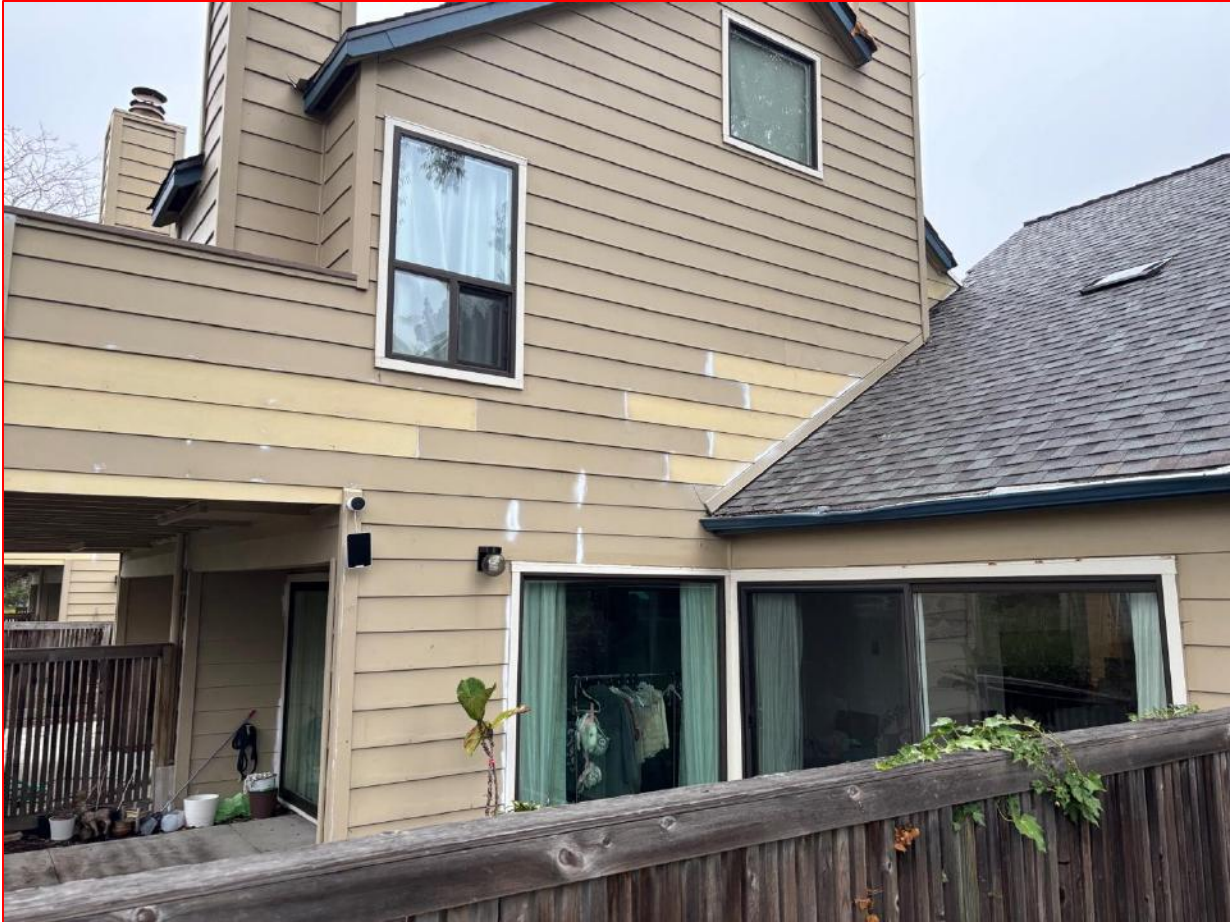
Aged, Worn, and Updated Vinyl Flanged Casement Windows, Bay Windows, Picture Windows, Awning Windows and Patio Doors

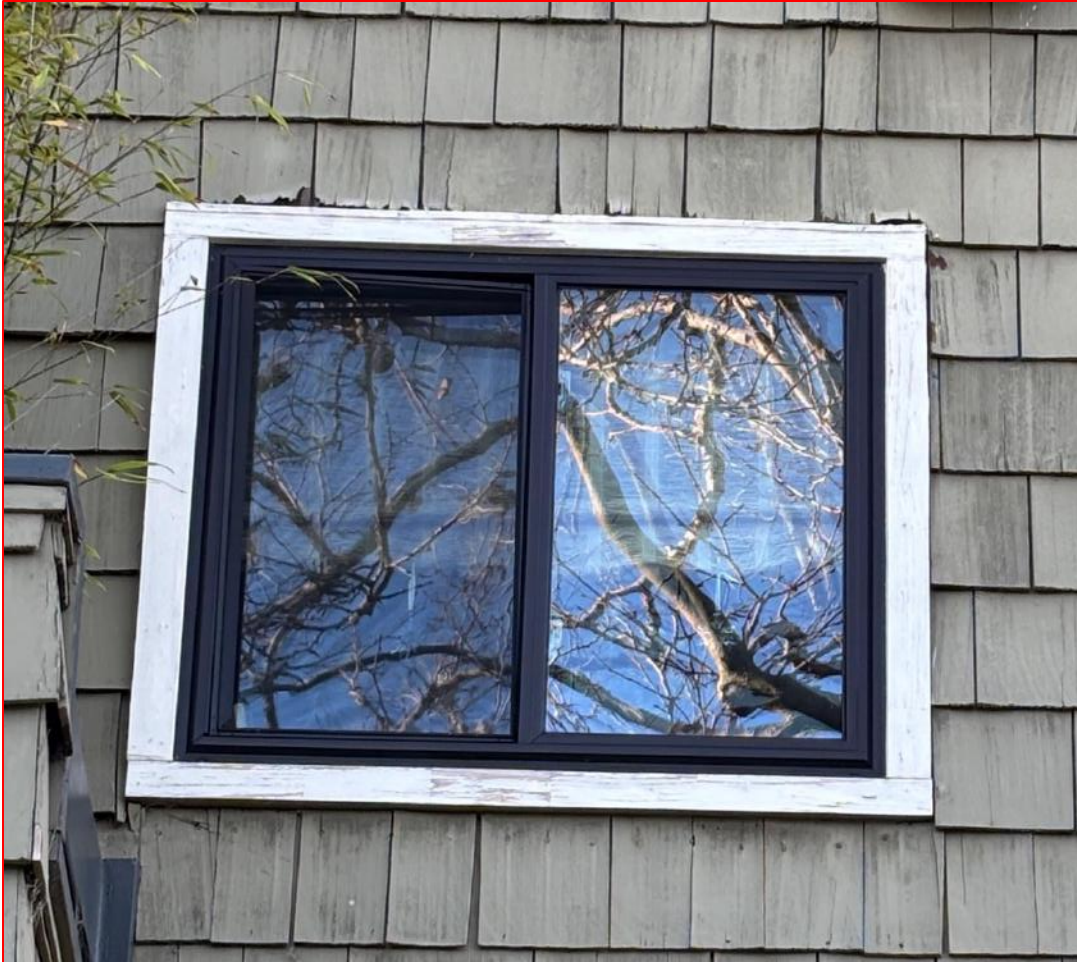
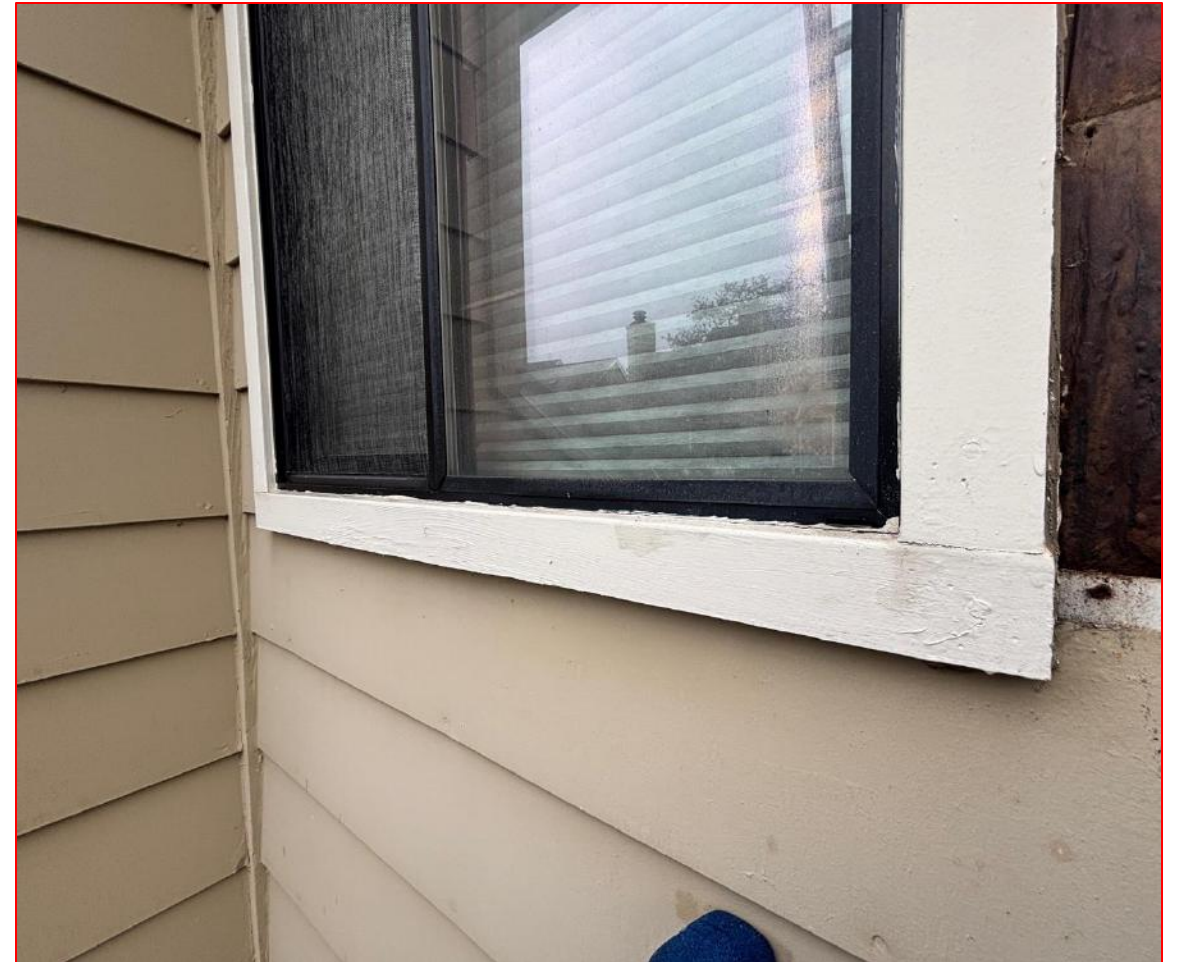
Aged, Worn, and Updated Vinyl Flanged Windows, Rolling Windows, Picture Windows, Awning Windows

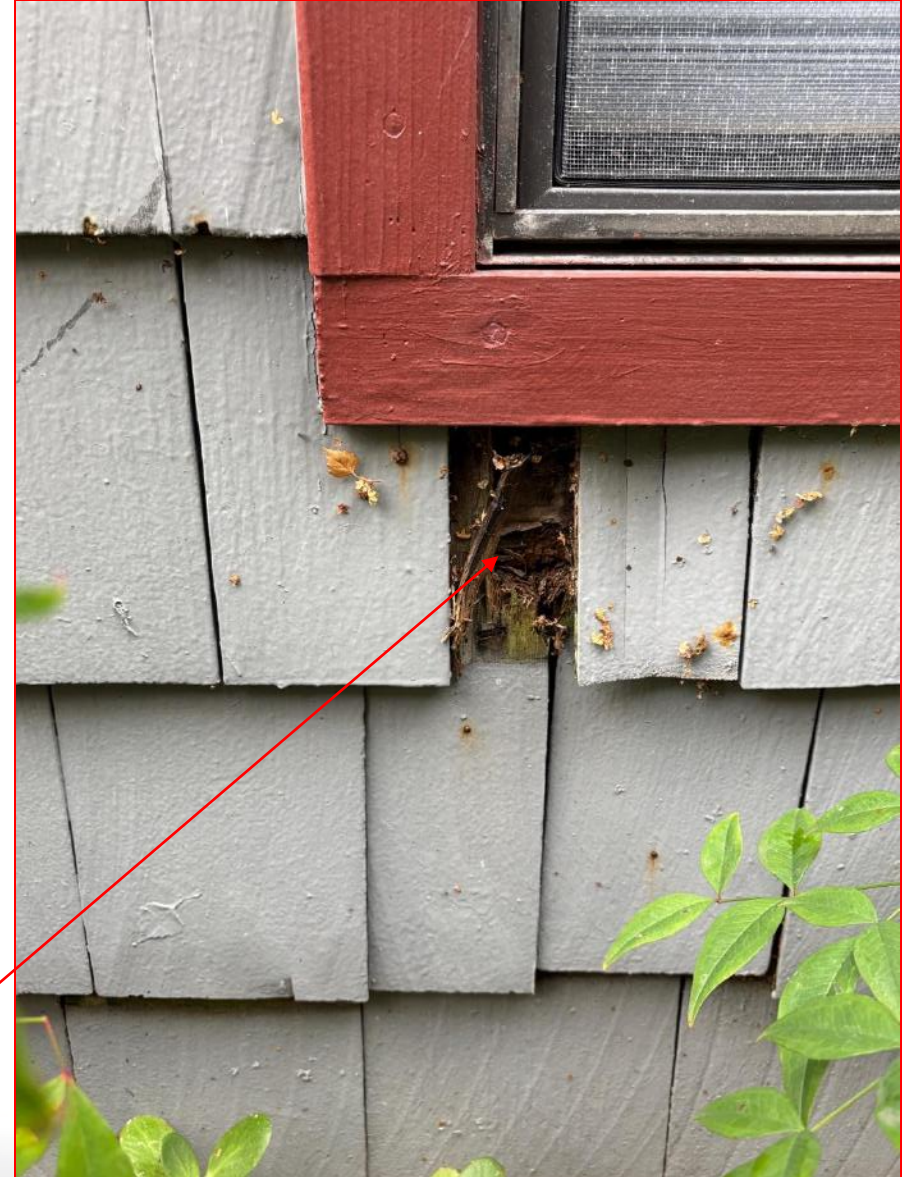
Visibly Missing wood shingles and sheathing Rot below windows

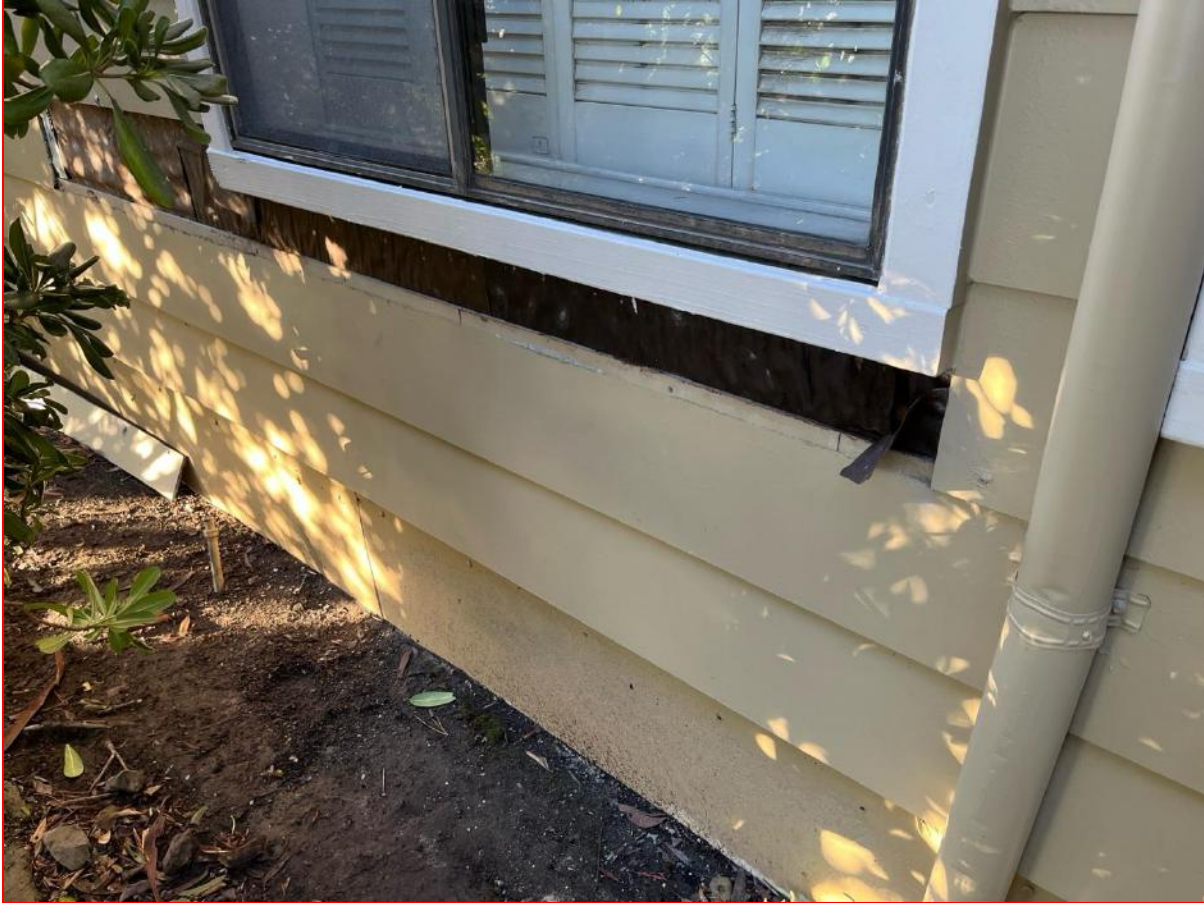
Noted Elevated Moisture Readings Below Window Corners – 26.4% Left and 48.6% Right – Please Note moisture readings of 12% and Less can be considered to be “Dry”

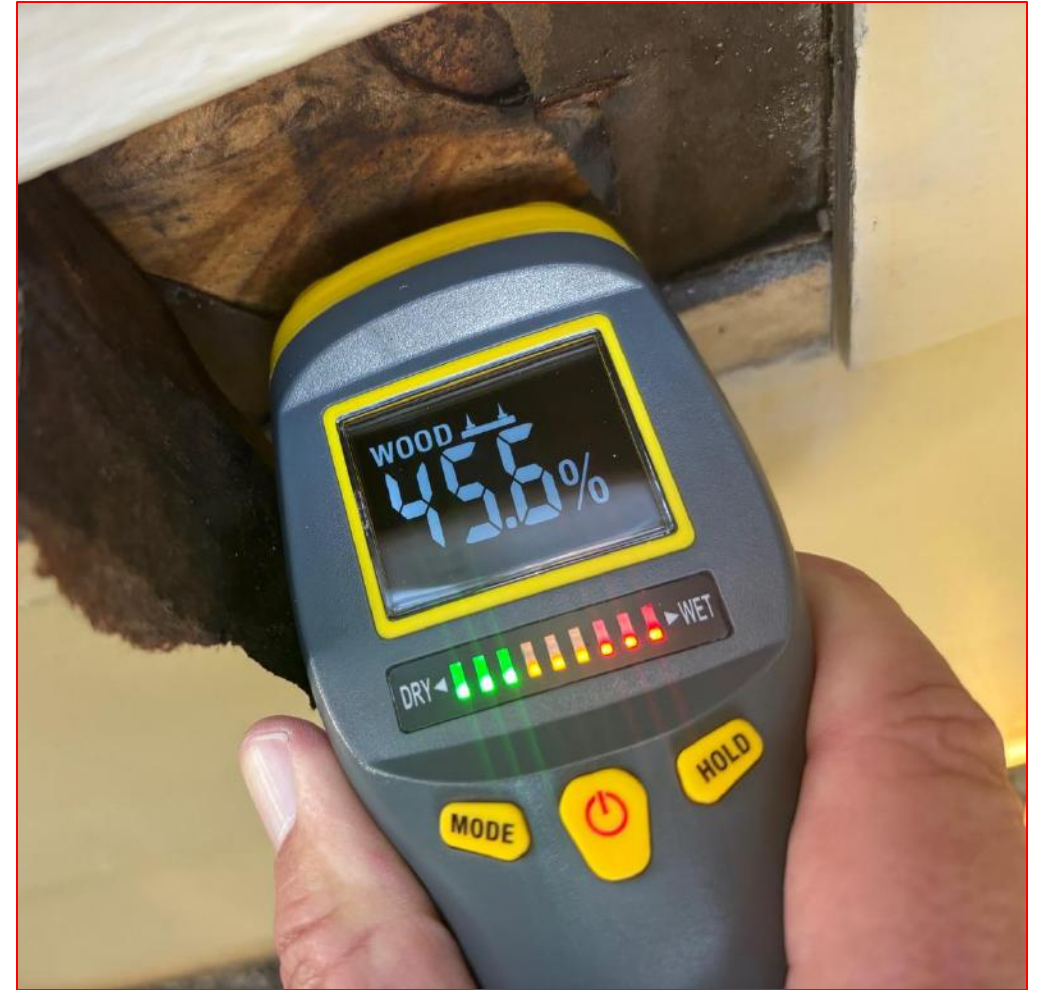
Noted Moisture Readings Below Left Siding Transition and Right Window Corners – Ranging from 15.2% up to 45.6% – Please Note moisture readings of 12% and Less can be considered to be “Dry”

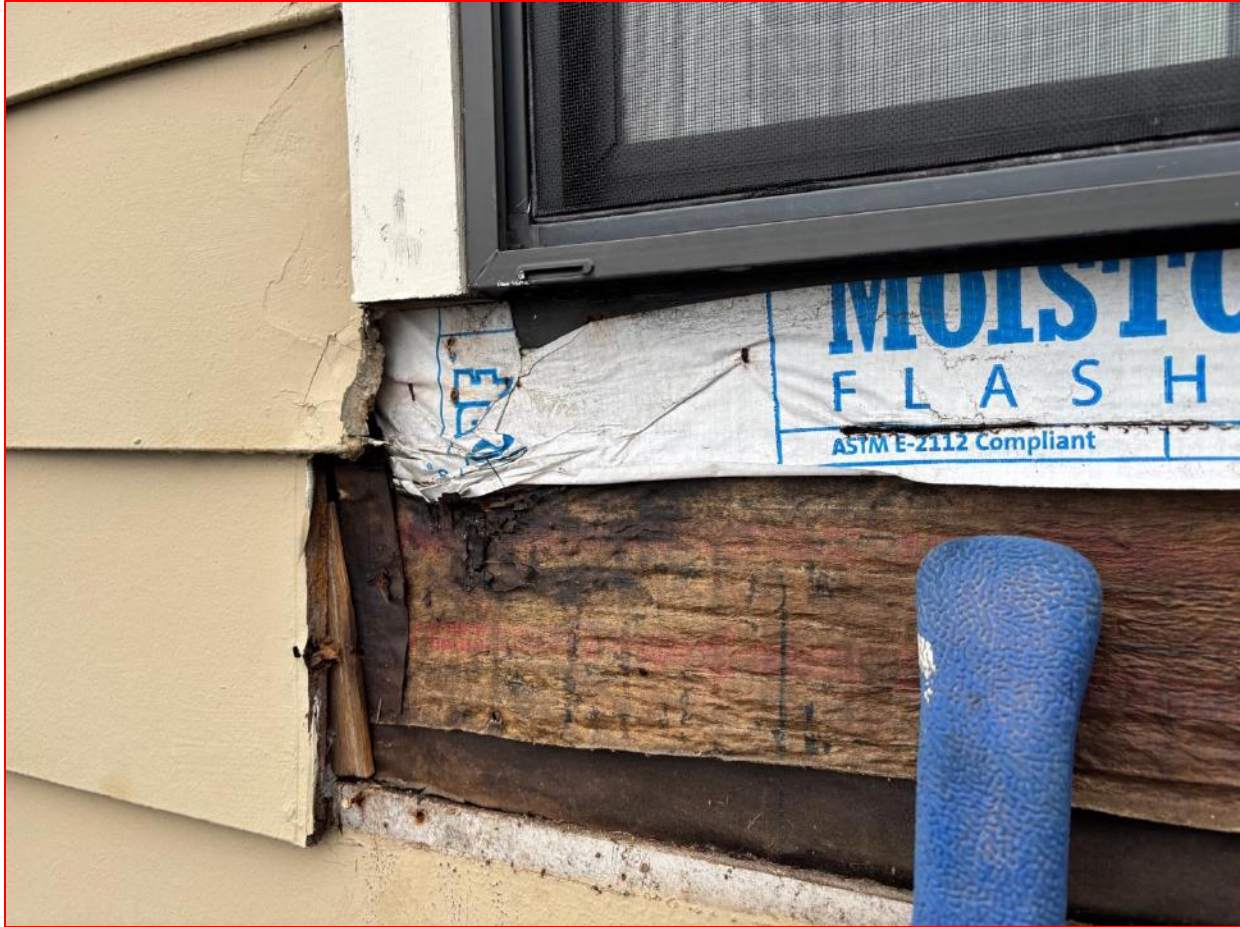
Typical Updated Flanged Window Installation and Flashing Sequences. Detected low moisture readings below the left corner of the windows

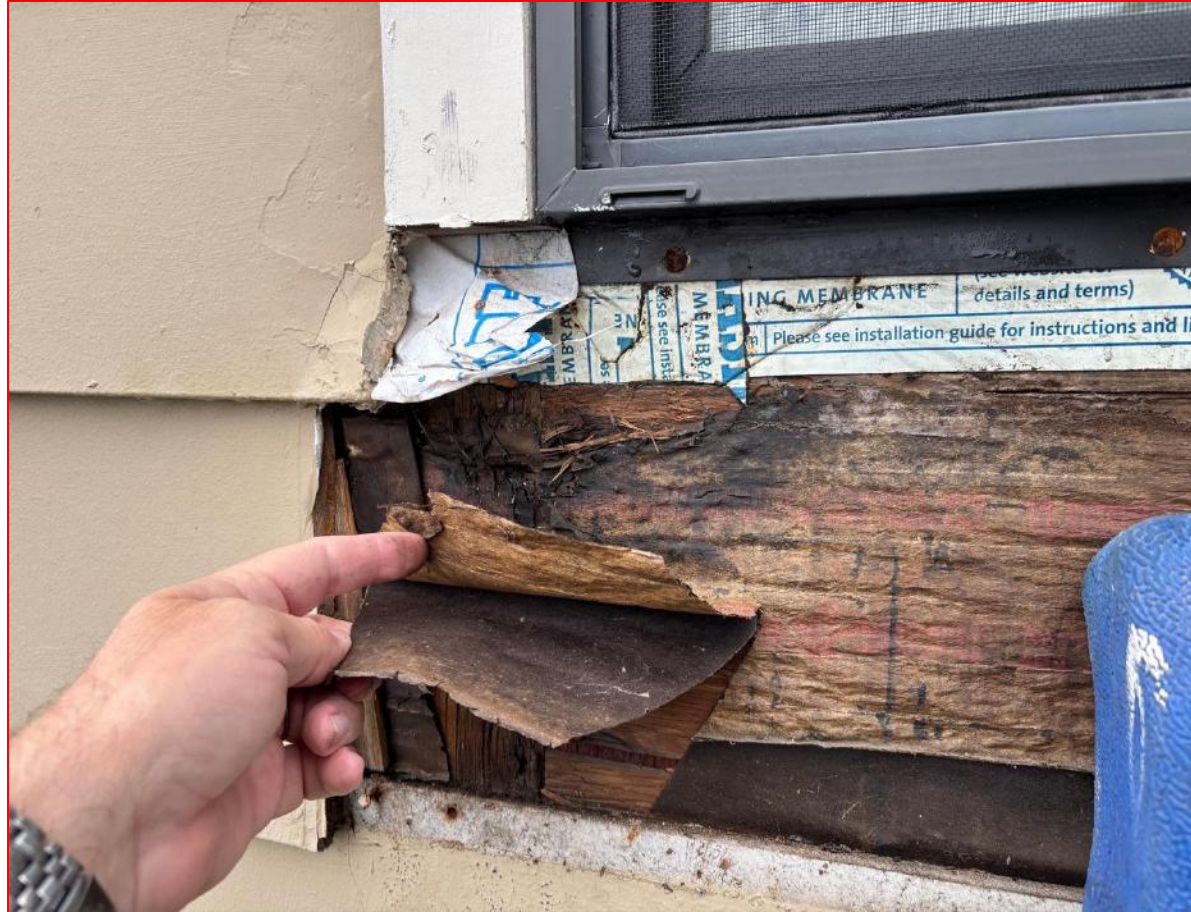
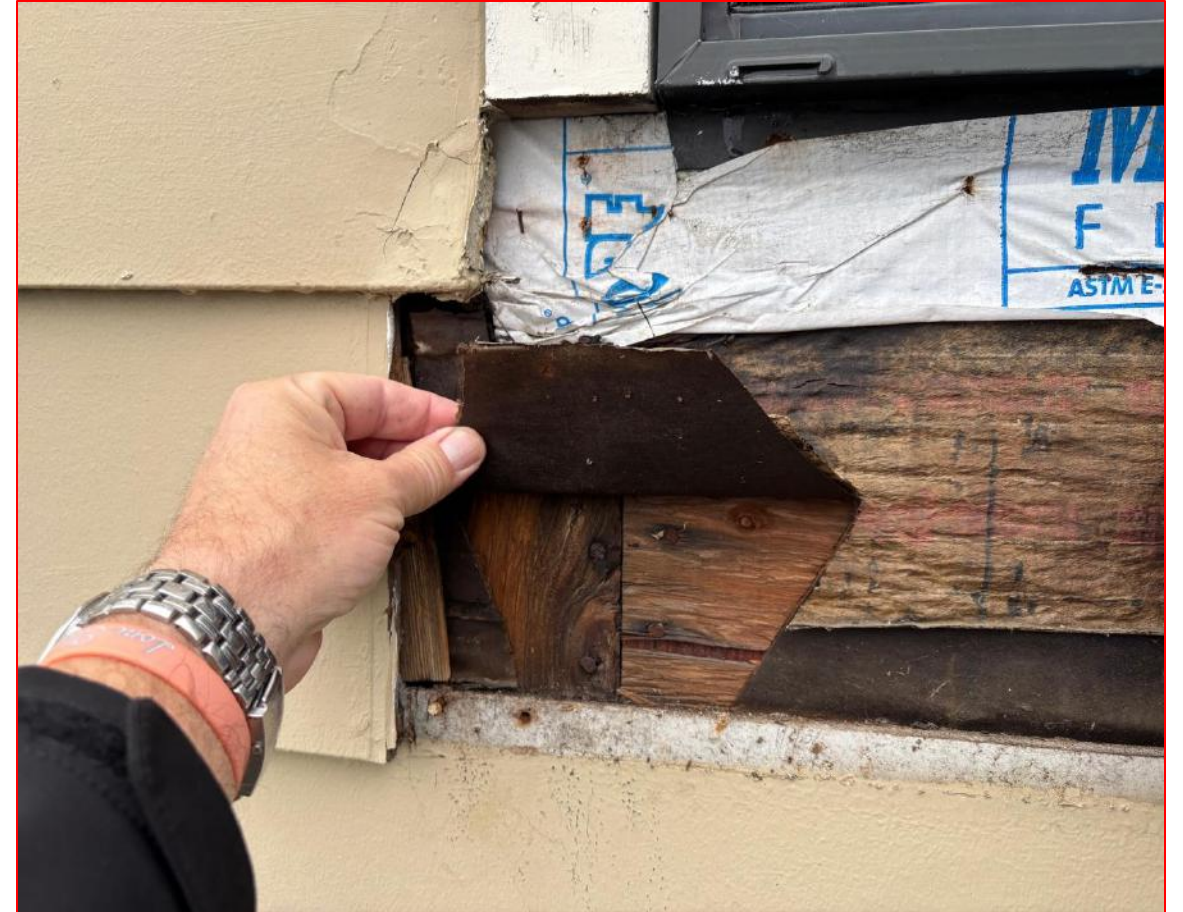
Noted multiple layers of flashing and WRB with signs of moisture intrusion, staining, and damaged CDX sheathing surfaces

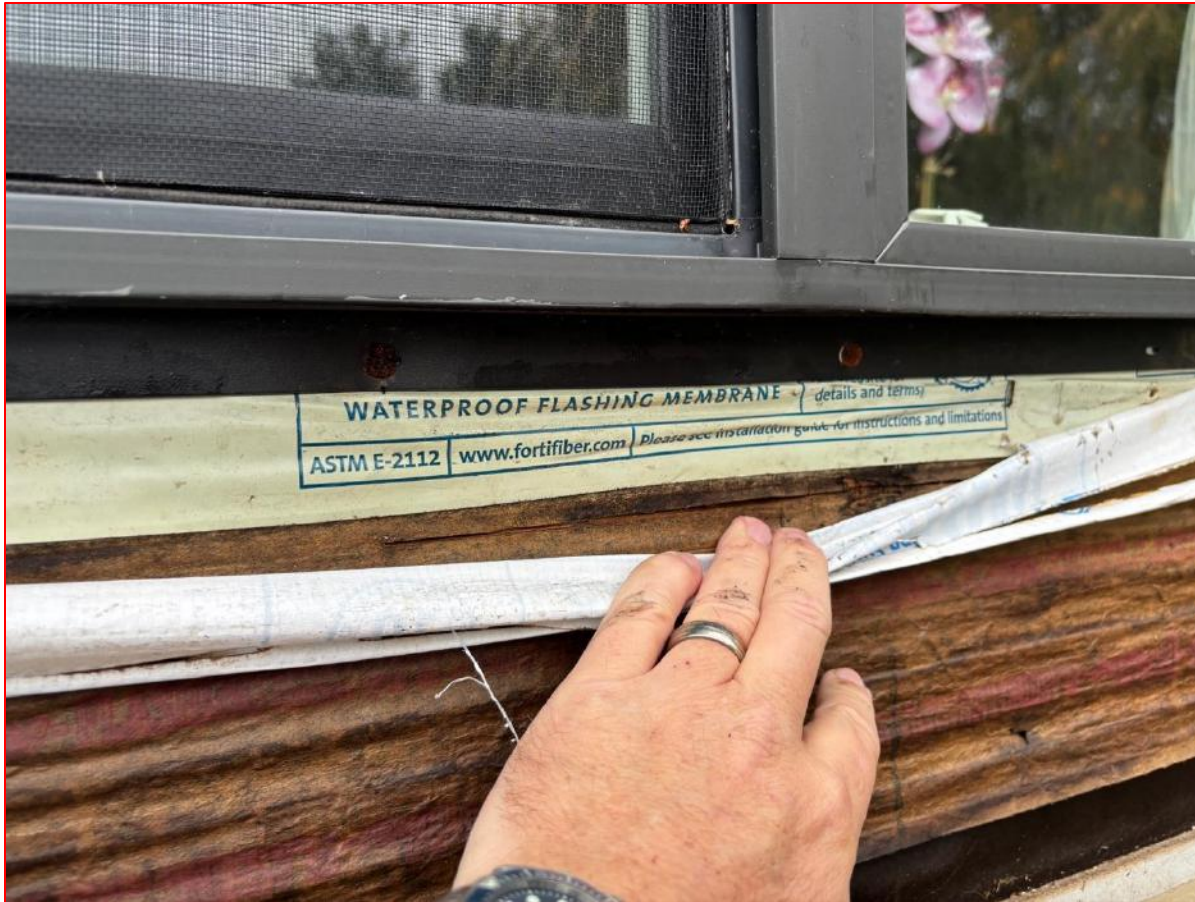
Noted Moisture Readings Below the Window of 23.6% - at center – Please Note moisture readings of 12%, and Less can be considered to be “Dry”

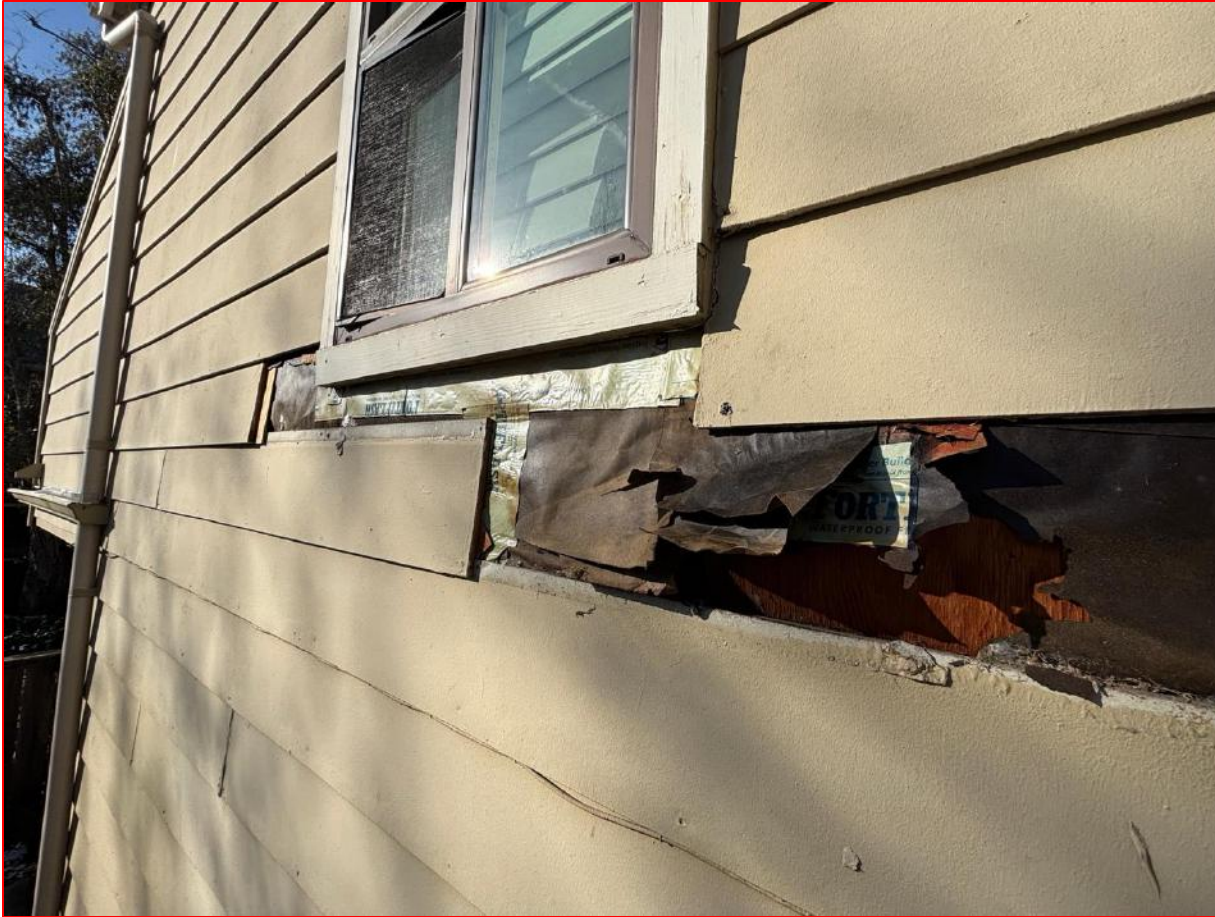
Typical Updated Flanged Window Installation and Flashing Sequencing. Noted signs of water staining, swelled, and damaged CDX sheathing surfaces

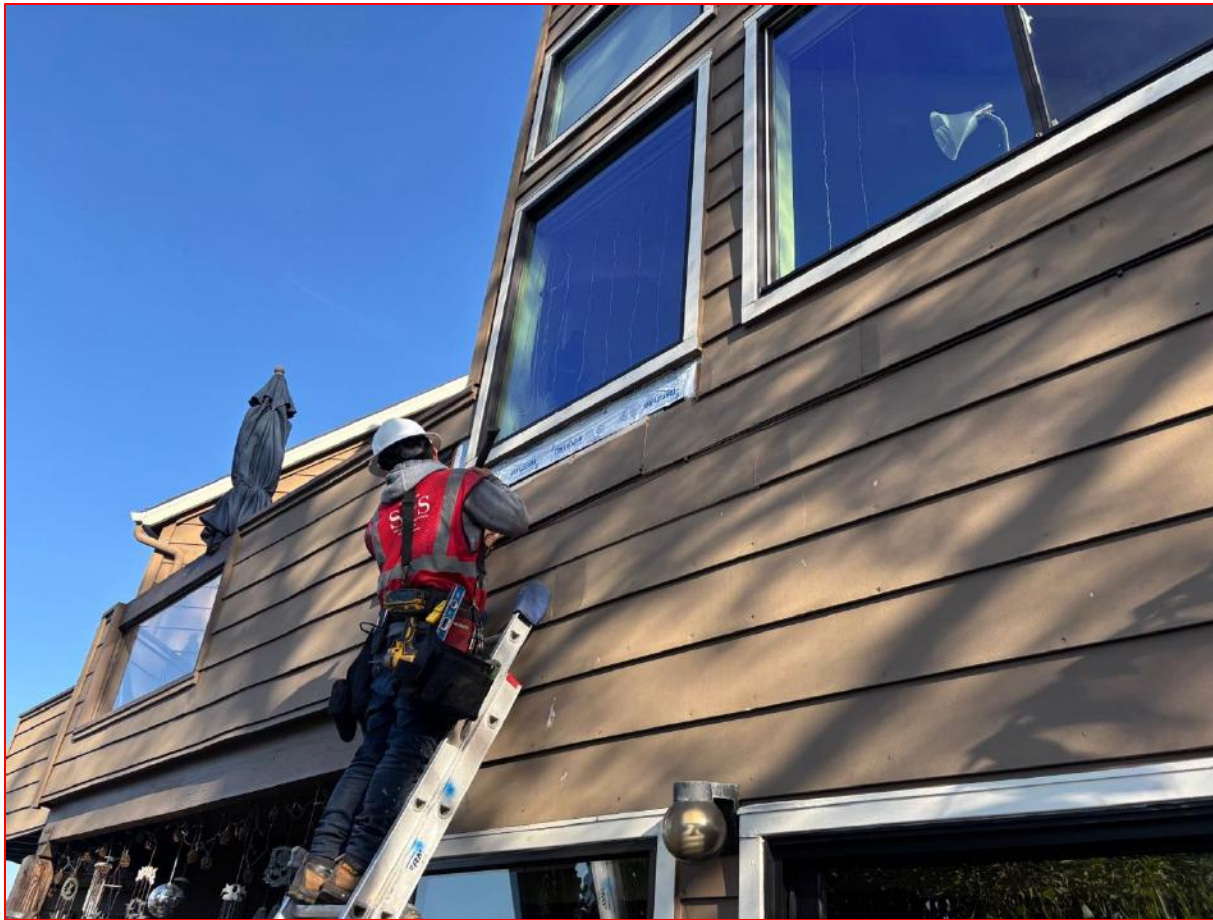
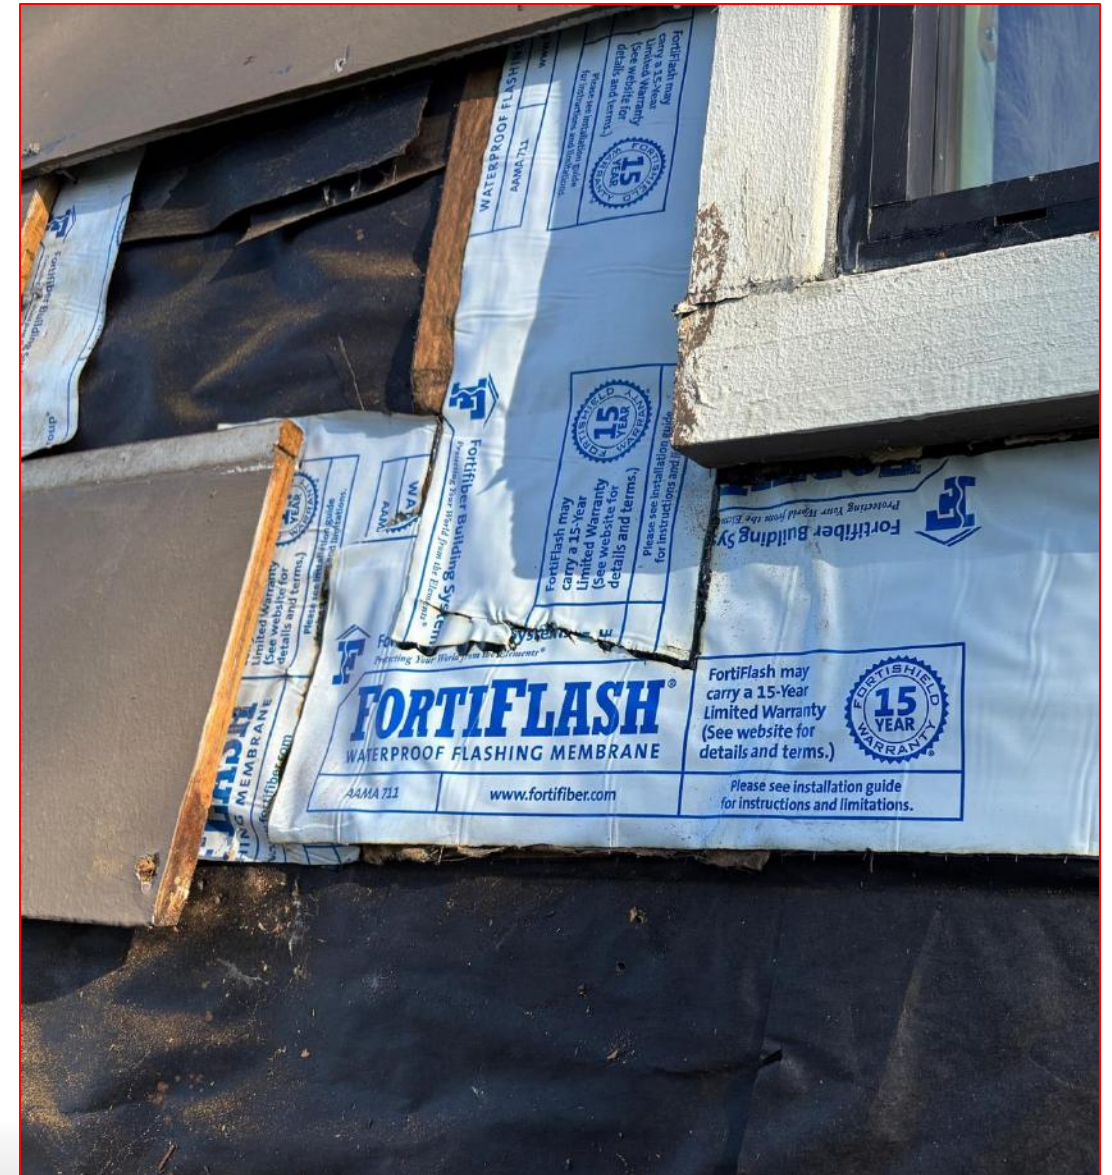
Typical Updated Flanged Window Installation, Aged WRB, and Existing Flashing Sequences. Noted Felt Paper WRB, Jamb Flashing, and Sill Flashing

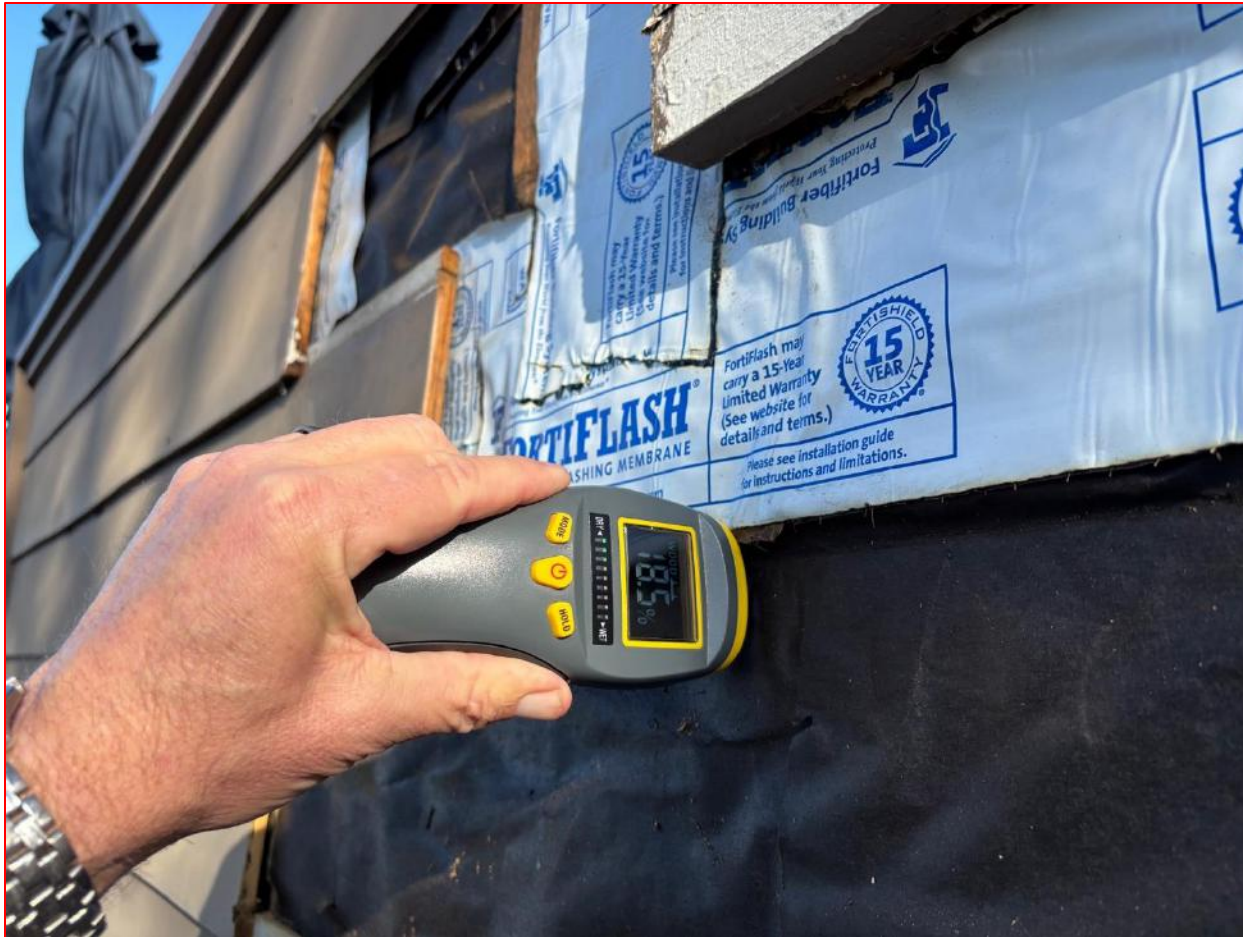
Noted Moisture Readings Below Updated Window Corners –
18.5 % Left and 19.7% Right – Please Note moisture readings
of 12% and Less can be considered to be “Dry”

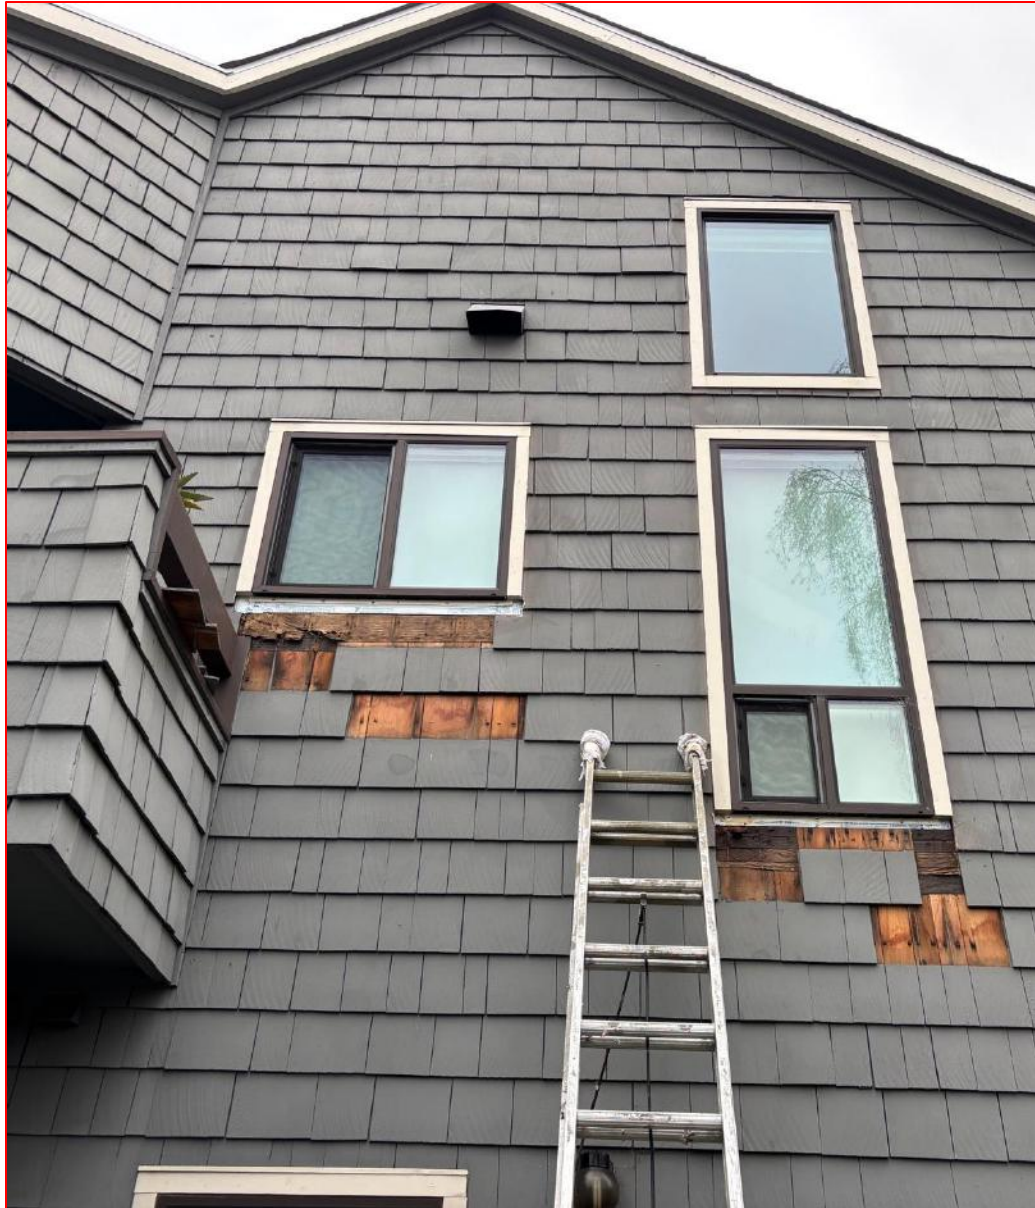
Typical Updated Flanged Window Installation, Aged WRB, and Existing Flashing Sequences. Noted Felt Paper WRB, Jamb Flashing, and Sill Flashing

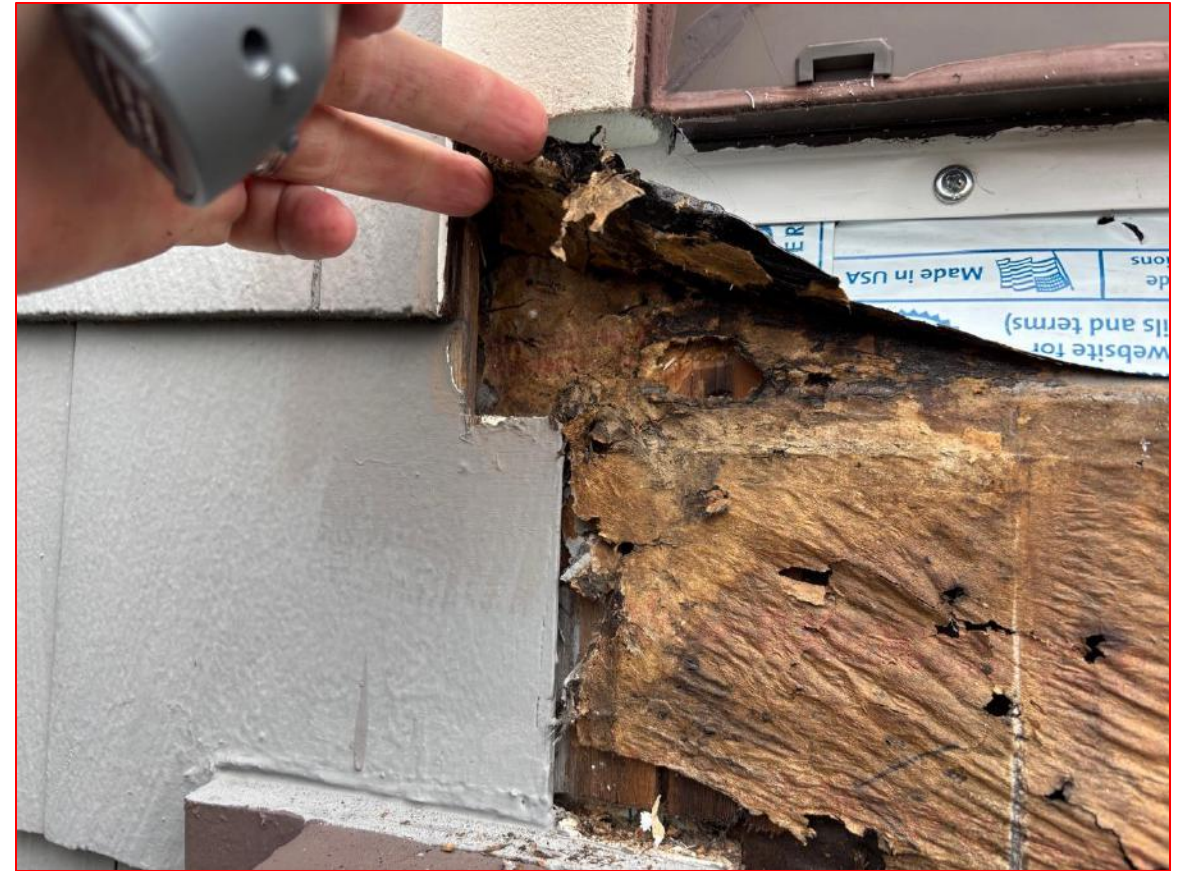
Noted updated window sill flashing installed on the aged, worn, and deteriorated WRB. Noted staining and surface damage on CDX sheathing below the window

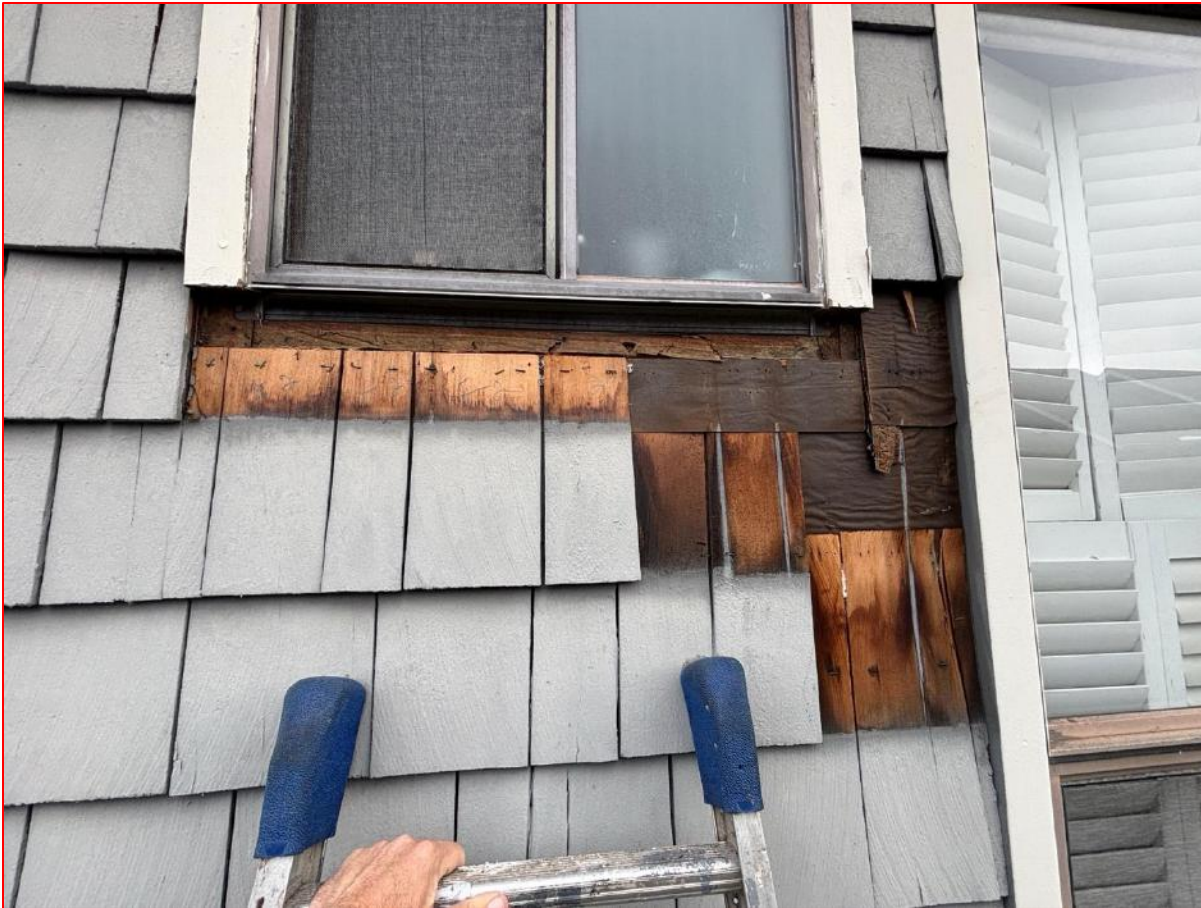
Typical Original Flanged Window Installation, Aged WRB, and Existing Flashing Sequence. Noted deteriorated window sill flashing, Felt Paper WRB, and Jamb Paper Flashing

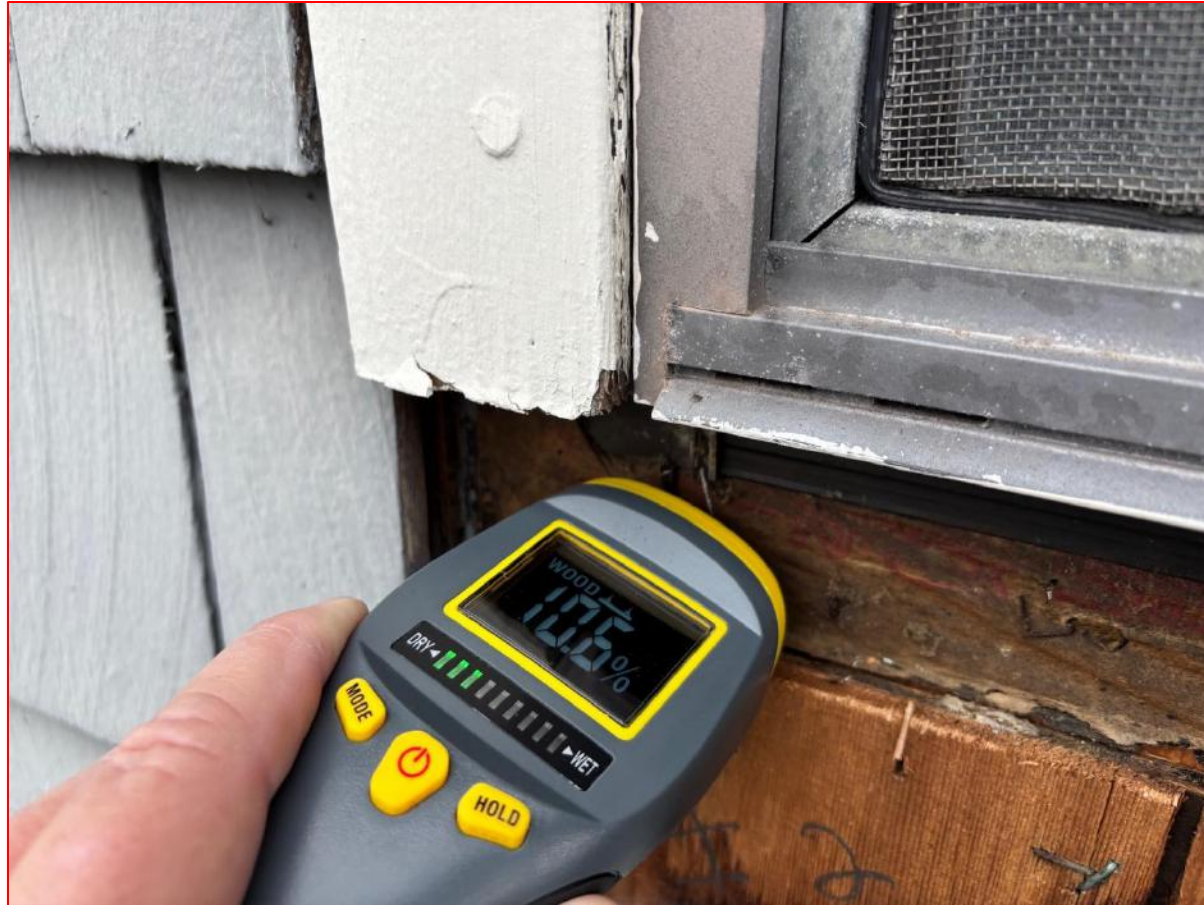
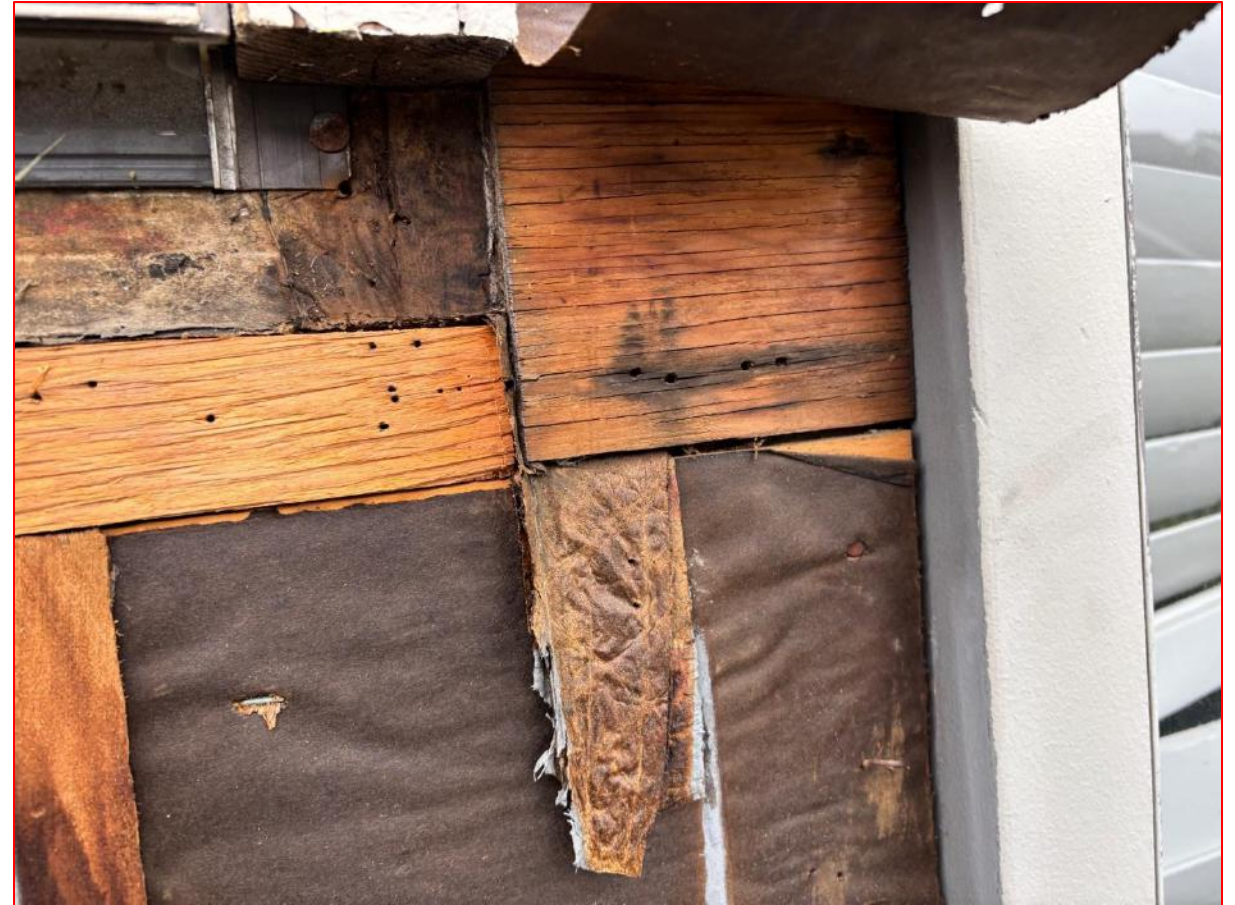
Noted LOW Moisture Readings Below Window Corners – 10.6% Left and 12.5% Right – Please Note moisture readings of 12% and Less can be considered to be “Dry”
