Harbortown

San Mateo, CA

INVASIVE BUILDING REVIEW

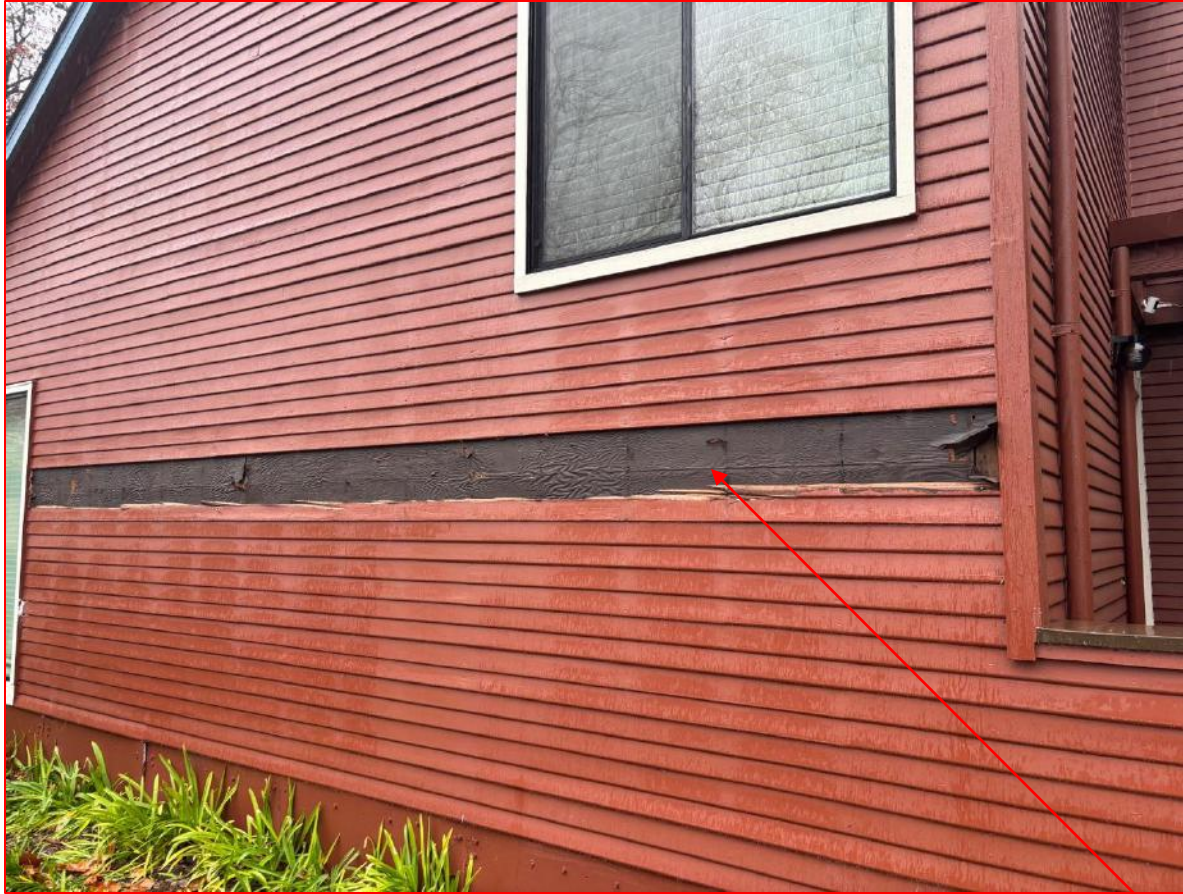
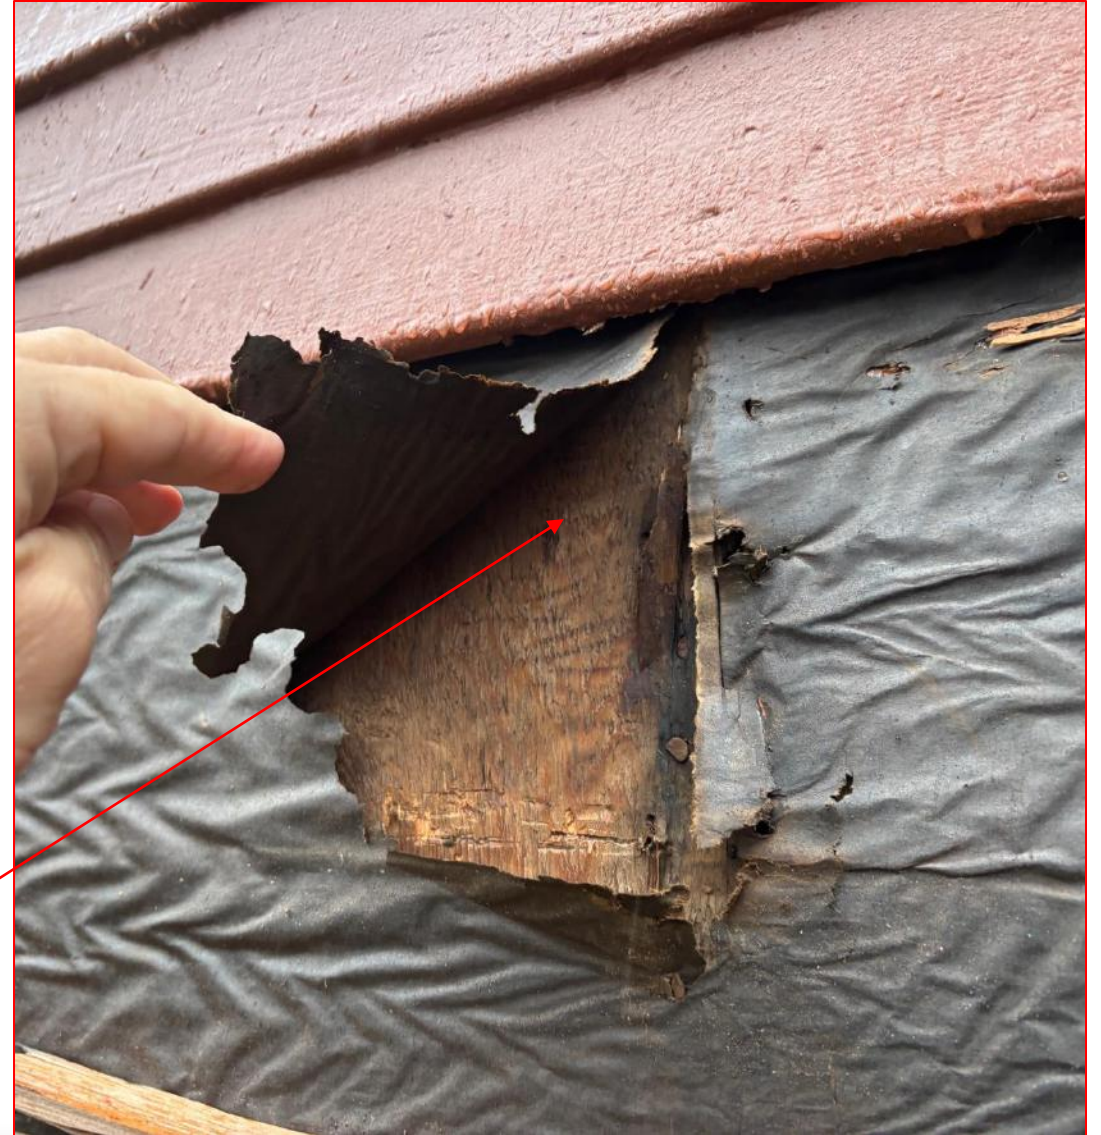
Typical Aged and Worn Felt Paper WRB behind the painted wood clapboard siding

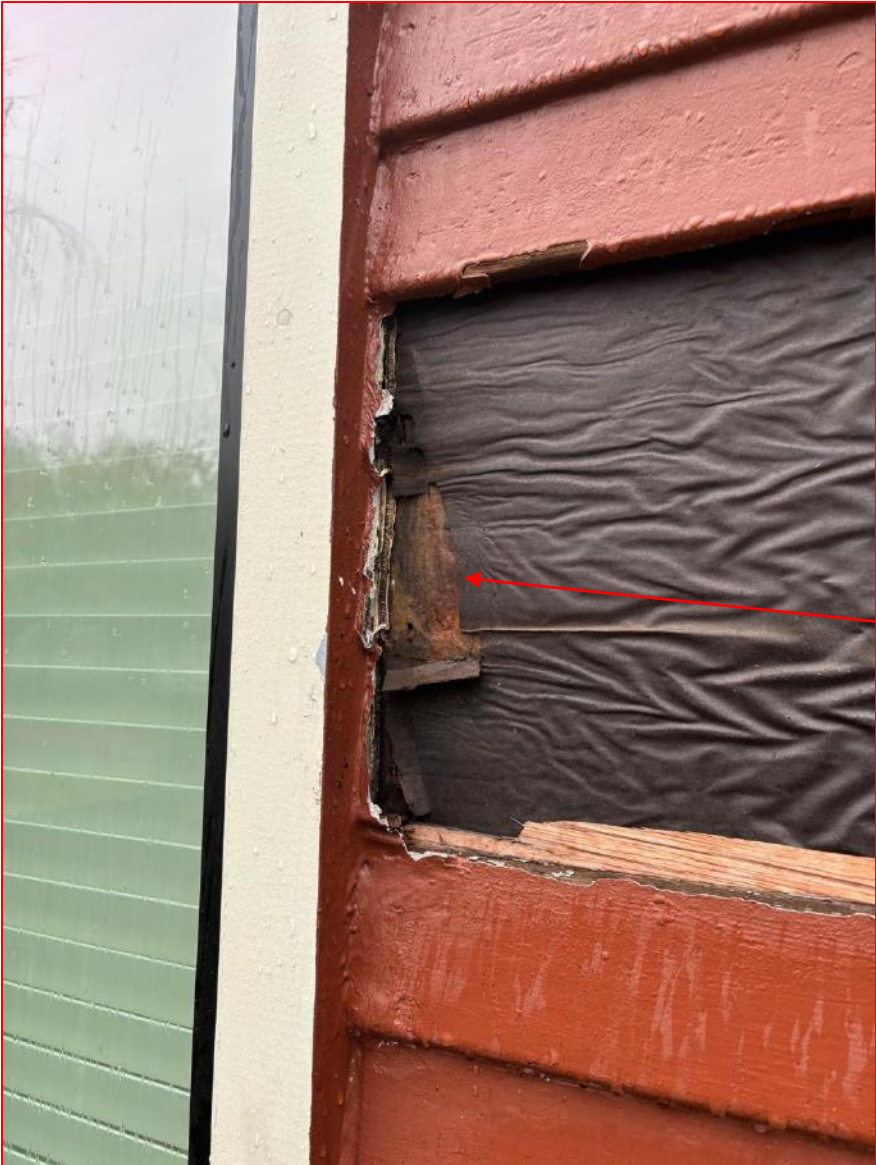
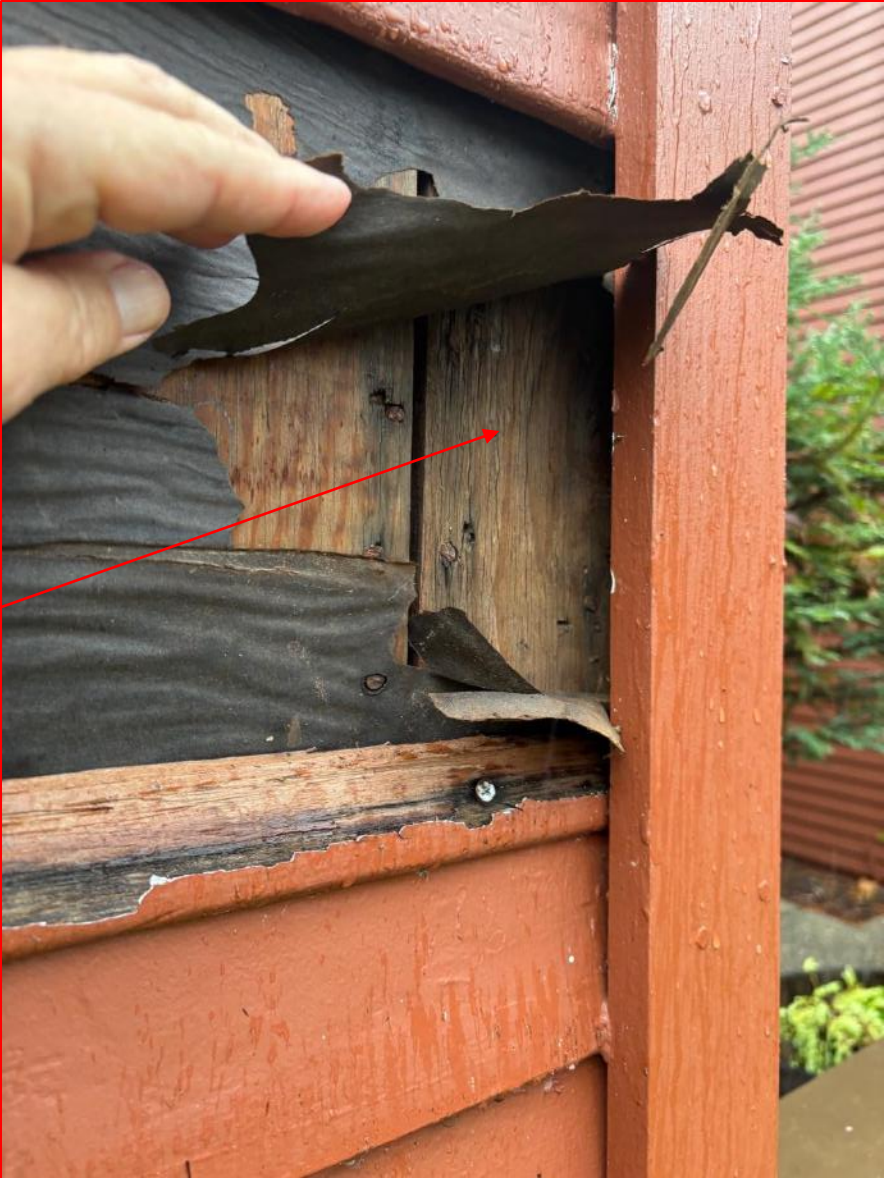
Typical Aged and Worn Original Installation of the Felt Paper WRB at Windows and Outside Corner Transitions. Noted

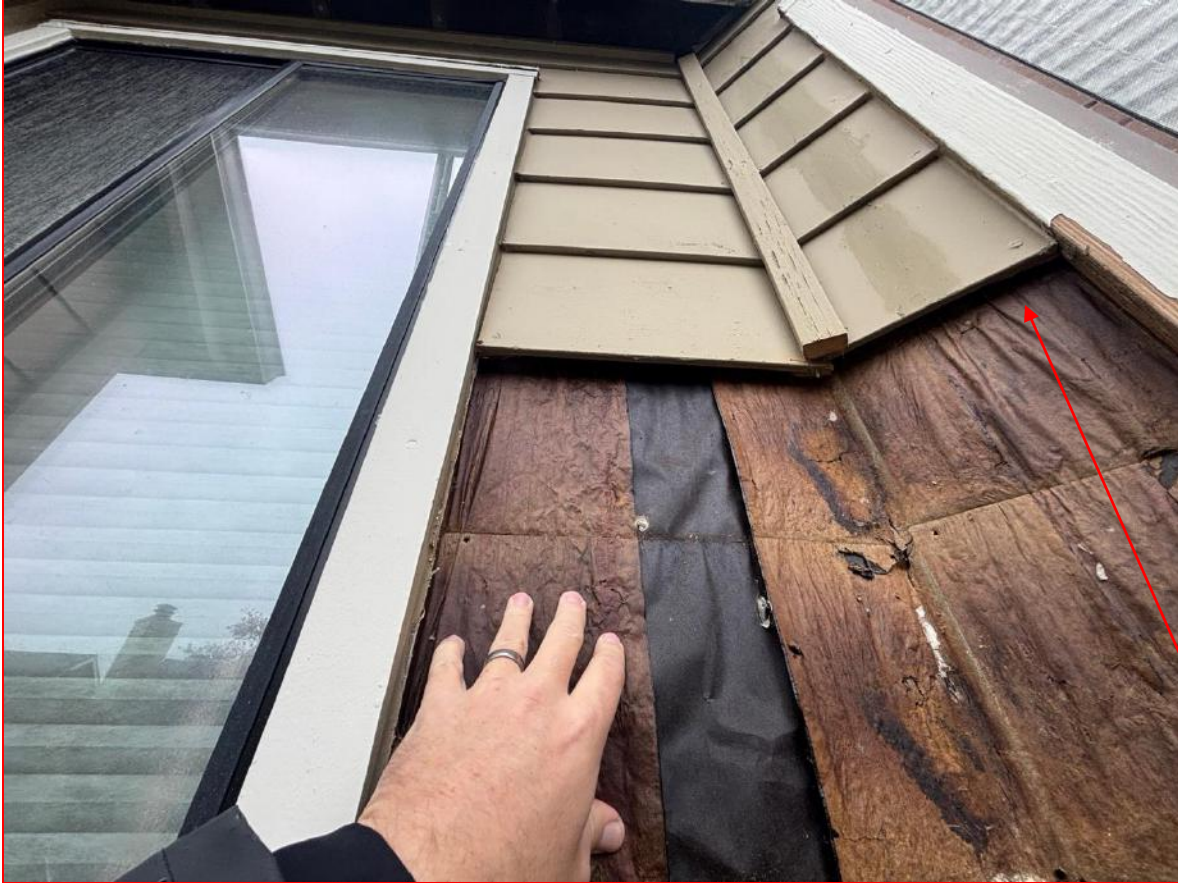
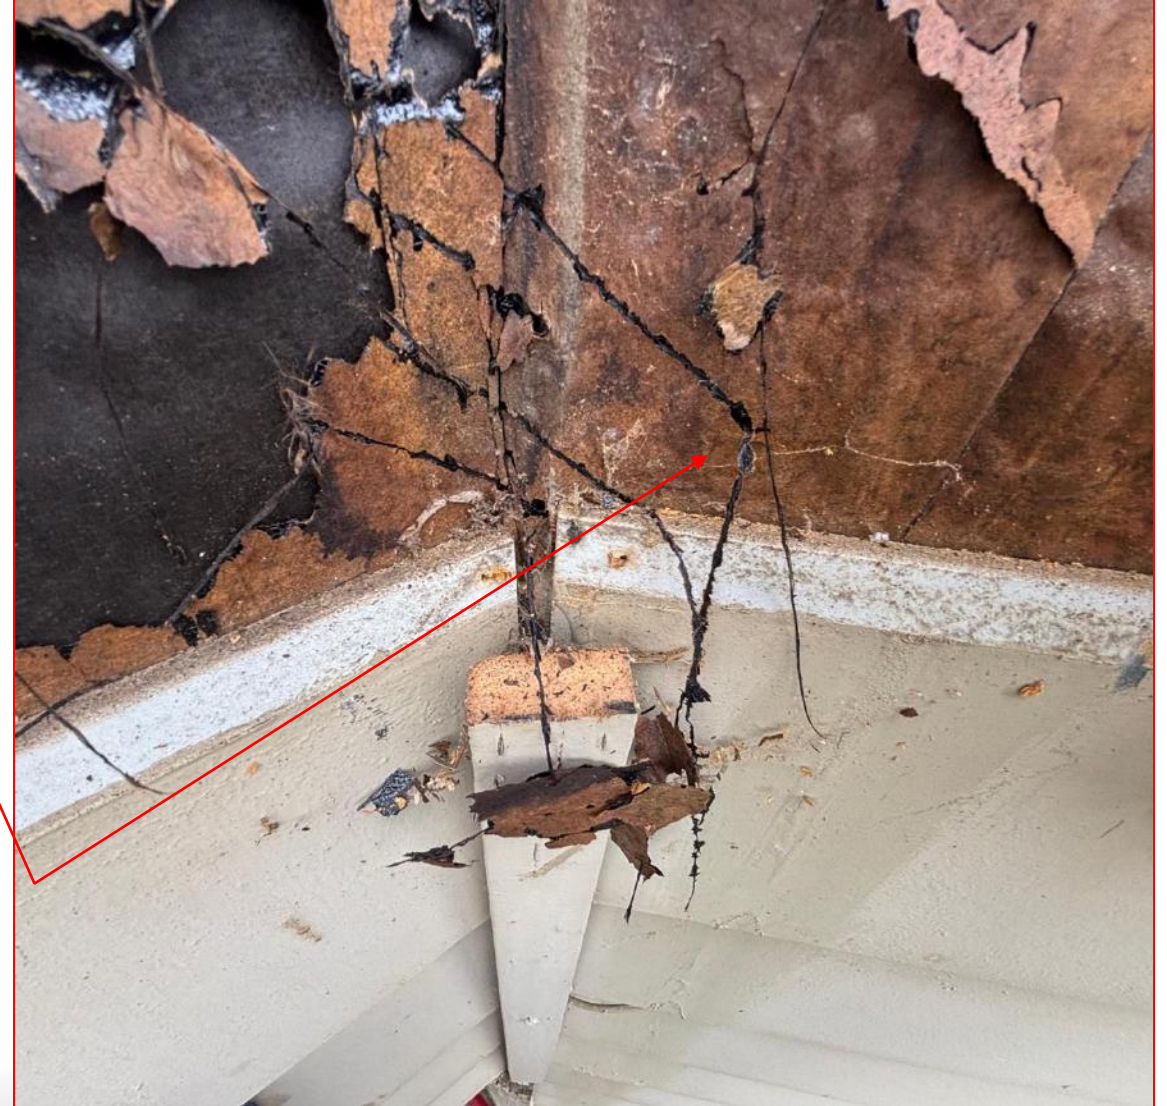
Noted Typical Felt Paper WRB System with Poly Reinforced Vertical Paper Flashing at windows, patio doors, and vertical wall transitions.

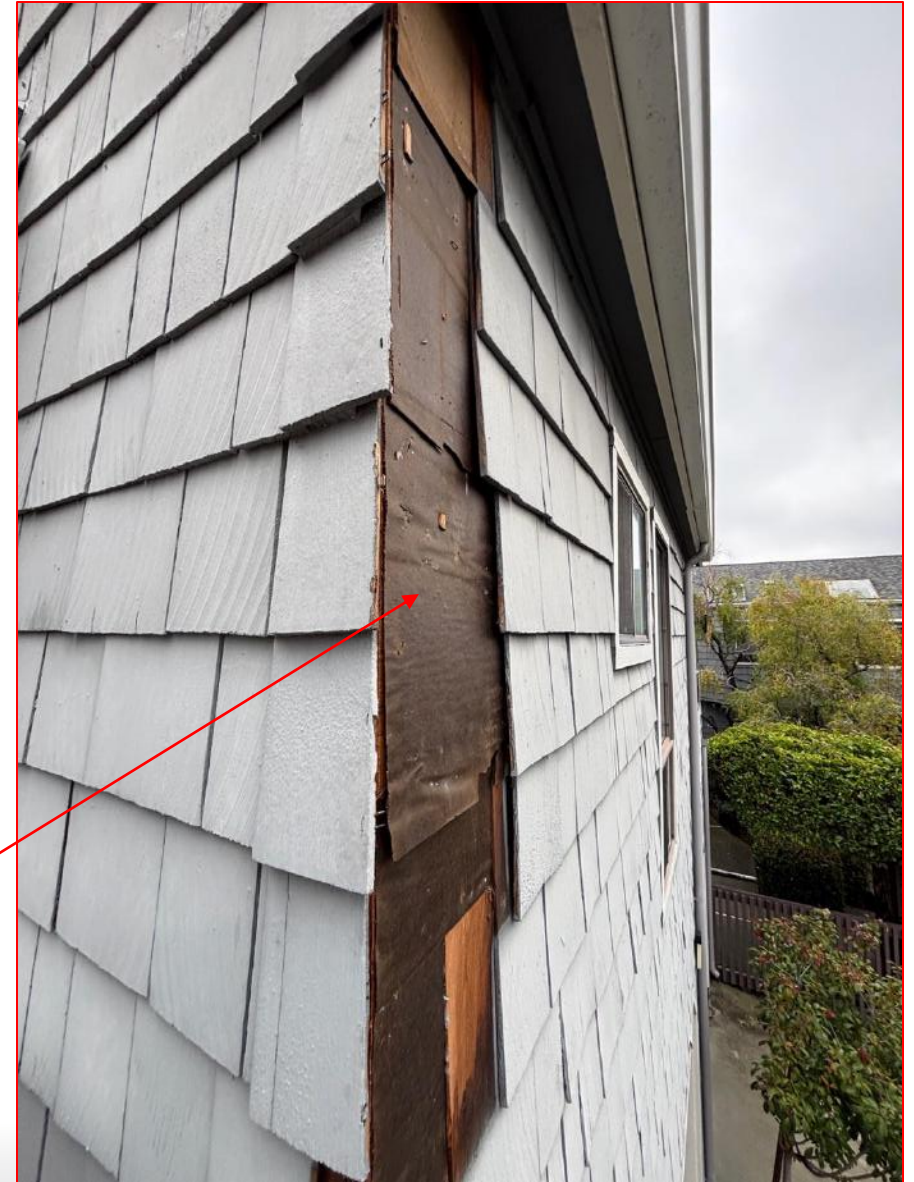
Updated "Spot" repaired WRB, Window flashing, and original aged and worn Felt Paper WRB

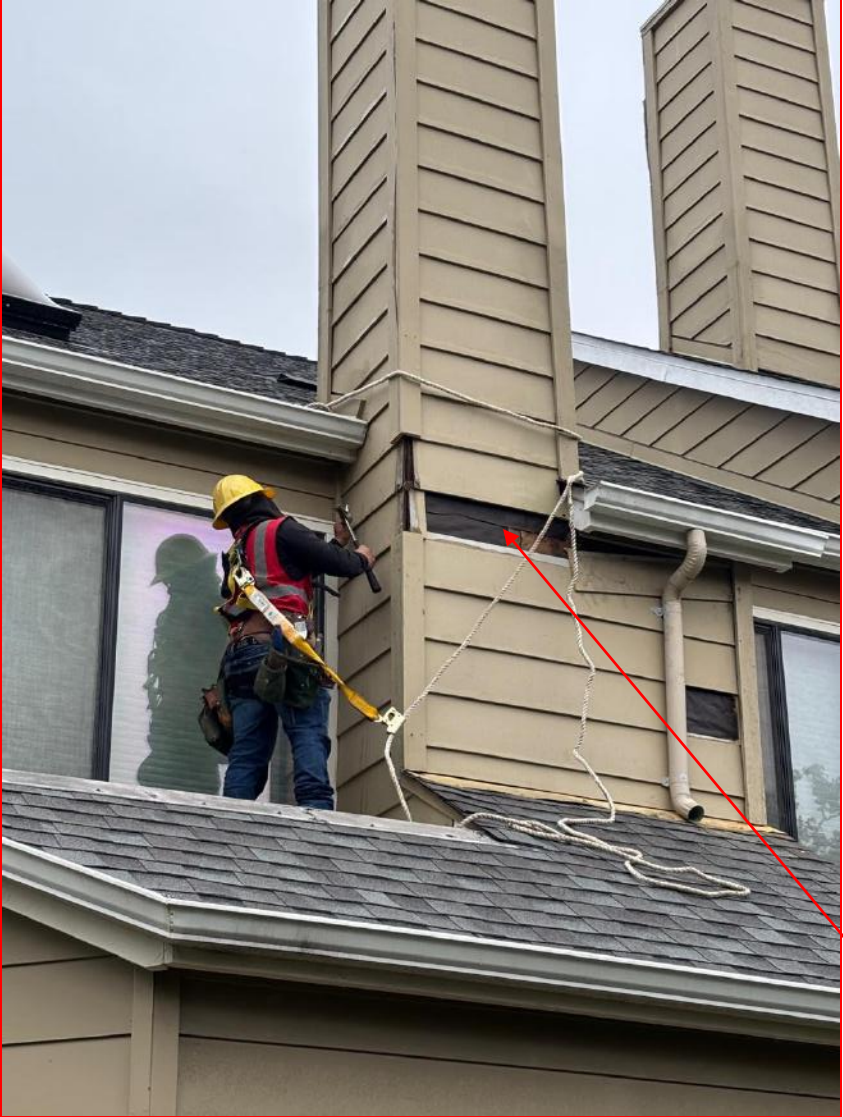
Typical Existing Aged and Worn Felt Paper WRB

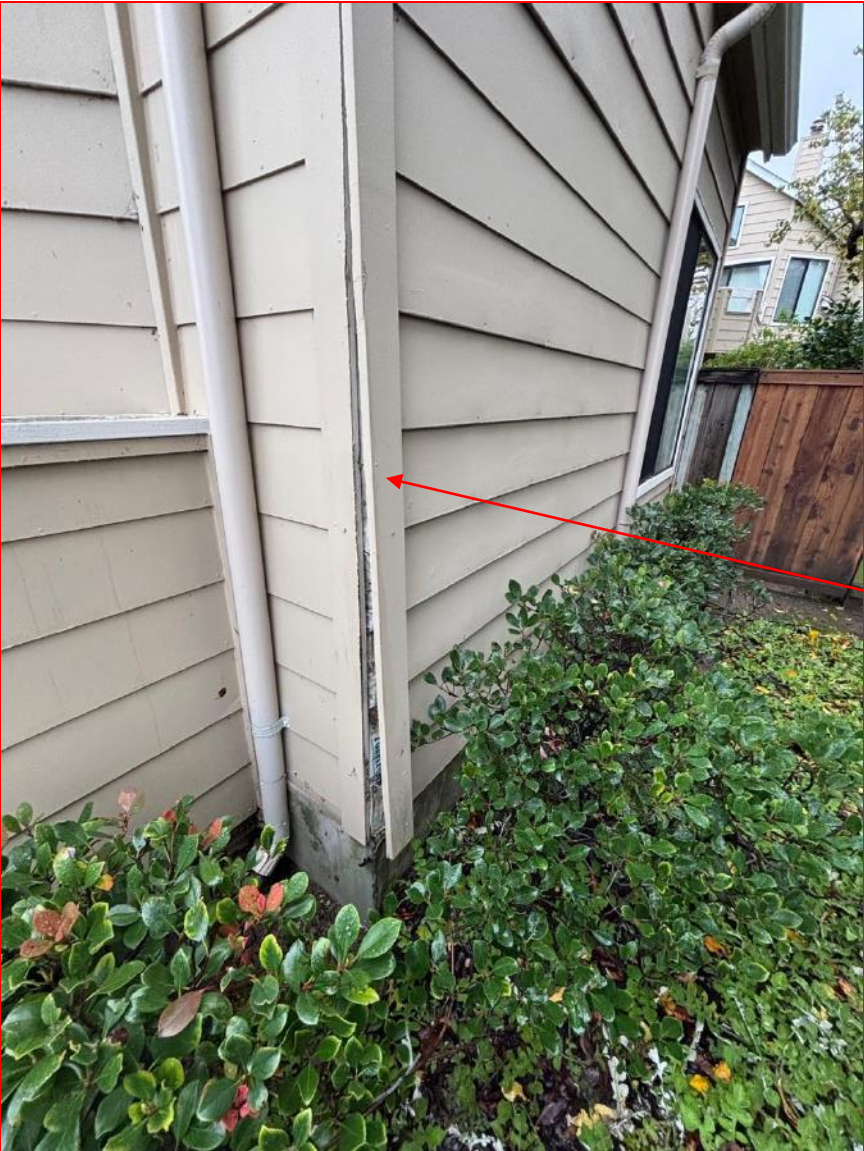
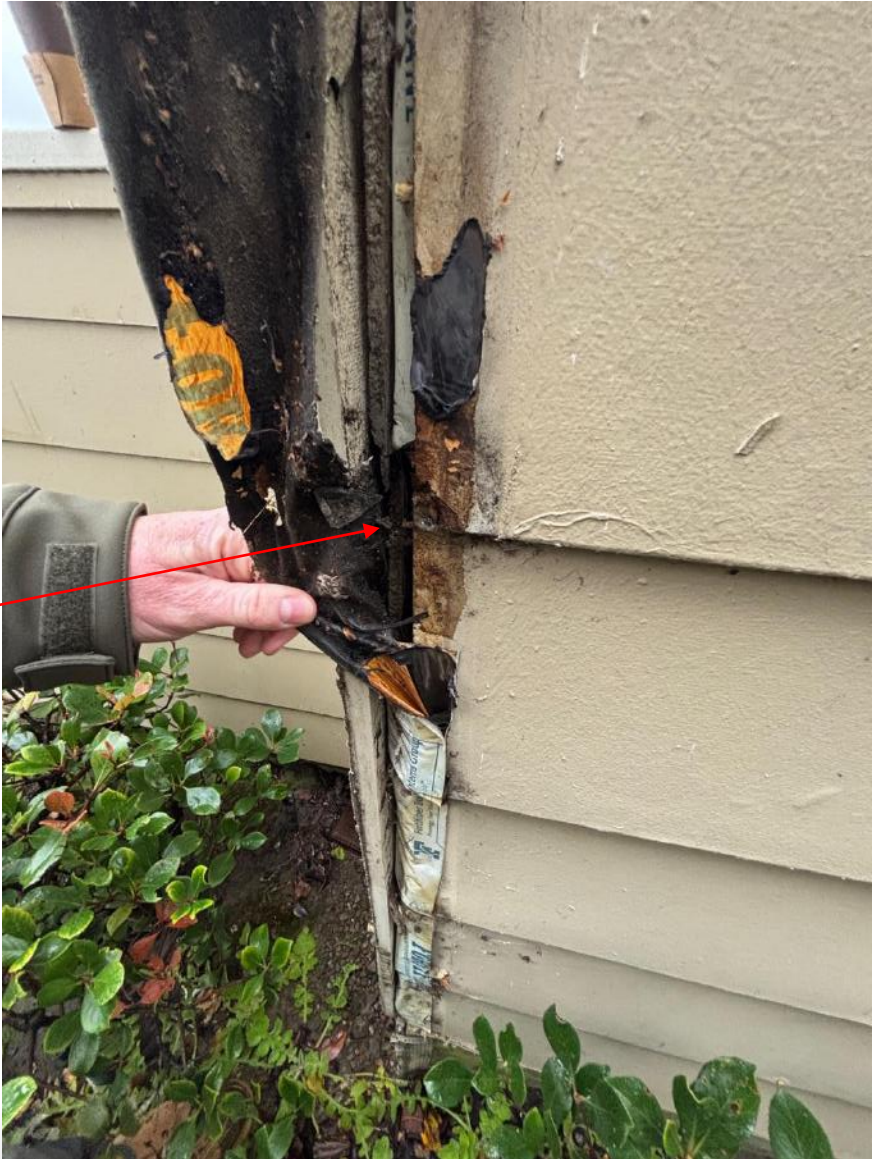
Noted Emergency
Repaired Corner Flashing
over Aged and Worn WRB
and Damaged CDX
Sheathing

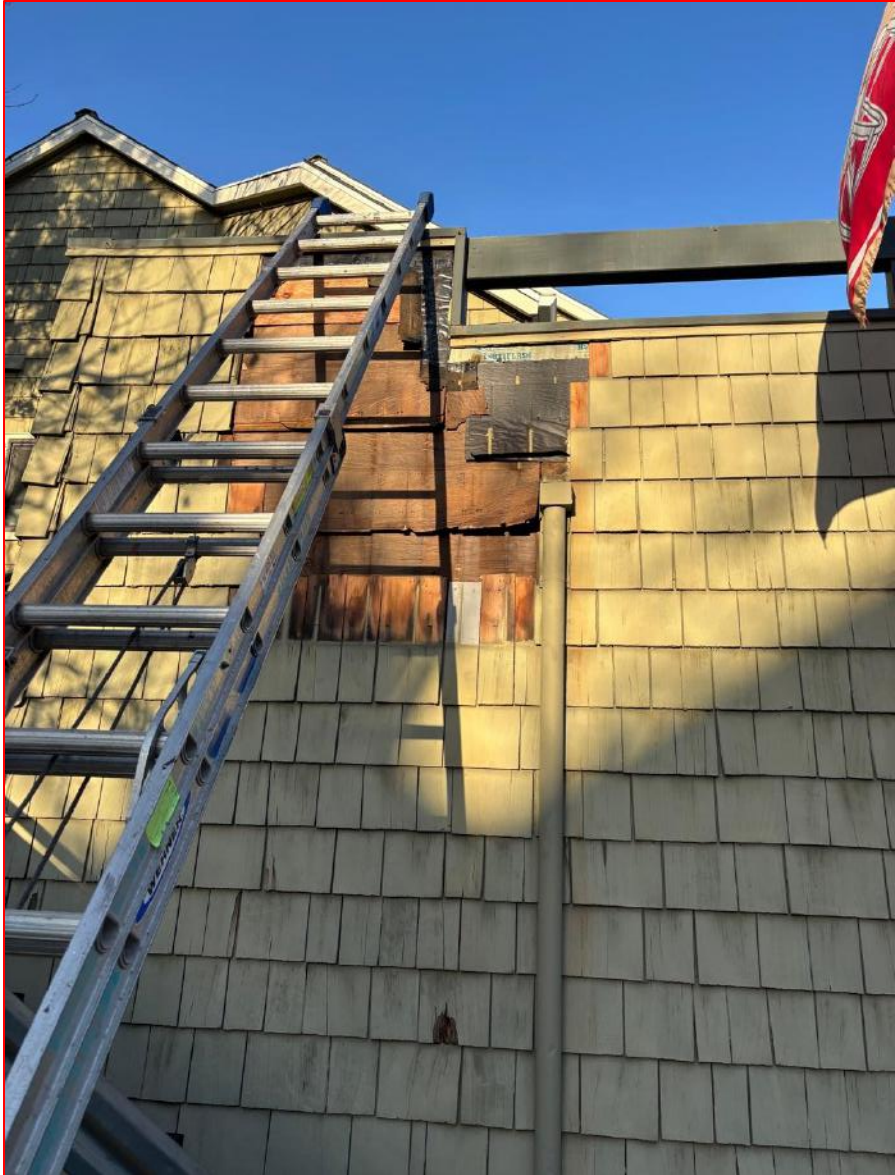
Typical Deck Wall and Cap Flashing and WRB Repairs. Noted Membrane flashing installed onto aged and worn Felt paper WRB. Detected low moisture readings.

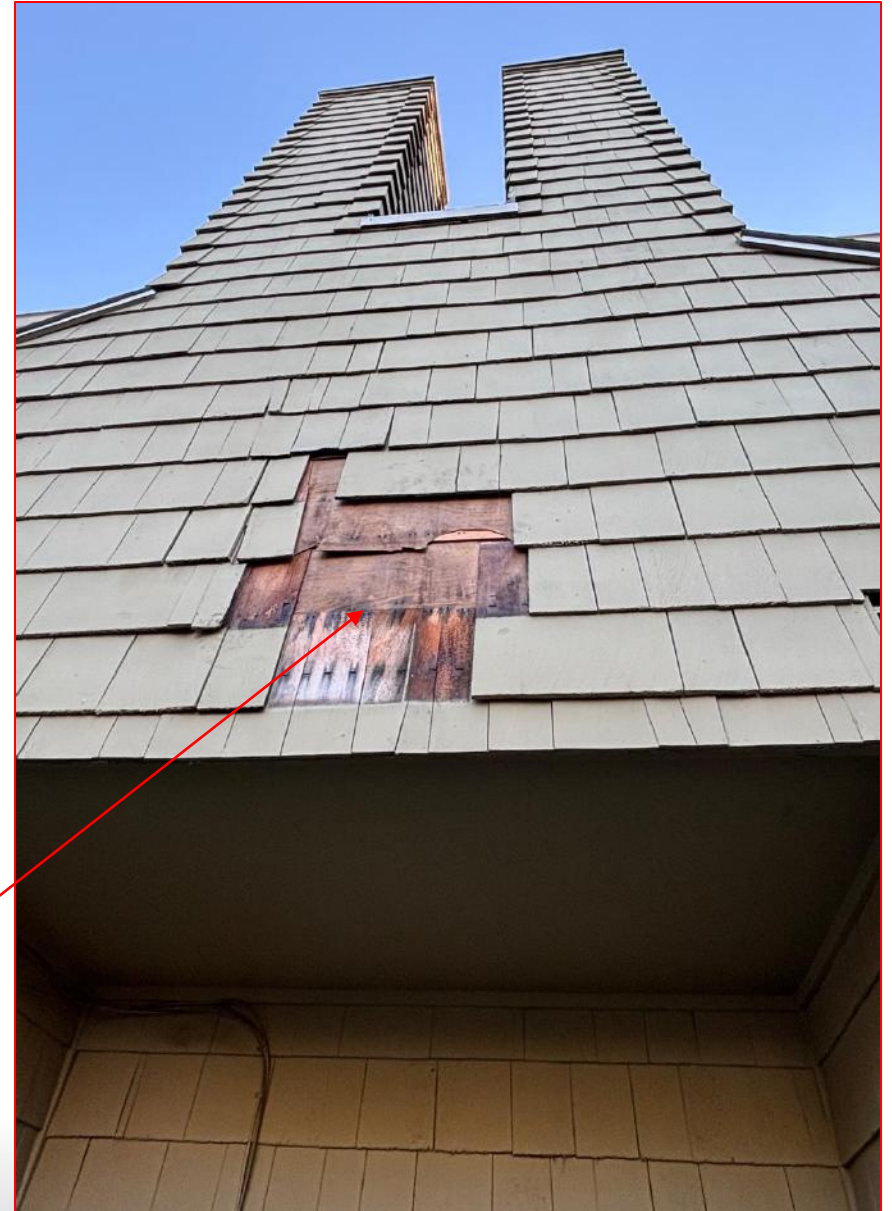
Noted Typical aged and worn WRB behind the cedar shingles.
Detected low moisture readings and noted surface of CDX sheathing was good shape and dry

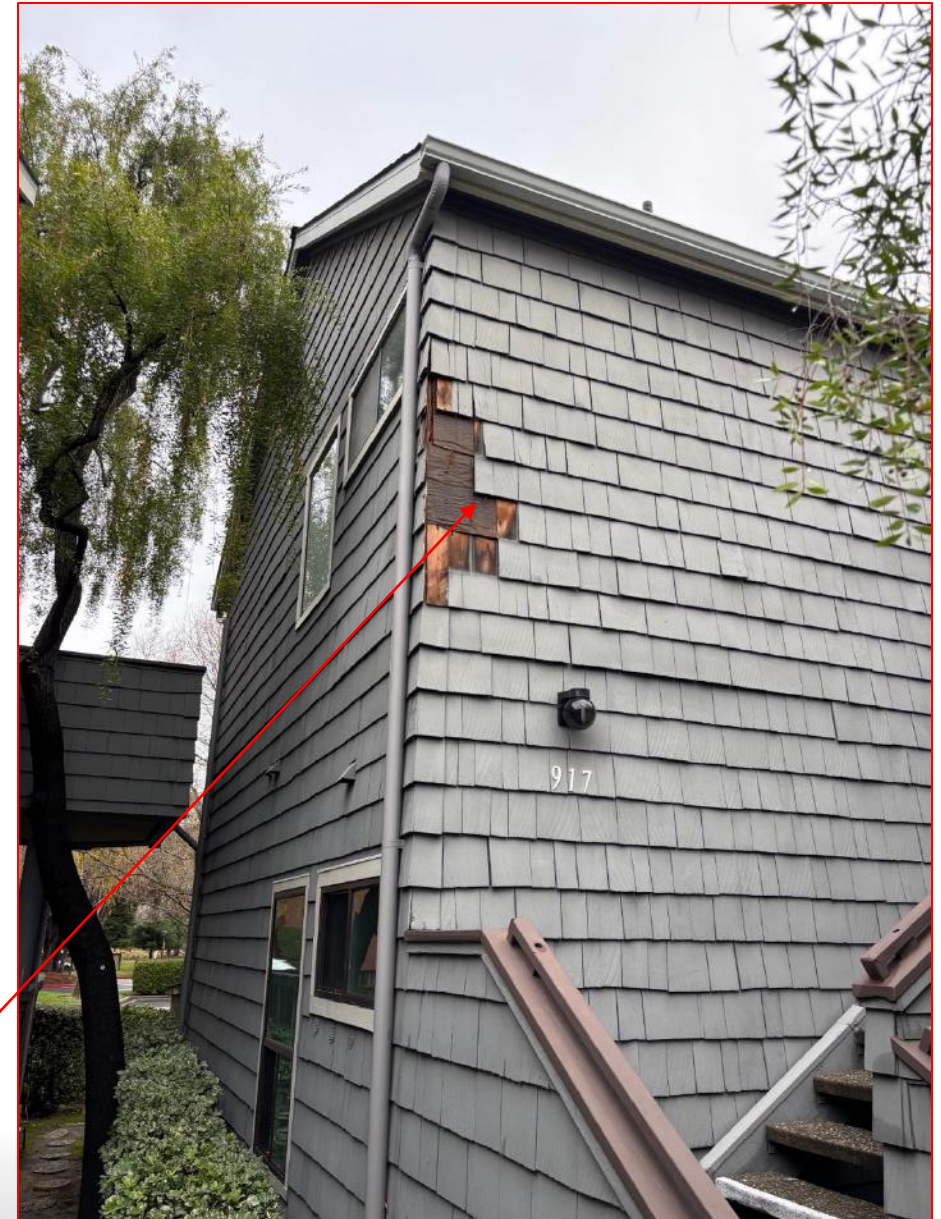
Noted typical original Felt paper WRB and wood shingle siding.
Noted aged and worn shingles, felt paper WRB, and CDX sheathing.
