Pepys Power & Hypergreening

Supplementary Material 2

Home Consultation Reports

BENCE HOUSE

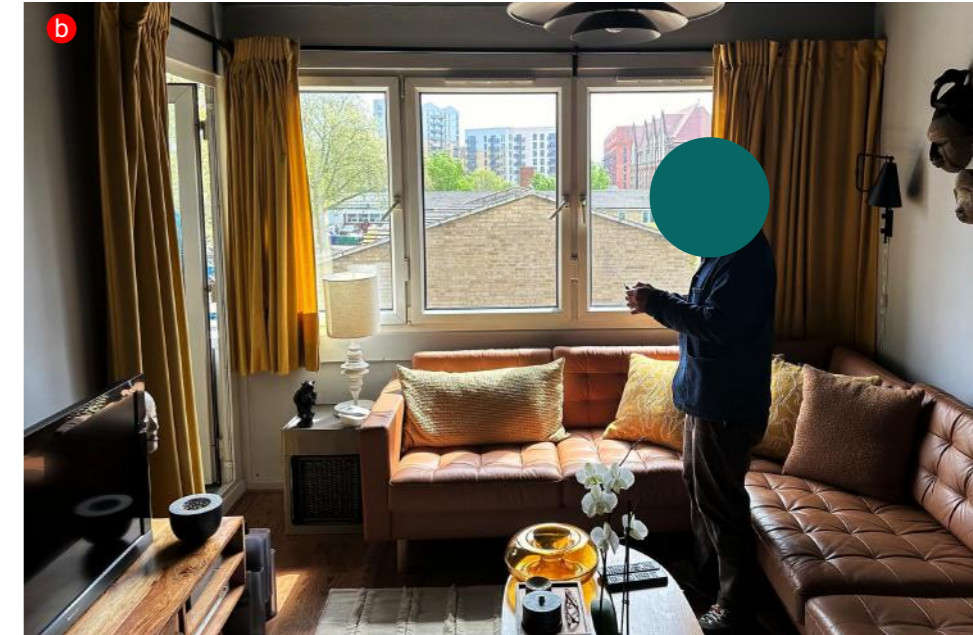
Living room with unshaded south-east glazing

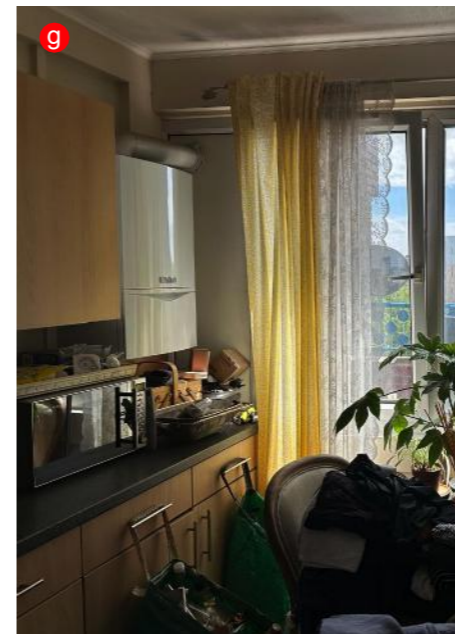
Gas boiler in kitchen with flue to external terrace
